PUBLIC REVIEW DRAFT REMEDIAL INVESTIGATION REPORT

**8th Avenue Terminals, Inc. Site
Seattle, Washington**

Project 101.00205.00037

May 2024

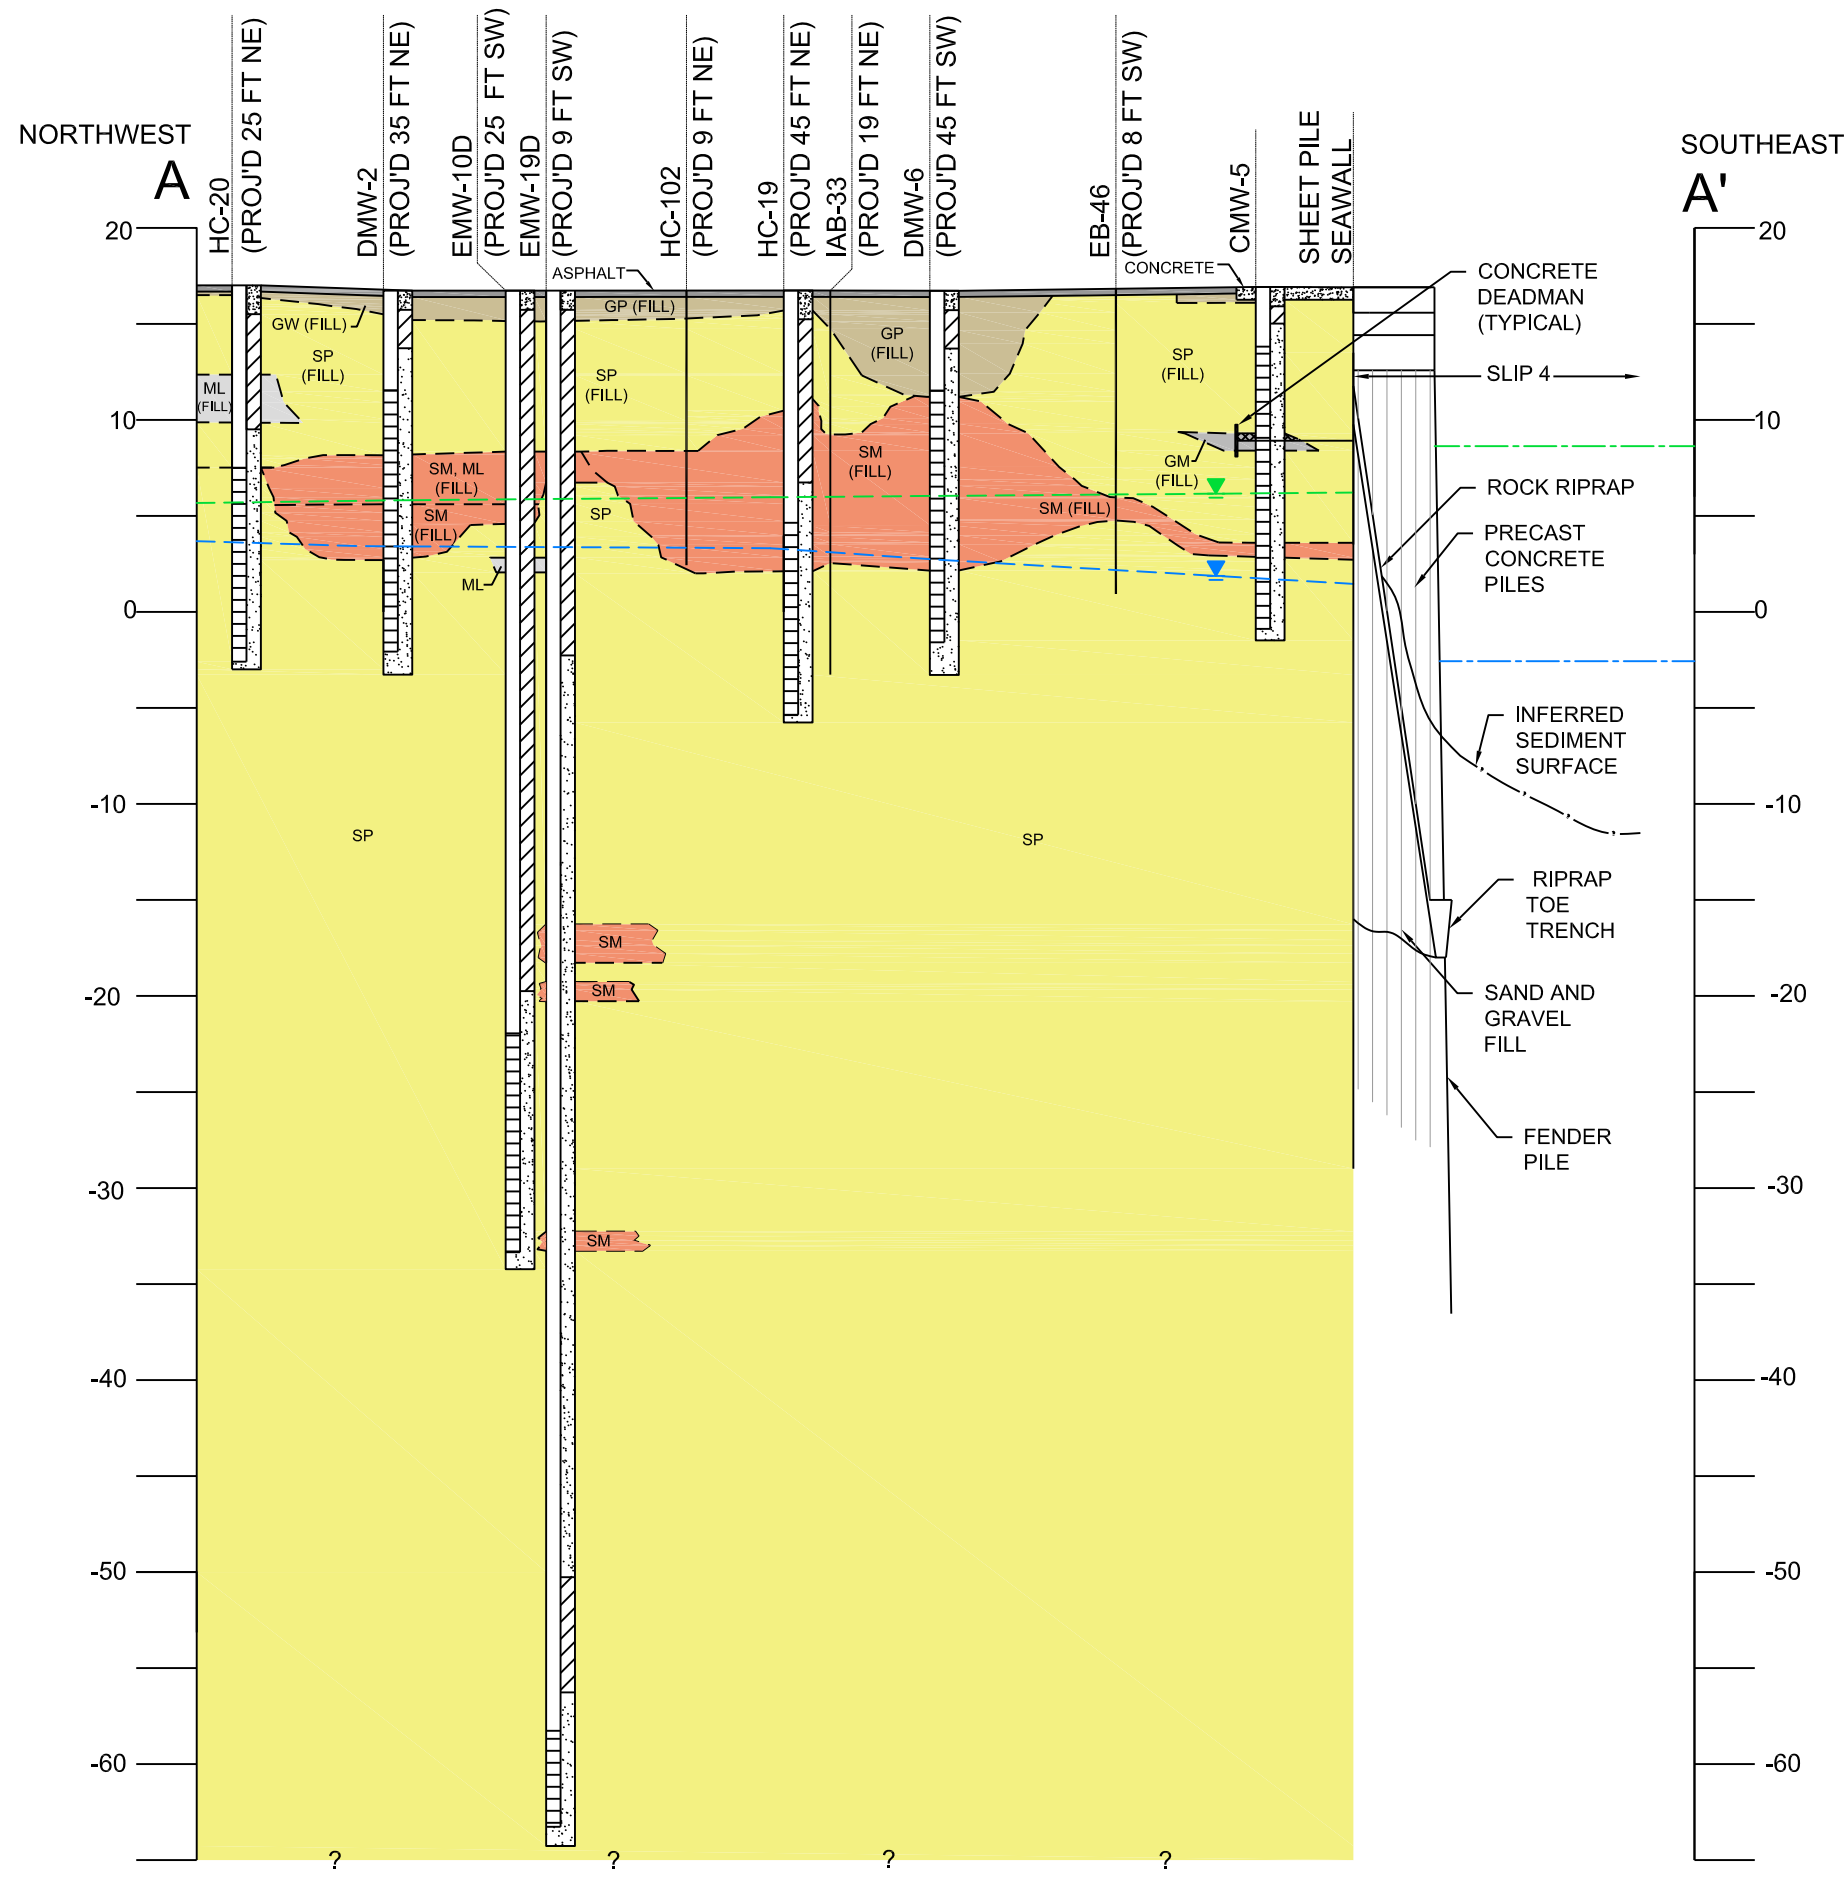
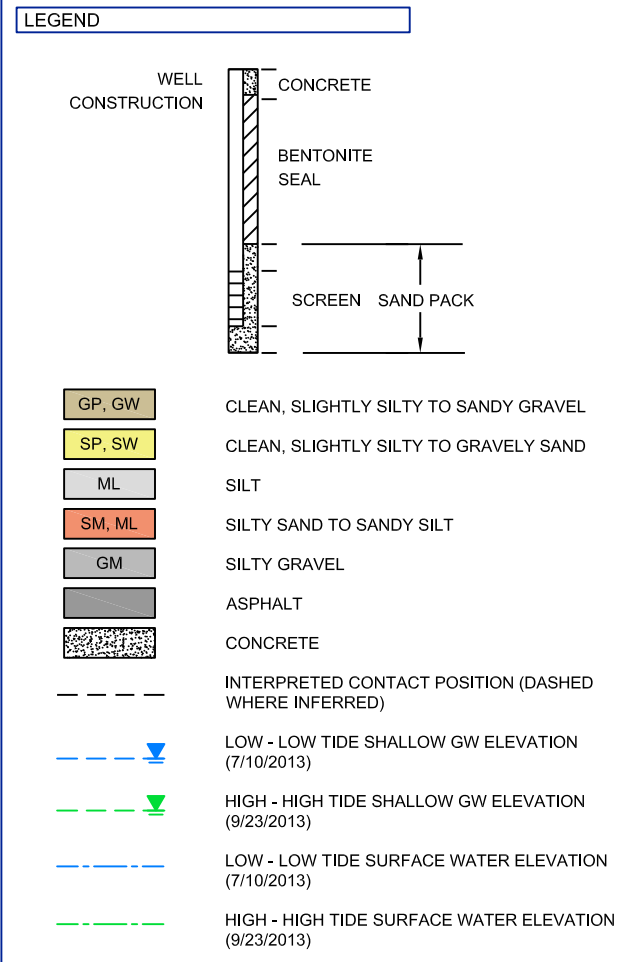
GEOLOGIC CROSS SECTION A-A'

NOTES
 VERTICAL ELEVATIONS RELATIVE TO NAVD 88 DATUM.
 THE LOCATION OF THE CROSS SECTION IS SHOWN ON FIGURE 12.

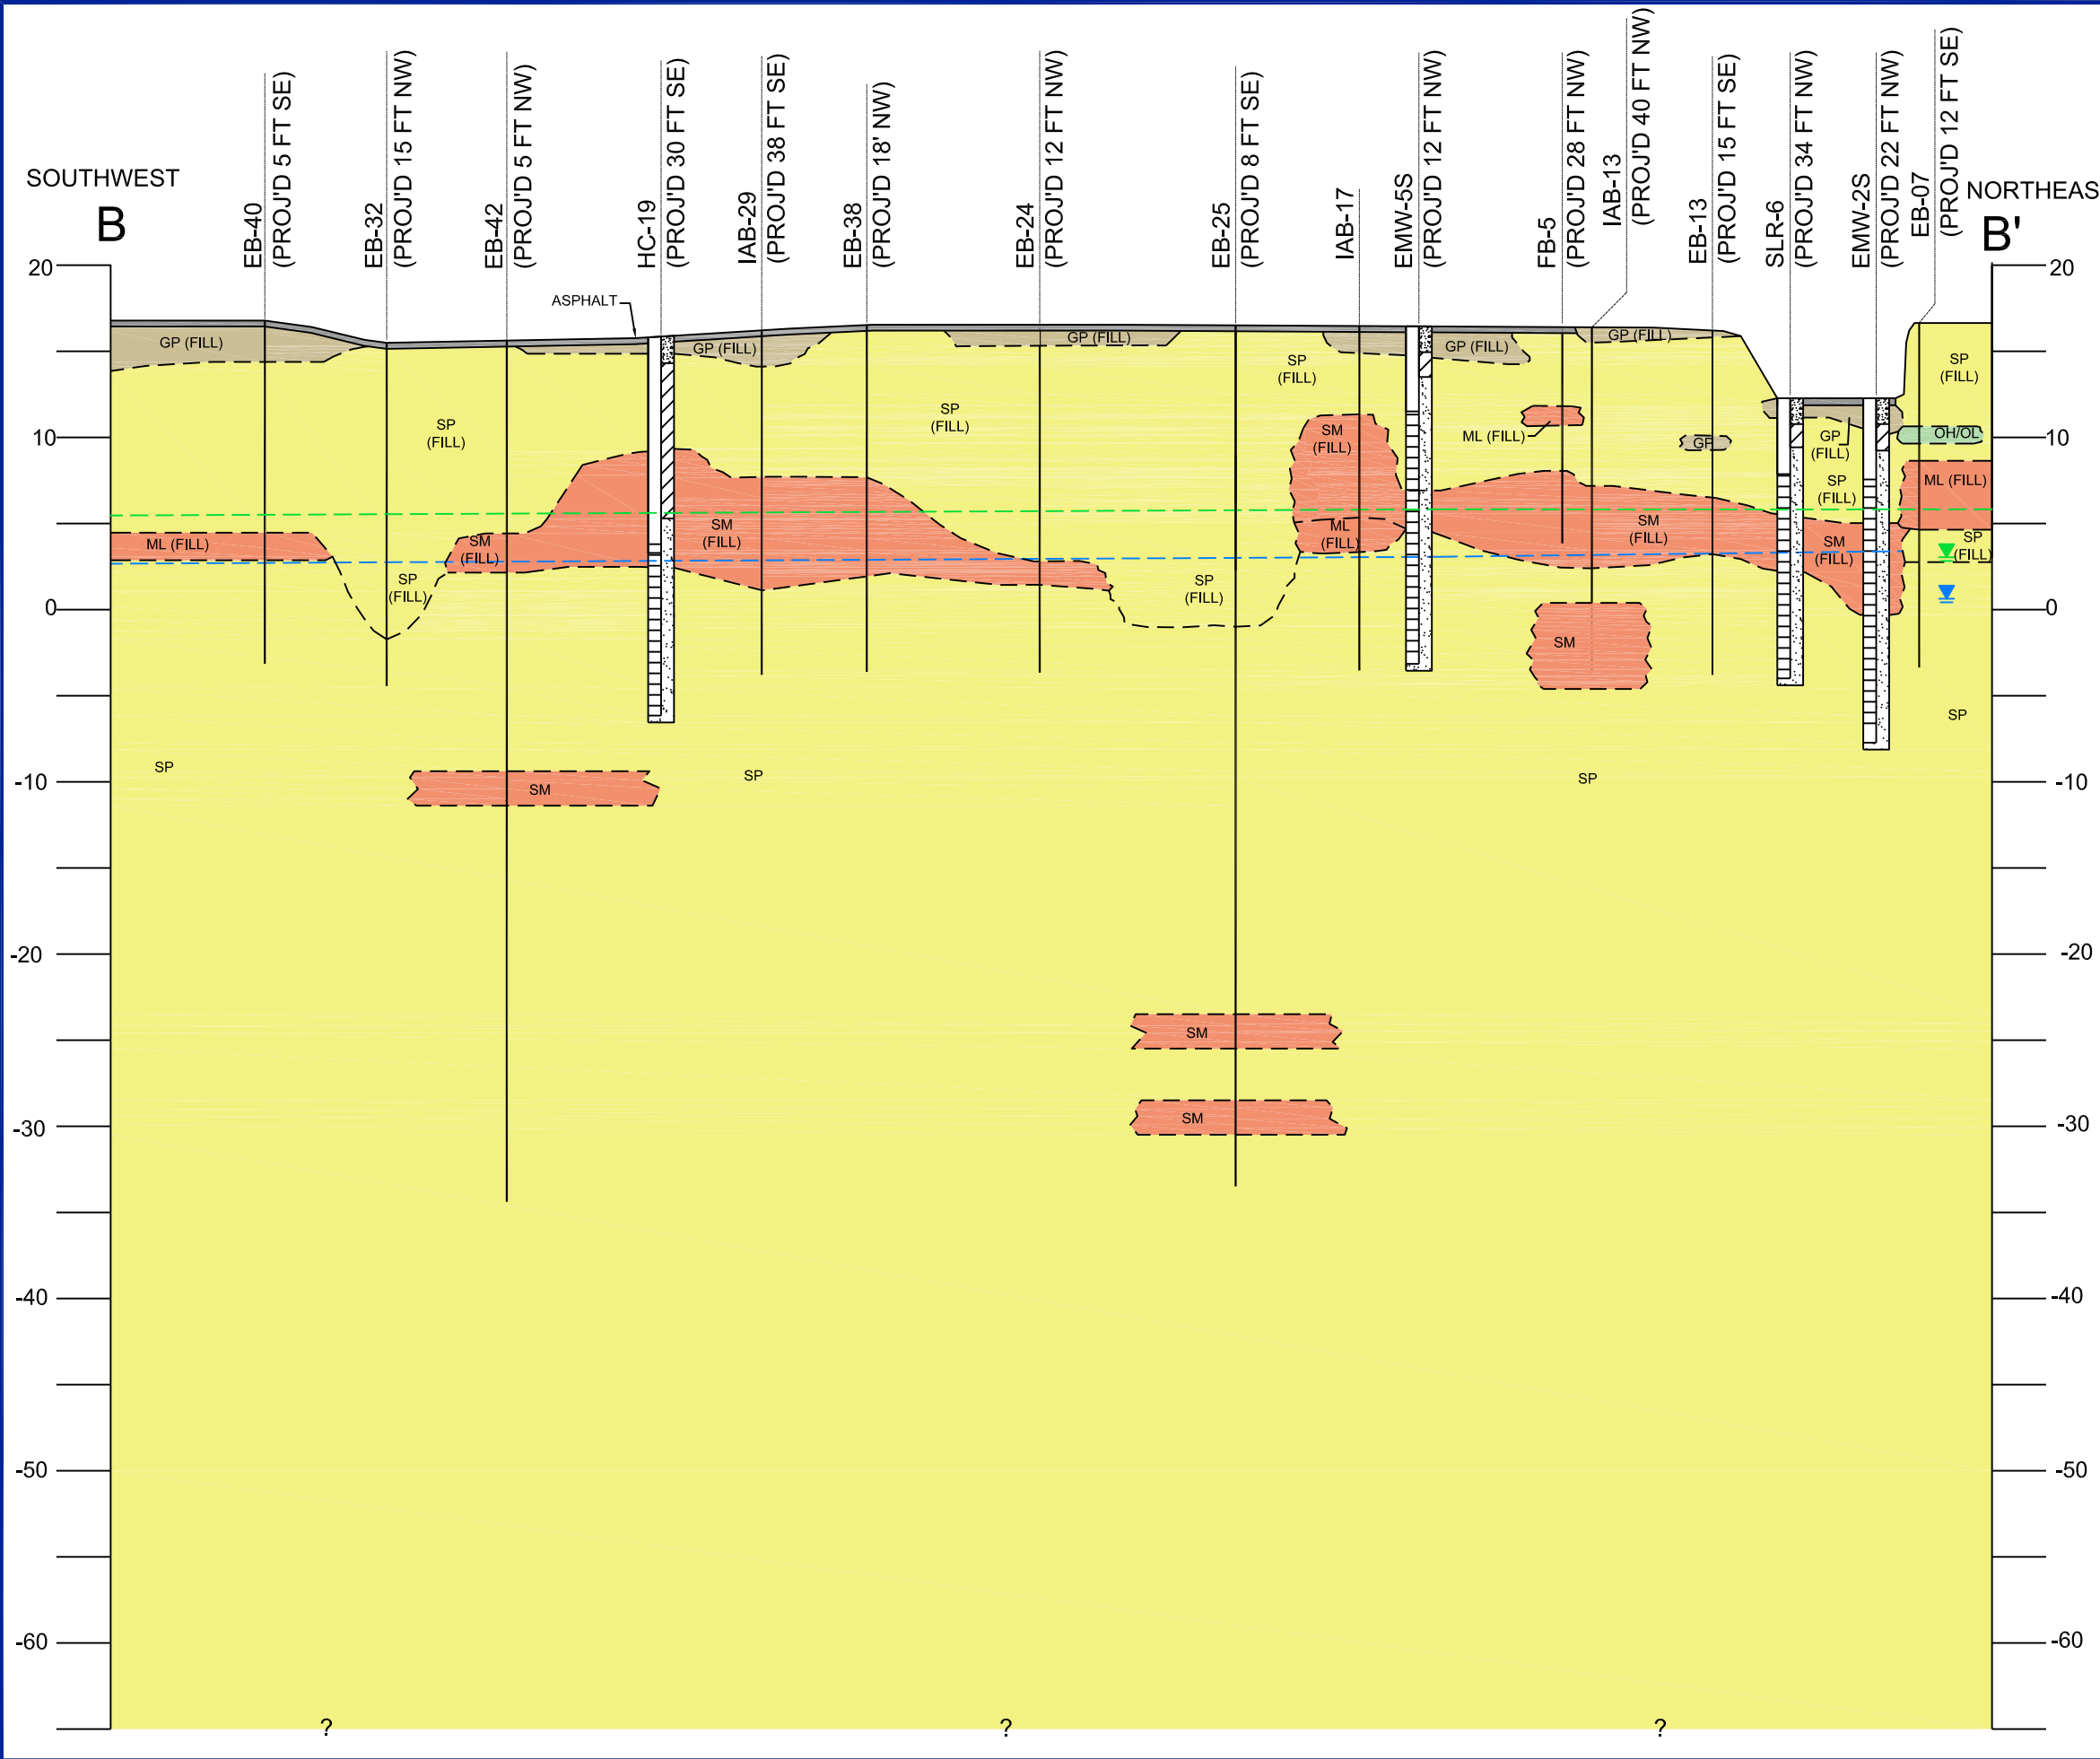
NOTES
 VERTICAL ELEVATIONS RELATIVE TO NAVD 88 DATUM.
 THE LOCATION OF THE CROSS SECTION IS SHOWN ON FIGURE 12.

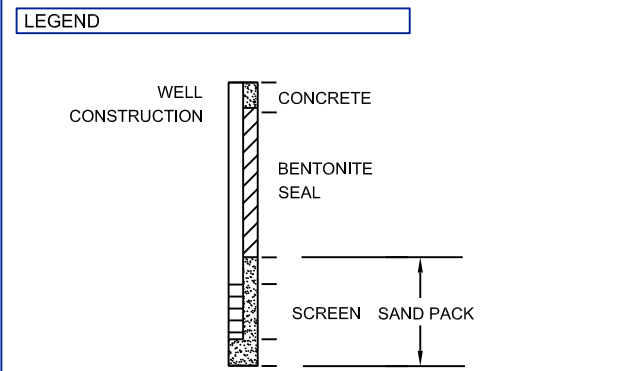
Drawing
GEOLOGIC CROSS SECTION B-B'

- GP CLEAN, SLIGHTLY SILTY TO SANDY GRAVEL
- SP CLEAN, SLIGHTLY SILTY TO GRAVELY SAND
- SM, ML SILTY SAND TO SANDY SILT
- GM SILTY GRAVEL
- OH/OL ORGANIC SOIL
- ASPHALT
- CONCRETE
- INTERPRETED CONTACT POSITION
- - - LOW - LOW TIDE SHALLOW GW ELEVATION (7/10/2013)
- - - HIGH - HIGH TIDE SHALLOW GW ELEVATION (9/23/2013)

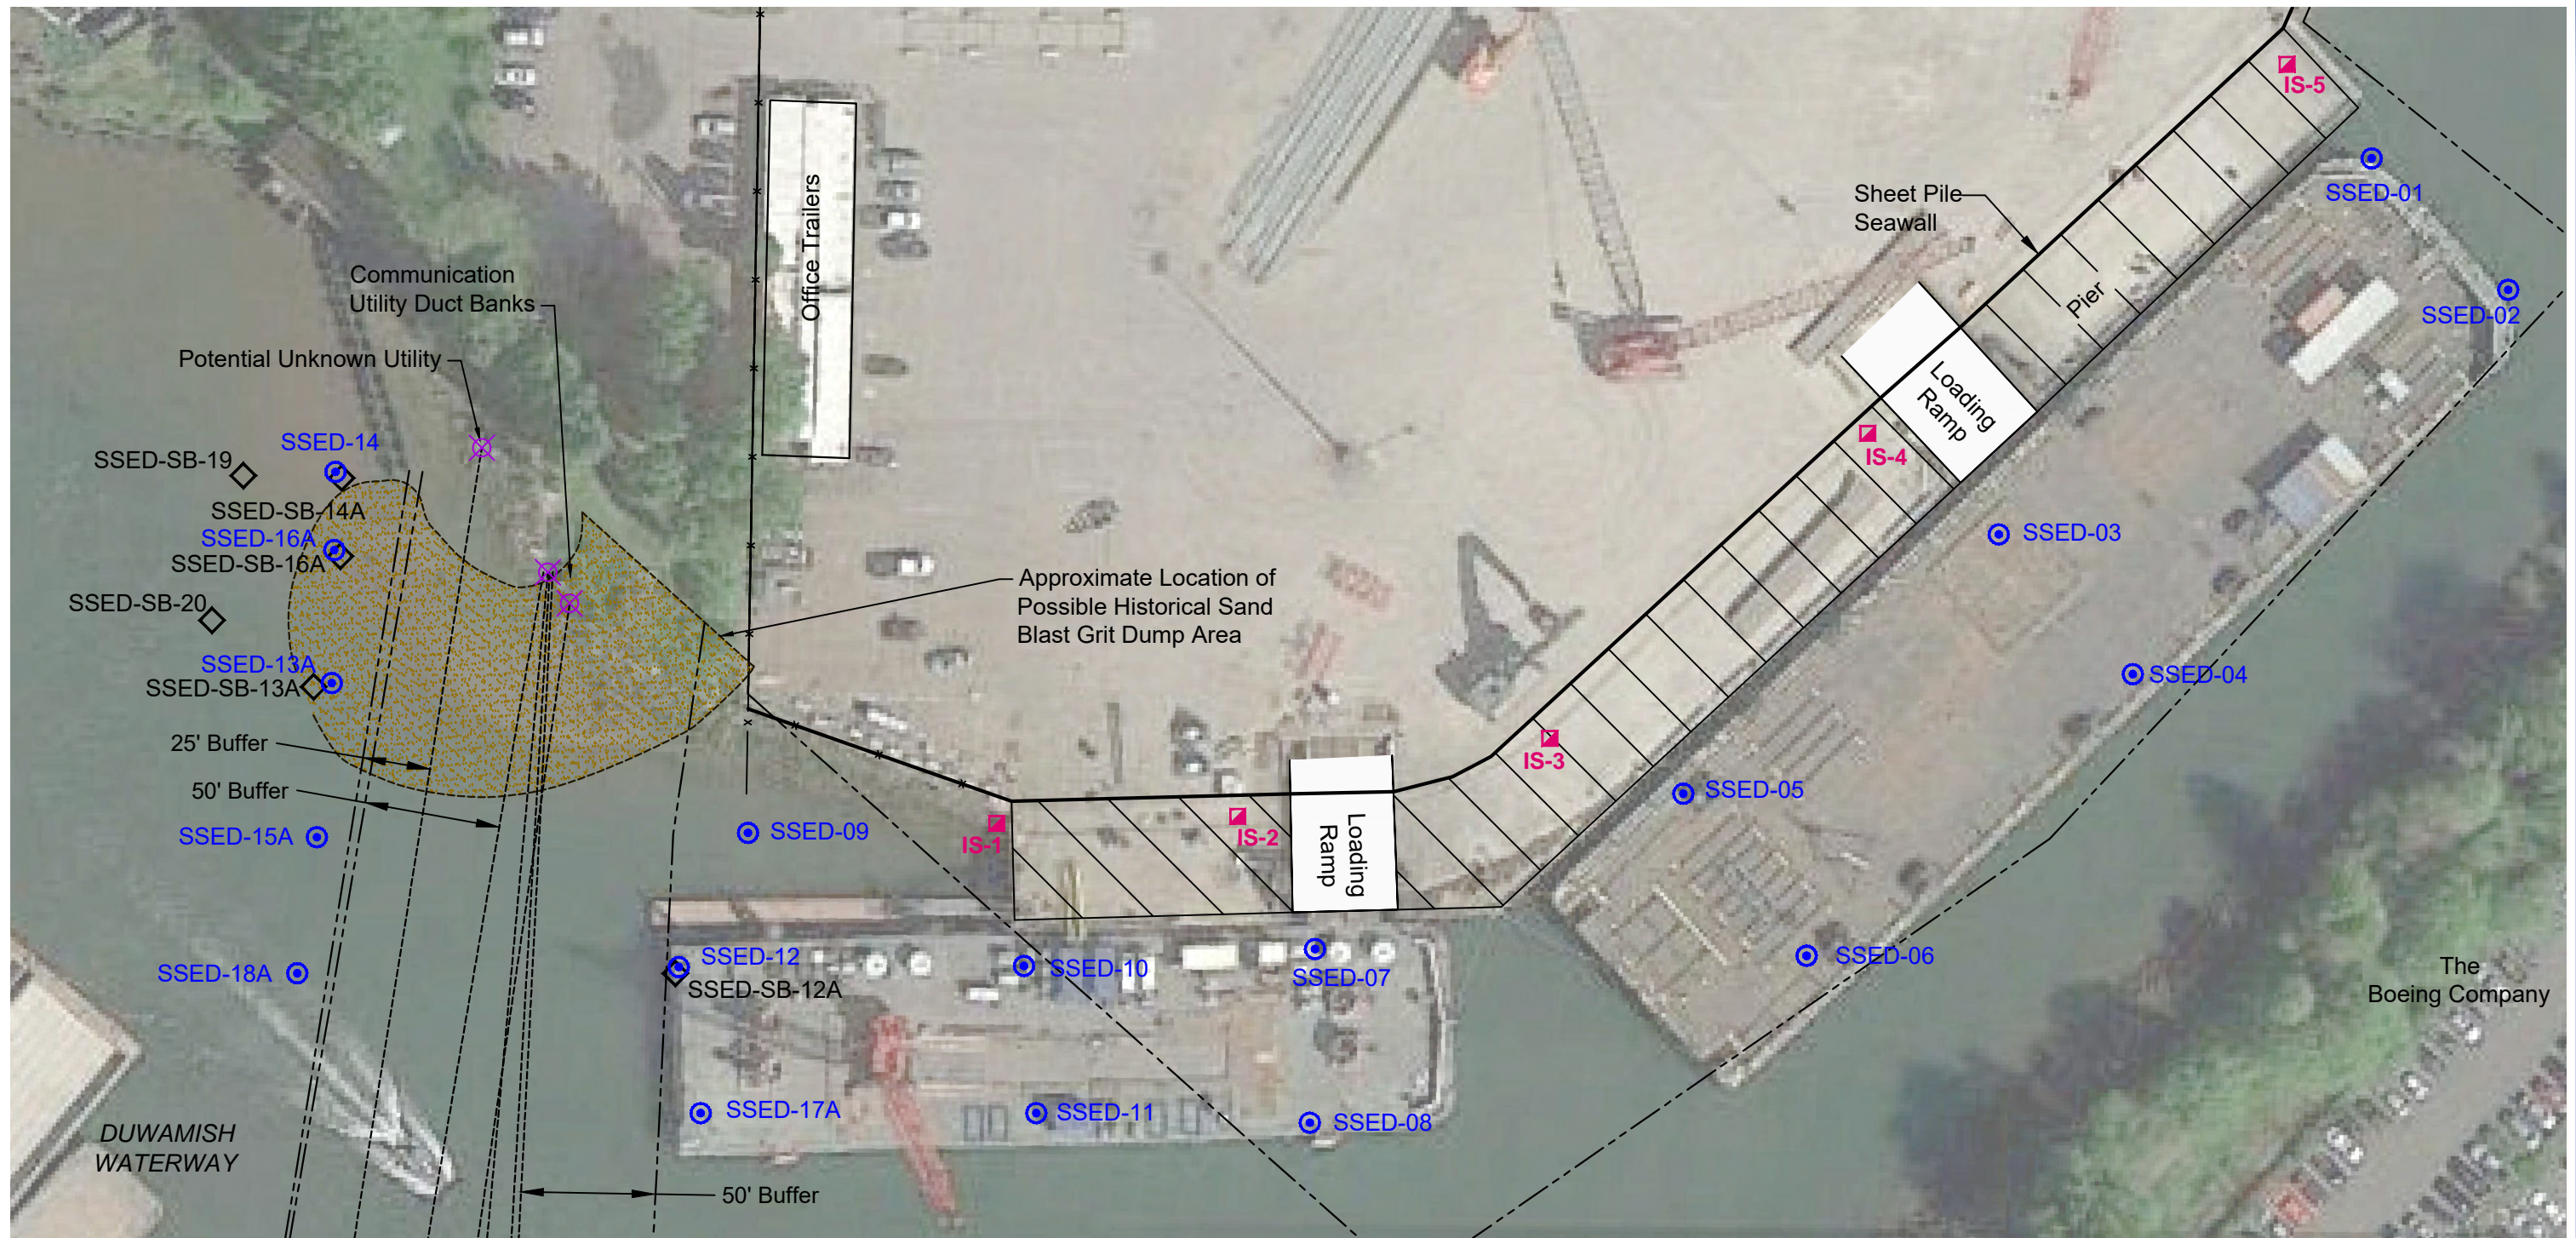
Date August 6, 2019	Scale 1" = 30 Feet	Fig. No. 13
File Name 01-13	Project No. 101.00205.00037

- x — FENCE
- - - - - PROPERTY BOUNDARY
- SHEET PILE SEAWALL
- - - - - UTILITY LINES
- ⊗ UTILITY LOCATION
- INTERTIDAL SEDIMENT SAMPLE LOCATION (PHASE 1)
- ⊙ SURFACE SEDIMENT SAMPLE LOCATION (PHASE 2)
- ◇ SEDIMENT CORE LOCATION (PHASE 2)

Multiple phases of sediment sampling were performed during the RI. Figure 13 shows the locations of the RI sediment samples. Details of each phase of RI sediment sampling are discussed in the following subsections.

During Phase 2 of the RI, Anchor conducted surface and subsurface sediment sampling within the LDW to address sediment data gaps. During the Phase 2 sediment investigation, several sampling stations that were targeting a possible historical sand blast grit dump area near the Subject Property were moved due to the presence of underwater utilities and safety concerns (see Figure 13).

In December 2014, a total of 18 surface sediment samples (designated SSED-01 through SSED-12 and SSED-13A, SSED-14, SSED-15A, SSED-16A, SSED-17A, and SSED-18A) were collected from within the berth areas on and near the Subject Property. The locations of the surface sediment samples are shown on Figure 13. The surface sediment samples were collected by using Van Veen methodology in accordance with the procedures described in the Draft Phase 2 SAP Addendum (Anchor, 2014). The samples were collected from the 0- to 10-cm biologically active zone, and were analyzed for D/F, GS, metals, PCBs, PAHs, SVOCs, TOC, TS, and VOCs. The results of the surface sediment sampling are discussed in Section 7.6.1.

The benzyl alcohol results were rejected by the laboratory for all of the samples from the sediment cores, except from core SSED-DB-12A. Three of the samples from core SSED-SB-12A were analyzed for benzyl alcohol, and the concentrations in the samples were above the screening level (57 µg/kg). The maximum concentration (260 µg/kg) is at the 4- to 6-foot depth interval. Station SSED-SB-12A is located approximately 100 feet offshore of the southwest corner of the Subject Property (see Figure 13).

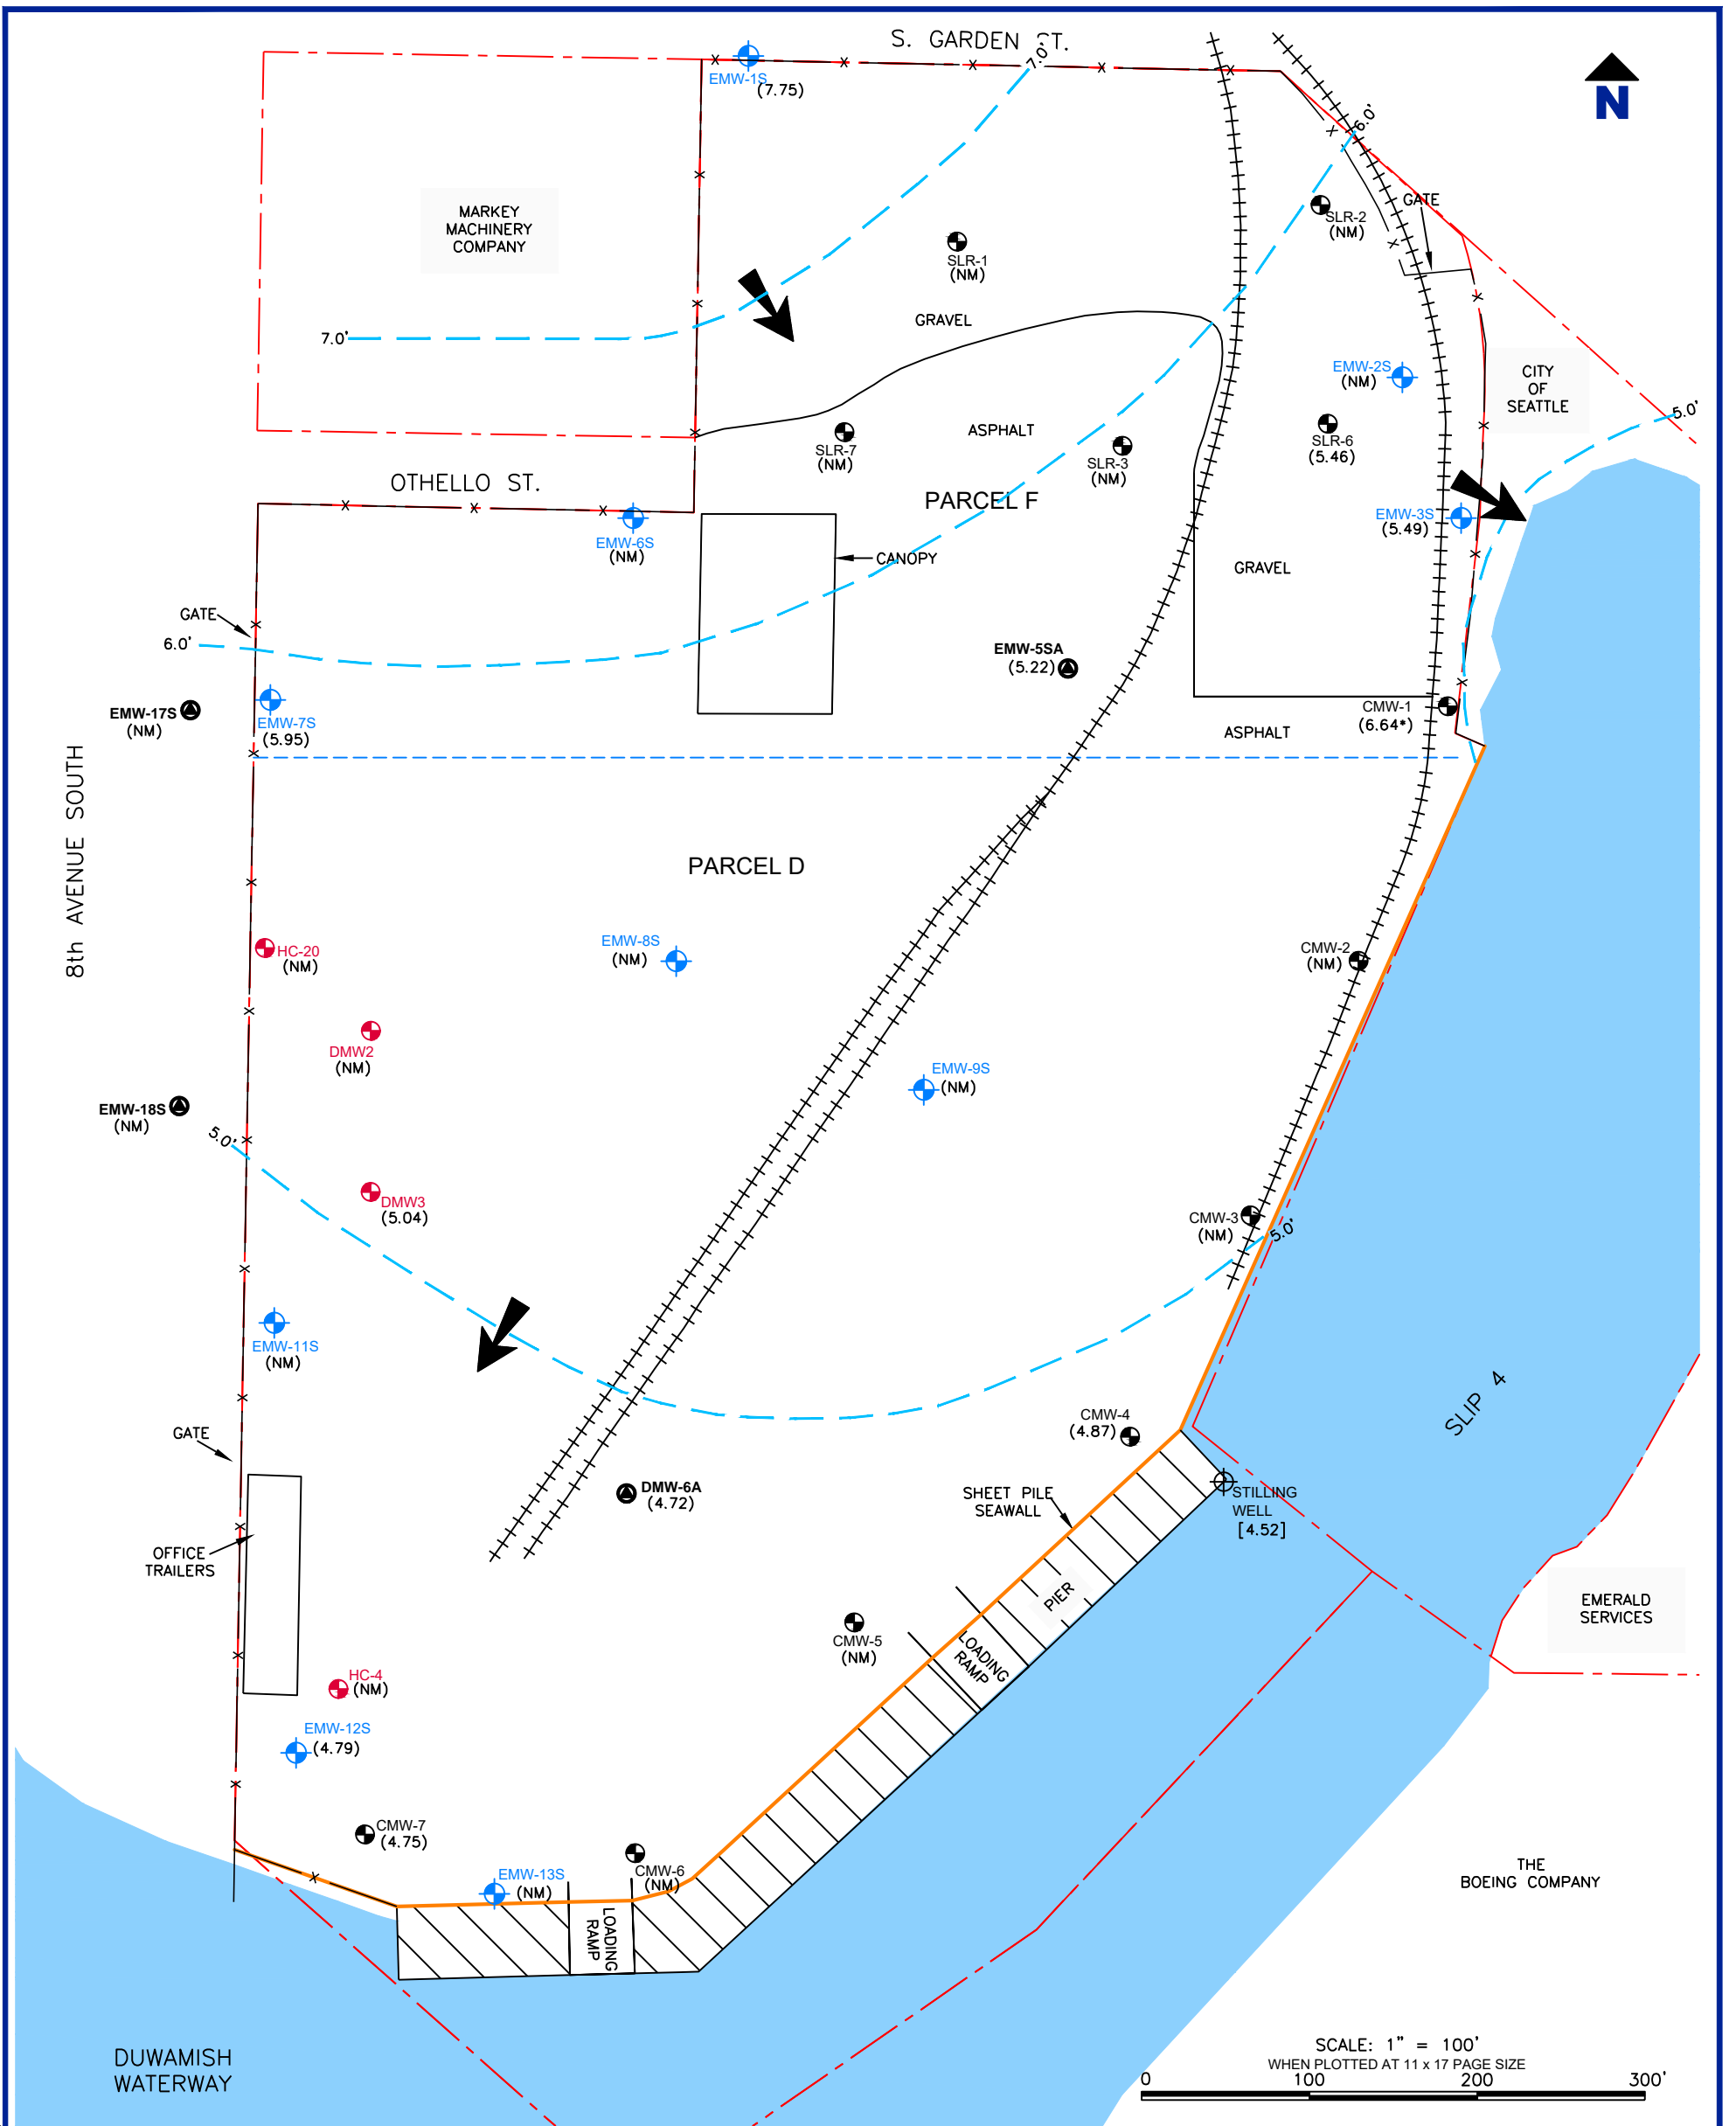
- PARCEL D/PARCEL F BOUNDARY
- PROPERTY BOUNDARIES
- RAIL LINE
- FENCE
- SHEET PILE SEAWALL
- 2008 SHALLOW GROUNDWATER MONITORING WELL
- 2013 SHALLOW GROUNDWATER MONITORING WELL
- 2014 SHALLOW GROUNDWATER MONITORING WELL
- [4.52] SLIP 4 SURFACE WATER ELEVATION (IN FEET) ABOVE NAVD 88 DATUM
- (4.87) SHALLOW GROUNDWATER ELEVATION (IN FEET) ABOVE NAVD 88 DATUM
- (NM) NOT MEASURED
- 5.0' INFERRED SHALLOW GROUNDWATER ELEVATION CONTOUR LINE (IN FEET)
- ← GENERAL SHALLOW GROUNDWATER FLOW DIRECTION

horizontal gradients behind the seawall and the mean downward vertical gradients along the seawall indicate that the seawall is retarding shallow groundwater flow as the groundwater abuts against the seawall and then the majority of the water flows to either end or under the wall. During high tides, waterway surface water flows inland primarily around the ends and beneath the seawall and recharges the groundwater beneath the Subject Property. Holes and cracks in the seawall allow some groundwater and surface water to flow through the wall. During low tide conditions, the unconfined groundwater at depths below 43 feet bgs (the bottom of the seawall) flows to the southeast towards Slip 4, and then under the seawall and riprap areas into the waterway. During high tide conditions, the deeper groundwater flows under the seawall and riprap areas, and inland at northwestern and northern directions.

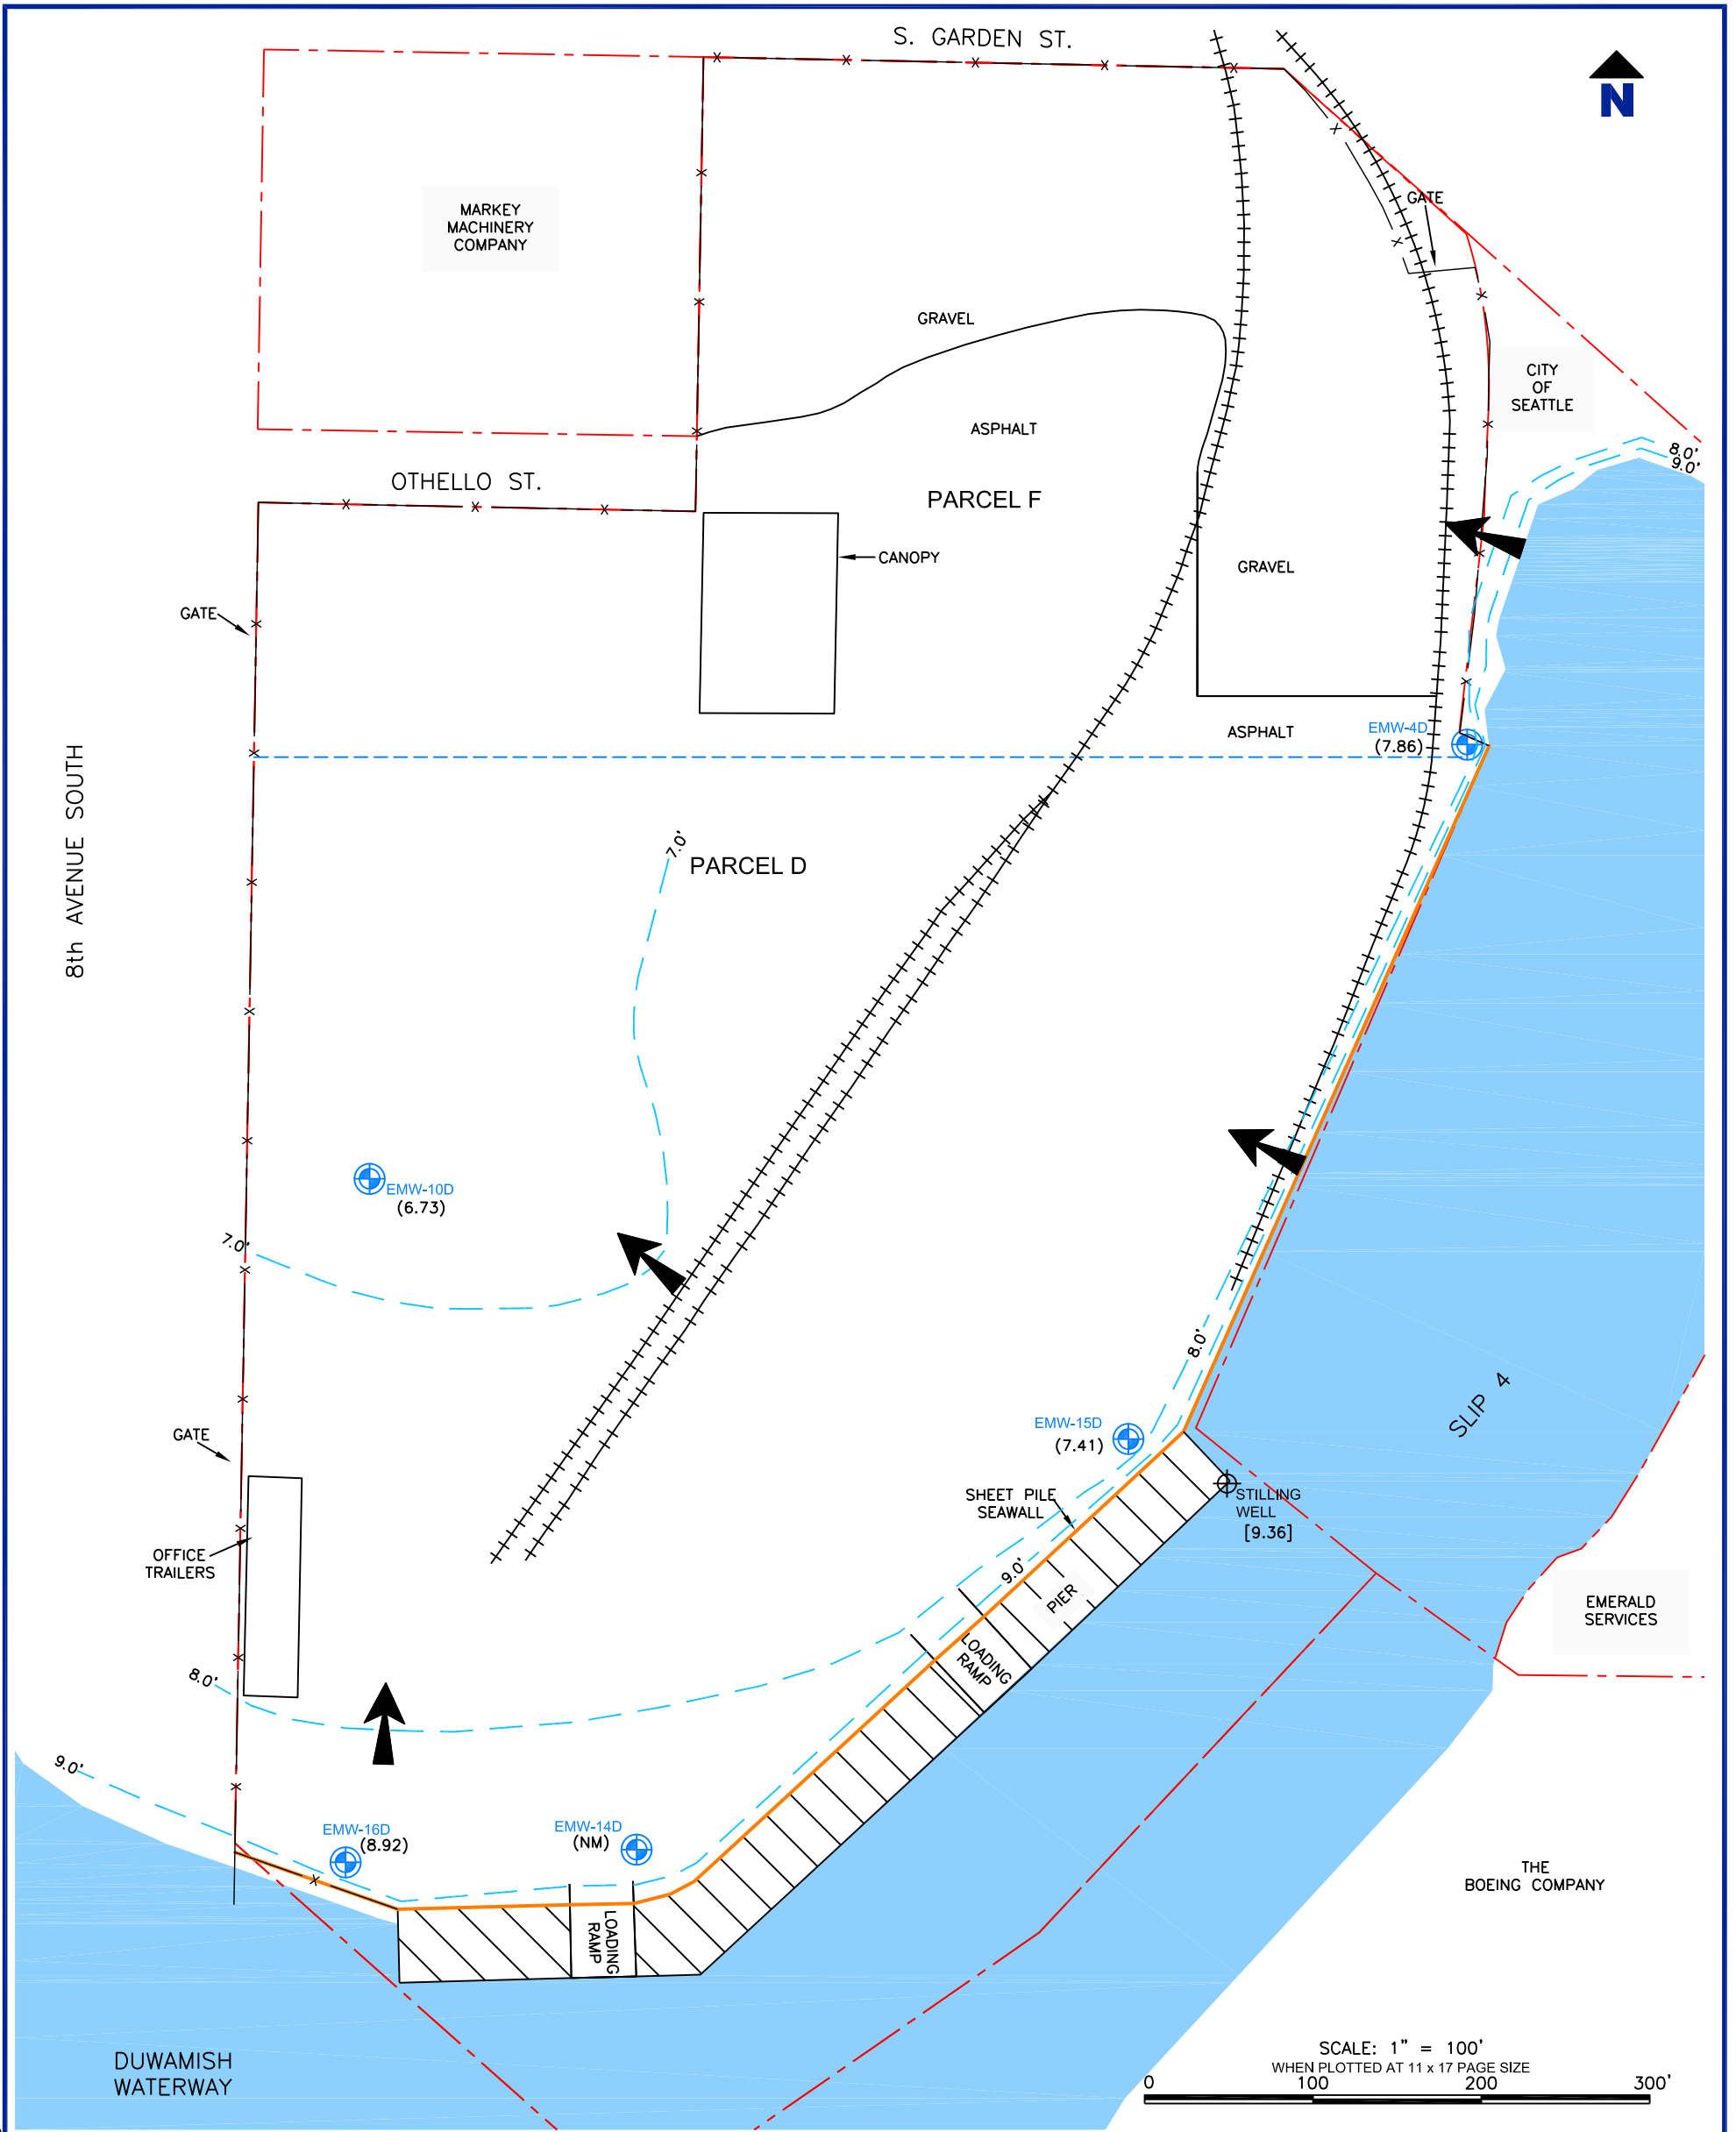
- PARCEL D/PARCEL F BOUNDARY
- PROPERTY BOUNDARIES
- +++++ RAIL LINE
- x-x- FENCE
- SHEET PILE SEAWALL
- ⊕ 2013 INTERMEDIATE-DEPTH GROUNDWATER MONITORING WELL
- [9.36] SLIP 4 SURFACE WATER ELEVATION (IN FEET) ABOVE NAVD 88 DATUM
- (6.73) INTERMEDIATE-DEPTH GROUNDWATER ELEVATION (IN FEET) ABOVE NAVD 88 DATUM
- (NM) NOT MEASURED
- 8.0' INFERRED INTERMEDIATE-DEPTH GROUNDWATER ELEVATION CONTOUR LINE (IN FEET)
- ← GENERAL INTERMEDIATE-DEPTH GROUNDWATER FLOW DIRECTION
