PUBLIC REVIEW DRAFT REMEDIAL INVESTIGATION REPORT

**8th Avenue Terminals, Inc. Site
Seattle, Washington**

Project 101.00205.00037

May 2024

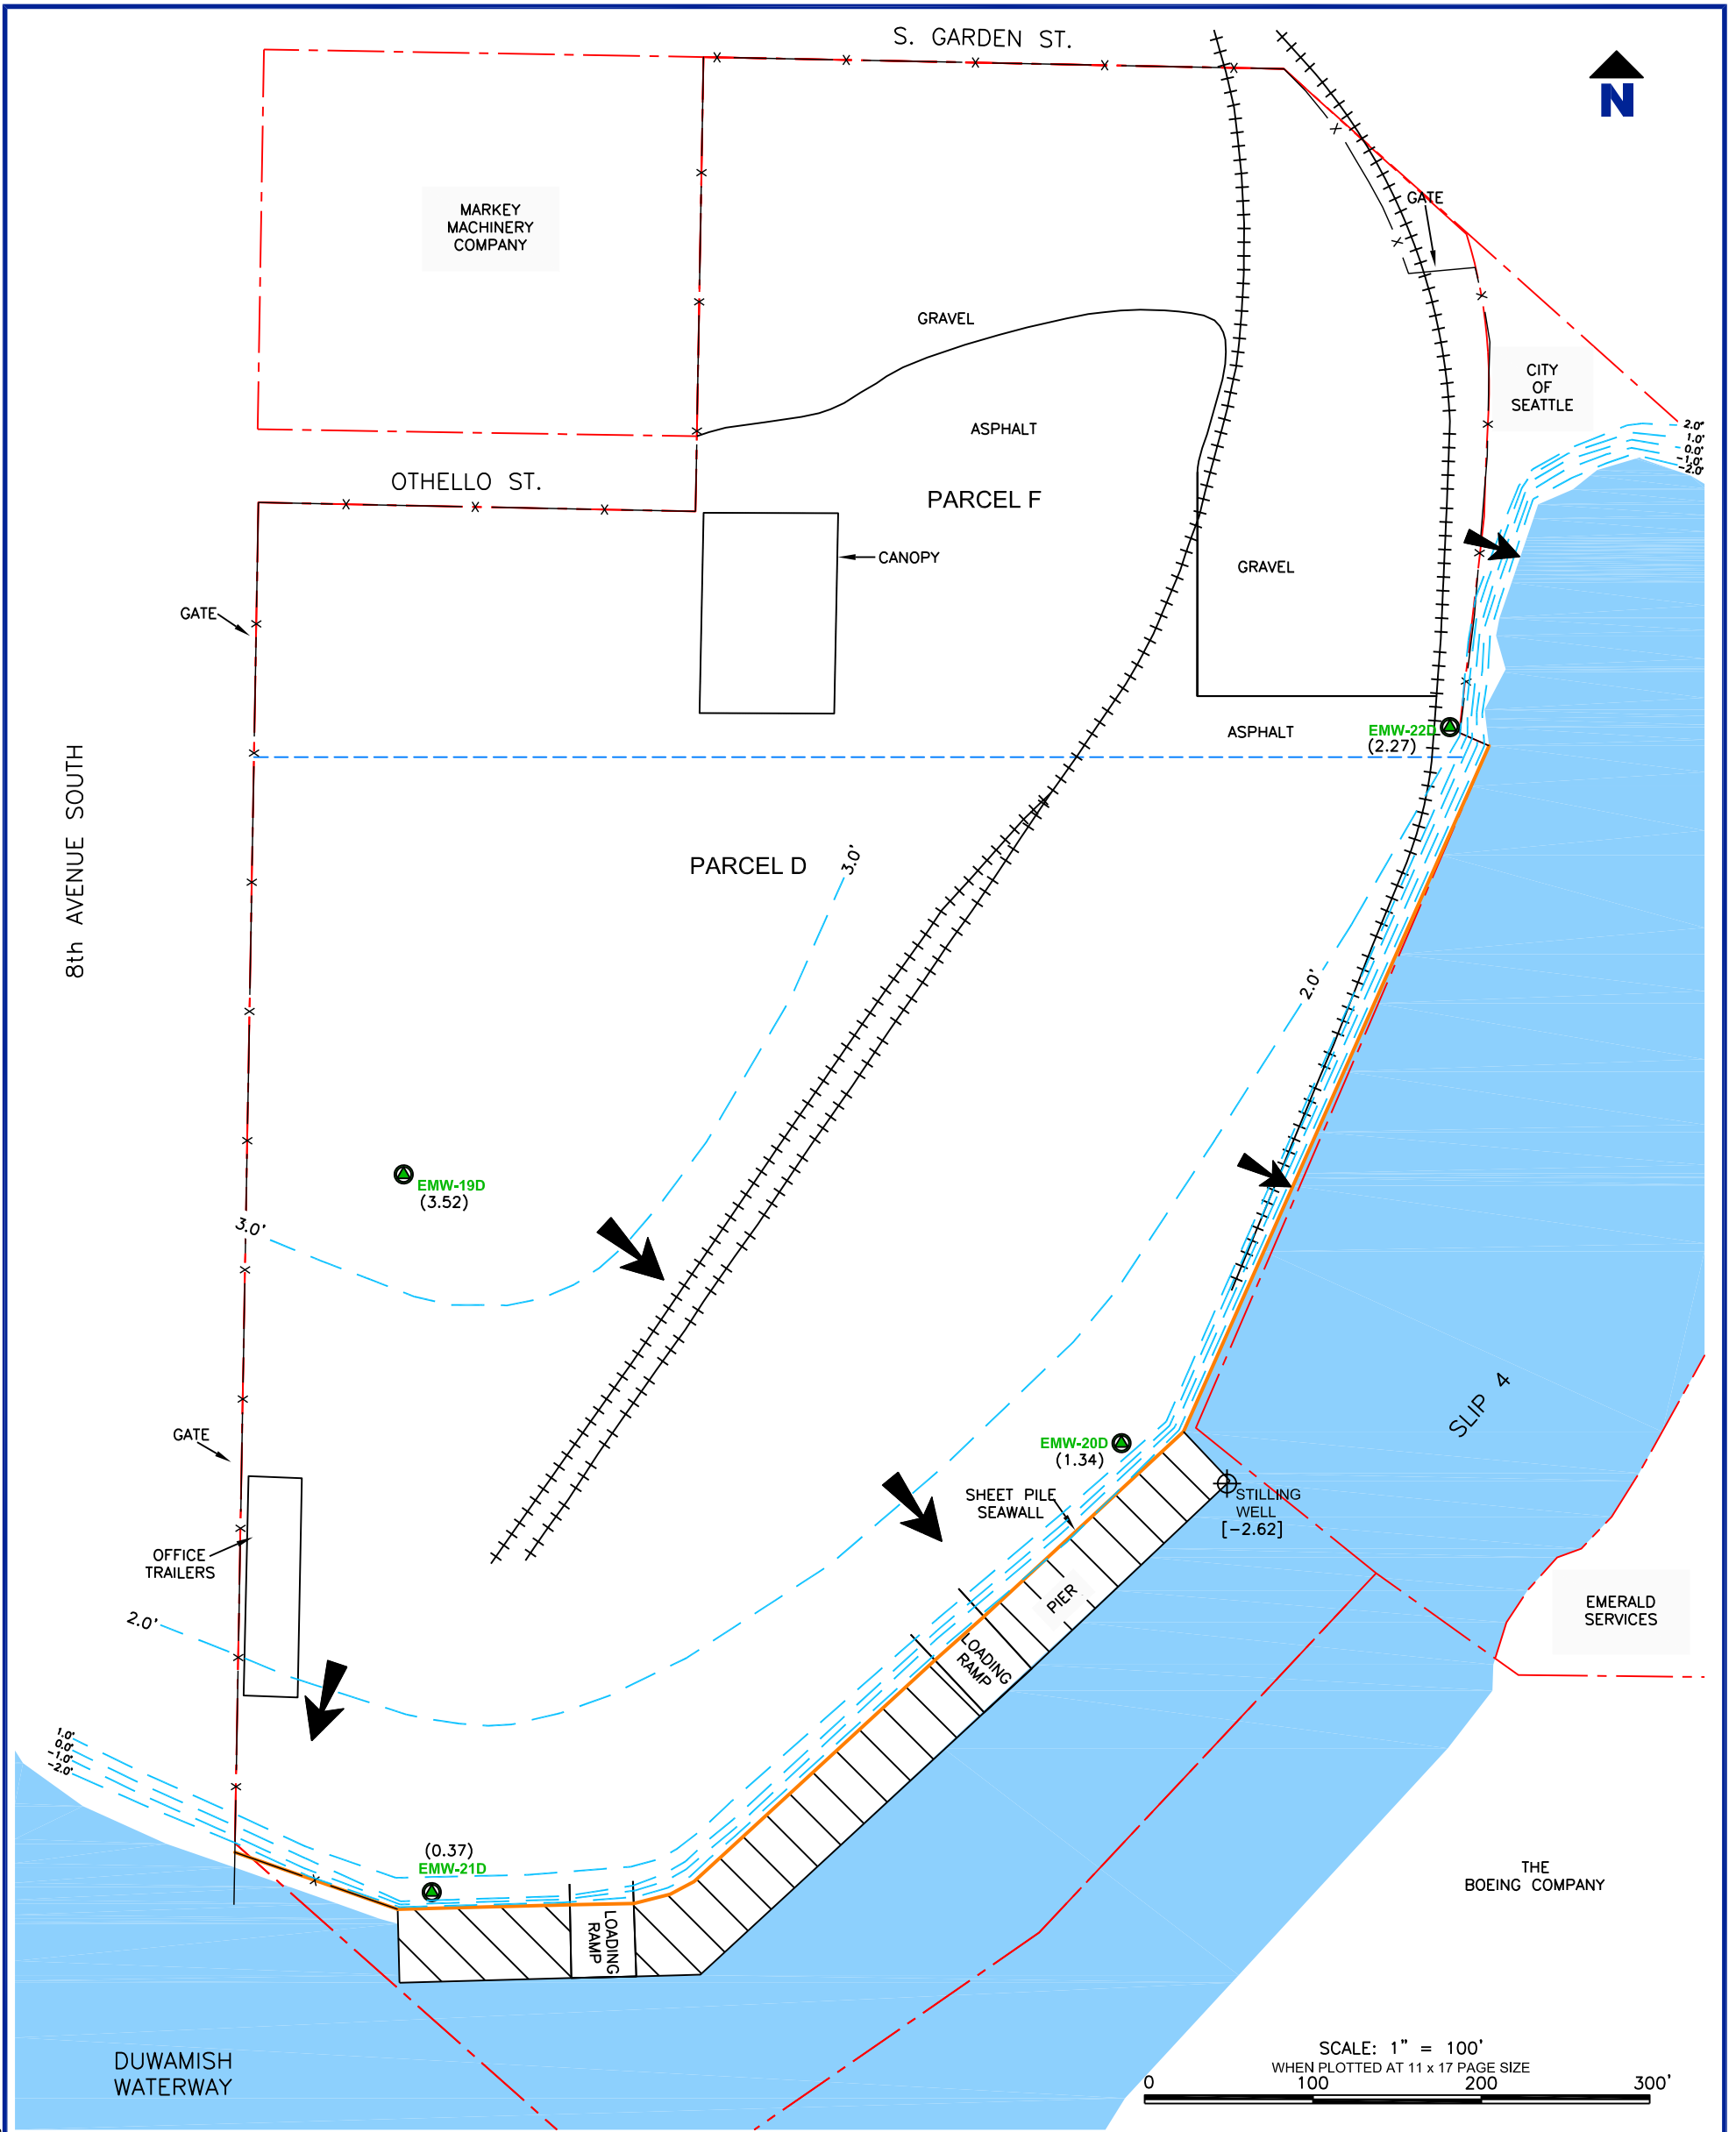
- PARCEL D/PARCEL F BOUNDARY
- PROPERTY BOUNDARIES
- +++++ RAIL LINE
- x-x- FENCE
- SHEET PILE SEAWALL
- 2014 DEEP GROUNDWATER MONITORING WELL
- [-2.62] SLIP 4 SURFACE WATER ELEVATION (IN FEET) ABOVE NAVD 88 DATUM
- (1.34) DEEP GROUNDWATER ELEVATION (IN FEET) ABOVE NAVD 88 DATUM
- 2.0' DEEP GROUNDWATER ELEVATION CONTOUR LINE (IN FEET)
- ← GENERAL DEEP GROUNDWATER FLOW DIRECTION

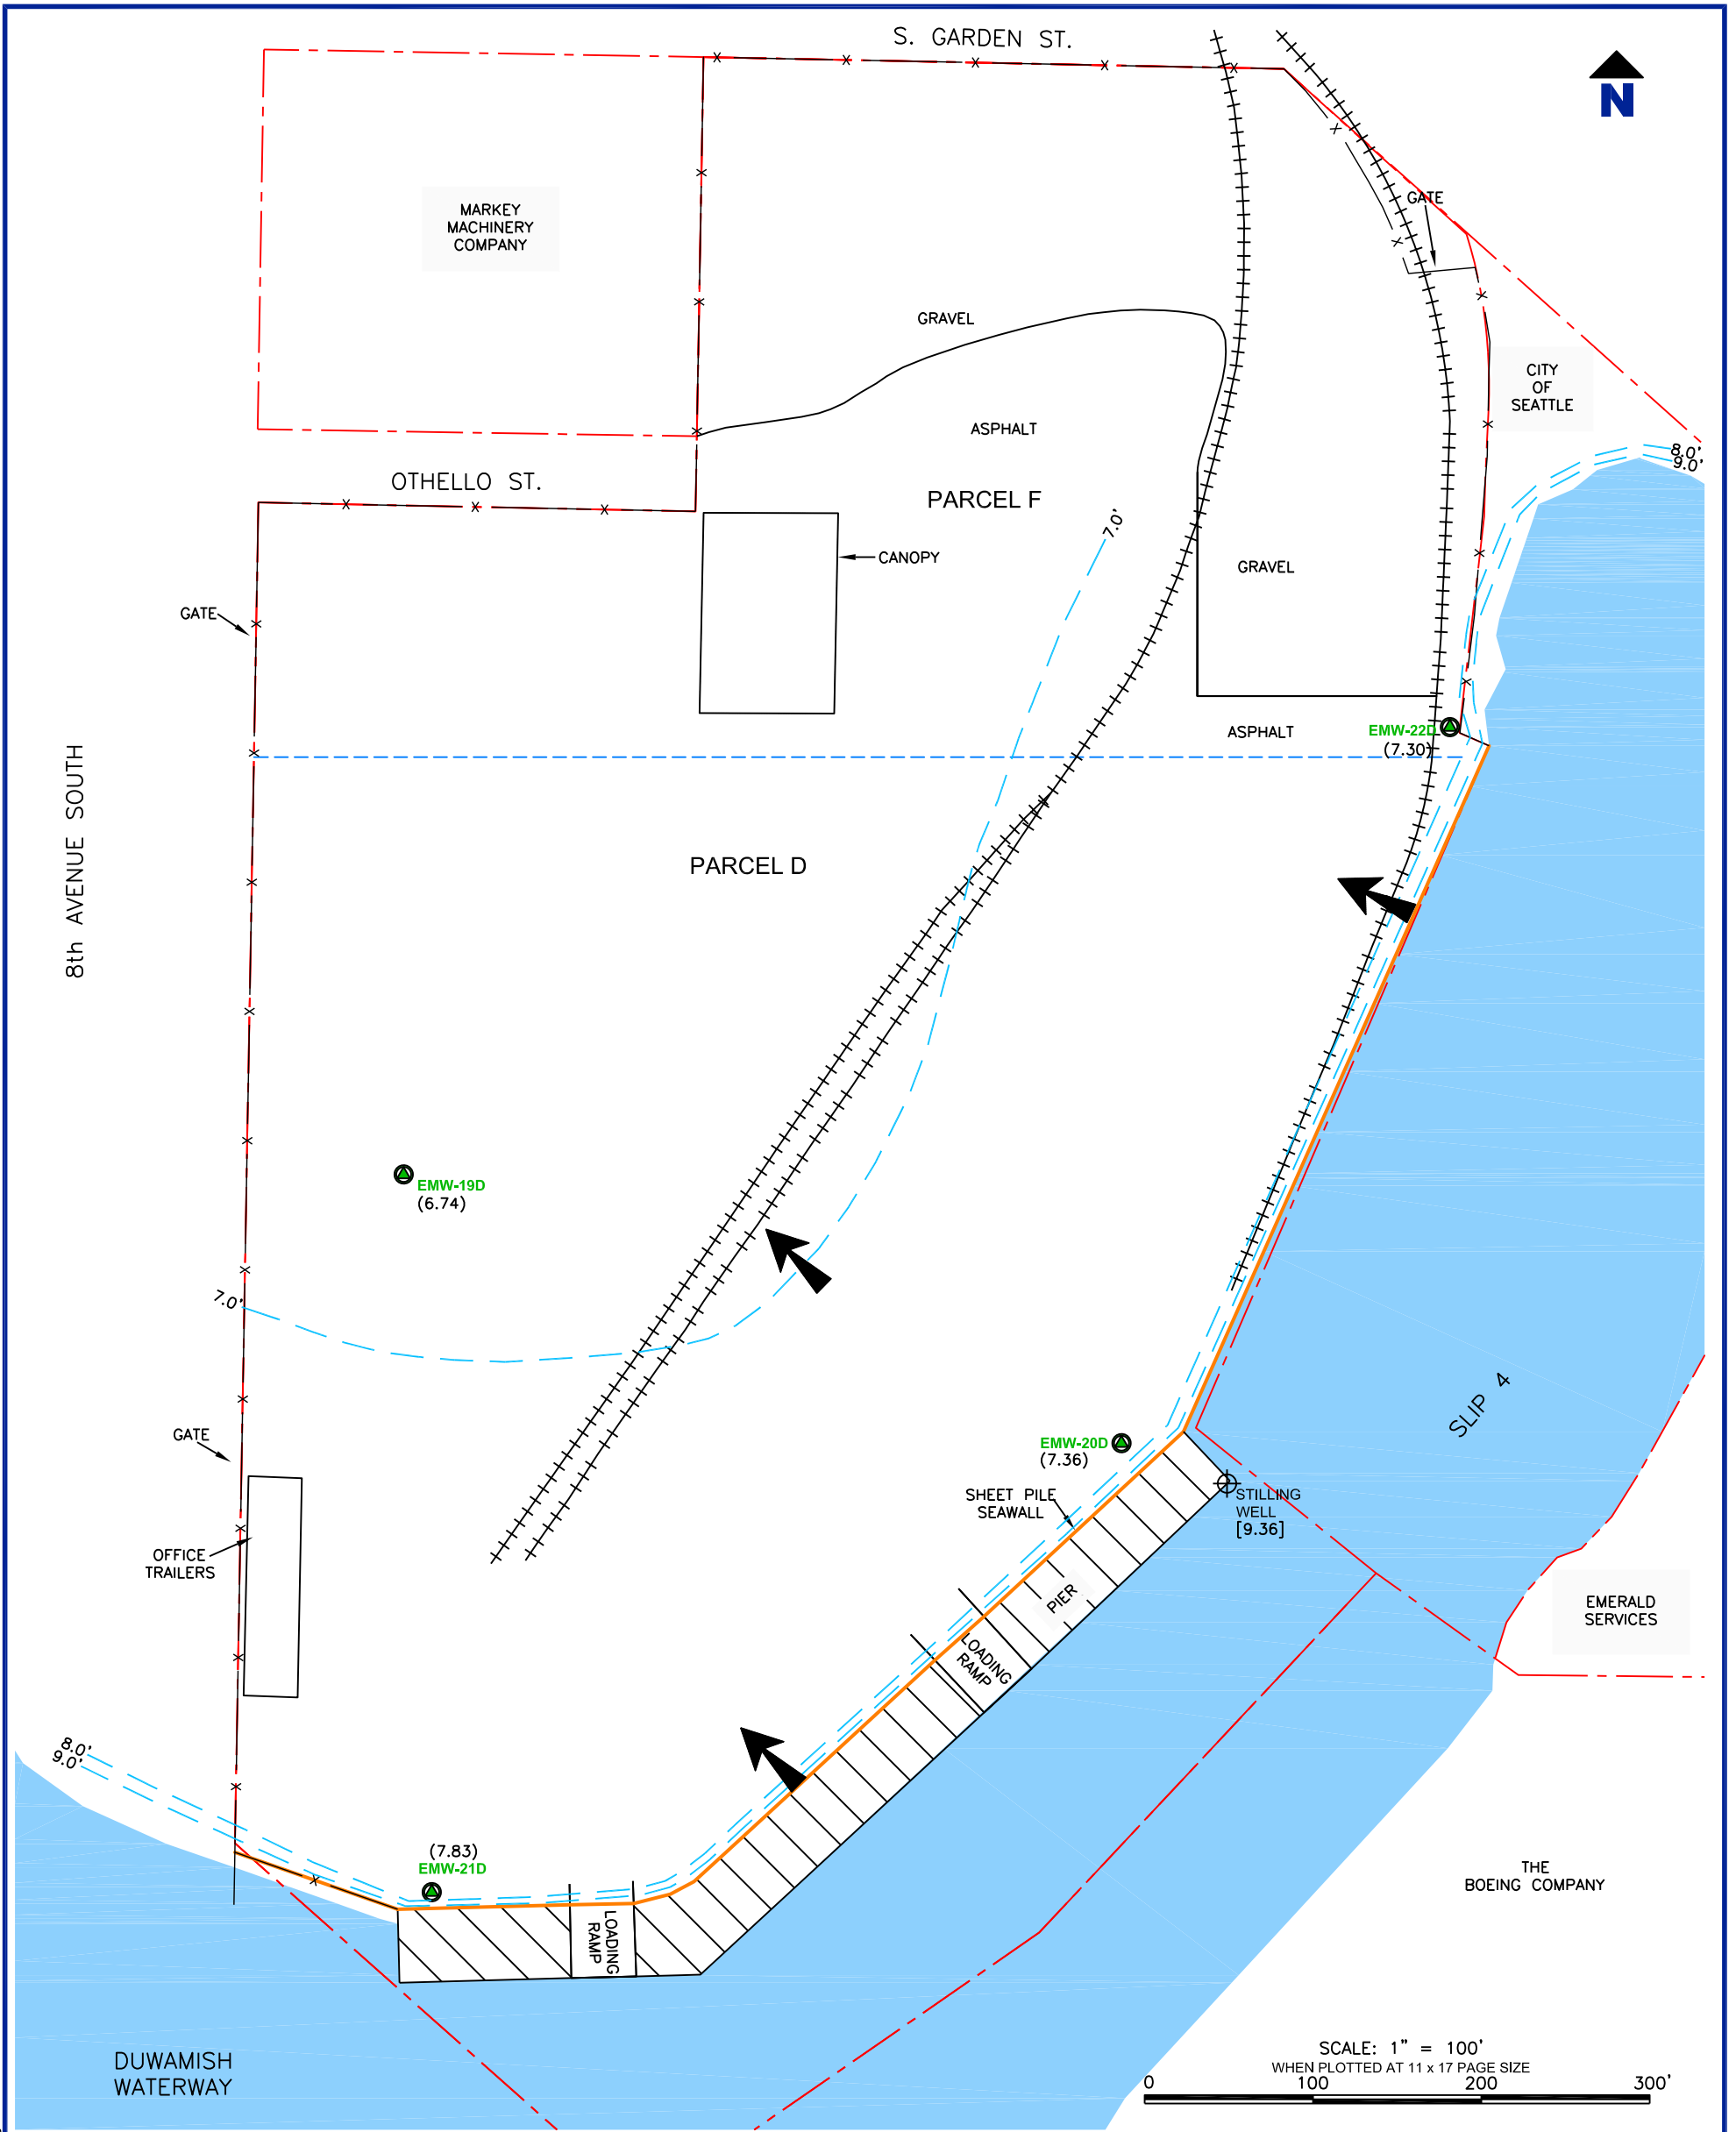
- - - - - PARCEL D/PARCEL F BOUNDARY
- - - - - PROPERTY BOUNDARIES
- +++++ RAIL LINE
- x x x FENCE
- SHEET PILE SEAWALL
- 2014 DEEP GROUNDWATER MONITORING WELL
- [9.36] SLIP 4 SURFACE WATER ELEVATION (IN FEET) ABOVE NAVD 88 DATUM
- (6.74) DEEP GROUNDWATER ELEVATION (IN FEET) ABOVE NAVD 88 DATUM
- - - - - 7.0' INFERRED DEEP GROUNDWATER ELEVATION CONTOUR LINE (IN FEET)
- ← GENERAL DEEP GROUNDWATER FLOW DIRECTION

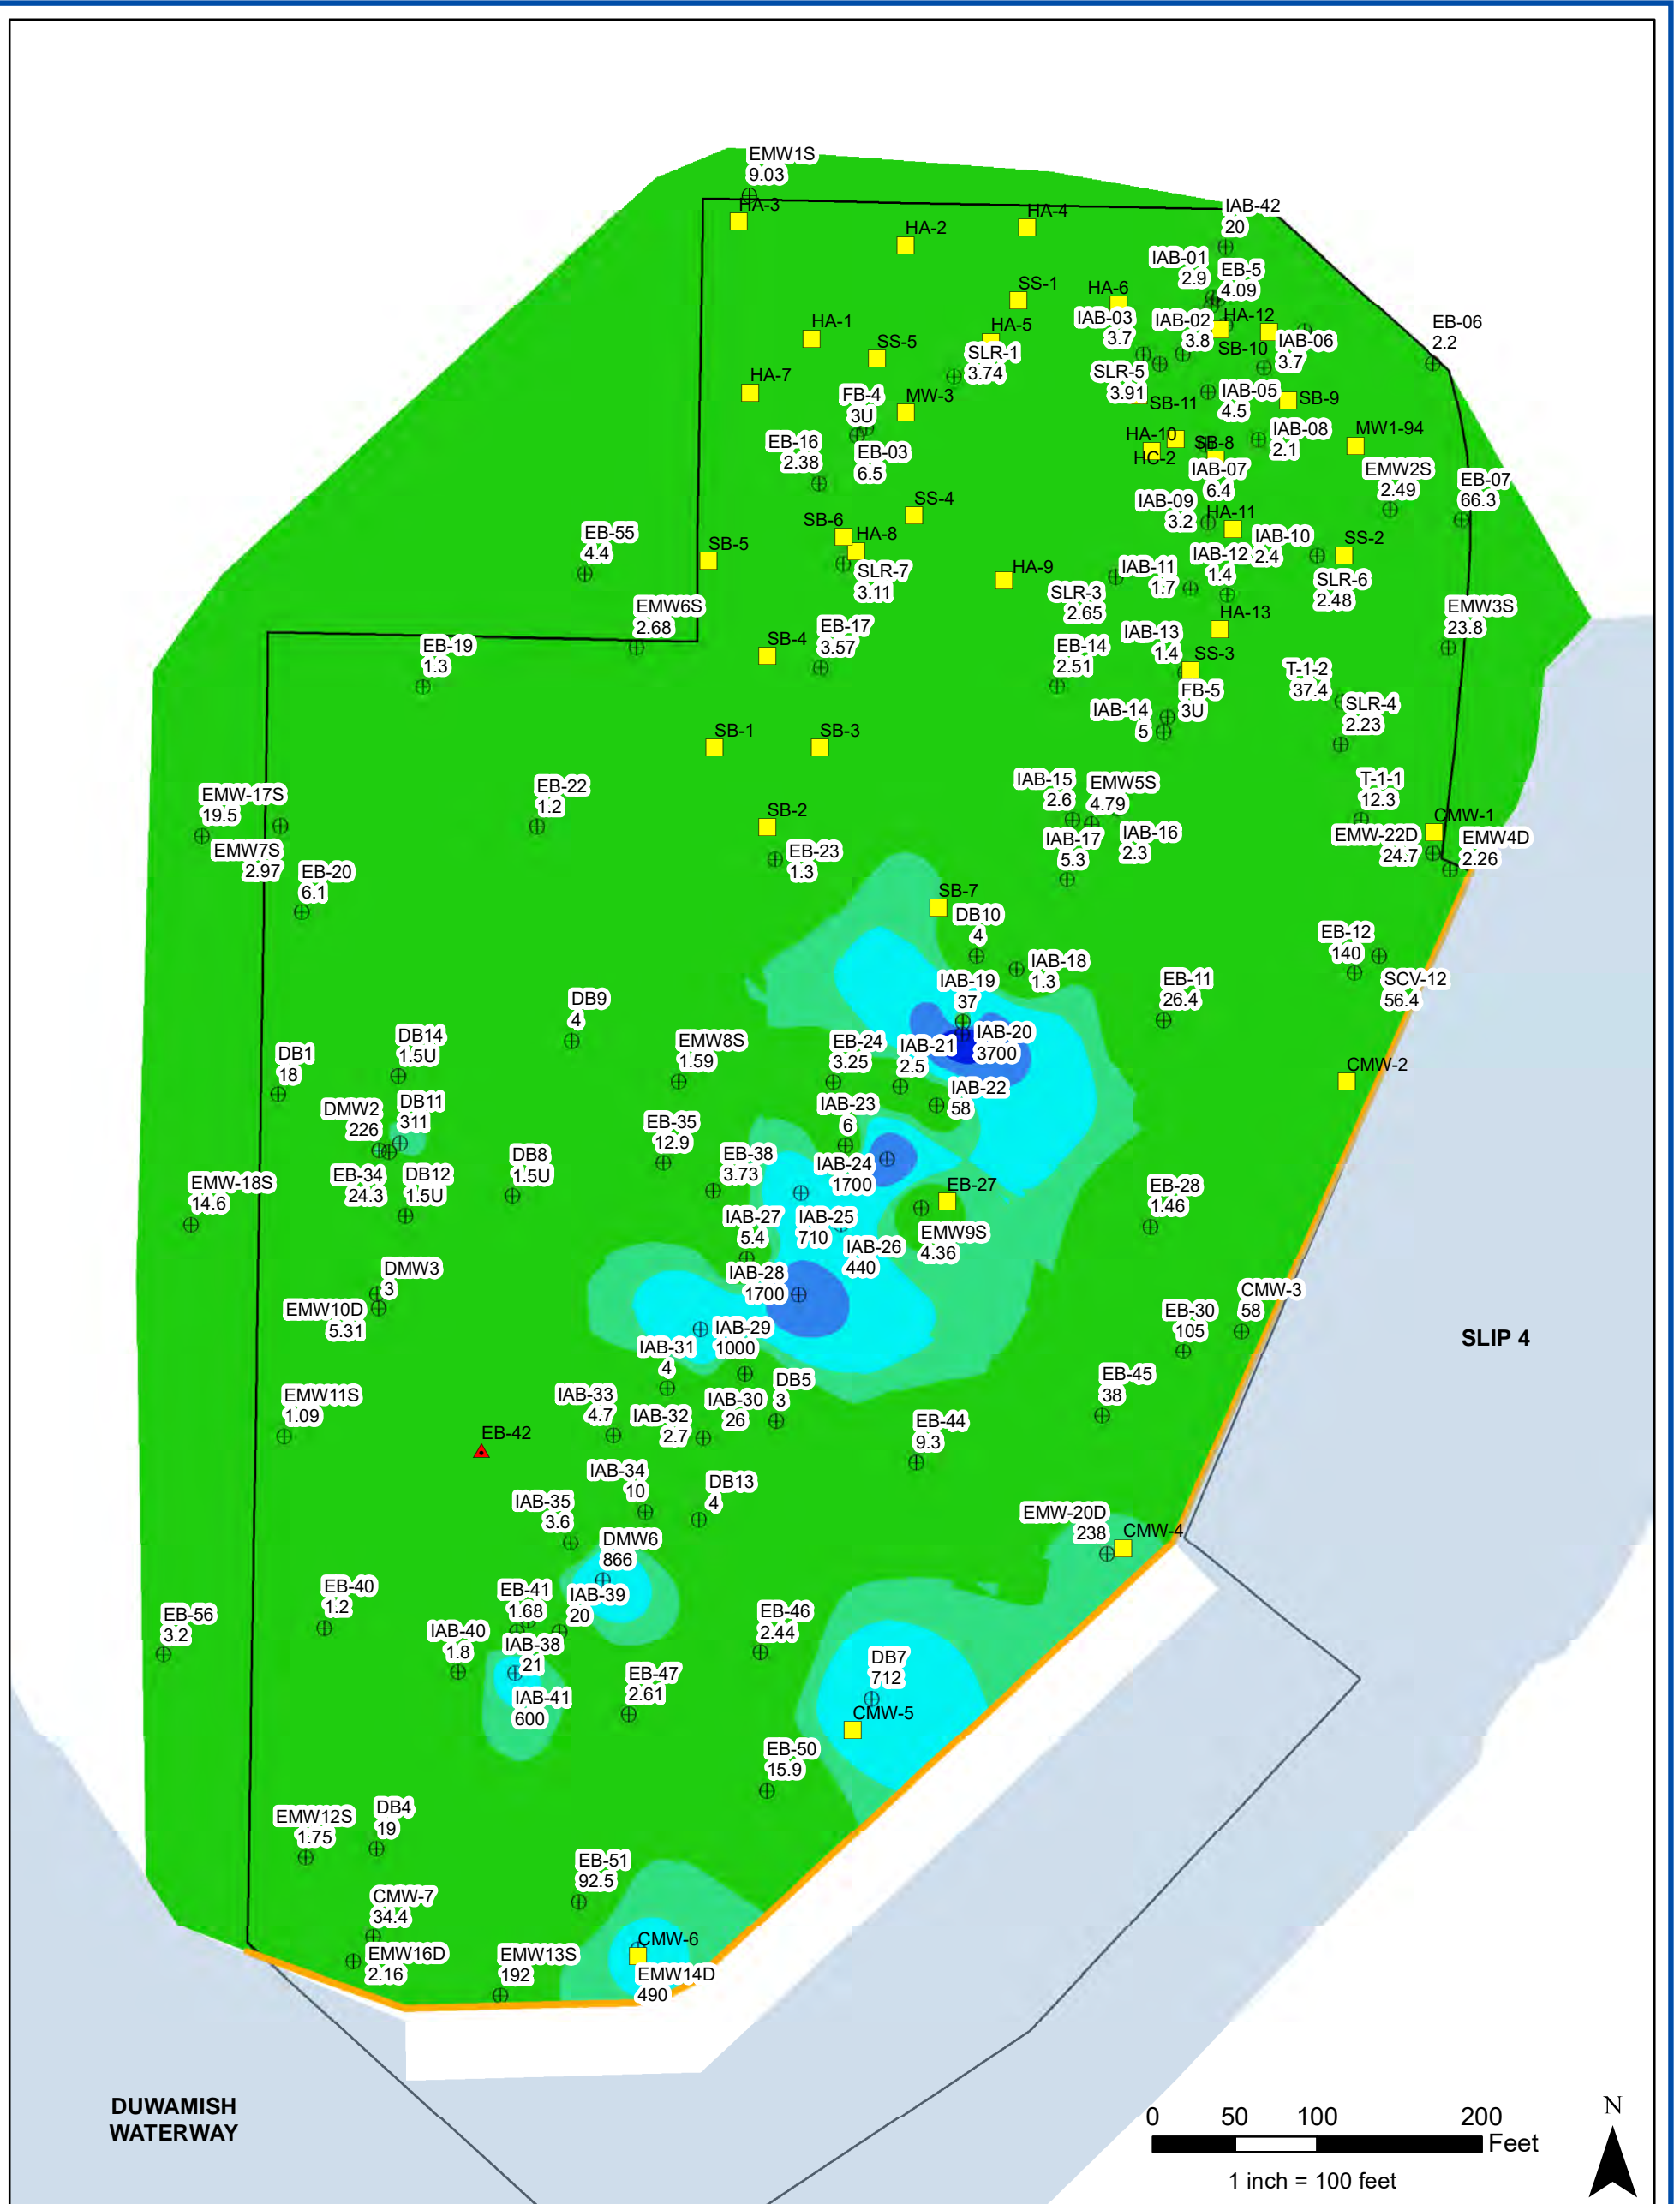
22118 20TH AVE SE BLDG. G, SUITE 202 BOTHELL, WA 98021 T: 425-402-8800	
⊕	Investigation Location		
Lead (mg/kg)			
■	< 220 (screening level)		
■	220 - 440 (2x)		
■	440 - 1,100 (5x)		
■	1,100 - 2,200 (10x)		
■	> 2,200		
U = 1/2 of the highest method reporting limit at each location was used for contouring.

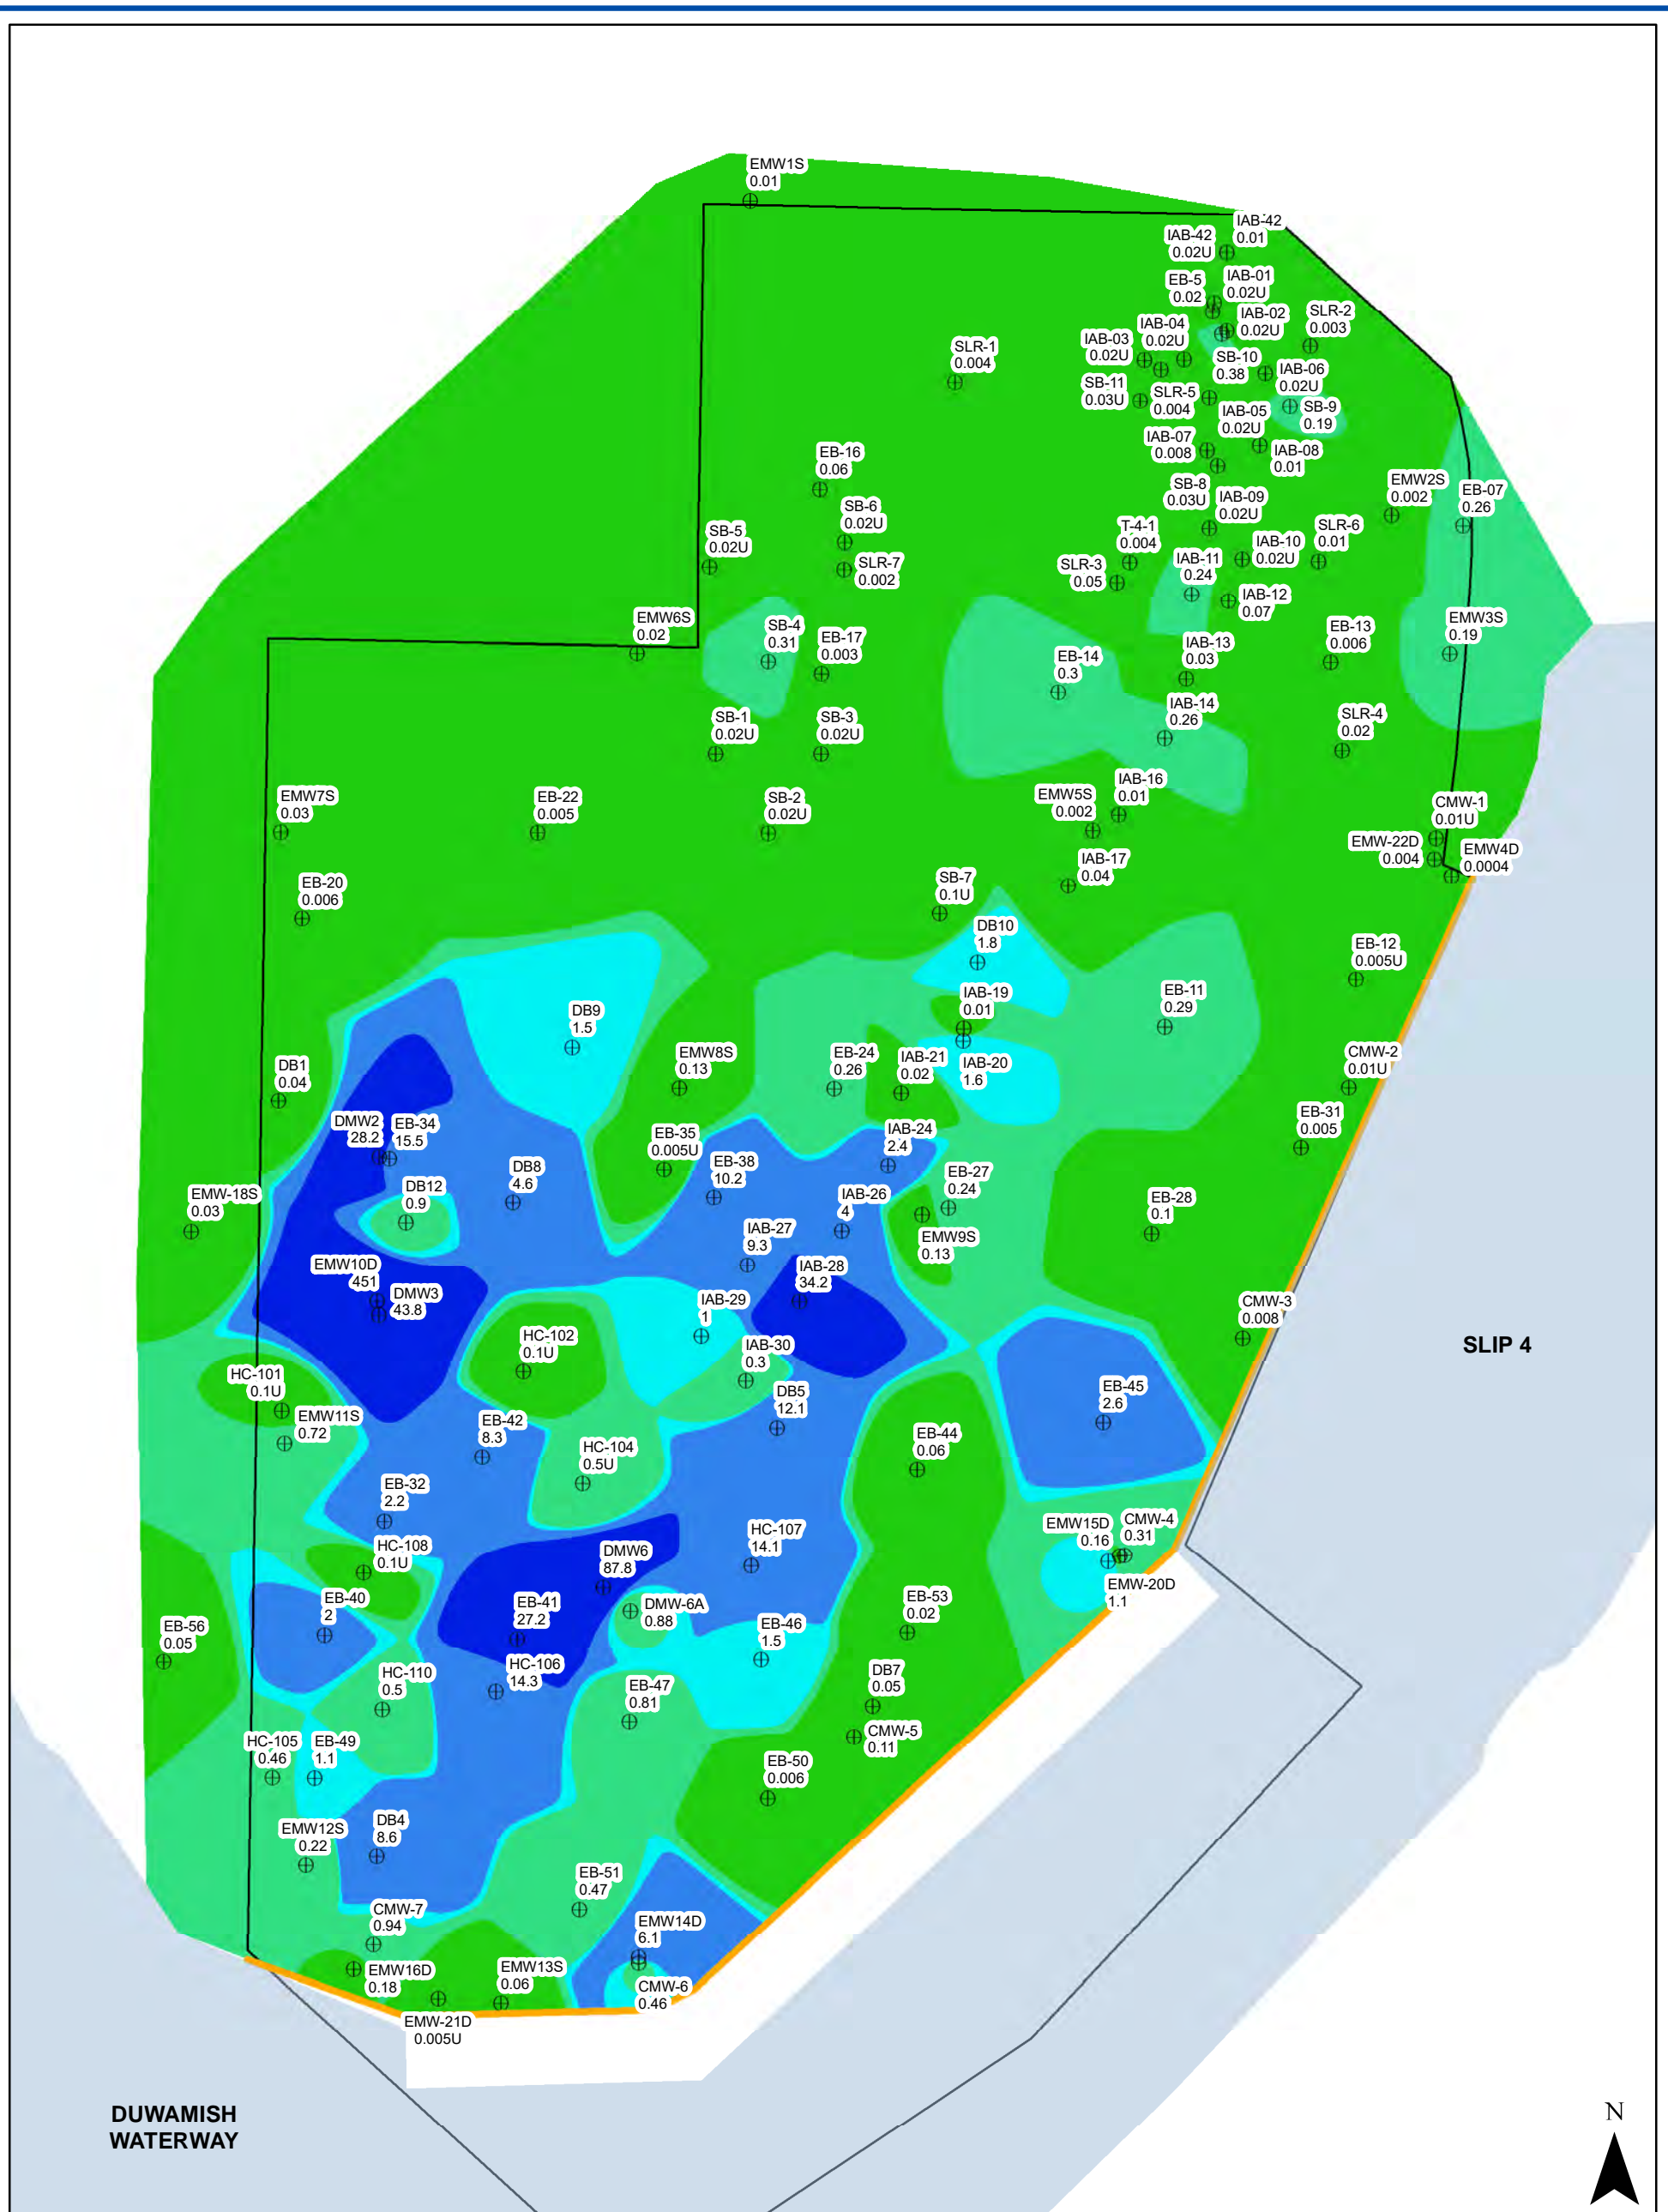
Project No. 101.00205.00037	Figure No. 36
---------------------------------------	-------------------------

- Sheet Pile Seawall
- Property Boundary
- Investigation Location

Total cPAH TEQ concentrations greater than the screening level (0.19 mg/kg) occur in the shallow soil throughout most of Parcel D and at localized areas on Parcel F (see Figure 36). The lateral extents of the total cPAH TEQ concentrations greater than the screening level have been delineated. The concentrations typically decrease with depth; however, there are several localized areas on Parcel D that exceed the screening level at depths below 12 feet bgs (see Figures 37 and 38). At boring EMW-10D, the total cPAH TEQ concentration is 111.84 mg/kg at a depth of approximately 35 feet bgs. The total cPAH TEQ concentrations at EMW-10D decrease to below the screening level at a depth between 35 and 49 feet bgs. EMW-10D is located in the vicinity of the former pole dipping tank, treated pole storage area, former creosote tanks, and former tanks/pump house. The vertical extent of the total cPAH TEQ concentrations greater than the screening level is delineated at the Site, except at boring EMW-21D. Total cPAH TEQ concentrations that are over 10 times greater than the screening level are present in the former wood treating operations area, the former sawmill area, the former pipe and chain manufacturing building, and the former dredge fill areas.

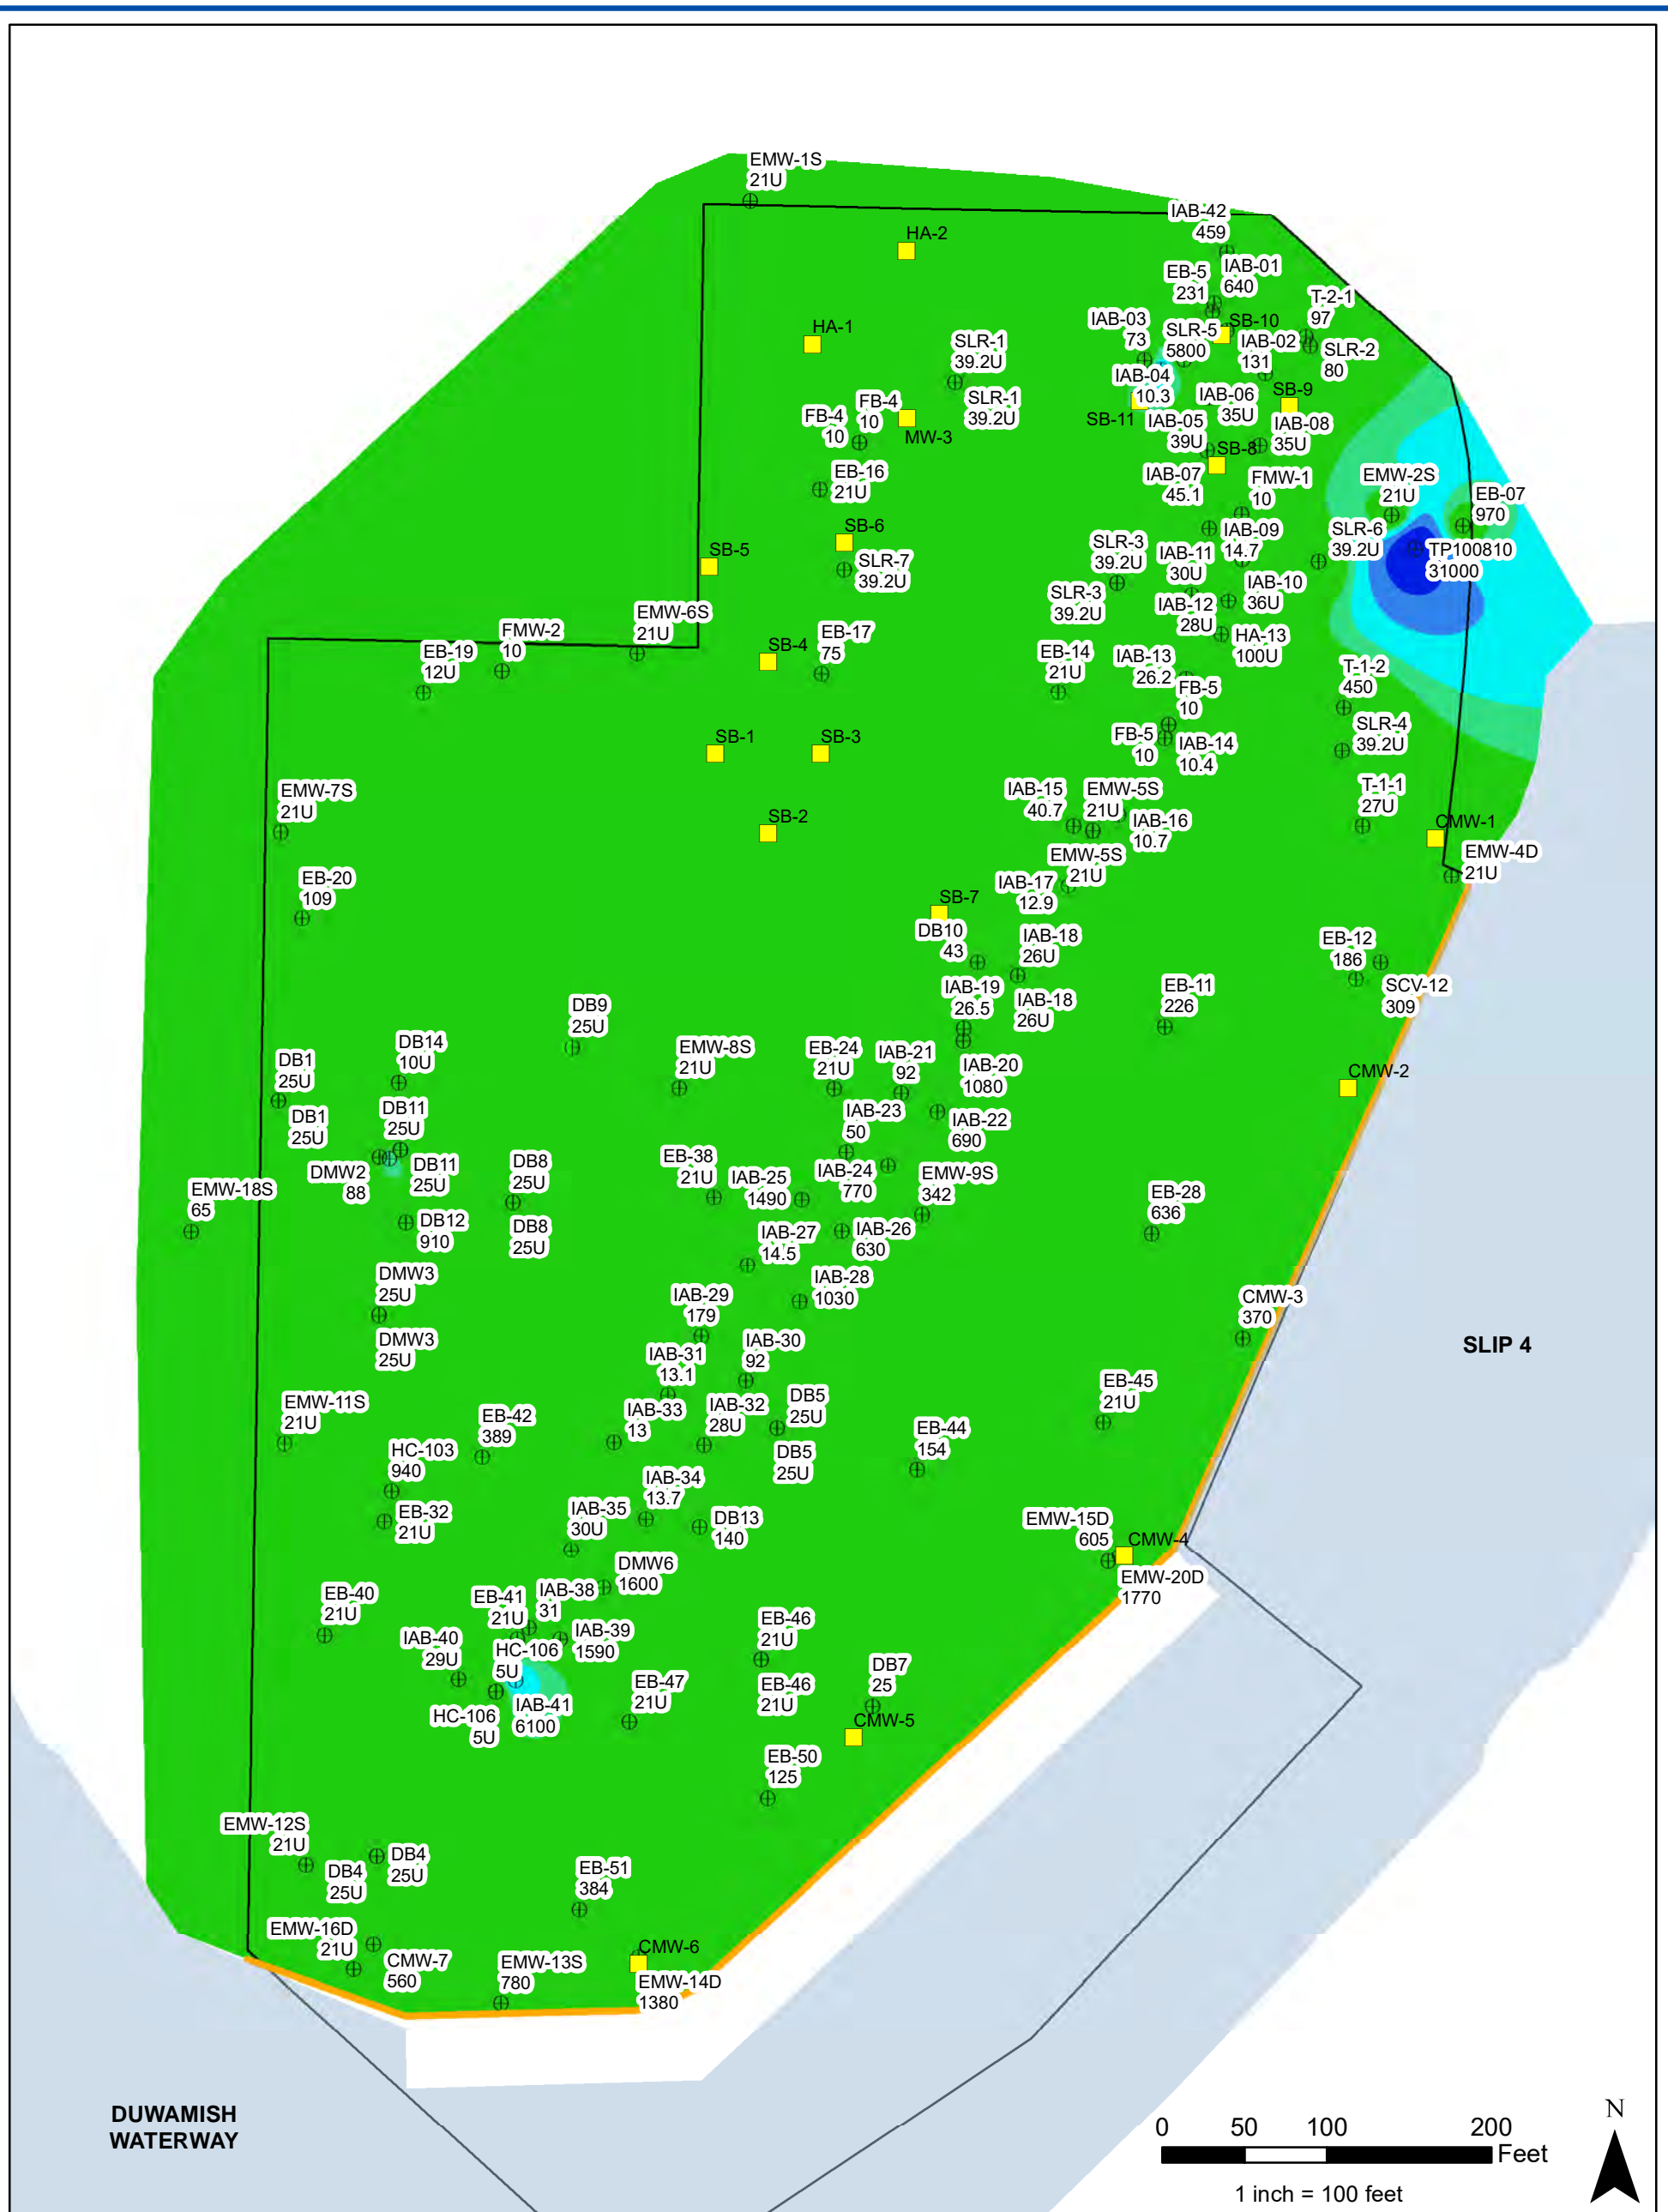
<p>8TH AVENUE TERMINALS, INC. SITE 7400 8TH AVENUE SOUTH SEATTLE, WASHINGTON</p>	
<p>Figure MAXIMUM CONCENTRATIONS OF TOTAL SEMI-VOLATILE PETROLEUM HYDROCARBONS (DRO + ORO) IN SOIL SAMPLES COLLECTED BETWEEN 6 AND 12 FEET BGS</p>	
<p>Project No. 101.00205.00037</p>	<p>Figure No. 46</p>
<p>22118 20TH AVE SE BLDG. G, SUITE 202 BOTHELL, WA 98021 T: 425-402-8800</p>
