Reference: ExxonMobil ADC Cleanup Action Plan

ExxonMobil ADC
2717/2731 Federal Avenue
Everett, Washington
Ecology Facility Site ID 2728

EXXONMOBIL ADC CLEANUP ACTION PLAN

GENERALIZED SITE PLAN EXXOMOBIL ADC 2717/2731 Federal Avenue Everett, Washington		PROJECT NO. 238000337
	EXPLANATION		PLATE 2 LEC: 03/28/23

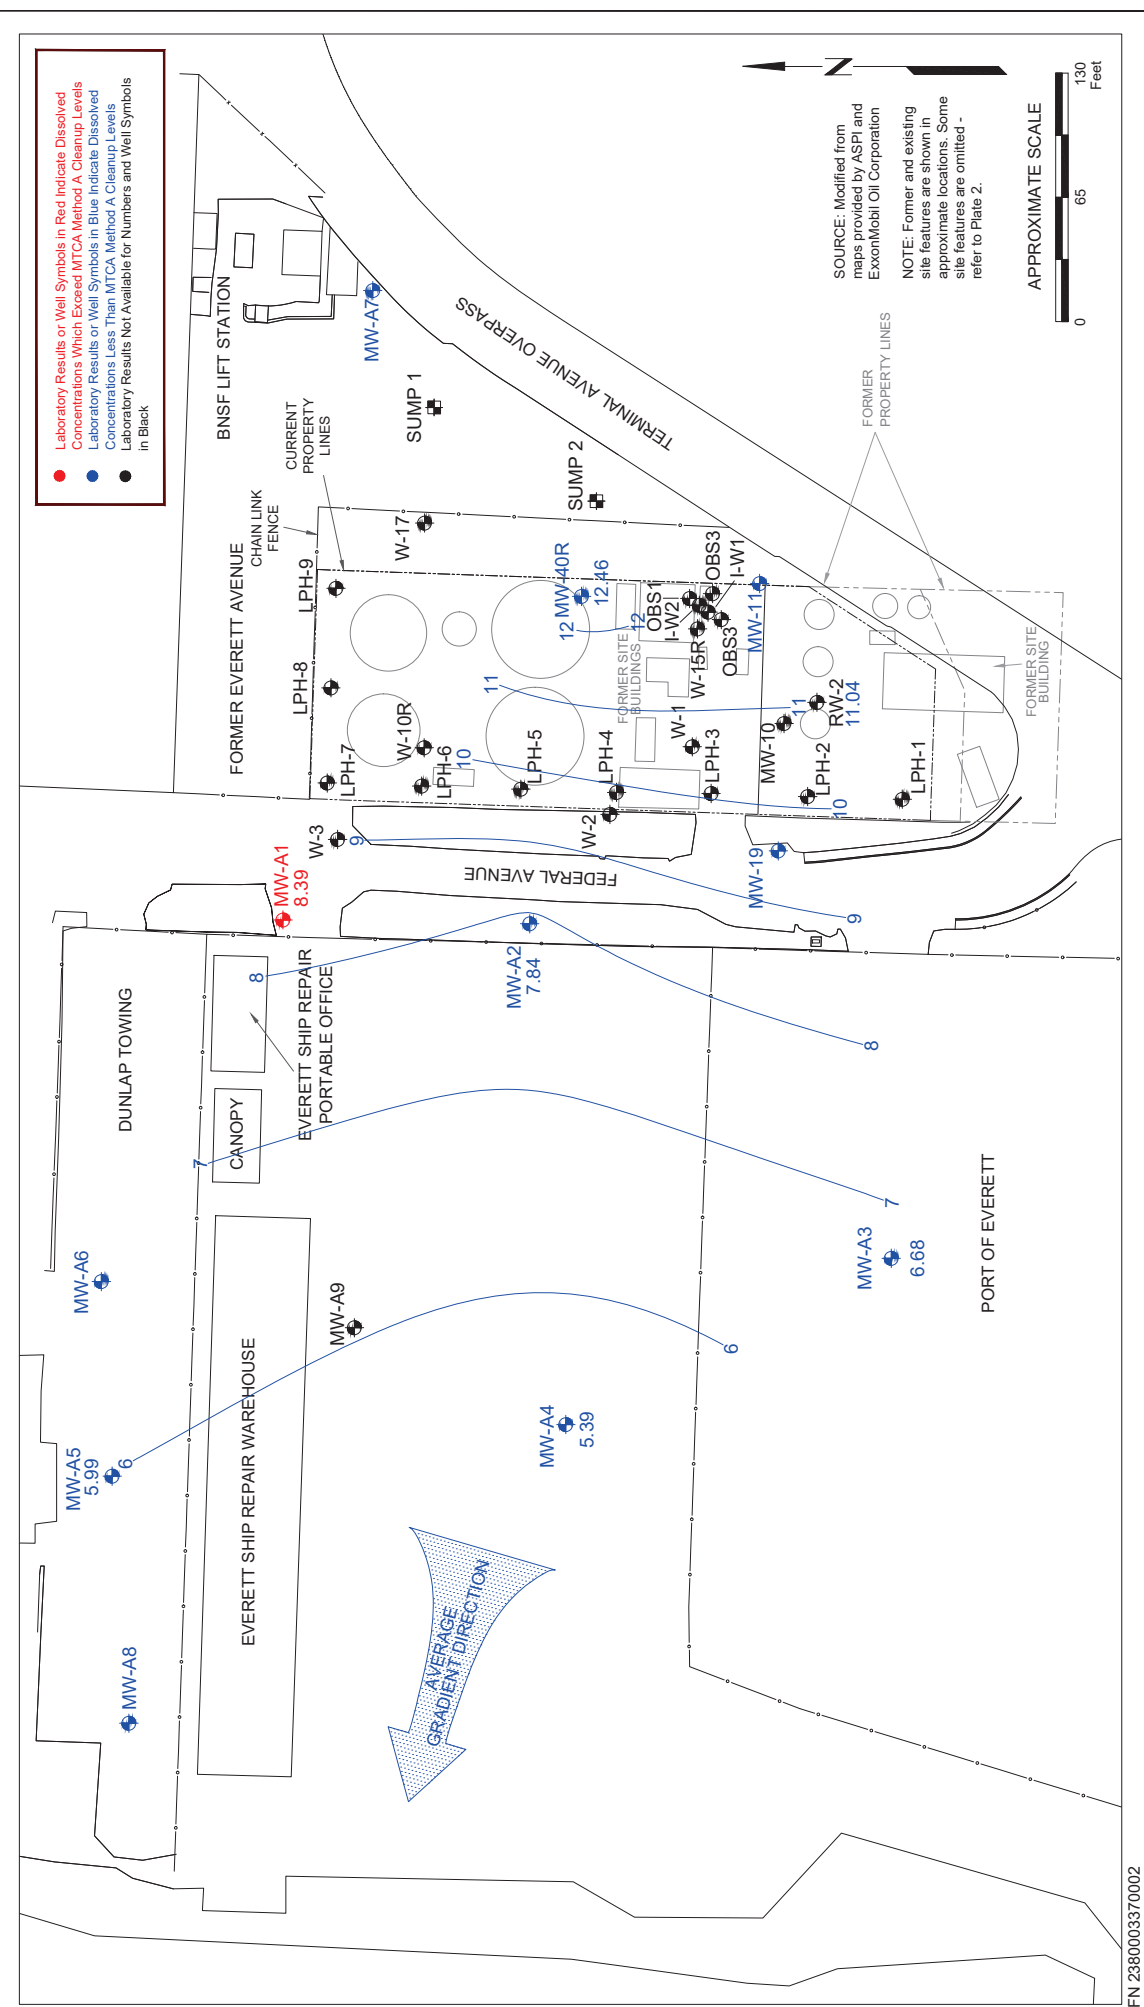
<h3>25-HOUR AVERAGED GROUNDWATER ELEVATION CONTOUR MAP - 10/01 - 10/02/21</h3> <p>EXXONMOBIL ADC 2717/2731 Federal Avenue Everett, Washington</p>		<p>EXPLANATION</p> <ul style="list-style-type: none"> MW-A9 Groundwater Monitoring Well 12.46 Groundwater Elevation SUMP 2 Groundwater Sump Groundwater Elevation Contour Line 	<p>PROJECT NO. 238000337</p> <p>PLATE 5</p> <p>LEC: 03/28/23</p>
	<p>APPROXIMATE SCALE</p>			<p>SOURCE: Modified from maps provided by ASPI and ExxonMobil Oil Corporation</p> <p>NOTE: Former and existing site features are shown in approximate locations. Some site features are omitted - refer to Plate 2.</p>

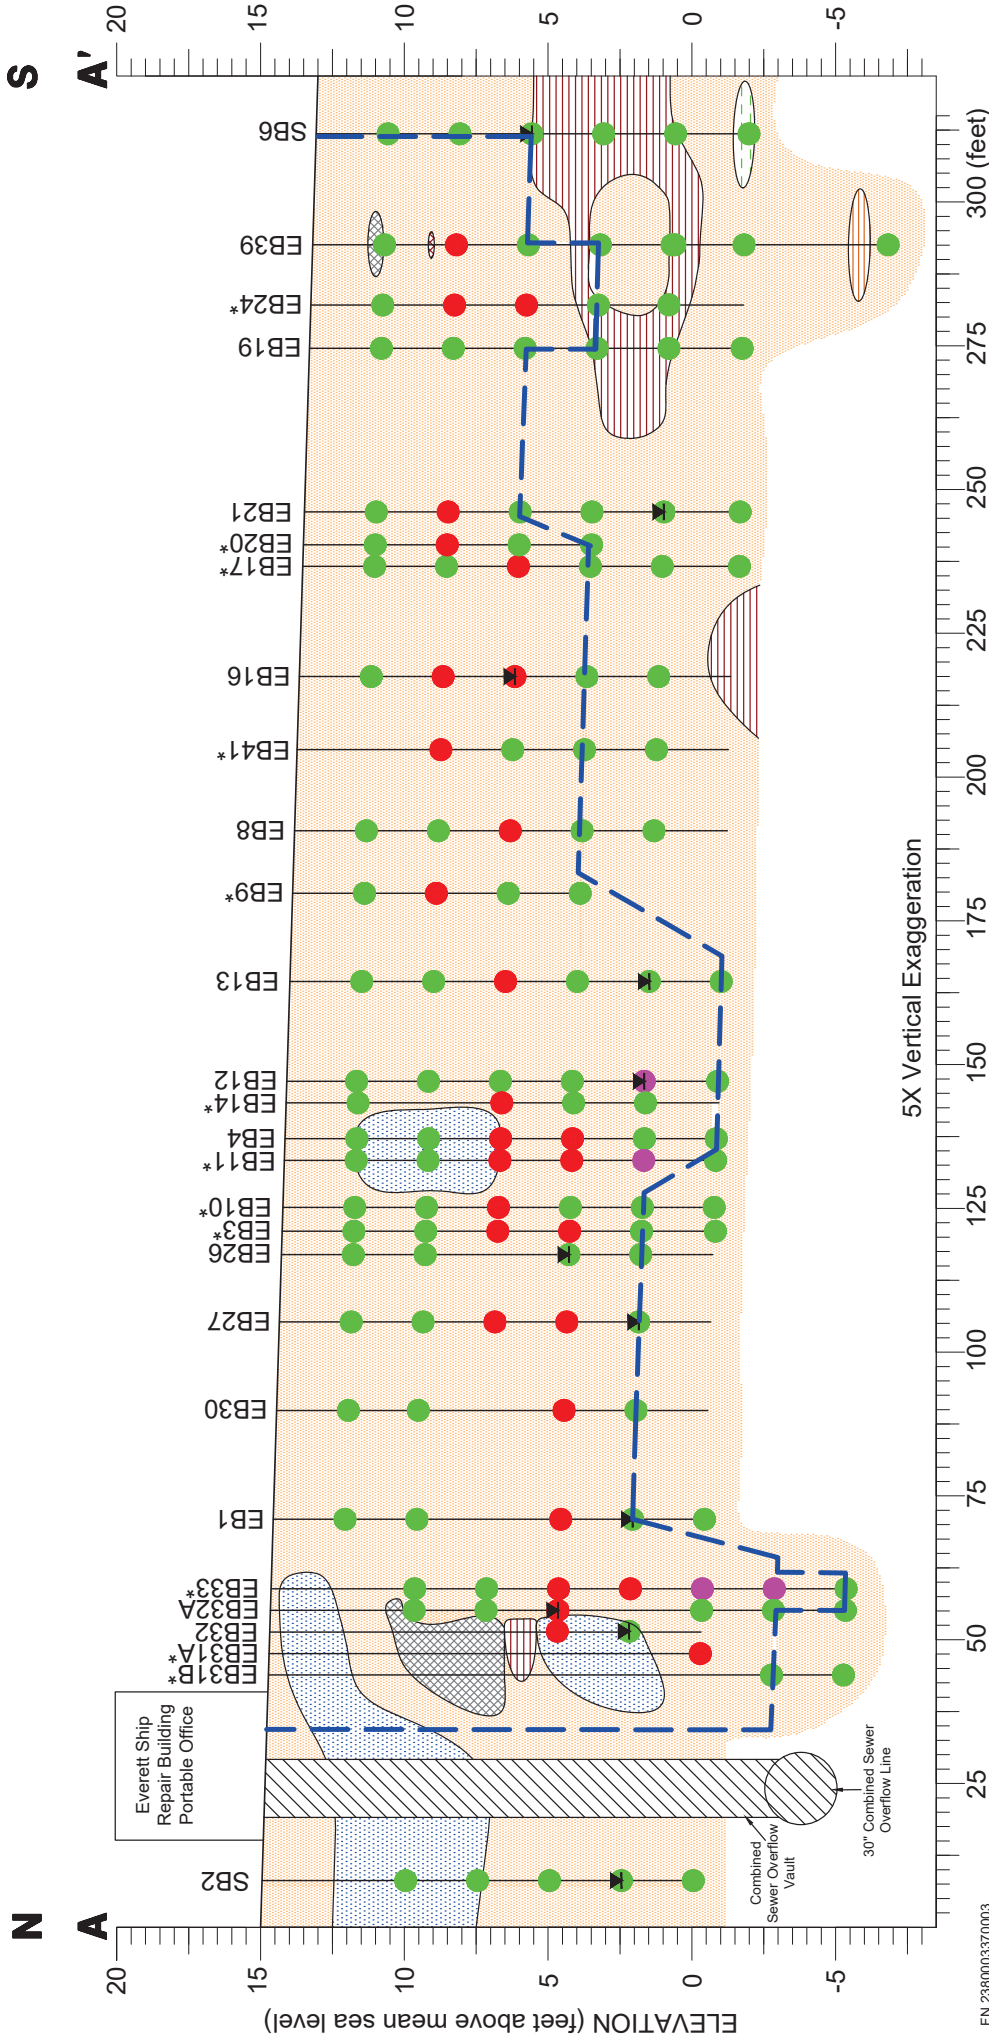
* = Borings EB1, EB3, EB9, EB10, EB11, EB14, EB17, EB20, EB24, EB31A, EB31B, EB33, and EB41 are projected onto the cross section for hydrocarbon concentration distribution purposes; projected borings were not used to construct lithology illustration

PORT OF EVERETT CROSS SECTION N-S EXXONMOBIL ADC 2717/2731 Federal Avenue Everett, Washington		PROJECT 238000337
			PLATE 15 LEC: 02/27/23
EXPLANATION			
	Water Level Encountered During Drilling		Coarse-grained Gravelly Sediments (GW, GC)
	Hydrocarbon Concentrations in Soil Less Than Site-Specific Residual Saturation Remediation Levels		Coarse-grained Sandy Sediments (SW, SP, SM, SC)
	Hydrocarbon Concentrations in Soil Greater Than Site-Specific Residual Saturation Remediation Levels		Fine-grained Sediments (CL, CH, ML)
	LNAPL Observed During Drilling		Organic Sediments (OH, PT, Wood Debris)
	Port Interim Action Excavation Extents		Concrete Debris

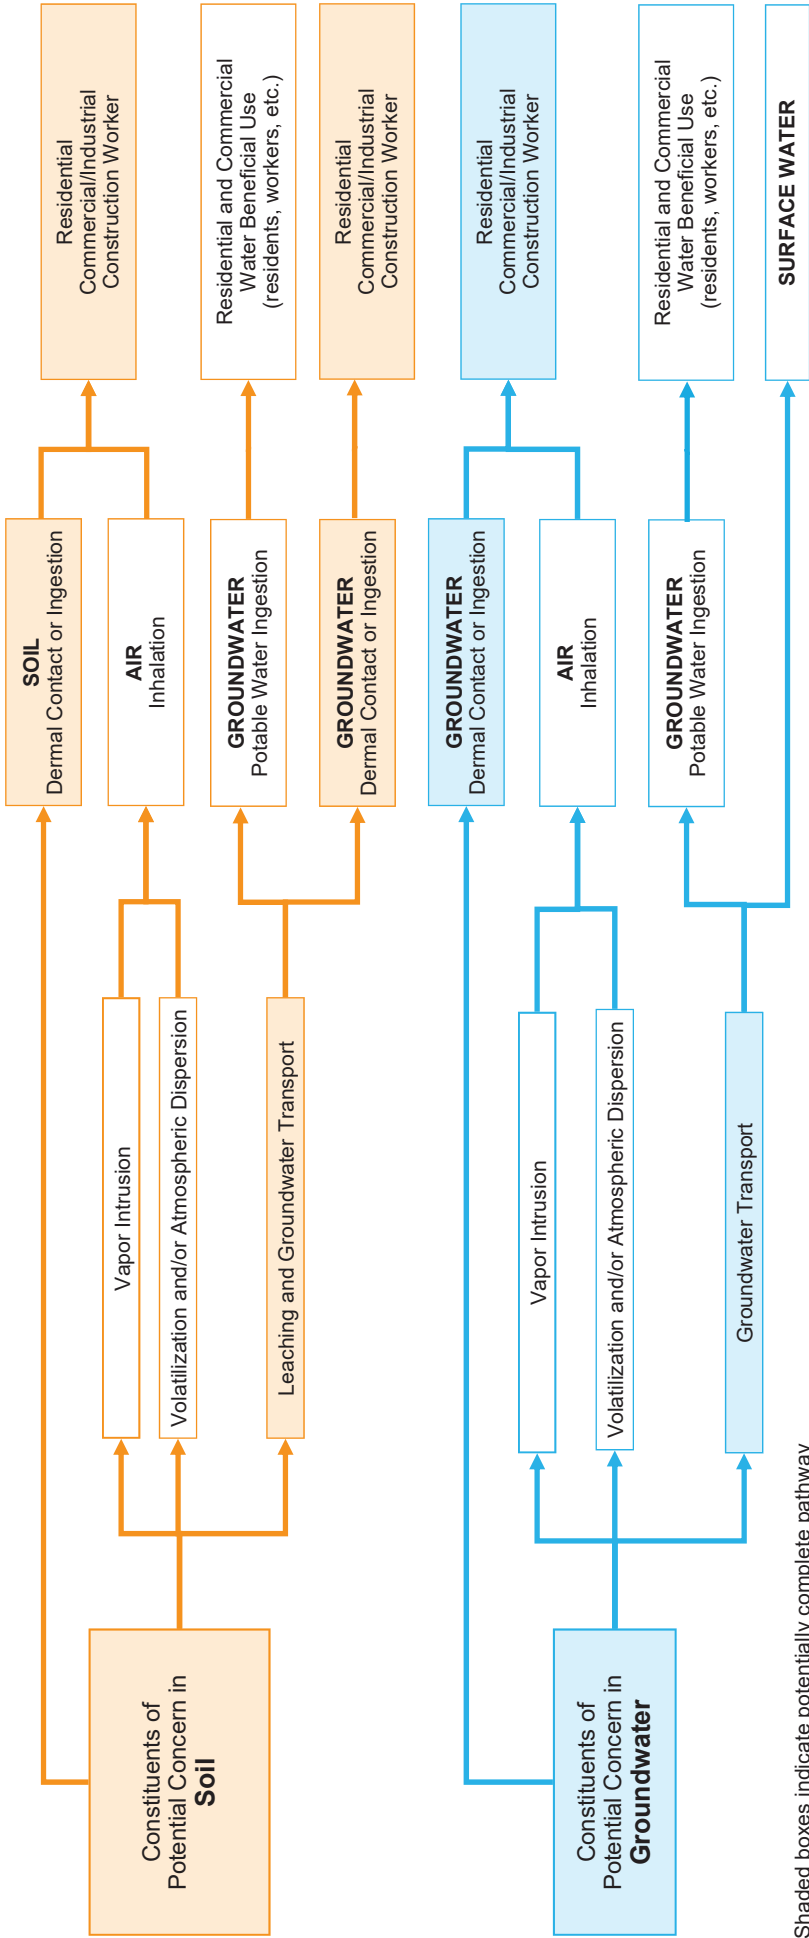
Constituents of Potential Concern in **Soil**

Constituents of Potential Concern in **Groundwater**

Shaded boxes indicate potentially complete pathway

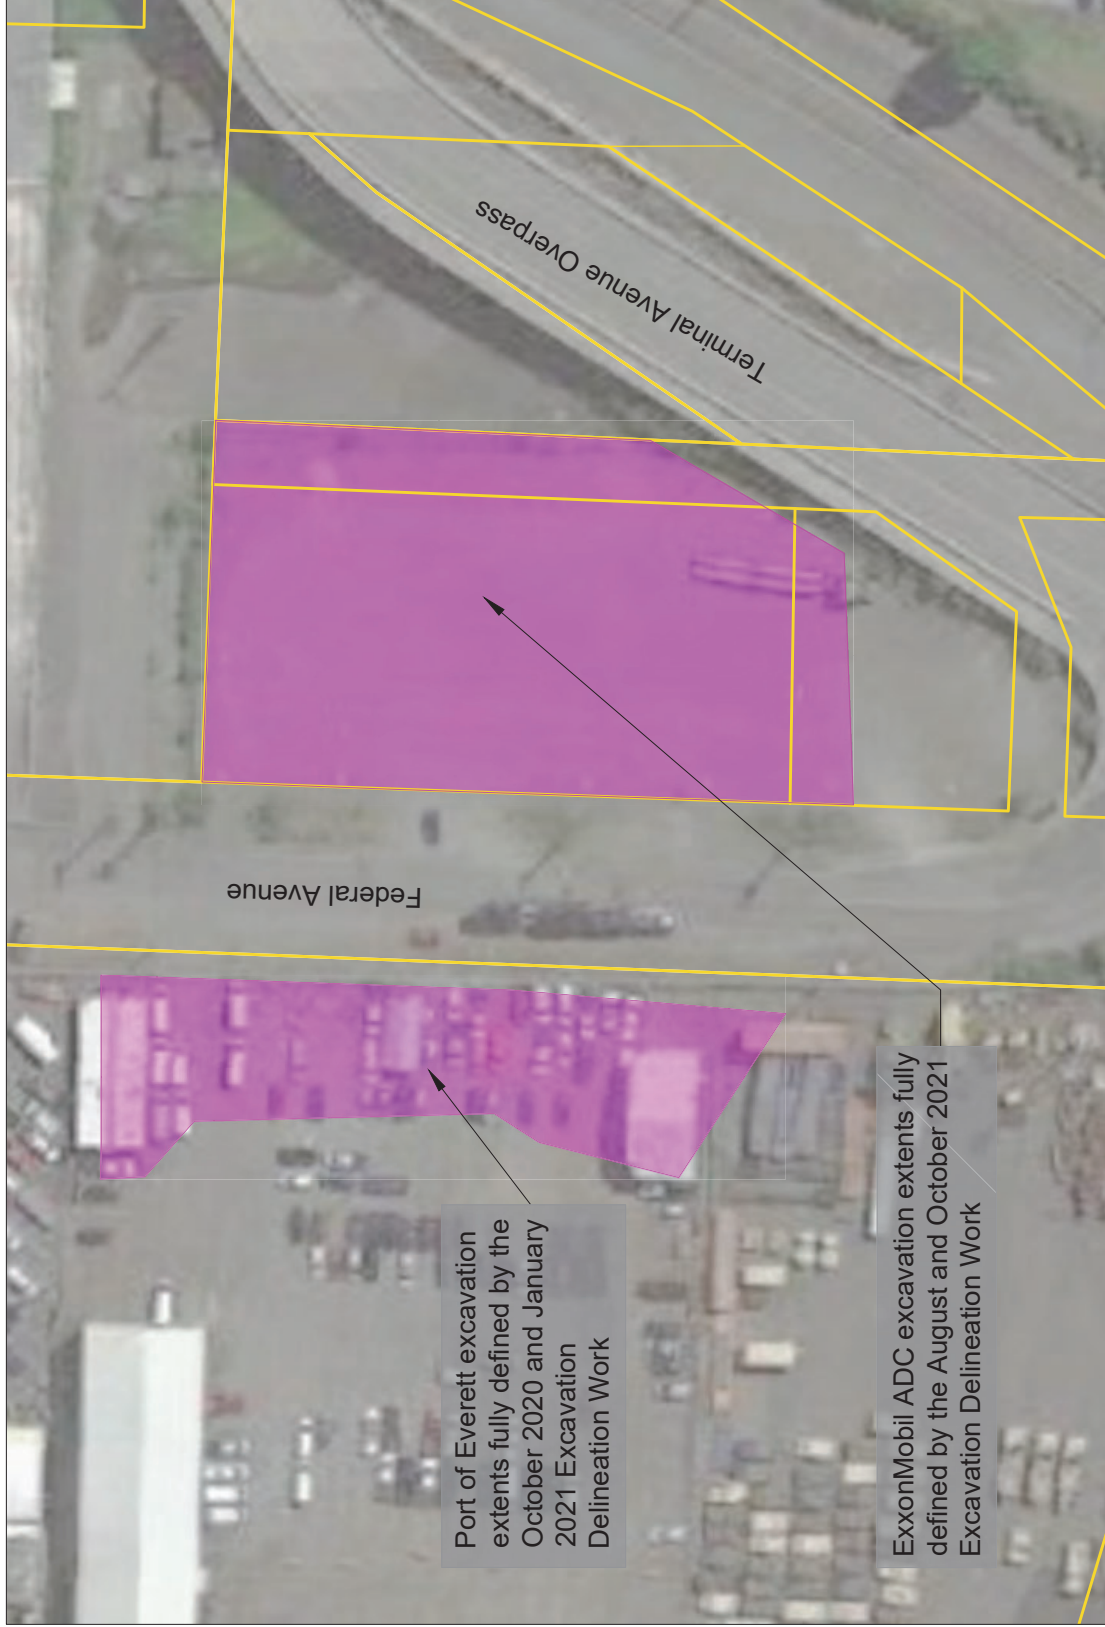
Port of Everett excavation extents fully defined by the October 2020 and January 2021 Excavation Delineation Work

ExxonMobil ADC excavation extents fully defined by the August and October 2021 Excavation Delineation Work

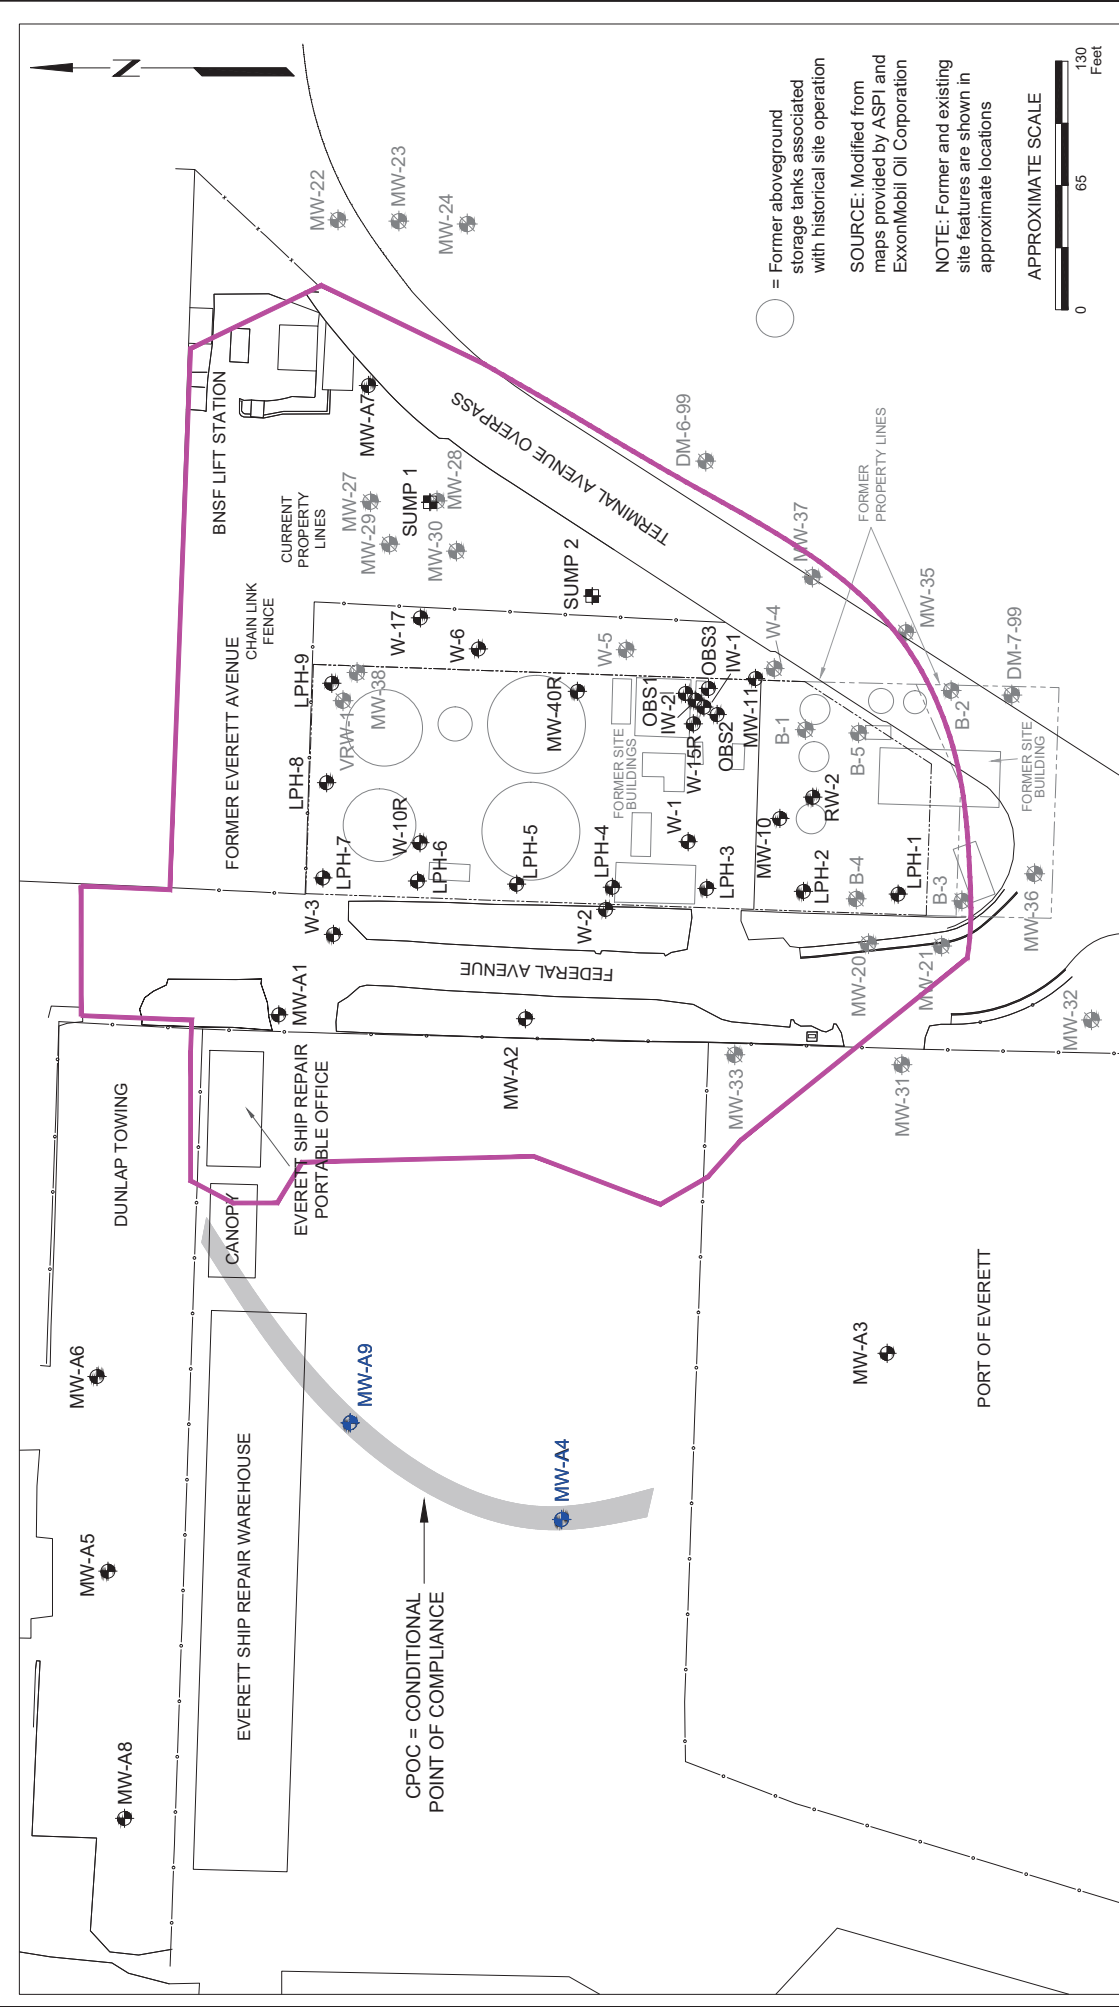
CONDITIONAL POINT OF COMPLIANCE WELL LOCATION MAP EXXONMOBIL ADC 2717/2731 Federal Avenue Everett, Washington	PROJECT NO. 238000337
	PLATE 28 LEC: 02/24/23
EXPLANATION MW-A9 Observation Well MW-A8 Groundwater Monitoring Well SUMP 2 Groundwater Sump MW-38 Destroyed Groundwater Monitoring Well	EXPLANATION OBS1 Observation Well MW-A9 Groundwater Monitoring Well SUMP 2 Groundwater Sump MW-38 Destroyed Groundwater Monitoring Well

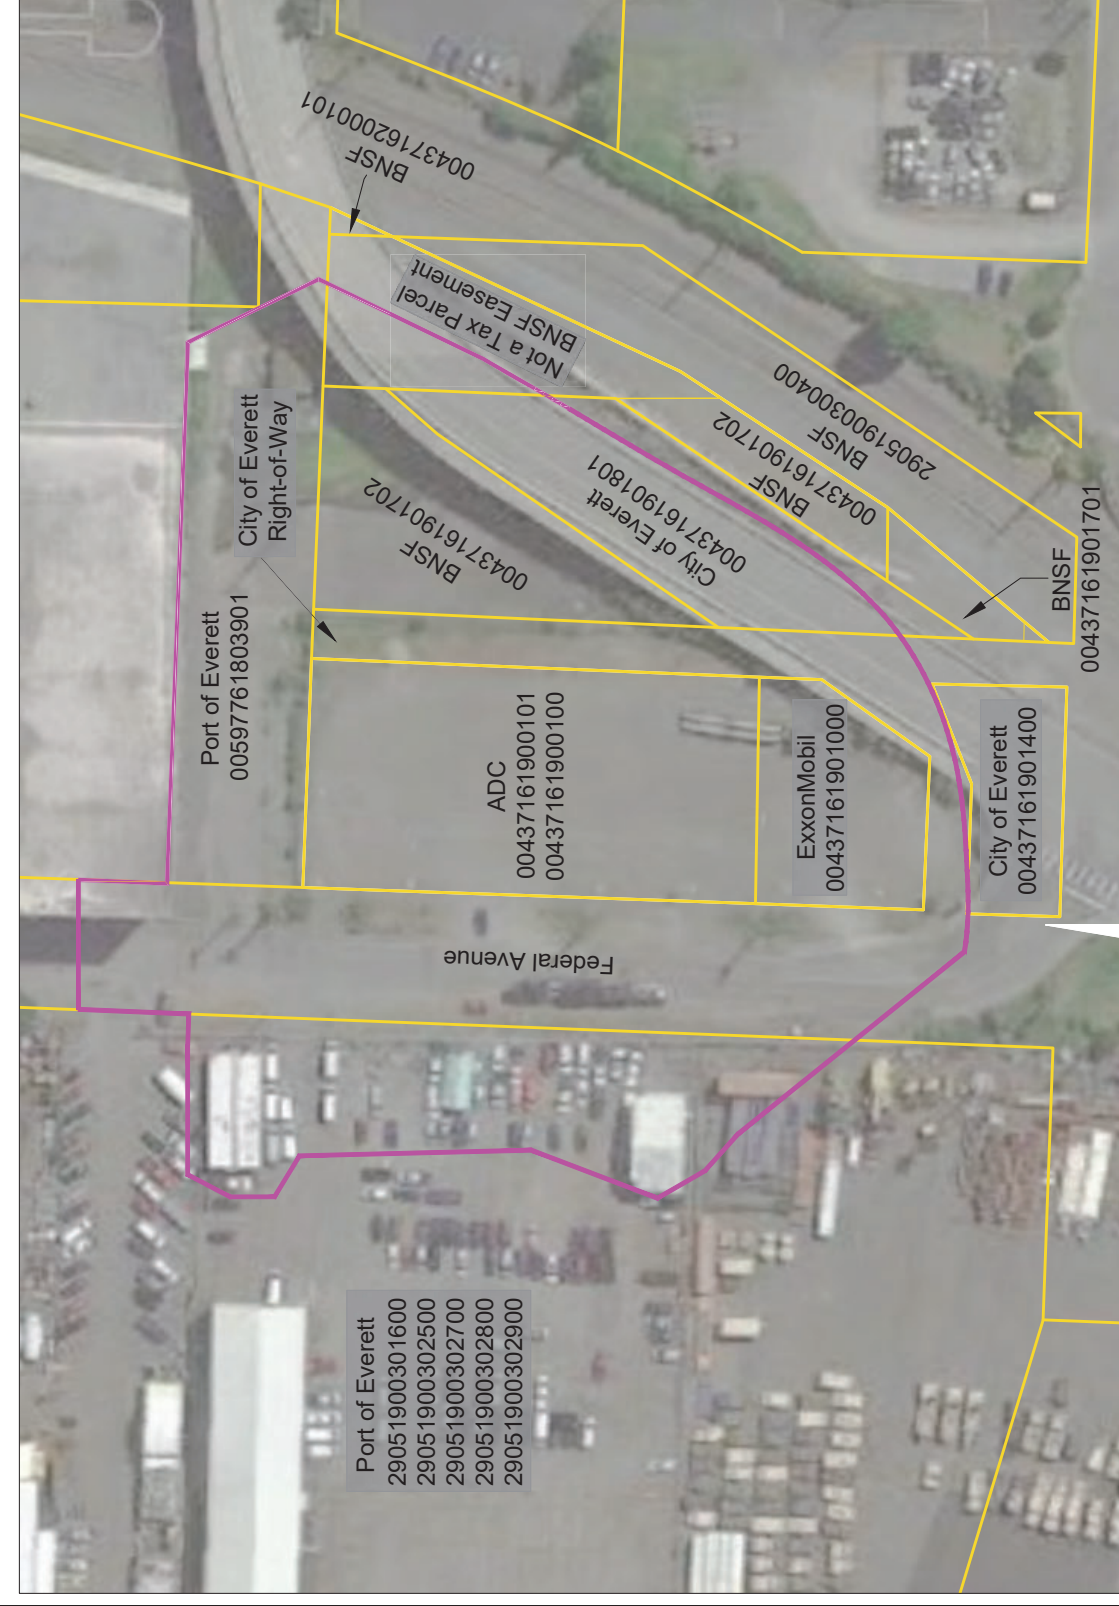
NOTE: Institutional controls in the form of restrictive covenants will be implemented to protect human health and the environment for parcels located within the Restrictive Covenant Boundary. These parcels include inaccessible areas as defined in the Cleanup Action Plan and in areas where soil and/or groundwater concentrations remain exceeding the MTCA Method A Cleanup Levels.

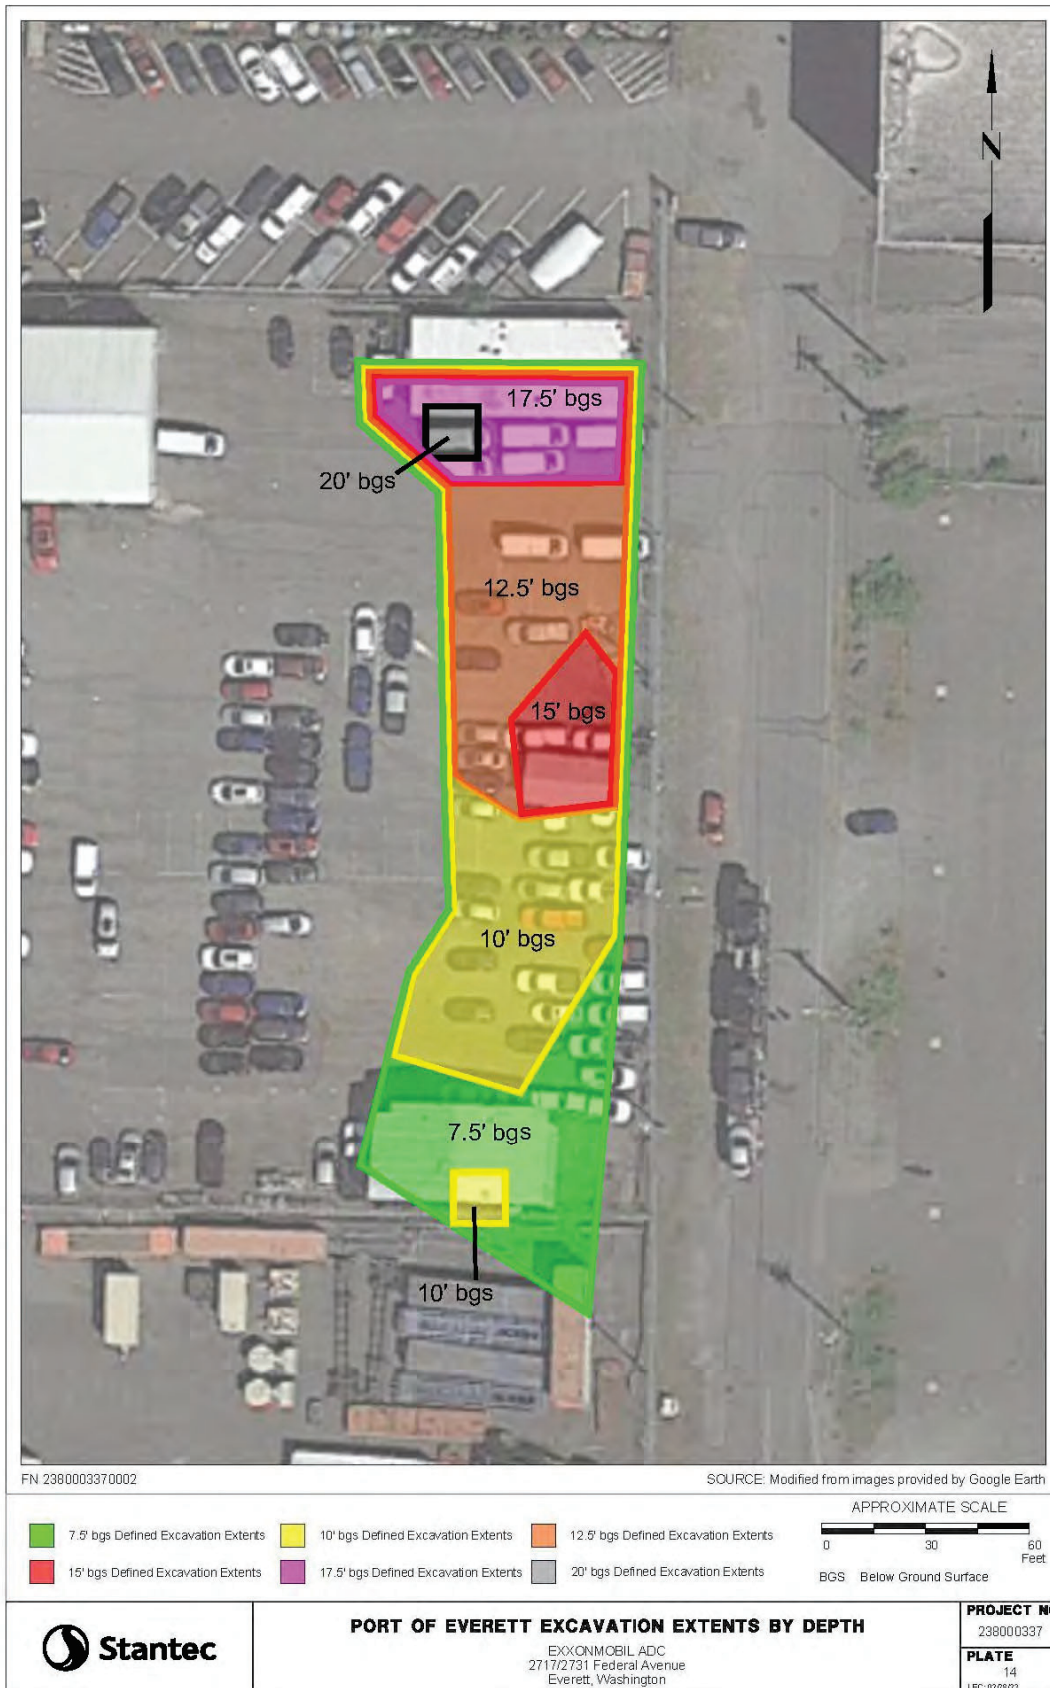
Figure 3 Proposed Excavation Extent on West Side of Federal Avenue

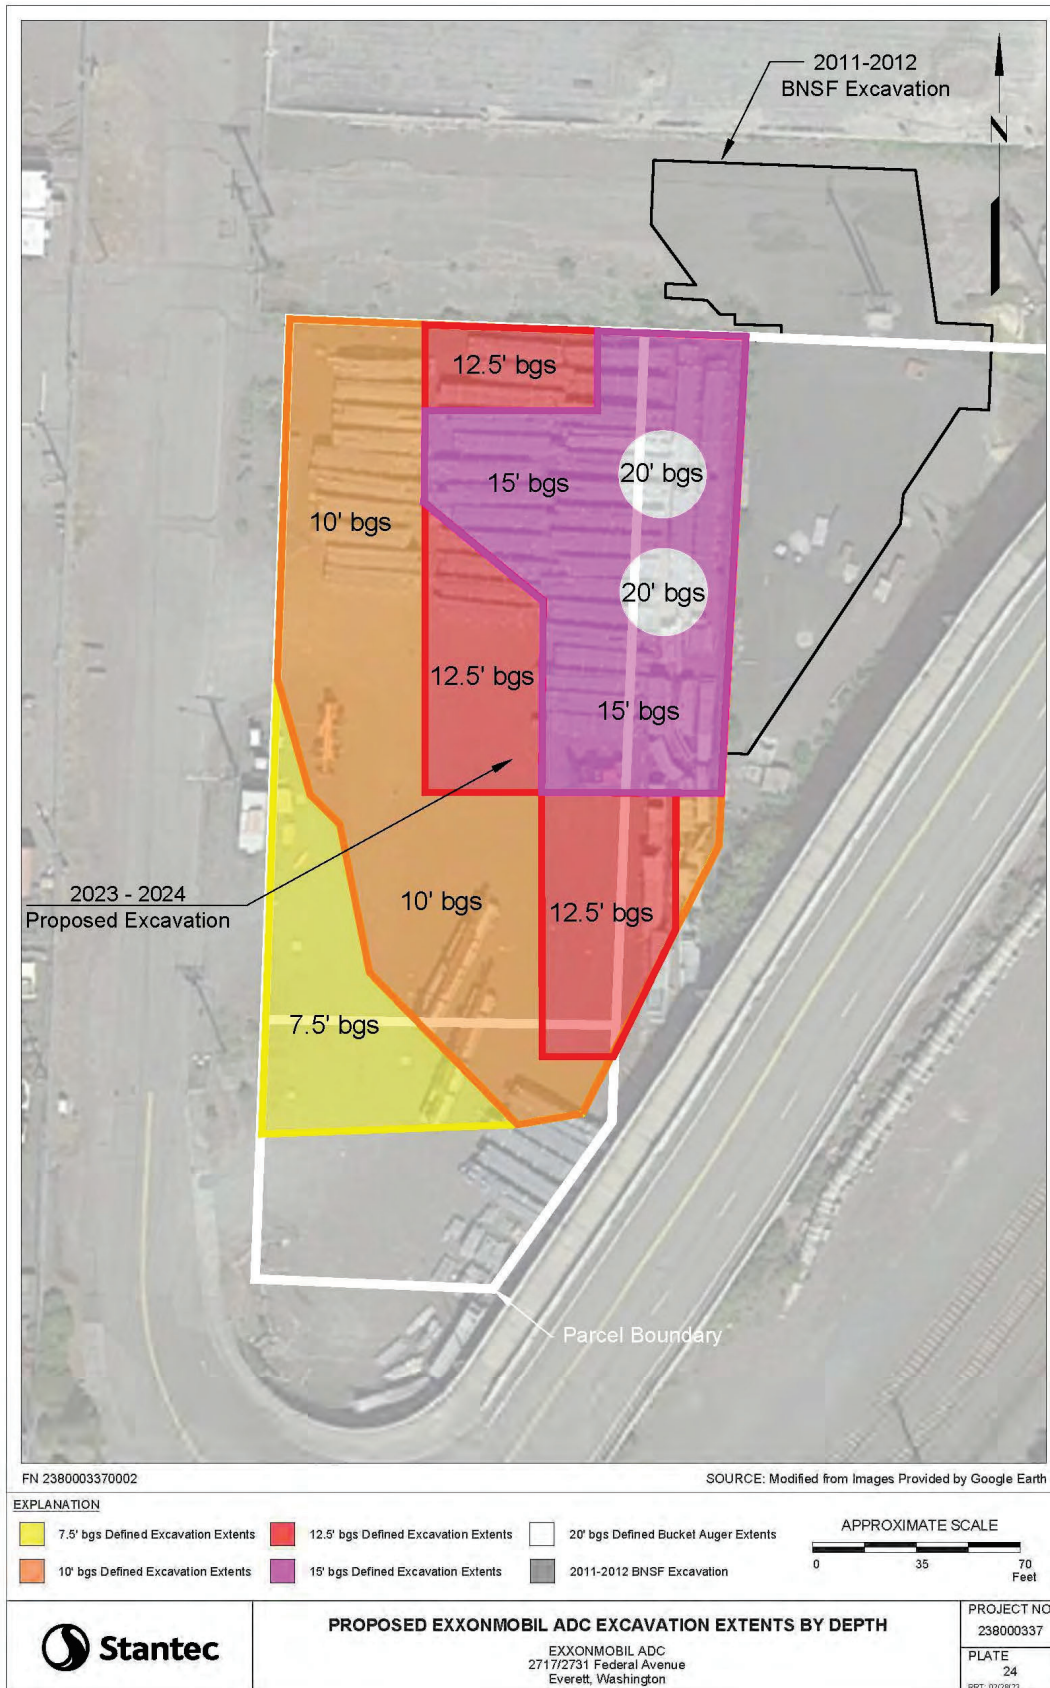
Figure 4 Proposed Excavation Extent on East Side of Federal Avenue

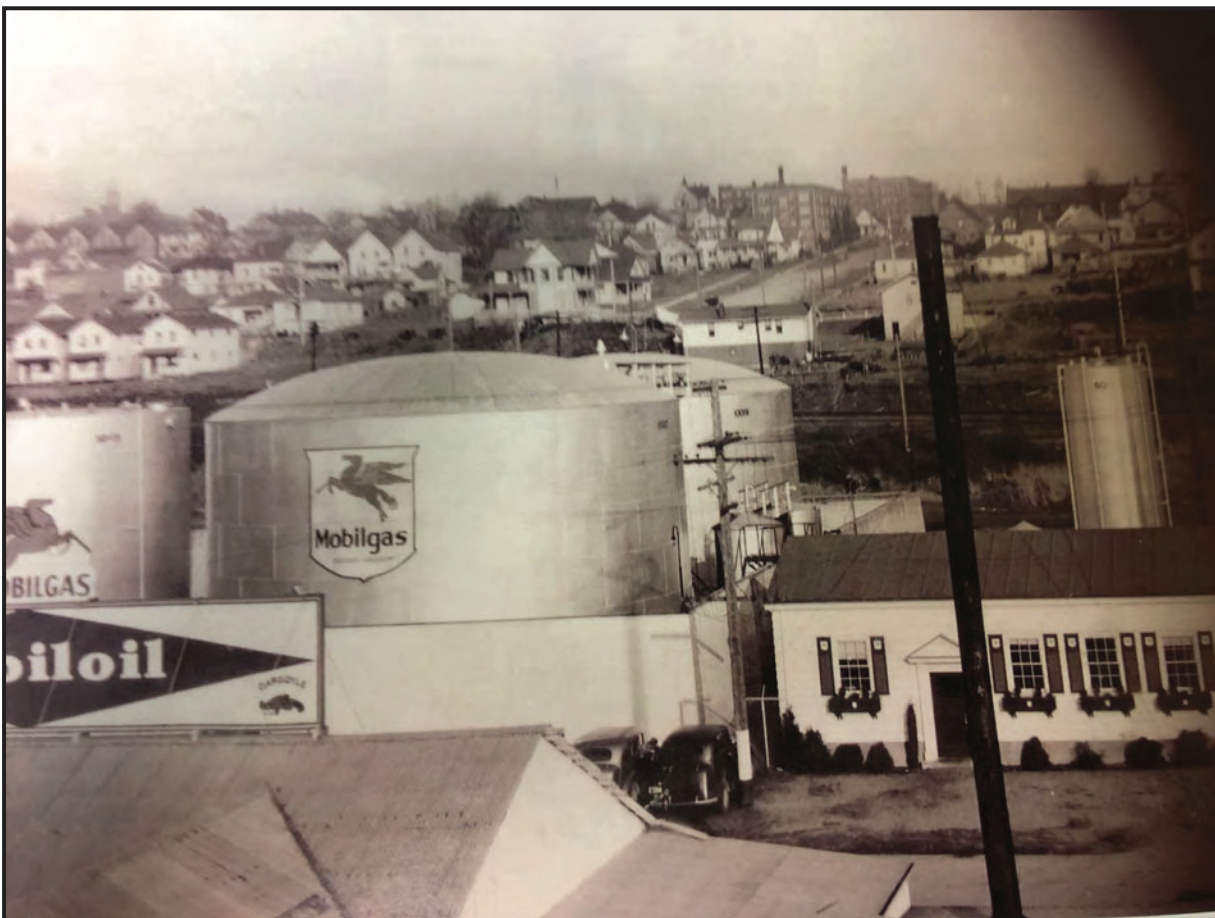
Figure 8. Undated photograph showing gasoline infrastructure after General Petroleum Corporation was rebranded to Mobilgas. The office building on the site is at the right. (Washington Department of Ecology 2014:65)
