SHARP Report — Part 1 of 2

401 Central Ave, Bellingham, Whatcom County, 98225

12378 401 Central Ave USTs 20240815

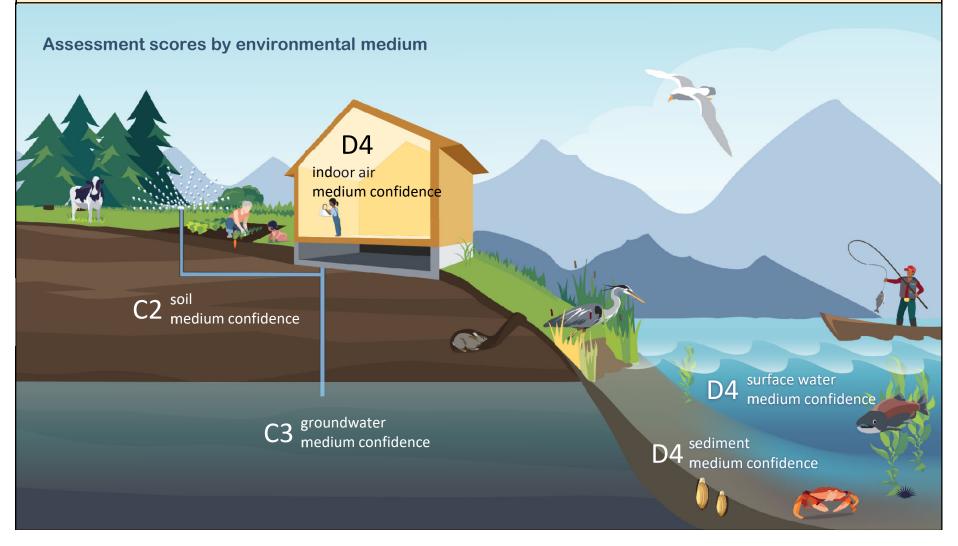
Conceptual site model 08/15/2024

53073000600	none
Local demographics co	omments
no comments	
Source/source area de	
	as caused by the release from a 300-gallon gasoline UST, a 1,000-gallon gasoline
UST, and a 1,300-gallon gaso	line UST. The USTs were associated with former fueling operations.

Contaminated soil has been removed from the property, but remains off the property in the street right of way. An NFA was issued for the Property on 1/19/23.

GW beneath the property does not have contaminants above the cleanup levels. The off-property extent of GW contamination has not been fully defined (in the street right of way).
