Coit Services

SHARP Report — Part 1 of 2

• SHARP first SHARP		v2024.04.29	Ecology Info	
• SHARP rating	Low		ERTS	715365
• SHARP date	08/21/2024		CSID	16672
• EJFlagged?	⊘ - No Override		FSID	36189742
• LD confidence level	low		VCP	NW3377
• Cleanup milestone	feasibility study		UST ID	none
• SHARPster	David Unruh		LUST ID	none

16750 Woodinville-Redmond Rd NE, Woodinville, King County, 98072

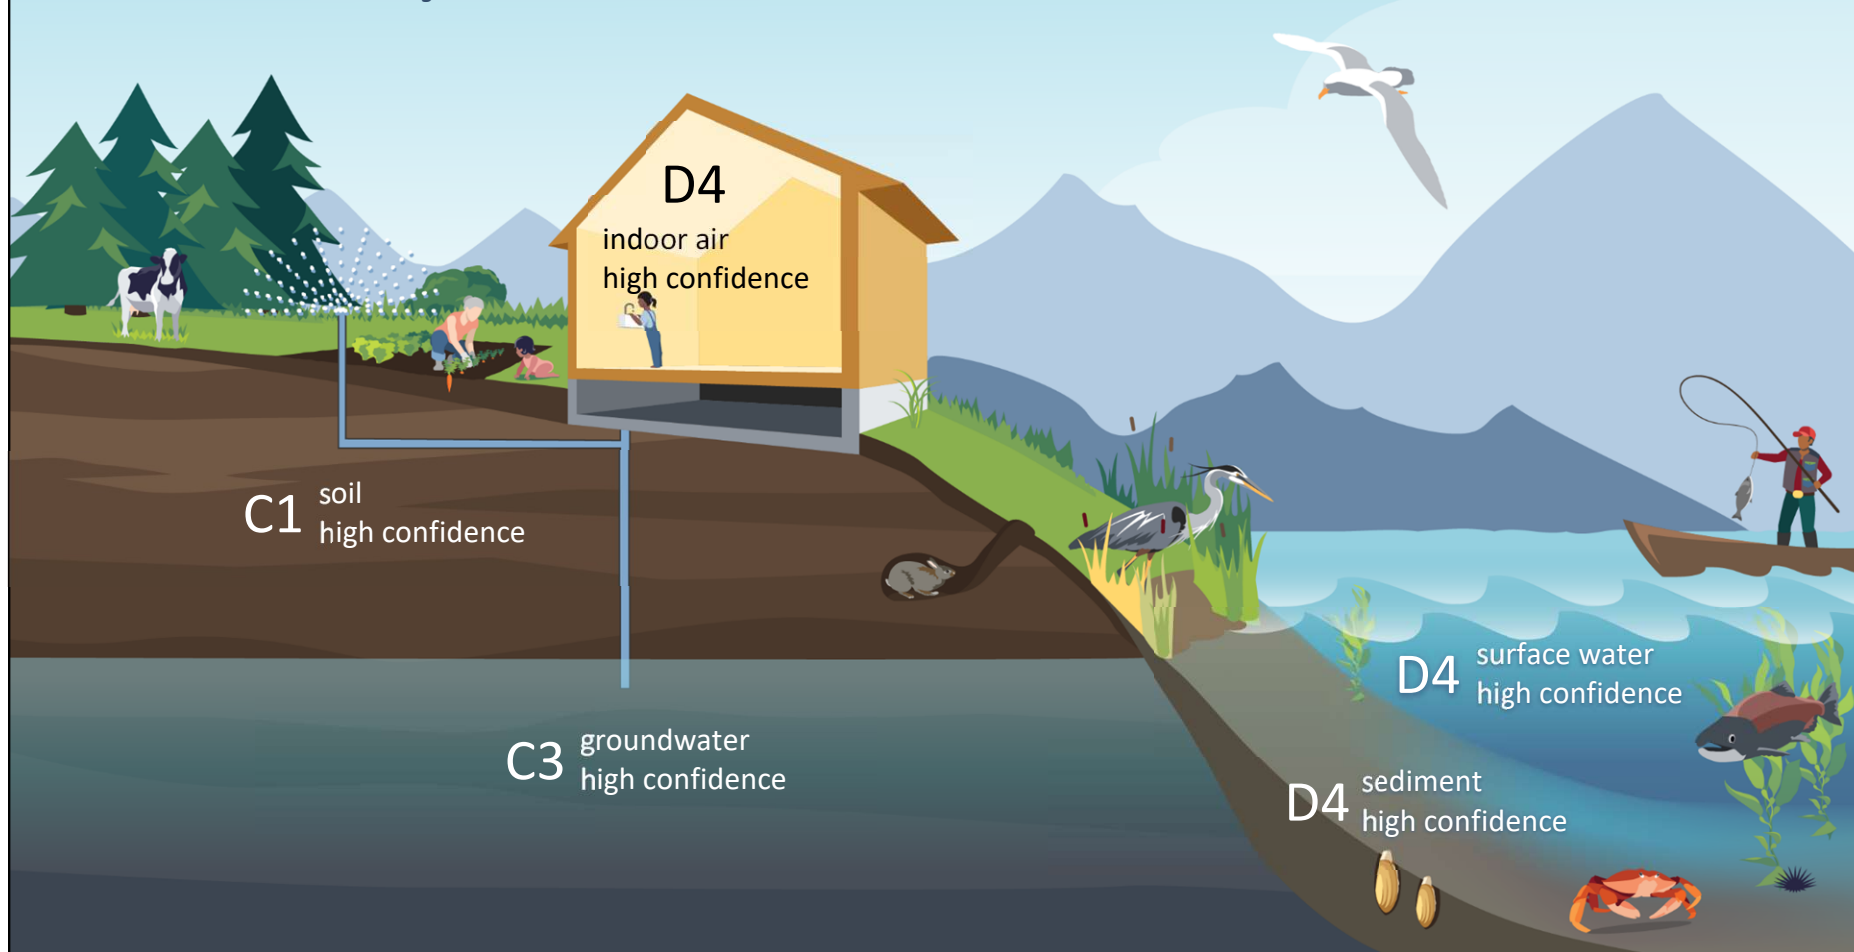
Conceptual site model

Releases at the Site are related to use of a dry-cleaning machine and potential improper disposal of dry-cleaning waste from 1999 to 2007. Halogenated volatile organic compounds (HVOCs) tetrachloroethylene (PCE); cis-1,2-dichloroethene (DCE); and vinyl chloride were released to soil. Groundwater sampling at the Site indicates the only contaminant above relevant cleanup levels is vinyl chloride.

Areas of soil contamination are limited to the areas adjacent to the former location of the dry cleaning machine and an oil-water separator located north of the building.

Groundwater contamination extends northeast of the source areas toward the Sammamish River. Groundwater samples collected from deep monitoring wells indicate that contamination is confined to the shallow groundwater interval.
