# Bothell Riverside HVOC

SHARP Report — Part 1 of 2

# SHARP Report — Part 2 of 2

Conceptual site model

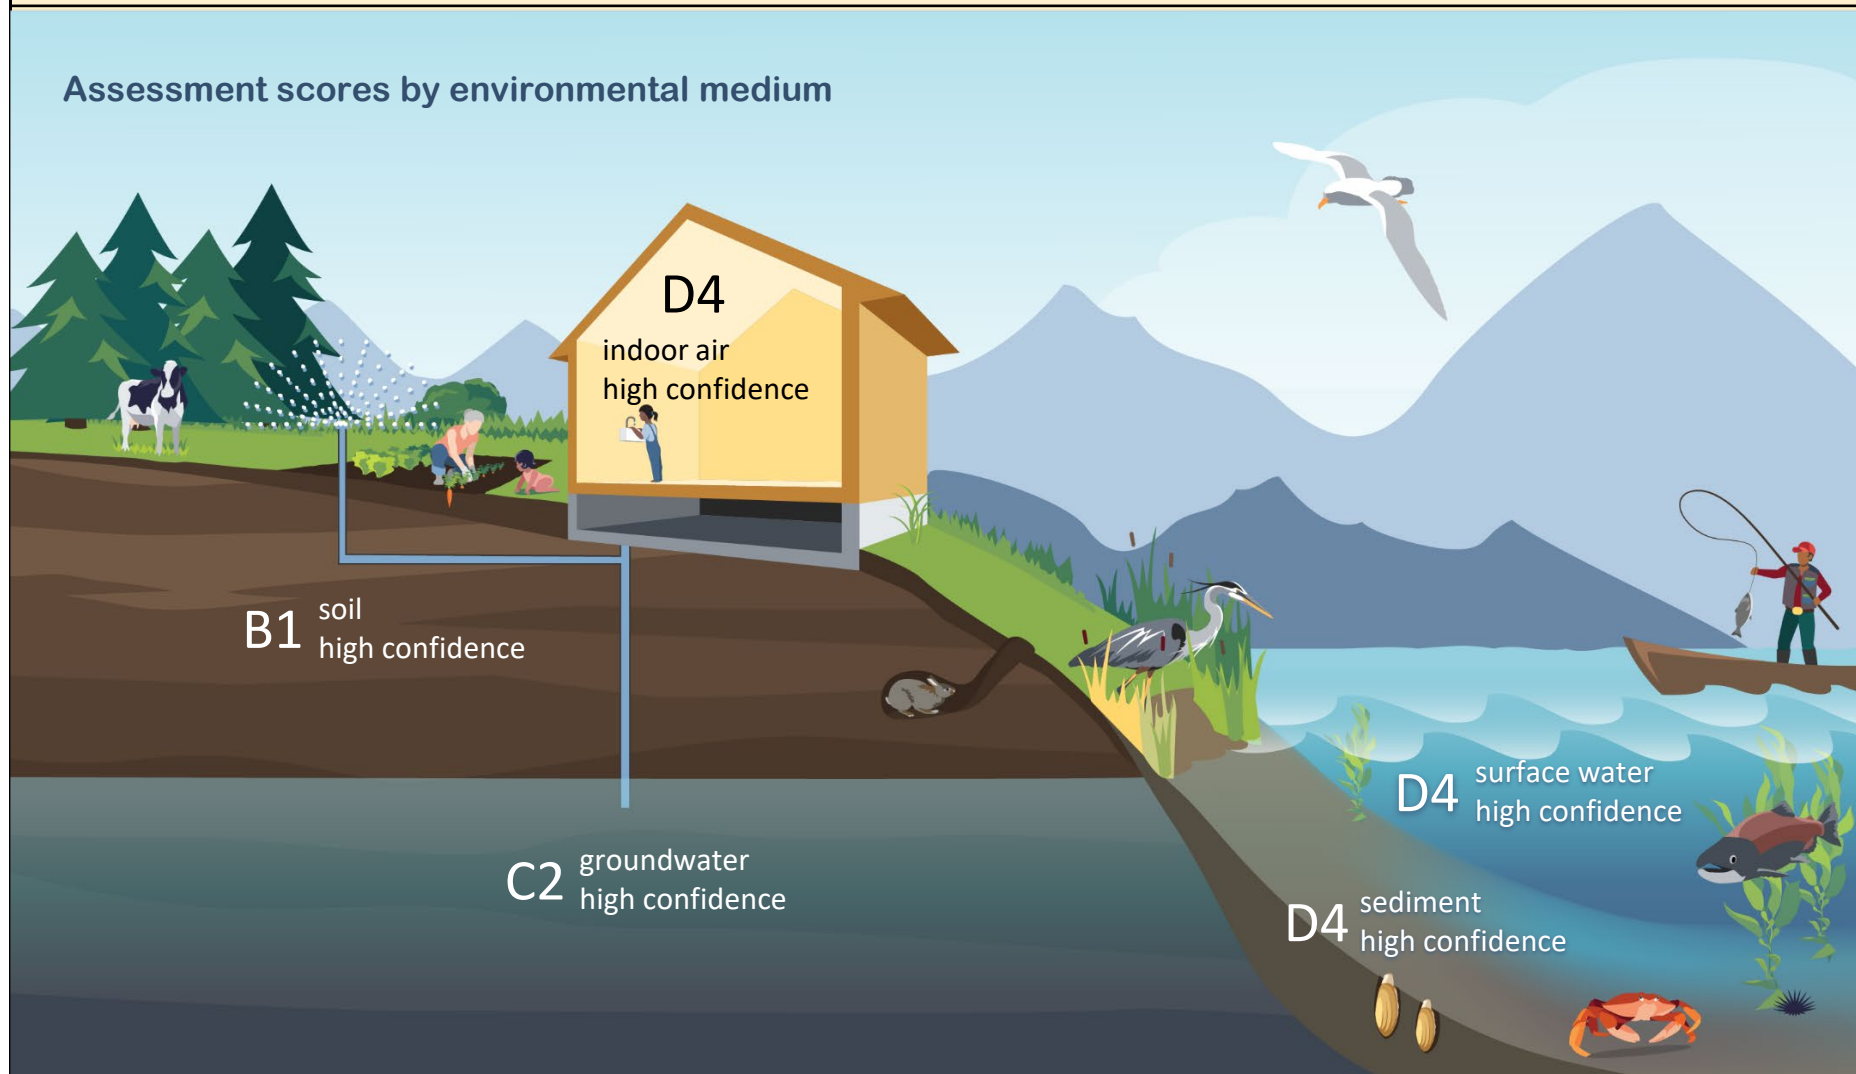
## Assessment scores by environmental medium

SHARP Media	Scores	Confidence	Additional Factors
Indoor air	D4	high	multiple chemical types ⊘
Groundwater	C2	high	risk to off-site people ⊘
Surface water	D4	high	climate change impacts ✓
Sediment	D4	high	plant/animal tissue data ⊘
Soil	B1	high
