University St & 6th Ave Plume

SHARP Report — Part 1 of 2

17084 University St & 6th Ave Plume 20240806

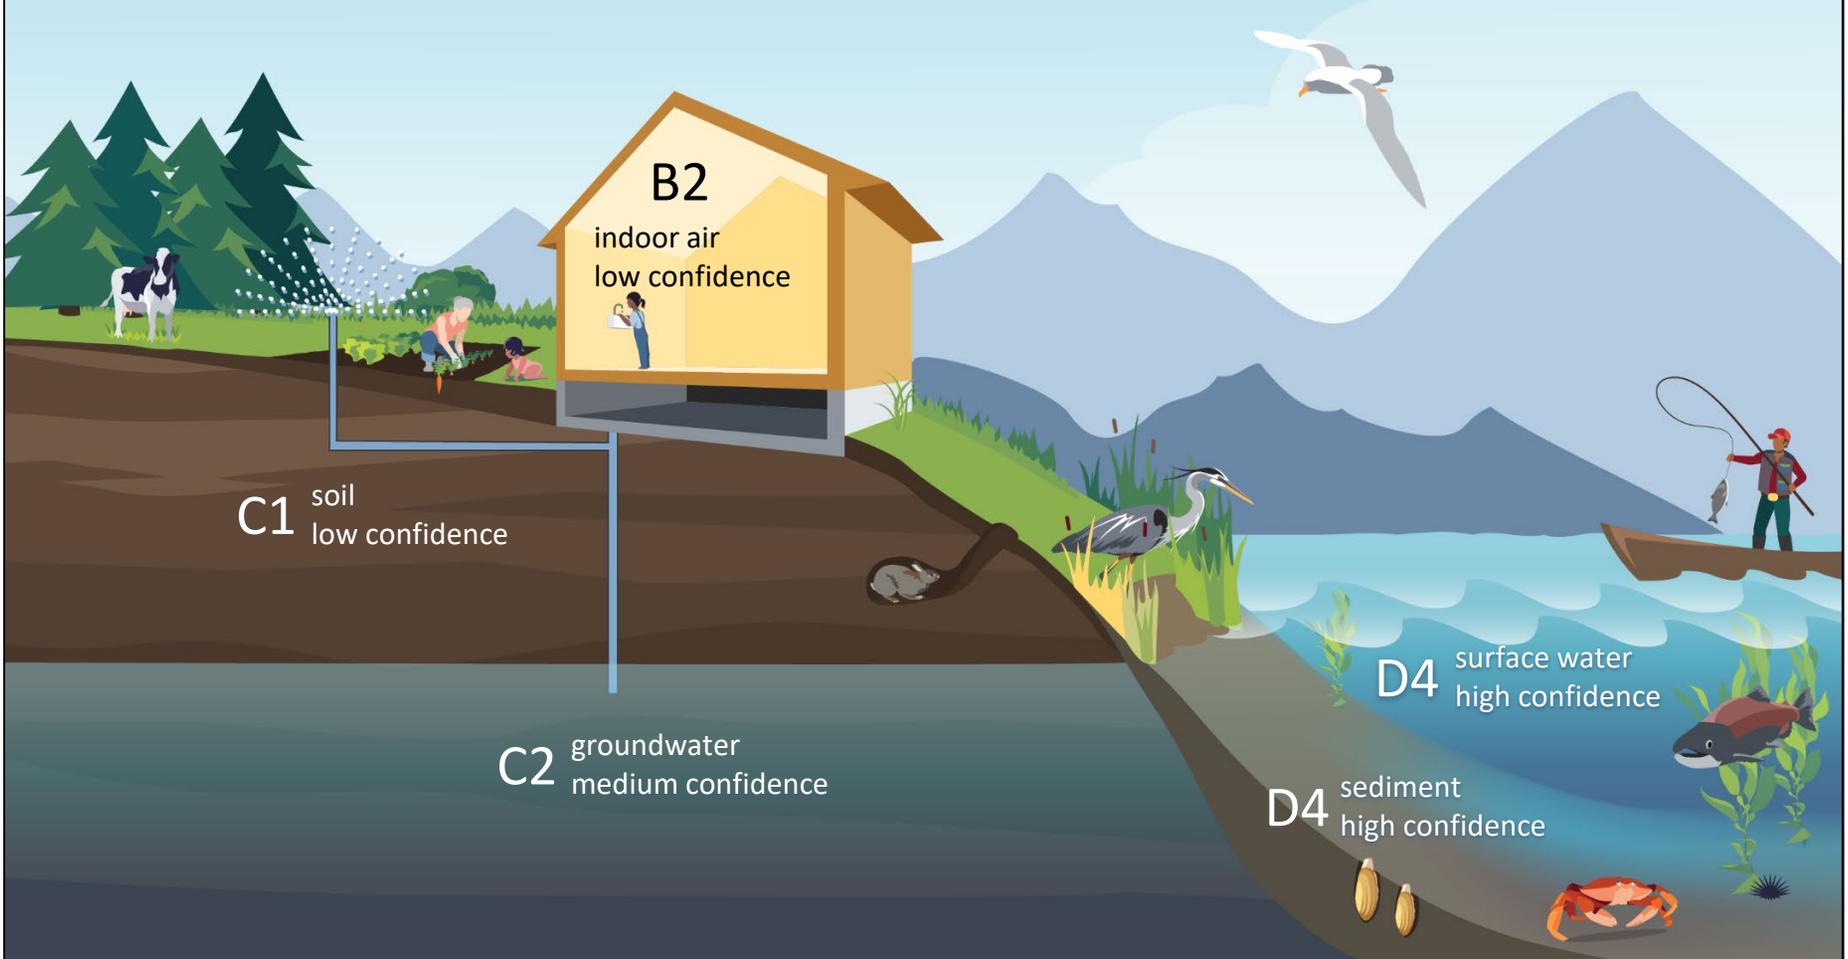
Assessment scores by environmental medium

SHARP Media	Scores	Confidence	Additional Factors
Indoor air	B2	low	multiple chemical types ✓
Groundwater	C2	medium	risk to off-site people ✓
Surface water	D4	high	climate change impacts ☒
Sediment	D4	high	plant/animal tissue data ☒
Soil	C1	low
