## **Periodic Review**

### **Peshastin Dryden Elementary School**

**850 N Western Ave, Peshastin, Chelan County**  
**Facility Site ID: 18617191, Cleanup Site ID: 5641**

July 2022

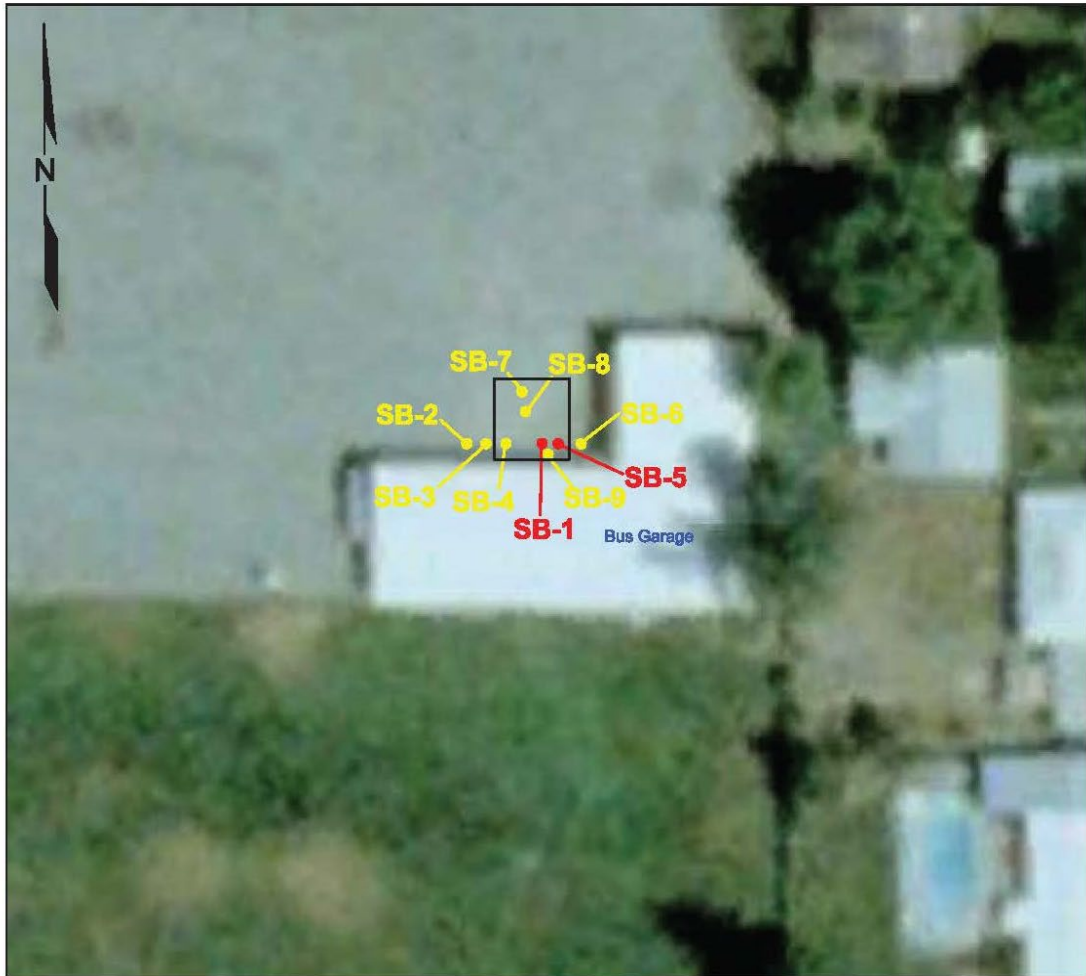
Figure 2  
Site Plan

In addition to the lead and arsenic in soil associated with historical orchard operations, Site contamination includes gasoline in soil associated with two underground storage tanks (USTs) that were removed in 1993. These USTs were located adjacent to a bus building located east of the school (see Figure 2 in Appendix B).

- **SB-3** Approximate Location of Soil Boring with Analytes Below Soil Cleanup Levels
- **SB-5** Approximate Location of Soil Boring with Analytes Exceeding Soil Cleanup Levels
- Former UST Excavation

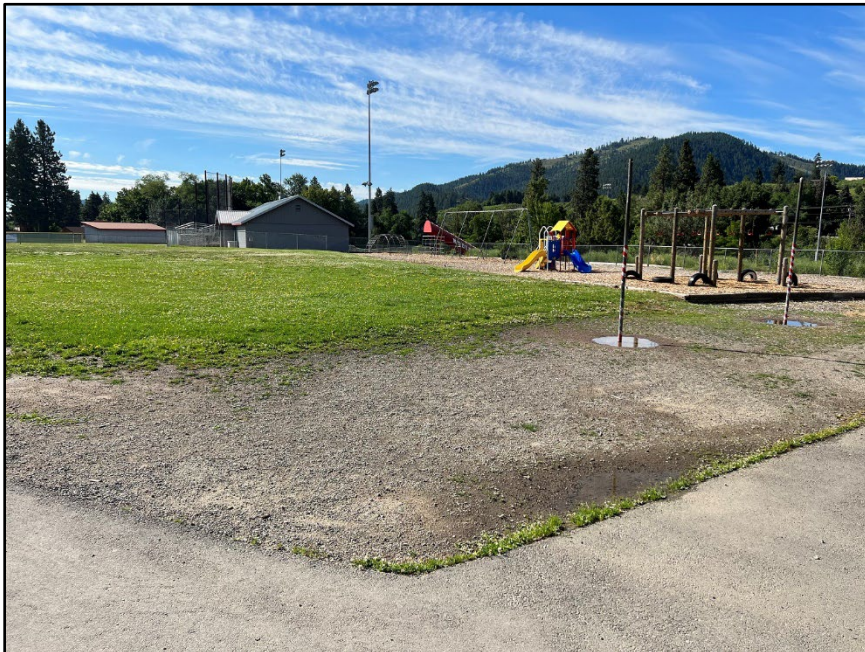
- Bare soil in the tetherball area (Photos 2 and 3).

**Photo 2: Field south of the school (view to the southeast). Note bare soil area.**

Maintenance activities are warranted to prevent erosion in areas of uncovered soil that could lead to potential future exposures to contaminated soils.

Based on this periodic review, Ecology has determined the requirements of the Covenant are being followed. Some surface maintenance activities are recommended as discussed herein. No additional cleanup actions are required by the property owner at this time. The property owner is responsible for continuing to inspect the Site to ensure the integrity of the cap is maintained.

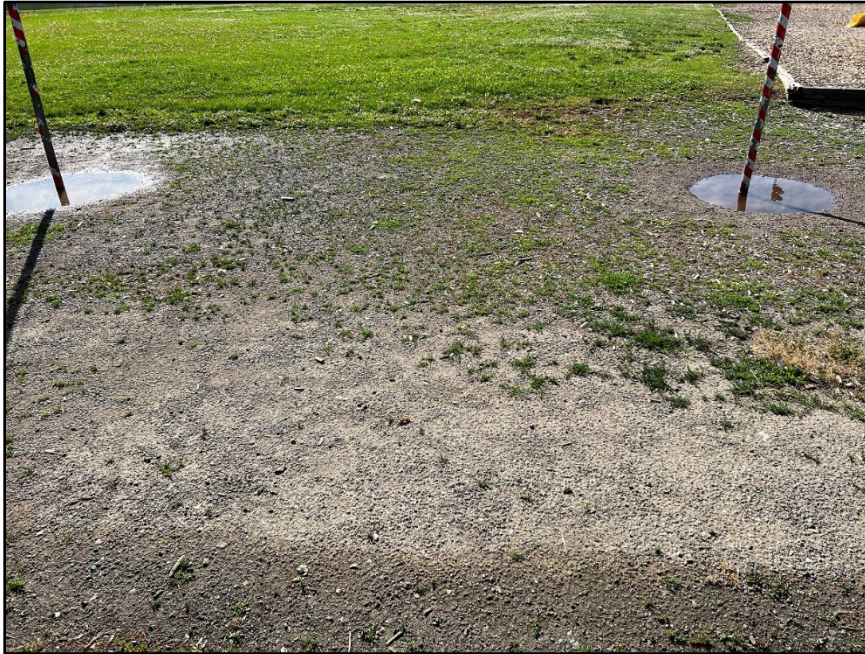
**Photo 3: Close up view of bare soil area**

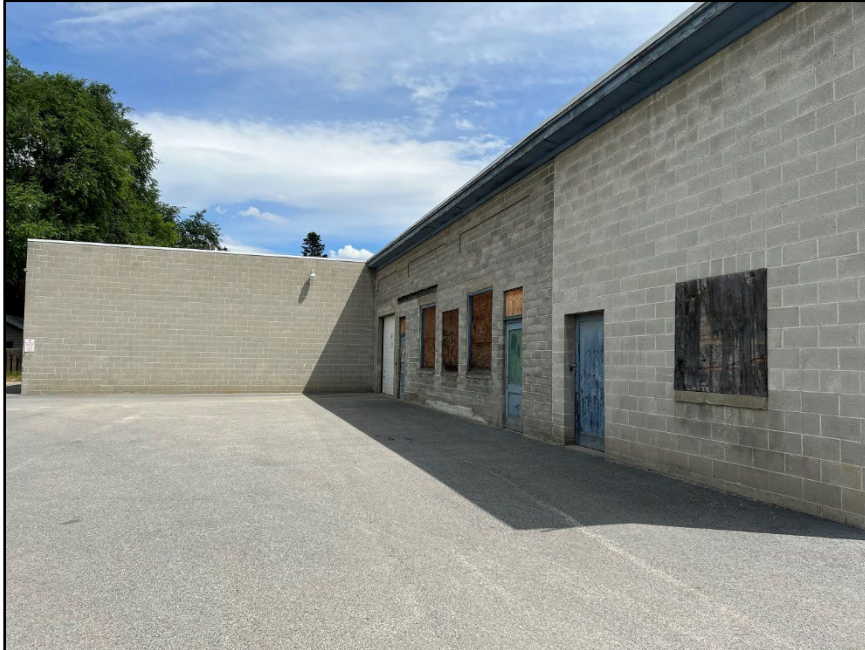
As discussed above, the two USTs at the bus building were removed in 1993 and most soil contamination was believed to have been removed from that area at that time. Some remaining gasoline in soil contamination was characterized in that area in 2010.

The field area was covered with turf grass, and the former UST location was paved. Ecology issued a NFA determination for the arsenic and lead in soil in April 2011 and a Department

**Photo 6: Former underground storage tank location at bus building (view to the east)**
