# Interlake Sporting Association Area

SHARP Report — Part 1 of 2

17136 Interlake Sporting Association Area 20240610

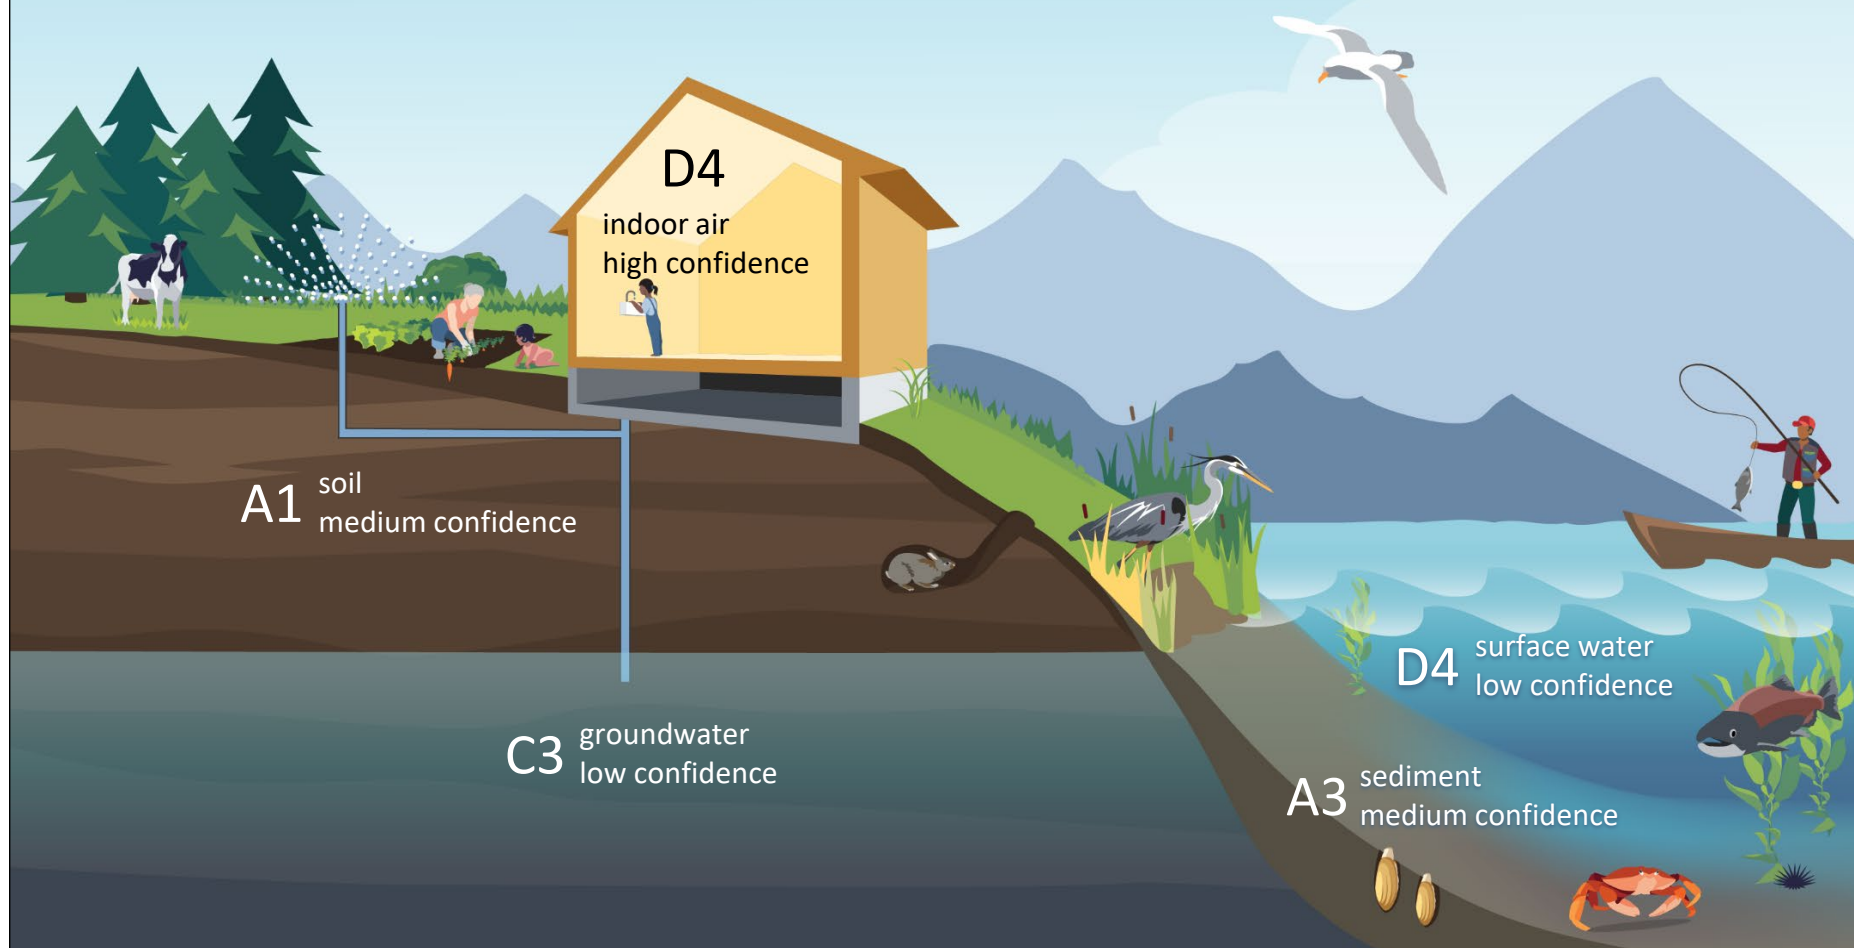
Conceptual site model

Parcel 0325059057 is where samples were collected, Gun Club Creek runs through this property.  
Parcel 0325059054 is the possible source property owned by Interlake Sporting Association.
