Snohomish PUD 3rd Ave NE

SHARP Report — Part 1 of 2

• SHARP first SHARP		v2024.04.29	Ecology Info	
• SHARP rating	Low		ERTS	657576
• SHARP date	08/05/2024		CSID	17116
• EJFlagged?	⊘ - No Override		FSID	49131
• LD confidence level	low		VCP	none
• Cleanup milestone	initial investigation		UST ID	none
• SHARPster	Priscilla Tomlinson		LUST ID	none

Location and land use info	
28514 3rd Ave NE (aka Kuhnhauser Rd), Arlington, Snohomish County, 98223	
Primary parcel	32041300400901
Land use	residential
Responsible unit	NWRO

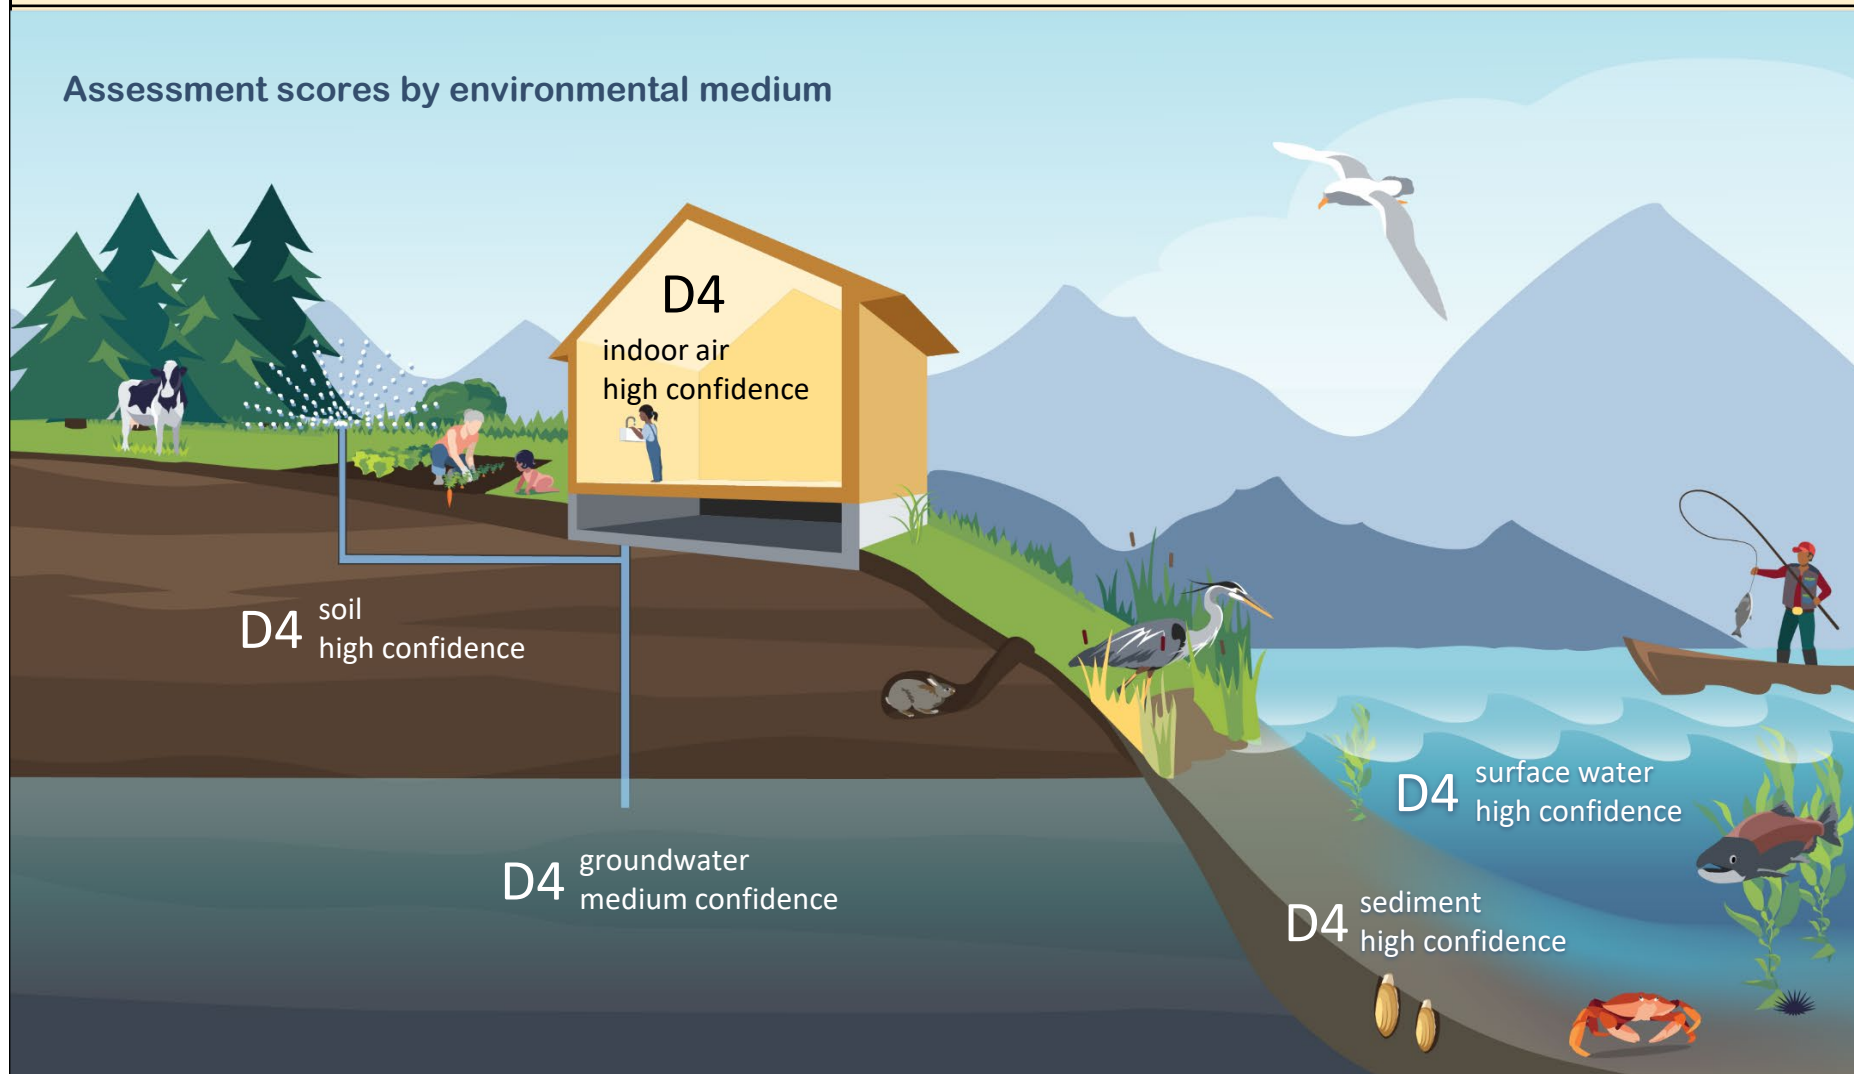
Assessment scores by environmental medium

SHARP Media	Scores	Confidence	Additional Factors	
Indoor air	D4	high	multiple chemical types	⊘
Groundwater	D4	medium	risk to off-site people	⊘
Surface water	D4	high	climate change impacts	⊘
Sediment	D4	high	plant/animal tissue data	⊘
Soil	D4	high
