SHARP Report — Part 1 of 2

10700 Minuteman Dr, Everett, Snohomish County, 98204

17199 Swamp Creek PFAS 20250115

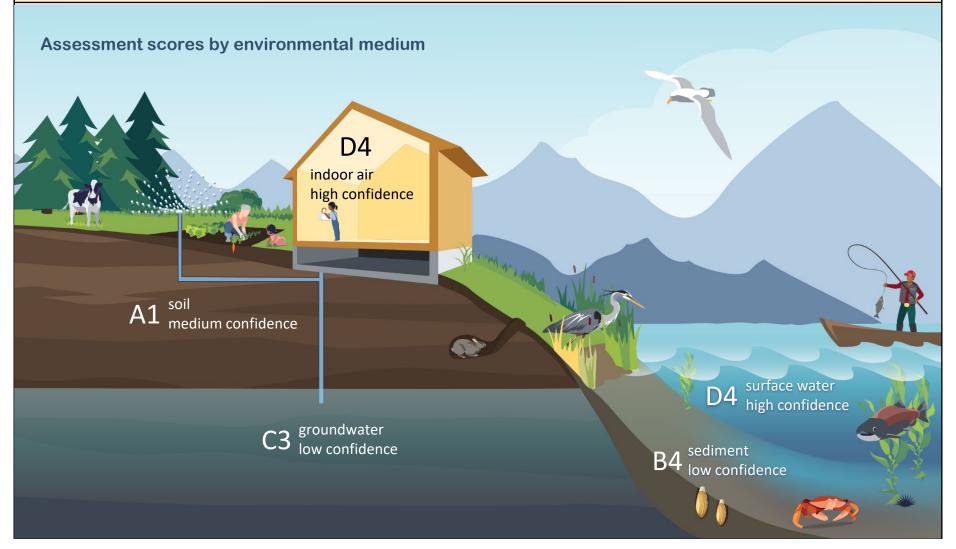
Conceptual site model 01/15/2025

Releases at the Site consist of per- and polyflouroalkyl substances (PFAS) including the compounds PFOA, PFOS, PFNA, and PFHxS. Samples collected at the Site to date have been collected near stormwater outfalls that drain the southeastern portion of Paine Field Airport and uses include light industral use, runways, and aircraft storage. Several releases of aqueous film forming form (AFFF), which contains PFAS compounds, were documented in the southeastern portion of Paine Field from 1990s through 2010.

Site history <u>Go to top</u>
Soil, catch basin solids, and surface water samples were collected from wetlands adjacent to stormwater outfalls
that drain the southeastern portion of Paine Field. Soil and surface water samples contained PFOA, PFOS, PFNA,
and PFHxS above Washington State's preliminary cleanup levels for these compounds.
