## **PHASE I ENVIRONMENTAL SITE ASSESSMENT REPORT**

**2885 78<sup>th</sup> Avenue Southeast  
Mercer Island, Washington**

**Farallon PN: 2049-001**

May 23, 2018

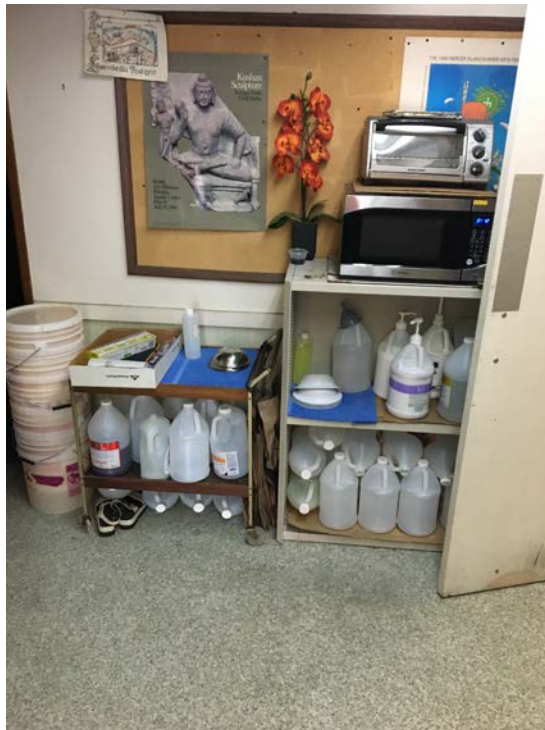
**Photograph 6:** Chemicals storage in the Q Nails tenant space.

At the time of the site reconnaissance, Farallon observed minor amounts of sealed chemicals in the Q. Nails tenant space and janitorial cleaning supplies in multiple tenant spaces. The containers ranged in size from 16-ounce plastic bottles to 1-gallon plastic jugs. Quart-sized or smaller containers of automotive maintenance chemicals were stored outside the Tiger Garden Chinese Restaurant and Lounge. The various chemicals stored in and outside the tenant spaces appeared to be in good condition, with no evidence of leaks or spills noted.

Farallon observed closed and sealed chemicals related to the operation of the Q. Nails tenant space, and janitorial cleaning supplies in multiple tenant spaces. The containers ranged in size from 16-ounce plastic bottles to 1-gallon plastic jugs. The various materials observed appeared to be in good condition, with no evidence of leaks or spills noted.

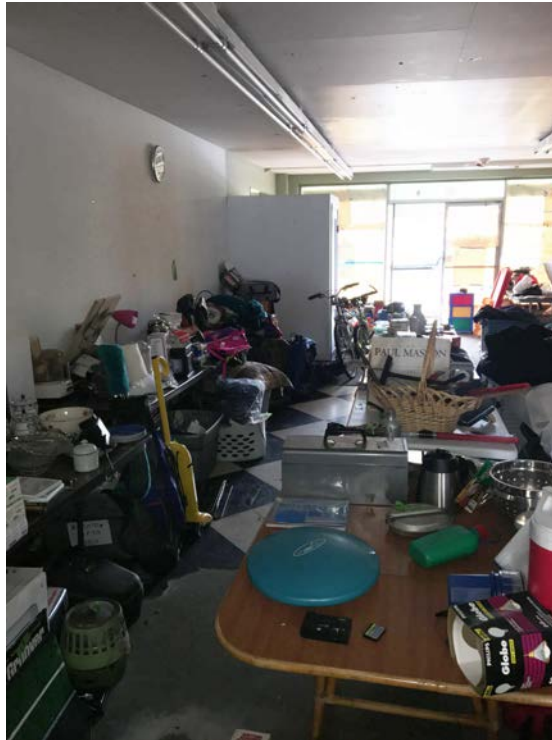
**Photograph 7:** Former dry cleaning facility.

A+ Cleaners, a dry cleaning facility, operated at the Site for approximately 12 years and ceased operations in April 2015. The former dry cleaning facility currently is used by the Site owner for storage of items being prepared for a garage sale. A confirmed release of hazardous substances associated with historical dry cleaning operations on the Site represents a recognized environmental condition in connection with the Site.

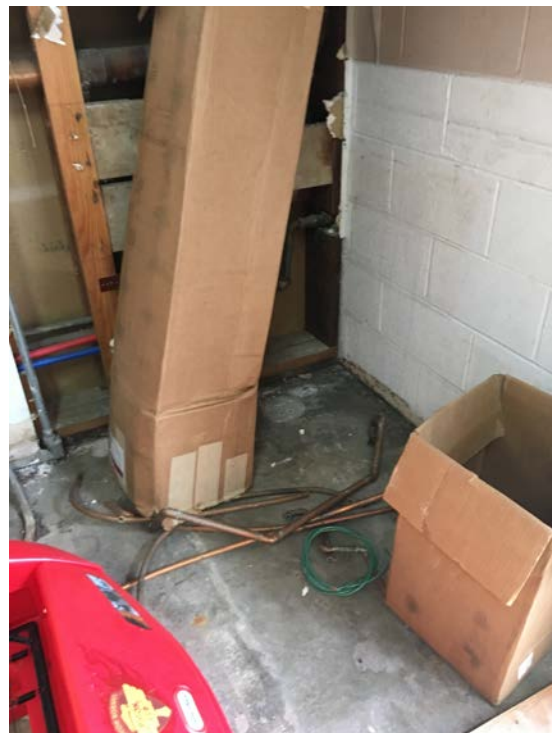
**Photograph 8:** Location of the former dry cleaning machine.

Farallon observed a floor drain in the former dry cleaning facility proximate to the location where the former dry cleaning machine existed, a floor drain in the second-floor men's restroom, and two floor drains in a former pizza restaurant on the second floor in the western portion of the building. According to the Site representative, the floor drains are connected to the sanitary sewer. No visible staining or evidence of improper disposal of hazardous materials was observed.

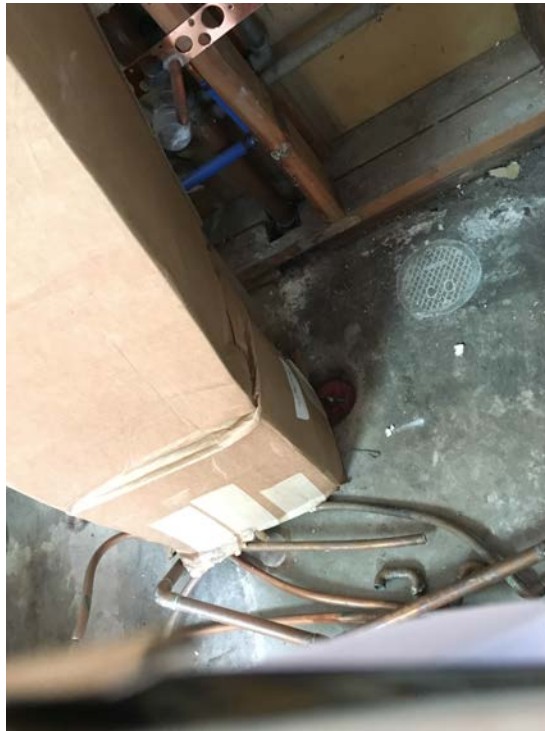
**Photograph 9:** Floor drain in the former dry cleaning facility.

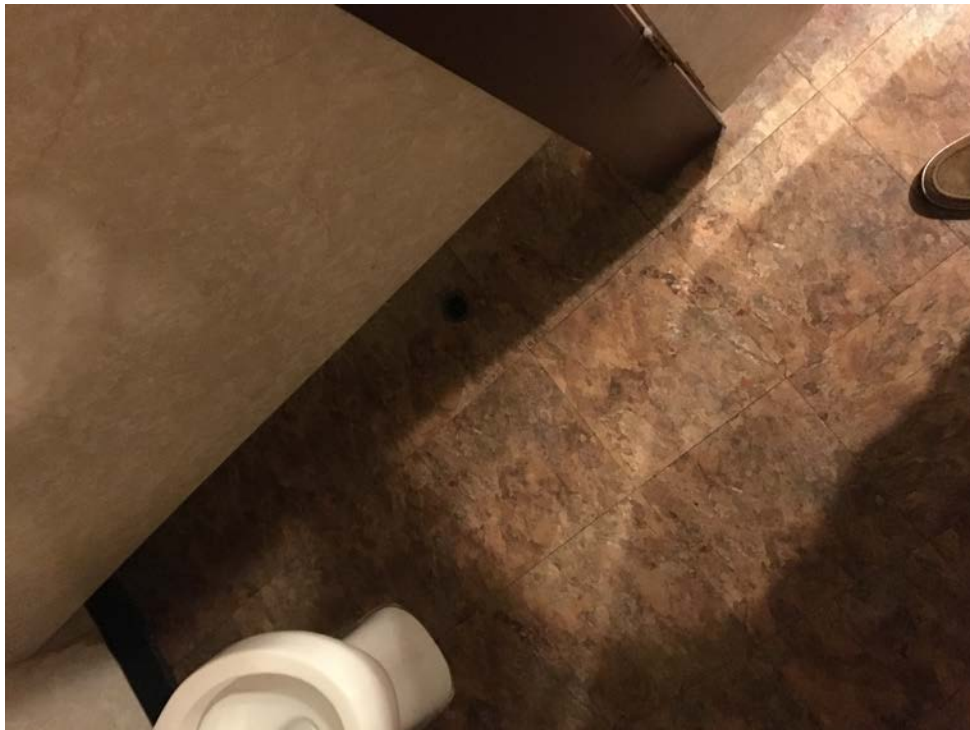
**Photograph 14:** Small floor drain in the second-floor restroom.

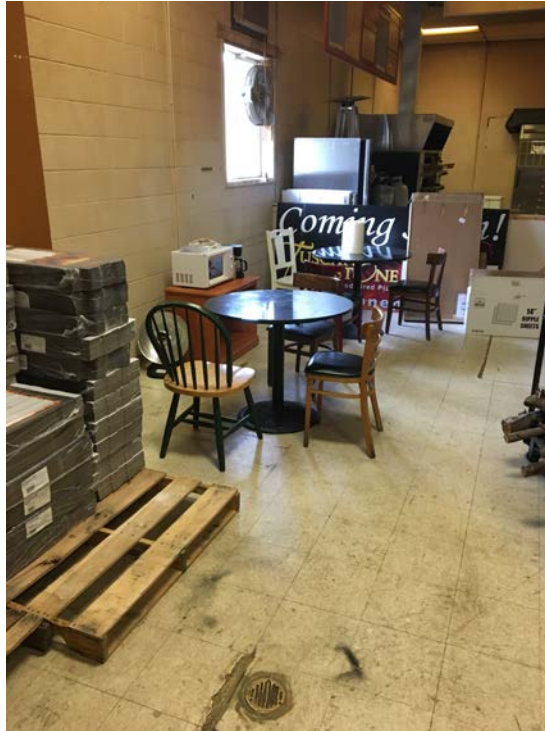
**Photograph 15:** Floor drain in the former pizza kitchen.

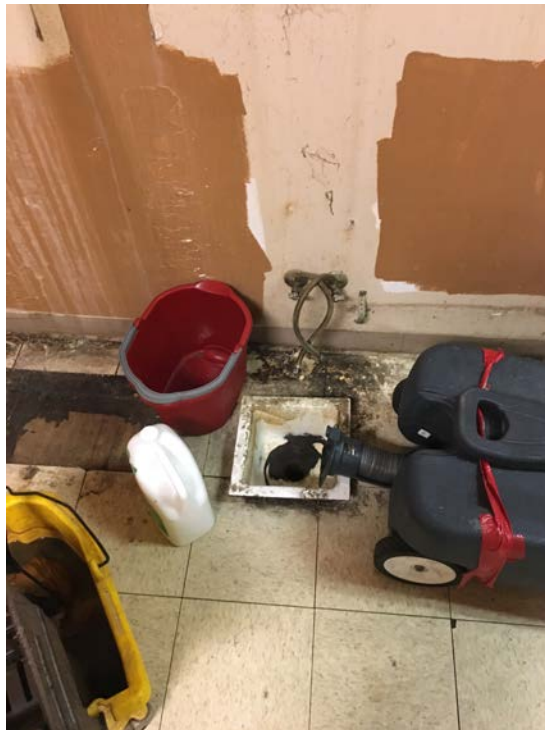
**Photograph 16:** Floor drain in the former pizza kitchen.

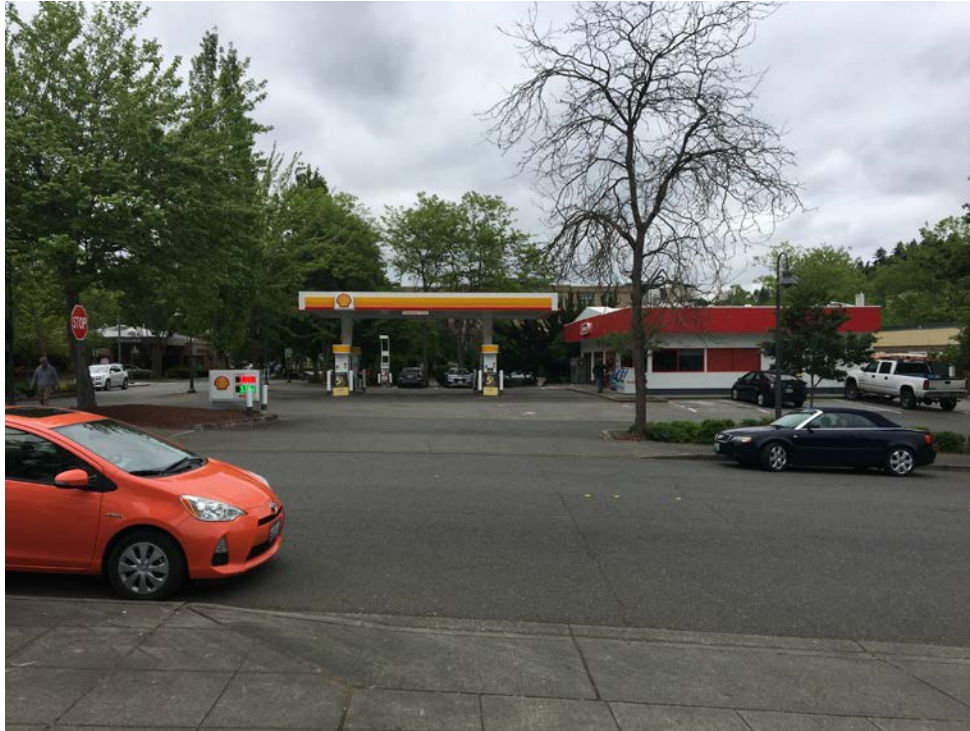
**Photograph 17:** South-adjacent gasoline station.

- **Texaco #63/Jacksons 623/Shell Oil Products US SAP**, south-adjacent to the Site and at a similar topographic elevation, was identified in the SPILLS, ICR, CSCSL NFA, ALLSITES, RCRA NonGen, UST, and VCP databases. According to the ERIS Report, the facility removed four USTs as of August 1996, and four operational USTs remain on the property. The facility was a handler of hazardous materials, with no reported violations. The facility had soil and groundwater contamination by petroleum products and received
