# Cameo Shop a.k.a Cameo Boutique

SHARP Report — Part 1 of 2

17205 Cameo Shop a.k.a Cameo Boutique 20250319

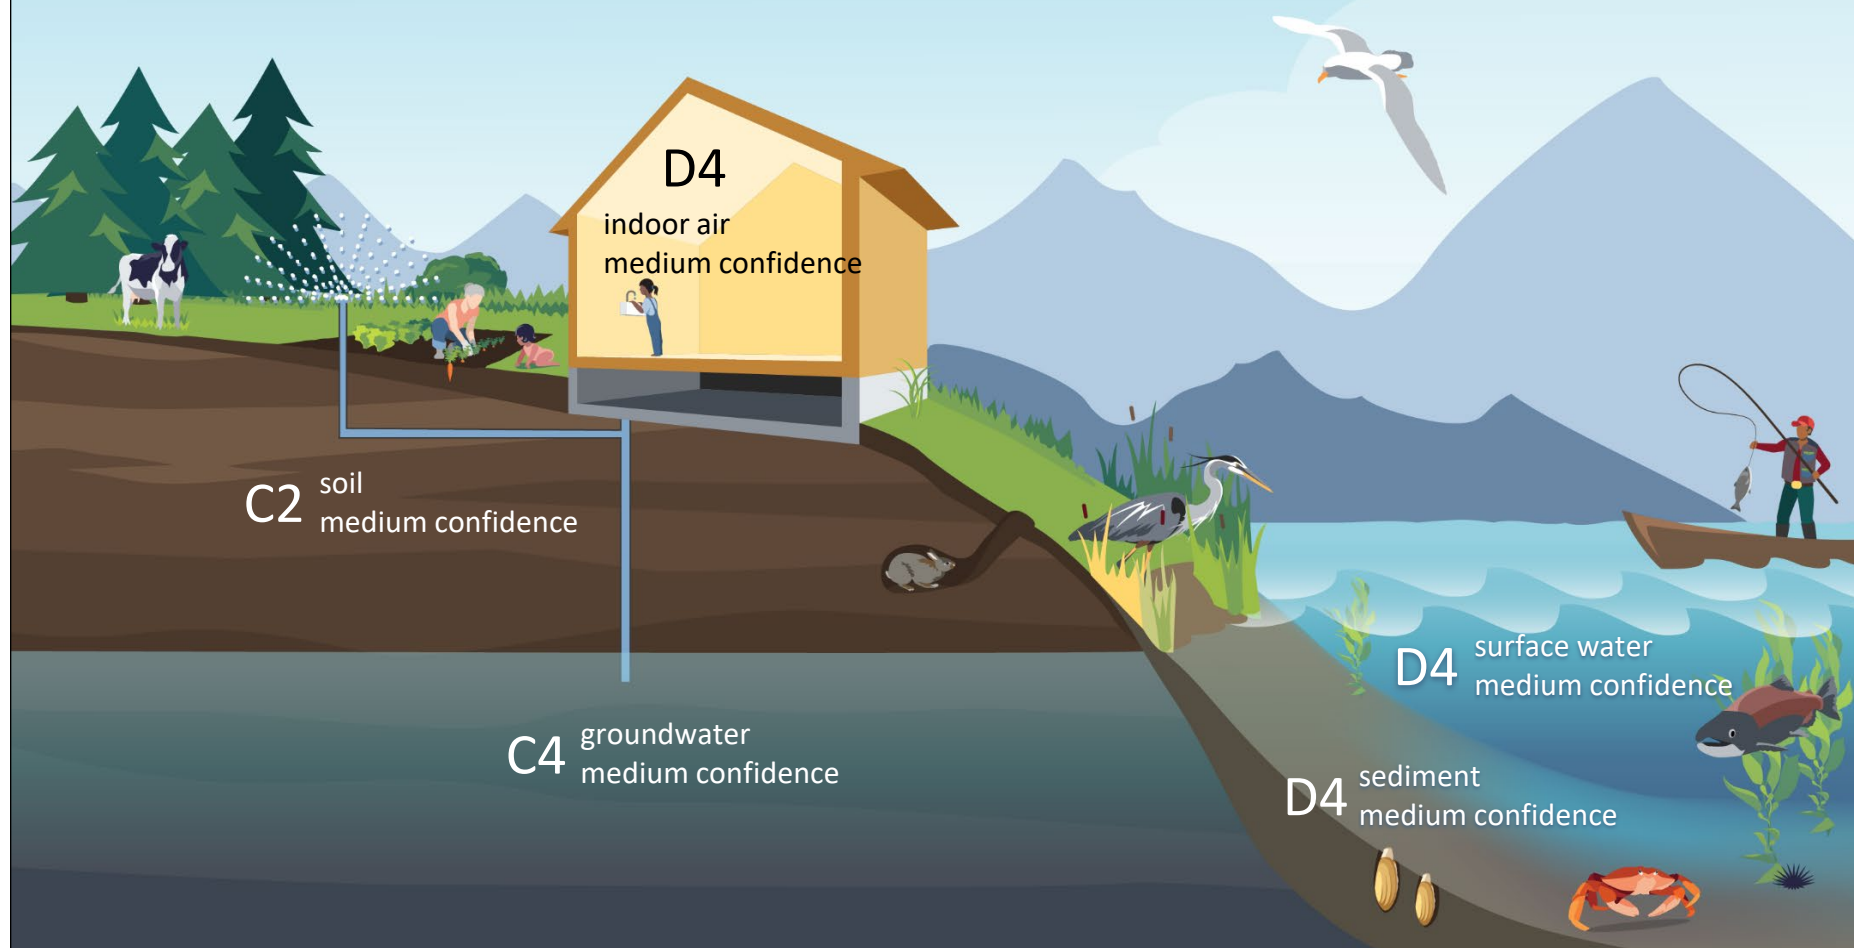
### Assessment scores by environmental medium

SHARP Media	Scores	Confidence	Additional Factors	
Indoor air	D4	medium	multiple chemical types	⊘
Groundwater	C4	medium	risk to off-site people	⊘
Surface water	D4	medium	climate change impacts	✓
Sediment	D4	medium	plant/animal tissue data	⊘
Soil	C2	medium
