# **Remedial Action Operation and Maintenance and Groundwater Monitoring Annual Report – 2024**

**Bonneville Power Administration Site  
Tacoma, Washington  
Consent Order No. 97206045**

February 2025

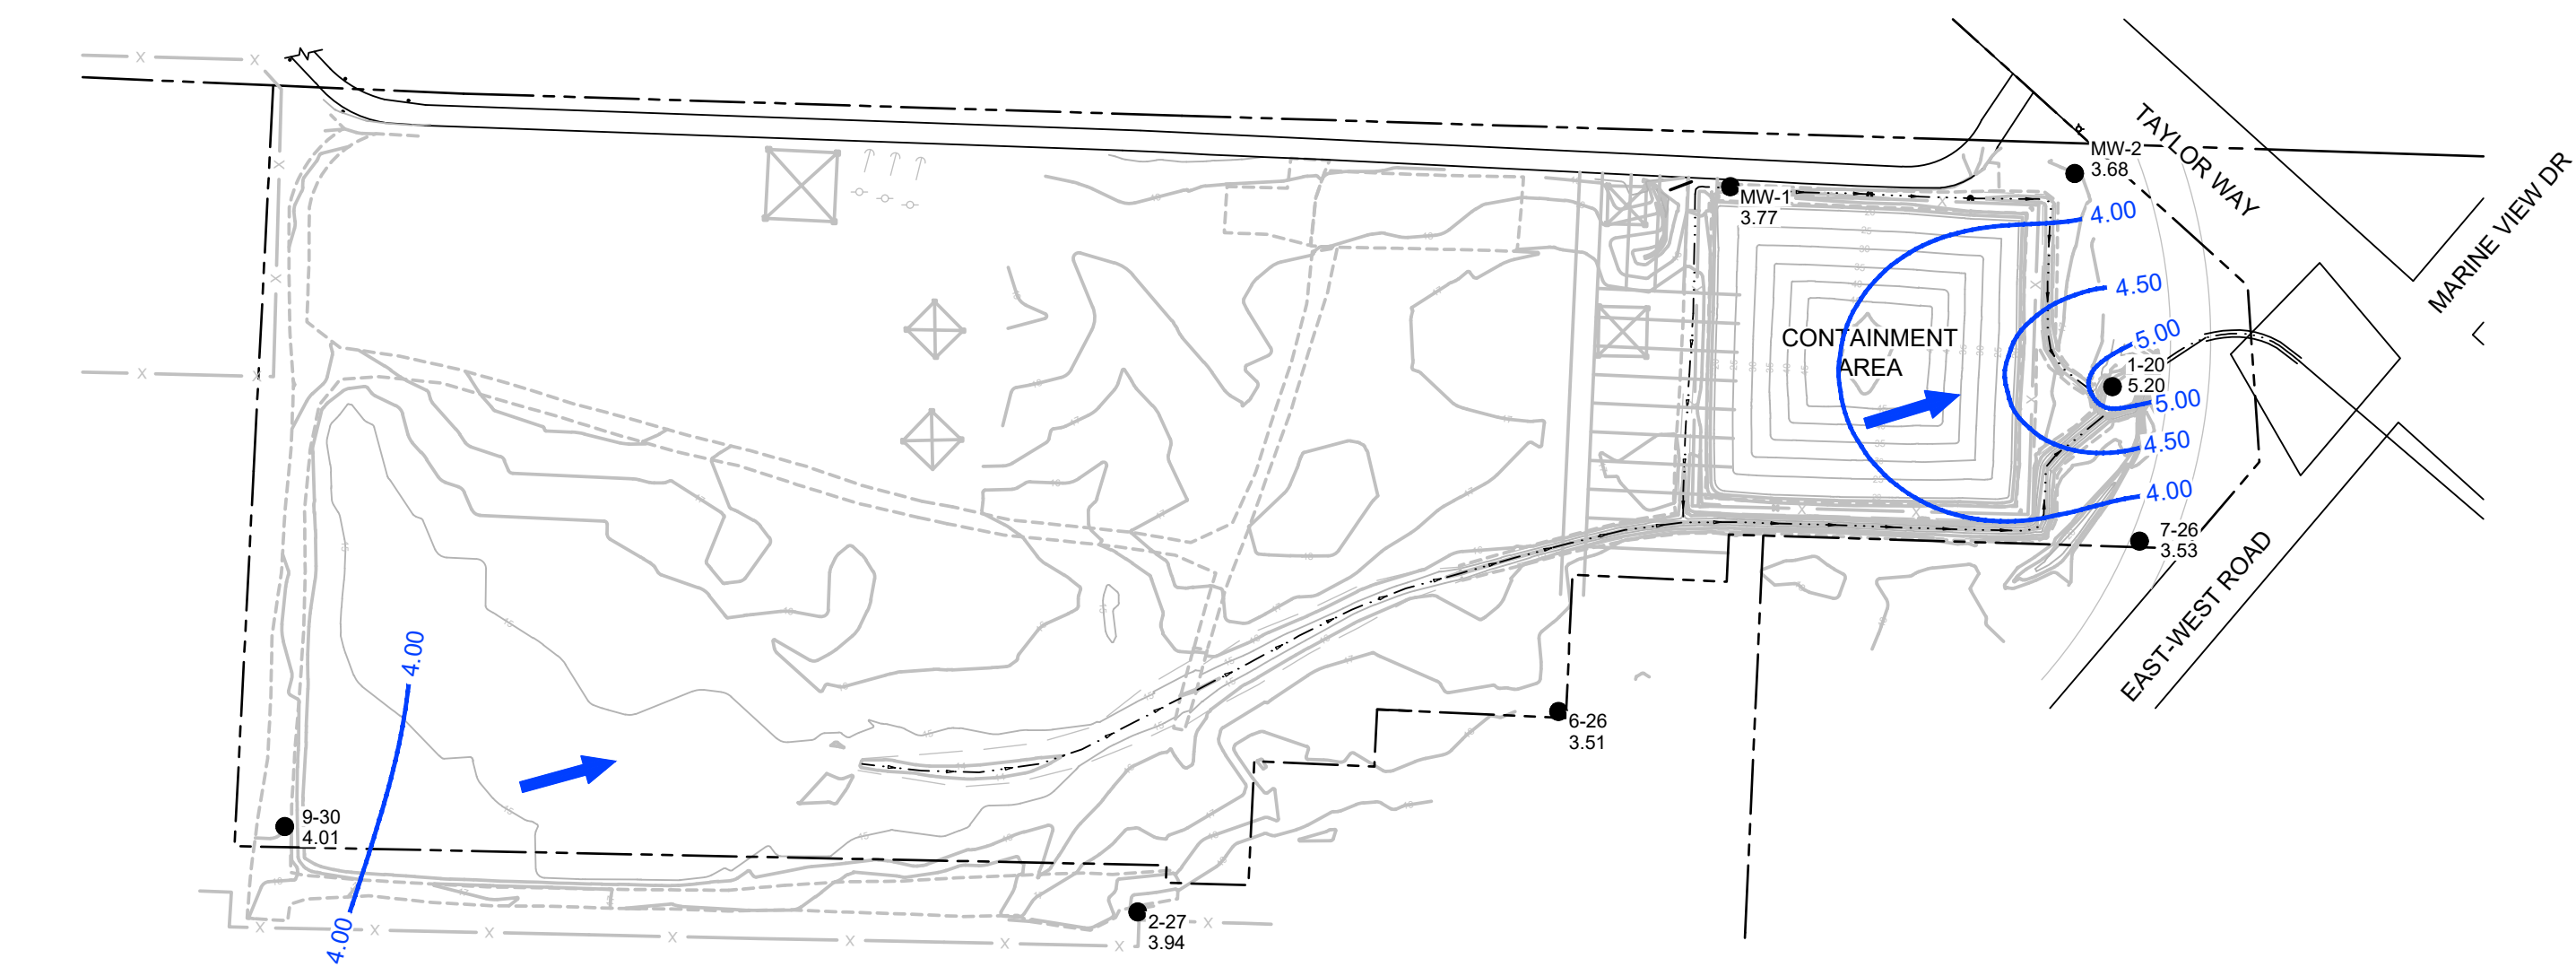
| FIGURE<br>3.1 | |

Site-wide hydraulic monitoring is performed in conjunction with each groundwater sampling event. A tabulation of the groundwater elevations measured since the commencement of the CMP is presented in Table 3.2. Groundwater elevations, potentiometric contour lines and groundwater flow direction are presented on Figure 3.1.

| SITE PLAN AND GROUNDWATER<br>CONTOUR MAP - NOVEMBER 2024<br>COMPLIANCE MONITORING PROGRAM<br>BONNEVILLE POWER ADMINISTRATION SITE<br>TACOMA, WASHINGTON | |

The monitoring wells included in the Site monitoring program are listed in Table 3.1 and shown on Figure 3.1.

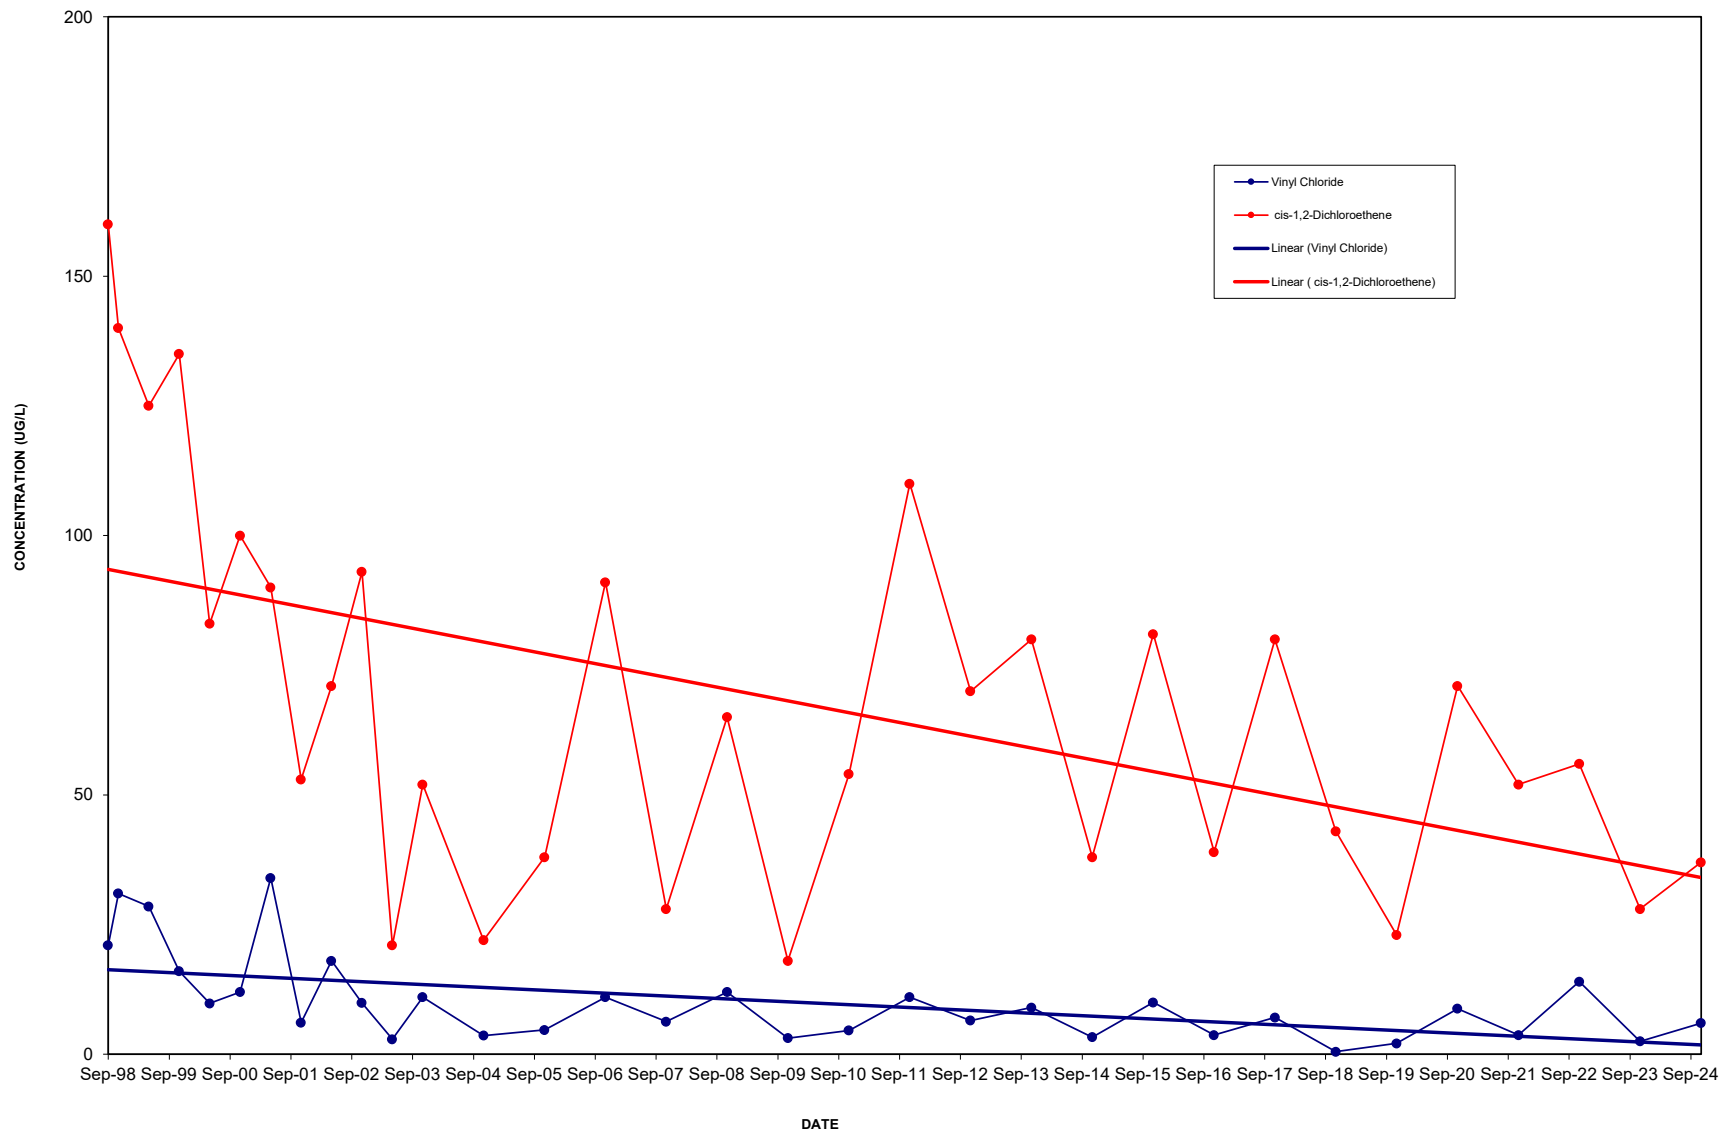
figure 4.1

CONCENTRATION VS. TIME - 1-20  
COMPLIANCE MONITORING PROGRAM  
BONNEVILLE POWER ADMINISTRATION  
*Tacoma, Washington*

The 2024 groundwater sampling event was conducted on November 19, 2024. Samples were collected from monitoring wells 1-20 and 7-26. There were detections of cis-1,2-DCE and Vinyl Chloride for both monitoring wells 1-20 and 7-26. The analytical data for cis-1,2-DCE and vinyl chloride in monitoring wells 1-20 and 7-26 have been graphed as shown on Figures 4.1 and 4.2. To assist in the evaluation of chemical presence at these locations, linear trend lines have been added to the graphs. The graphs show overall downward trends in the cis-1,2-DCE concentrations in these wells since the baseline monitoring event was conducted in September 1998. The graphs also show a downward trend in vinyl chloride concentrations in well 1-20 and stable concentrations in well 7-26.

For the last 8 years the concentrations of cis-1,2-DCE in well 1-20 have continued to show some variability hovering at or below the clean-up criteria for the site. These detections are consistent with the historic data and the general decreasing trend of both contaminants continues. This increase will be further assessed following the fall 2025 sampling event. Continued monitoring is scheduled and appropriate.

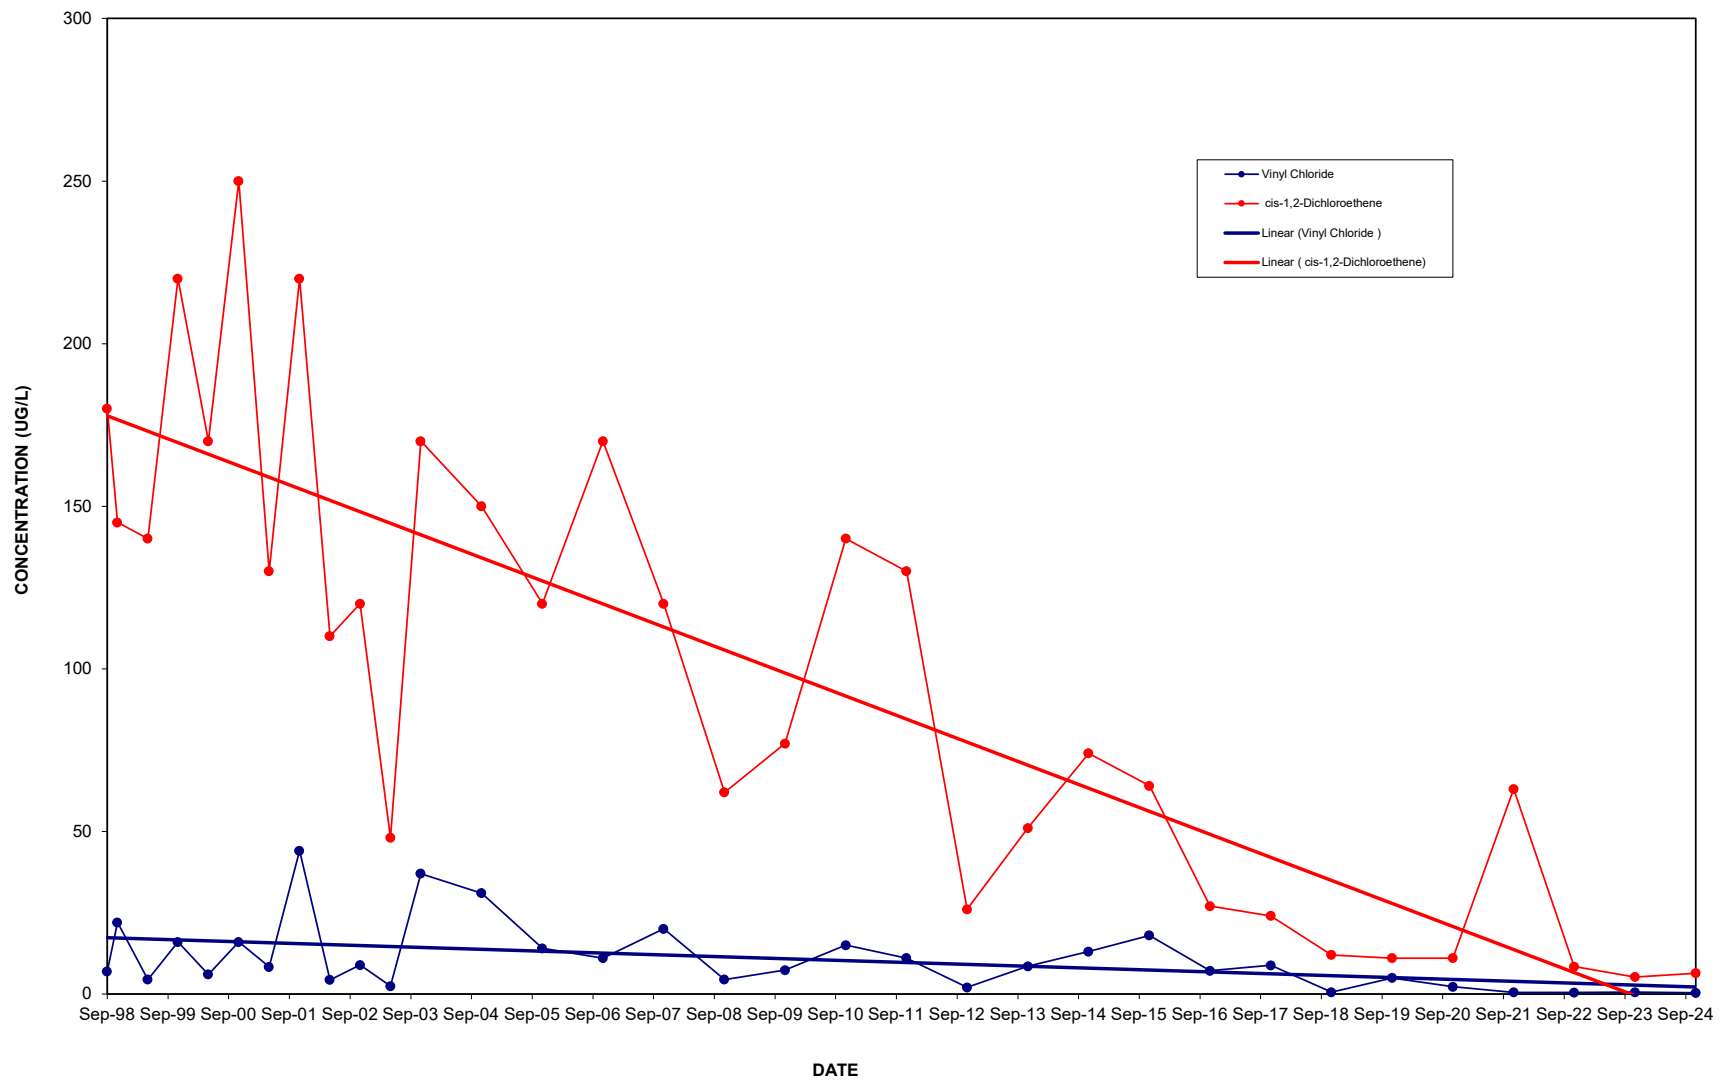
figure 4.2

CONCENTRATION VS. TIME - 7-26  
COMPLIANCE MONITORING PROGRAM  
BONNEVILLE POWER ADMINISTRATION  
*Tacoma, Washington*
