Cascade Millwork & Supply Tacoma

SHARP Report — Part 1 of 2

11925 Cascade Millwork & Supply Tacoma 20241210

Conceptual site model

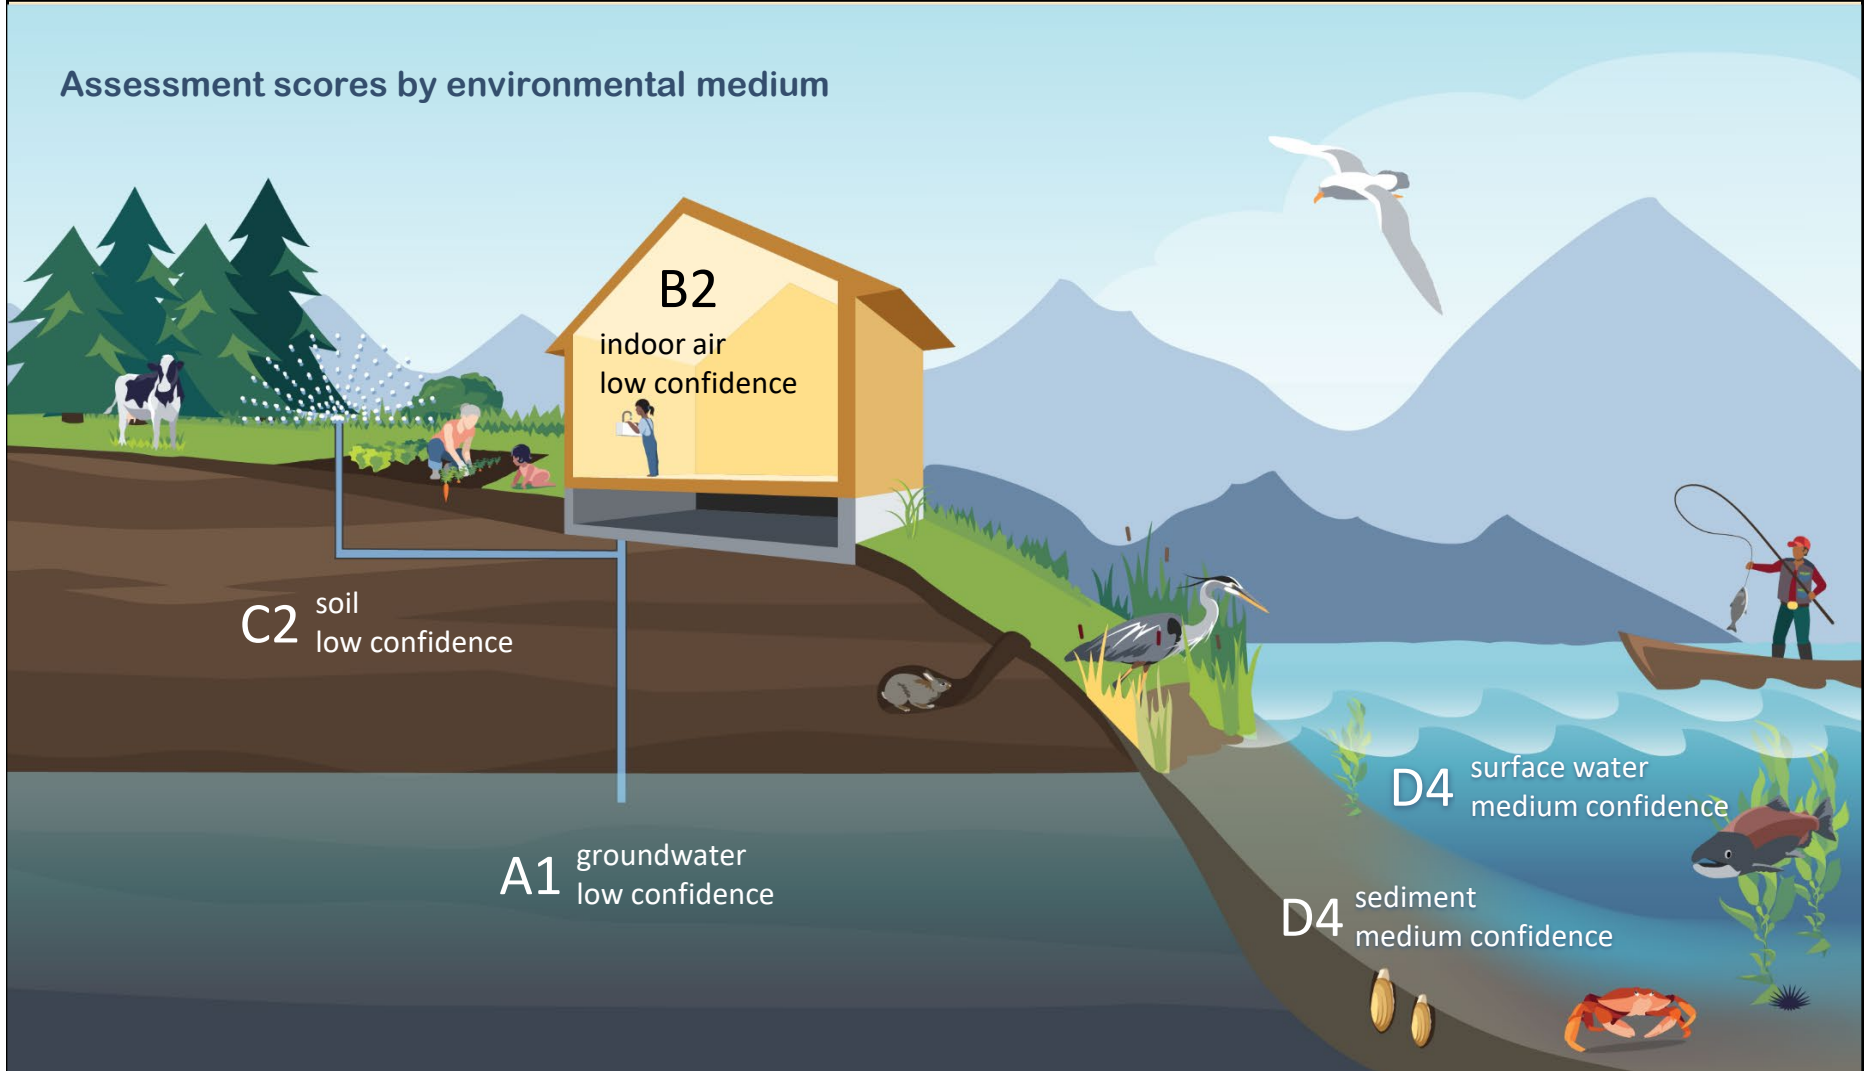
A furniture refinishing business had been operating at the site. Solvents were not handled properly, leading to site contamination.

No soil data was available. Suspected soil contaminants are methylene chloride, toluene, benzenes, phenol, xylenes, arsenic, lead, and zinc.

No groundwater data was available. Suspected contaminants are methylene chloride, toluene, benzenes, phenol, xylenes, arsenic, lead, and zinc.

No soil gas or indoor air data was available. Given the age of the building and the improper storage of solvents at the site, albeit years ago, vapor intrusion is a potential concern.
