Chevron Pipeline Co. Pasco Bulk Fuel Terminal

SHARP Report — Part 1 of 2

SHARP Report — Part 2 of 2

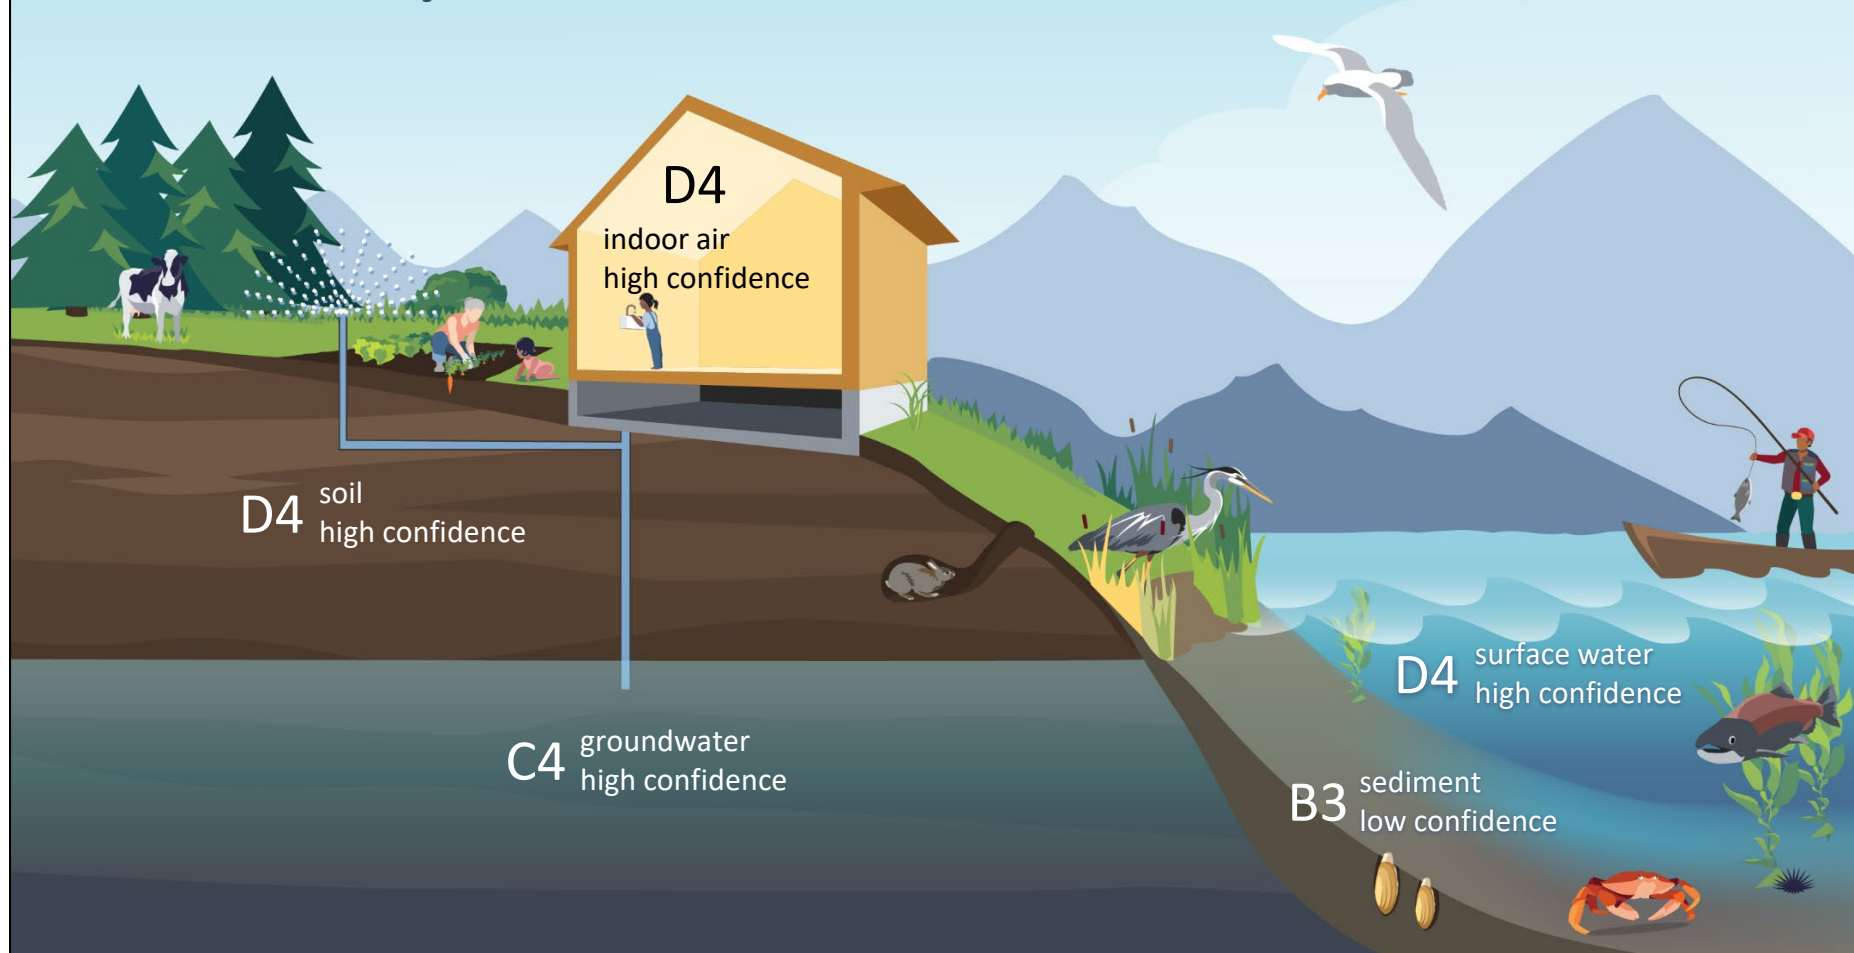
Assessment scores by environmental medium

SHARP Media	Scores	Confidence	Additional Factors	
Indoor air	D4	high	multiple chemical types	✓
Groundwater	C4	high	risk to off-site people	⊗
Surface water	D4	high	climate change impacts	⊗
Sediment	B3	low	plant/animal tissue data	⊗
Soil	D4	high
