**Attachment A**  
**Well Completion Table**  
**American Linen Supply Co–Dexter Avenue Site**  
**Seattle, Washington**

**CVOC TIME-TREND PLOTS**

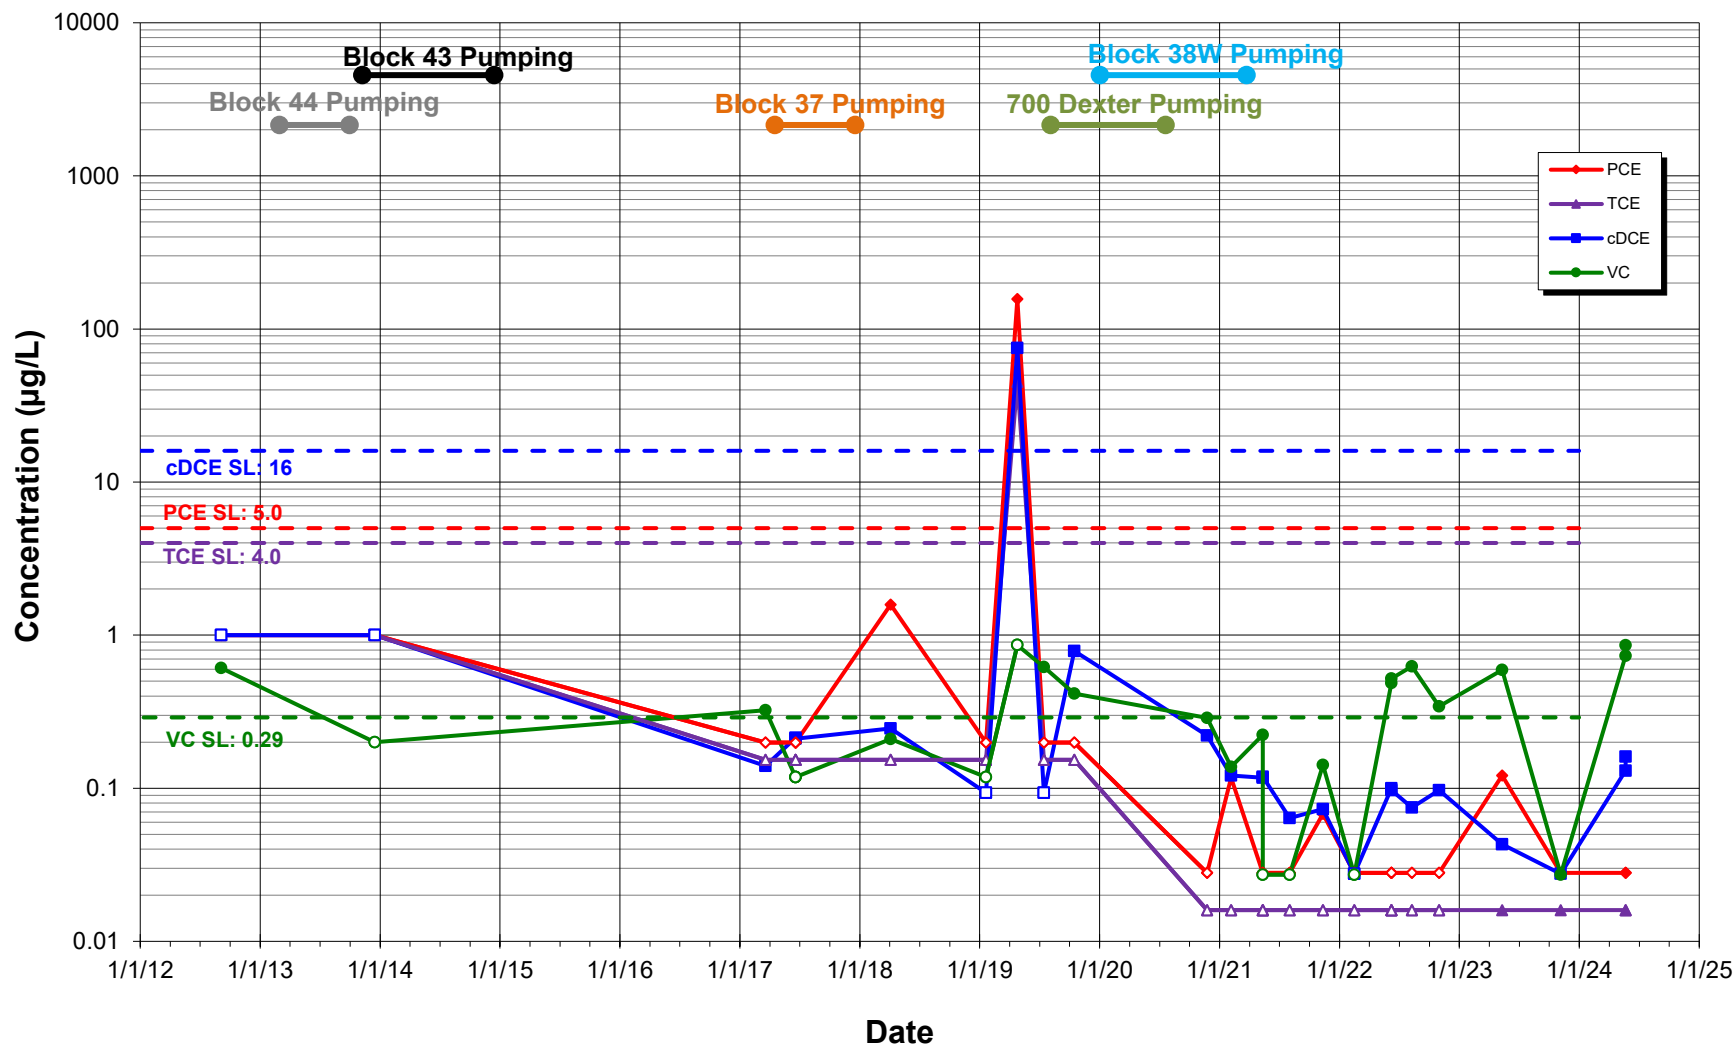
**Concentration vs Time**  
**MW-9 (34.1 to 19.1 feet NAVD), 8th Ave N ROW, E side**  
**American Linen Supply Co Dexter Ave Site**

- 1) All results detected below the laboratory MDLs are shown as hollow data points .
- 2) Preliminary Cleanup Levels: PCE = 5 µg/L, TCE = 4 µg/L, cDCE = 16 µg/L, and VC = 0.29 µg/L.

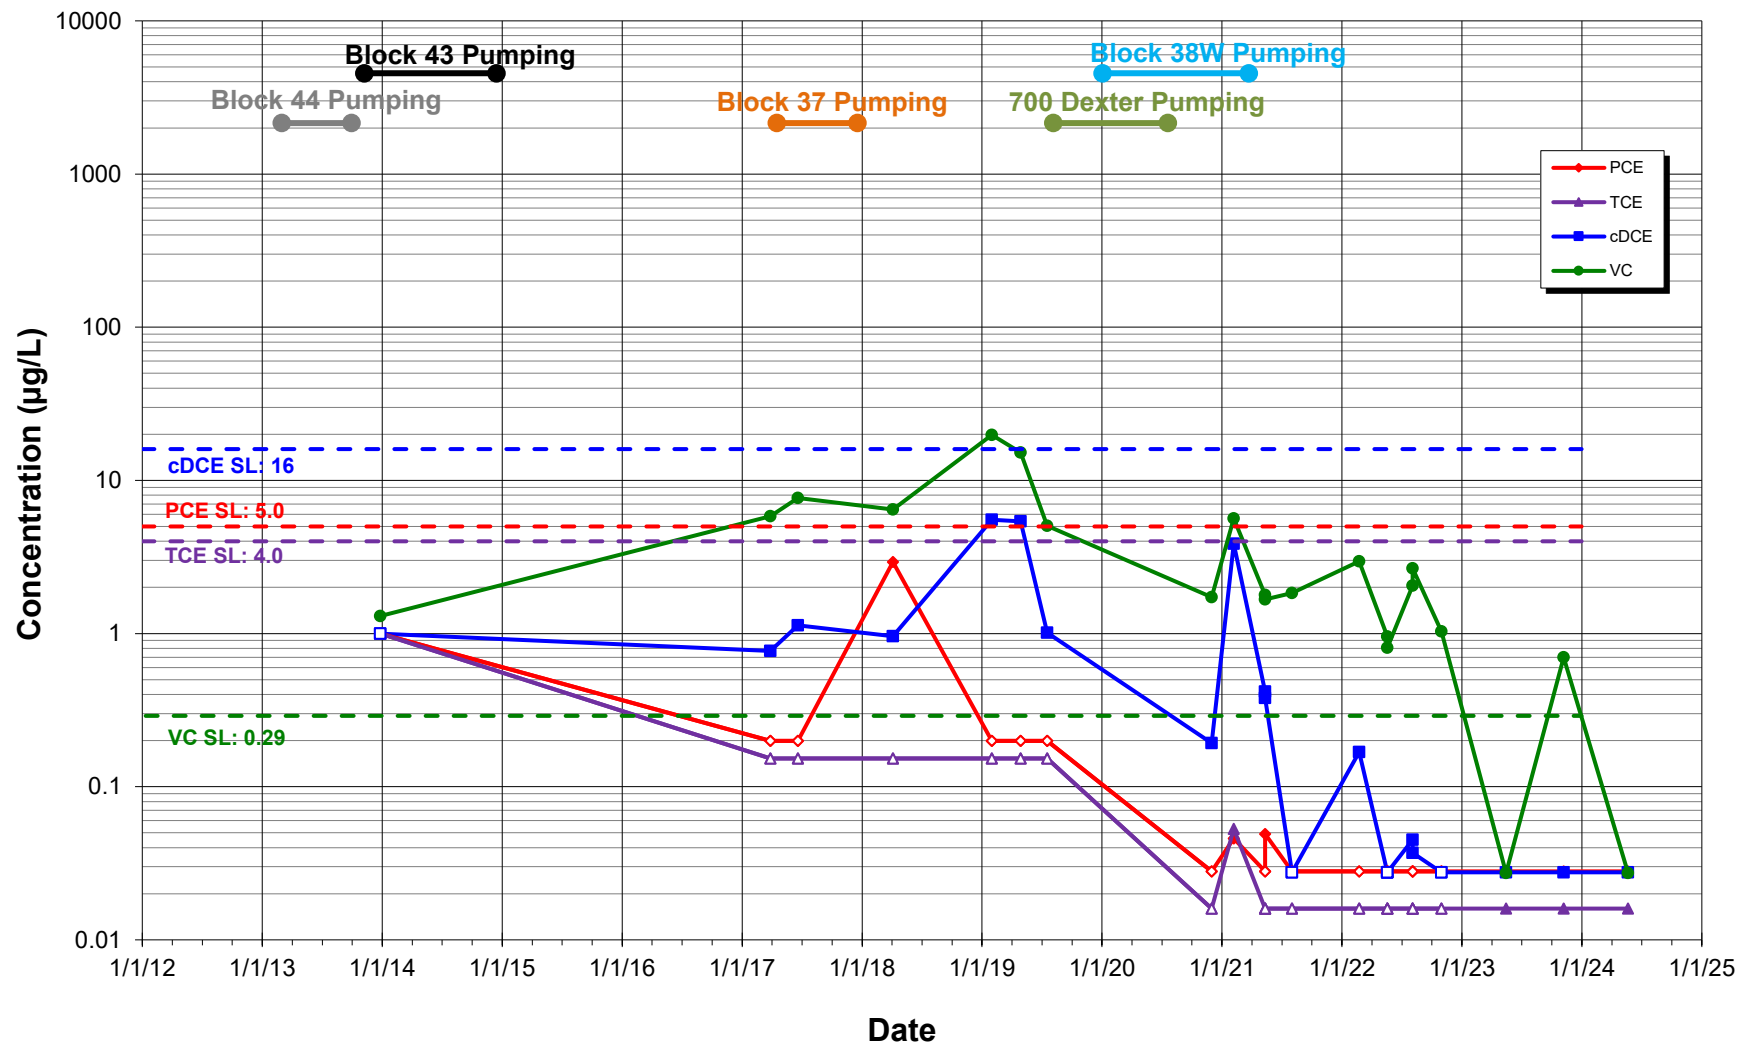
**Concentration vs Time**  
**MW121 (26.7 to 16.7 feet NAVD), 8th Ave N ROW, E side**  
**American Linen Supply Co Dexter Ave Site**

- 1) All results detected below the laboratory MDLs are shown as hollow data points .
- 2) Preliminary Cleanup Levels: PCE = 5 µg/L, TCE = 4 µg/L, cDCE = 16 µg/L, and VC = 0.29 µg/L.

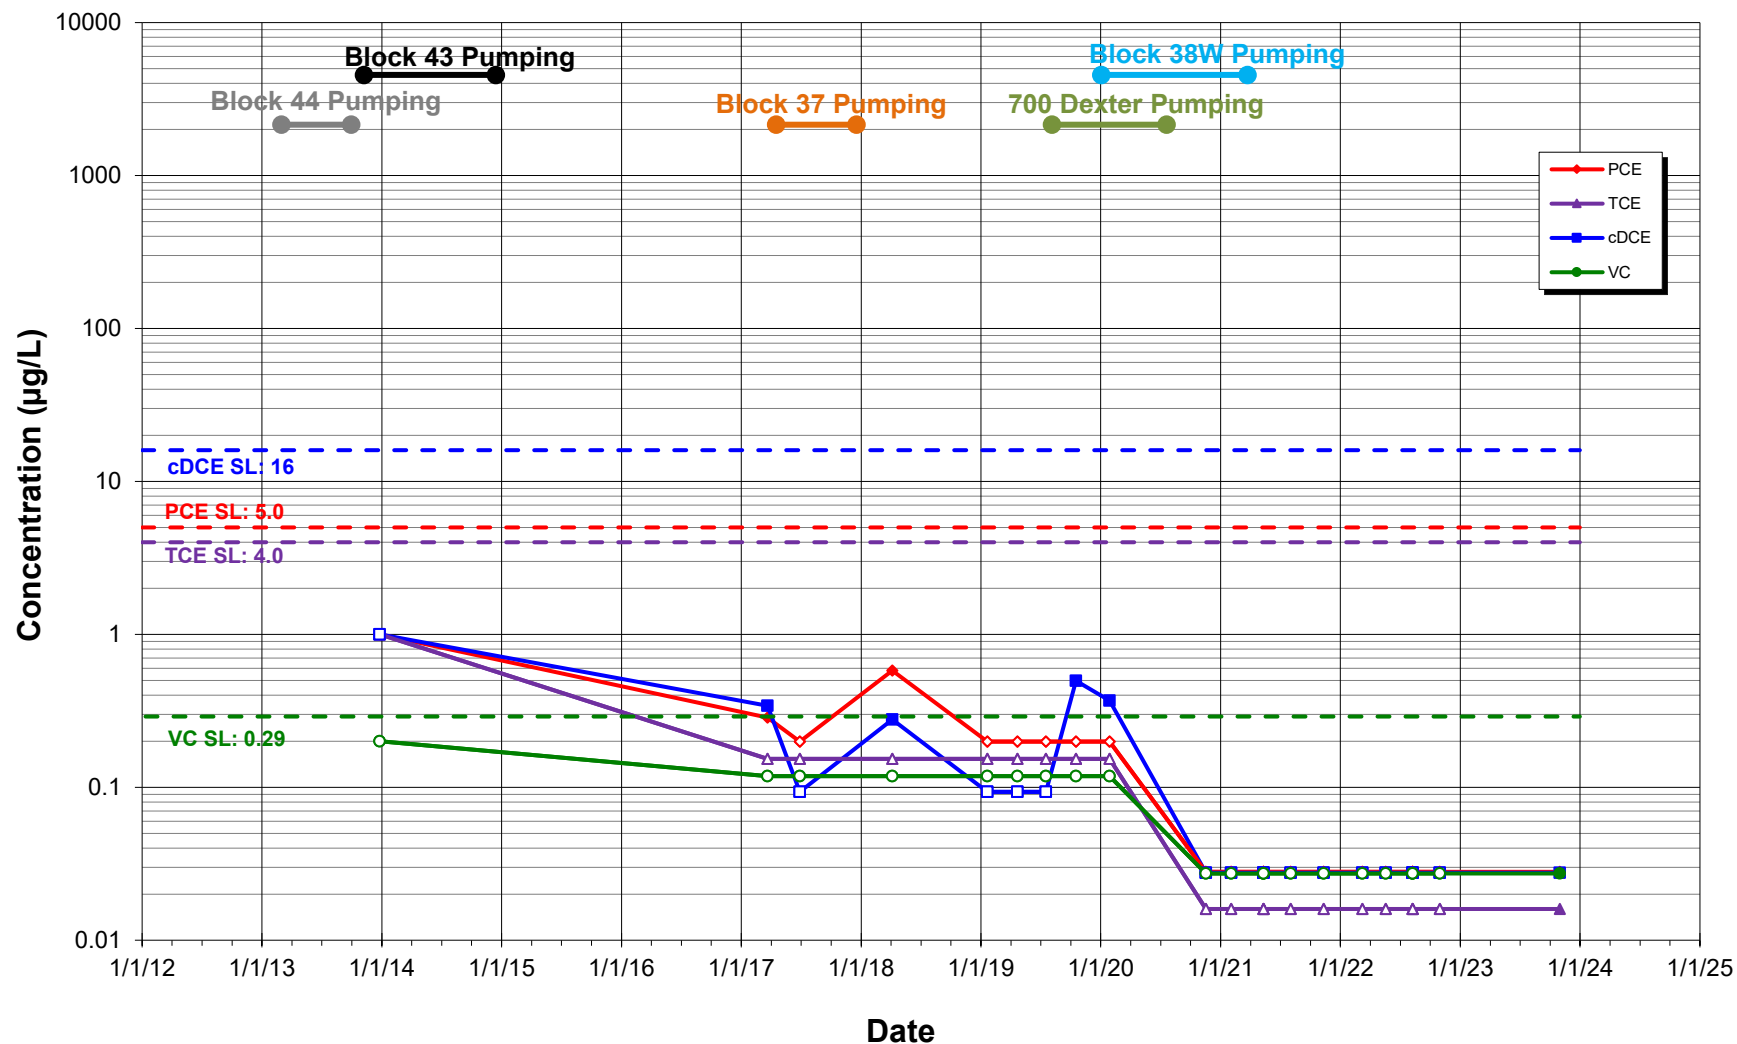
**Concentration vs Time**  
**MW125 (28.6 to 13.6 feet NAVD), Valley St ROW, N side**  
**American Linen Supply Co Dexter Ave Site**

- 1) All results detected below the laboratory MDLs are shown as hollow data points .
- 2) Preliminary Cleanup Levels: PCE = 5 µg/L, TCE = 4 µg/L, cDCE = 16 µg/L, and VC = 0.29 µg/L.

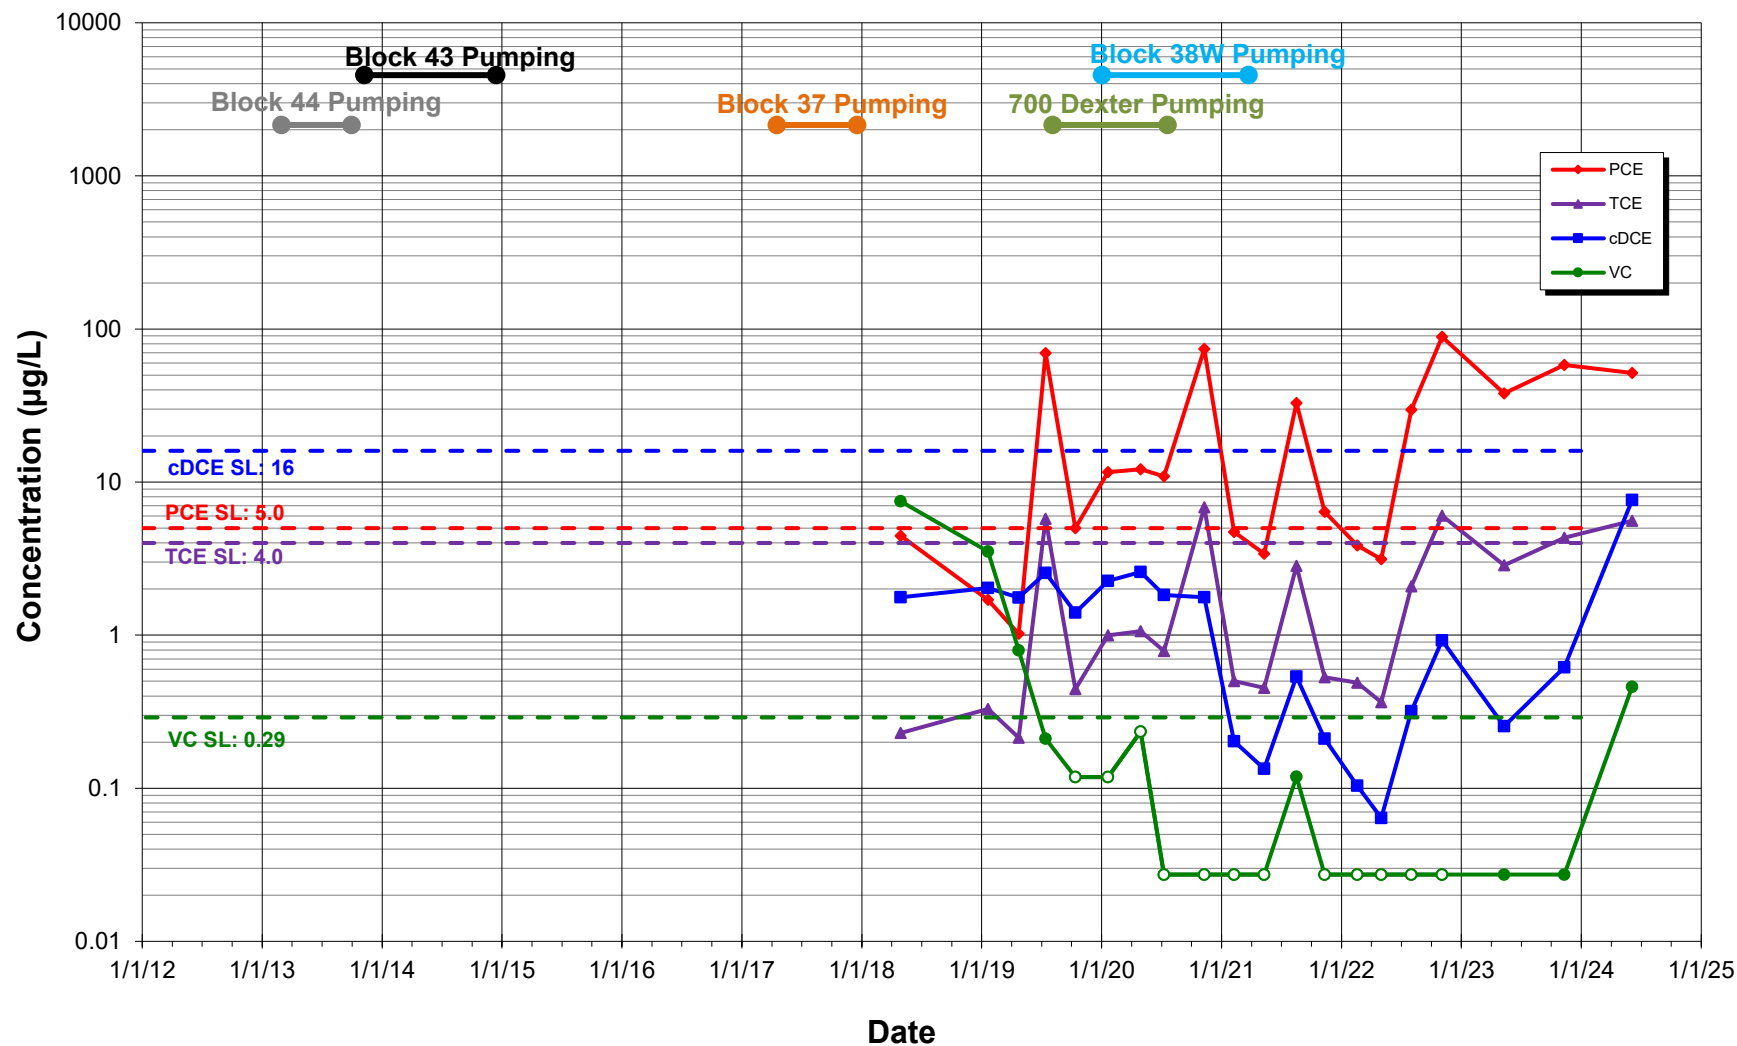
**Concentration vs Time**  
**MW-154 (27.8 to 17.9 feet NAVD), Roy St ROW, S side**  
**American Linen Supply Co-Dexter Ave Site**

- 1) All results detected below the laboratory MDLs are shown as hollow data points .
- 2) Preliminary Cleanup Levels: PCE = 5 µg/L, TCE = 4 µg/L, cDCE = 16 µg/L, and VC = 0.29 µg/L.

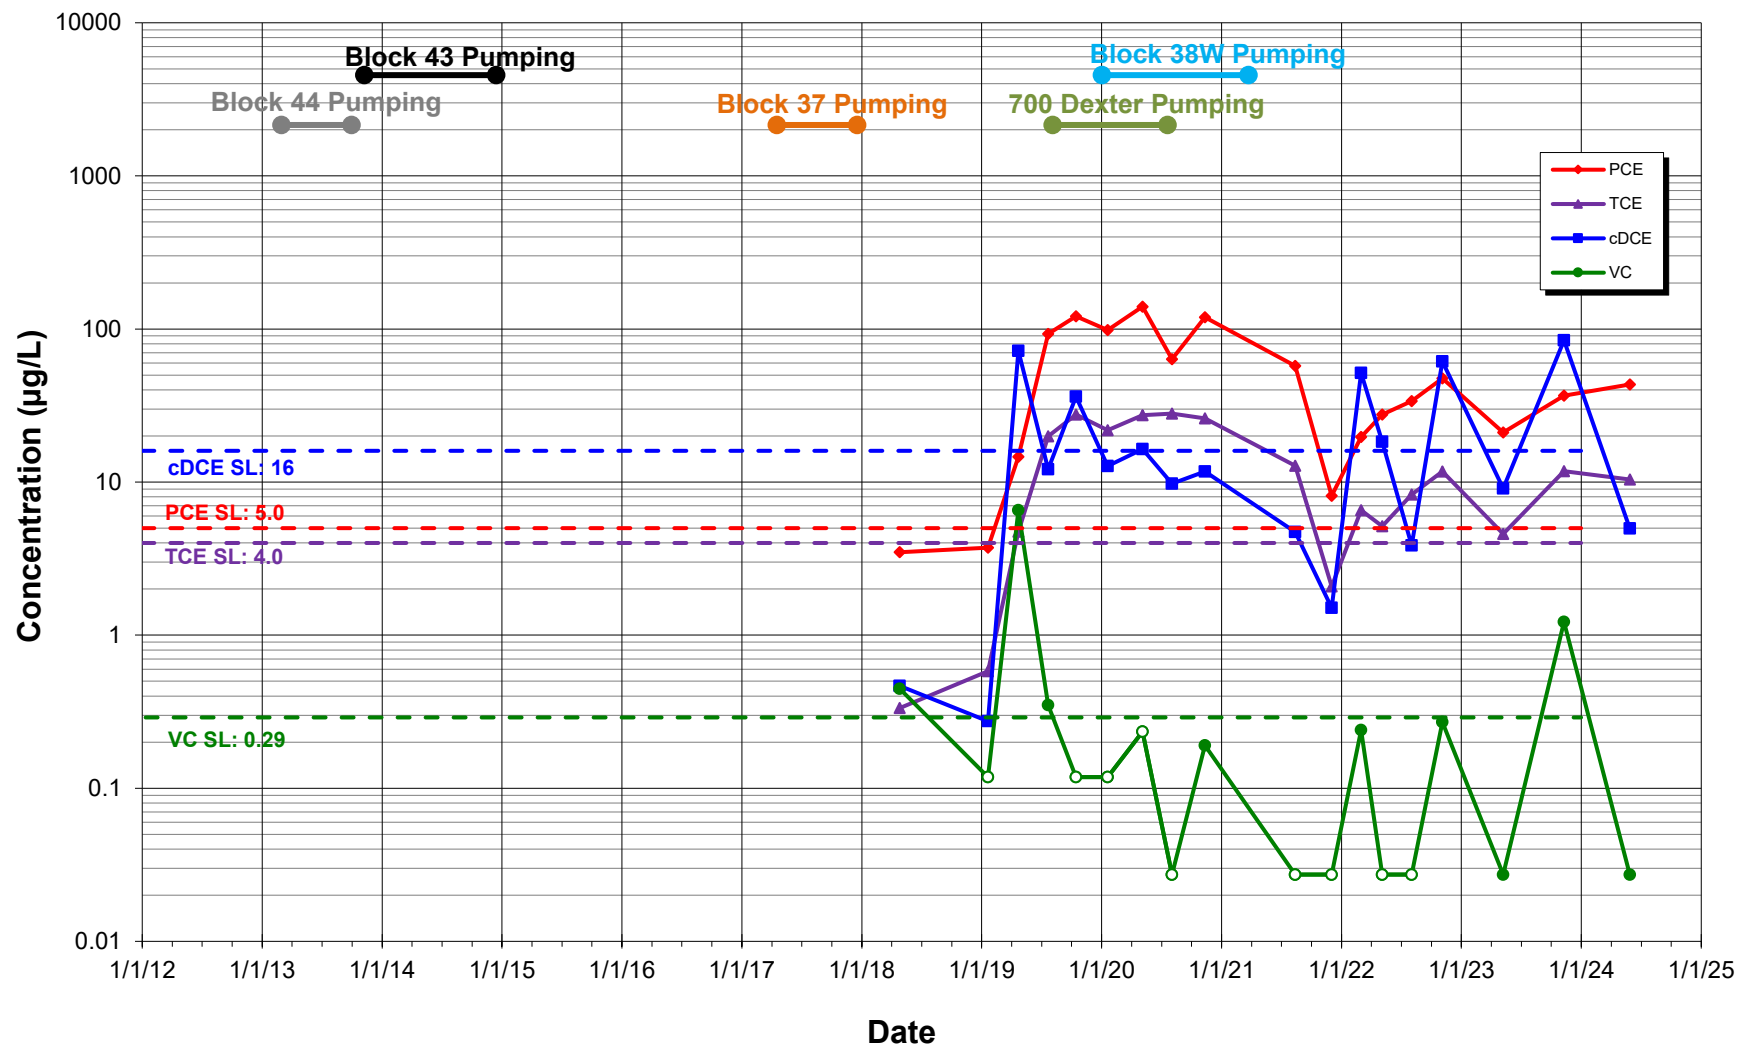
**Concentration vs Time**  
**MW-155 (24.4 to 14.4 feet NAVD), Roy St ROW, S side**  
**American Linen Supply Co Dexter Ave Site**

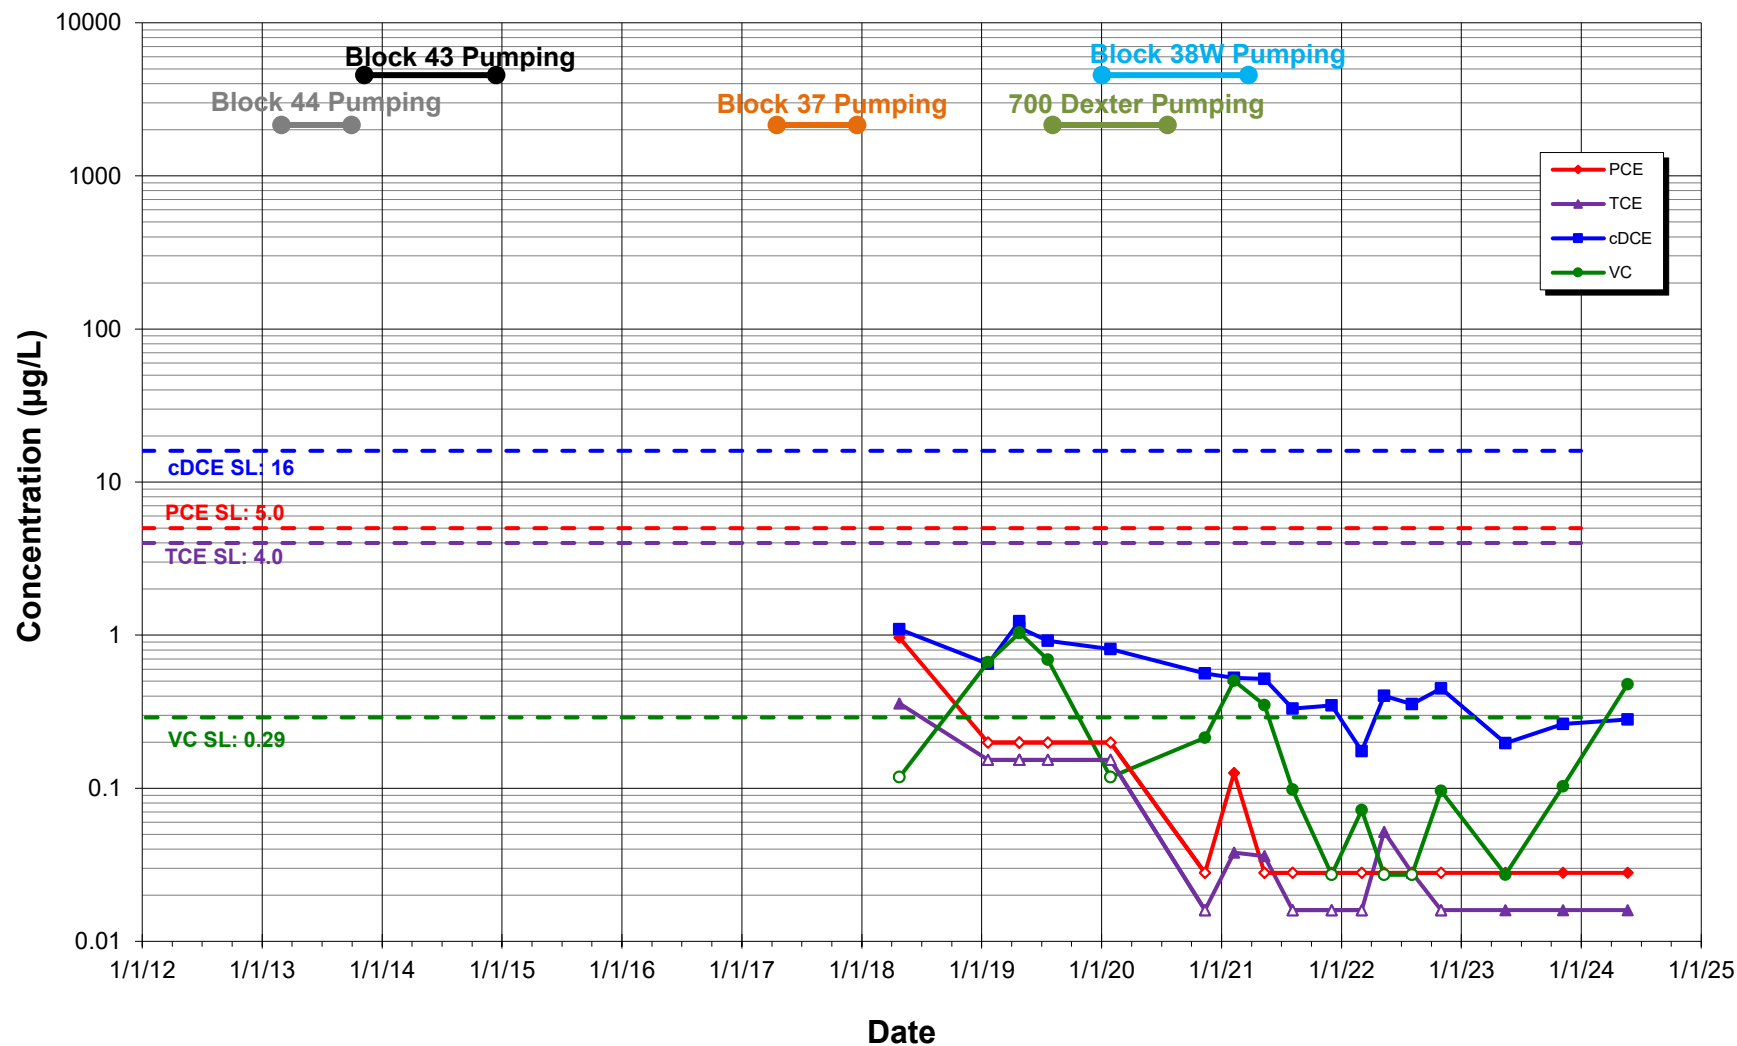
**Concentration vs Time**  
**MW-159 (22.9 to 12.9 feet NAVD), 8th Ave N, E side**  
**American Linen Supply Co Dexter Ave Site**

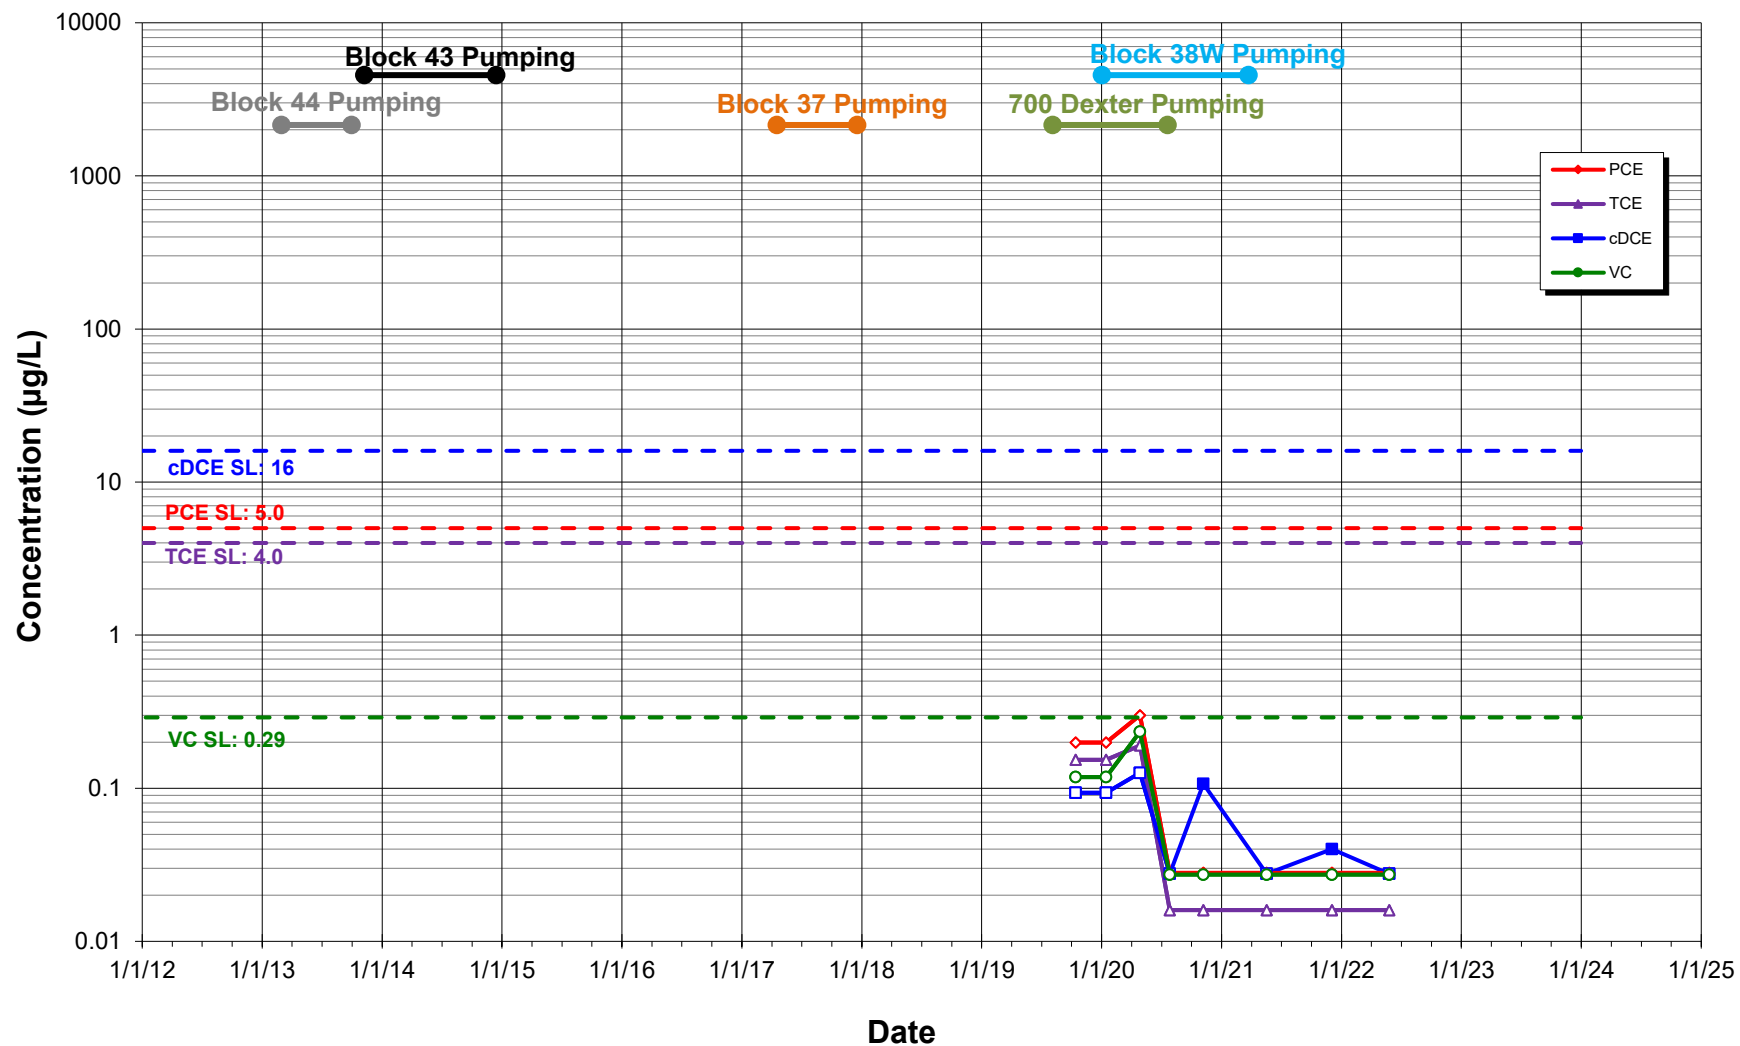
**Concentration vs Time**  
**MW-305 (37.4 to 27.4 feet NAVD), Roy St ROW, S side**  
**American Linen Supply Co Dexter Ave Site**

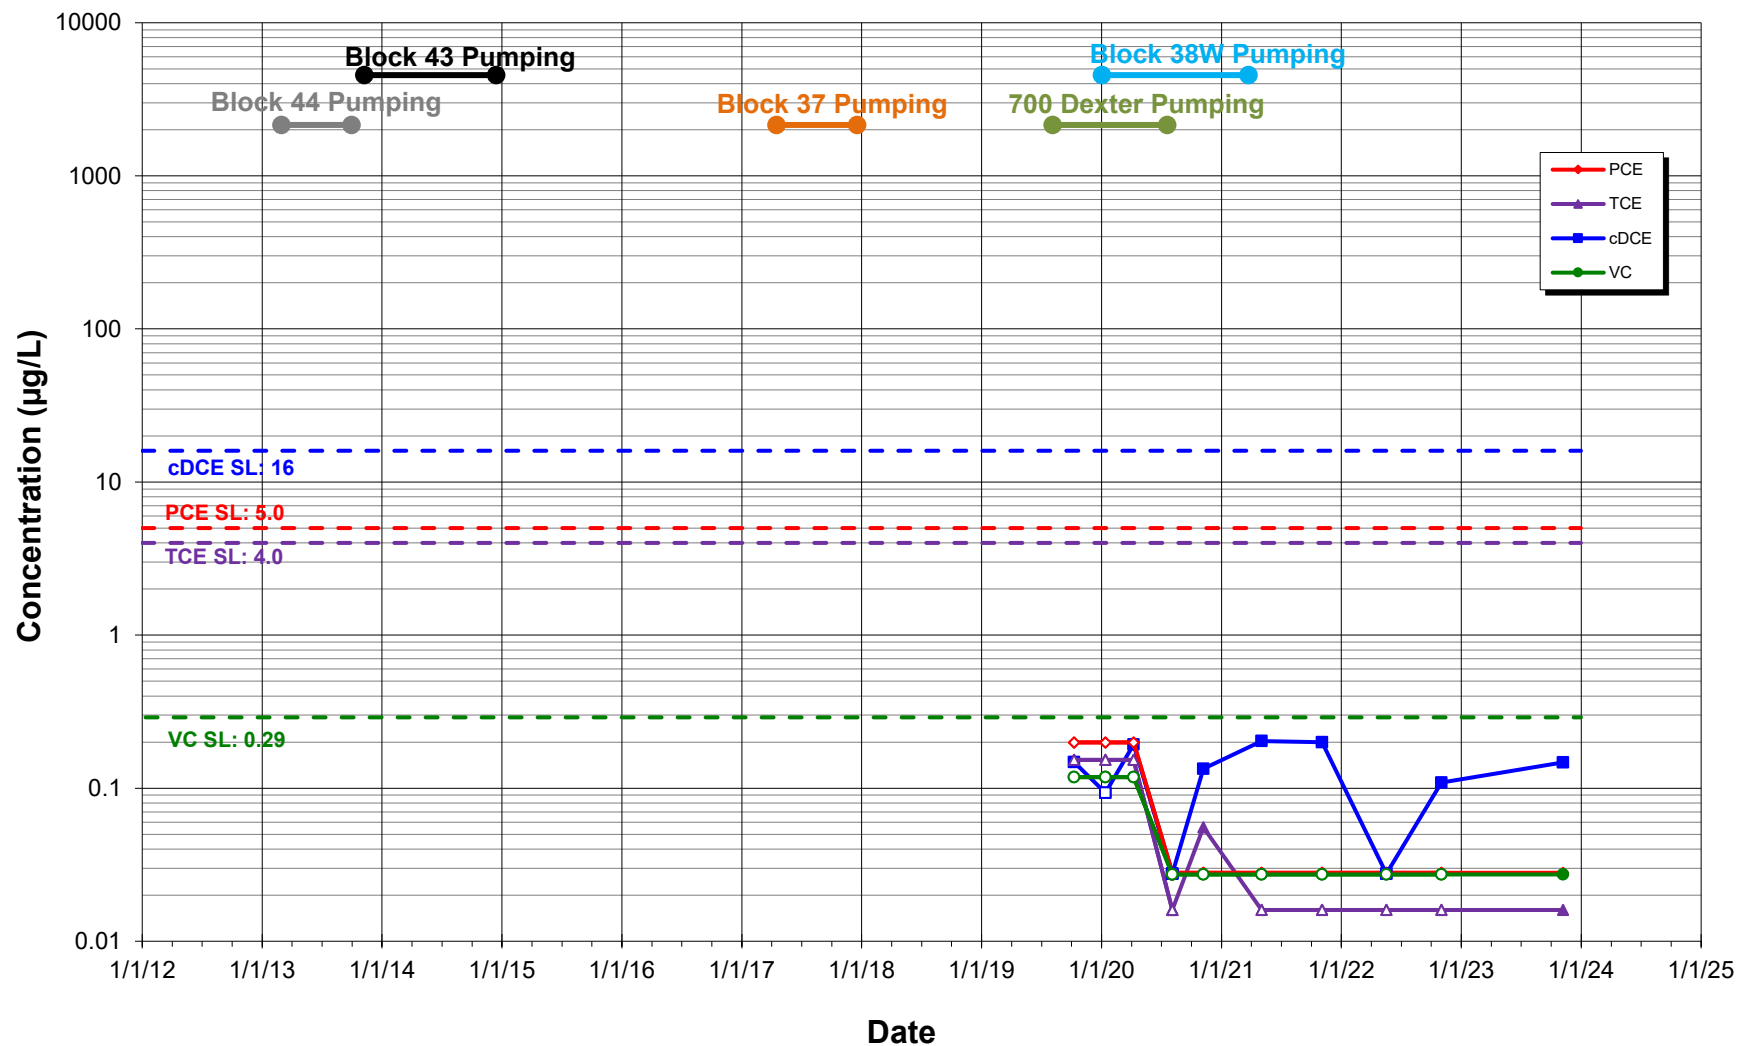
**Concentration vs Time**  
**MW-310 (19.2 to 9.2 feet NAVD), Alley E of Seattle Roy Aloha Shops**  
**American Linen Supply Co Dexter Ave Site**

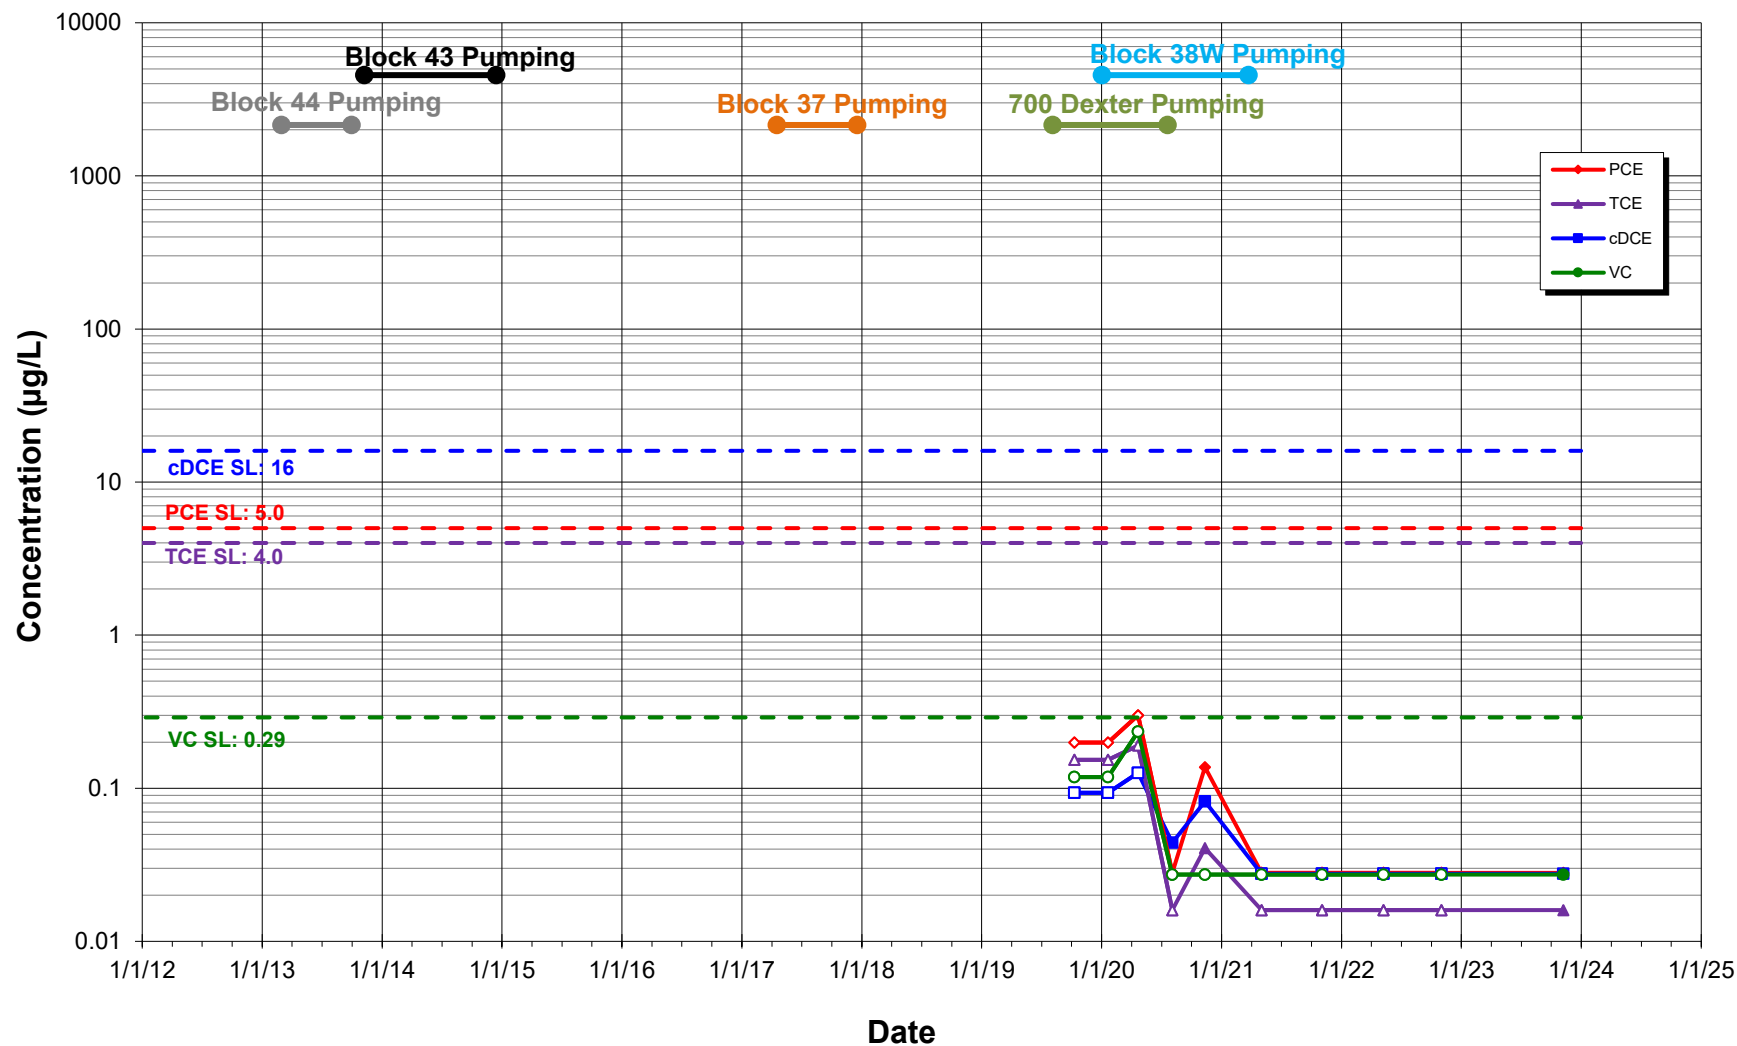
**Concentration vs Time**  
**MW-312 (19.9 to 9.9 feet NAVD), Alley E of Seattle Roy Aloha Shops**  
**American Linen Supply Co Dexter Ave Site**

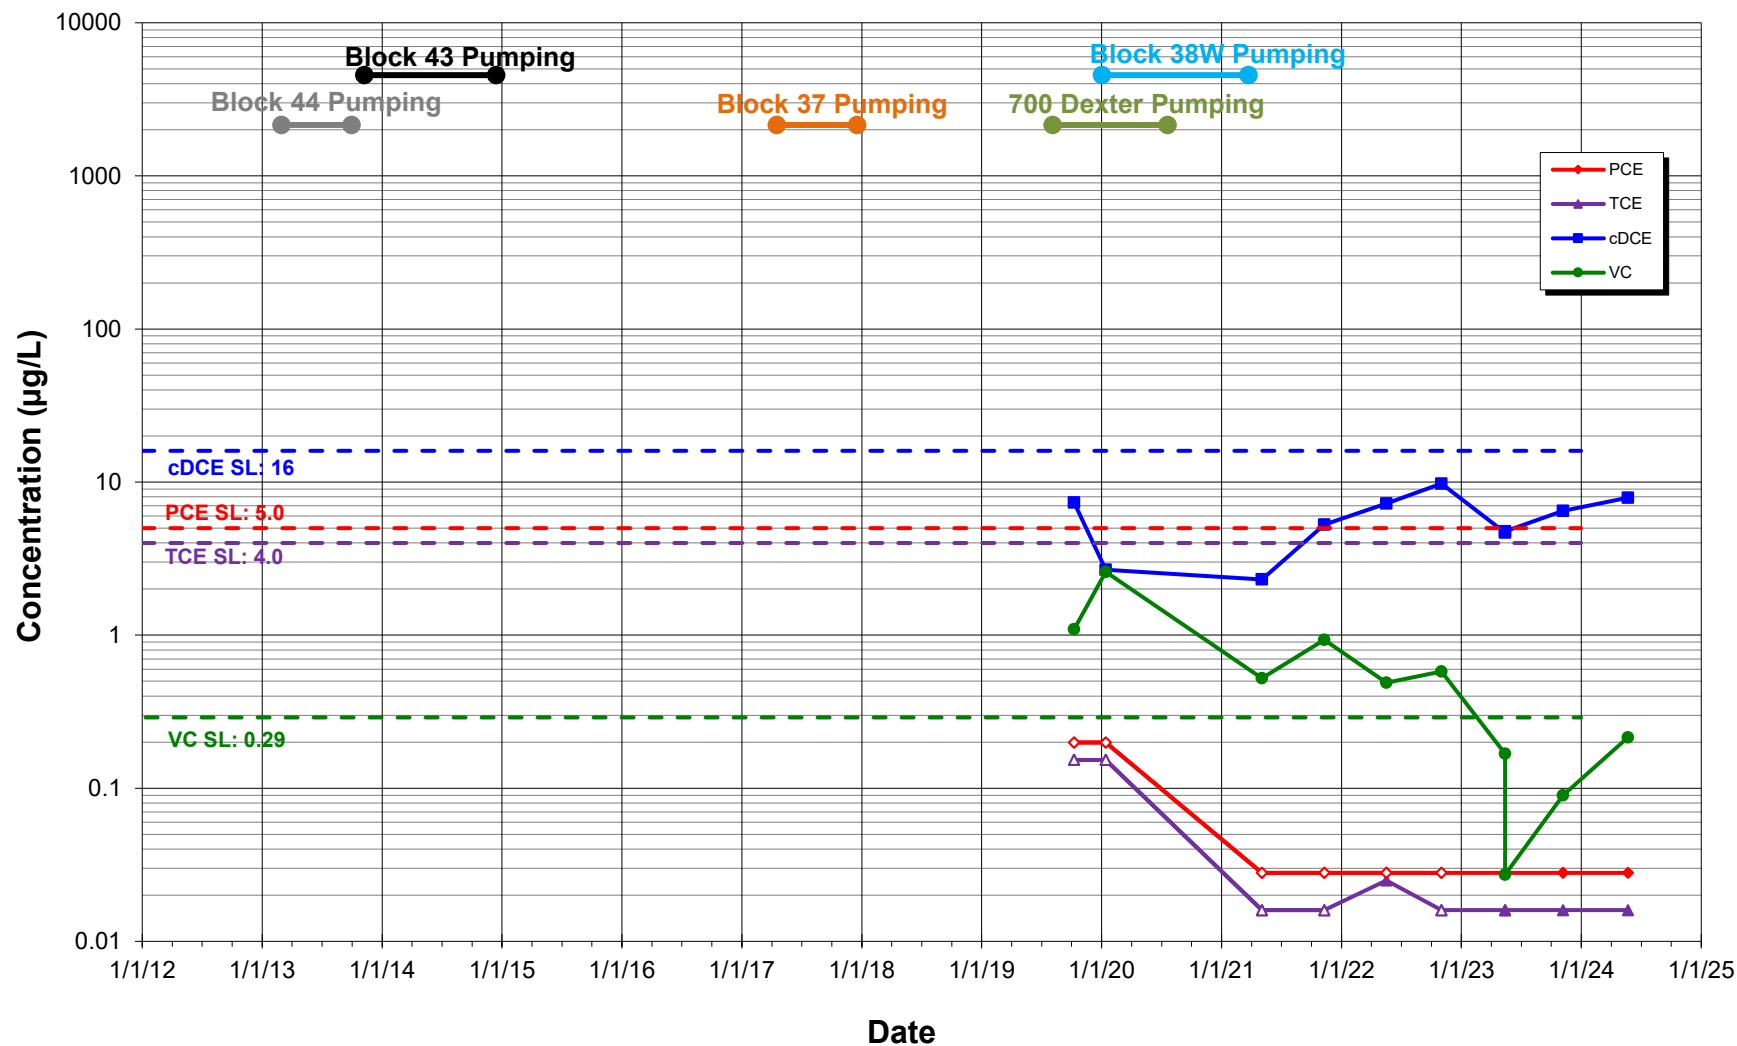
**Concentration vs Time**  
**MW-313 (20.4 to 10.4 feet NAVD), Alley E of Seattle Roy Aloha Shops**  
**American Linen Supply Co Dexter Ave Site**

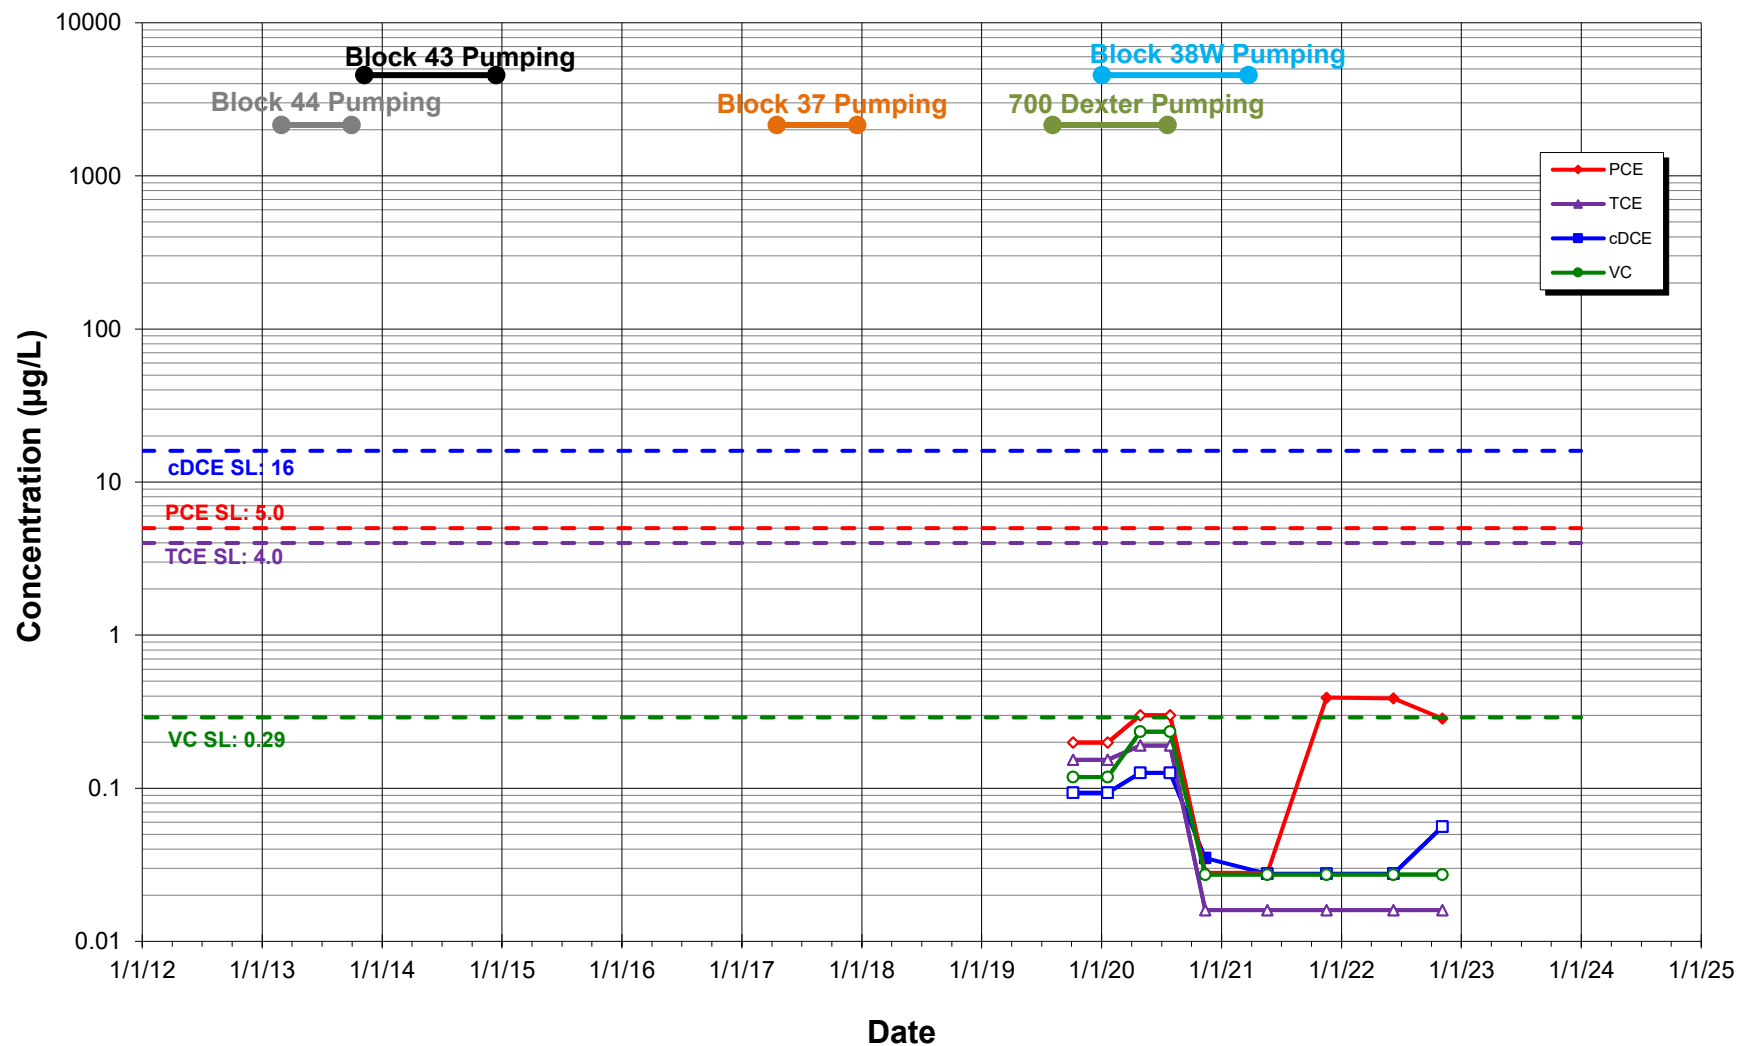
**Concentration vs Time**  
**MW-320 (18.6 to 8.6 feet NAVD), 9th Ave N, W side**  
**American Linen Supply Co Dexter Ave Site**

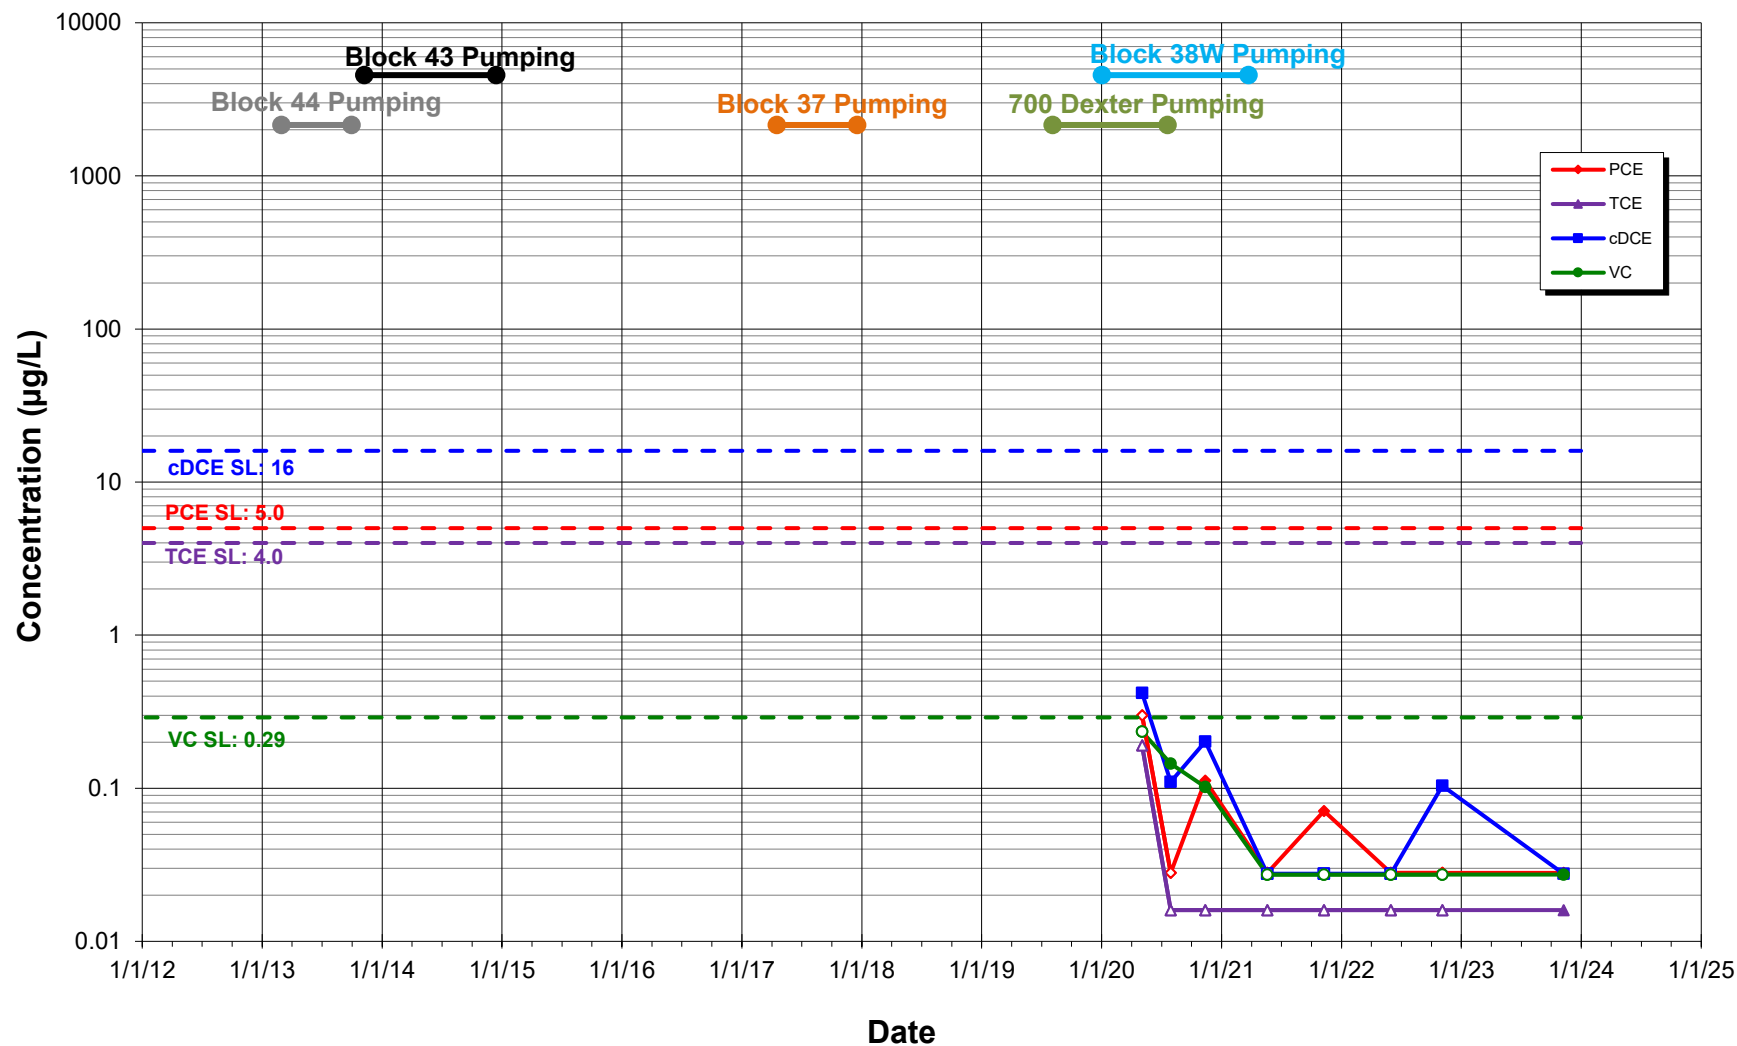
**Concentration vs Time**  
**MW-332 (16.0 to 6.0 feet NAVD), Roy St ROW, N side**  
**American Linen Supply Co Dexter Ave Site**
