**Attachment A**  
**Well Completion Table**  
**American Linen Supply Co–Dexter Avenue Site**  
**Seattle, Washington**

**CVOC TIME-TREND PLOTS**

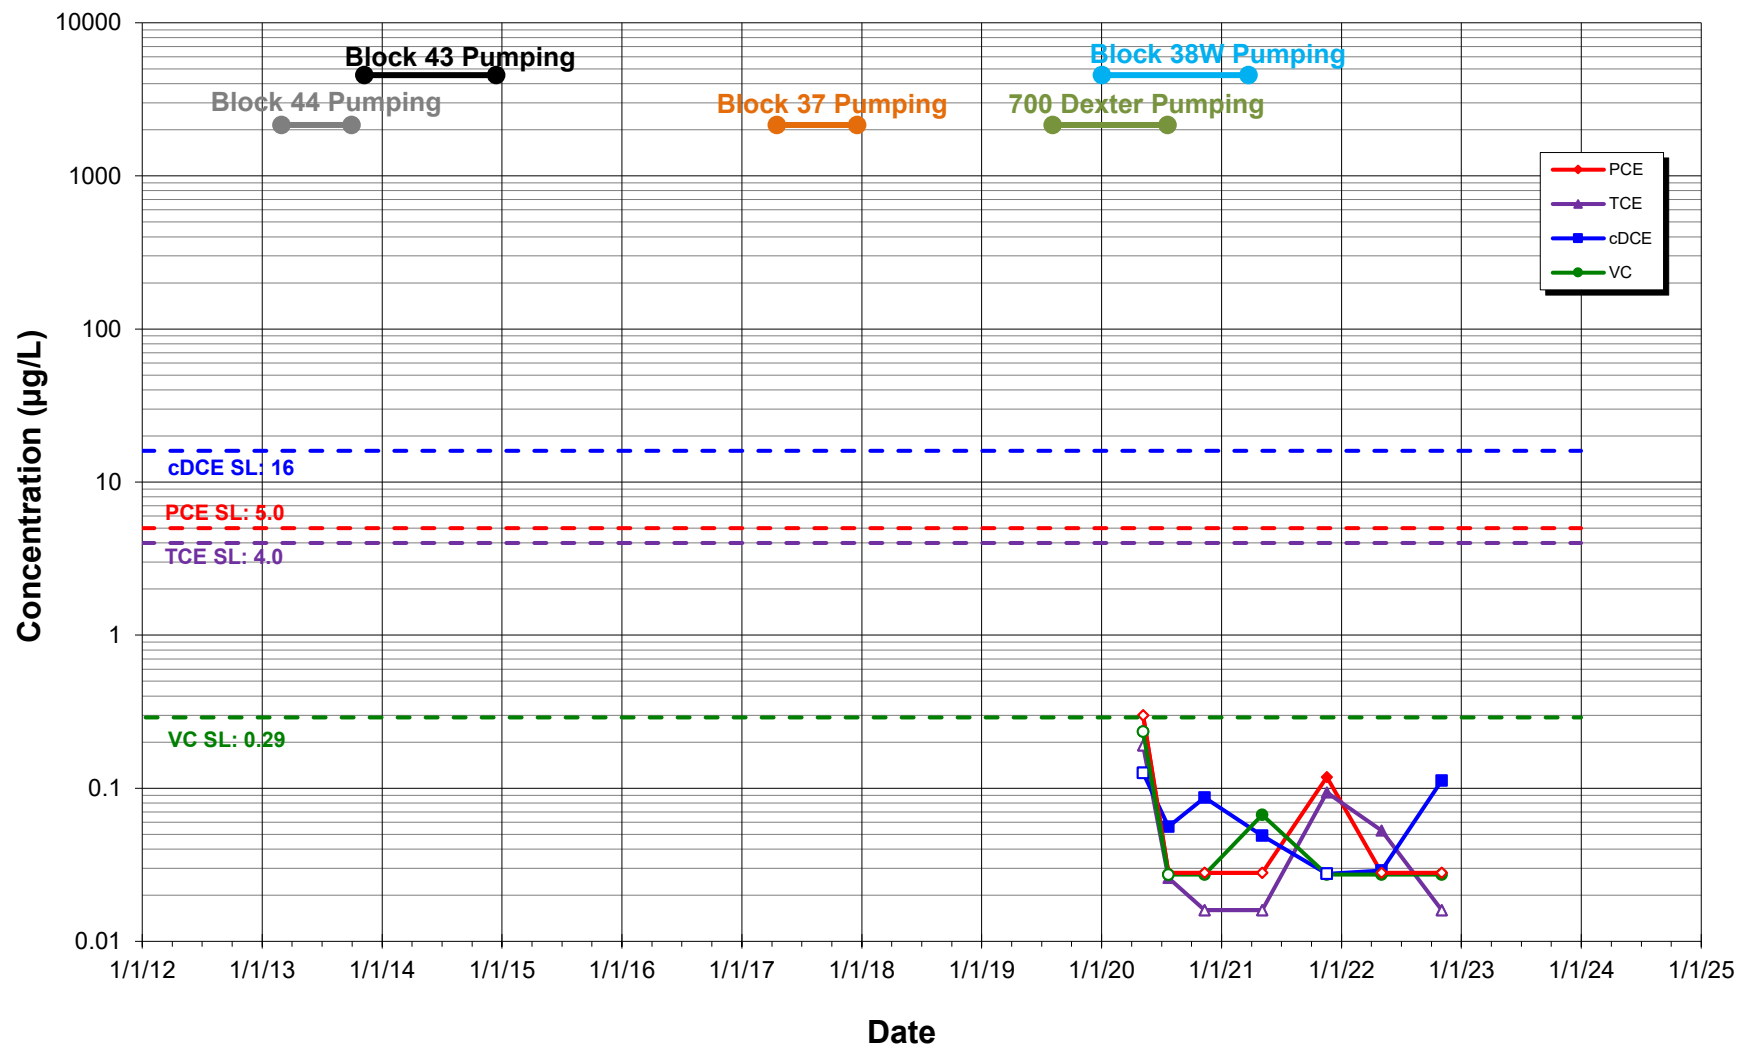
**Concentration vs Time**  
**MW-337 (18.1 to 8.1 feet NAVD), Lake Union Park, N end**  
**American Linen Supply Co Dexter Ave Site**

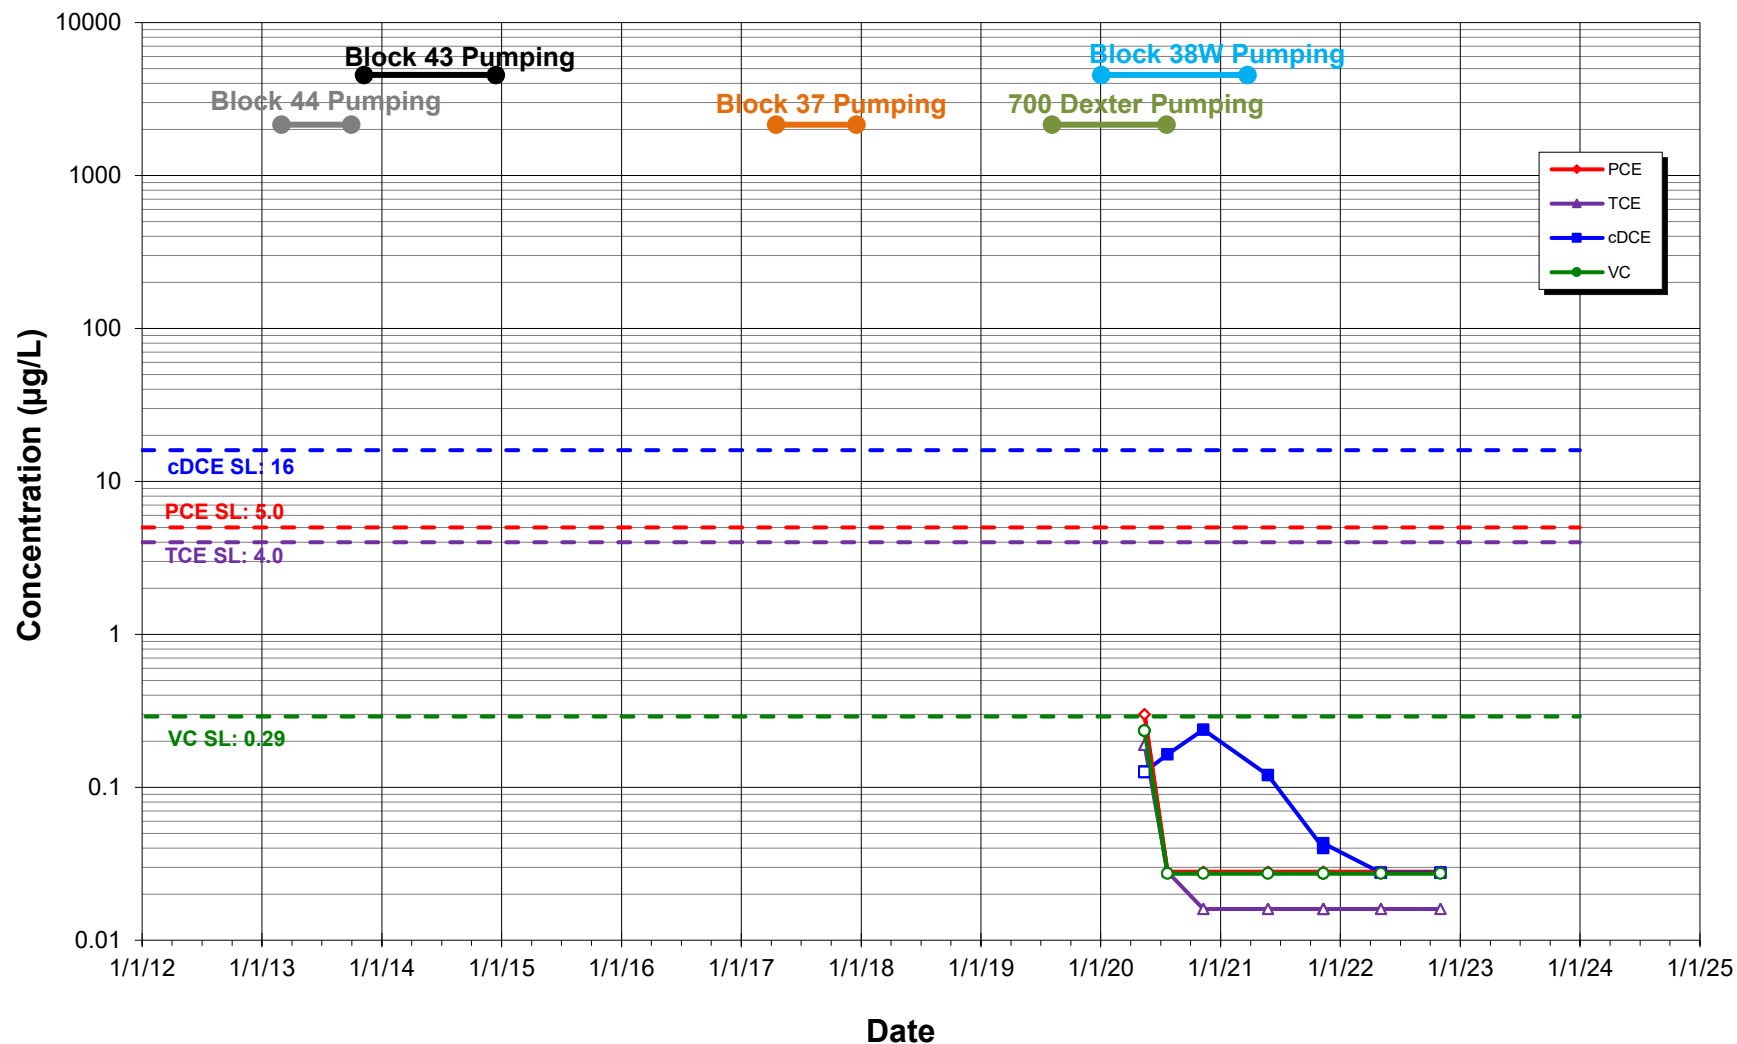
**Concentration vs Time**  
**MW-339 (18.2 to 8.2 feet NAVD), Lake Union Park, S end**  
**American Linen Supply Co Dexter Ave Site**

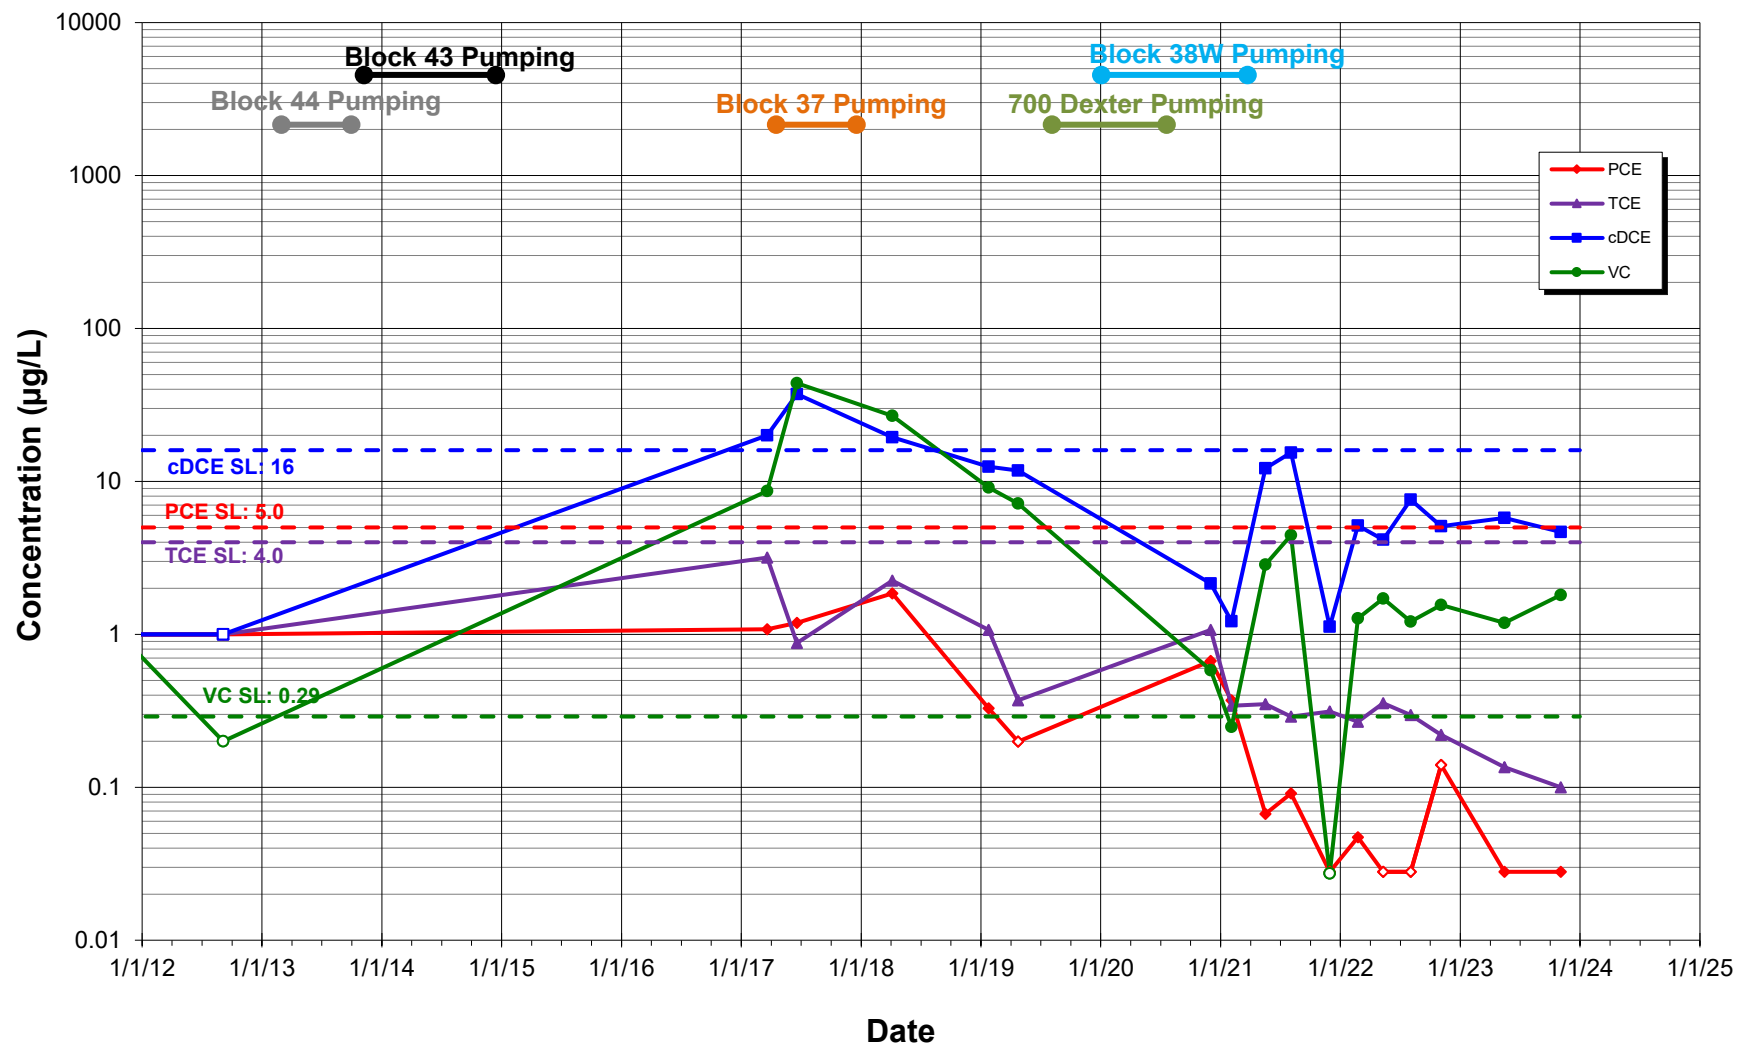
**Concentration vs Time**  
**R-MW6 (33.3 to 23.3 feet NAVD), 8th Ave N ROW, W side**  
**American Linen Supply Co Dexter Ave Site**

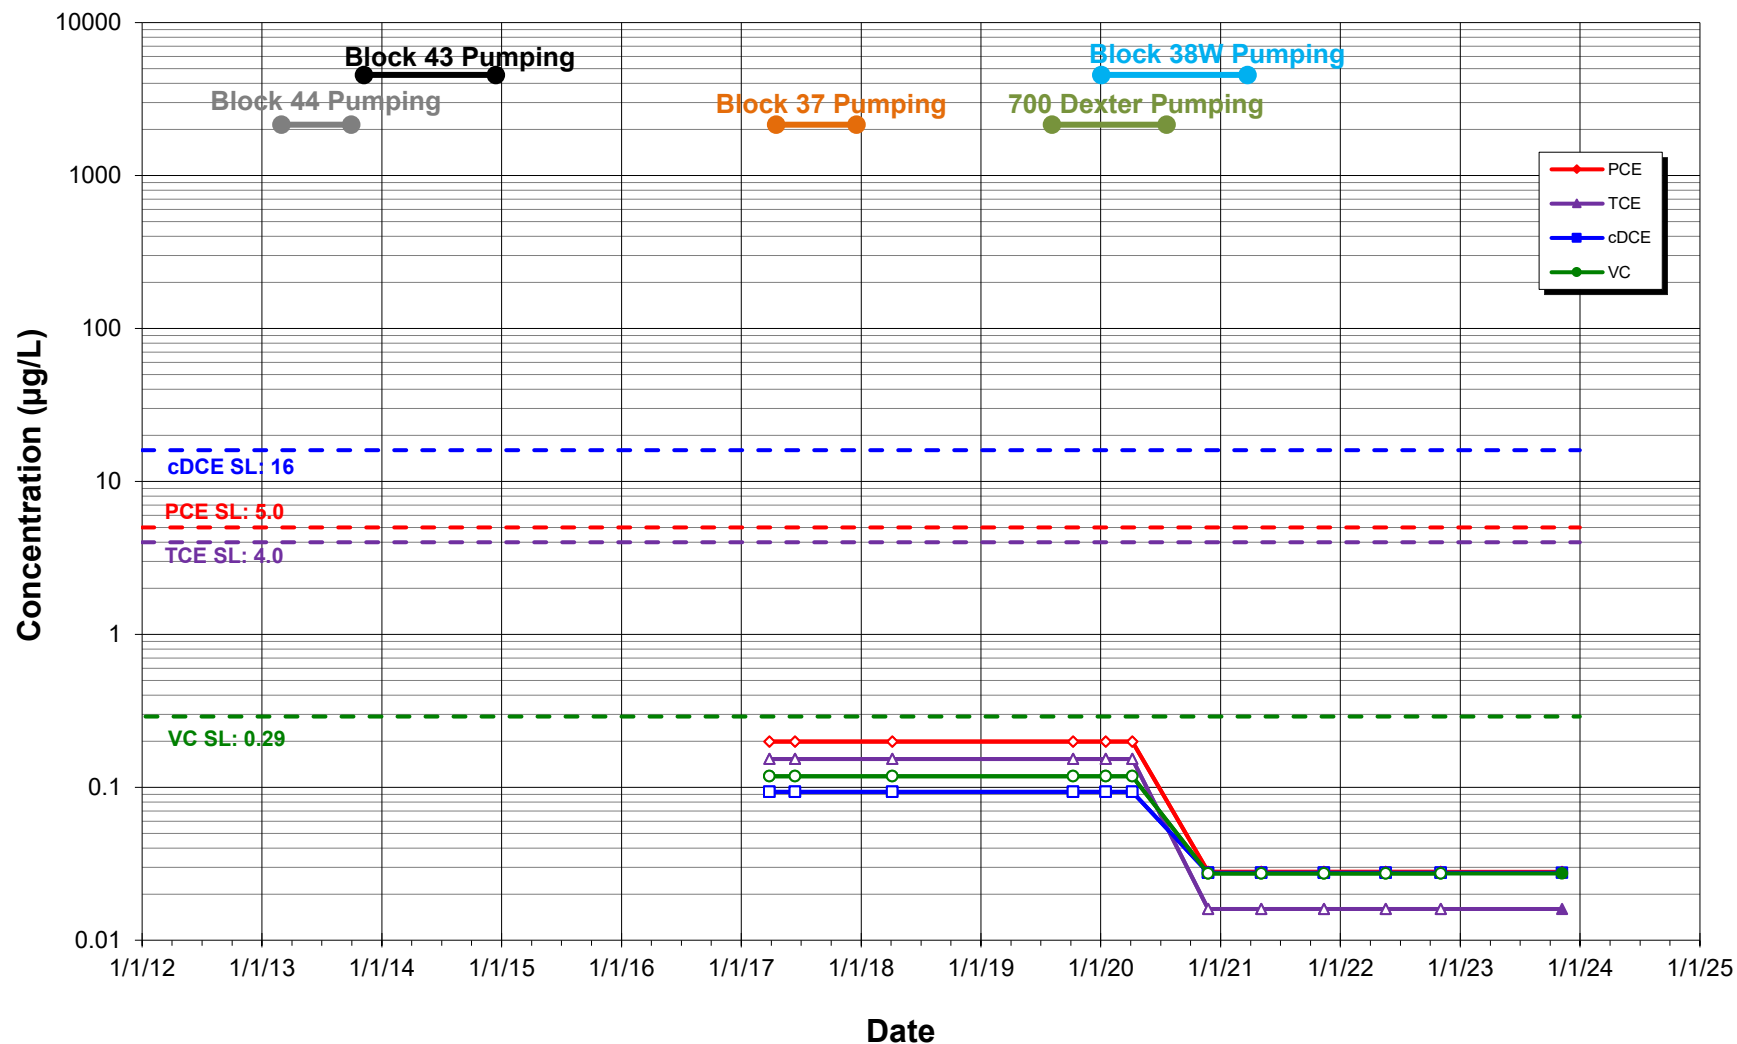
**Concentration vs Time**  
**SCL-MW101 (25.5 to 15.5 feet NAVD), Alley E of Seattle Roy Aloha Shops**  
**American Linen Supply Co Dexter Ave Site**

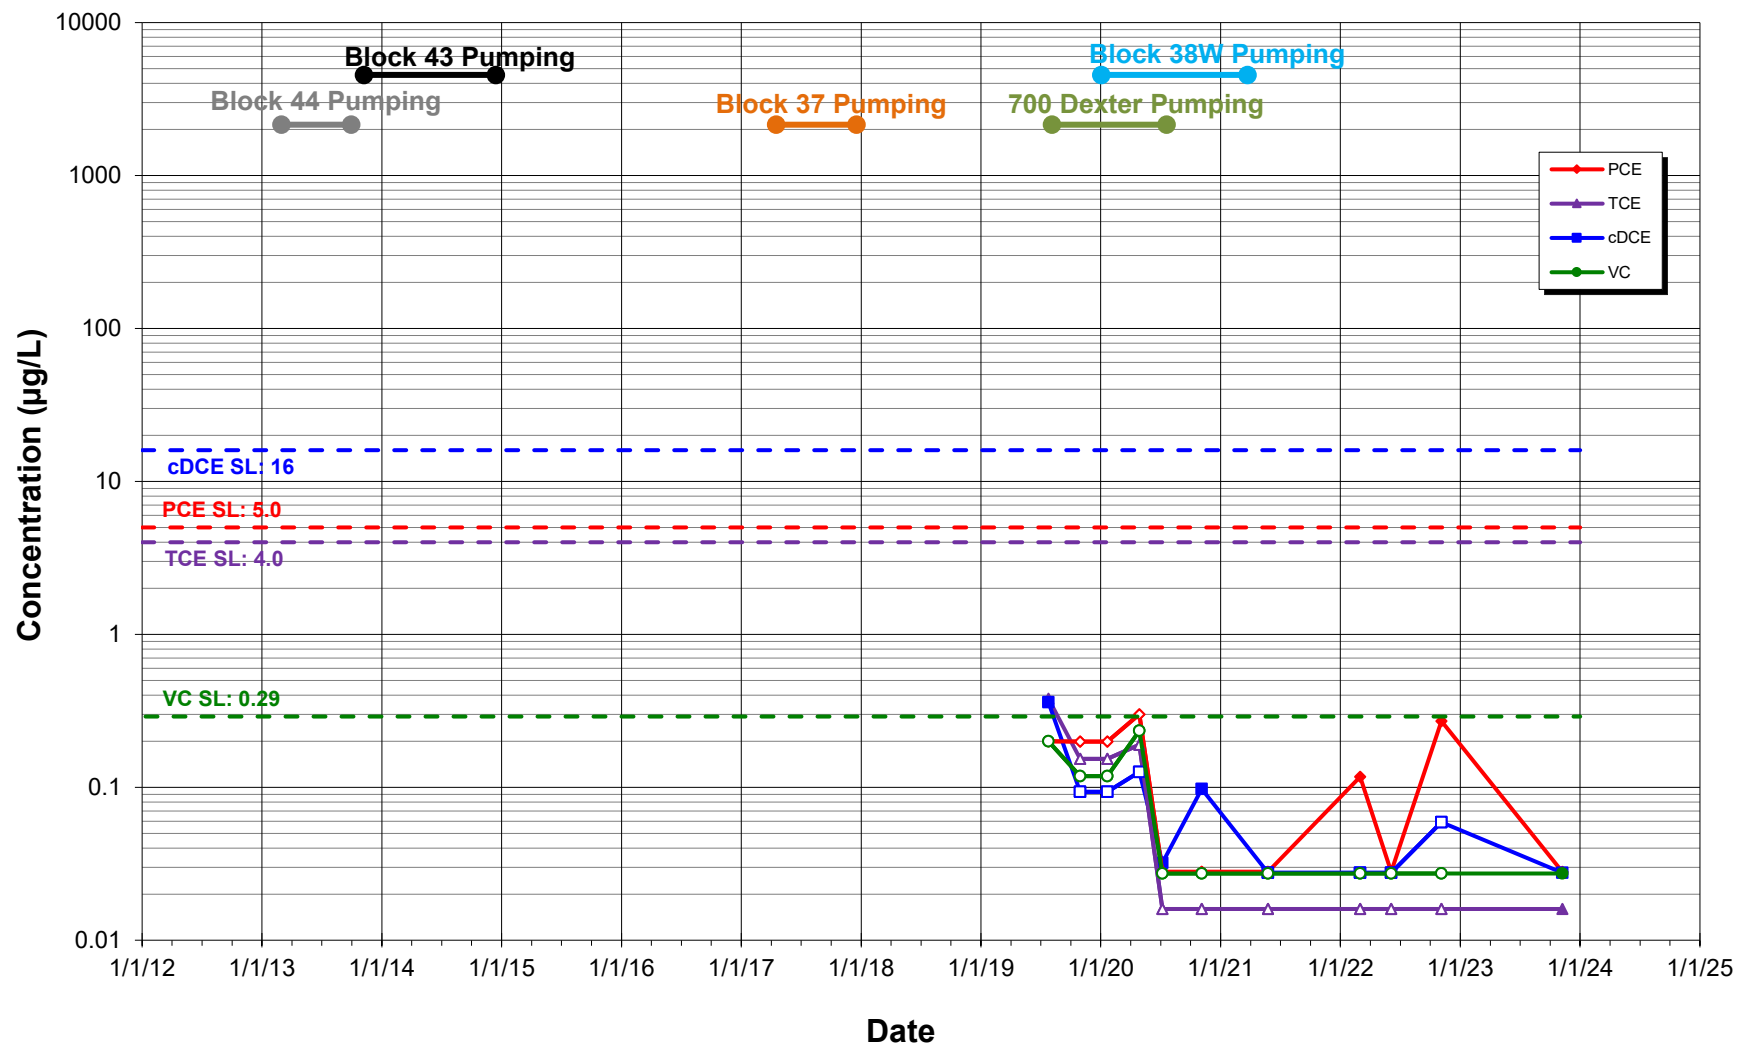
**Concentration vs Time**  
**FMW-142 (-4.2 to -9.6 feet NAVD), 9th Ave N ROW, E side**  
**American Linen Supply Co Dexter Ave Site**

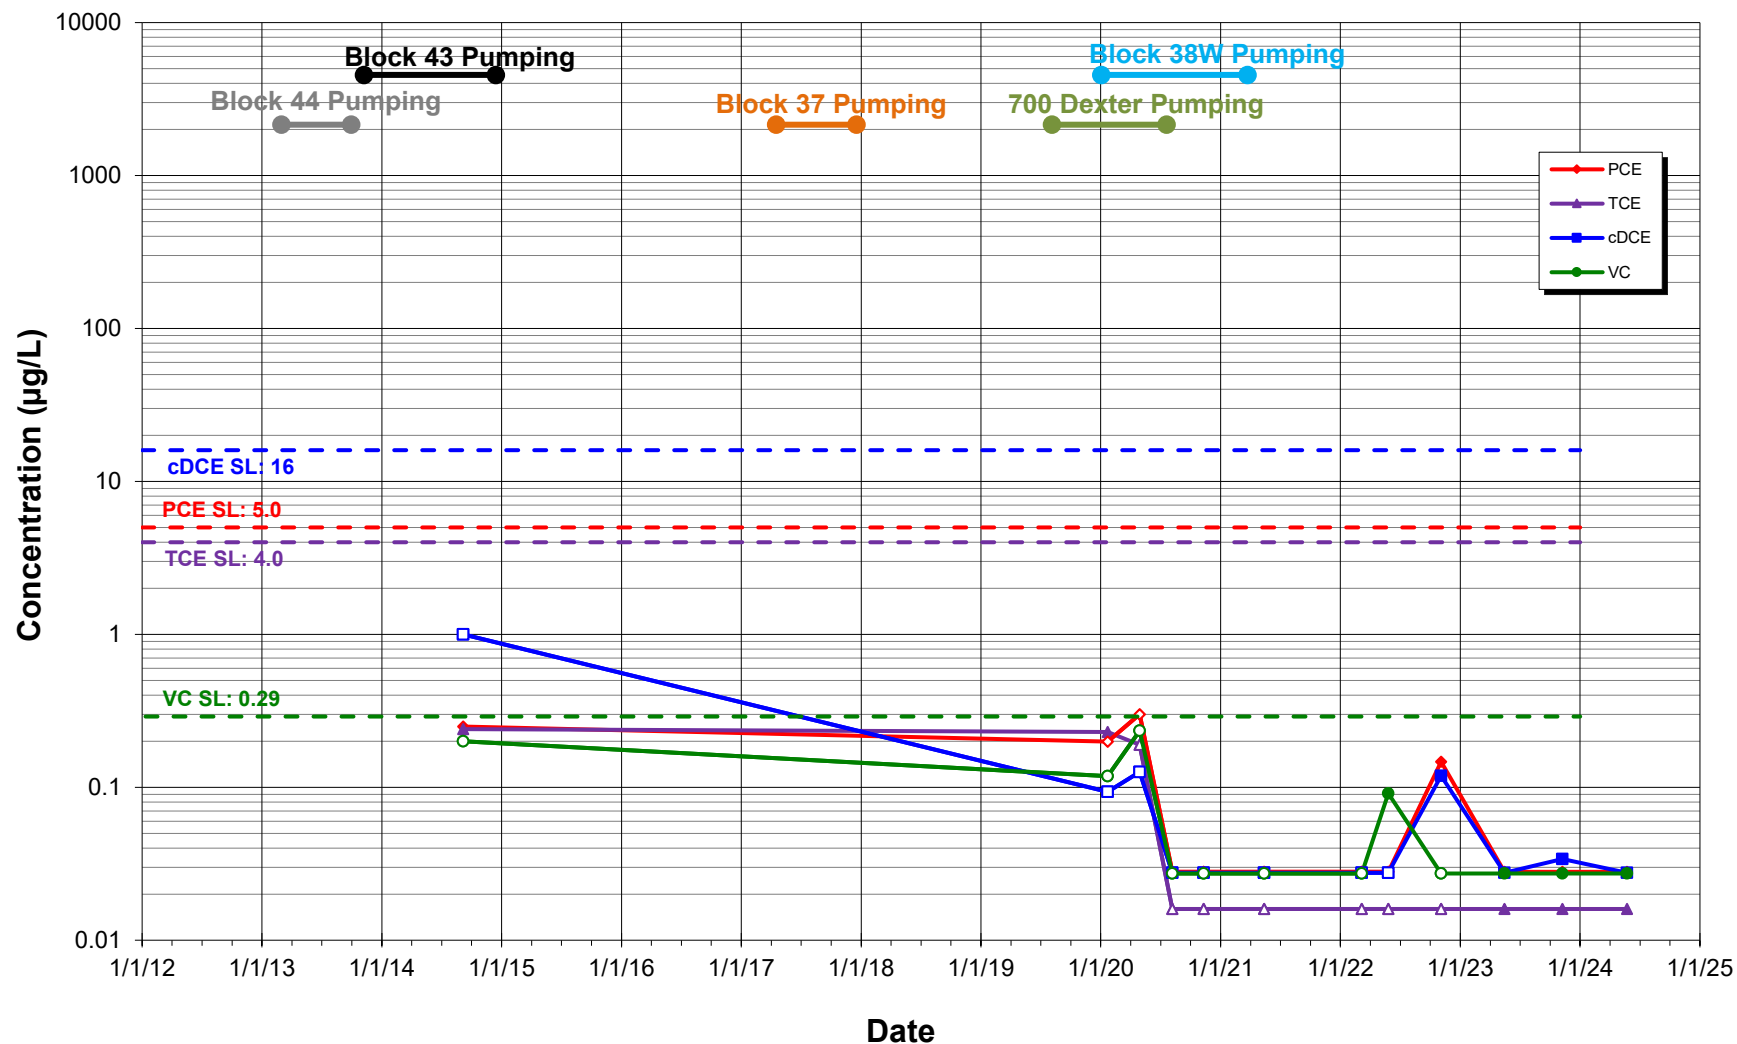
**Concentration vs Time**  
**GEI-MW-1 (-9.7 to -29.7 feet NAVD), Block 79 East, N end**  
**American Linen Supply Co Dexter Ave Site**

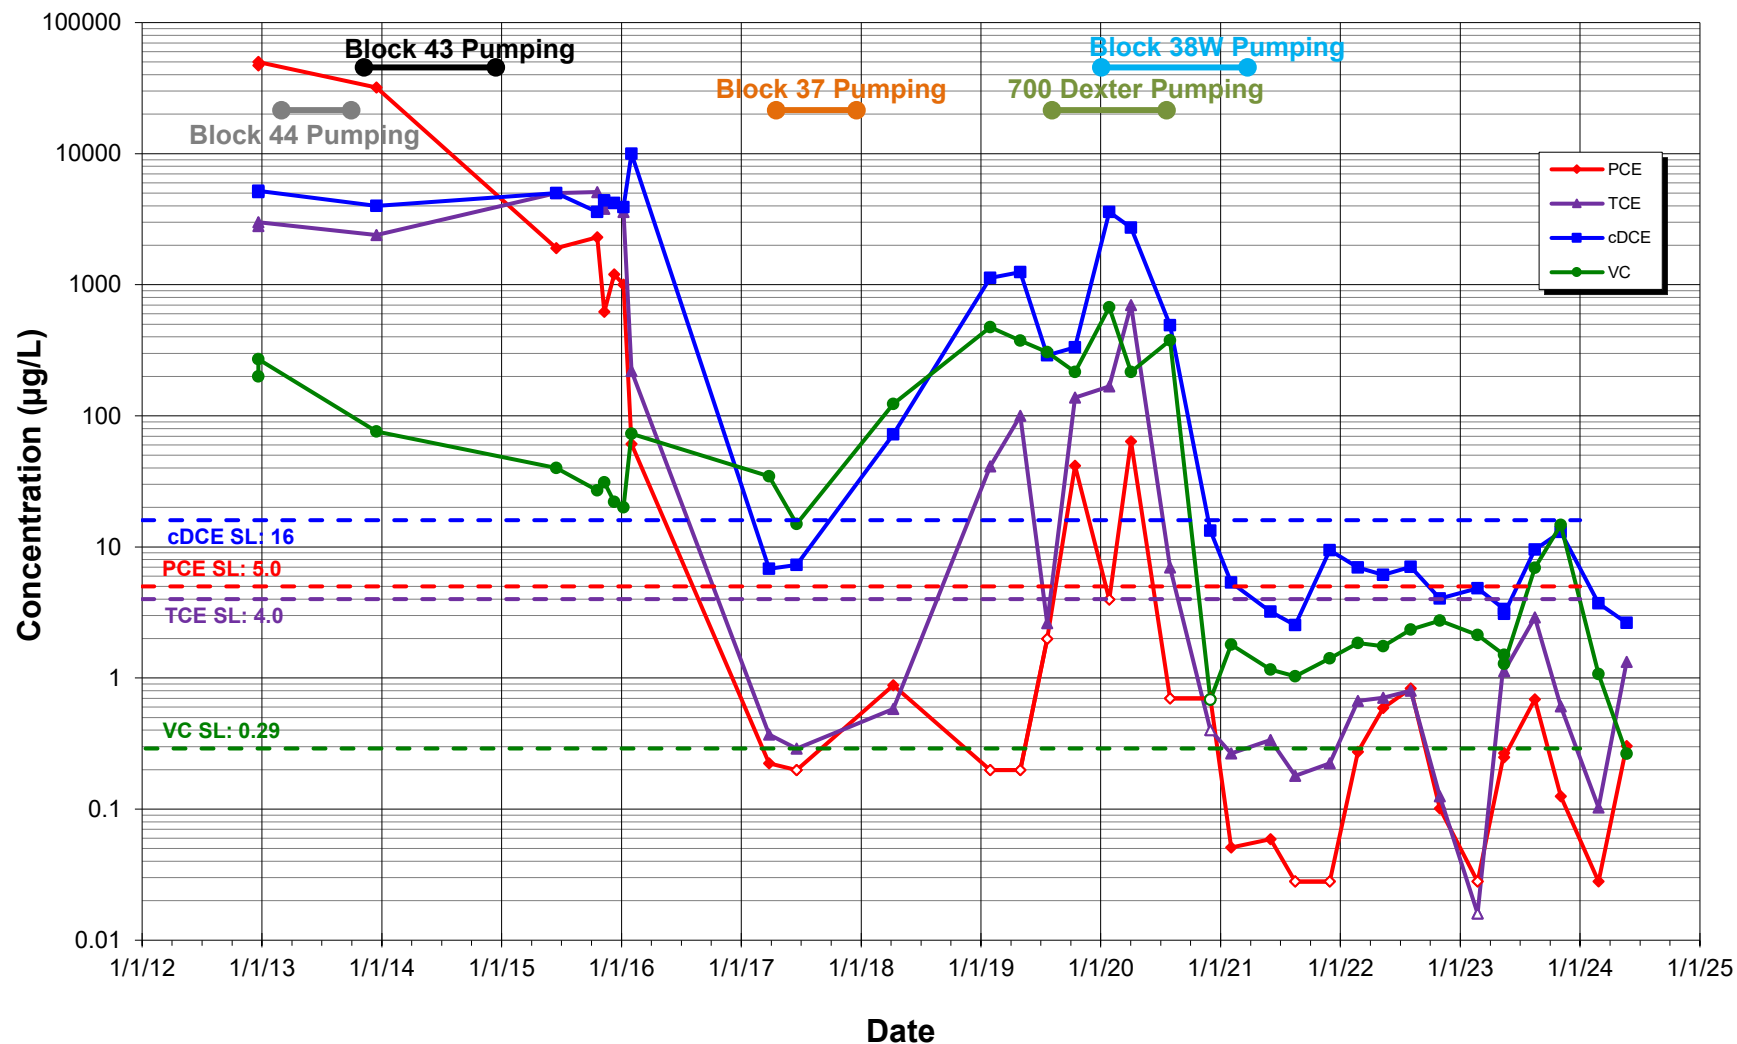
**Concentration vs Time**  
**MW107 (8.8 to -1.2 feet NAVD), 8th Ave N ROW, W side**  
**American Linen Supply Co Dexter Ave Site**

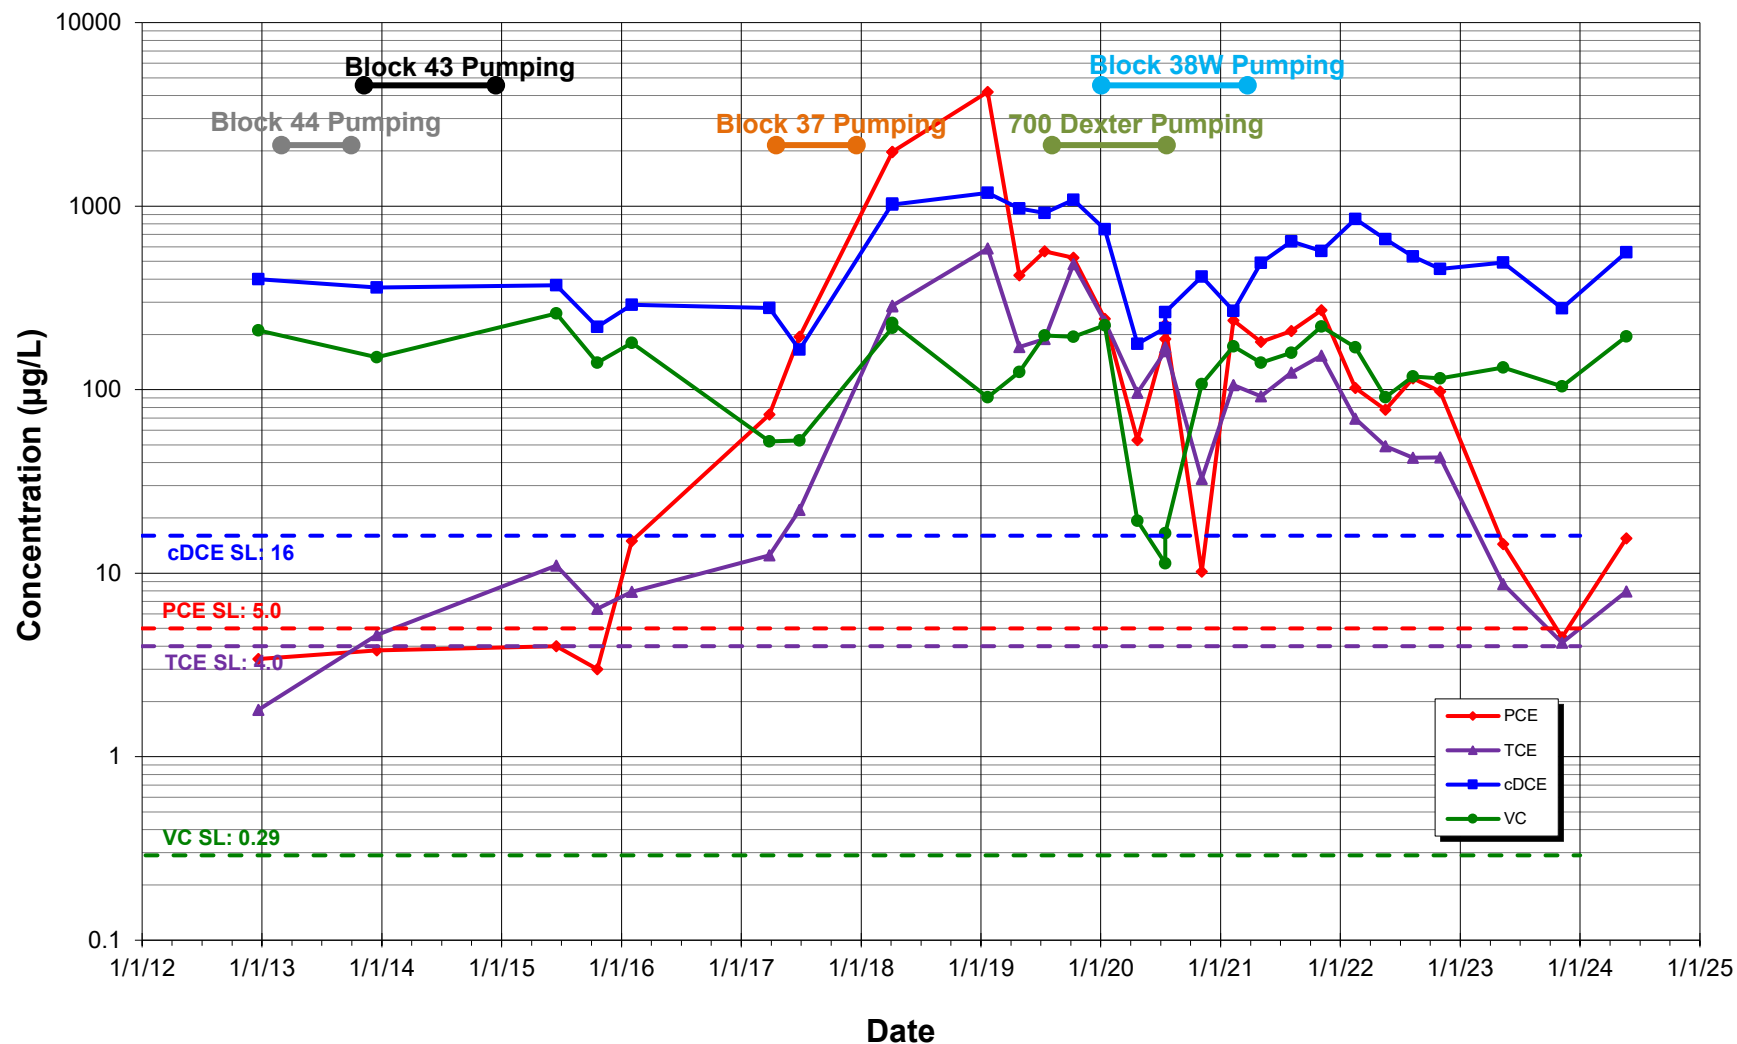
**Concentration vs Time**  
**MW108 (-7.2 to -17.2 feet NAVD), Alley E of Seattle Roy Aloho Shops**  
**American Linen Supply Co Dexter Ave Site**

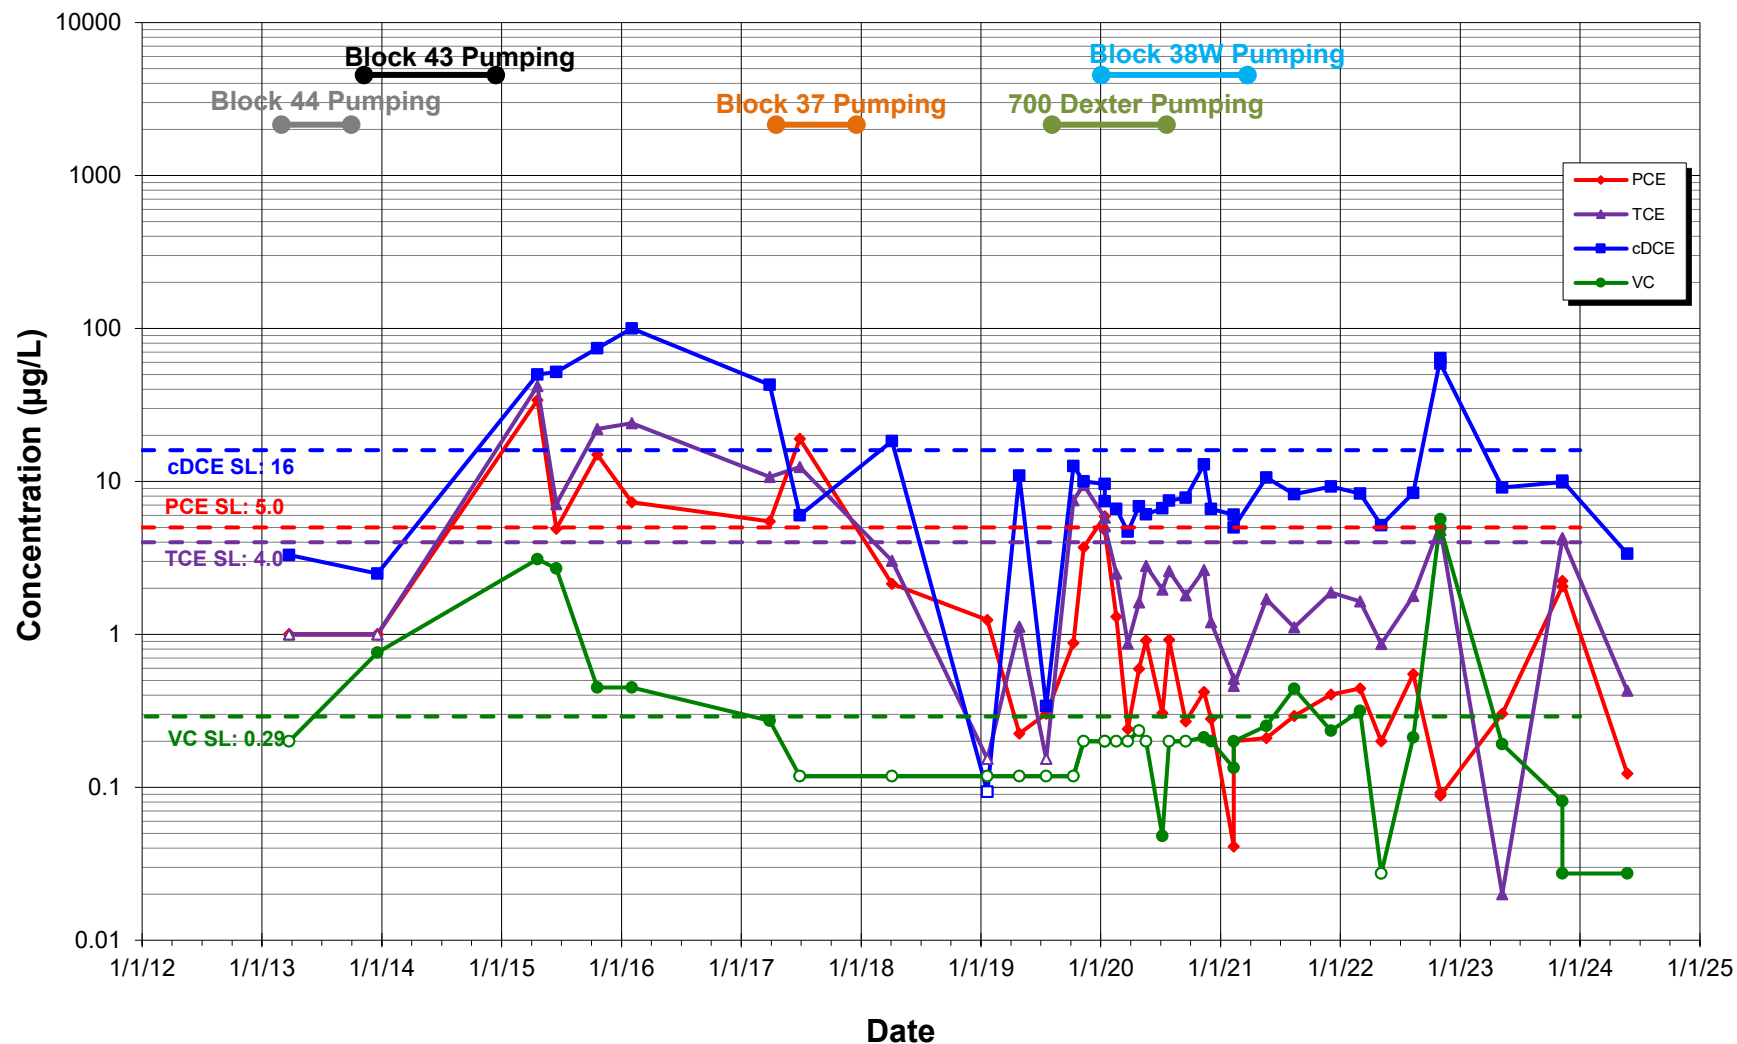
**Concentration vs Time**  
**MW119 (2.7 to -7.3 feet NAVD), 9th Ave N ROW, W side**  
**American Linen Supply Co Dexter Ave Site**

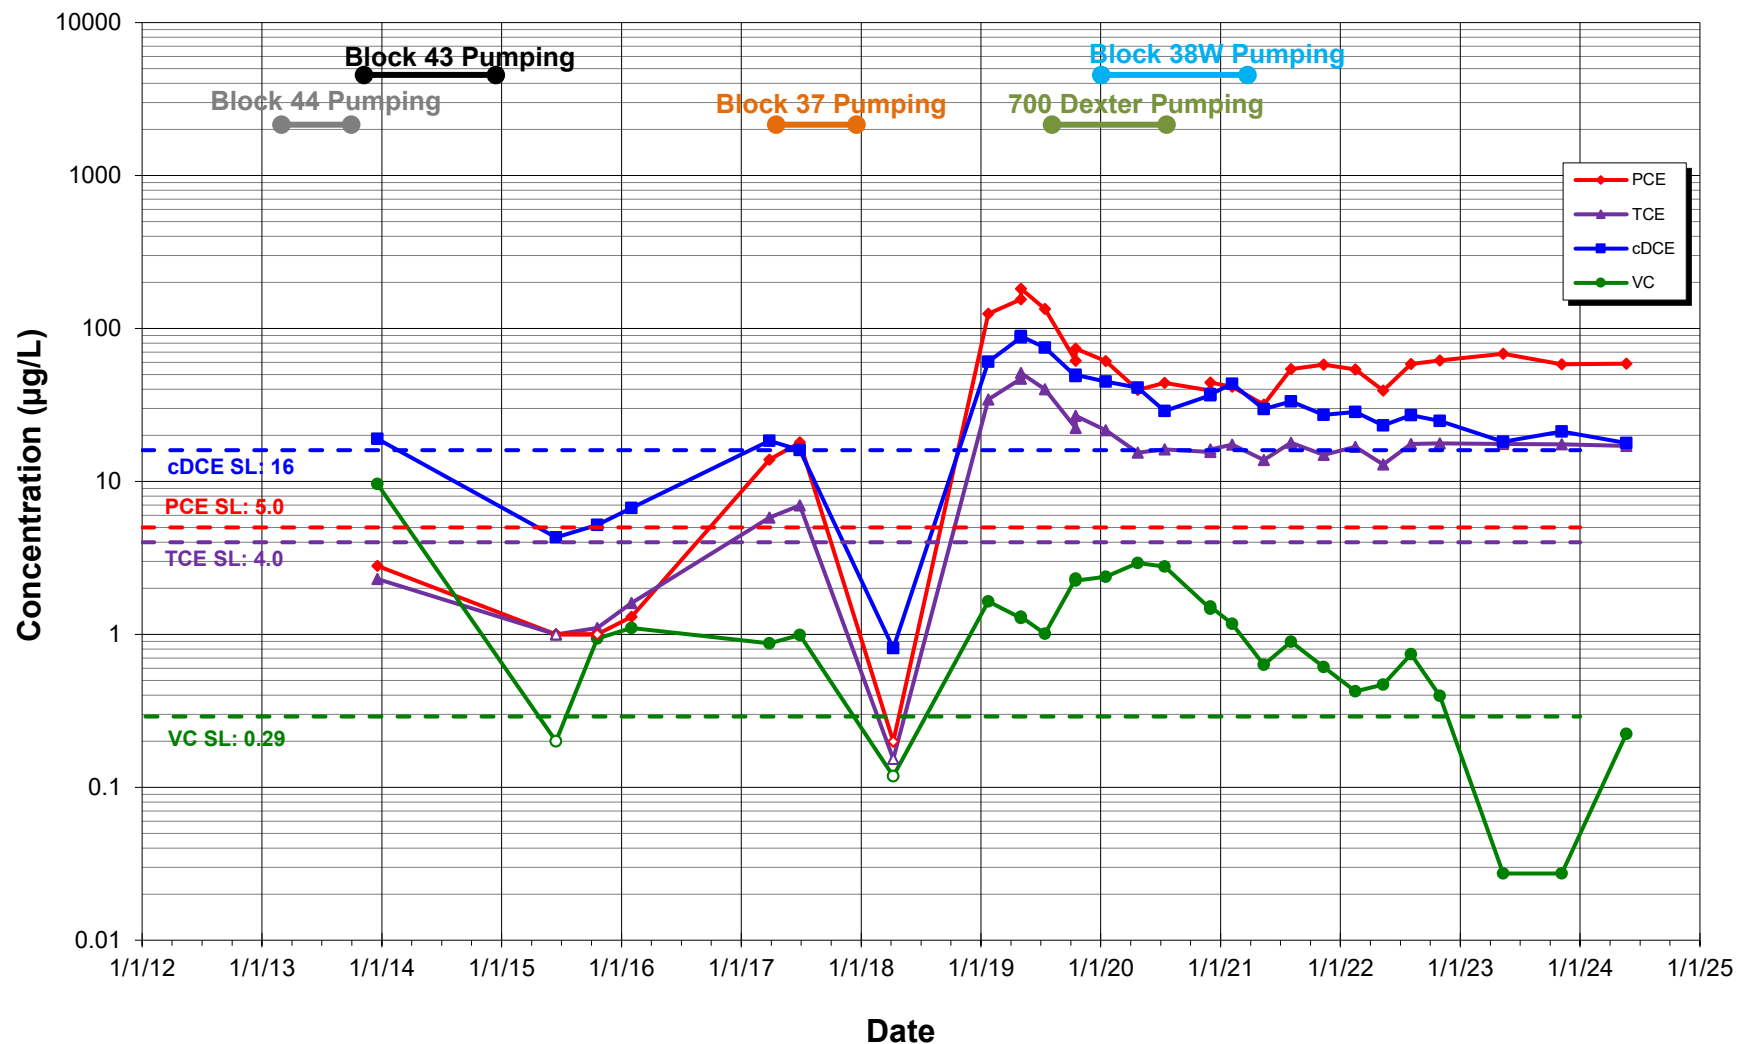
**Concentration vs Time**  
**MW120 (0.0 to -10.0 feet NAVD), 8th Ave N ROW, E side**  
**American Linen Supply Co Dexter Ave Site**

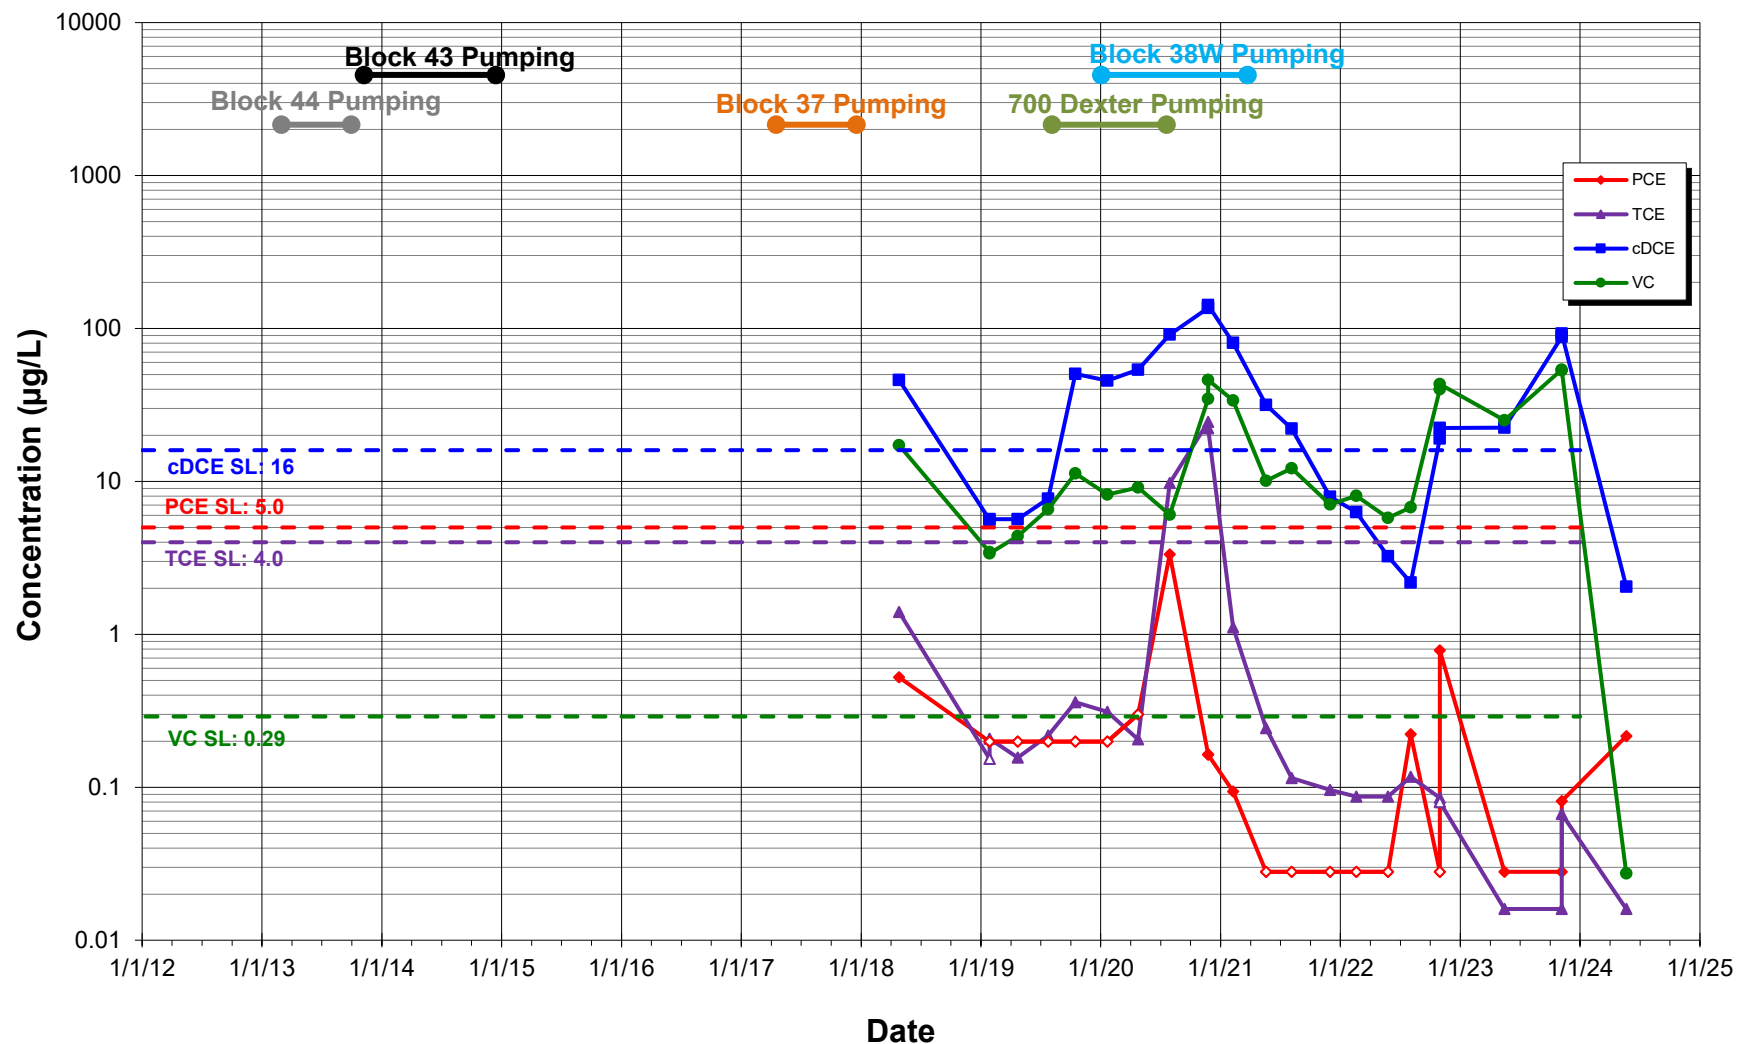
**Concentration vs Time**  
**MW-142 (2.4 to -7.6 feet NAVD), 8th Ave N ROW, E side**  
**American Linen Supply Co-Dexter Ave Site**

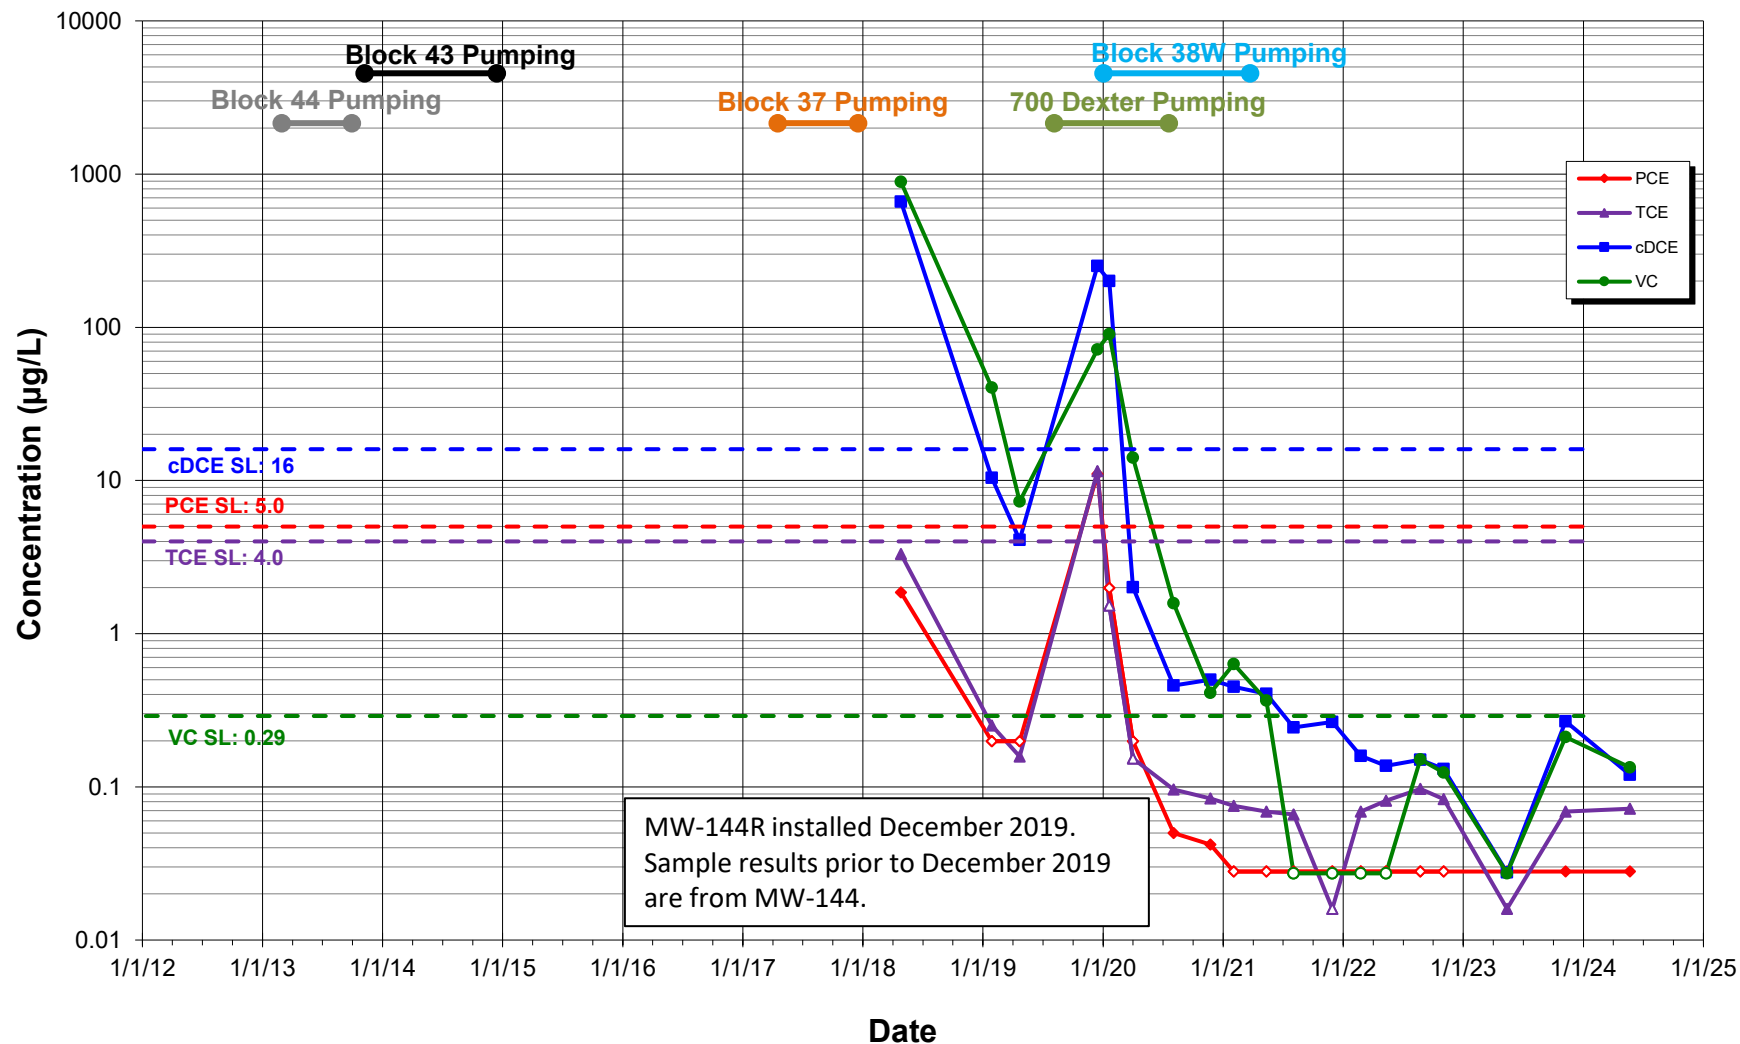
**Concentration vs Time**  
**MW-144R (3.9 to -6.5 feet NAVD), 8th Ave N ROW, E side**  
**American Linen Supply Co Dexter Ave Site**
