**Attachment A**  
**Well Completion Table**  
**American Linen Supply Co–Dexter Avenue Site**  
**Seattle, Washington**

**CVOC TIME-TREND PLOTS**

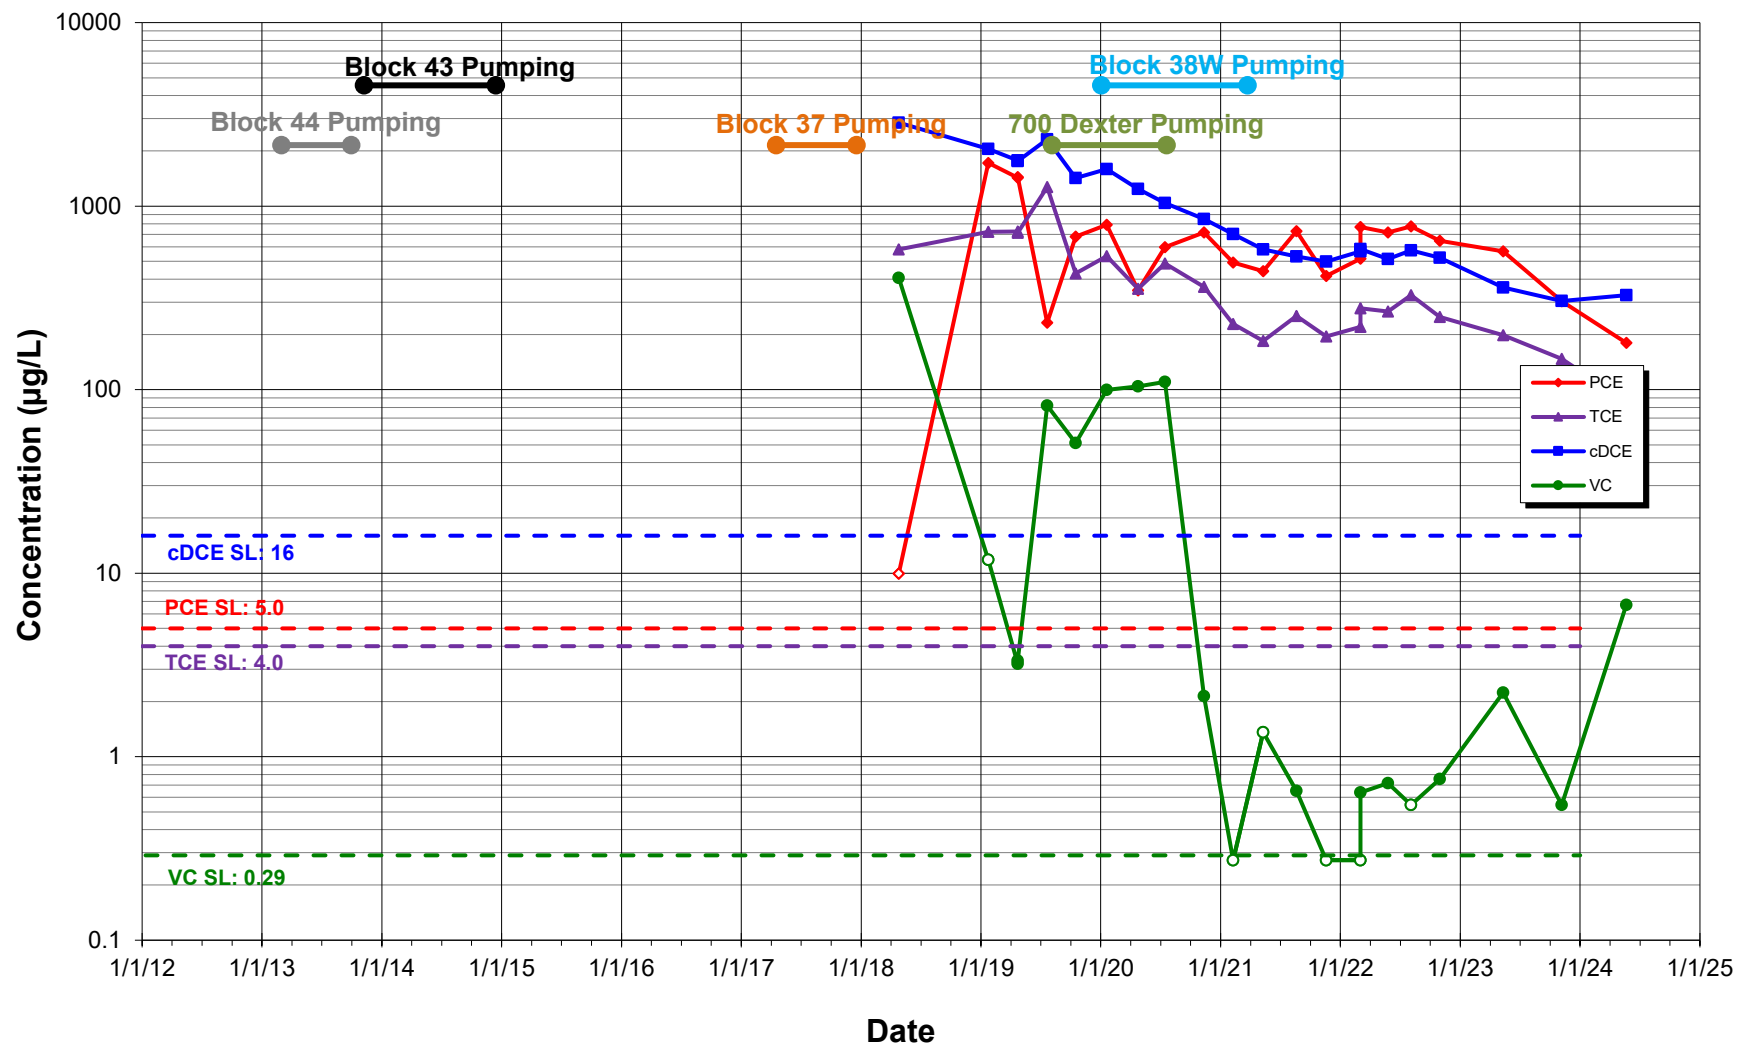
**Concentration vs Time**  
**MW-156 (2.0 to -8.0 feet NAVD), 8th Ave N ROW, E side**  
**American Linen Supply Co Dexter Ave Site**

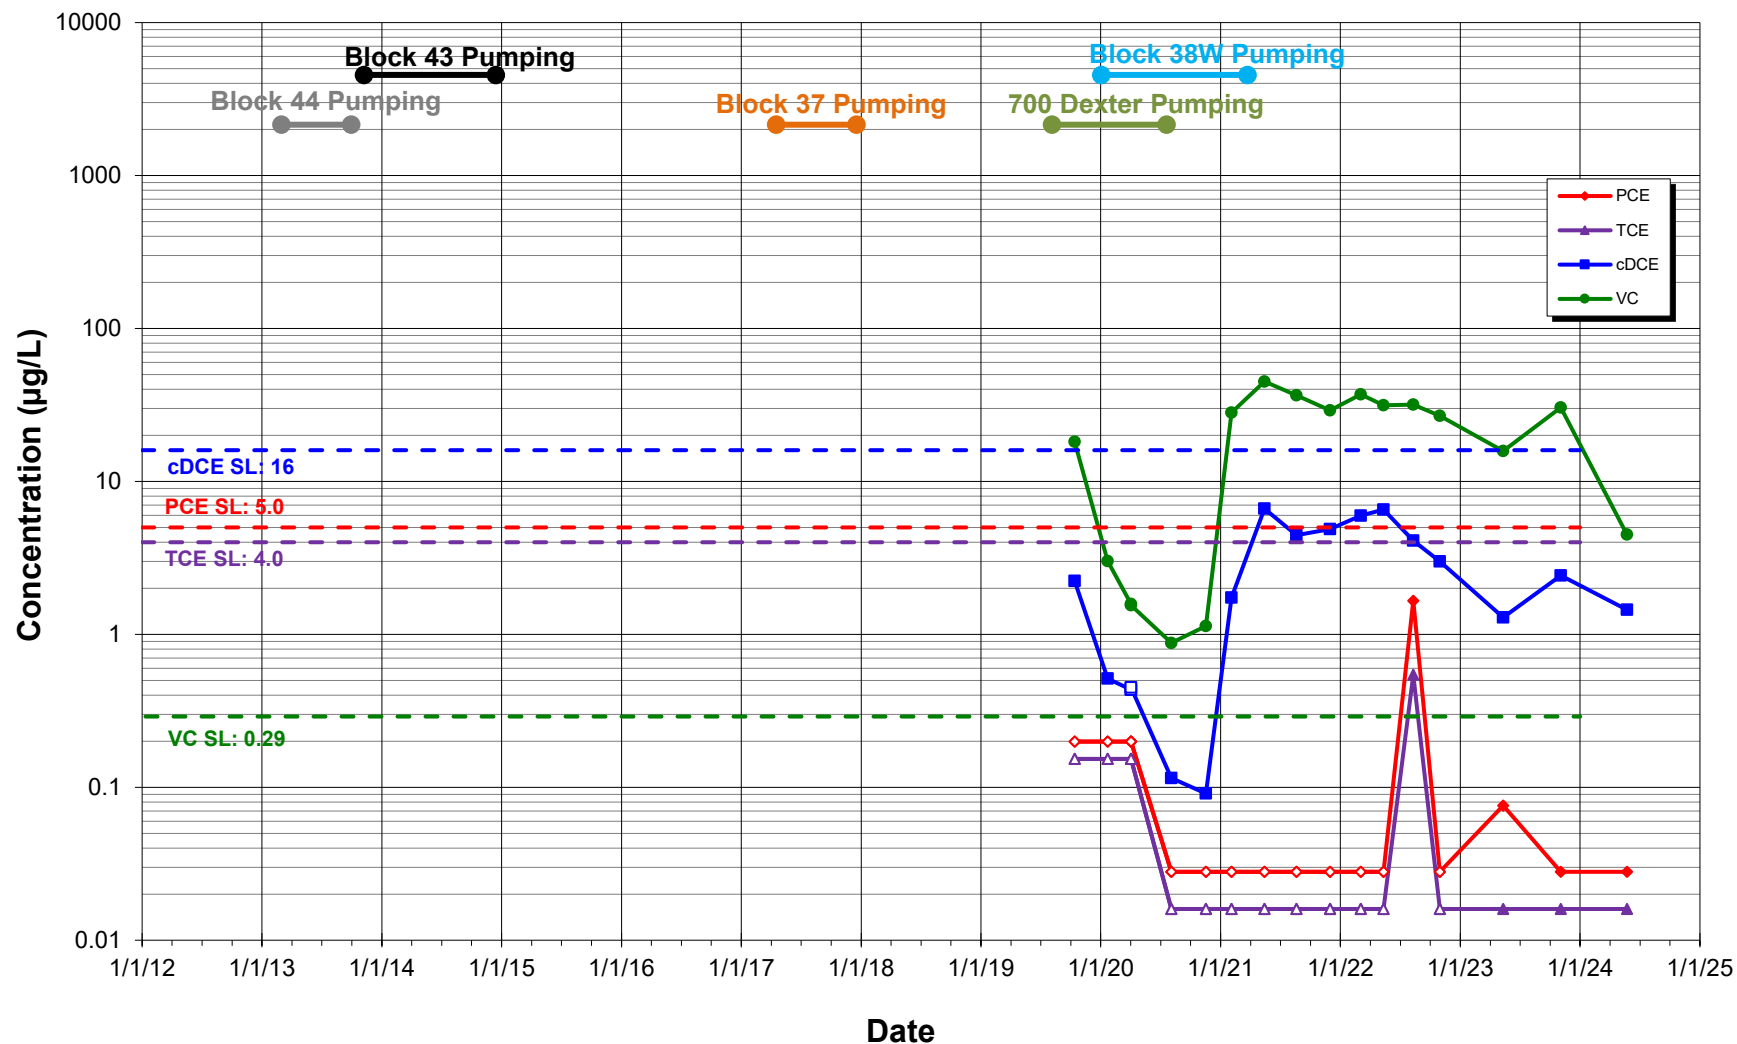
**Concentration vs Time**  
**MW-189 (-1.2 to -11.2 feet NAVD), Valley St ROW, S side**  
**American Linen Supply Co Dexter Ave Site**

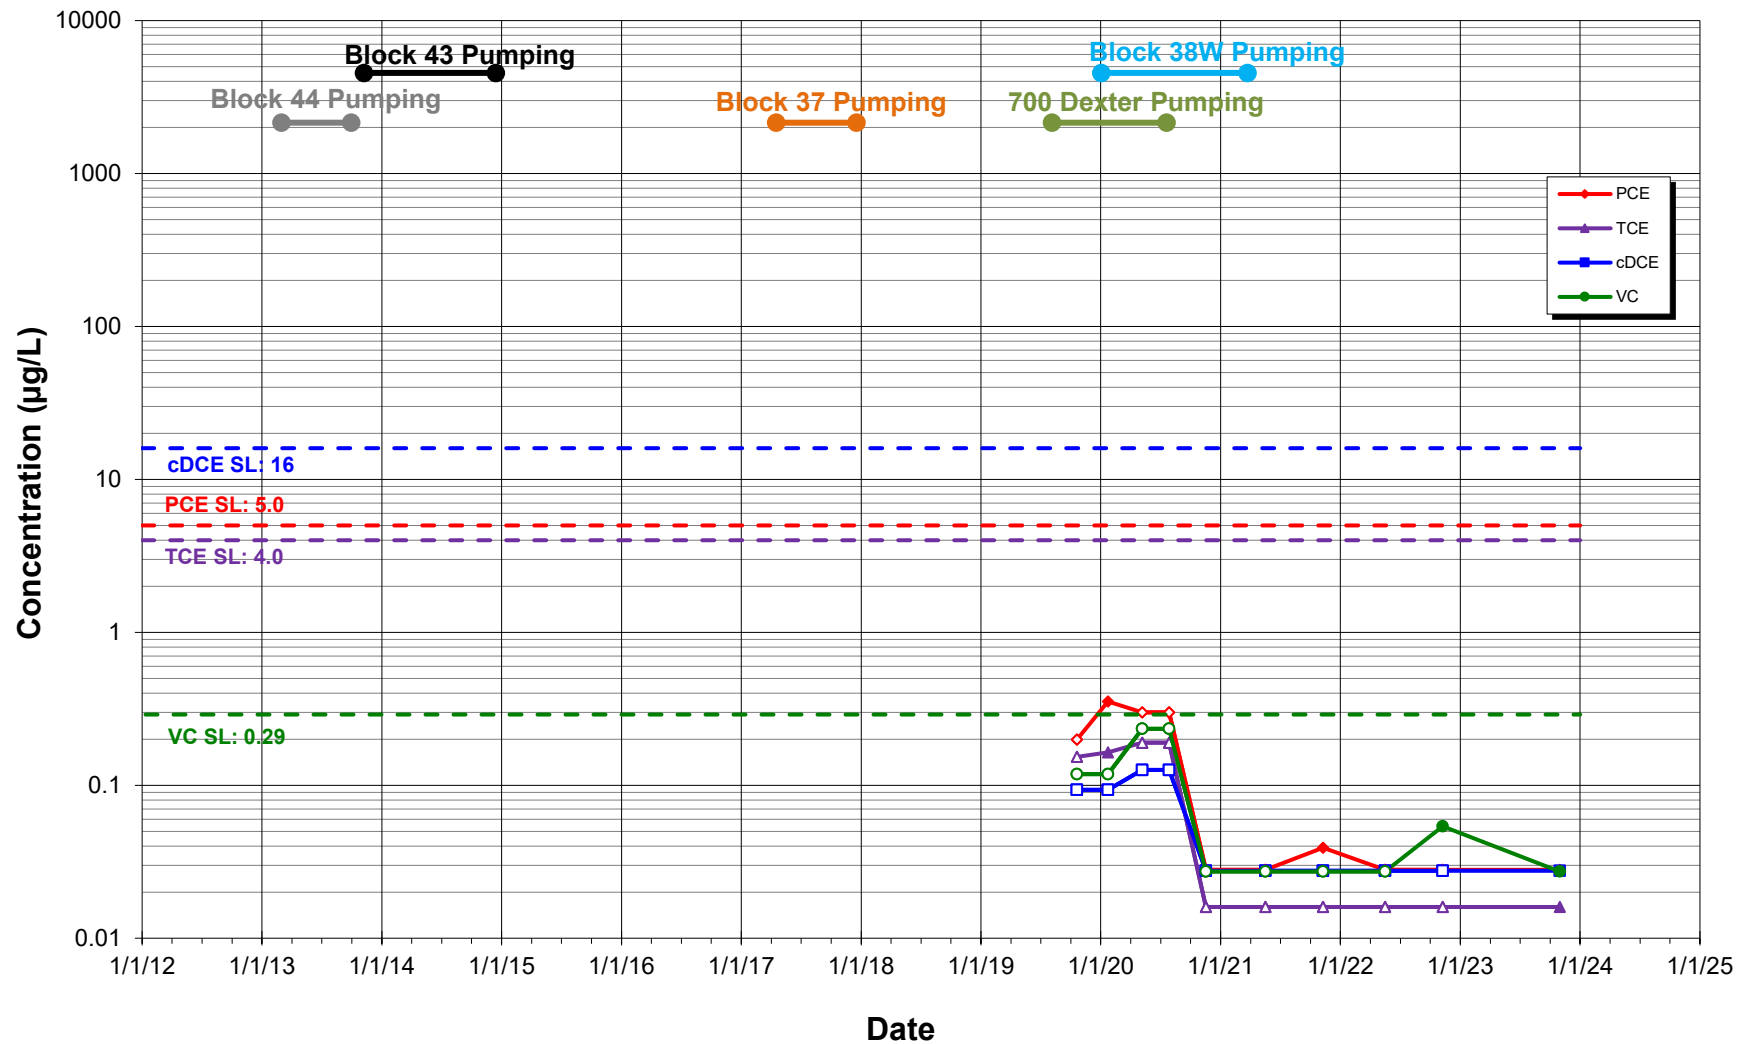
**Concentration vs Time**  
**MW-302 (3.0 to -7.0 feet NAVD), Dexter Ave N ROW, E side**  
**American Linen Supply Co Dexter Ave Site**

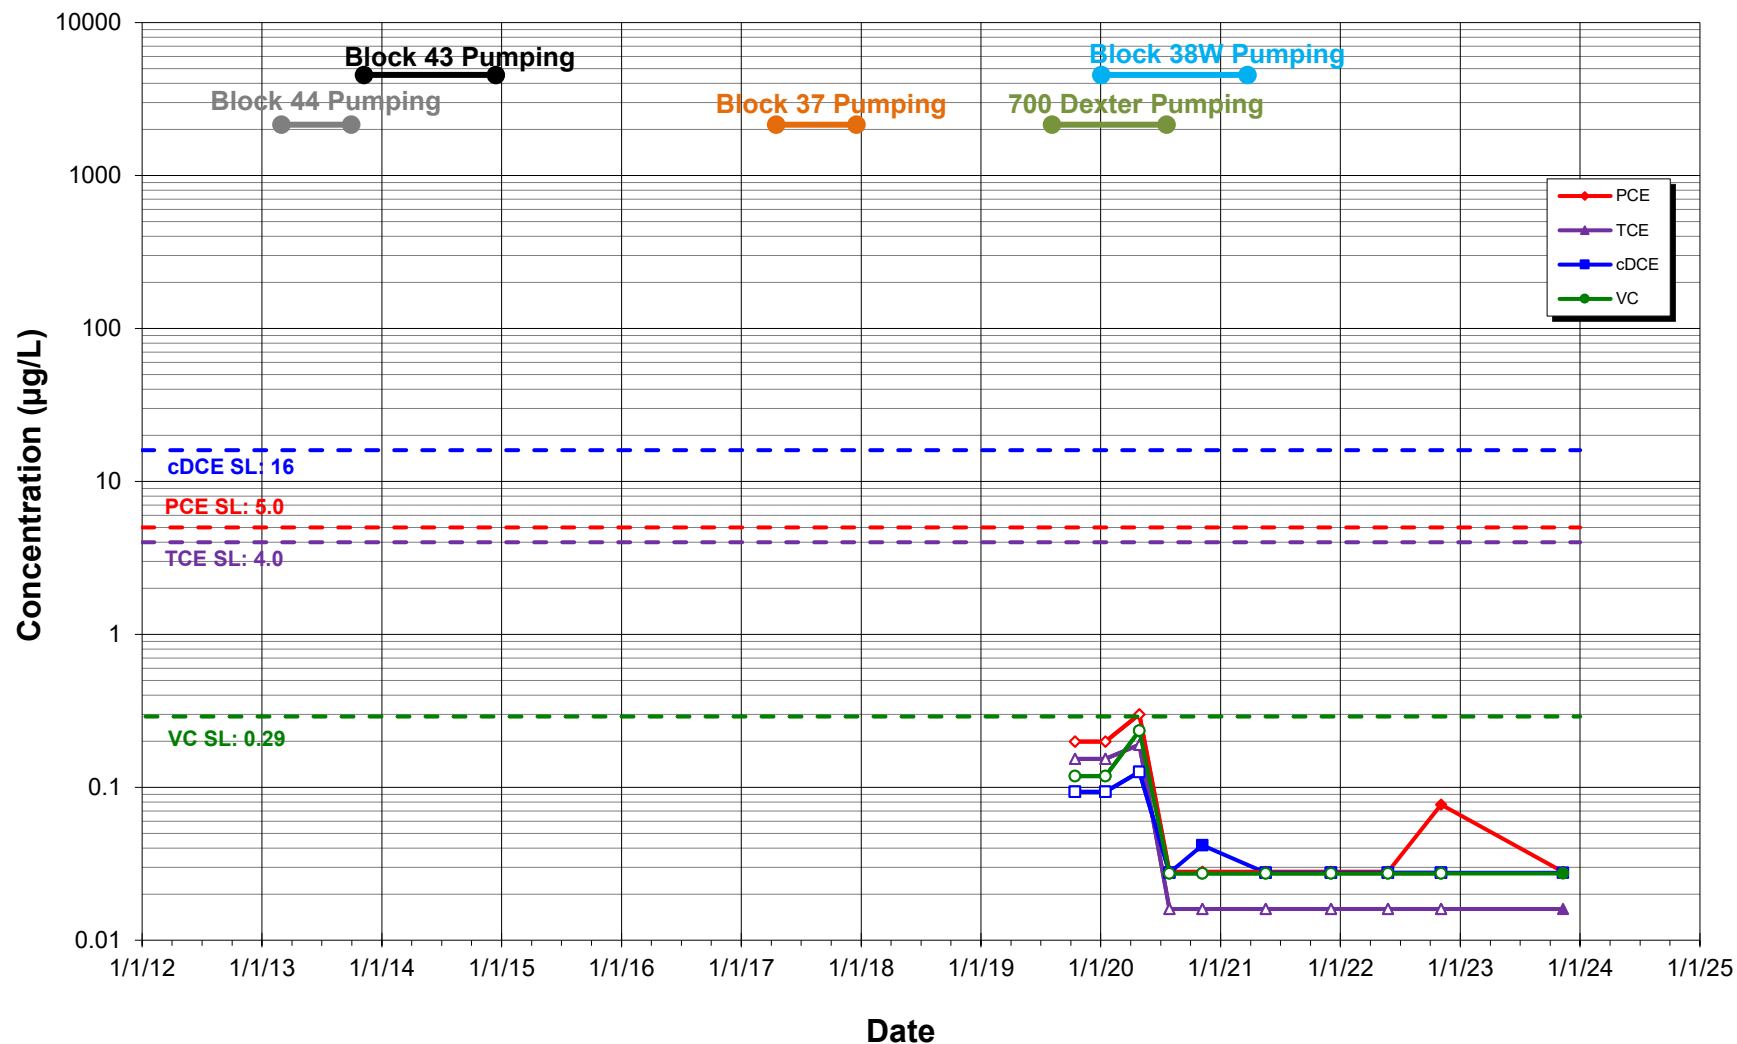
**Concentration vs Time**  
**MW-306 (17.2 to 7.2 feet NAVD), Roy St ROW, S side**  
**American Linen Supply Co Dexter Ave Site**

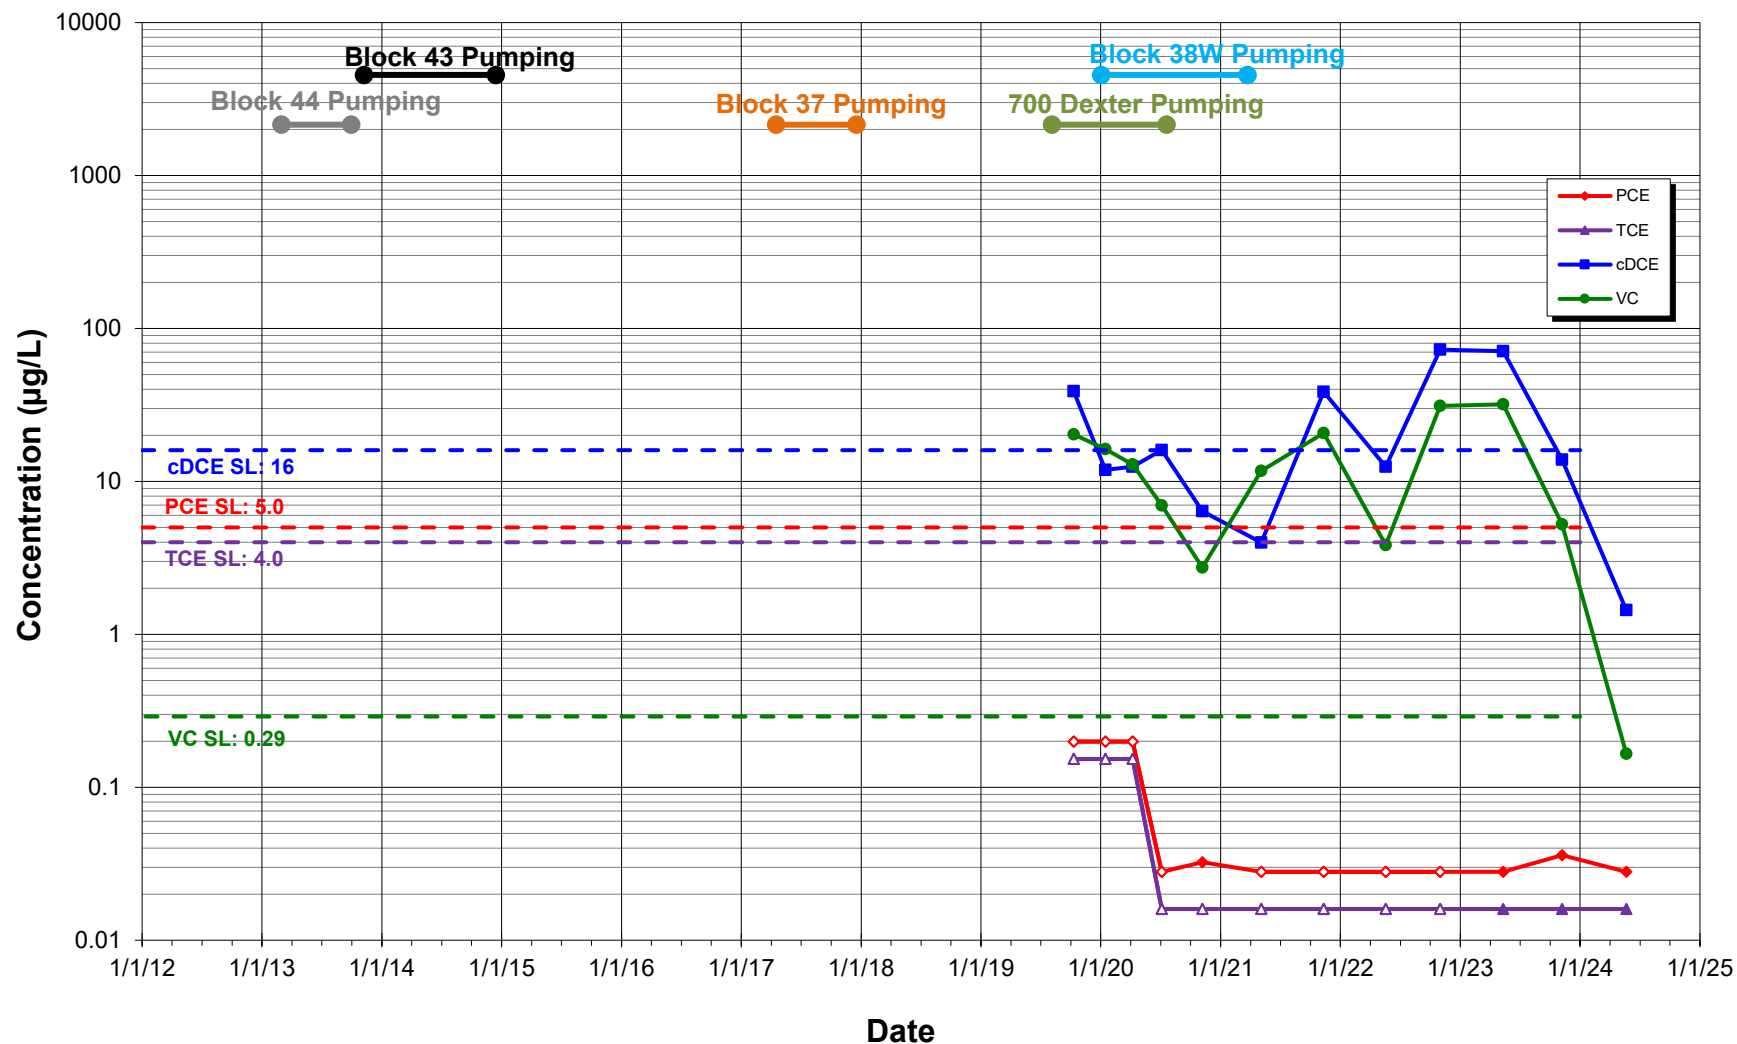
**Concentration vs Time**  
**MW-308 (-4.7 to -14.7 feet NAVD), Alley E of Seattle Roy Aloha Shops**  
**American Linen Supply Co Dexter Ave Site**

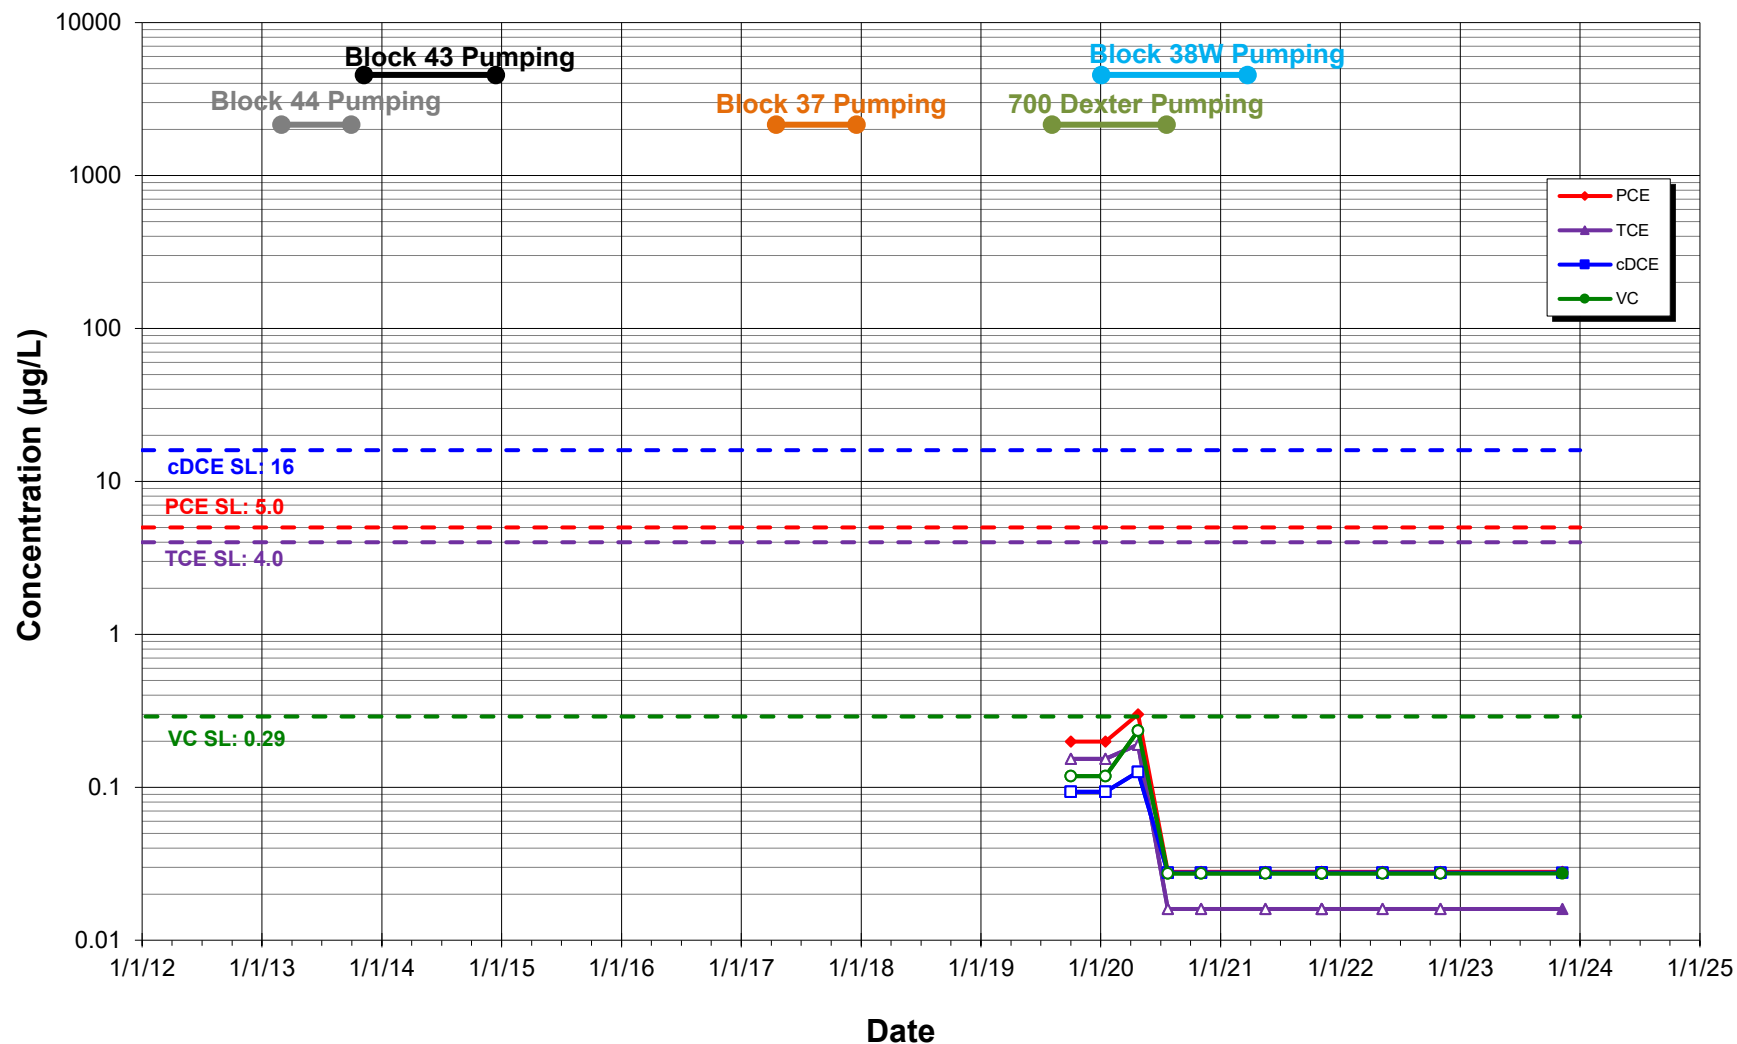
**Concentration vs Time**  
**MW-315 (12.2 to 2.3 feet NAVD), Mercer St ROW, N side**  
**American Linen Supply Co Dexter Ave Site**

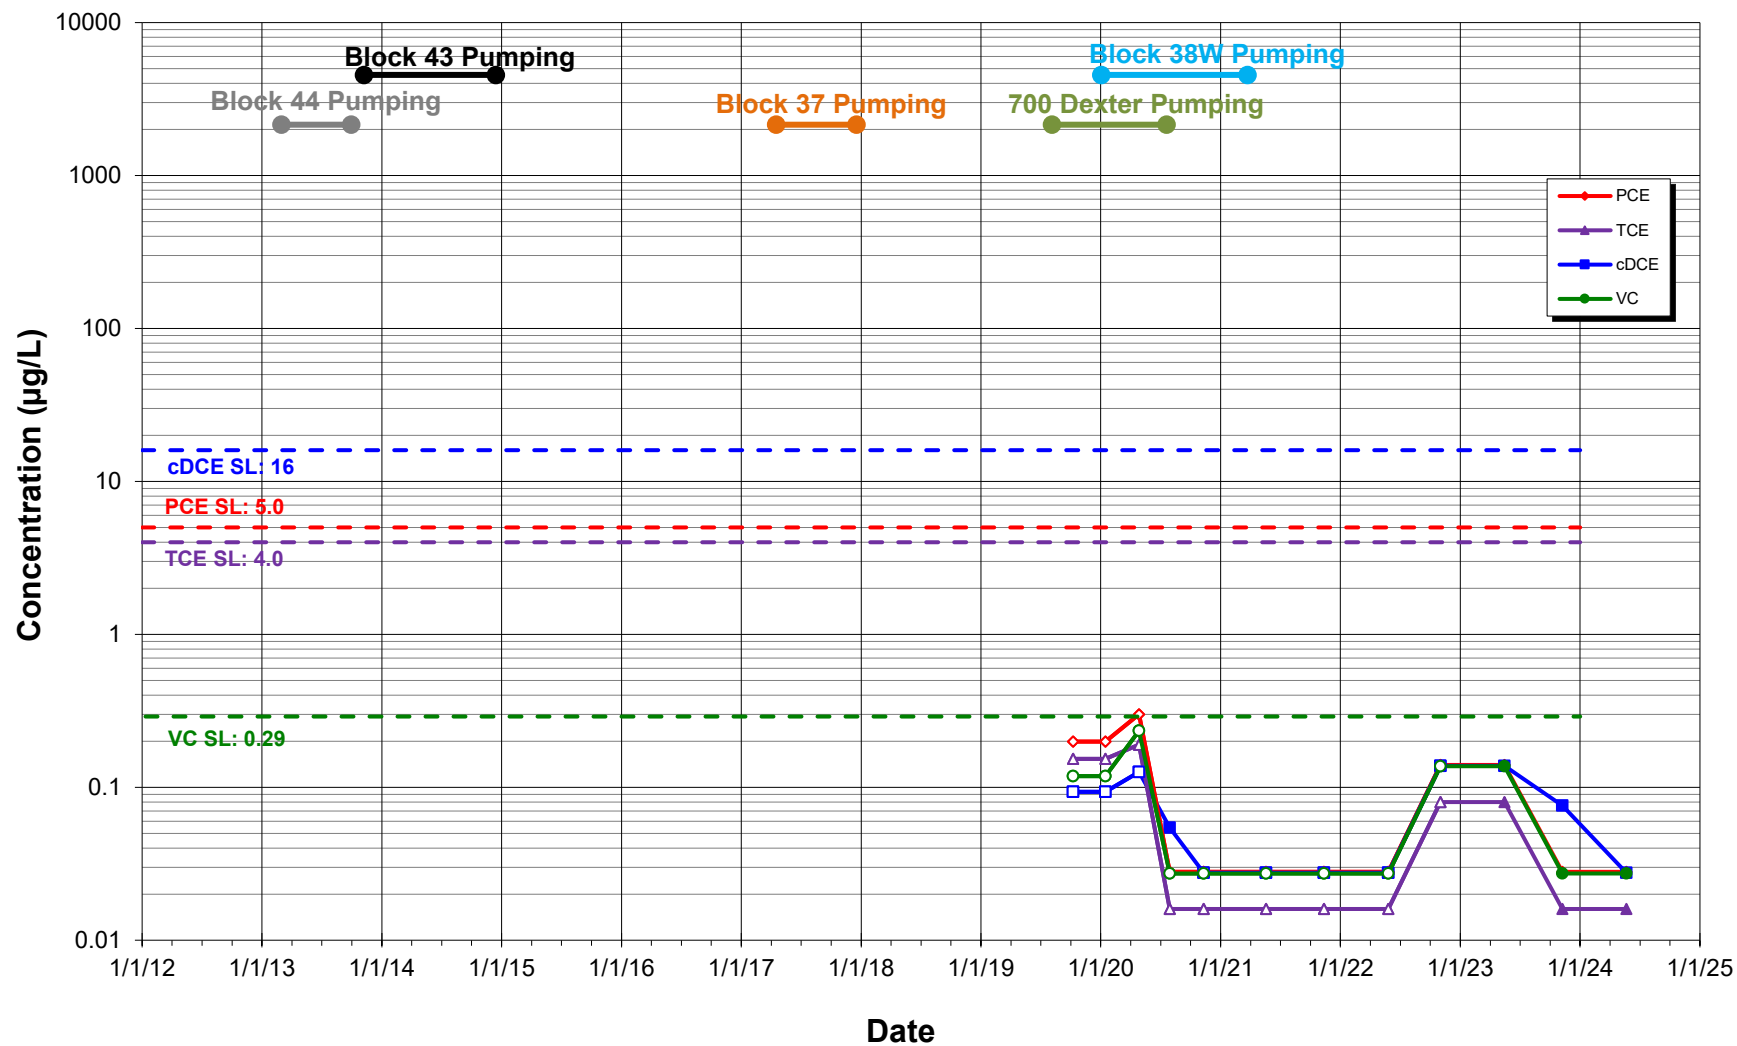
**Concentration vs Time**  
**MW-317 (3.4 to -6.6 feet NAVD), 9th Ave N ROW, W side**  
**American Linen Supply Co Dexter Ave Site**

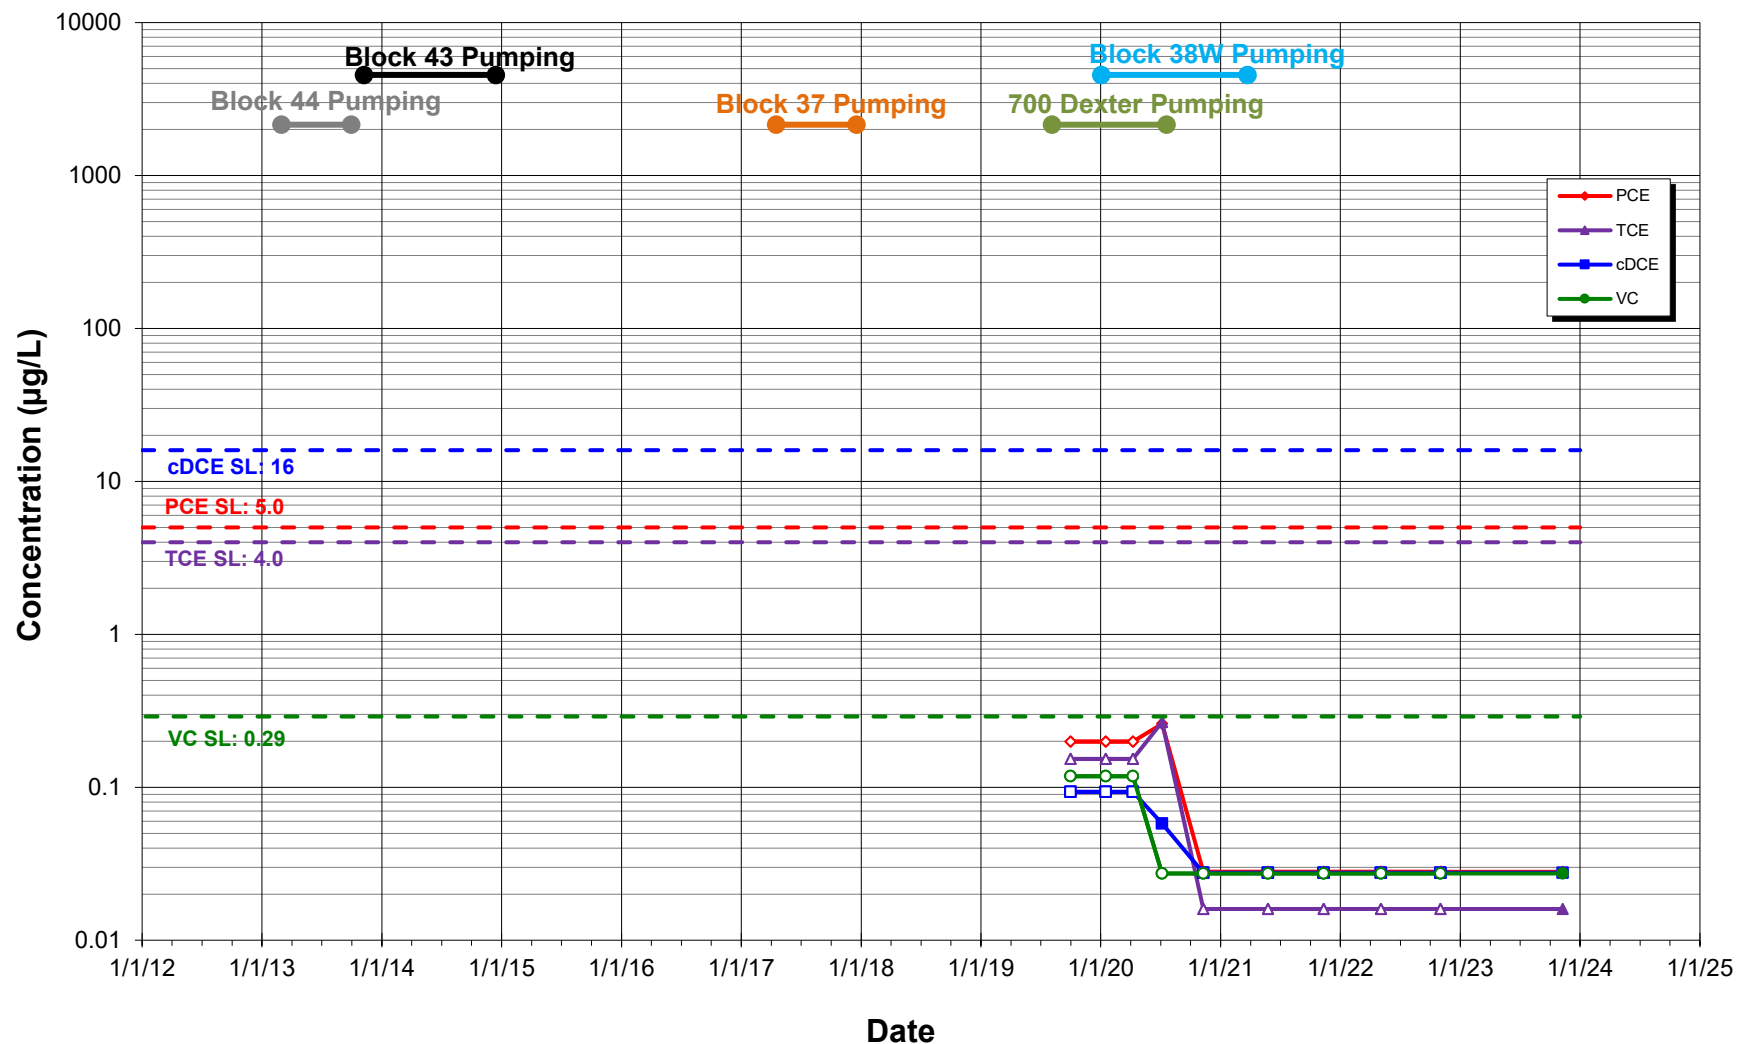
**Concentration vs Time**  
**MW-327 (3.6 to -6.3 feet NAVD), Lake Union Park, S side**  
**American Linen Supply Co Dexter Ave Site**

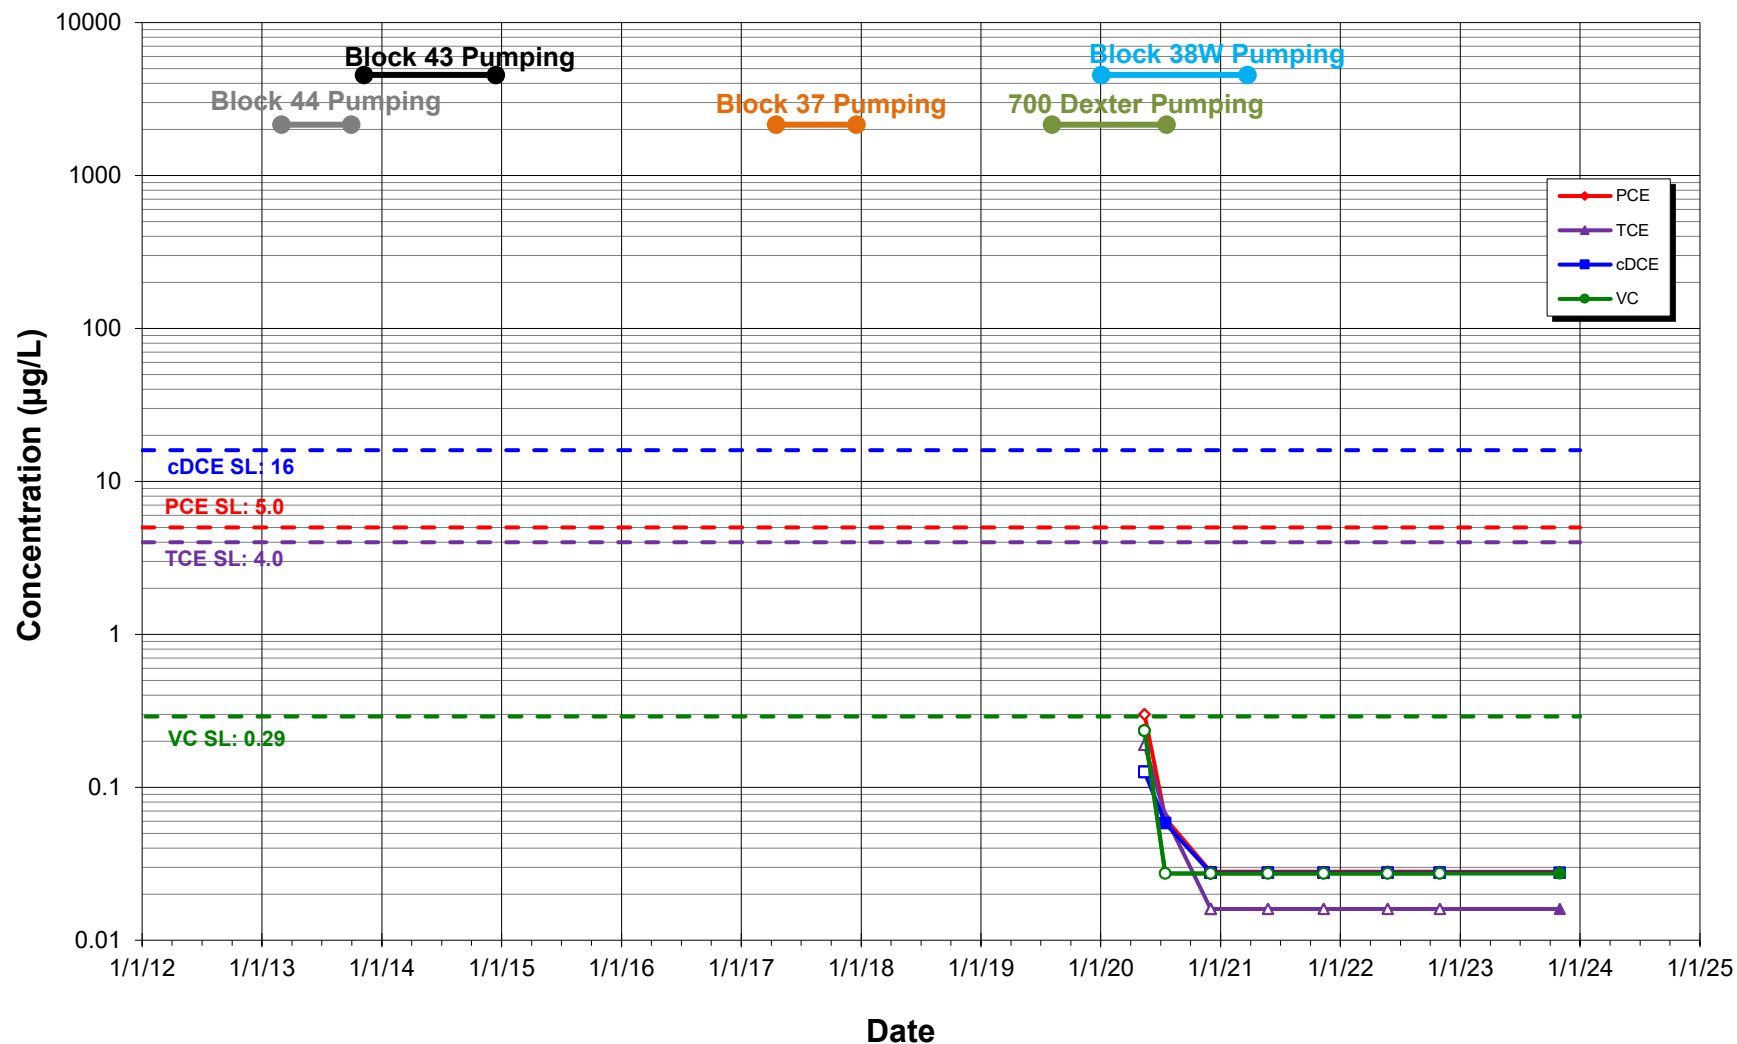
**Concentration vs Time**  
**MW-330 (0.0 to -10.0 feet NAVD), Valley St ROW, N side**  
**American Linen Supply Co Dexter Ave Site**

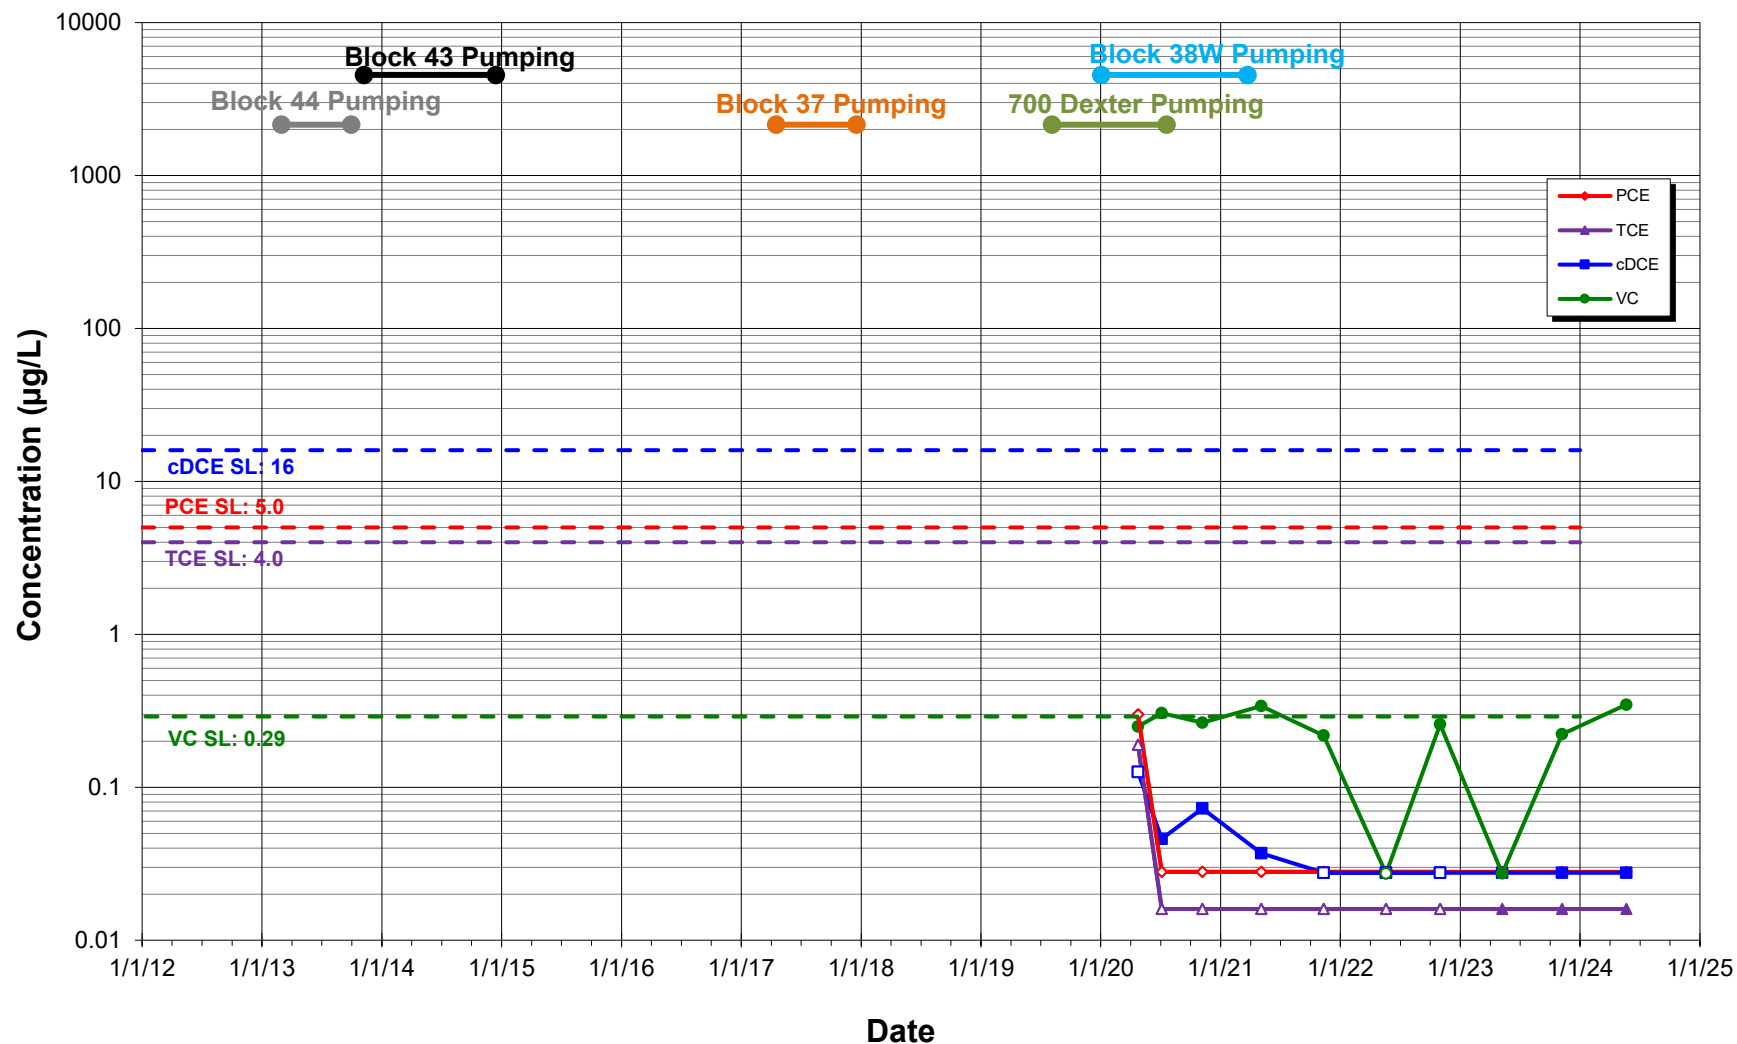
**Concentration vs Time**  
**MW-331 (-4.3 to -14.3 feet NAVD), Alley E of Seattle Roy Aloha Shops**  
**American Linen Supply Co Dexter Ave Site**

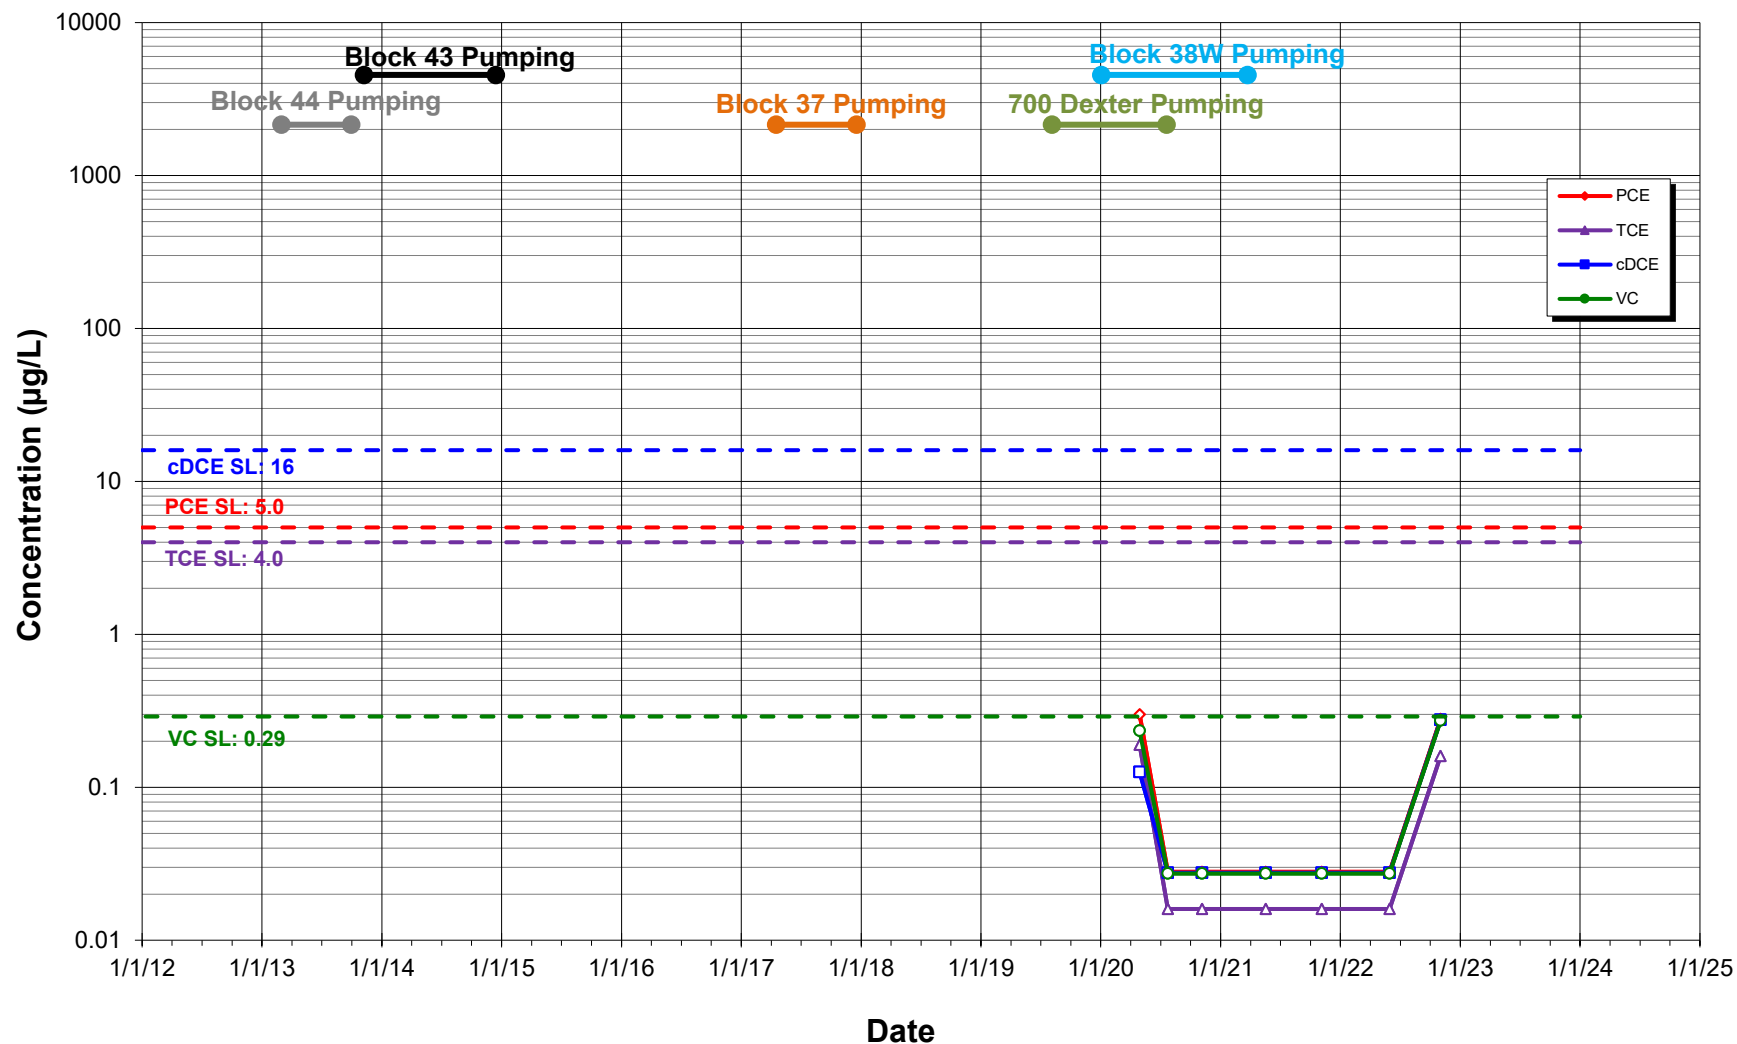
**Concentration vs Time**  
**MW-333 (-1.5 to -11.5 feet NAVD), 900 Roy St, S end**  
**American Linen Supply Co Dexter Ave Site**

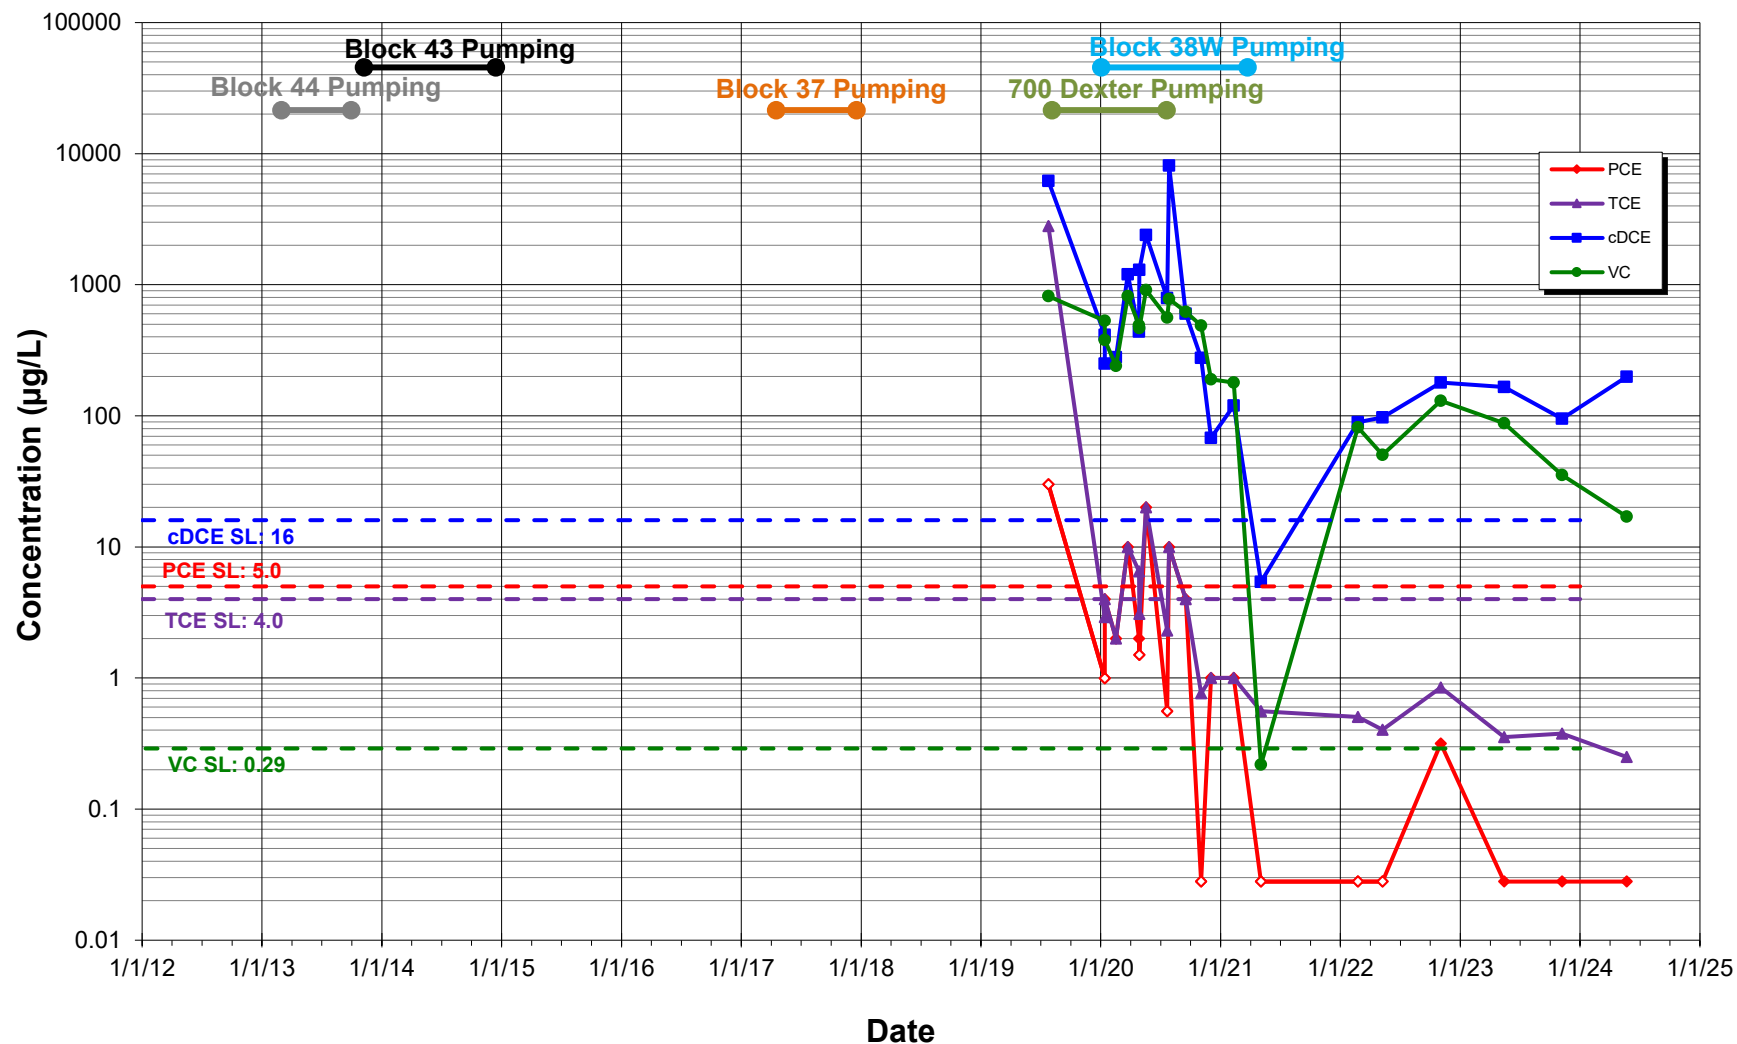
**Concentration vs Time**  
**FMW-141 (-12.1 to -22.1 feet NAVD), Alley E of Seattle Roy Aloha Shops**  
**American Linen Supply Co Dexter Ave Site**
