**Attachment A**  
**Well Completion Table**  
**American Linen Supply Co–Dexter Avenue Site**  
**Seattle, Washington**

**CVOC TIME-TREND PLOTS**

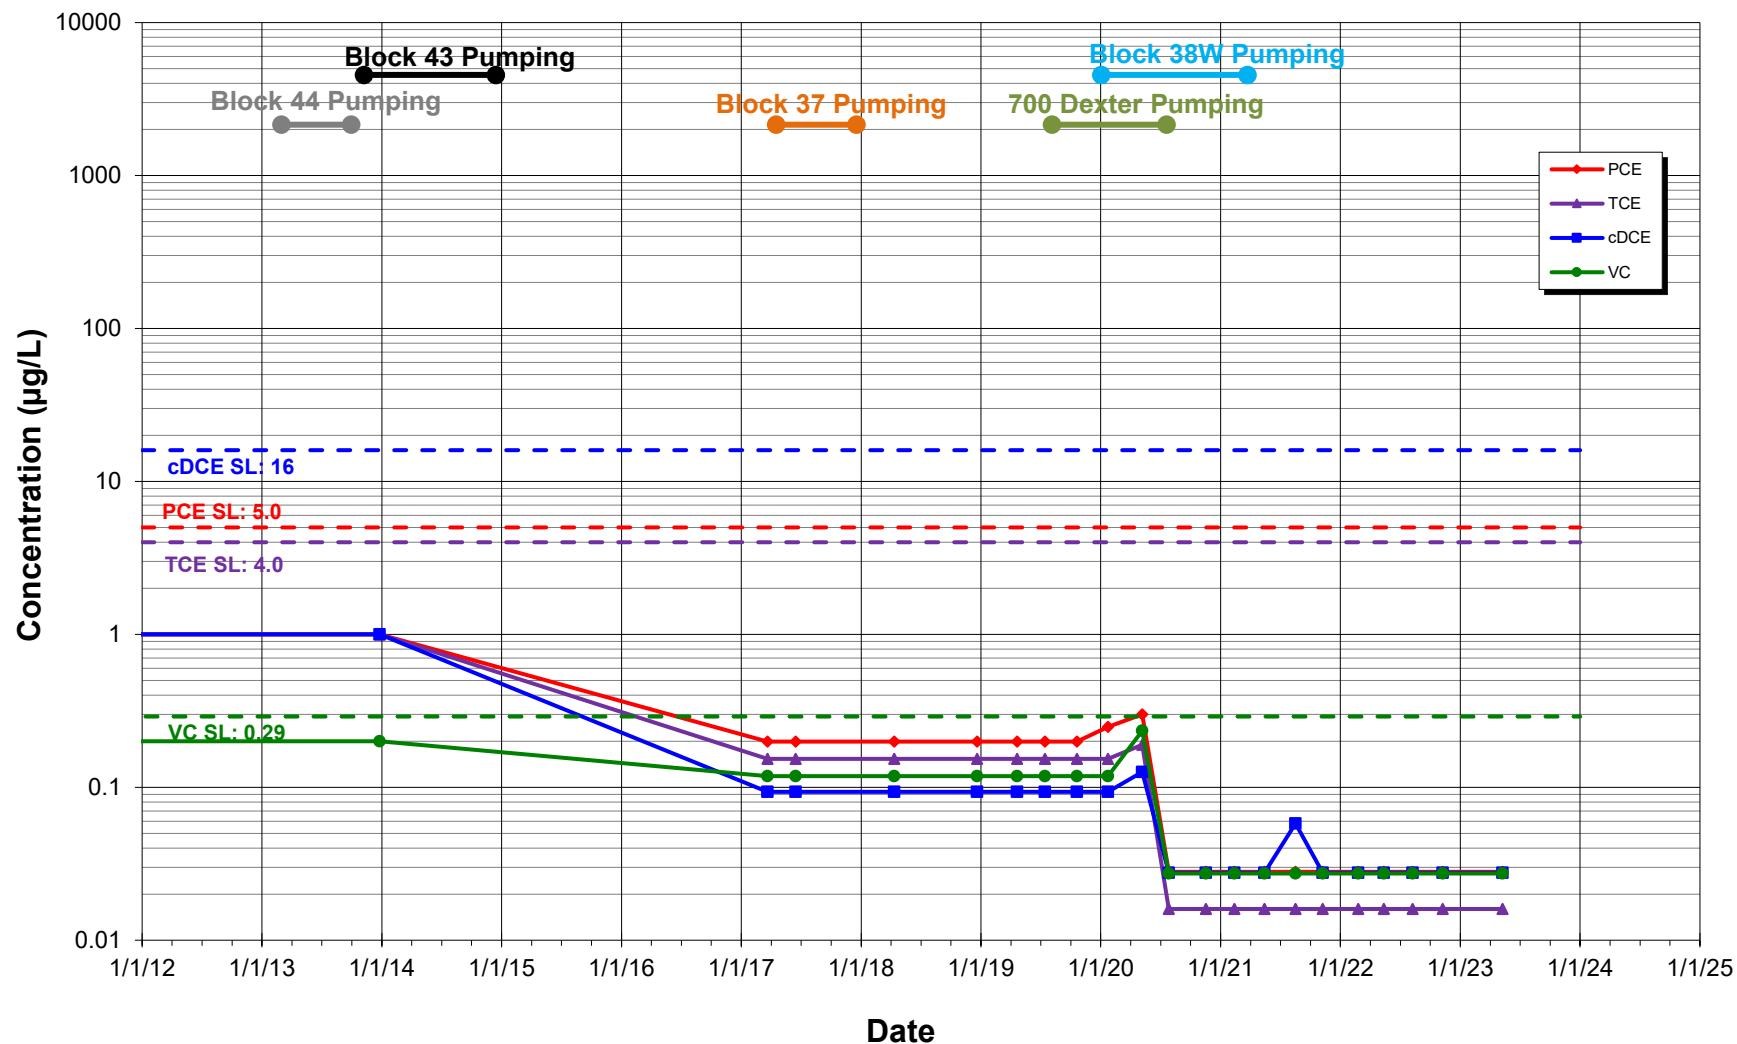
**Concentration vs Time**  
**MW112 (-17.2 to -27.2 feet NAVD), Dexter Ave N ROW, W side**  
**American Linen Supply Co Dexter Ave Site**

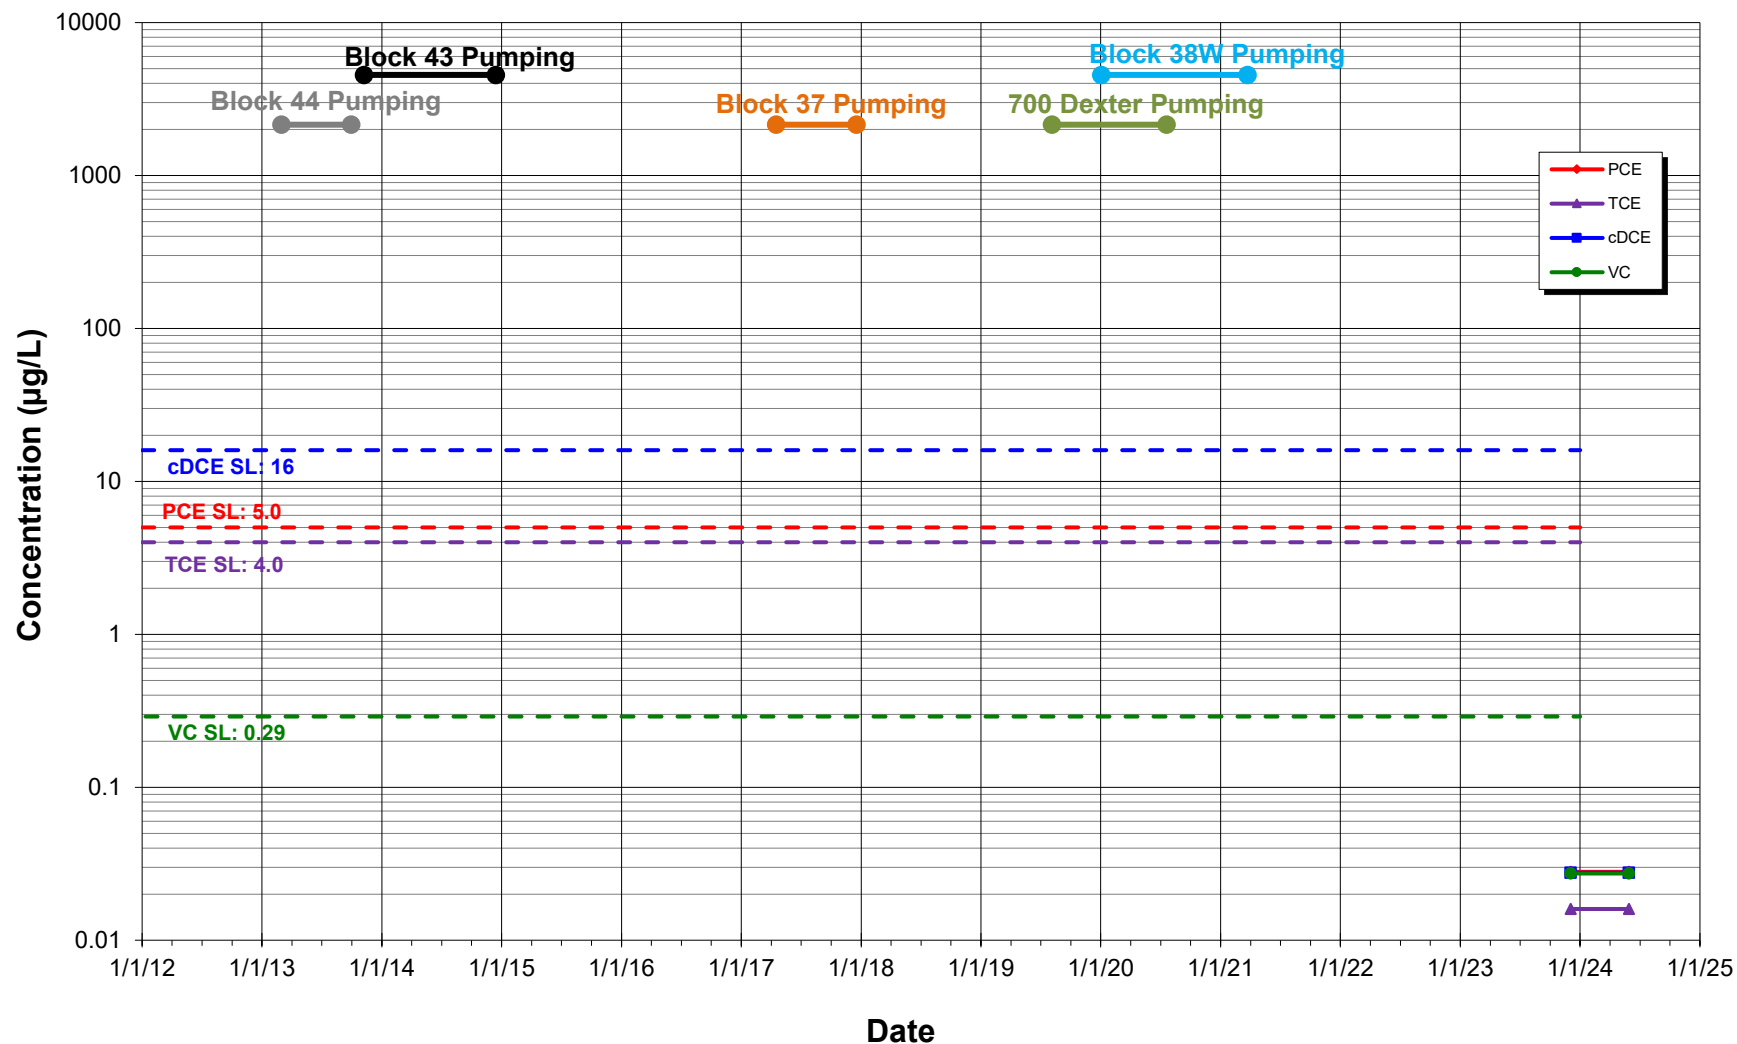
**Concentration vs Time**  
**MW112R (Not Yet Surveyed), Dexter Ave N ROW, W side**  
**American Linen Supply Co Dexter Ave Site**

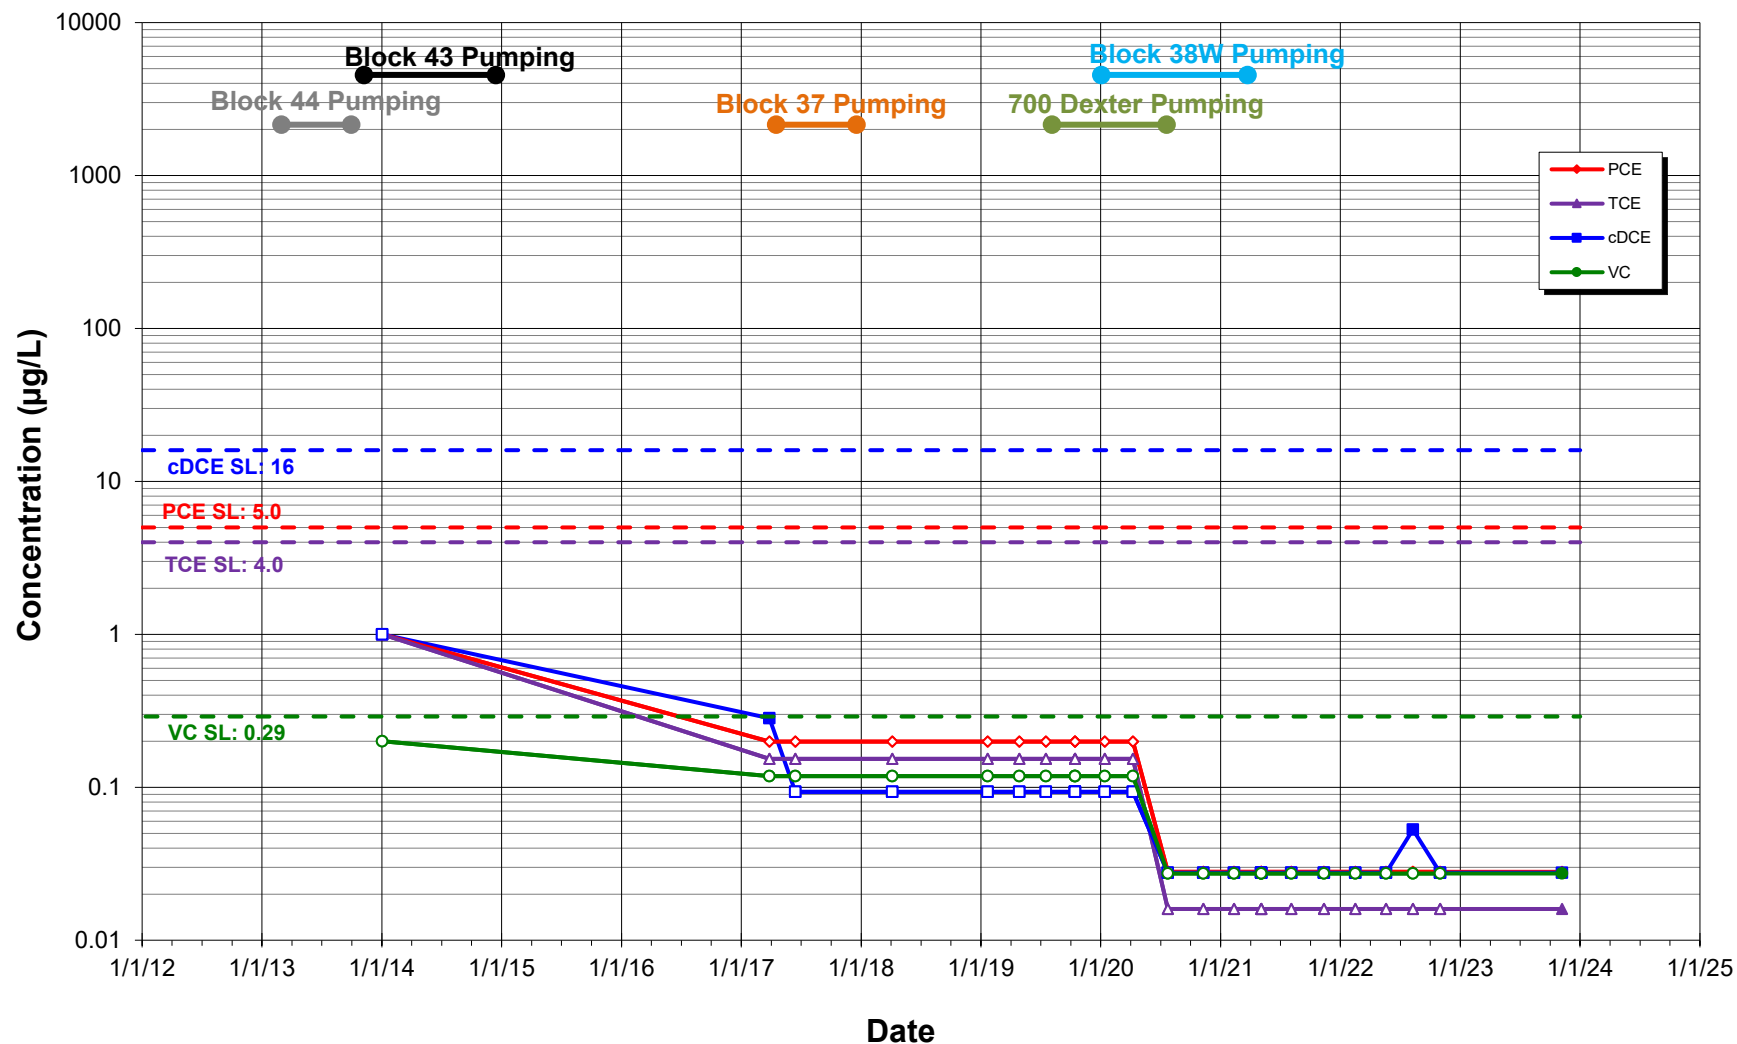
**Concentration vs Time**  
**MW126 (-54.1 to -64.1 feet NAVD), Alley E of Seattle Roy Aloha Shops**  
**American Linen Supply Co Dexter Ave Site**

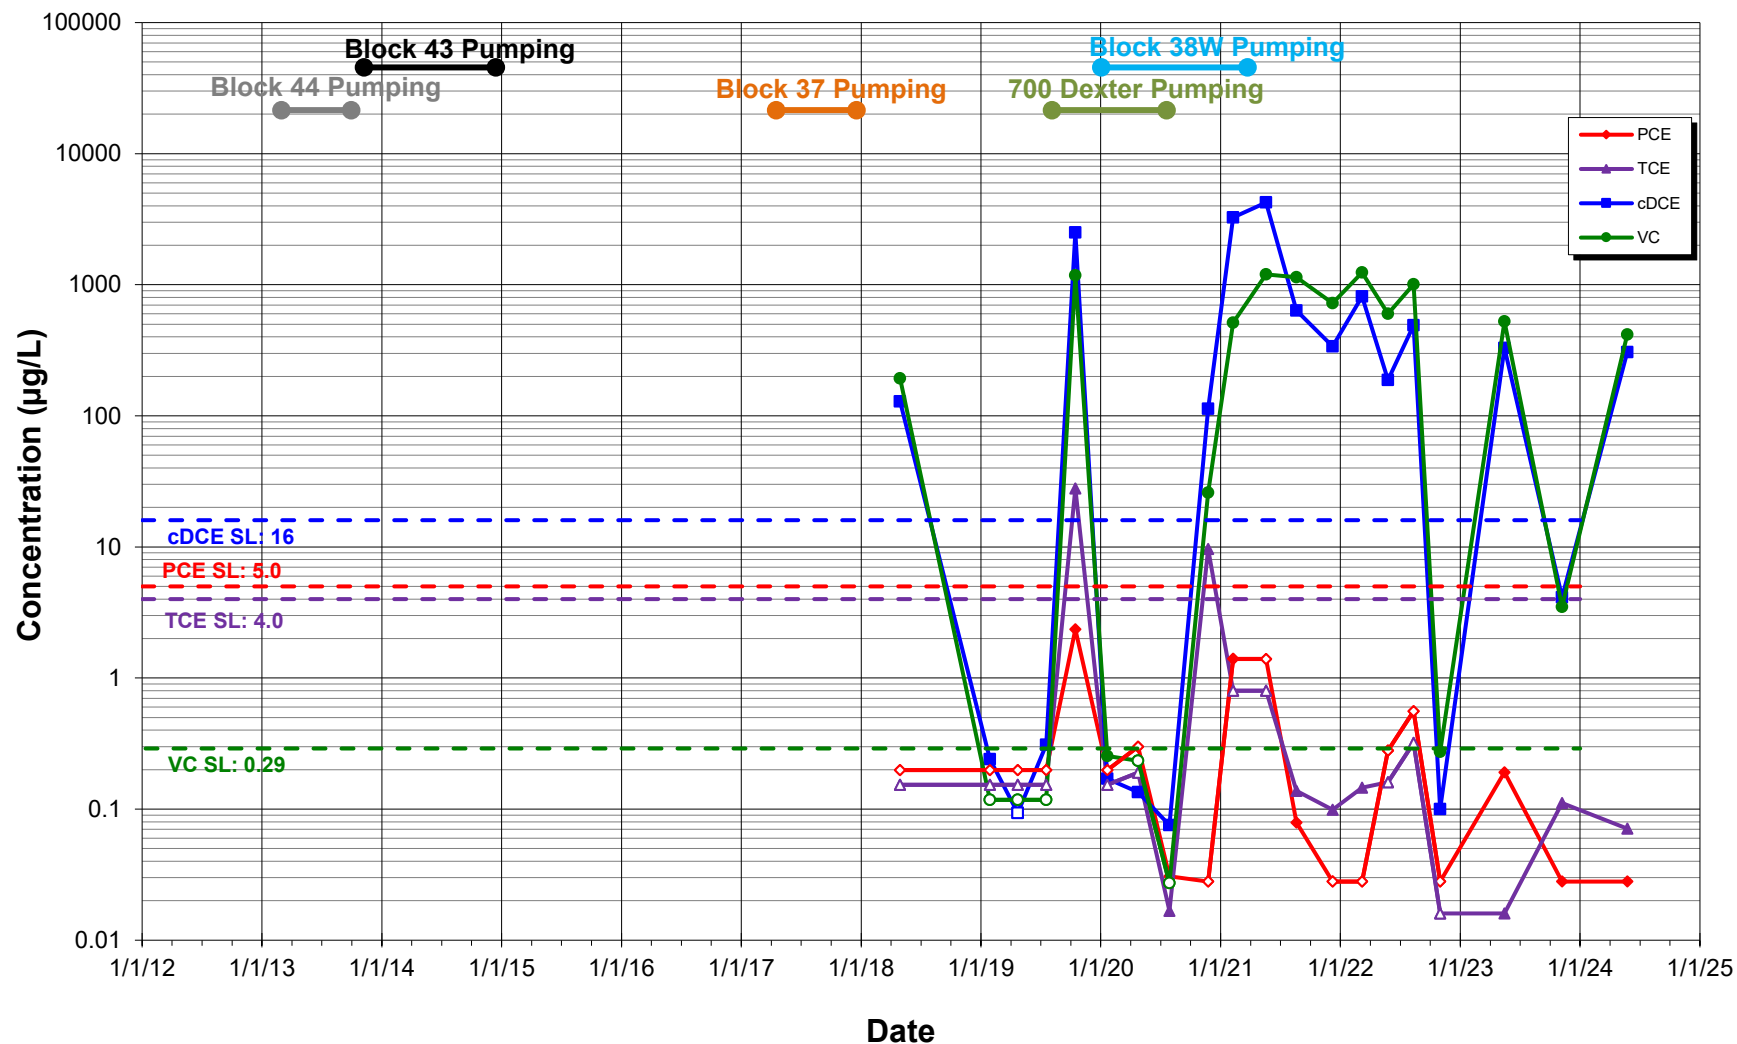
**Concentration vs Time**  
**MW-143 (-27.7 to -37.6 feet NAVD), 8th Ave N ROW, E side**  
**American Linen Supply Co Dexter Ave Site**

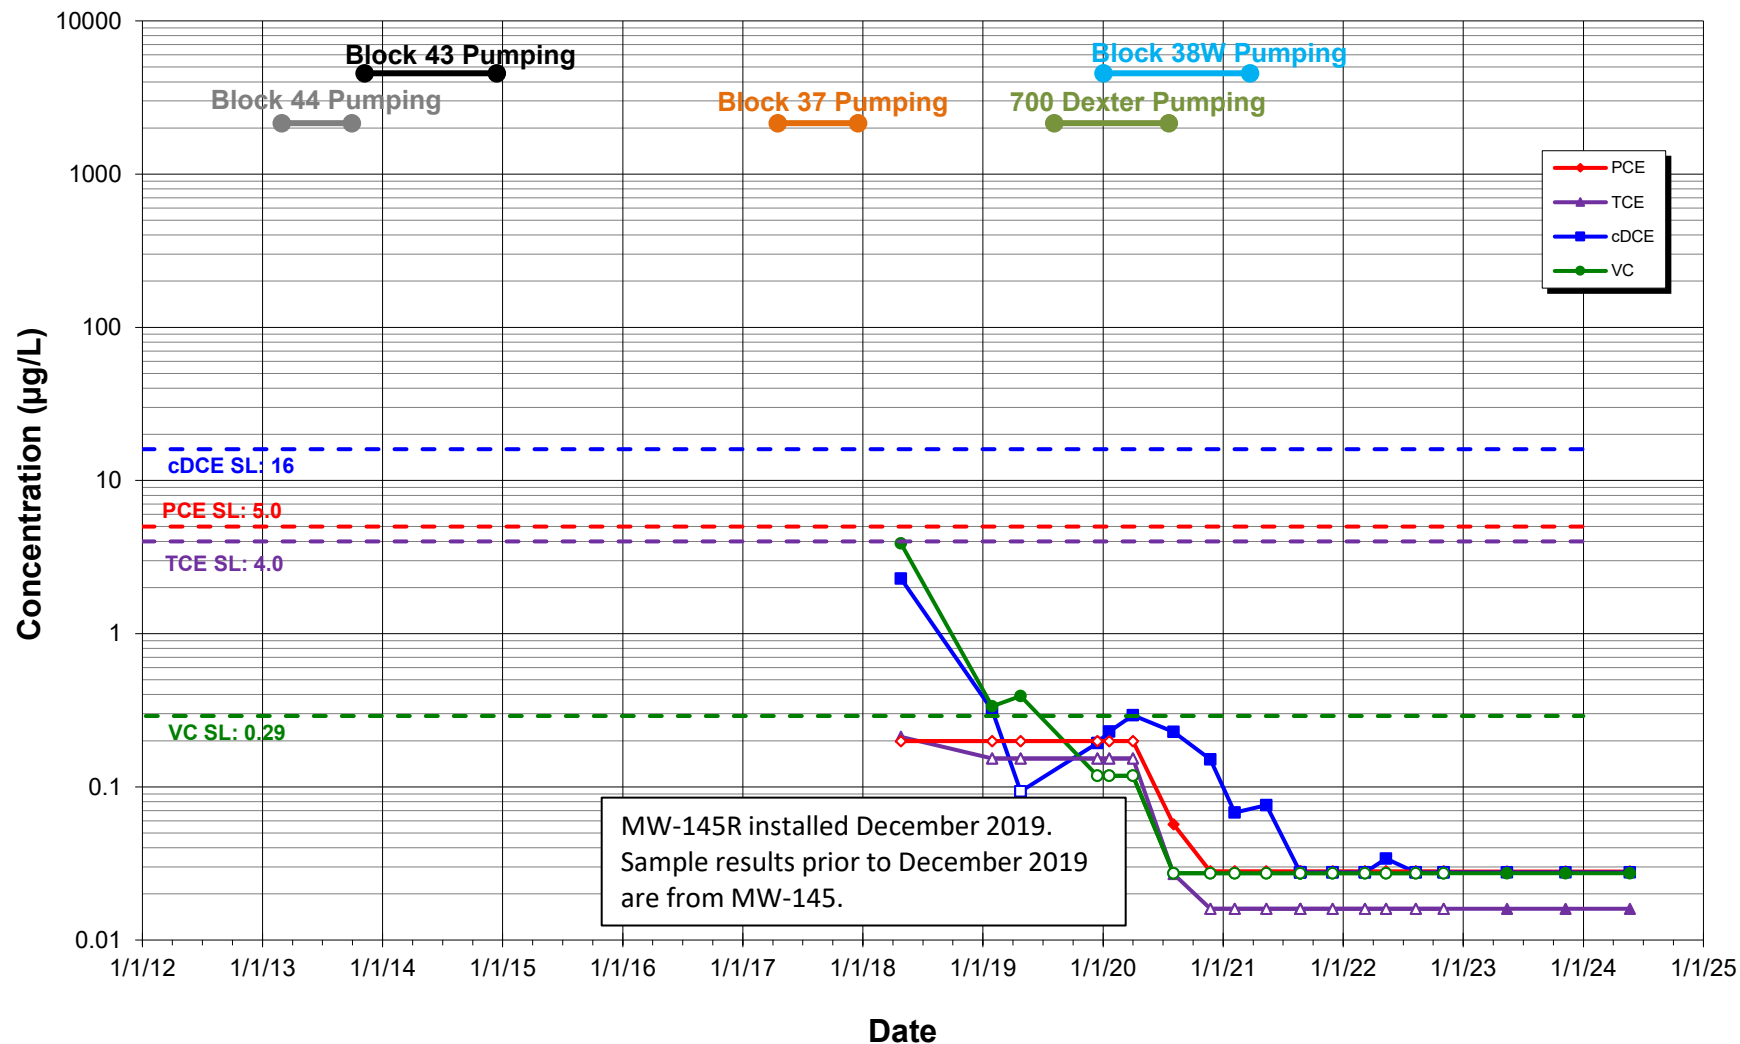
**Concentration vs Time**  
**MW-145R (-27.2 to -37.2 feet NAVD), 8th Ave N ROW, E side**  
**American Linen Supply Co Dexter Ave Site**

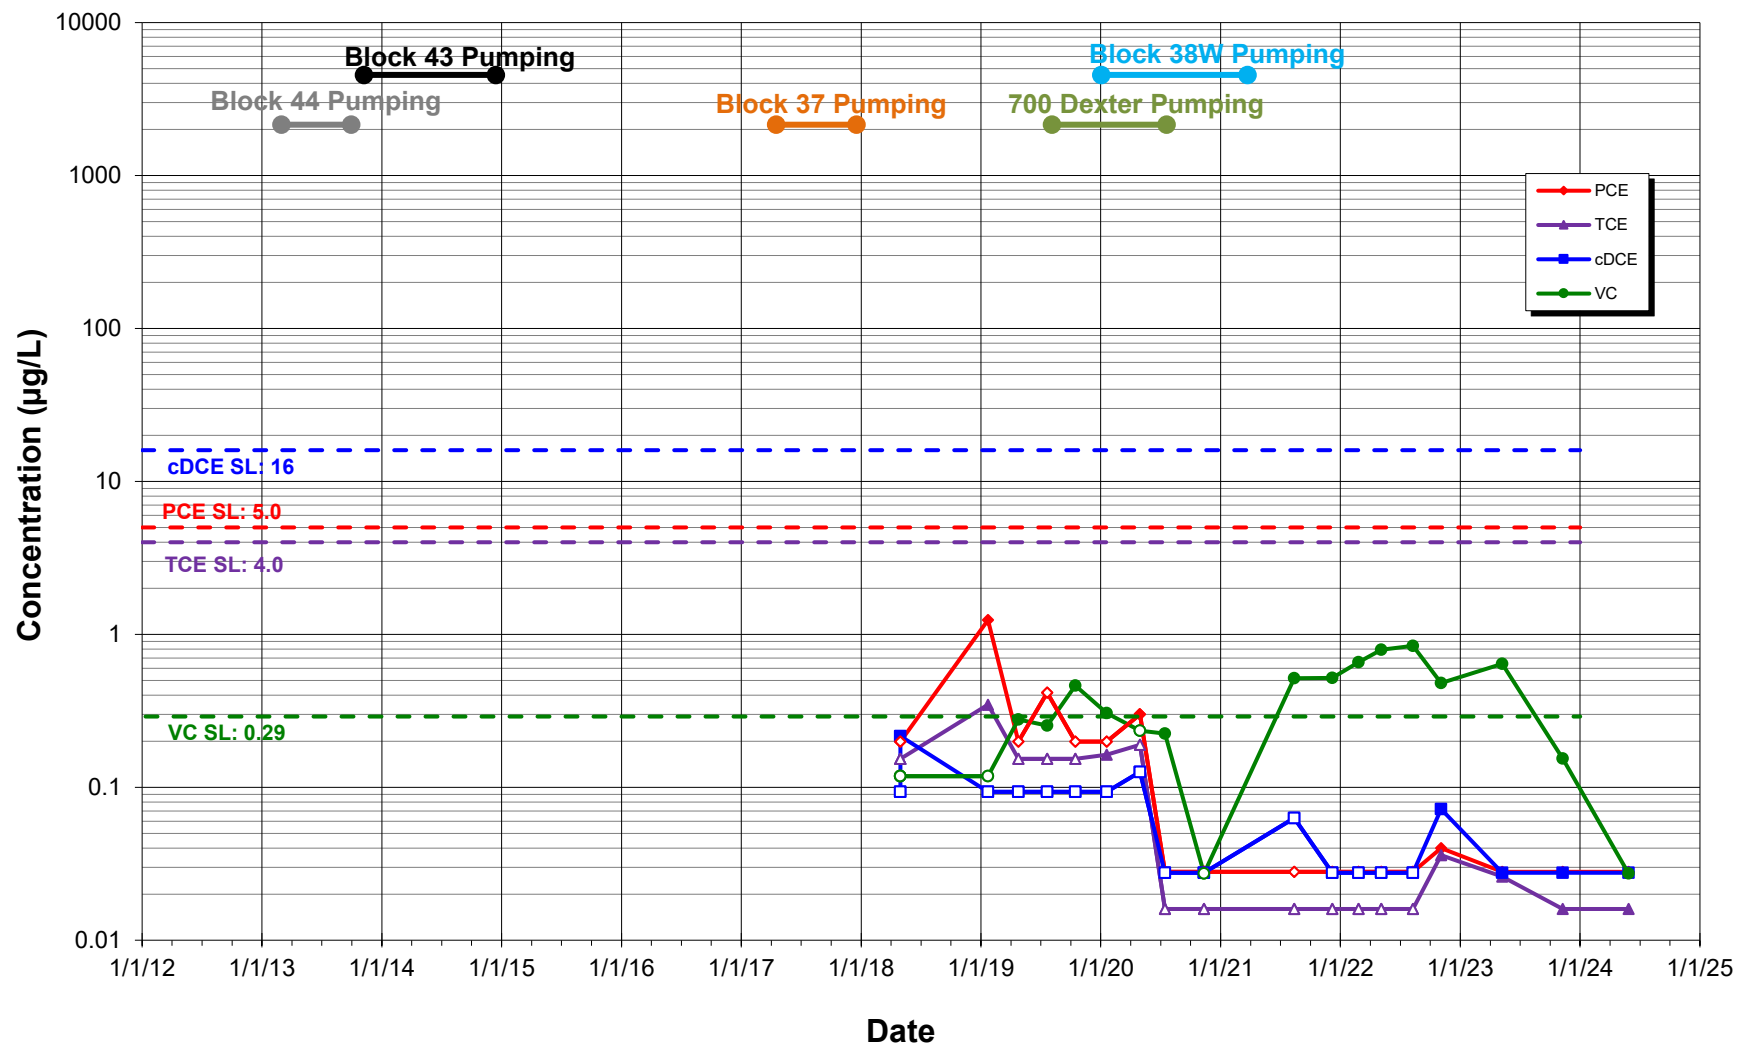
**Concentration vs Time**  
**MW-148 (-25.7 to -35.7 feet NAVD), Roy St ROW, S side**  
**American Linen Supply Co Dexter Ave Site**

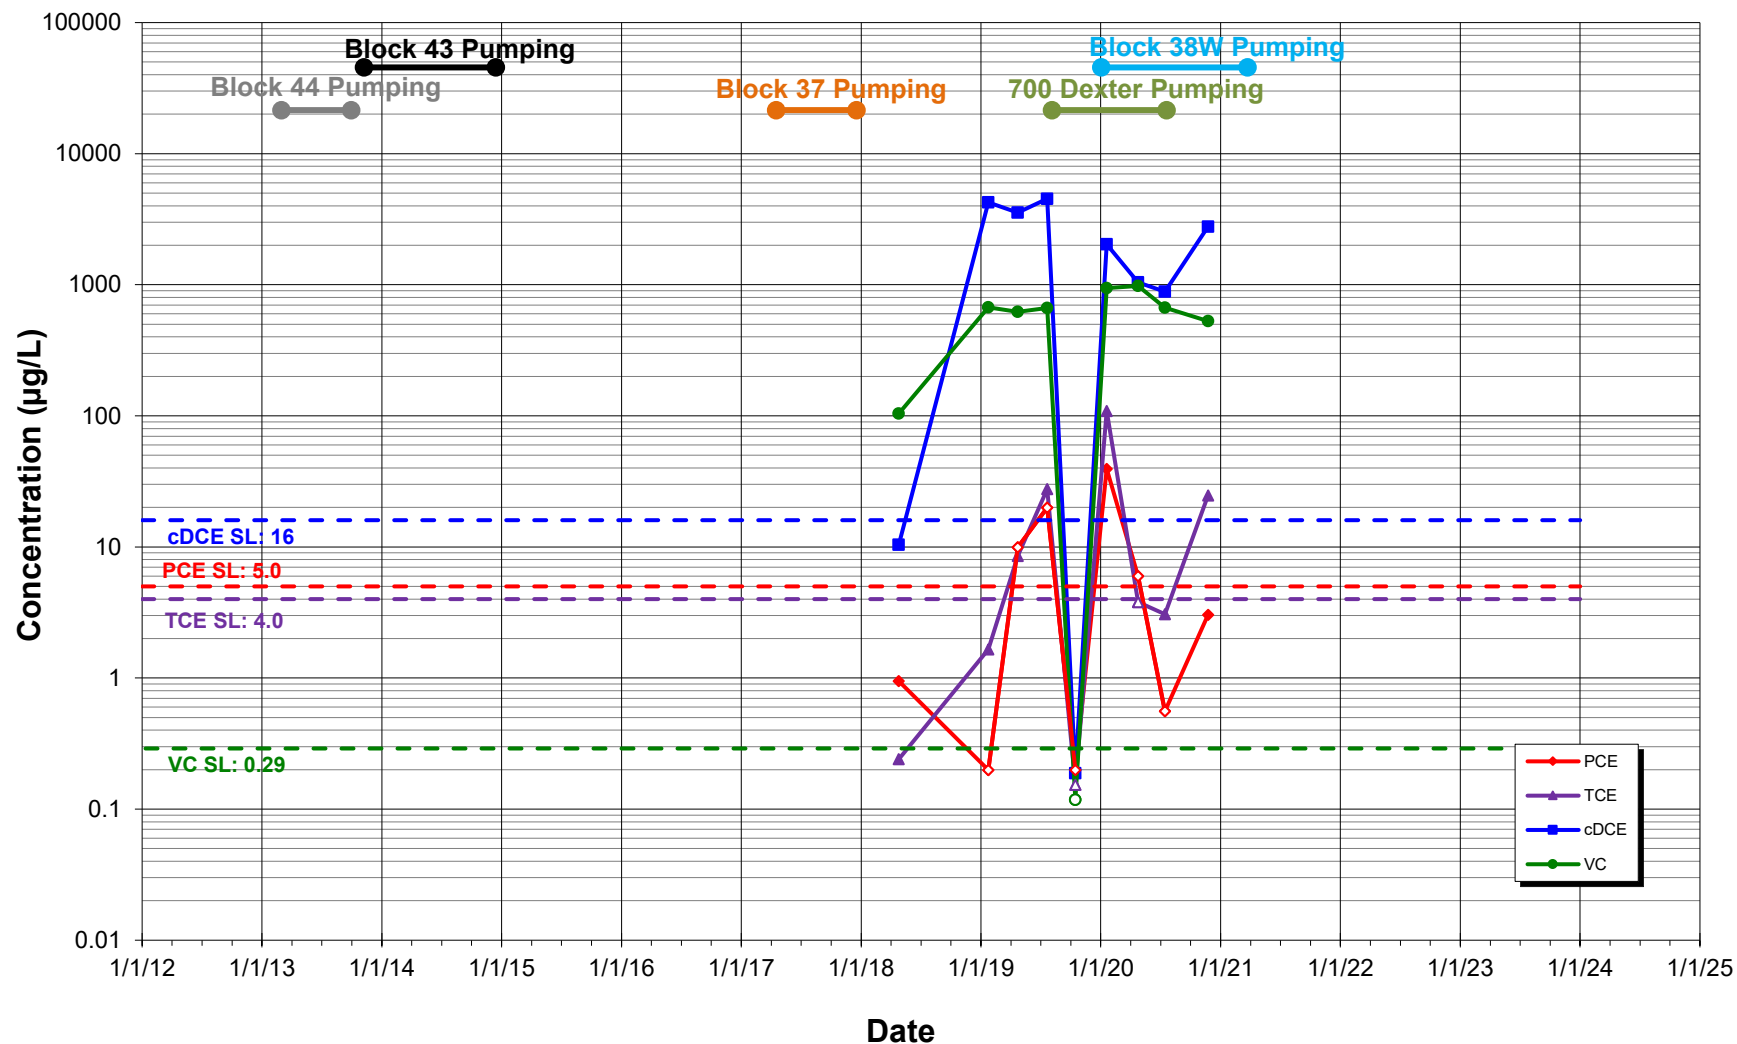
**Concentration vs Time**  
**MW-157 (-28.3 to -38.2 feet NAVD), 8th Ave N ROW, E side**  
**American Linen Supply Co Dexter Ave Site**

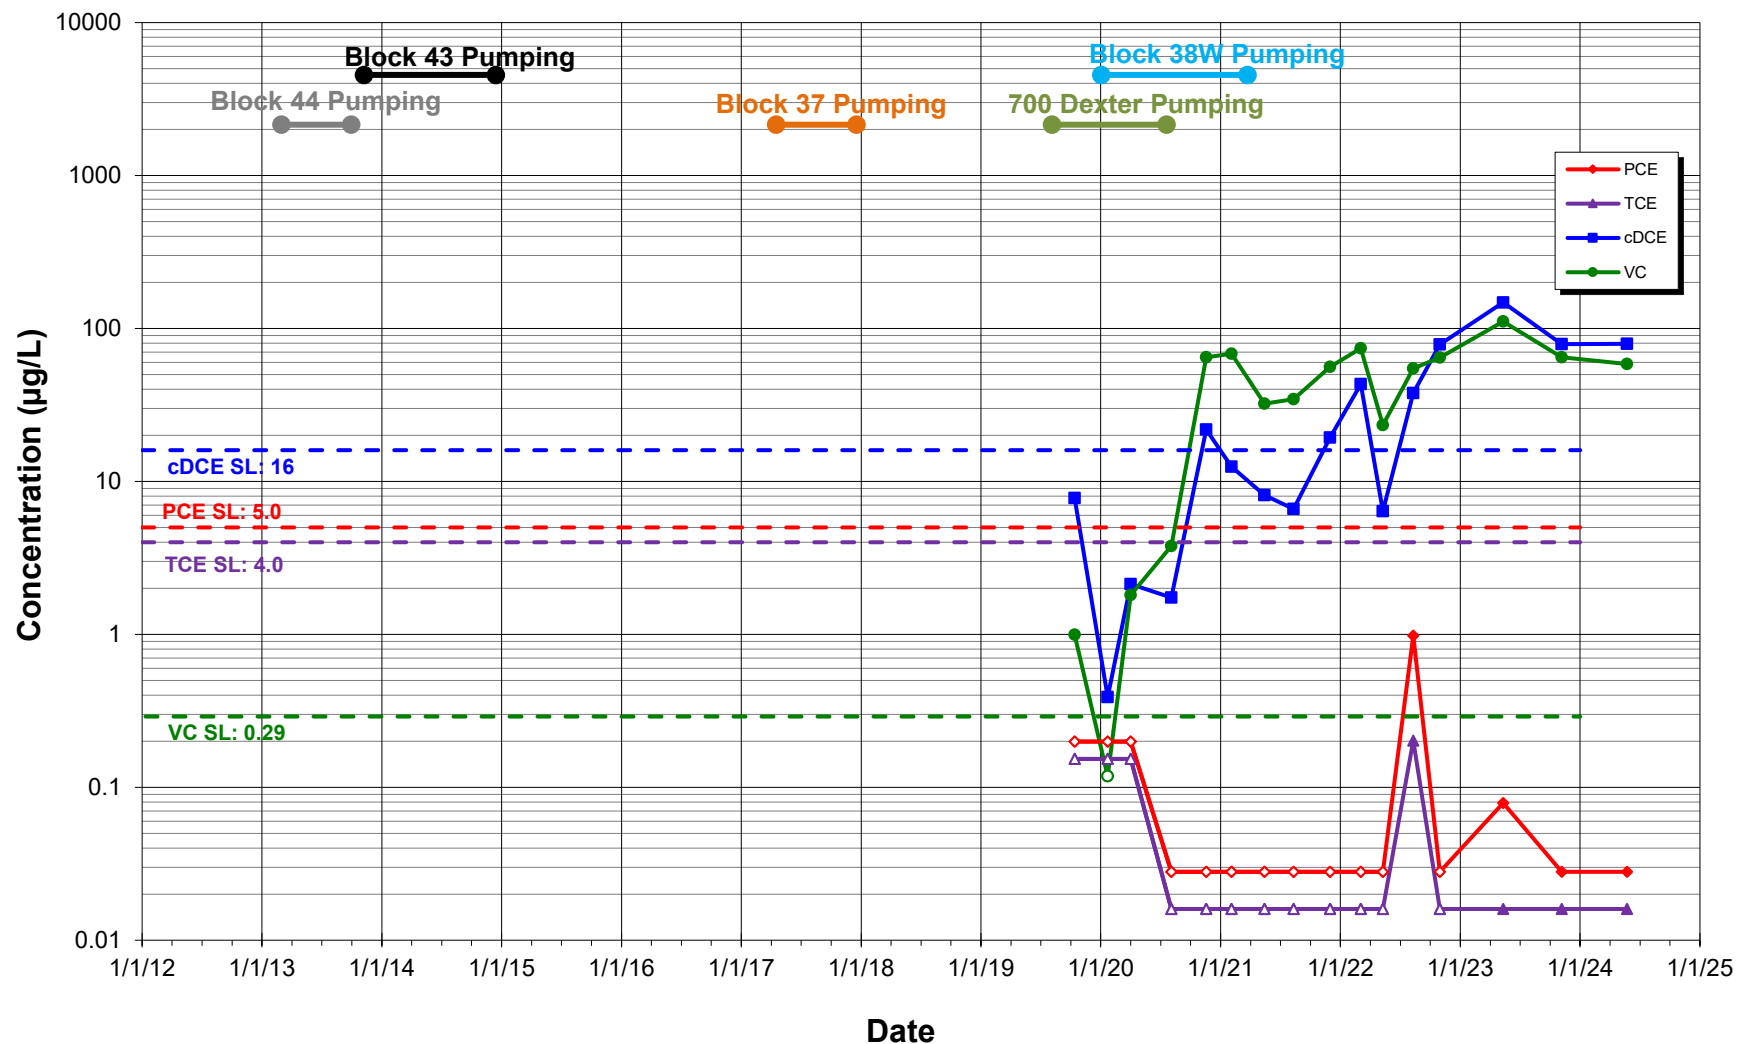
**Concentration vs Time**  
**MW-190 (-30.2 to -40.2 feet NAVD), Valley St ROW, S side**  
**American Linen Supply Co Dexter Ave Site**

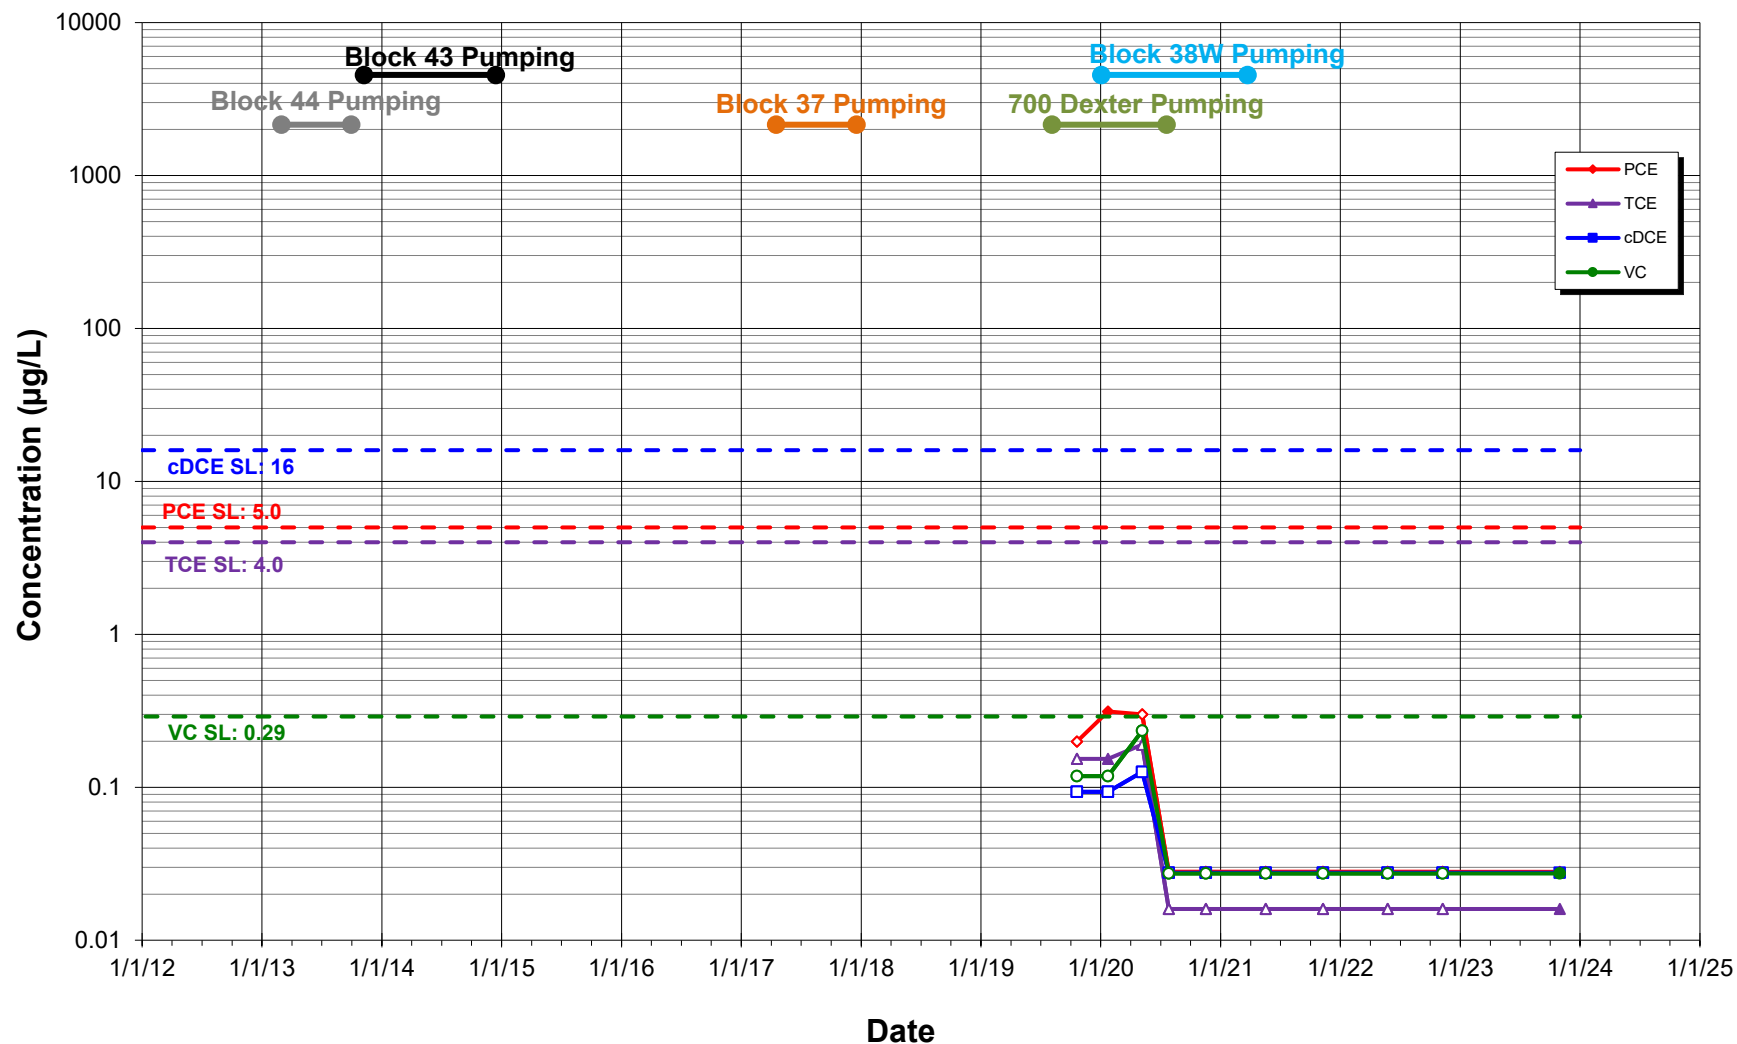
**Concentration vs Time**  
**MW-303 (-13.8 to -23.8 feet NAVD), Dexter Ave N ROW, E side**  
**American Linen Supply Co Dexter Ave Site**

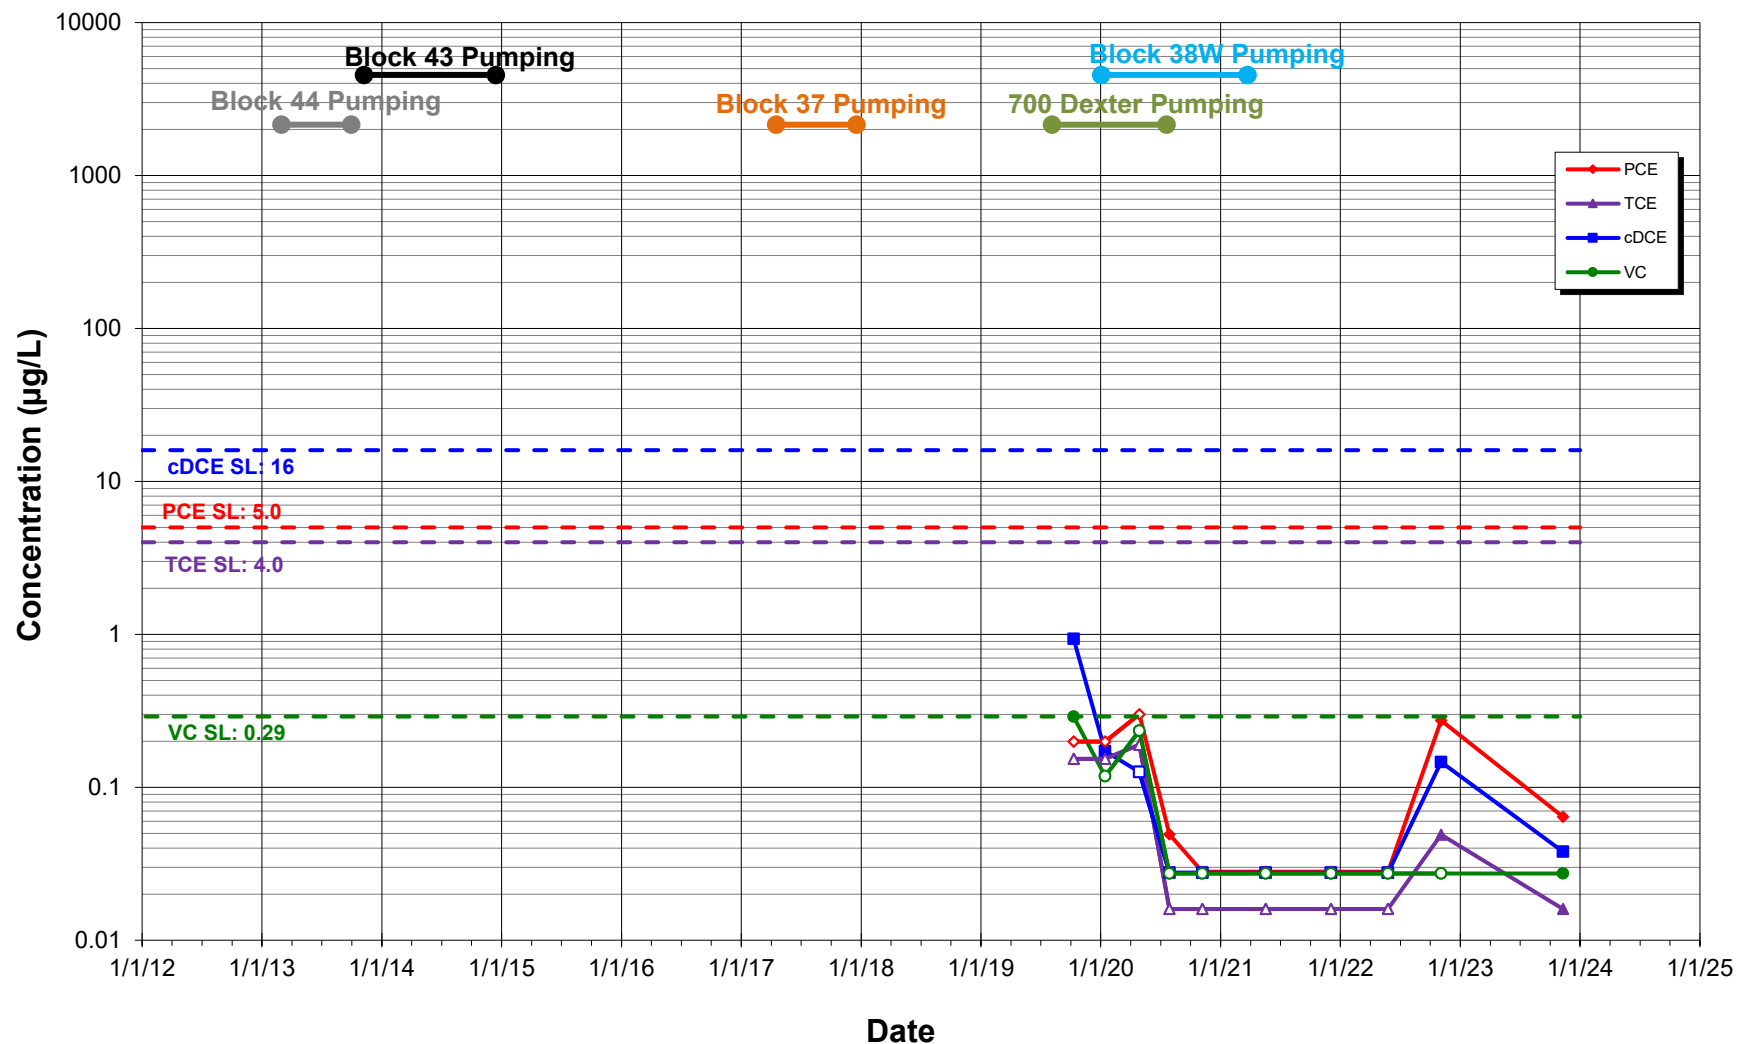
**Concentration vs Time**  
**MW-307 (-12.4 to -22.4 feet NAVD), Roy St ROW, S side**  
**American Linen Supply Co Dexter Ave Site**

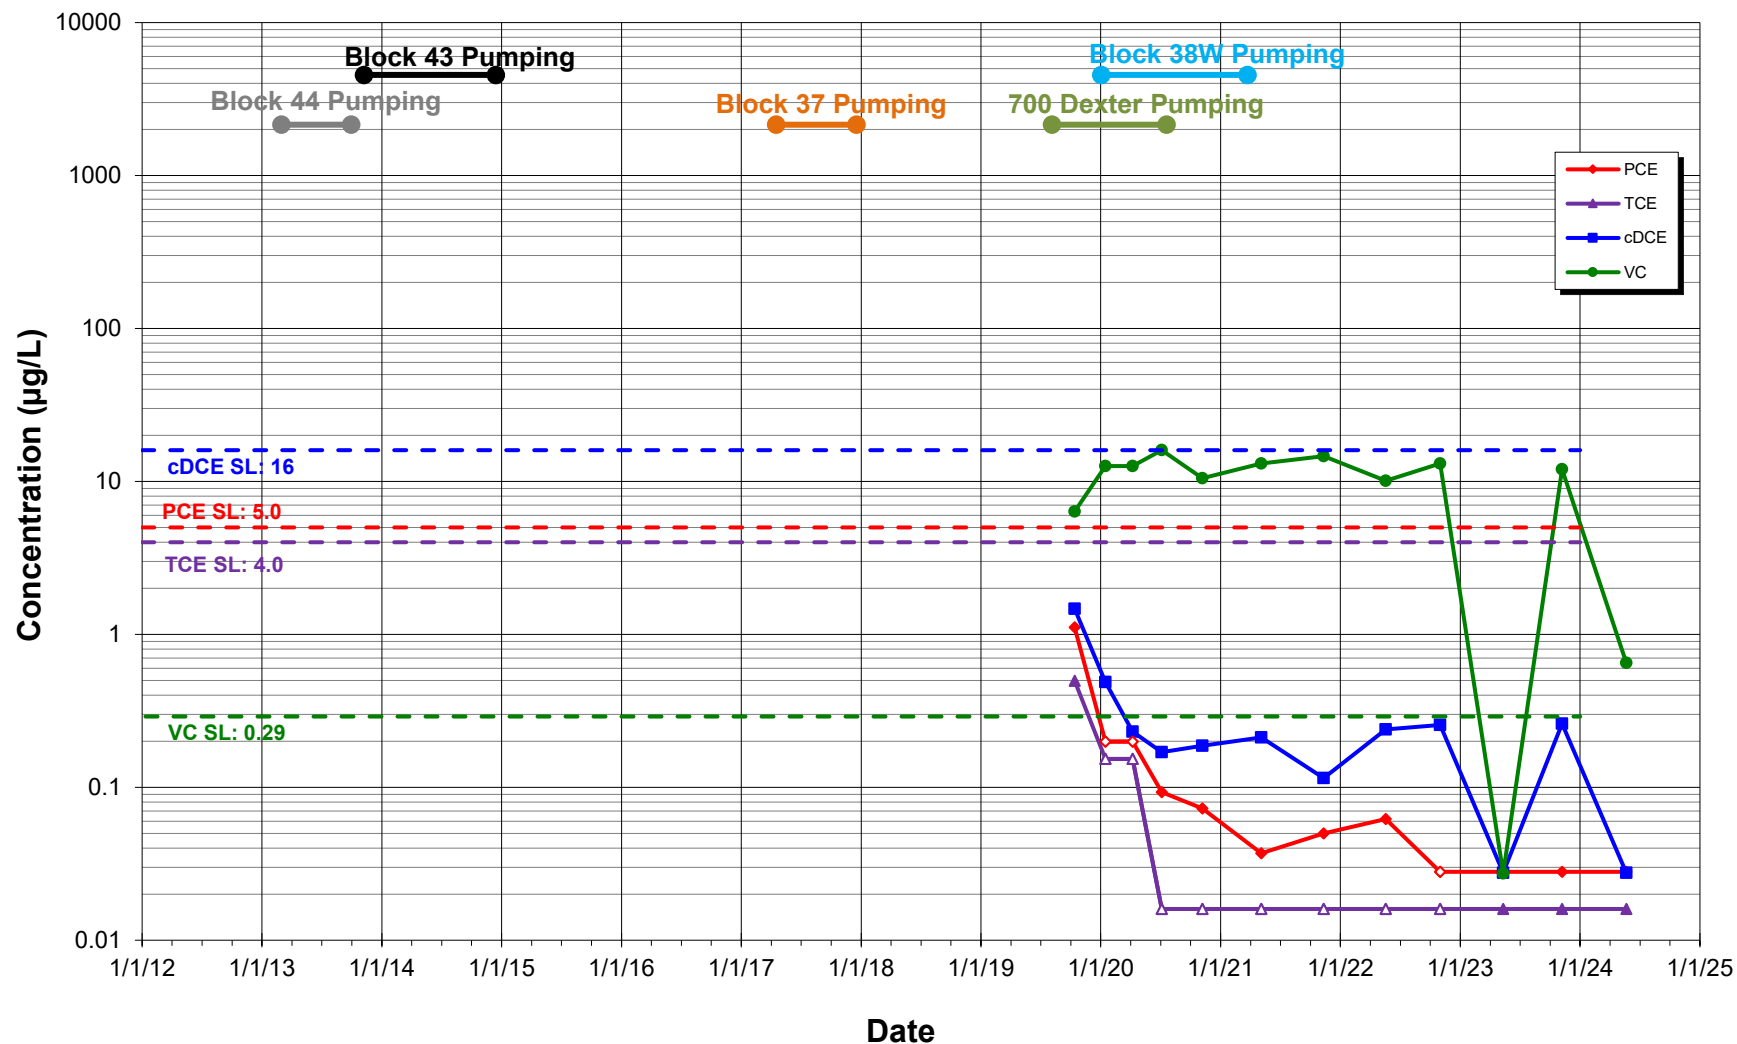
**Concentration vs Time**  
**MW-309 (-32.0 to -42.0 feet NAVD), Alley E of Seattle Roy Aloha Shops**  
**American Linen Supply Co Dexter Ave Site**

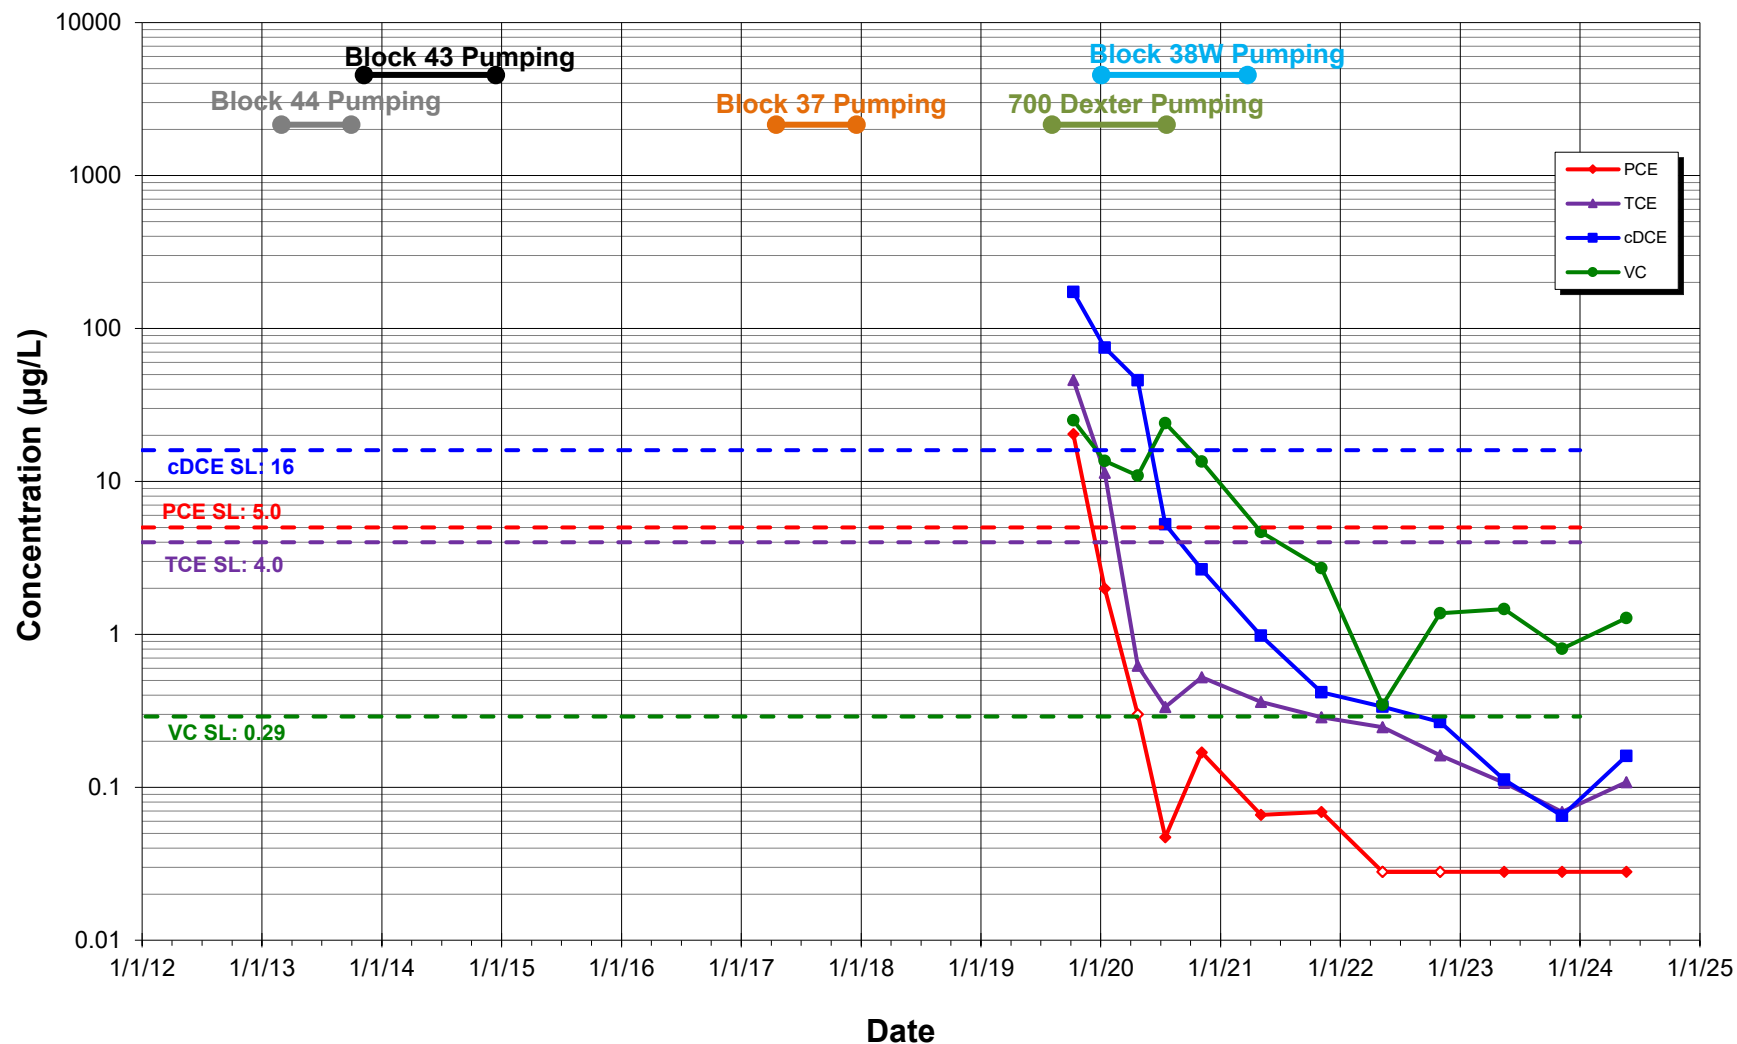
**Concentration vs Time**  
**MW-311 (-29.1 to -39.1 feet NAVD), Alley E of Seattle Roy Aloha Shops**  
**American Linen Supply Co Dexter Ave Site**
