**Attachment A**  
**Well Completion Table**  
**American Linen Supply Co–Dexter Avenue Site**  
**Seattle, Washington**

**CVOC TIME-TREND PLOTS**

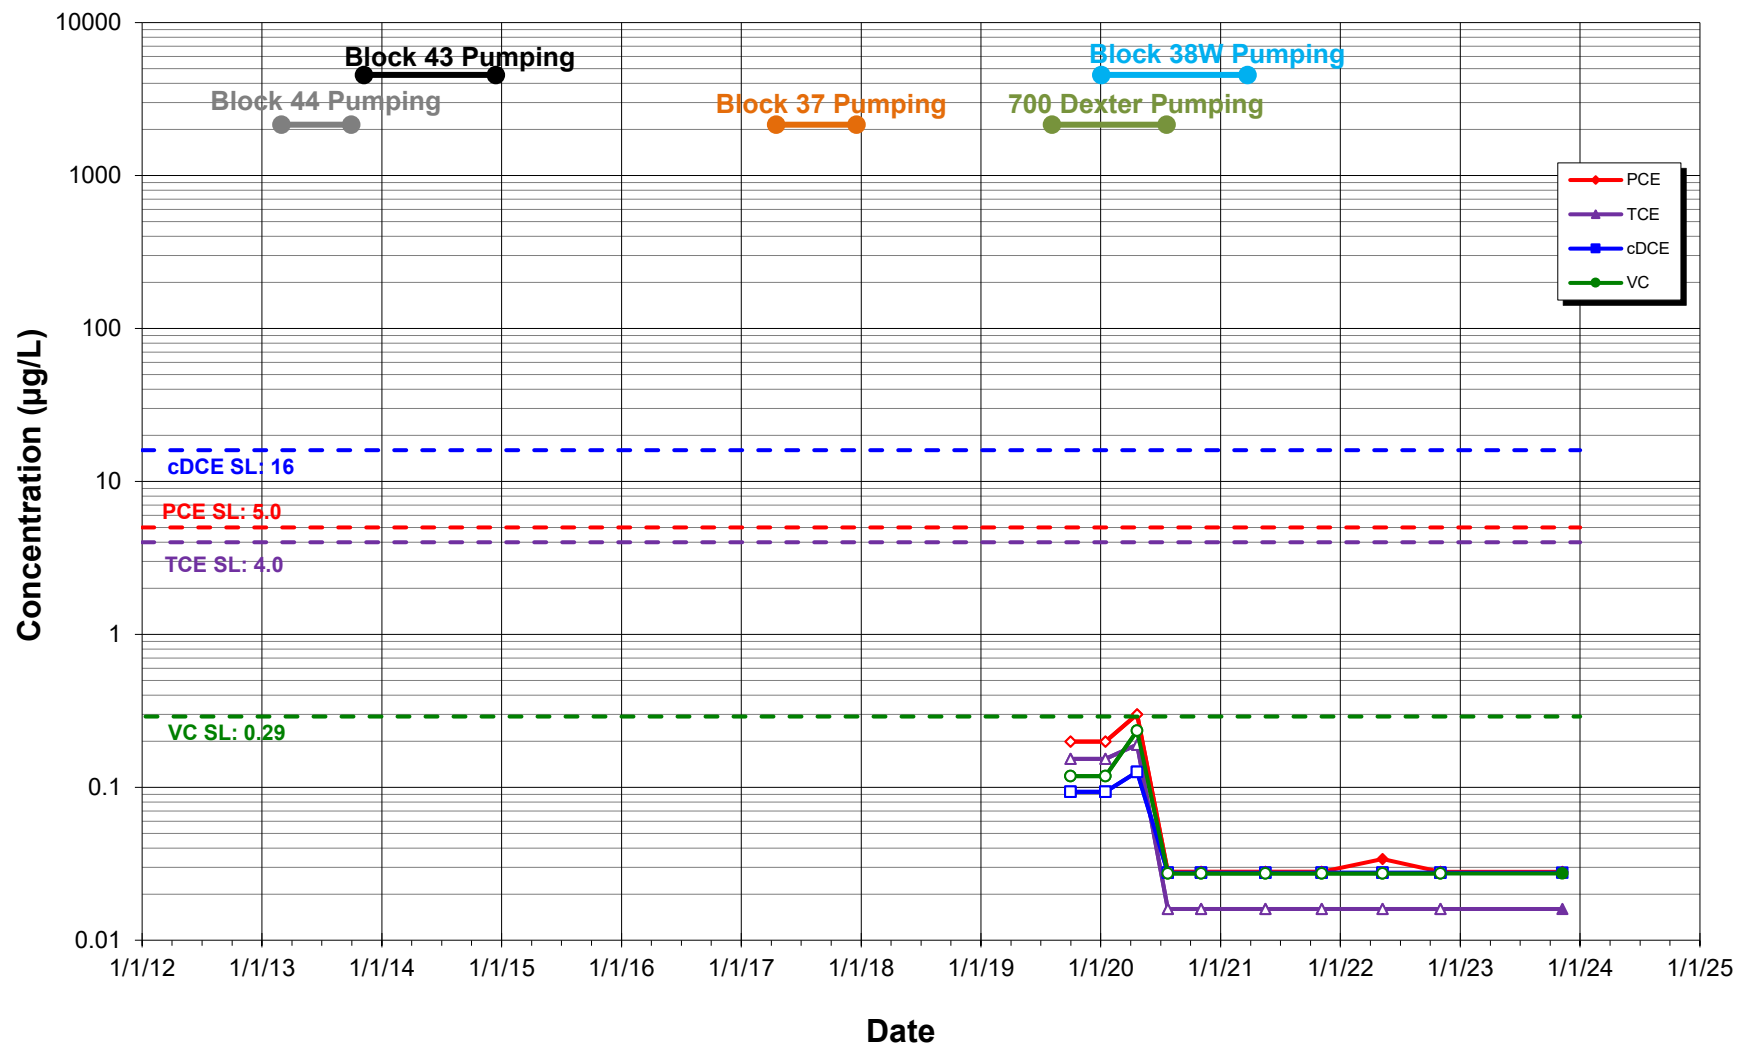
**Concentration vs Time**  
**MW-316 (-10.0 to -20.0 feet NAVD), Mercer St ROW, N side**  
**American Linen Supply Co Dexter Ave Site**

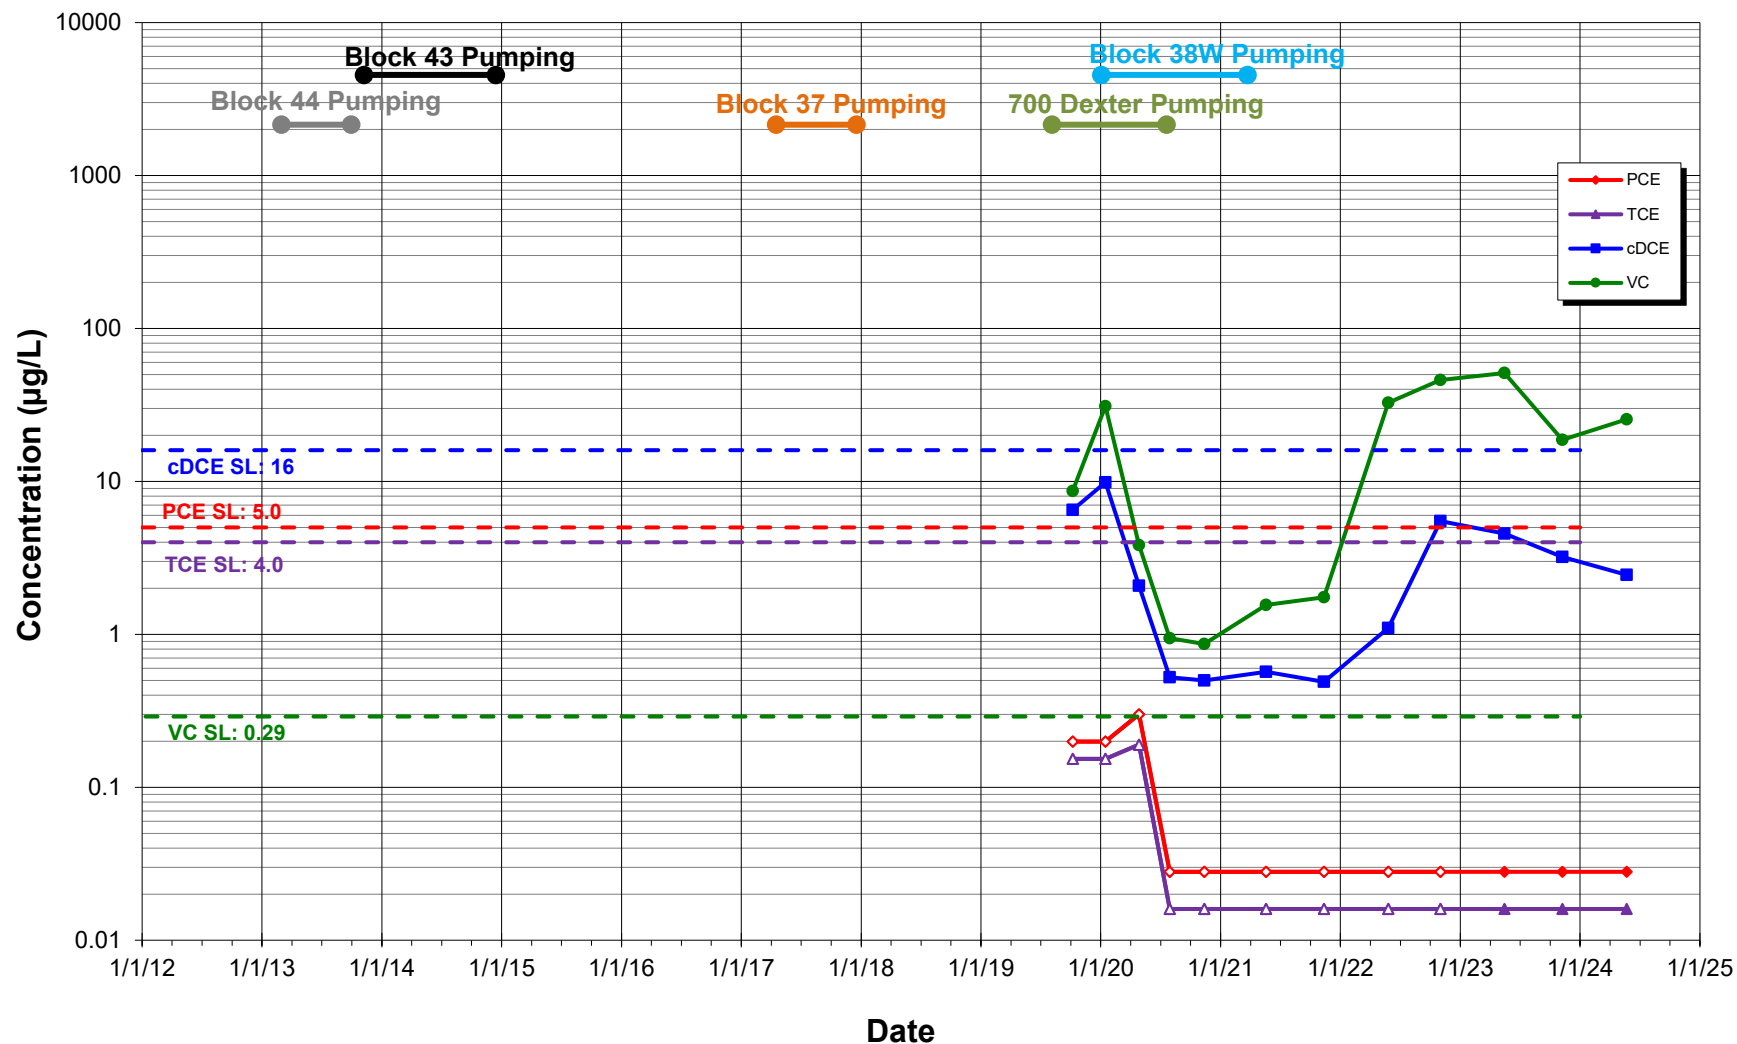
**Concentration vs Time**  
**MW-318 (-23.1 to -33.1 feet NAVD), 9th Ave N ROW, W side**  
**American Linen Supply Co Dexter Ave Site**

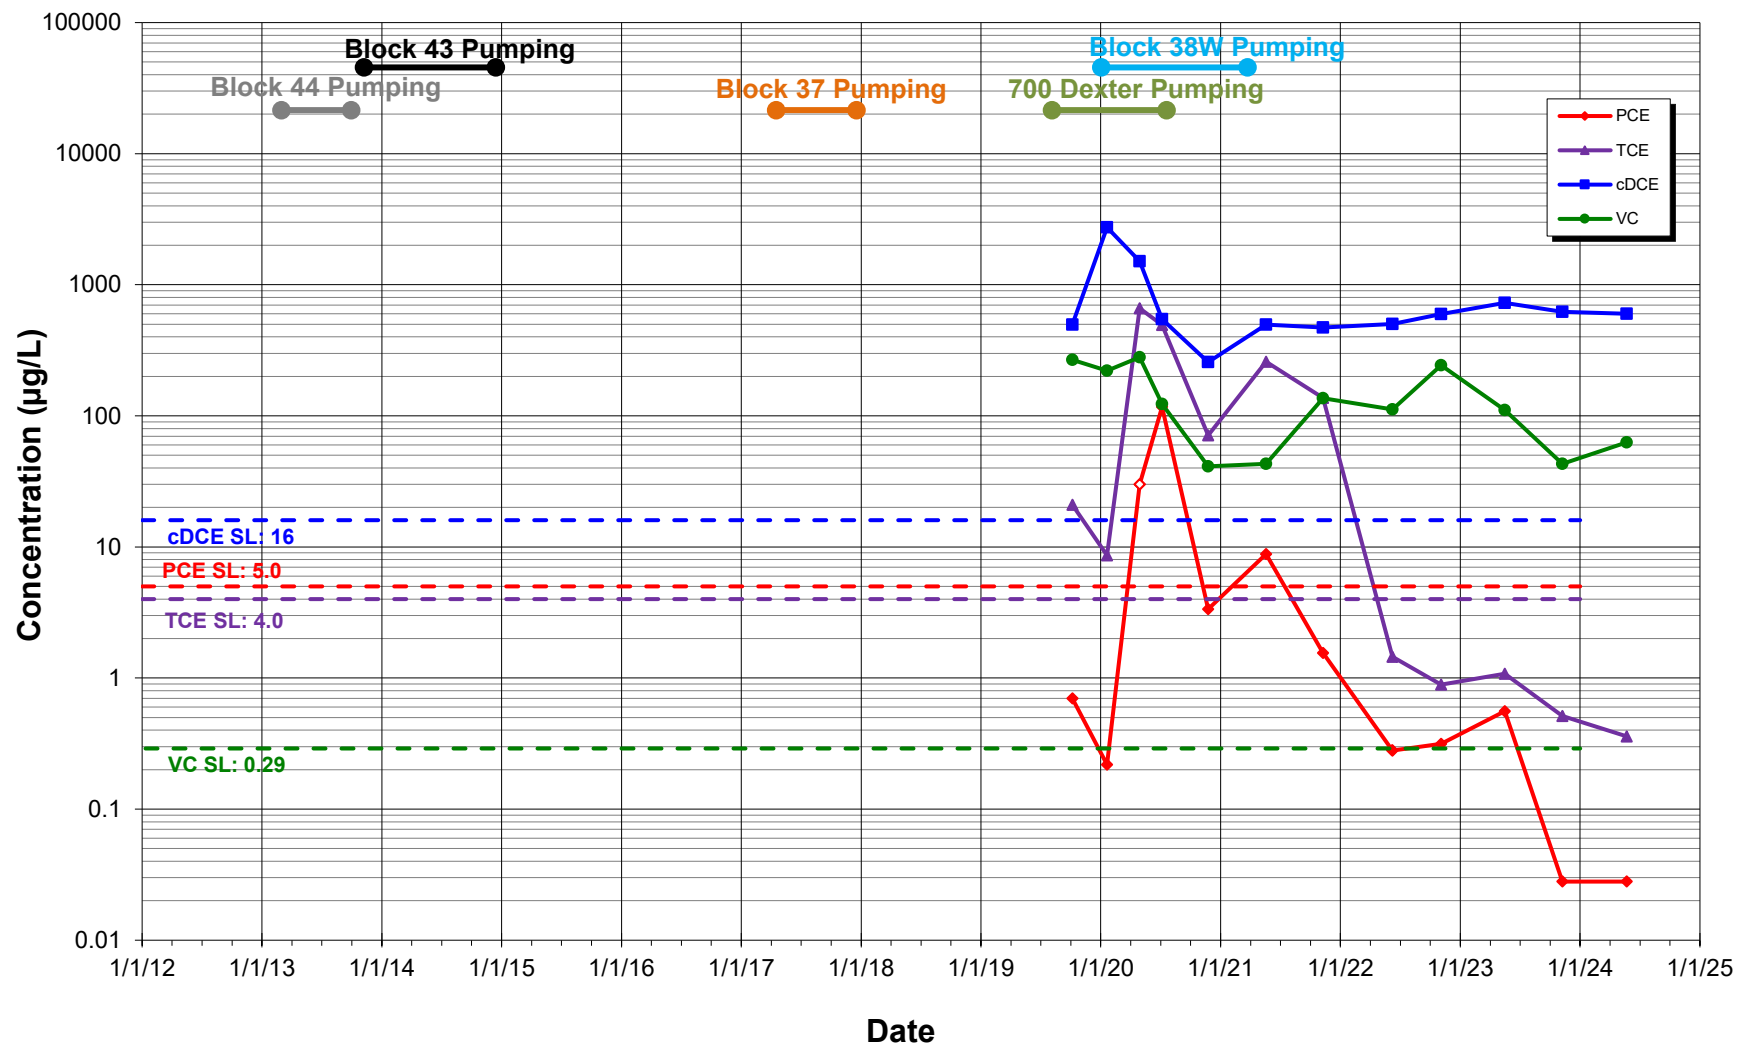
**Concentration vs Time**  
**MW-322 (-23.1 to -31.3 feet NAVD), 9th Avenue North**  
**American Linen Supply Co-Dexter Ave Site**

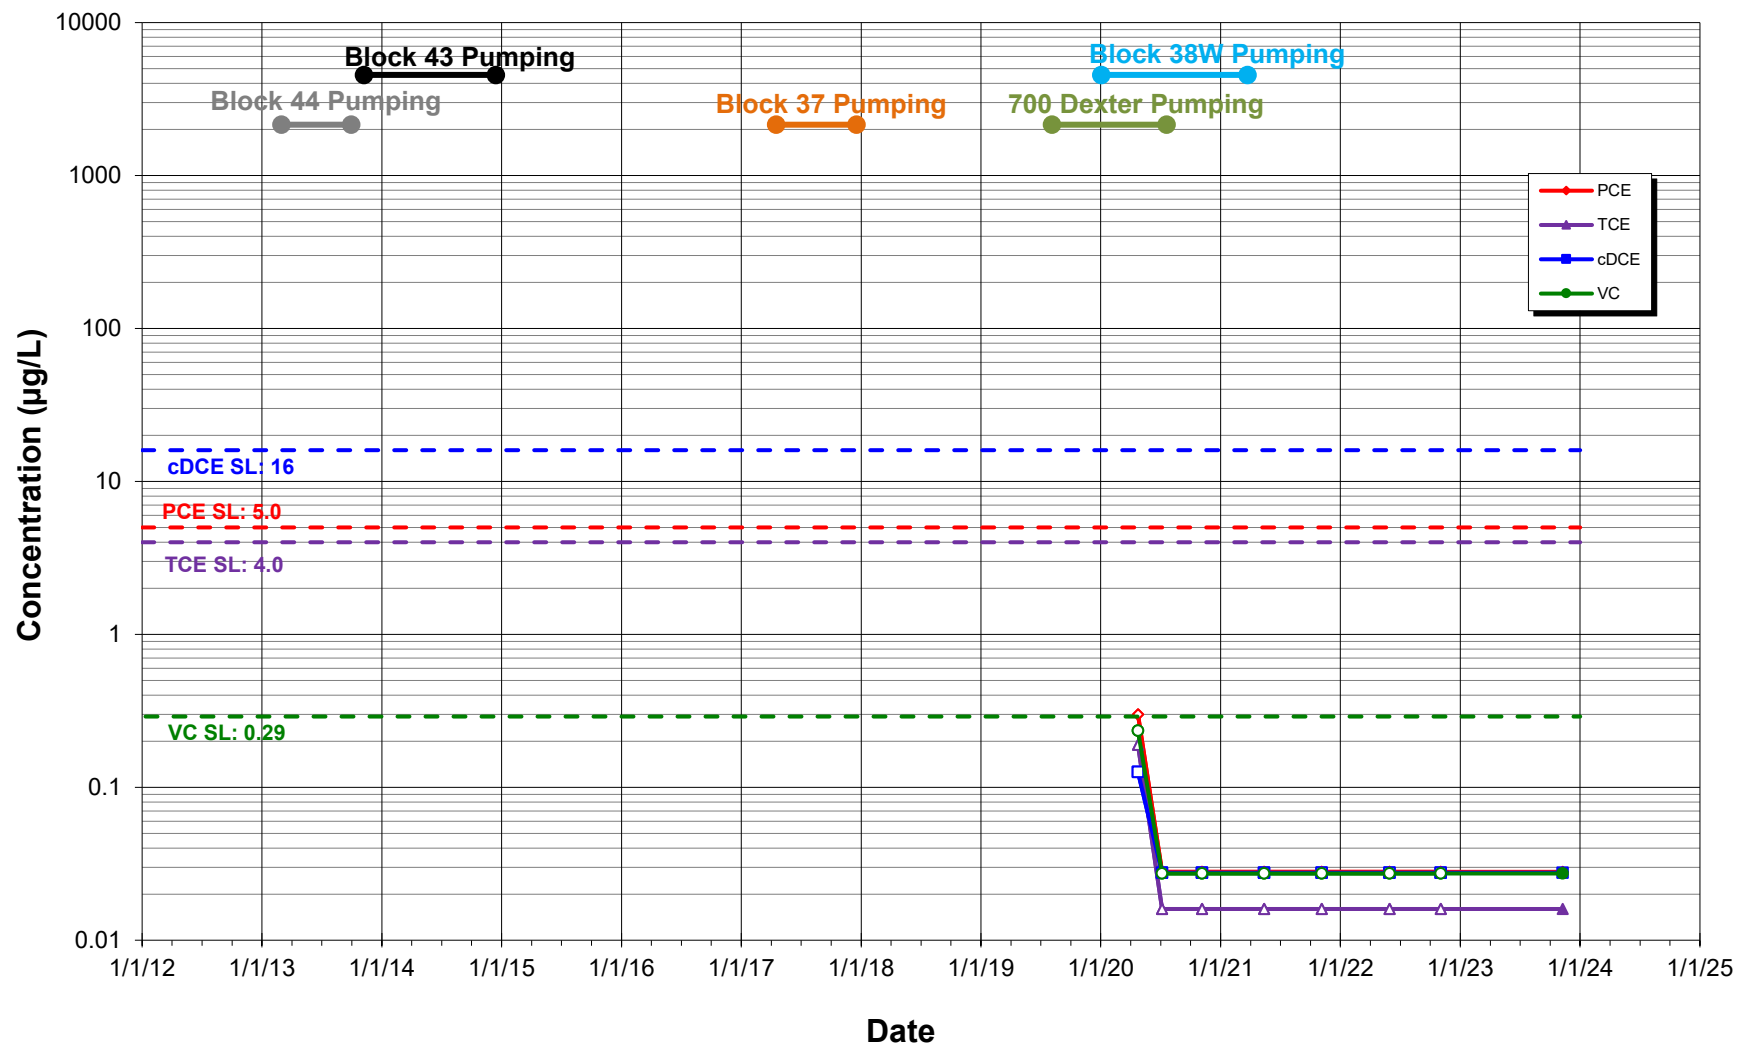
**Concentration vs Time**  
**MW-334 (-21.7 to -31.7 feet NAVD), 900 Roy Street, S end**  
**American Linen Supply Co Dexter Ave Site**

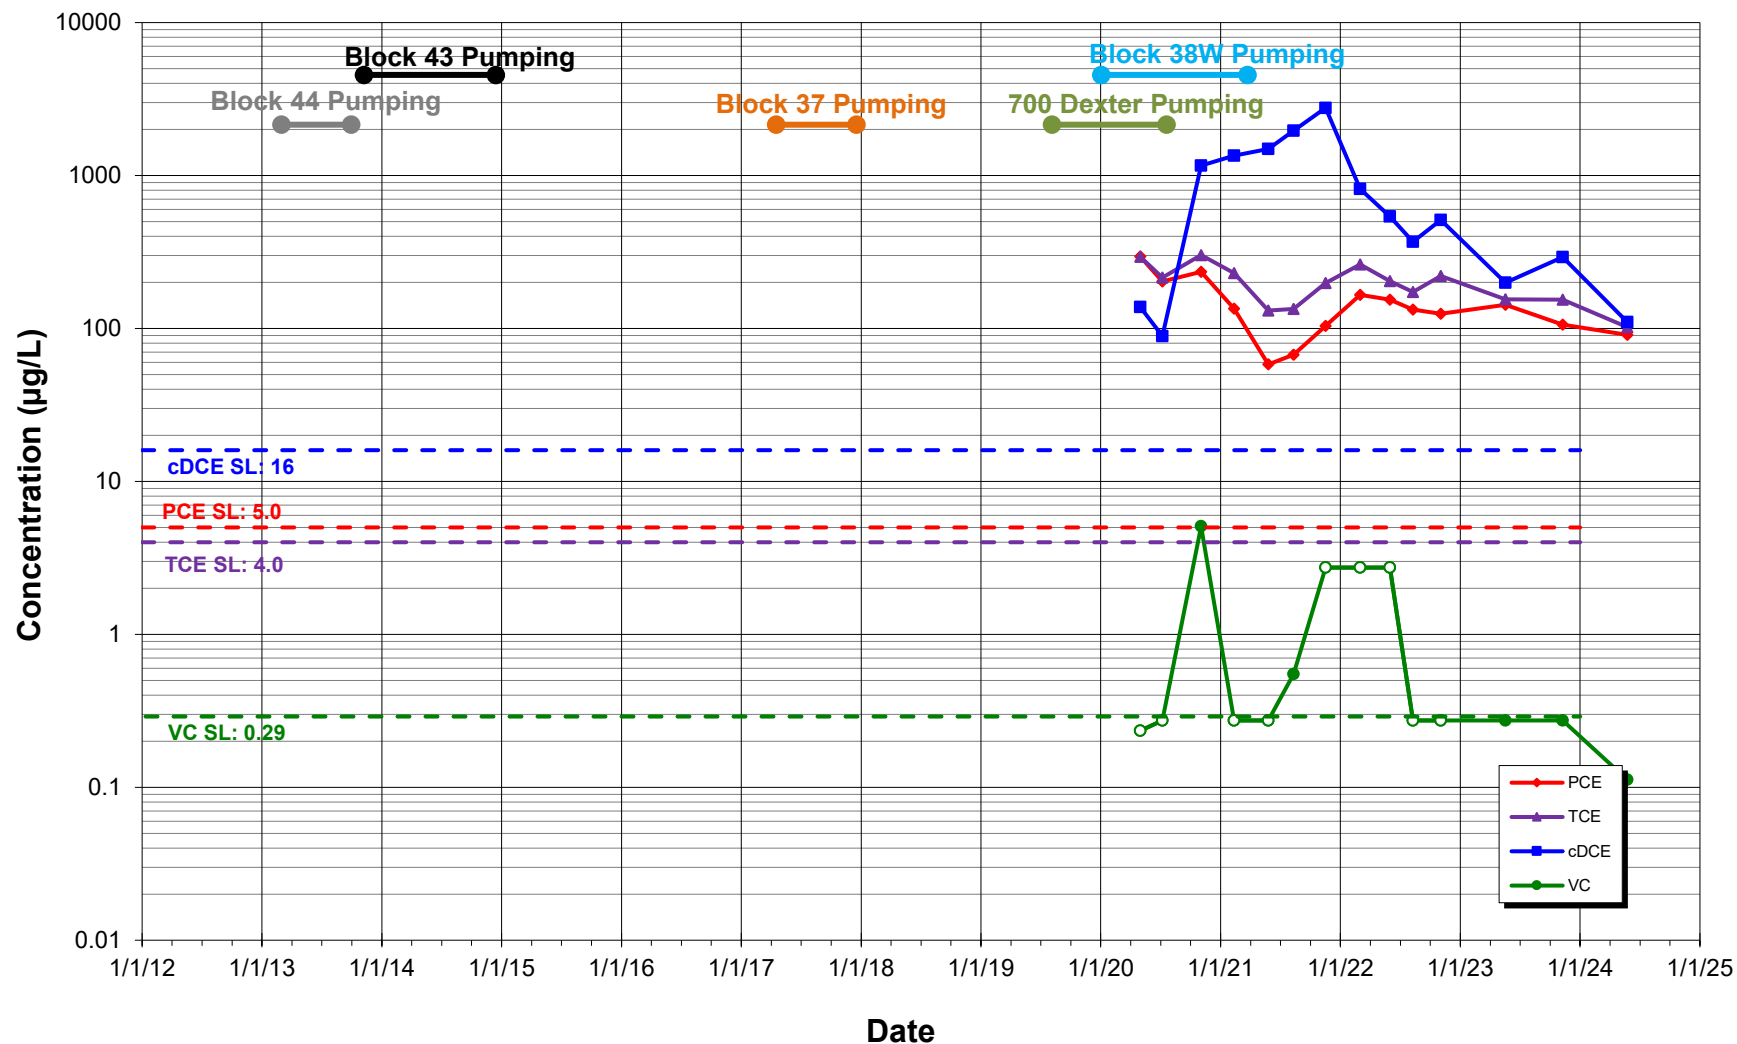
**Concentration vs Time**  
**MW-335 (-25.6 to -35.6 feet NAVD), Mercer St ROW, N side**  
**American Linen Supply Co Dexter Ave Site**

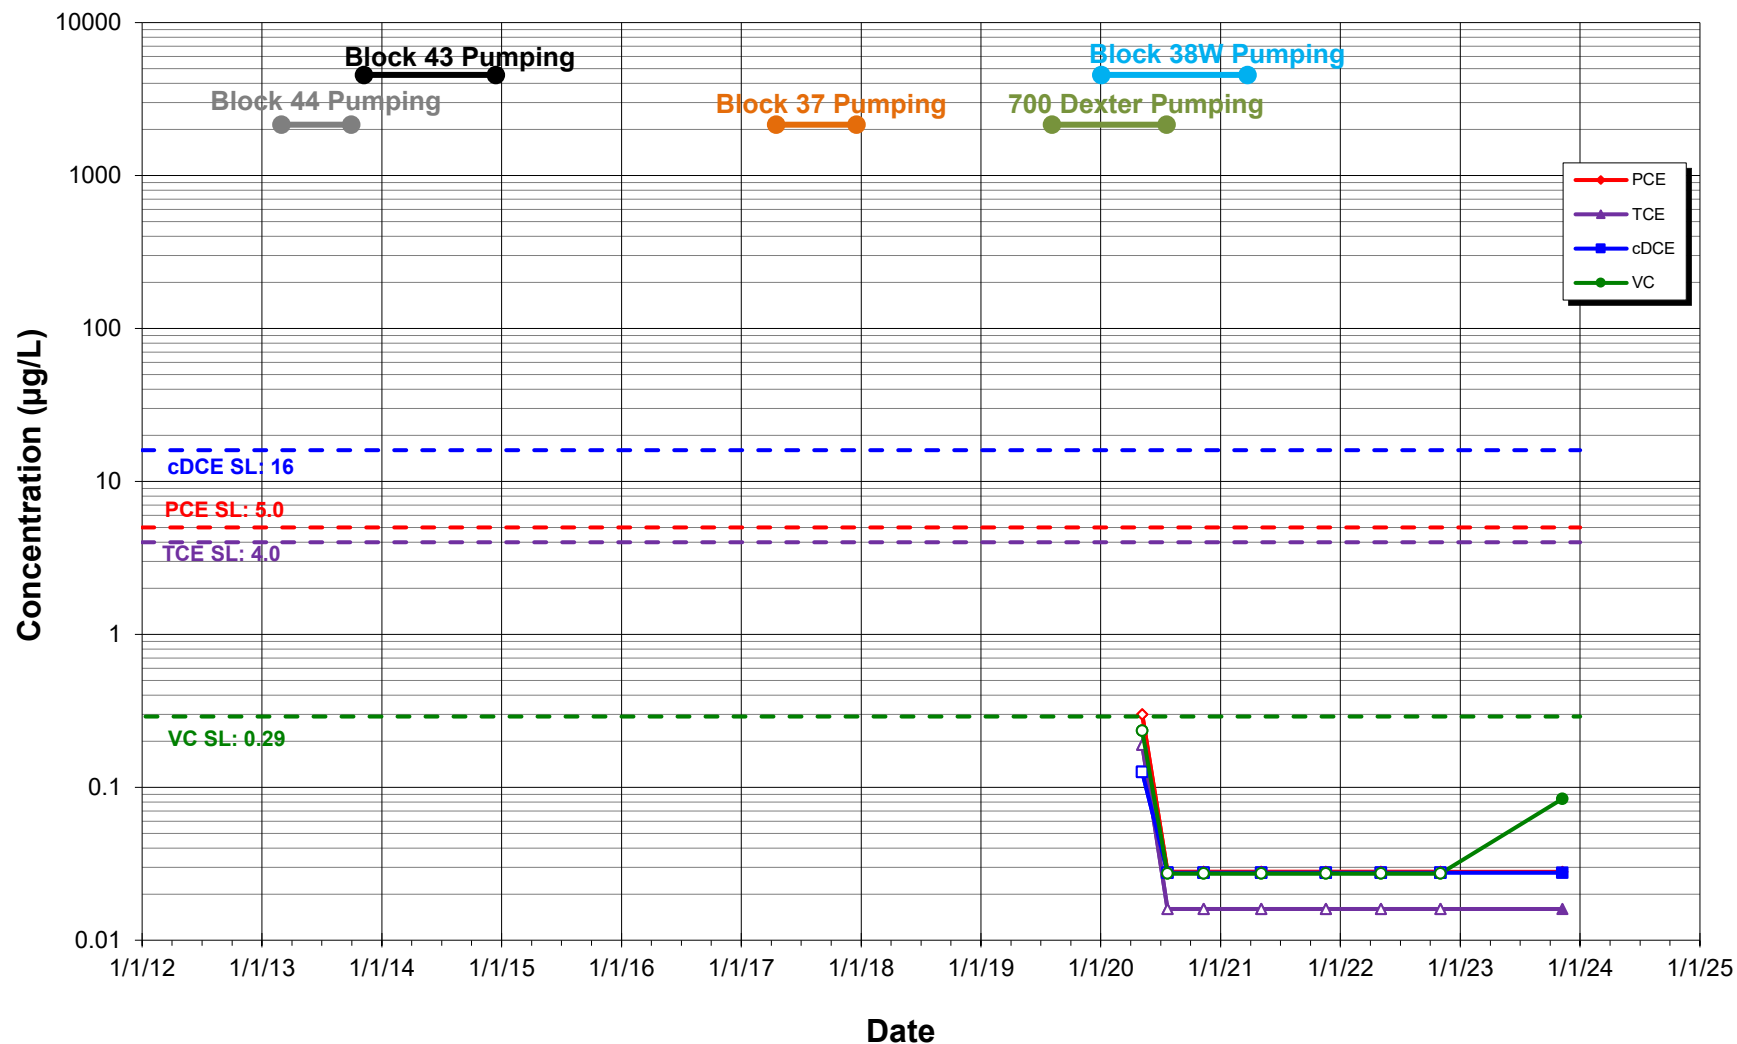
**Concentration vs Time**  
**MW-338 (-16.6 to -26.6 feet NAVD), Lake Union Park, N end**  
**American Linen Supply Co Dexter Ave Site**

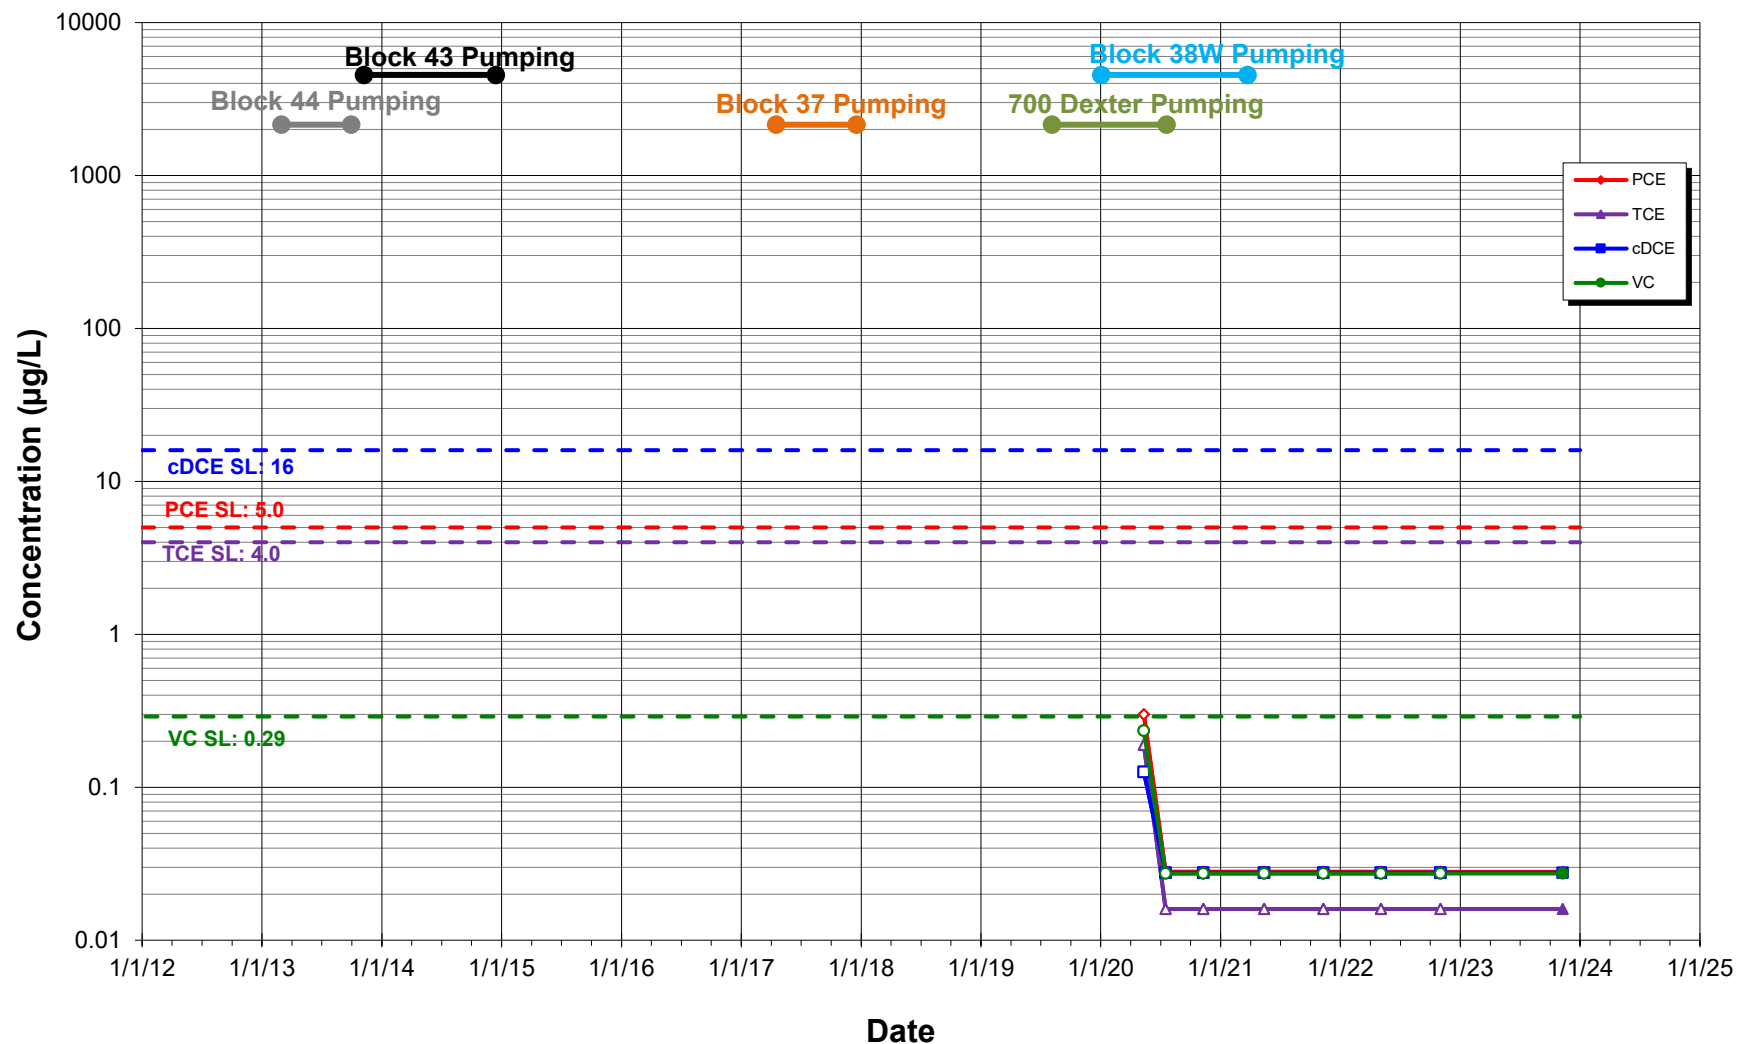
**Concentration vs Time**  
**MW-340 (-16.1 to -26.1 feet NAVD), Lake Union Park, S end**  
**American Linen Supply Co-Dexter Ave Site**

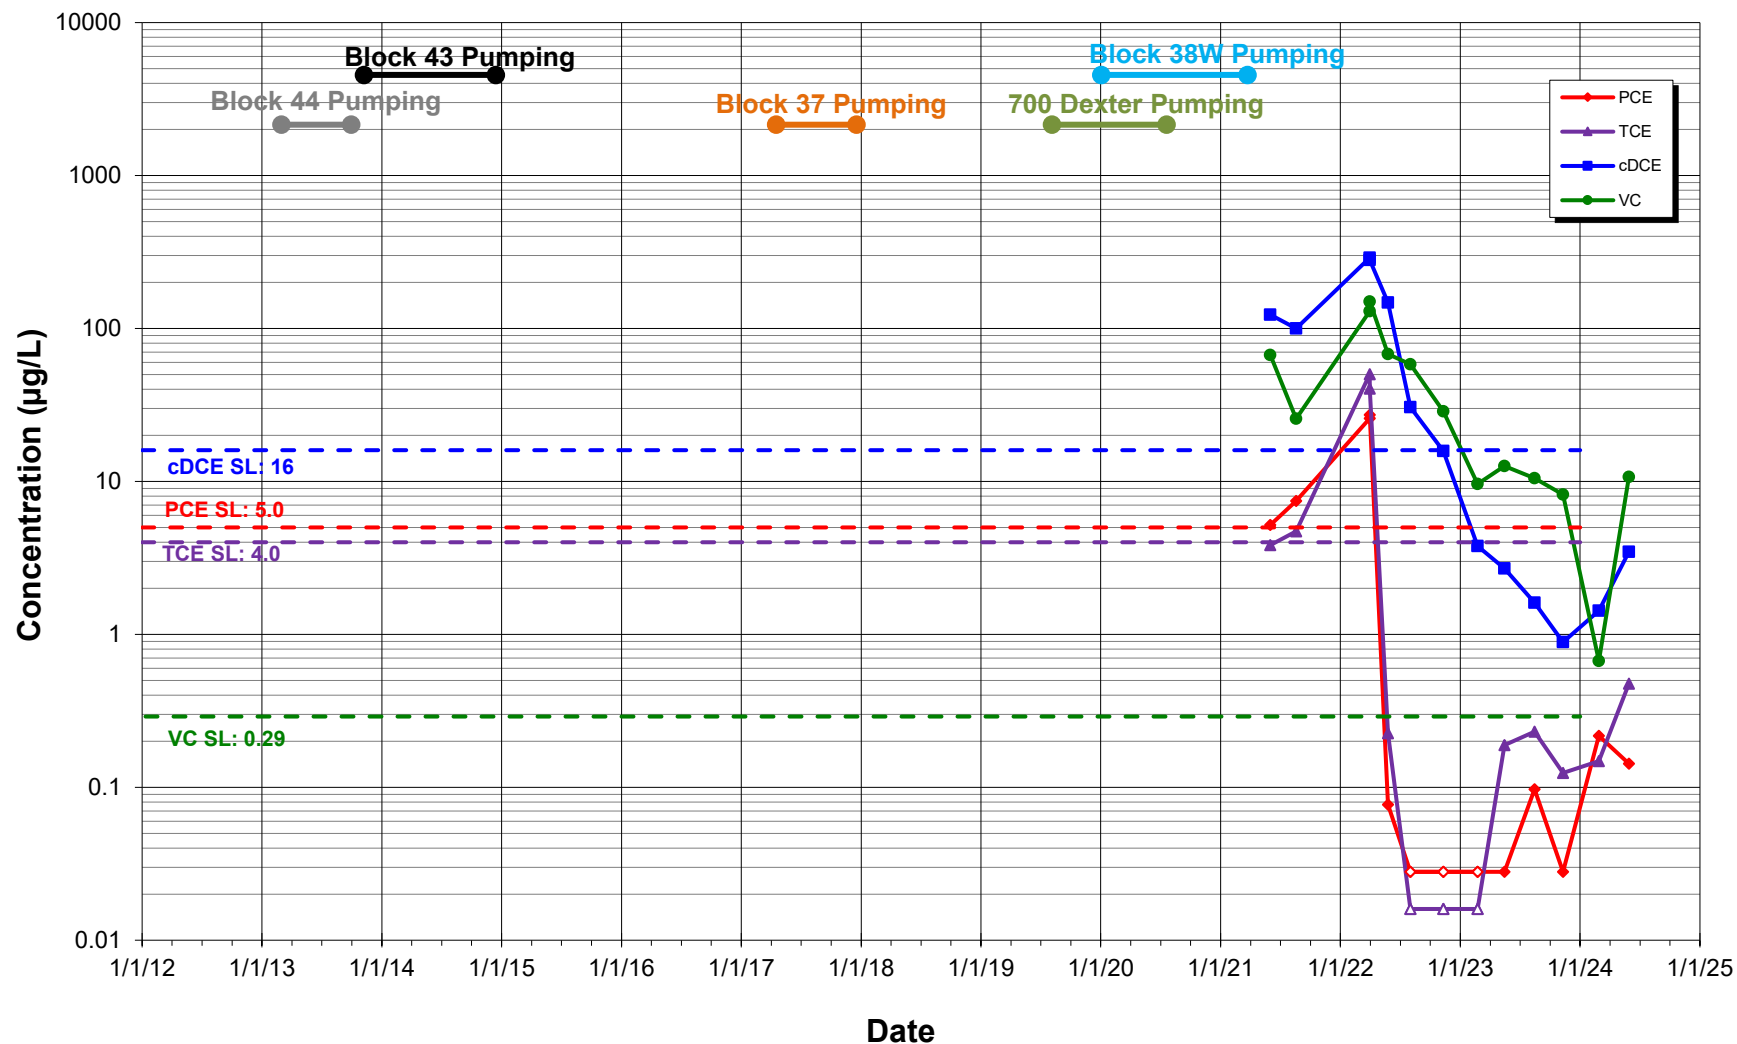
**Concentration vs Time**  
**MW-347 (-1.3 to -11.3 feet NAVD), Seattle DOT Mercer Parcels, NW quadrant**  
**American Linen Supply Co Dexter Ave Site**

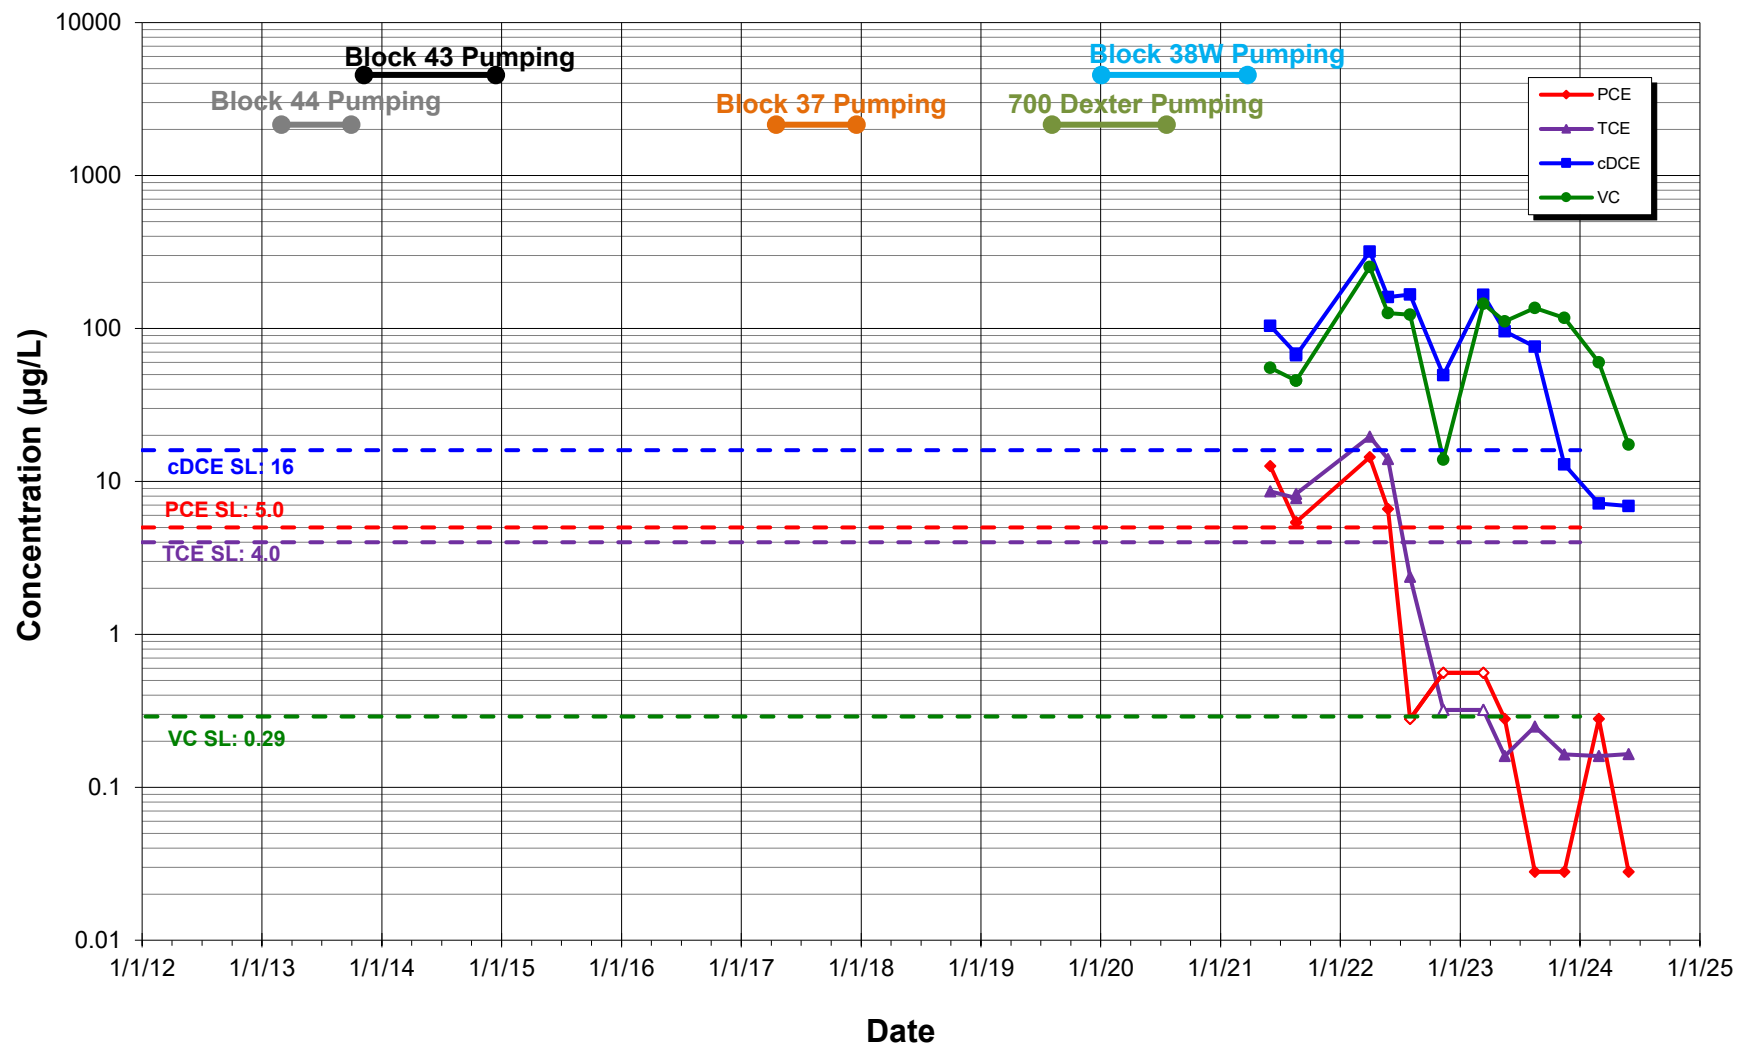
**Concentration vs Time**  
**MW-348 (-4.6 to -14.6 feet NAVD), Seattle DOT Mercer Parcels, SW quadrant**  
**American Linen Supply Co Dexter Ave Site**

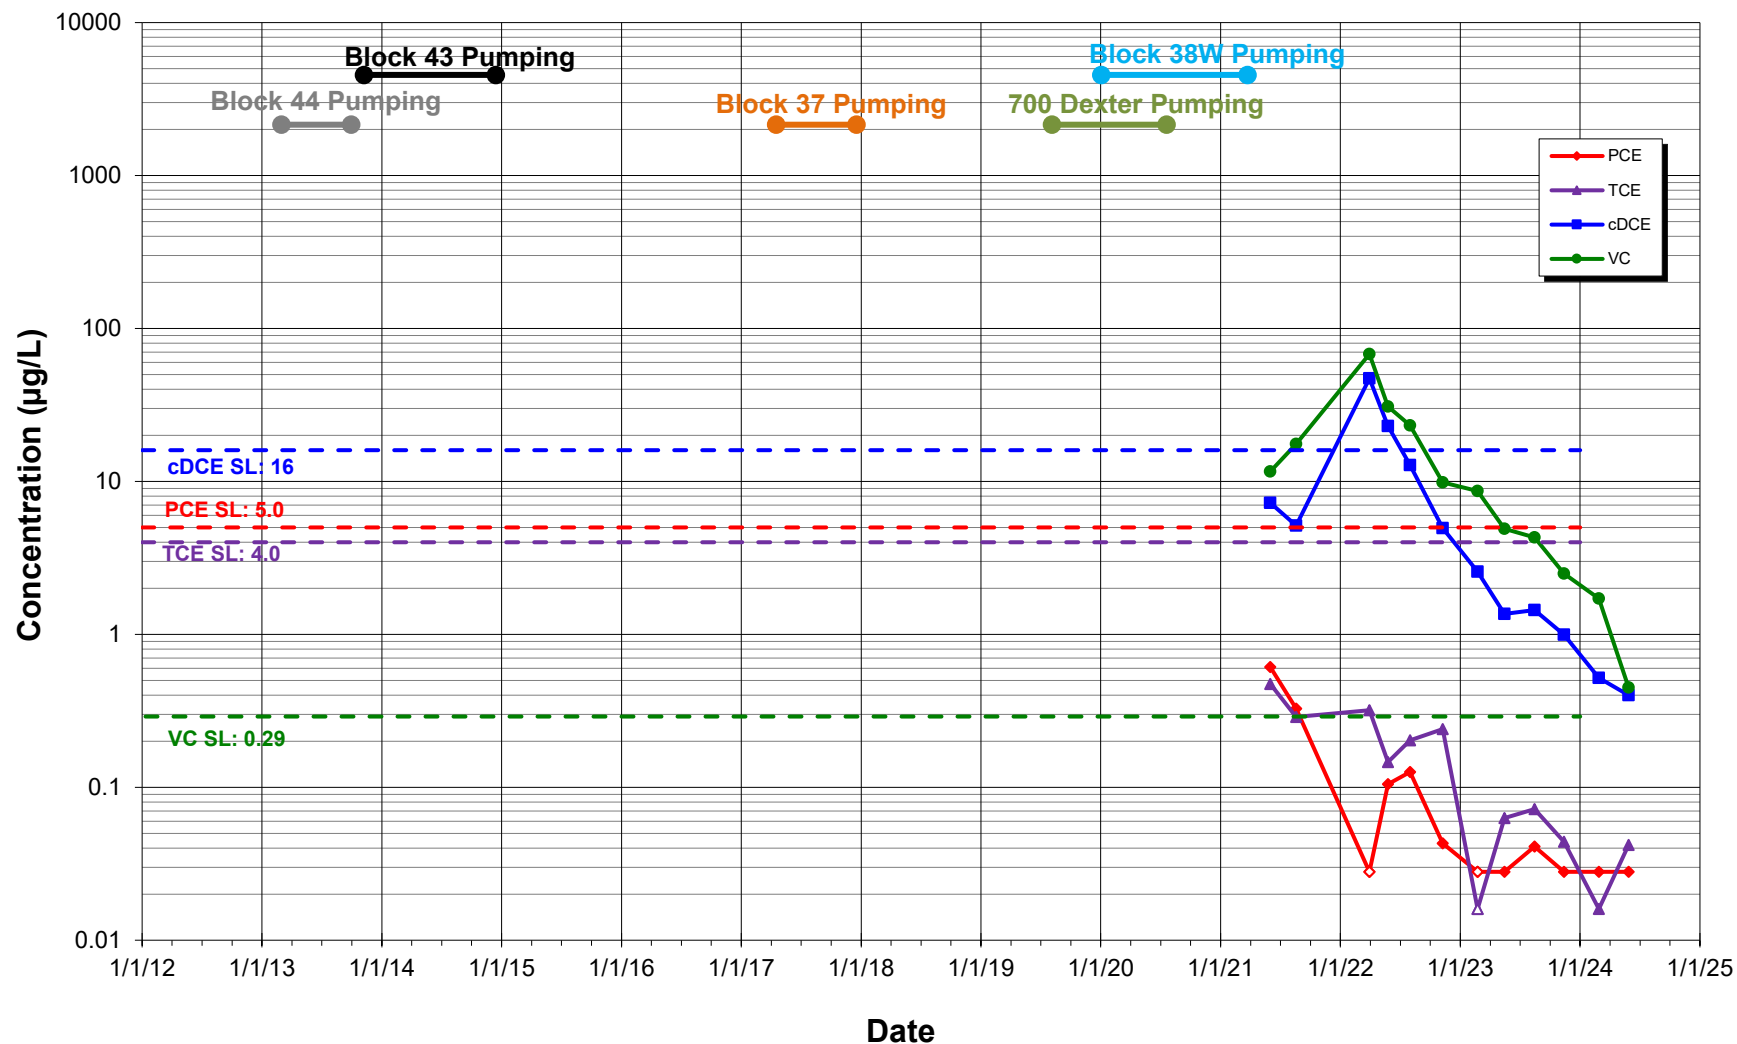
**Concentration vs Time**  
**MW-349 (-2.8 to -12.8 feet NAVD), Seattle DOT Mercer Parcels, SW quadrant**  
**American Linen Supply Co Dexter Ave Site**

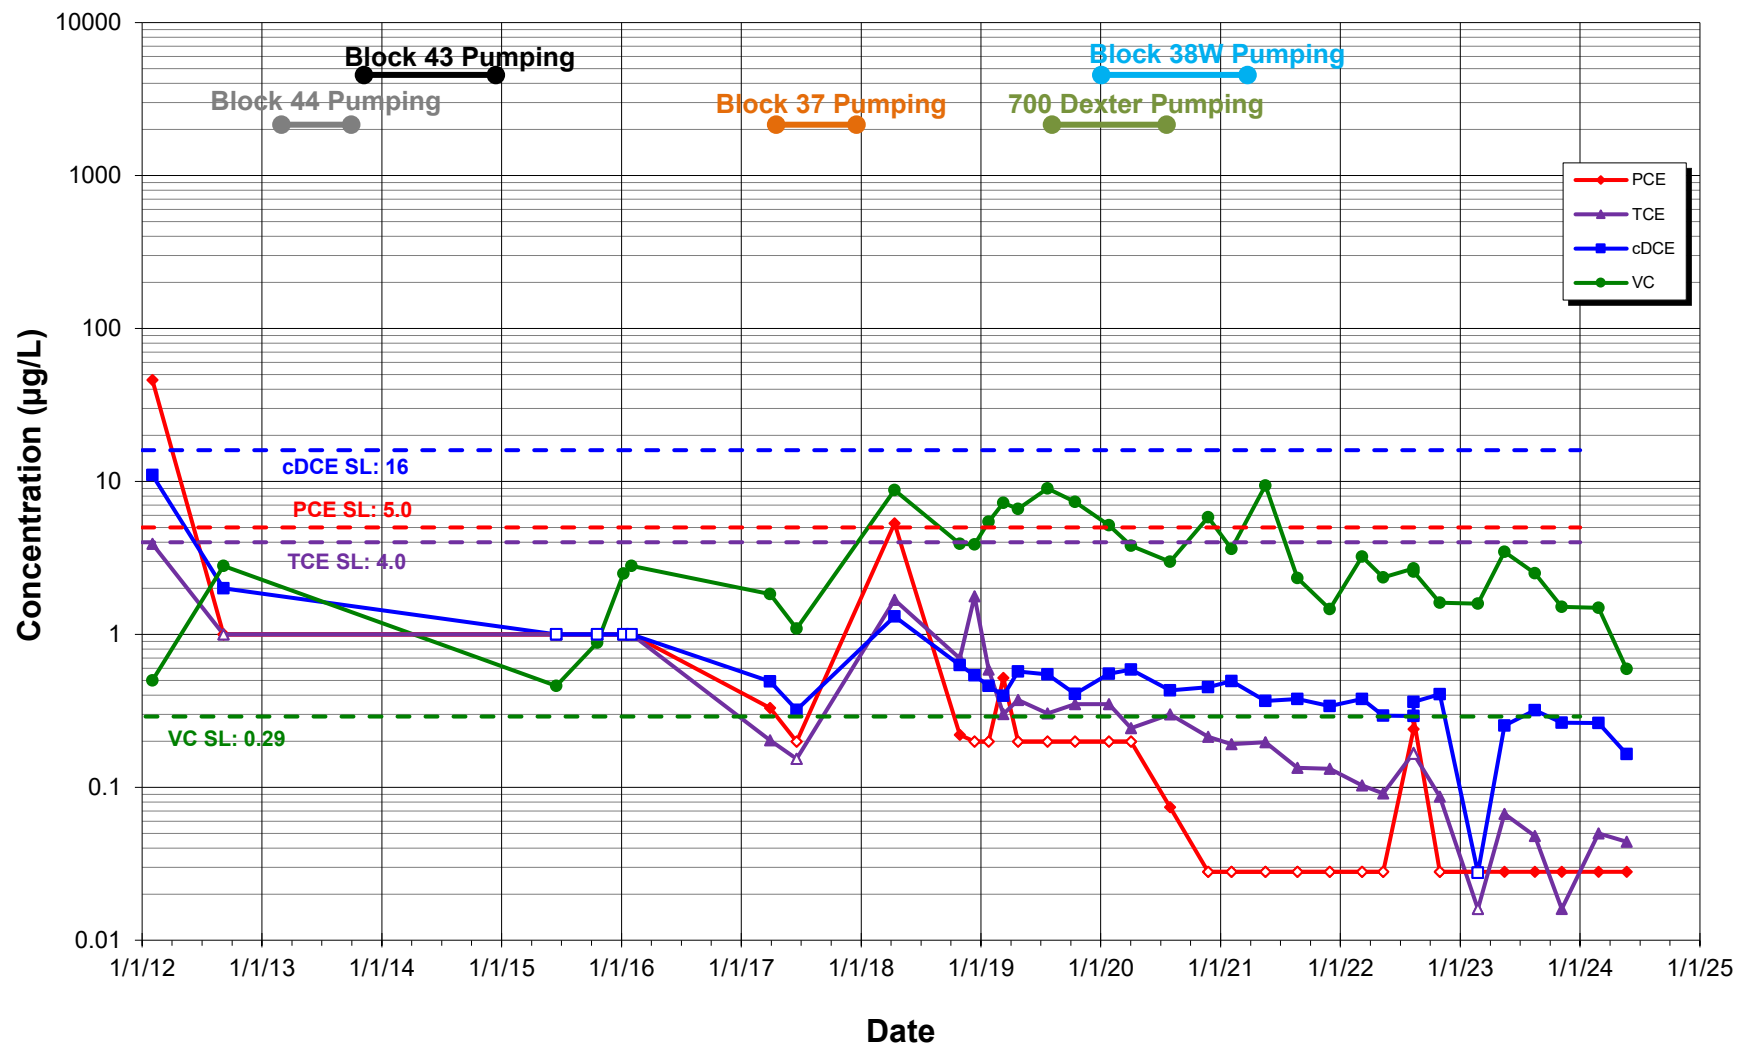
**Concentration vs Time**  
**W-MW-01 (-25.1 to -35.1 feet NAVD), 8th Ave N ROW, W side**  
**American Linen Supply Co Dexter Ave Site**

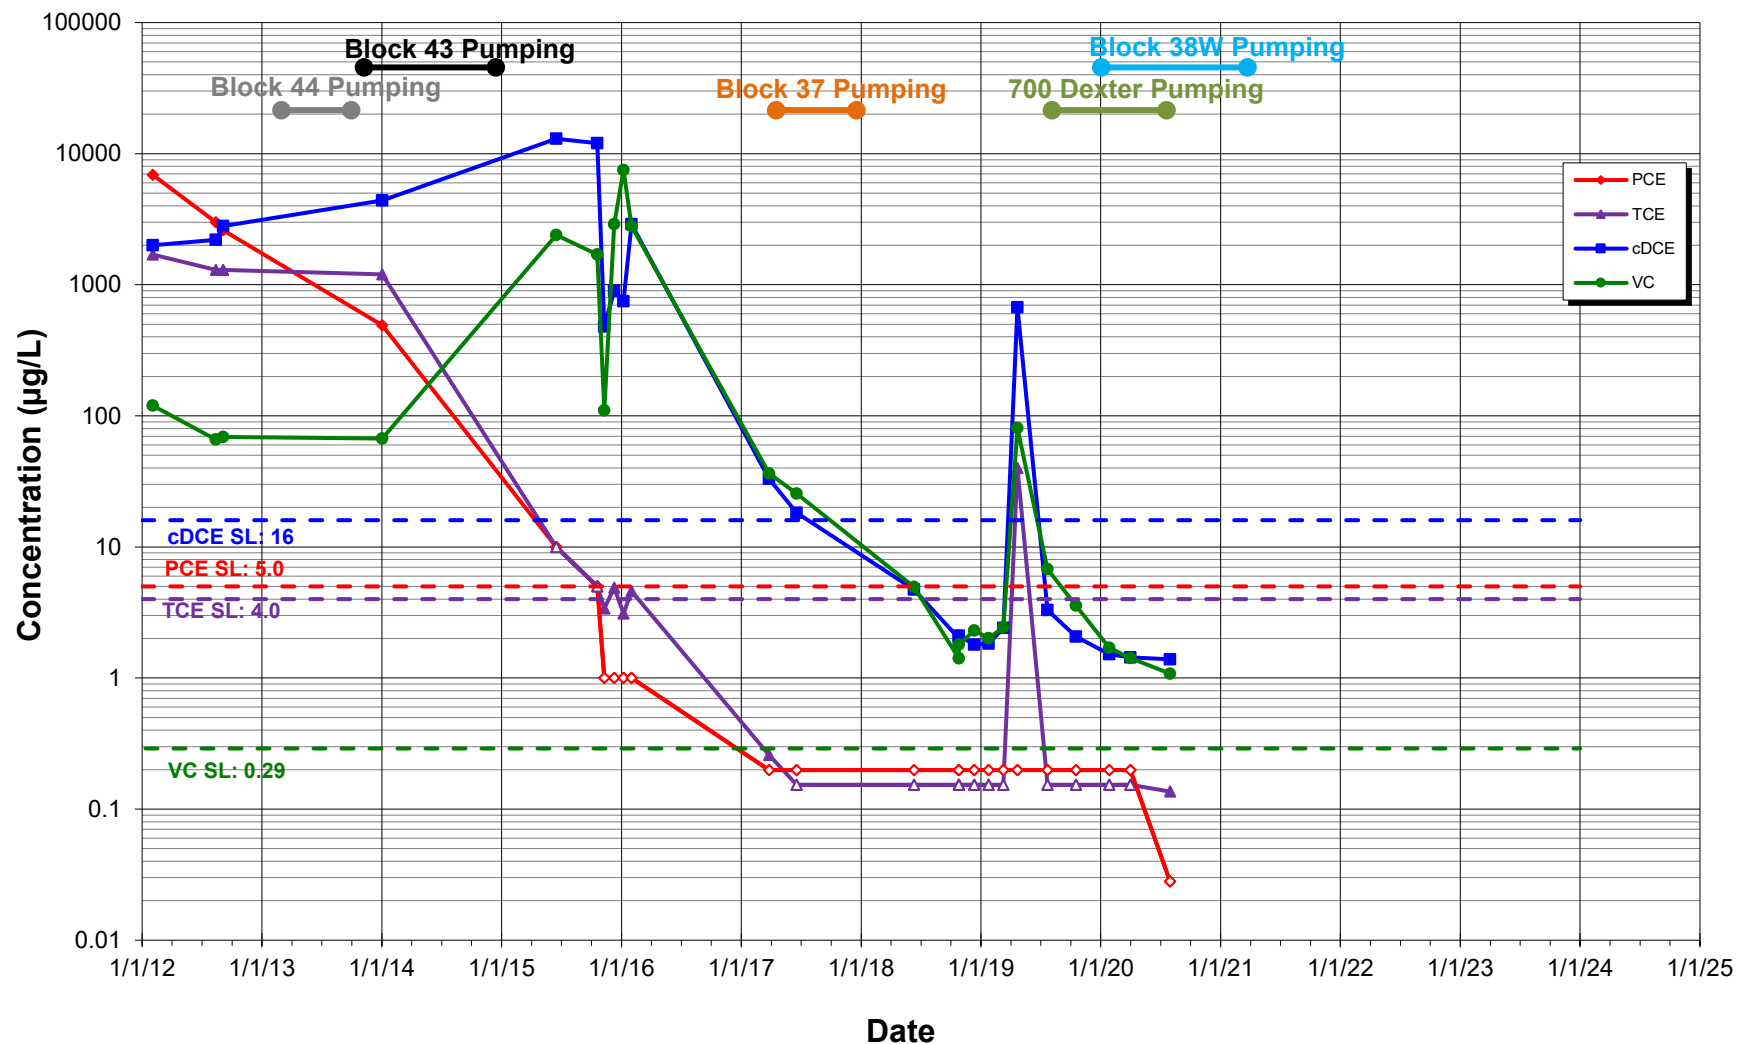
**Concentration vs Time**  
**W-MW-02 (-26.3 to -36.3 feet NAVD), 8th Ave N ROW, W side**  
**American Linen Supply Co Dexter Ave Site**
