**Attachment A**  
**Well Completion Table**  
**American Linen Supply Co–Dexter Avenue Site**  
**Seattle, Washington**

**CVOC TIME-TREND PLOTS**

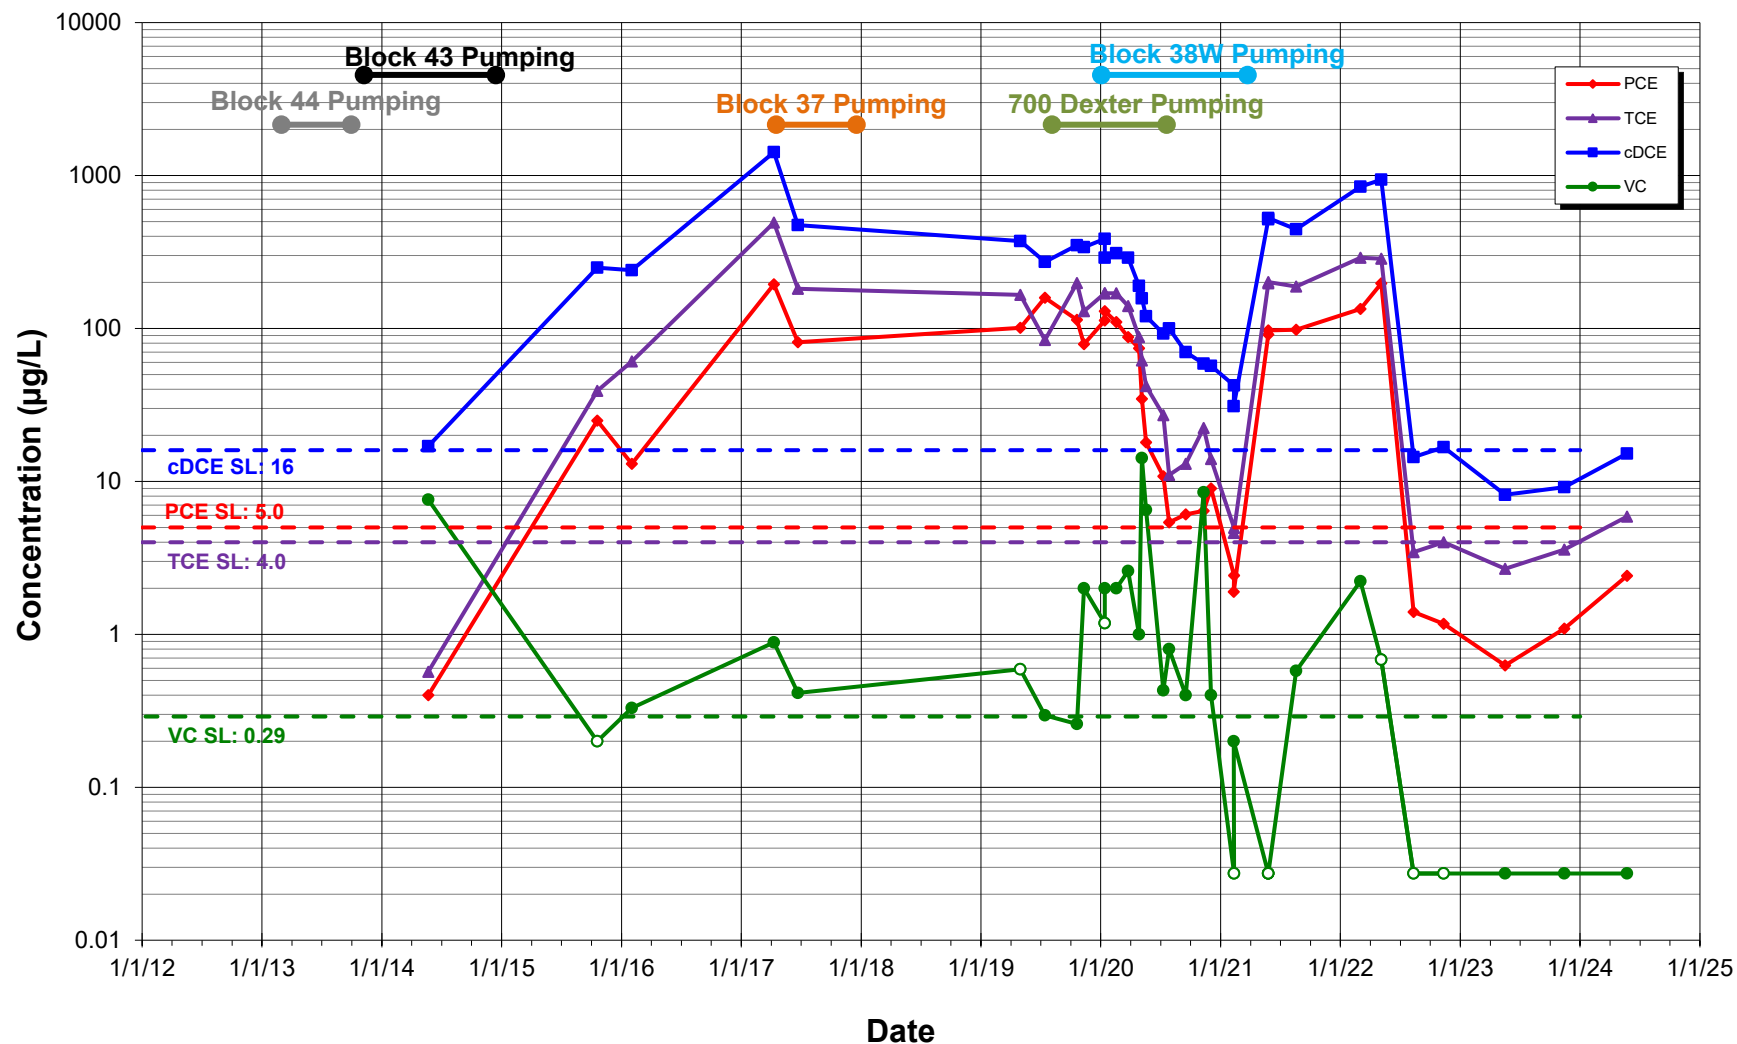
**Concentration vs Time**  
**FMW-129 (-45.6 to -50.6 feet NAVD), SDOT Mercer Parcels, NE Quadrant**  
**American Linen Supply Co Dexter Ave Site**

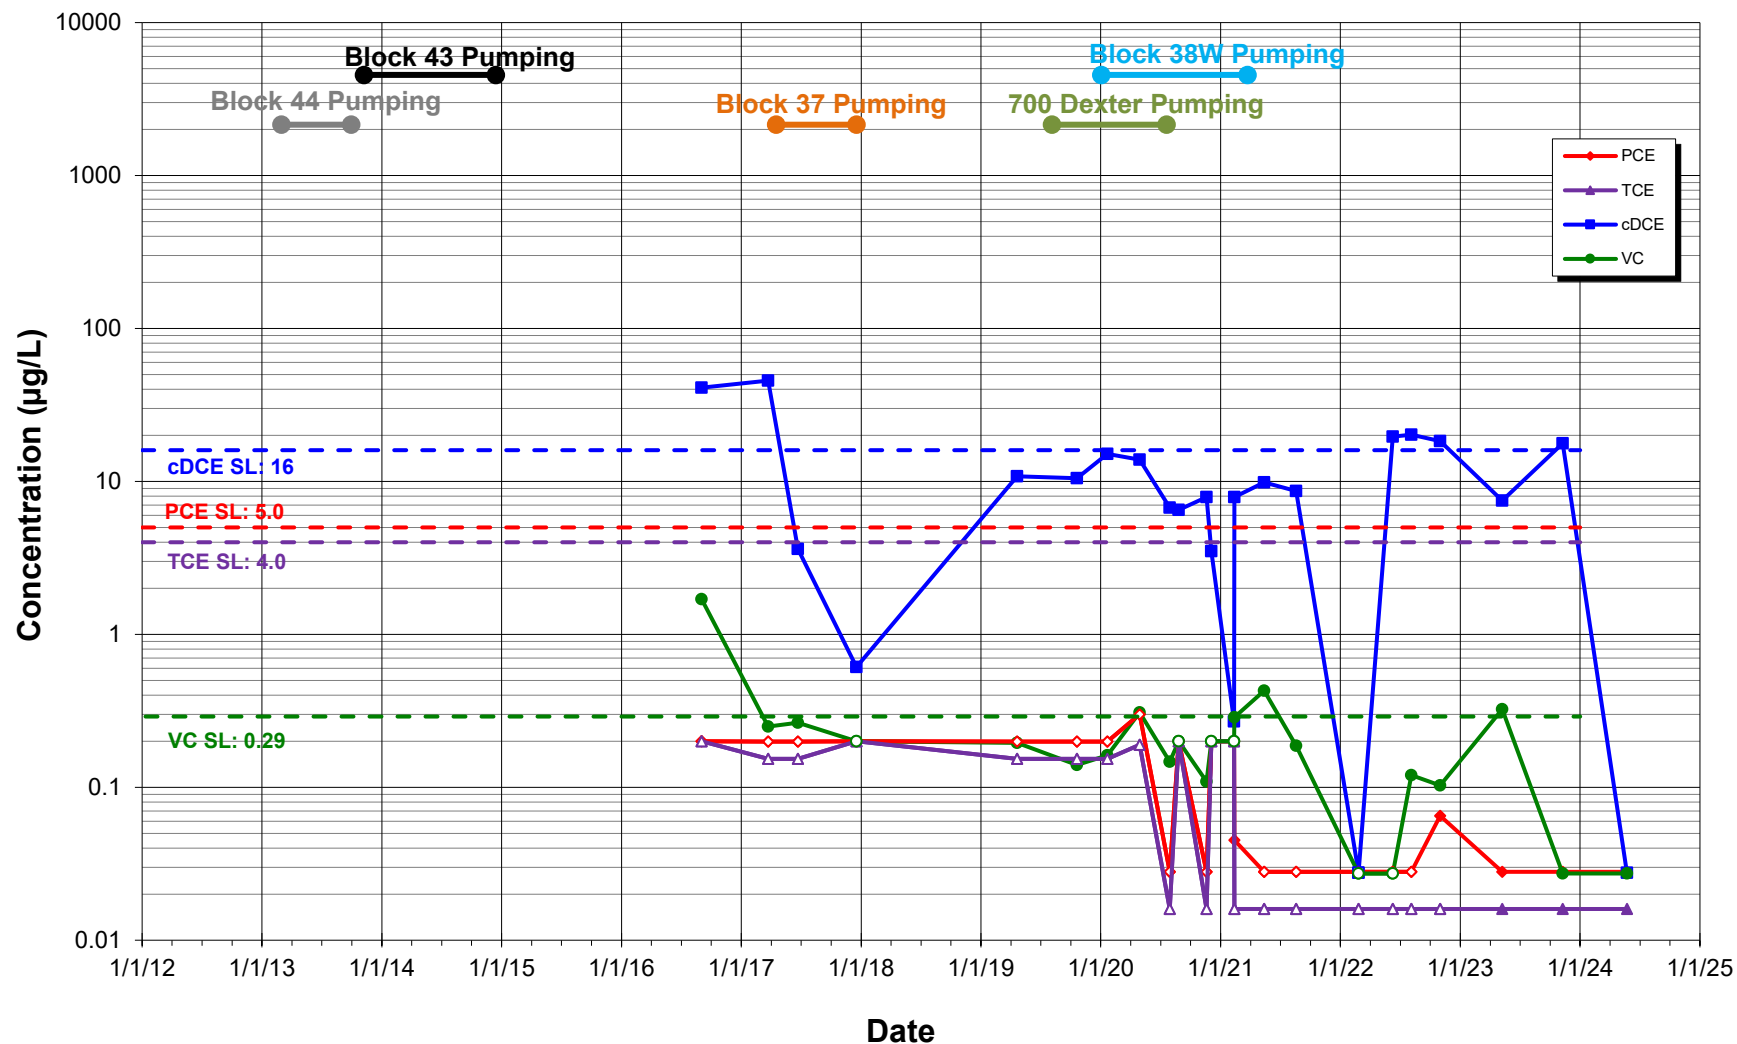
**Concentration vs Time**  
**FMW-131 (-34.7 to -44.7 feet NAVD), Block 37, SE Quadrant**  
**American Linen Supply Co Dexter Ave Site**

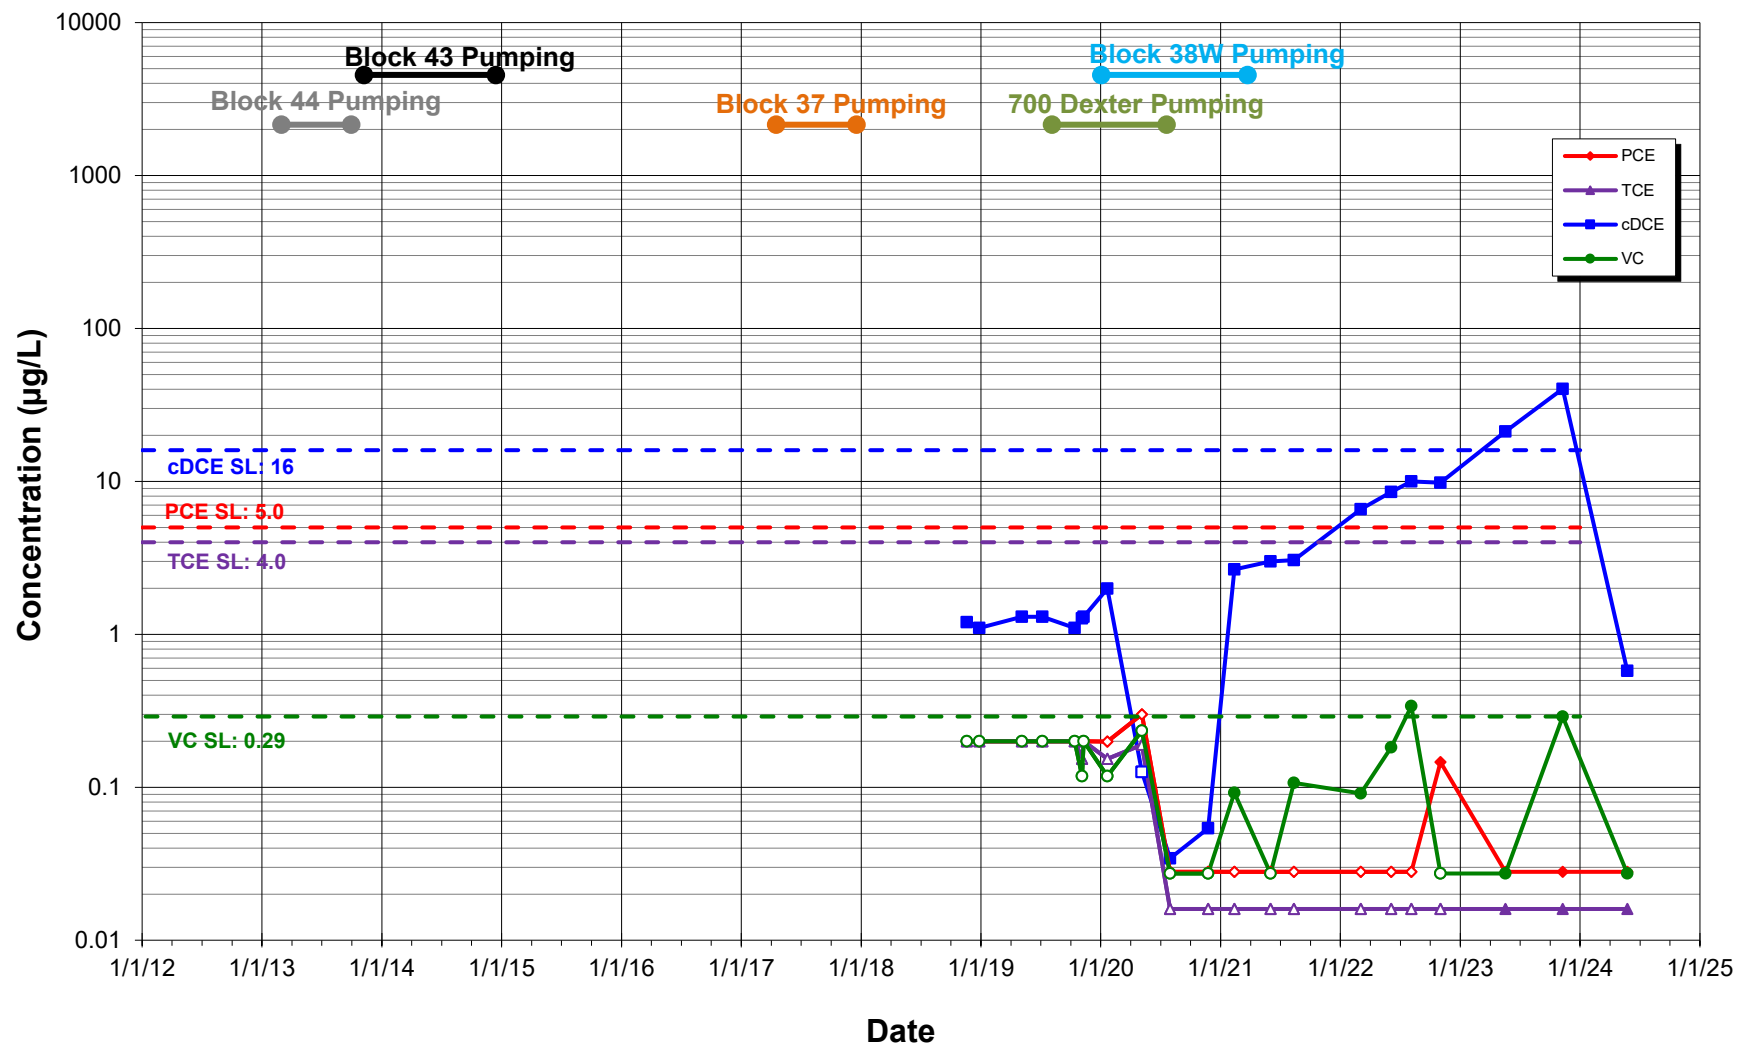
**Concentration vs Time**  
**FMW-137 (-39.9 to -54.9 feet NAVD), Alley E of Block 38W**  
**American Linen Supply Co Dexter Ave Site**

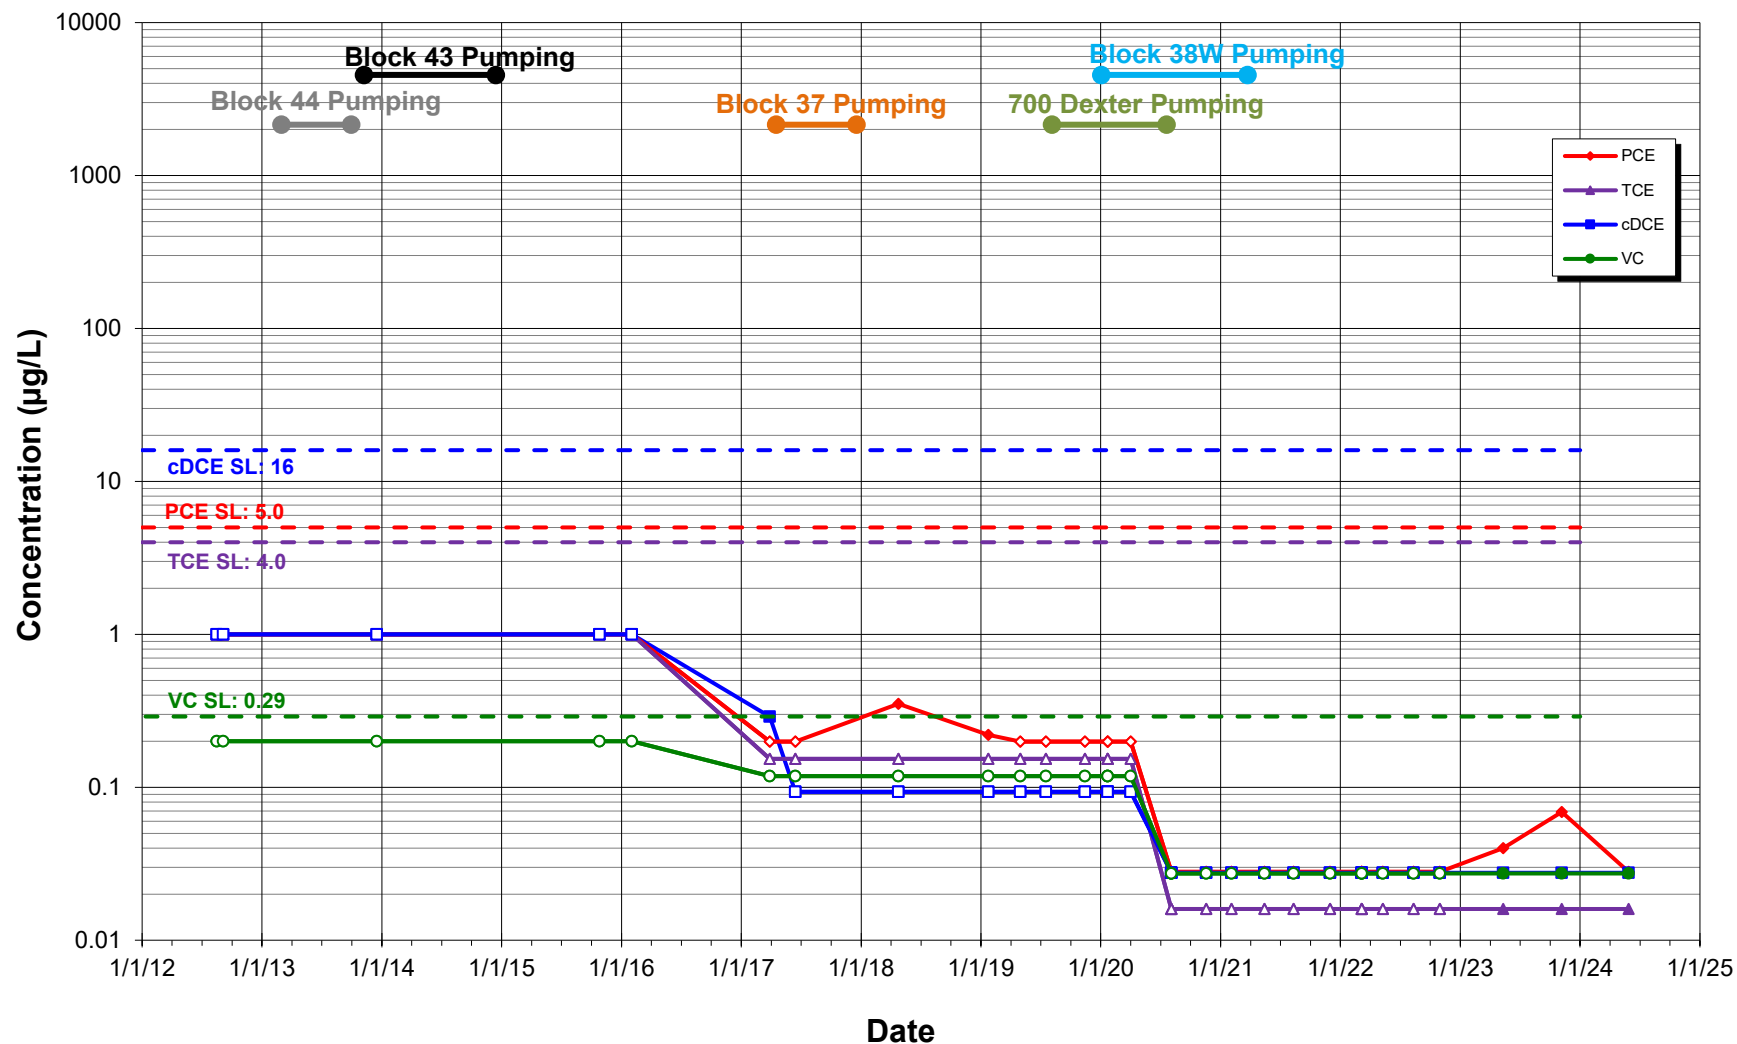
**Concentration vs Time**  
**MW102 (-65.8 to -75.8 feet NAVD), Valley St ROW, S side**  
**American Linen Supply Co Dexter Ave Site**

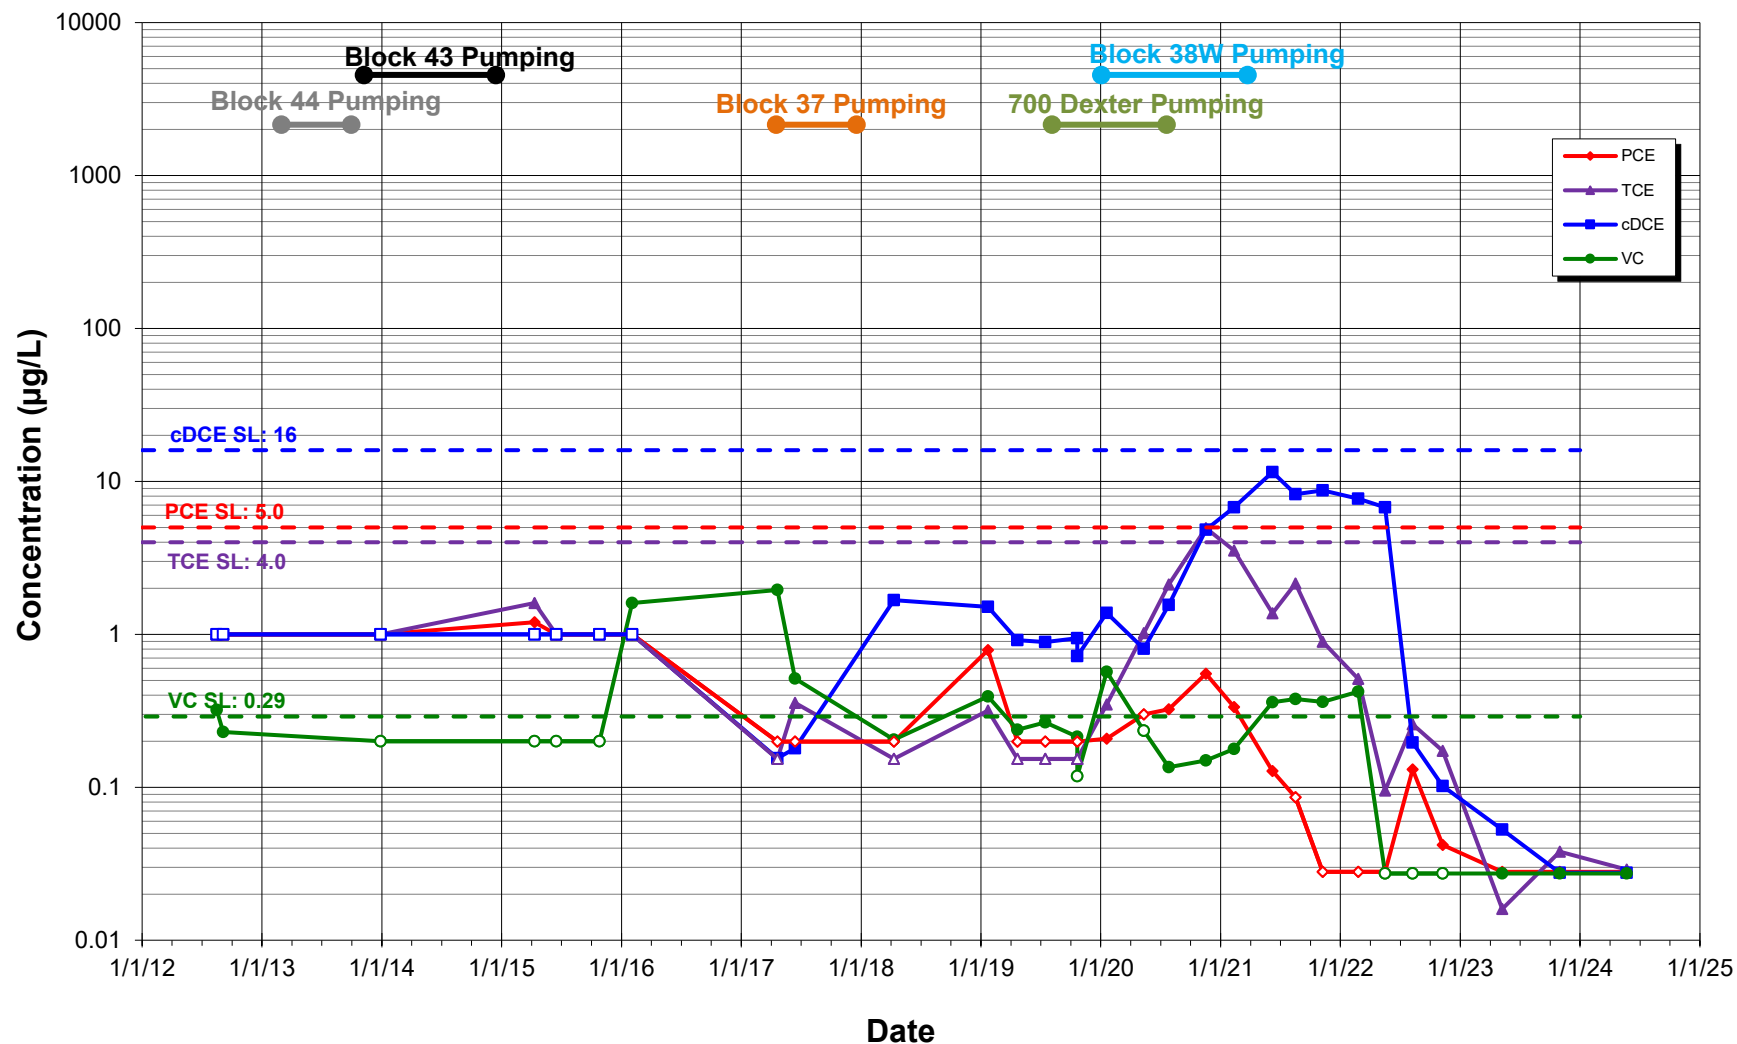
**Concentration vs Time**  
**MW105 (-85.8 to -95.8 feet NAVD), Roy St ROW, S side**  
**American Linen Supply Co Dexter Ave Site**

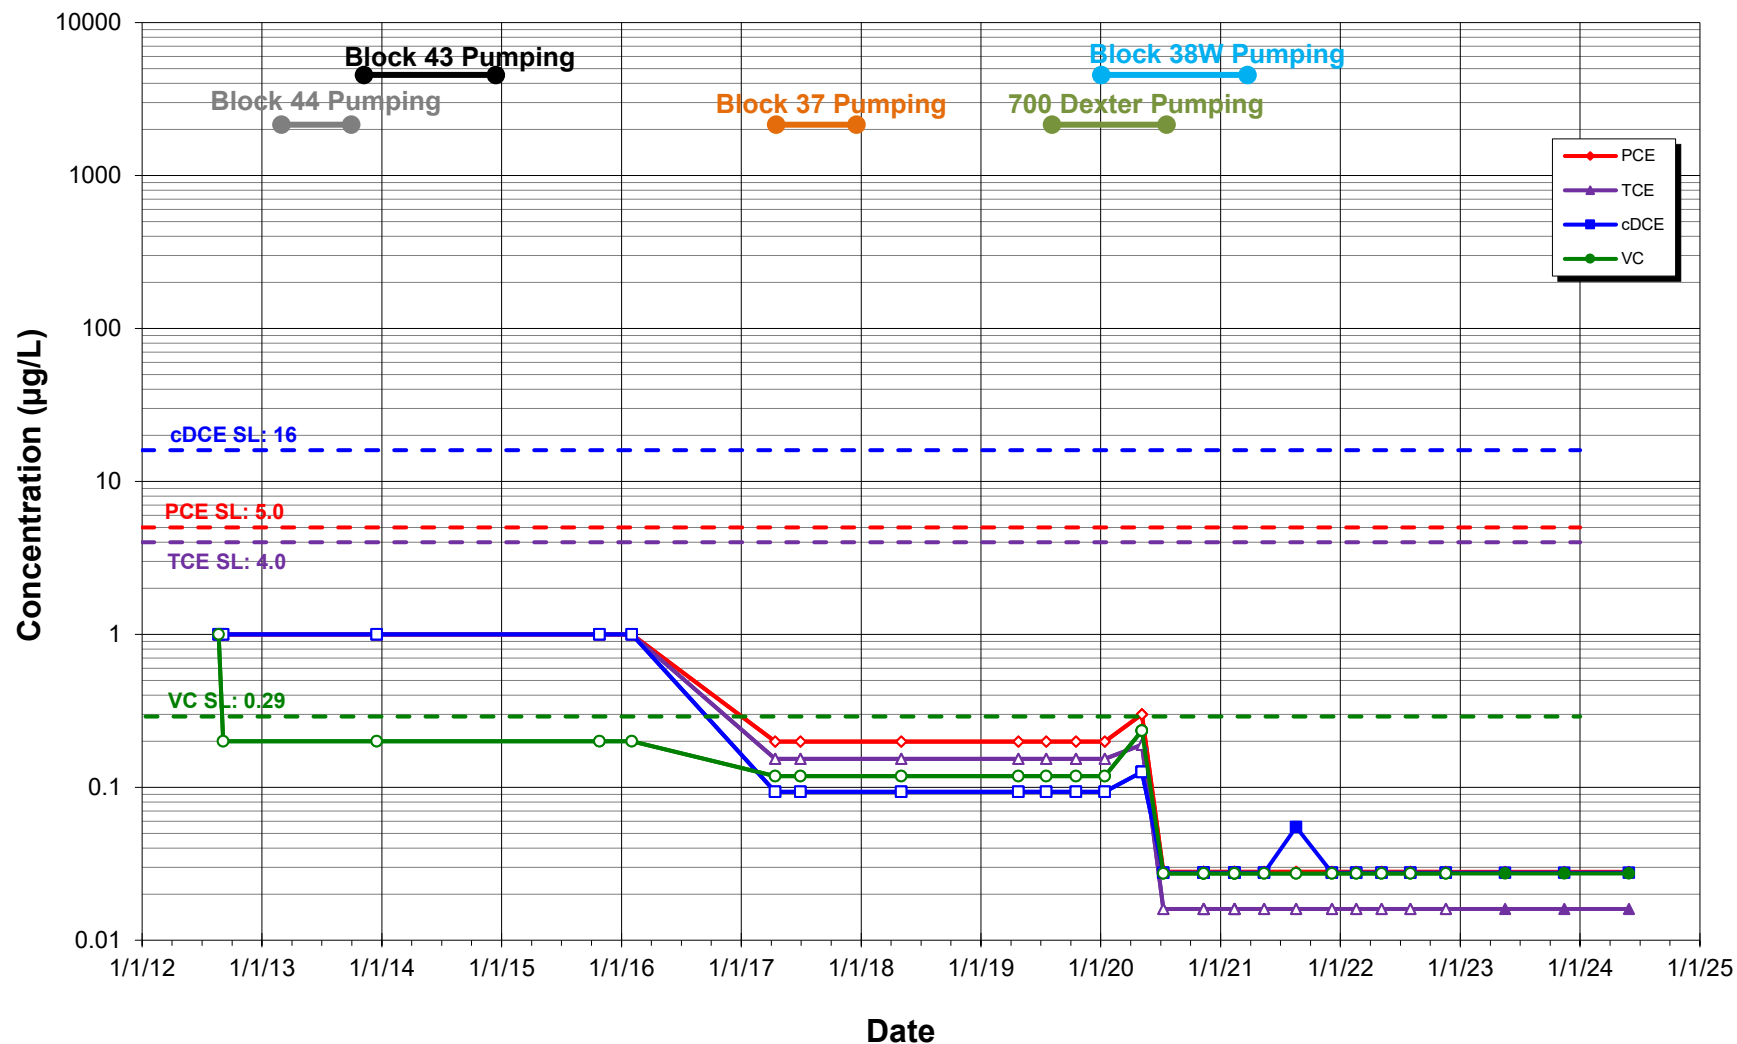
**Concentration vs Time**  
**MW106 (-78.0 to -88.0 feet NAVD), SDOT Mercer Parcels, NW quadrant**  
**American Linen Supply Co Dexter Ave Site**

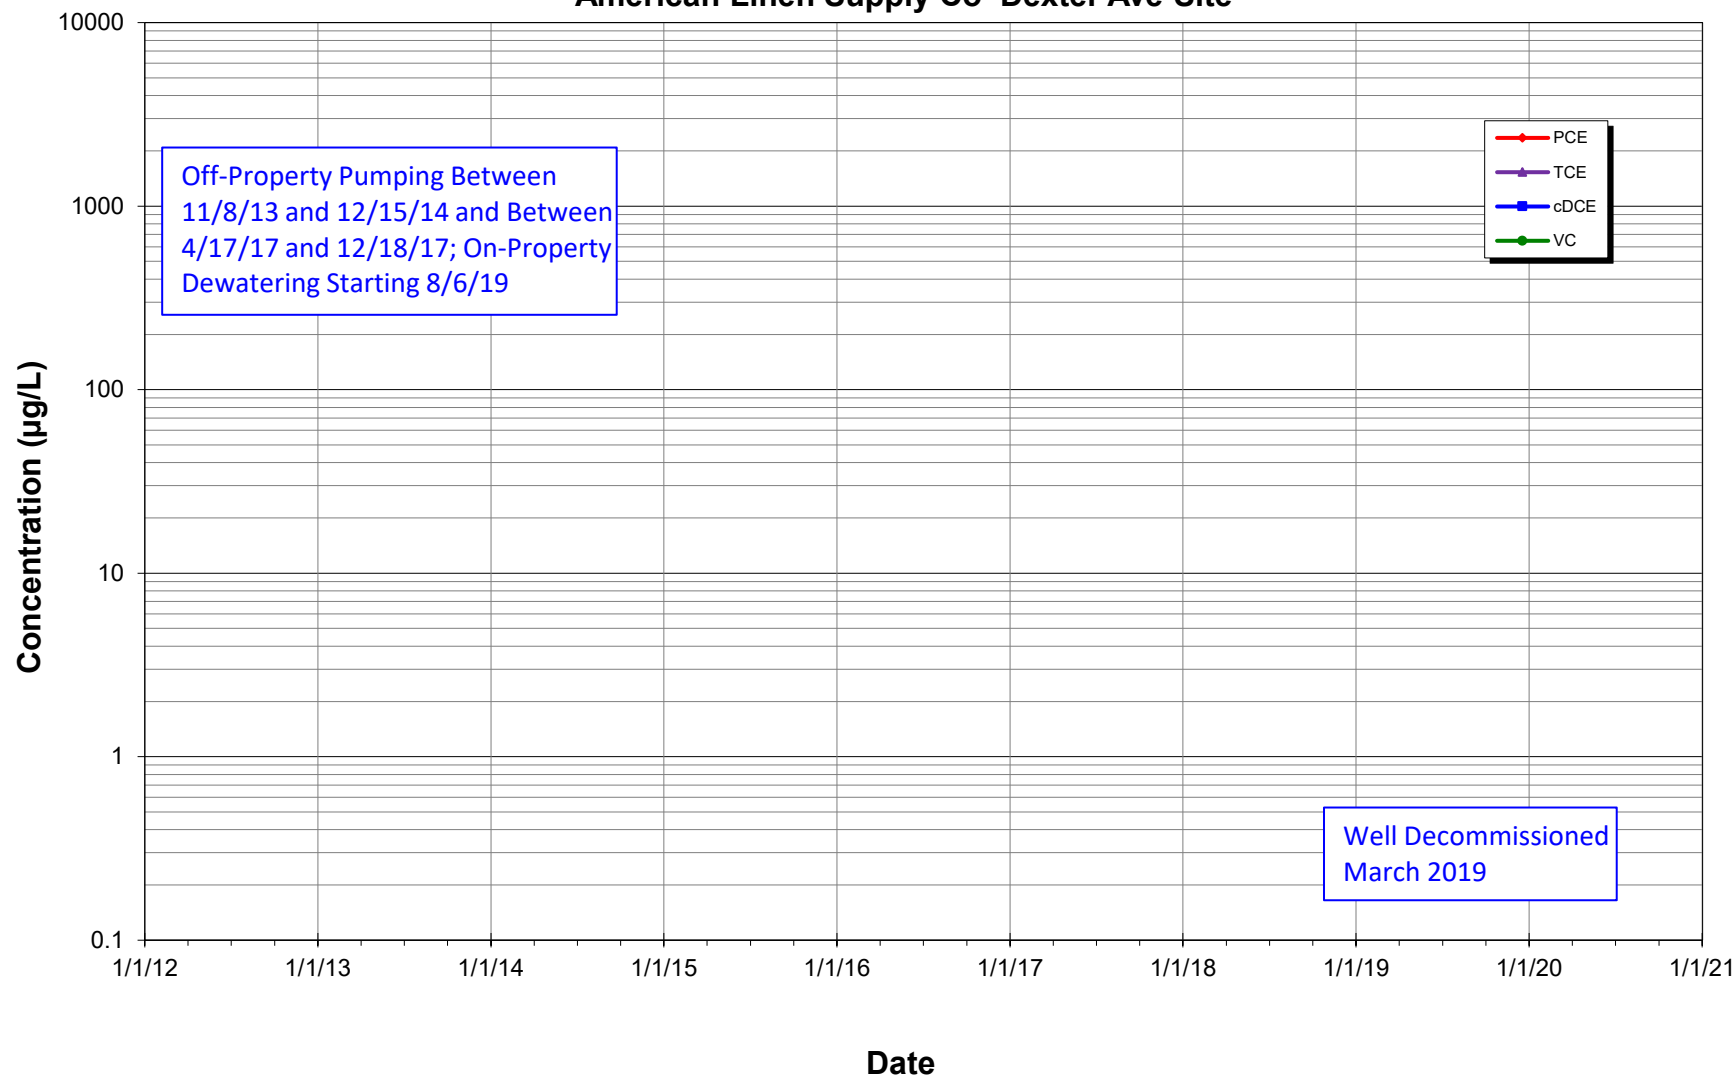
**Concentration vs Time**  
**MW-133 (-88.9 to -98.9 feet NAVD), Property**  
**American Linen Supply Co–Dexter Ave Site**

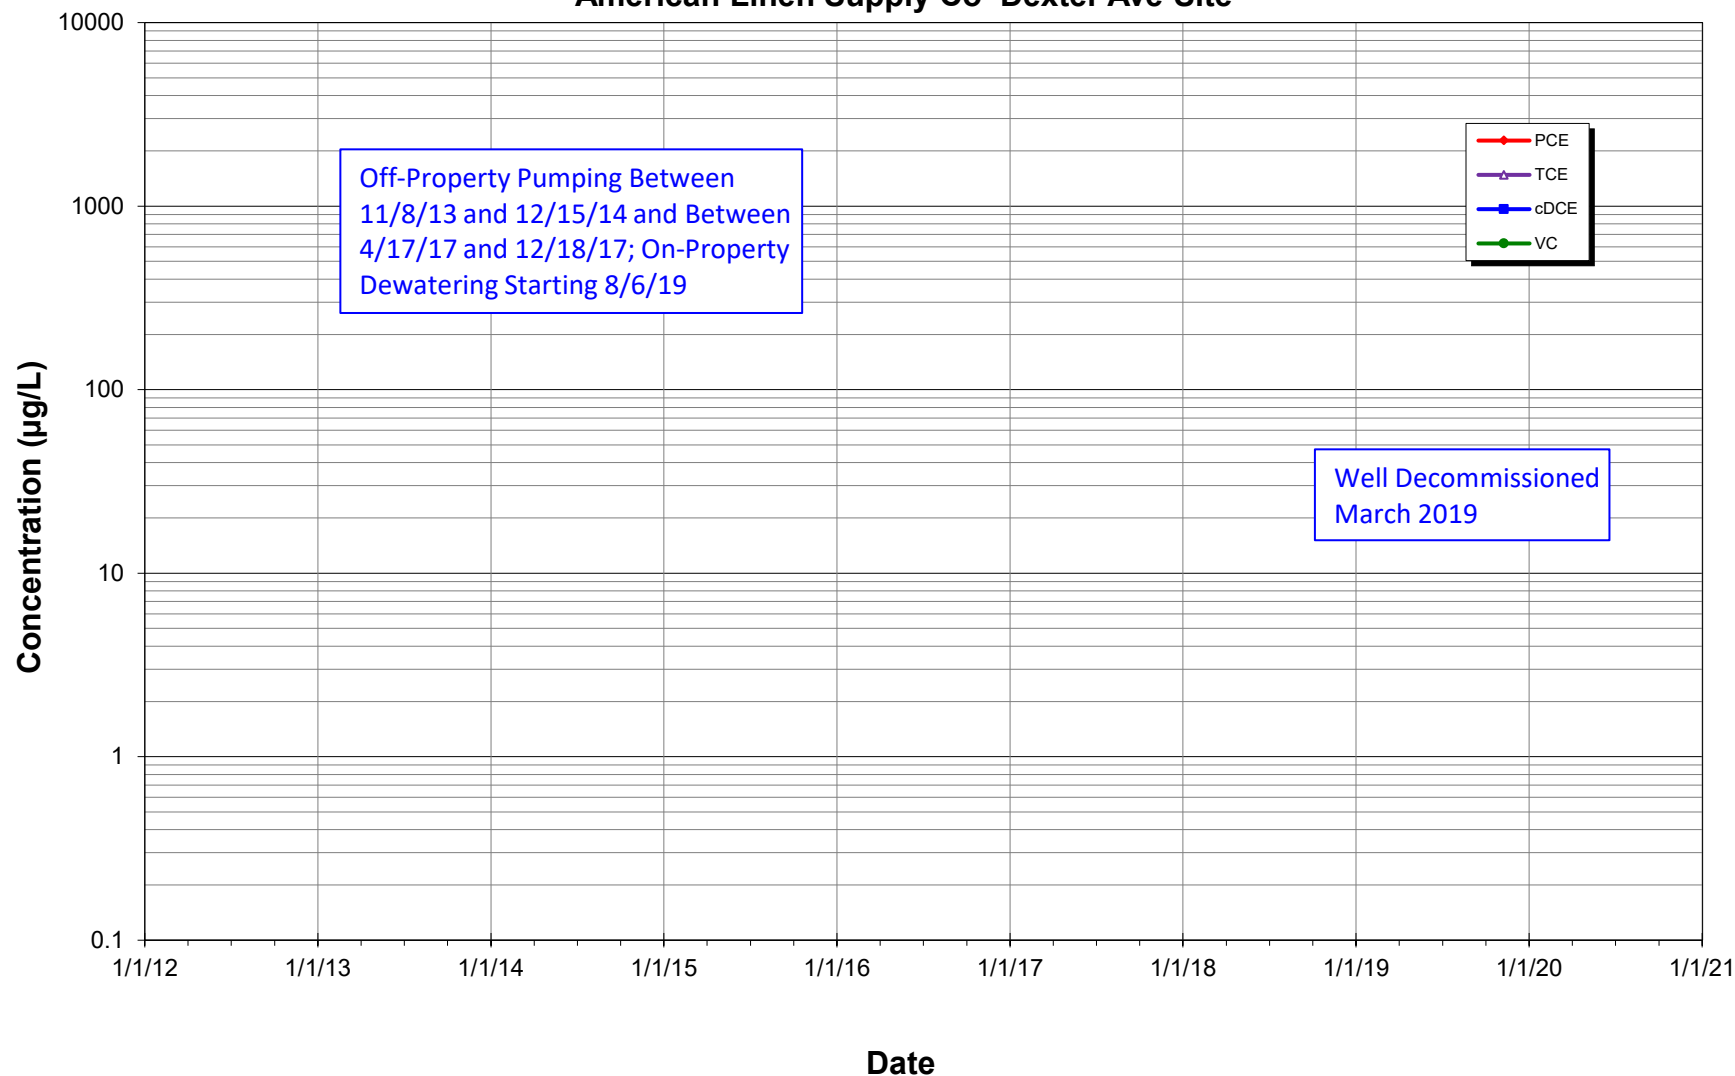
**Concentration vs Time**  
**MW-137 (-53.3 to -63.3 feet NAVD), Property**  
**American Linen Supply Co–Dexter Ave Site**

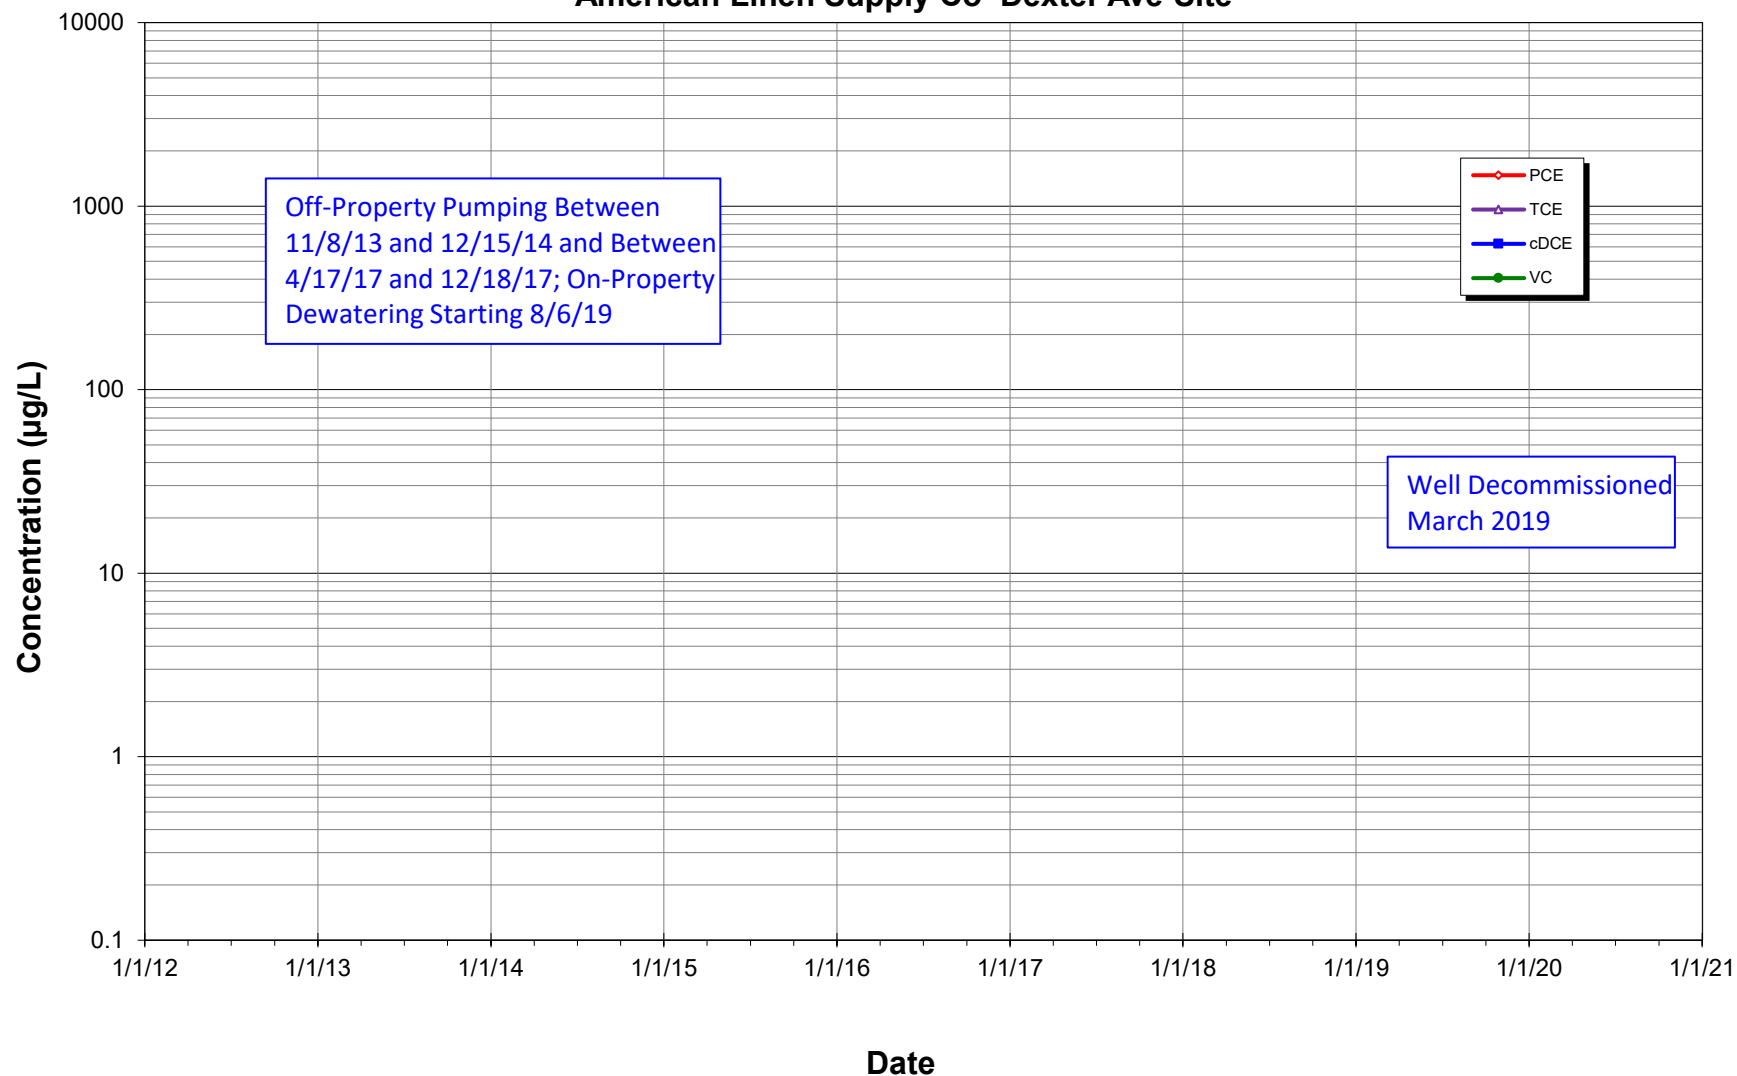
**Concentration vs Time**  
**MW-141 (-55.4 to -65.4 feet NAVD), Property**  
**American Linen Supply Co–Dexter Ave Site**

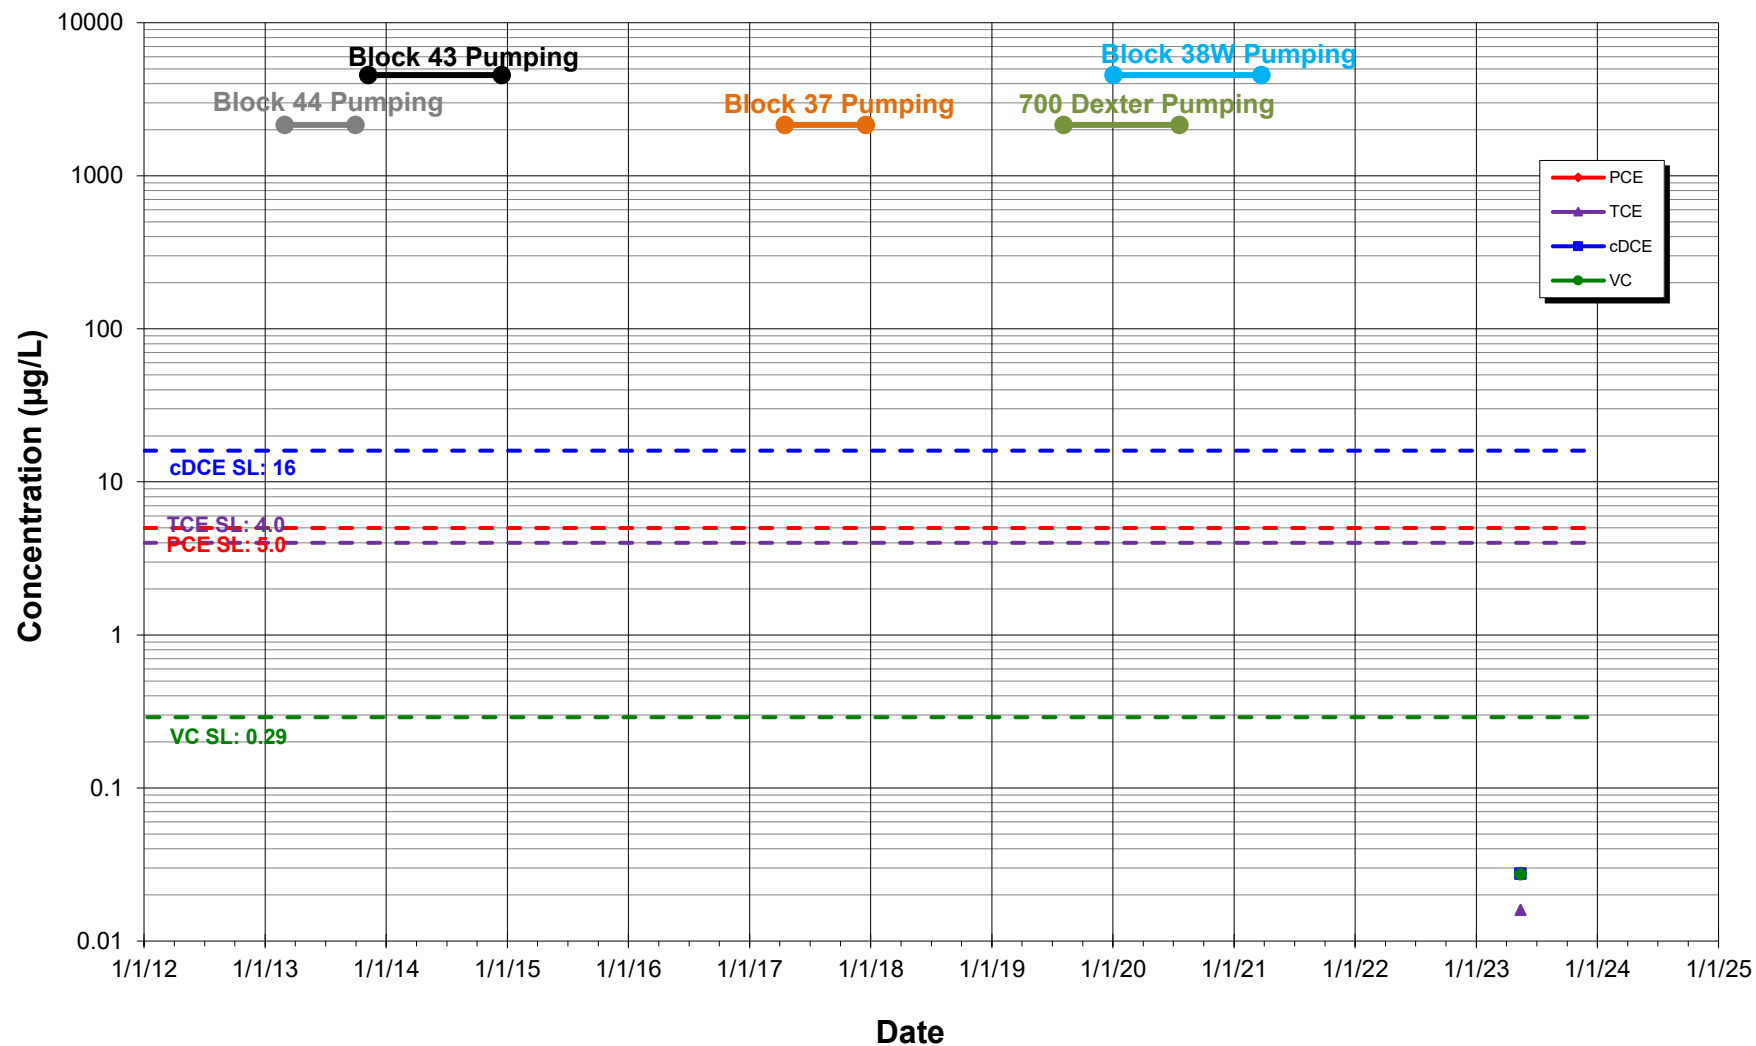
**Concentration vs Time**  
**MW-326R (-48.7 to -58.7 feet NAVD), Mercer St ROW, N side**  
**American Linen Supply Co Dexter Ave Site**
