**Attachment A**  
**Well Completion Table**  
**American Linen Supply Co Dexter Ave Site**  
**700 Dexter Avenue North**  
**Seattle, Washington**

**ATTACHMENT B**

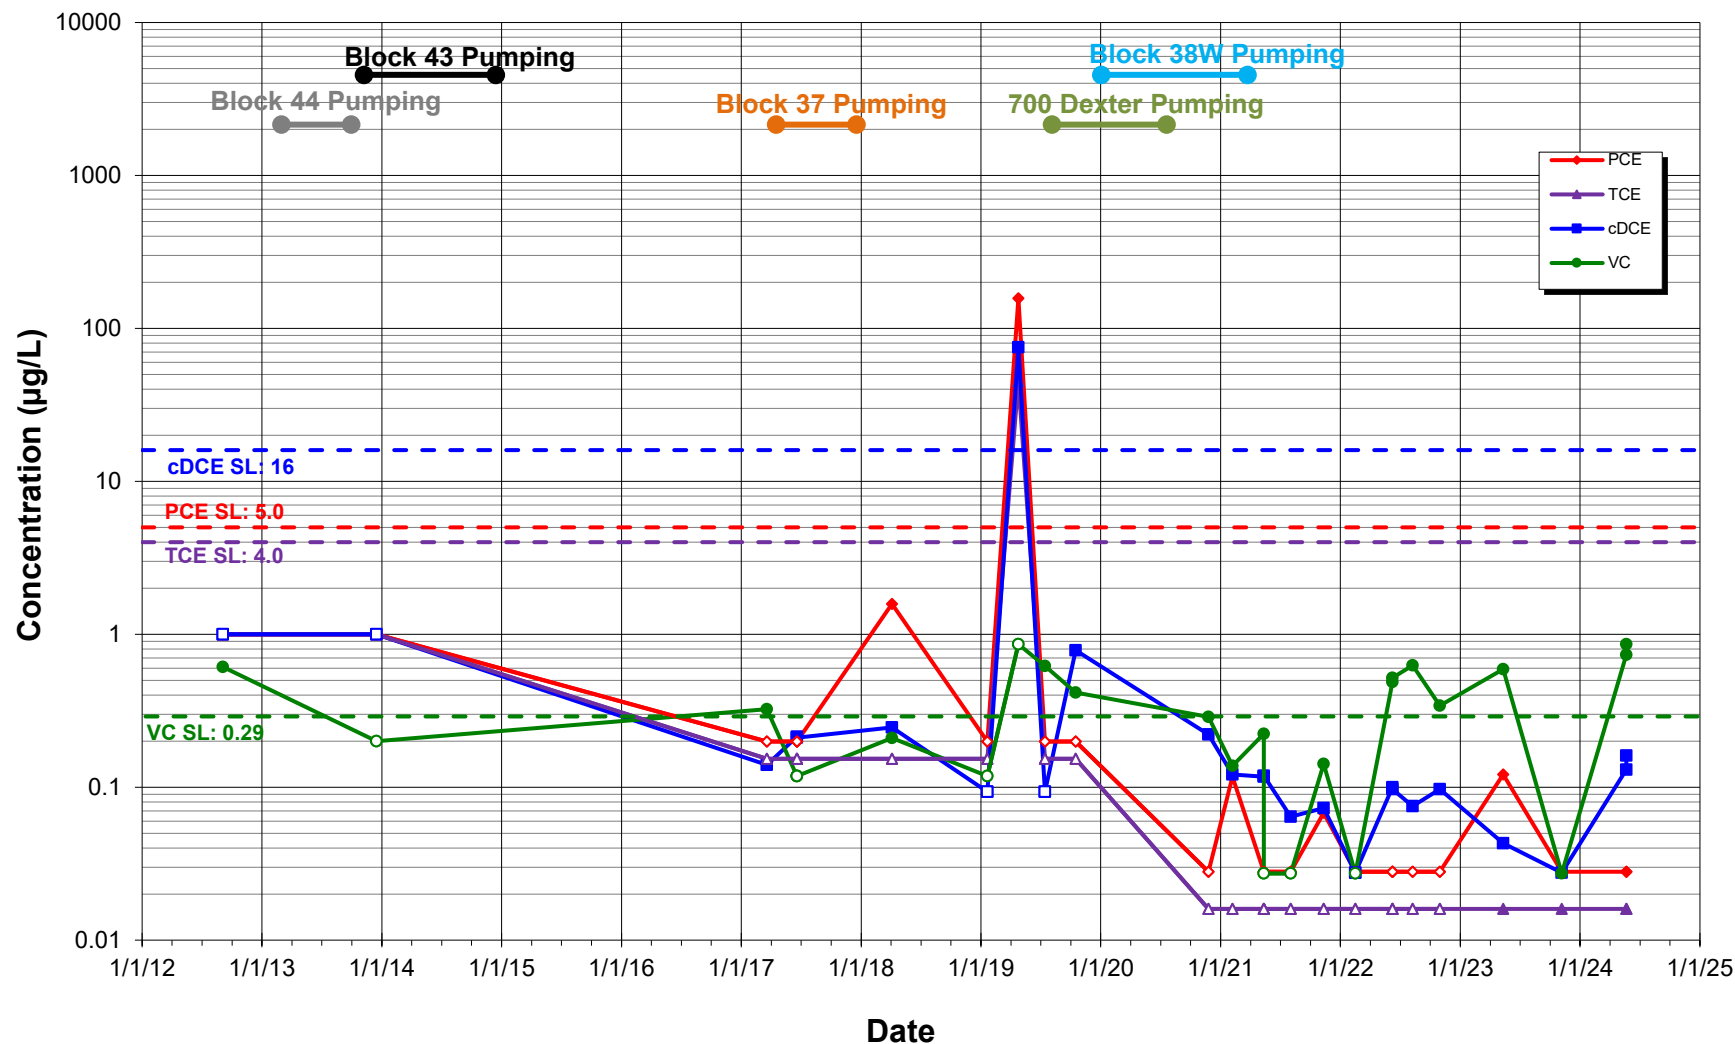
**Concentration vs Time**  
**MW-9 (34.1 to 19.1 feet NAVD), 8th Ave N ROW, E side**  
**American Linen Supply Co Dexter Ave Site**

1. All results detected below the laboratory MDLs are shown as hollow data points.
2. Preliminary Cleanup Levels: PCE = 5 µg/L, TCE = 4 µg/L, cDCE = 16 µg/L, and VC = 0.29 µg/L.

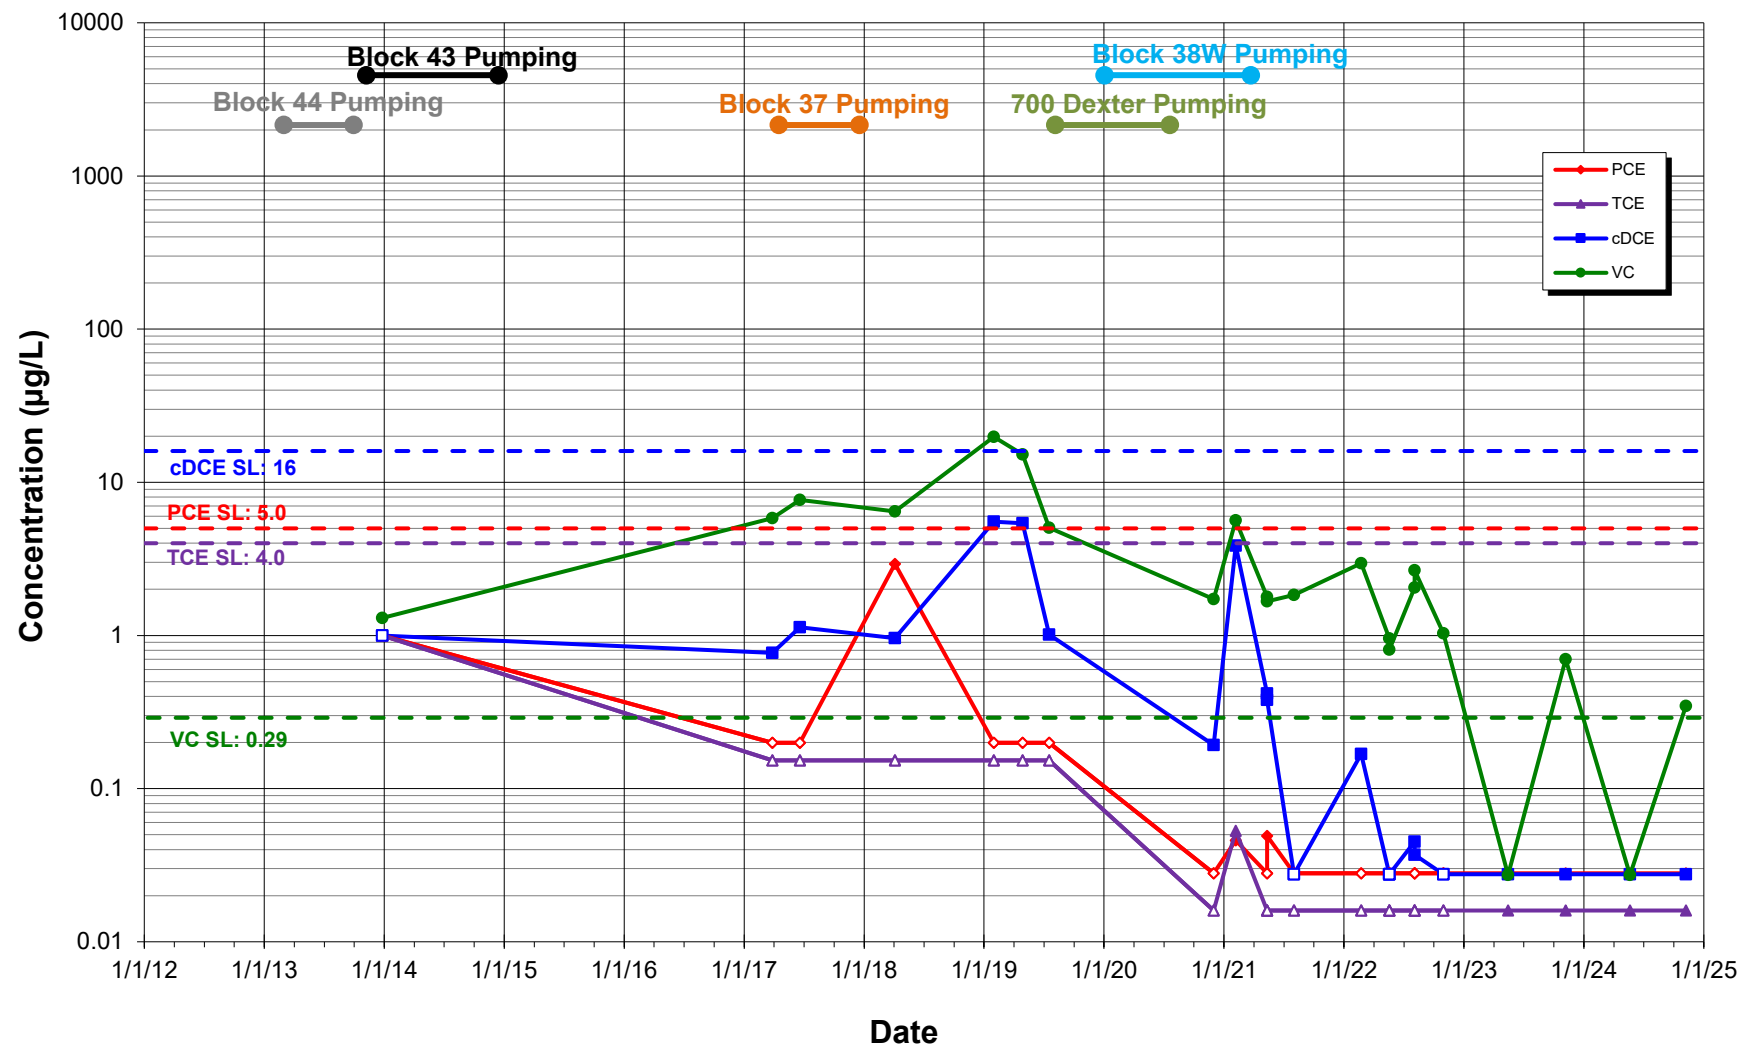
**Concentration vs Time**  
**MW121 (26.7 to 16.7 feet NAVD), 8th Ave N ROW, E side**  
**American Linen Supply Co Dexter Ave Site**

1. All results detected below the laboratory MDLs are shown as hollow data points.
2. Preliminary Cleanup Levels: PCE = 5 µg/L, TCE = 4 µg/L, cDCE = 16 µg/L, and VC = 0.29 µg/L.

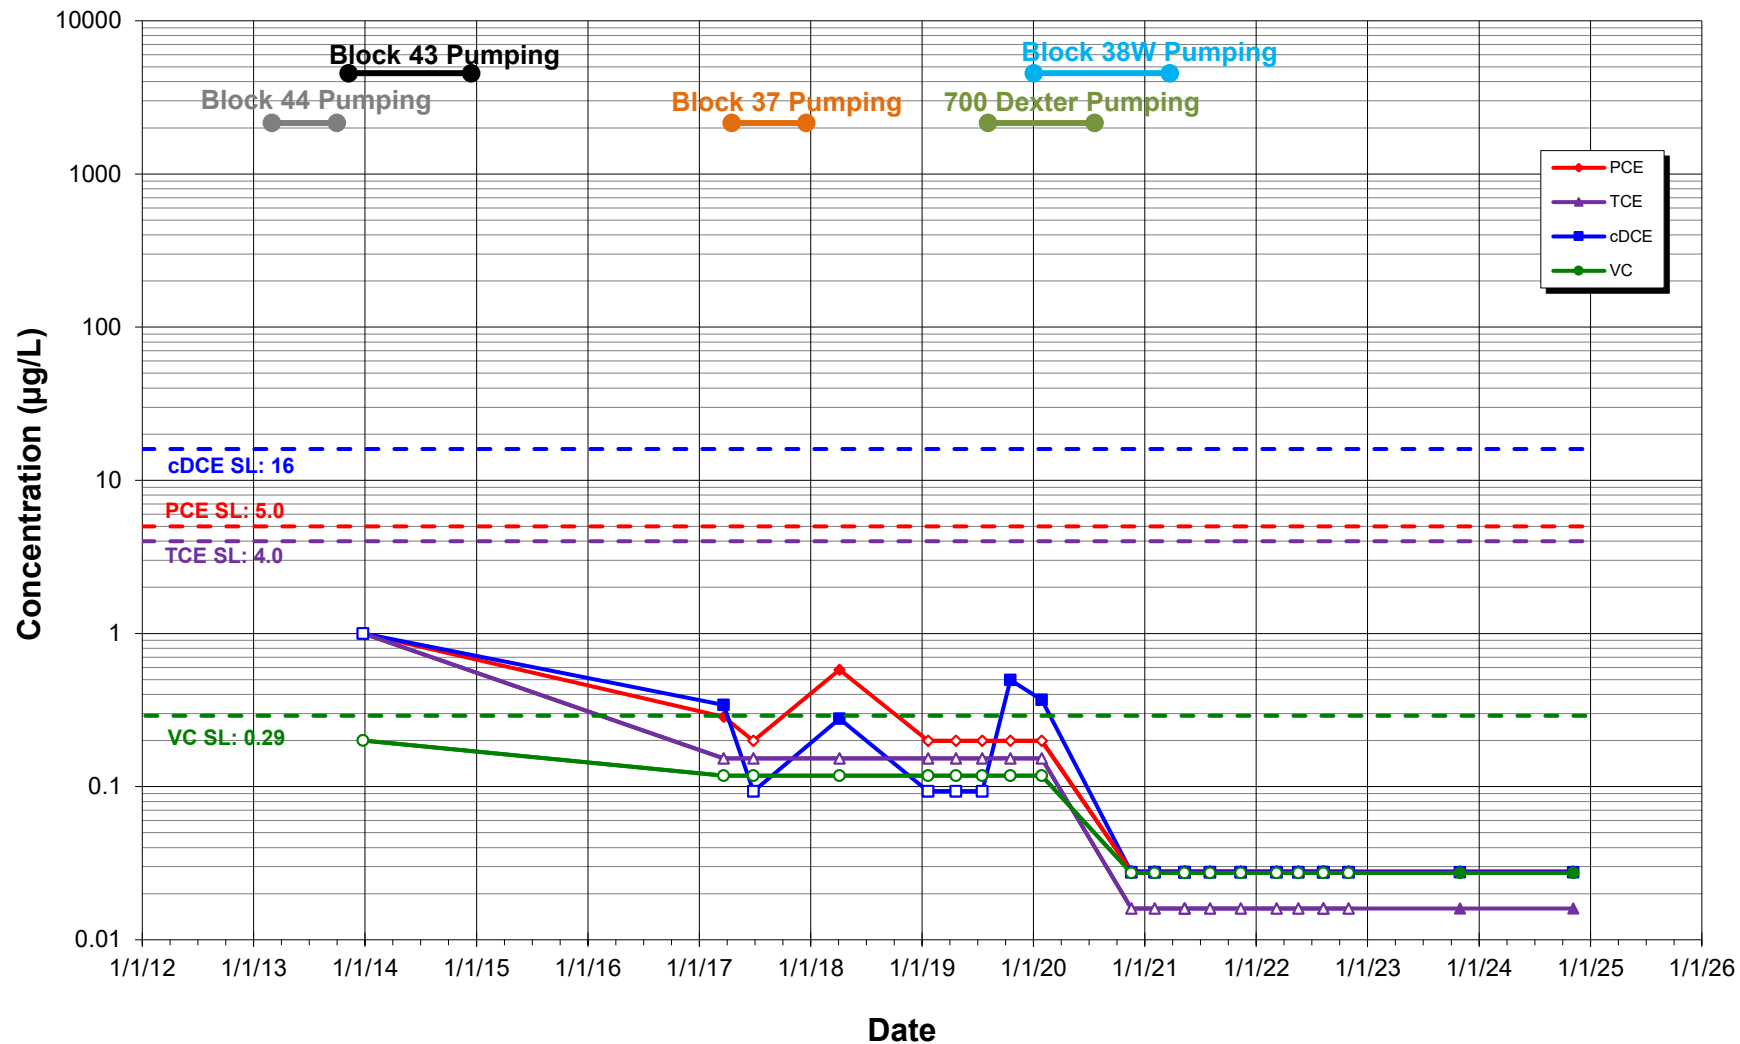
**Concentration vs Time**  
**MW125 (28.6 to 13.6 feet NAVD), Valley St ROW, N side**  
**American Linen Supply Co Dexter Ave Site**

1. All results detected below the laboratory MDLs are shown as hollow data points.
2. Preliminary Cleanup Levels: PCE = 5 µg/L, TCE = 4 µg/L, cDCE = 16 µg/L, and VC = 0.29 µg/L.

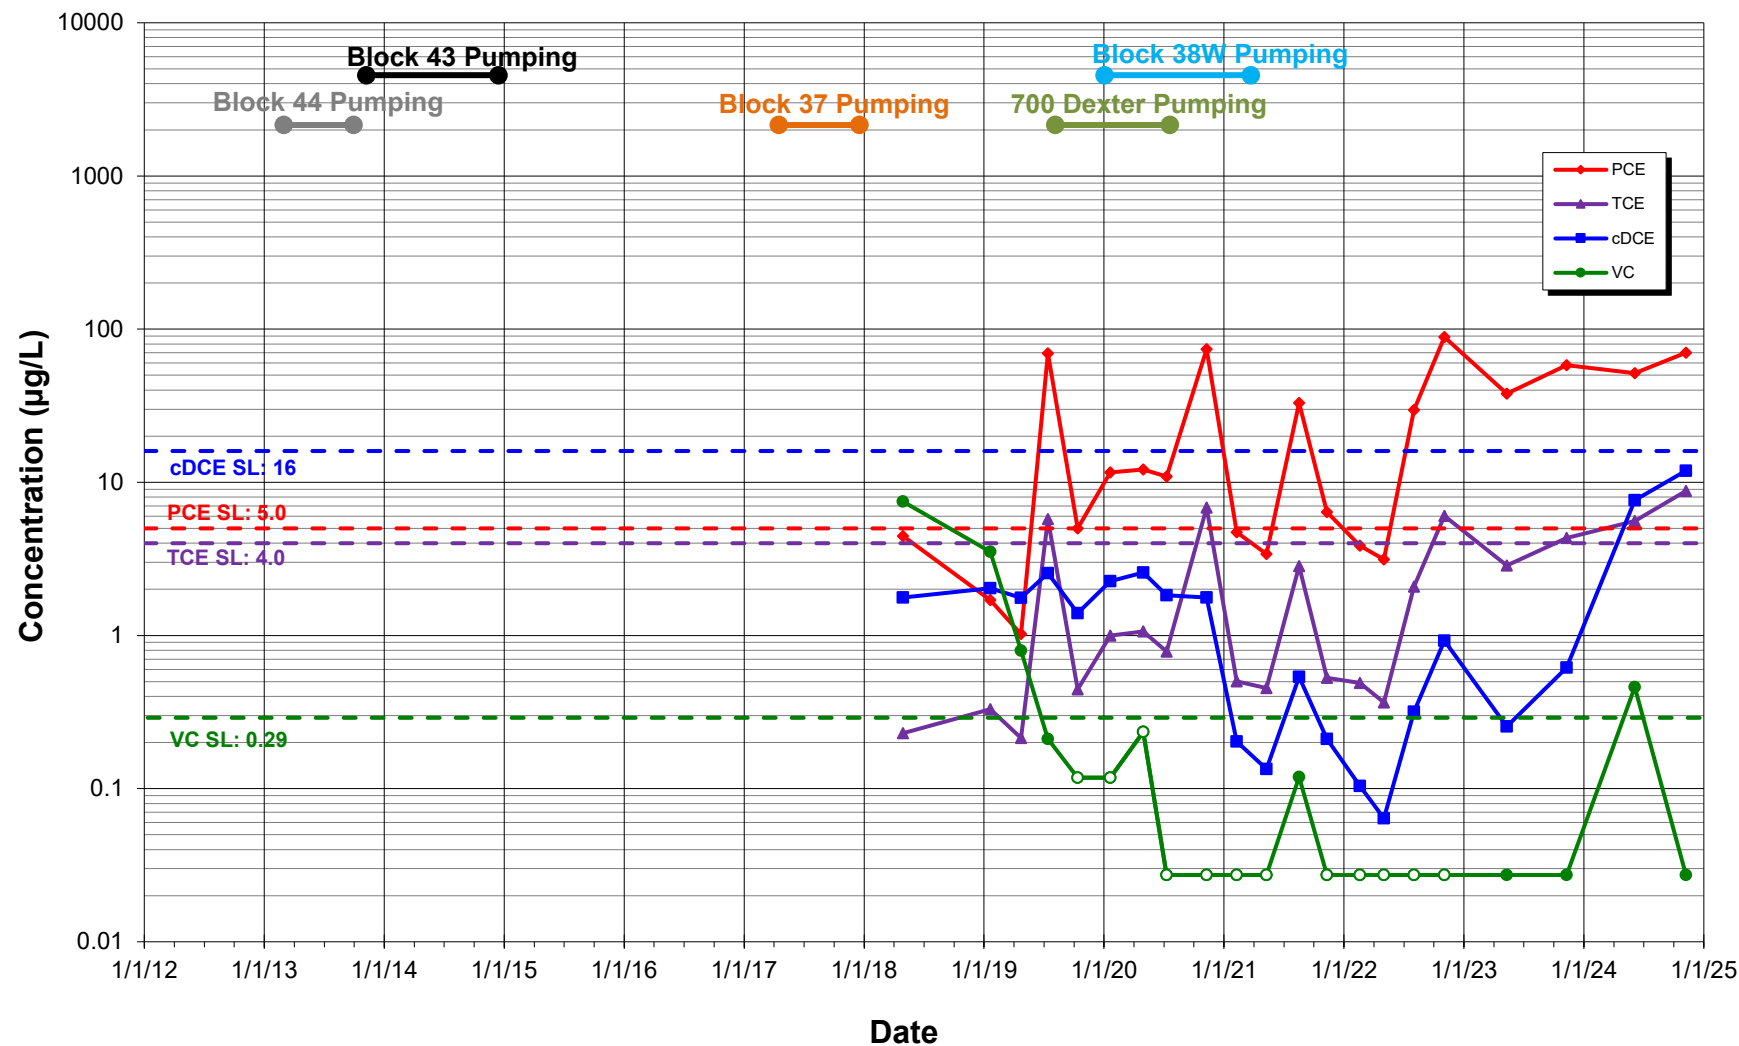
**Concentration vs Time**  
**MW-154 (27.8 to 17.9 feet NAVD), Roy St ROW, S side**  
**American Linen Supply Co-Dexter Ave Site**

1. All results detected below the laboratory MDLs are shown as hollow data points.
2. Preliminary Cleanup Levels: PCE = 5 µg/L, TCE = 4 µg/L, cDCE = 16 µg/L, and VC = 0.29 µg/L.

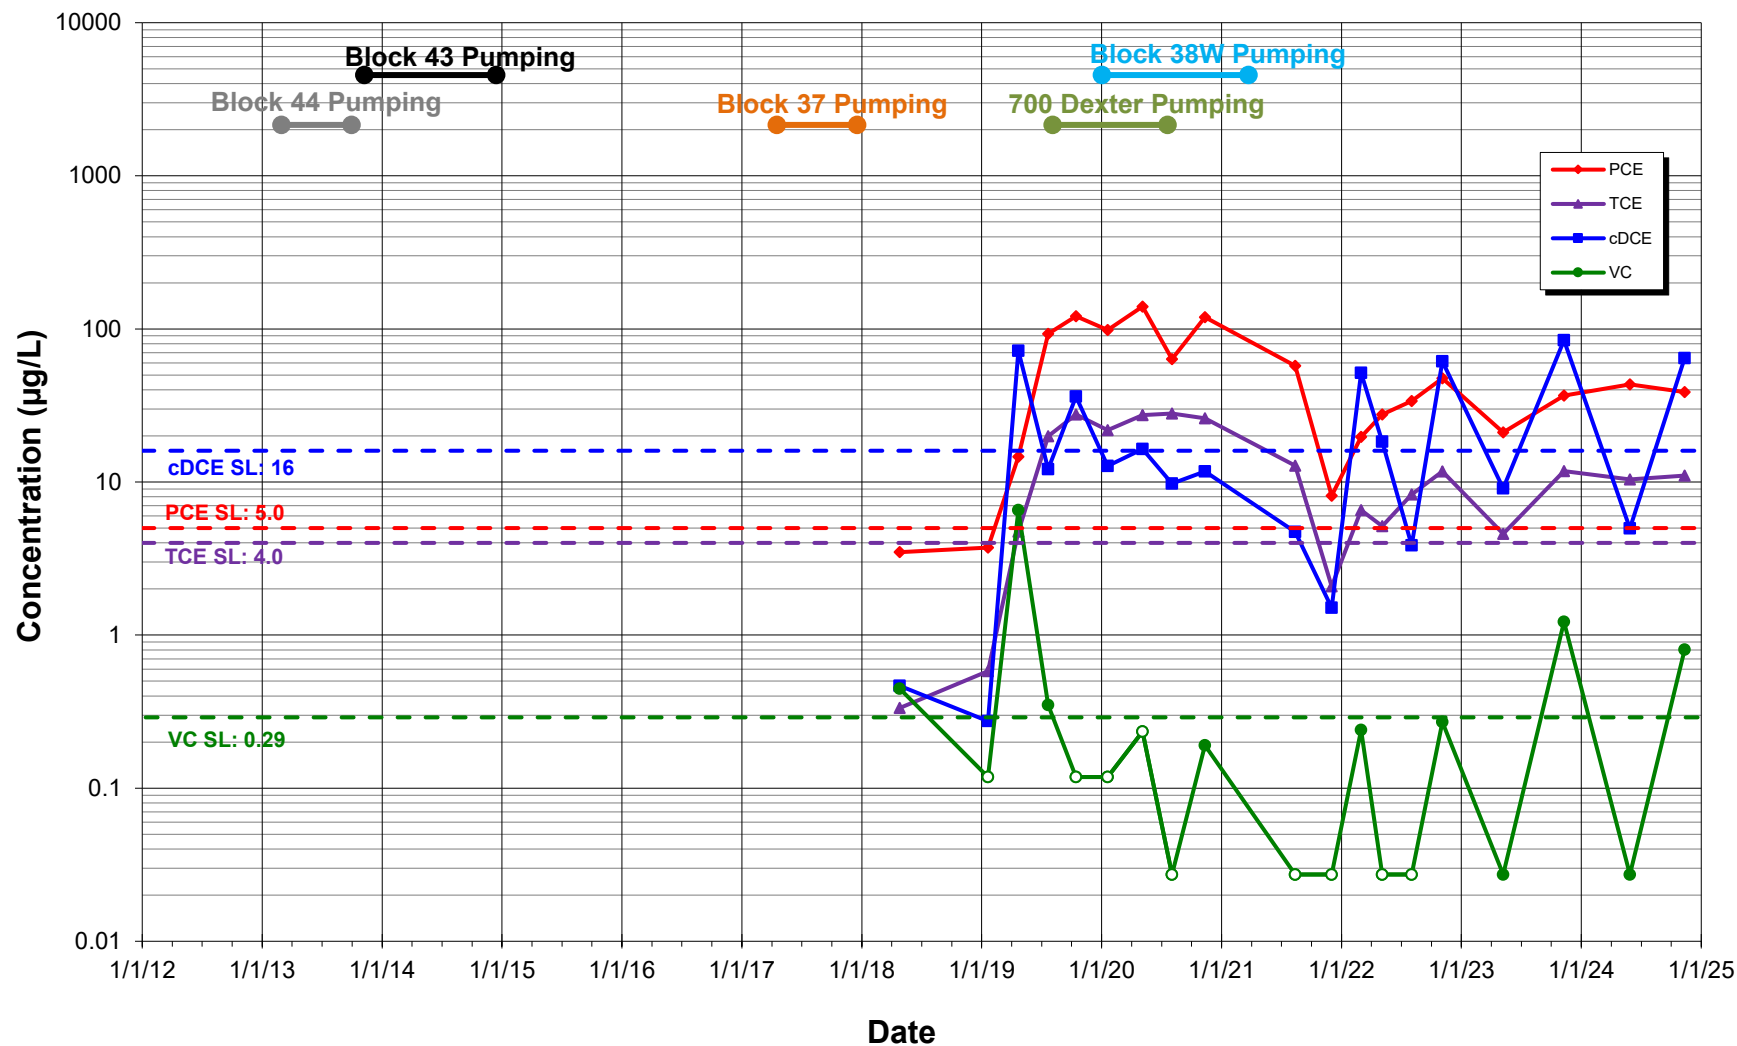
**Concentration vs Time**  
**MW-155 (24.4 to 14.4 feet NAVD), Roy St ROW, S side**  
**American Linen Supply Co Dexter Ave Site**

1. All results detected below the laboratory MDLs are shown as hollow data points.
2. Preliminary Cleanup Levels: PCE = 5 µg/L, TCE = 4 µg/L, cDCE = 16 µg/L, and VC = 0.29 µg/L.

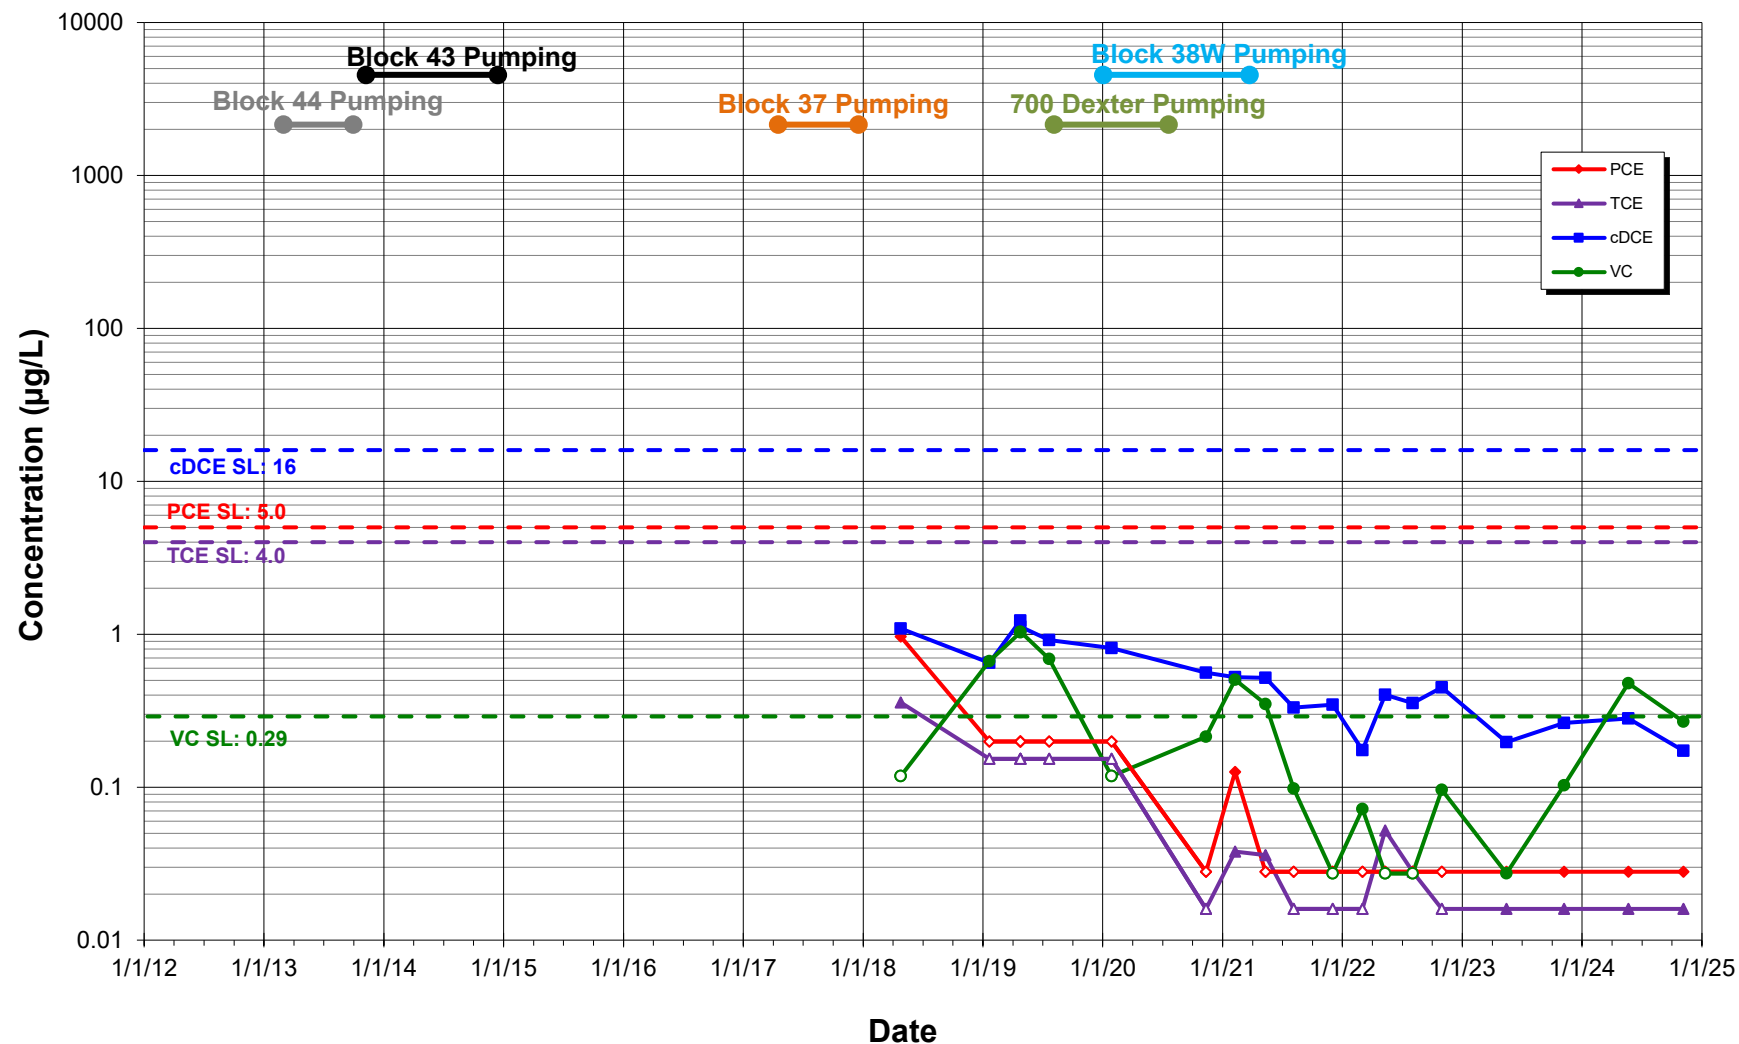
**Concentration vs Time**  
**MW-159 (22.9 to 12.9 feet NAVD), 8th Ave N, E side**  
**American Linen Supply Co Dexter Ave Site**

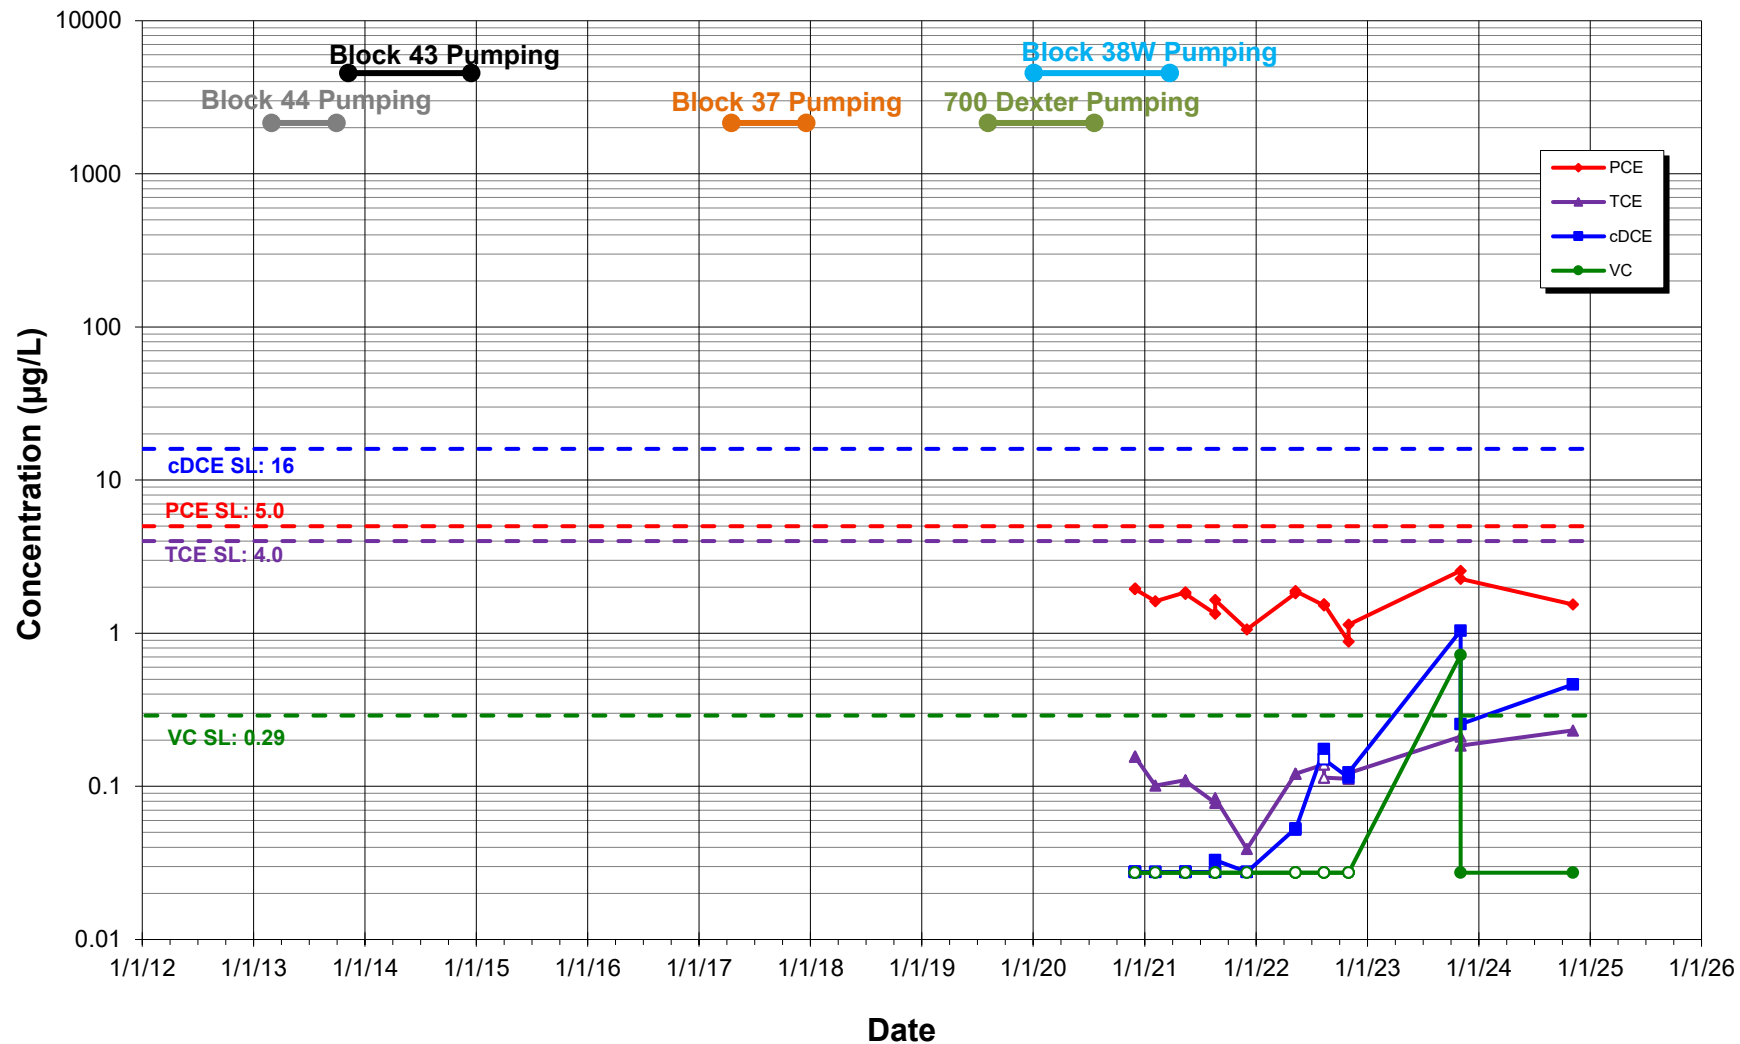
**Concentration vs Time**  
**MW-301 (35.6 to 25.6 feet NAVD), Valley St ROW, S side**  
**American Linen Supply Co Dexter Ave Site**

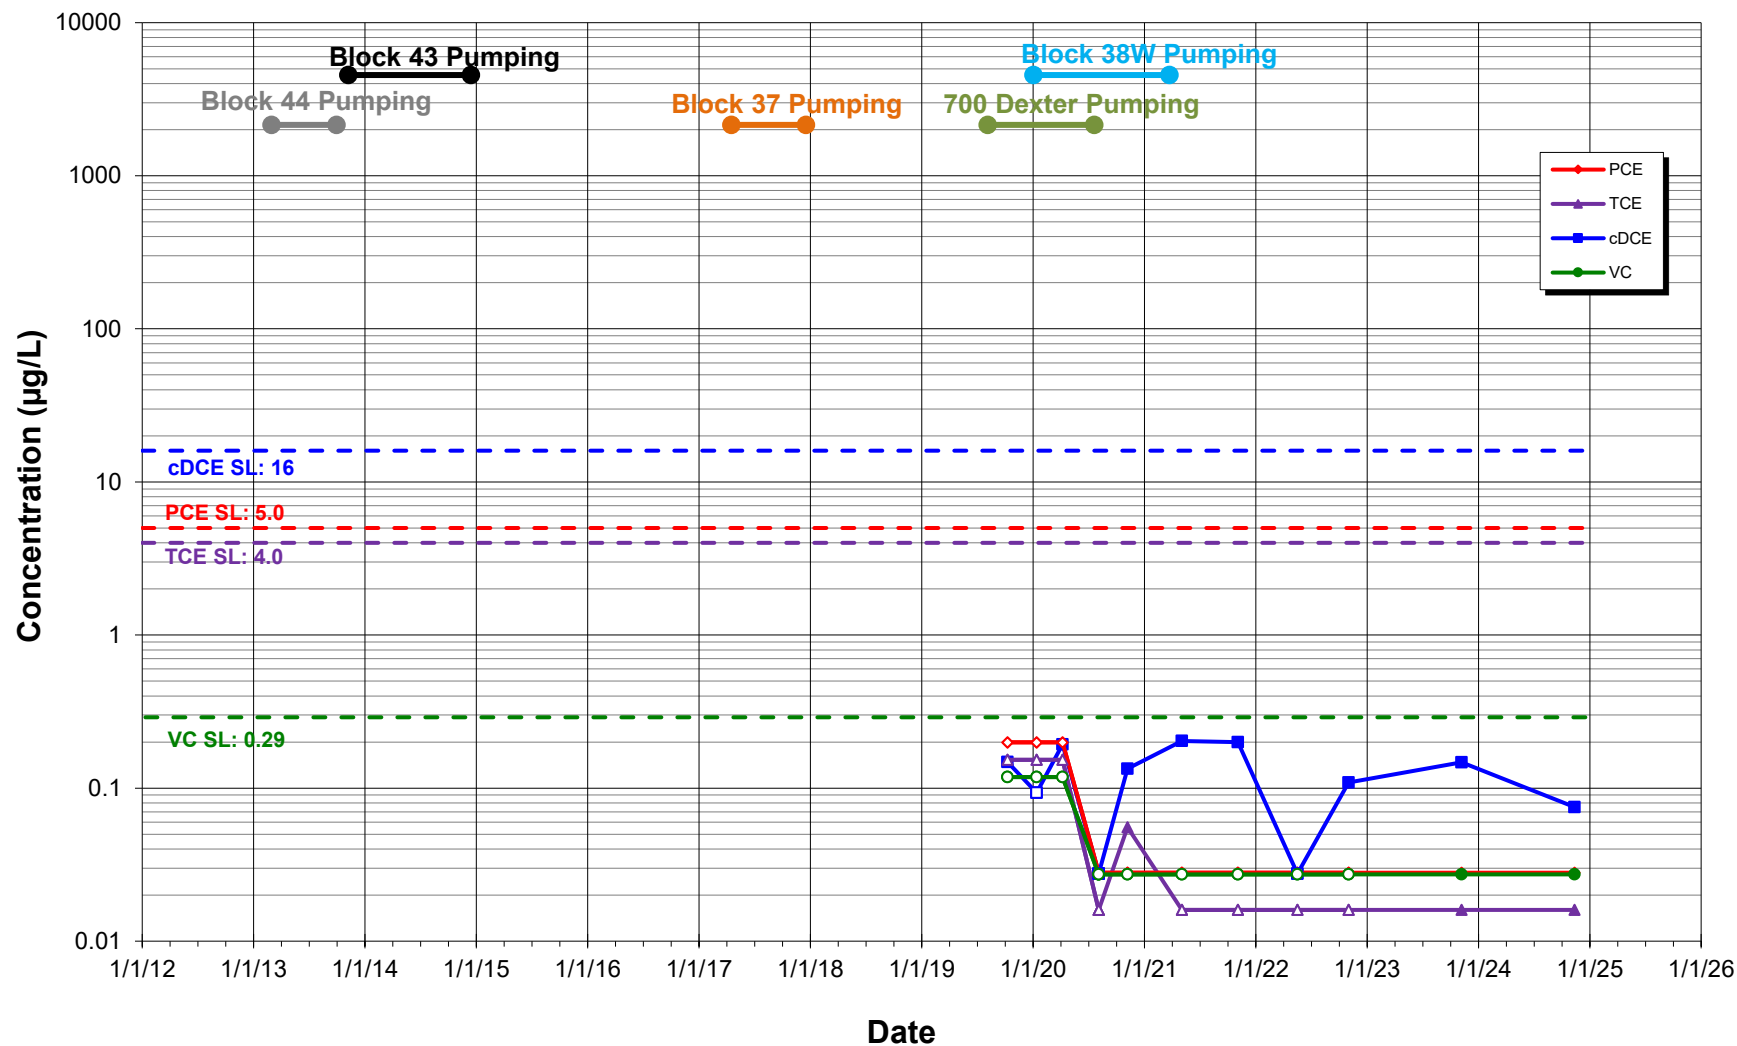
**Concentration vs Time**  
**MW-310 (19.2 to 9.2 feet NAVD), Alley E of Seattle Roy Aloha Shops**  
**American Linen Supply Co Dexter Ave Site**

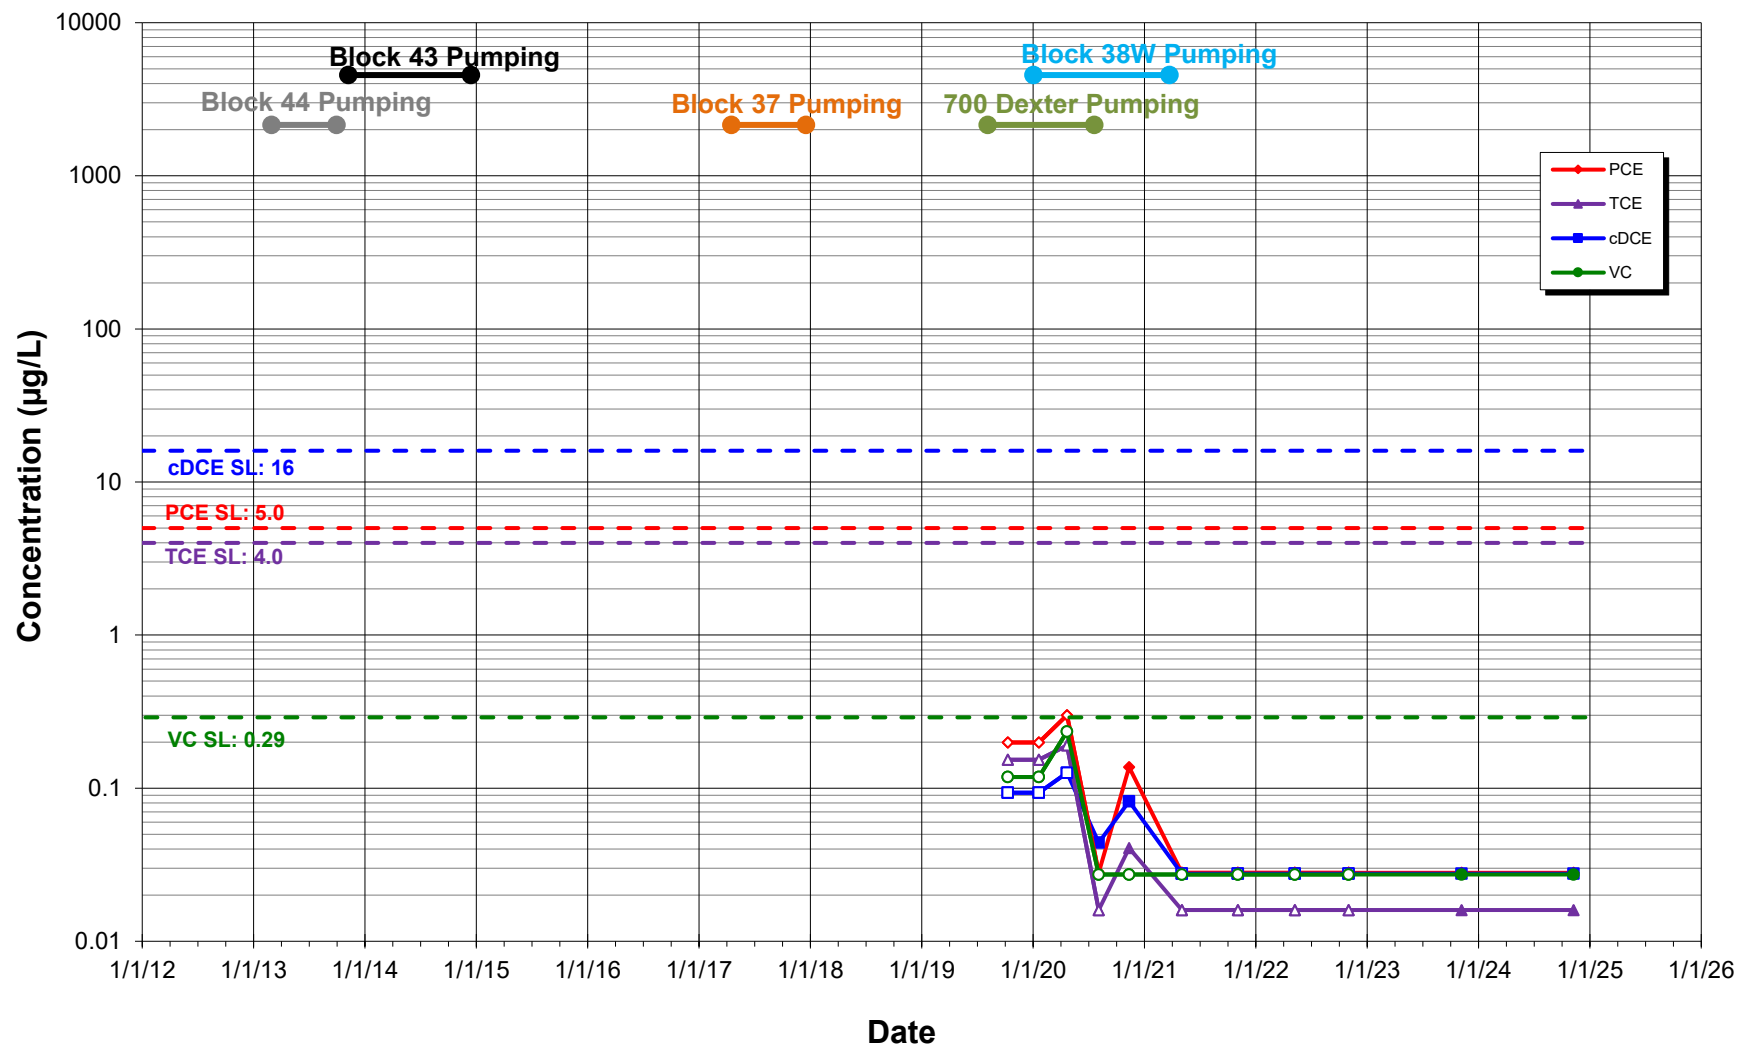
**Concentration vs Time**  
**MW-312 (19.9 to 9.9 feet NAVD), Alley E of Seattle Roy Aloha Shops**  
**American Linen Supply Co Dexter Ave Site**

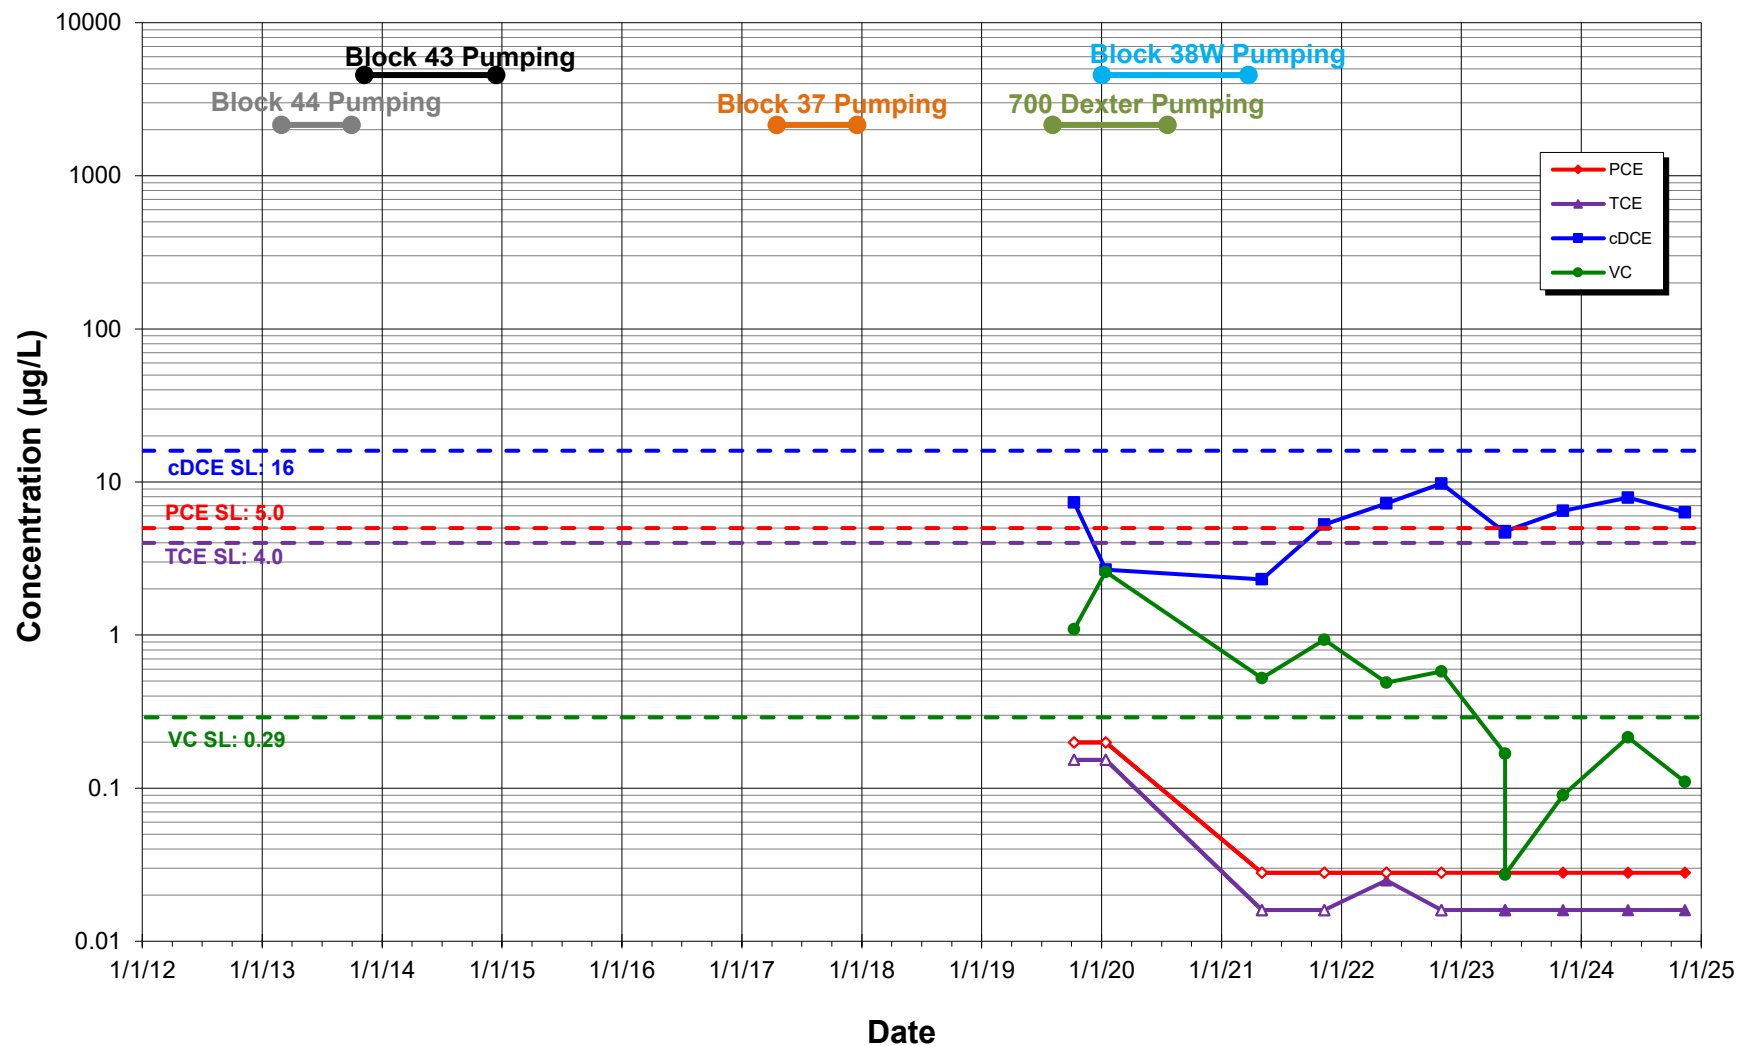
**Concentration vs Time**  
**MW-313 (20.4 to 10.4 feet NAVD), Alley E of Seattle Roy Aloha Shops**  
**American Linen Supply Co Dexter Ave Site**

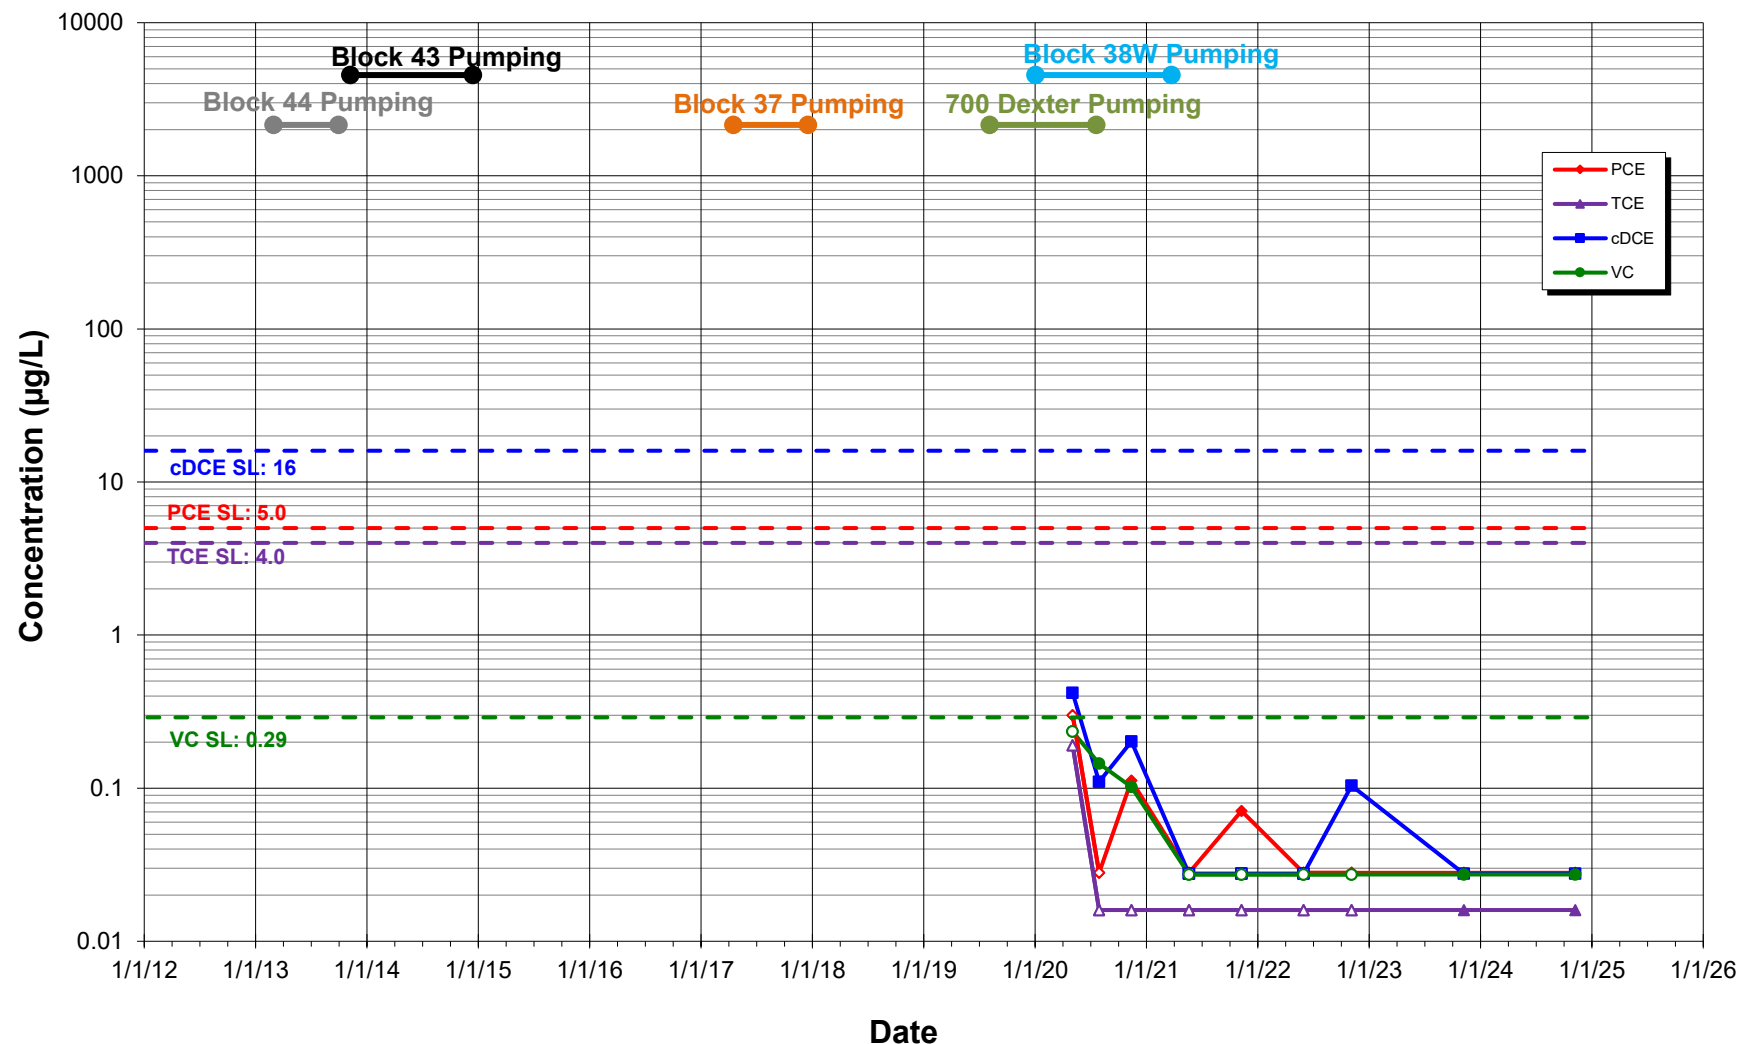
**Concentration vs Time**  
**MW-332 (16.0 to 6.0 feet NAVD), Roy St ROW, N side**  
**American Linen Supply Co Dexter Ave Site**

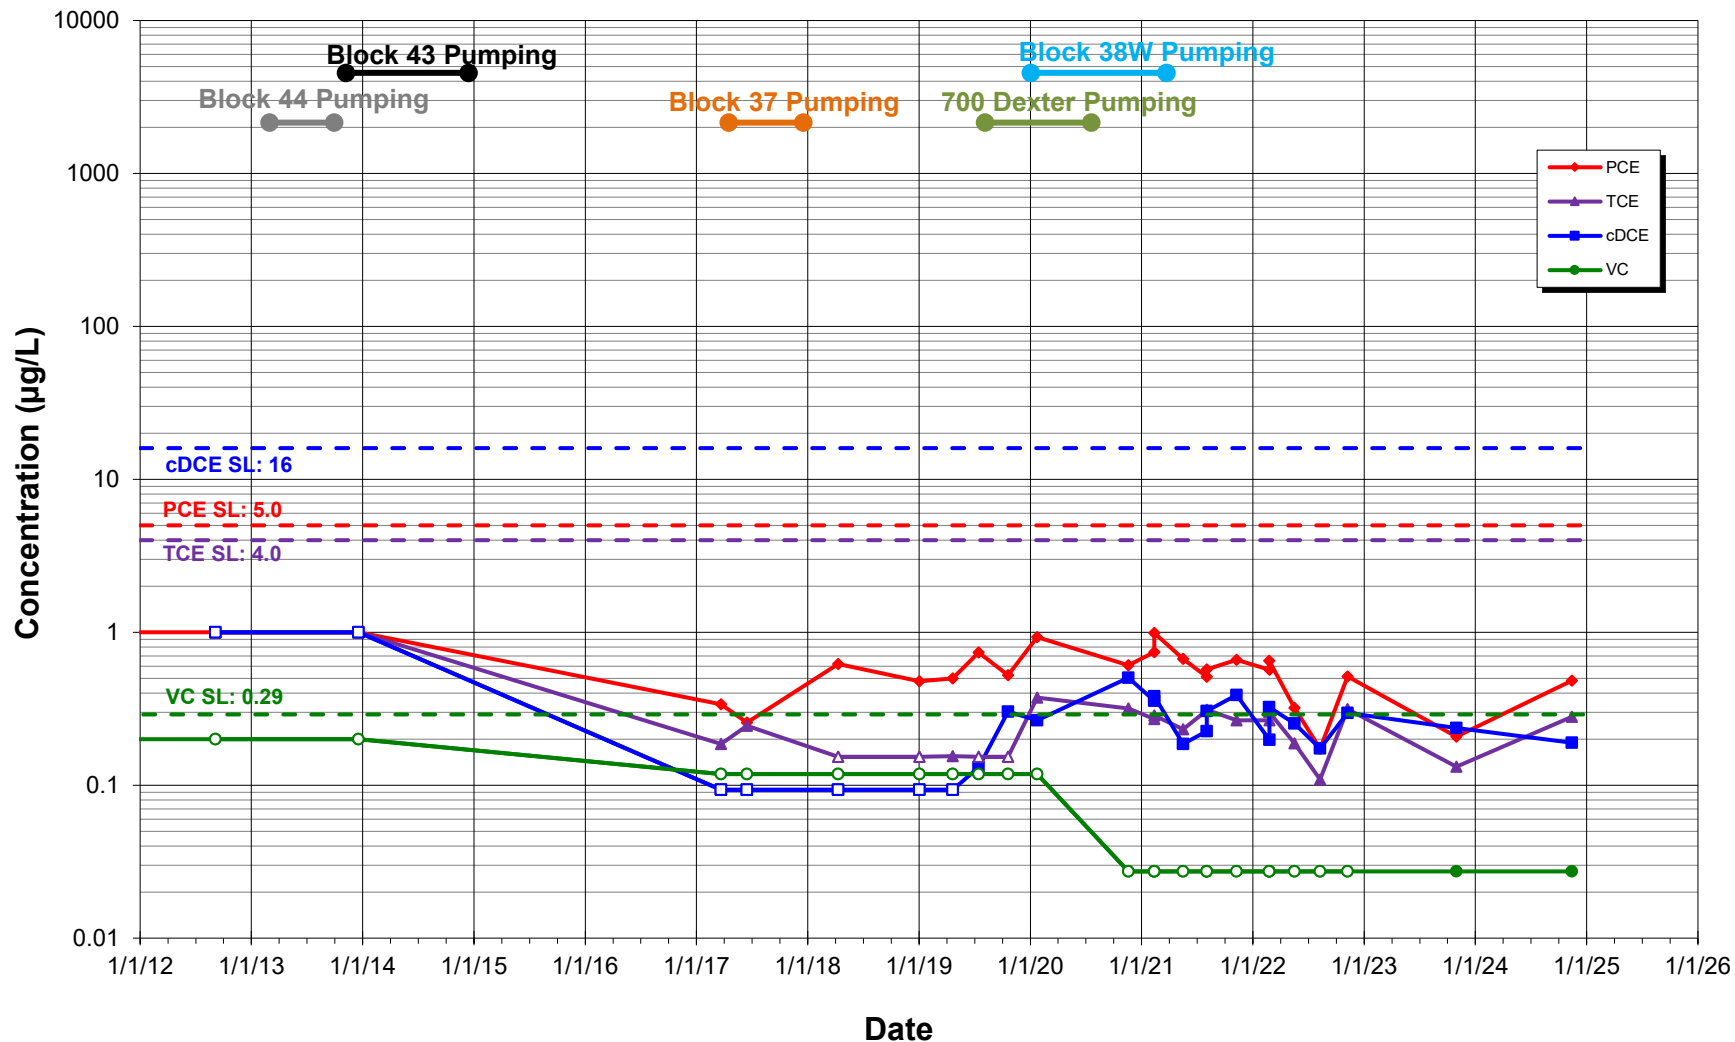
**Concentration vs Time**  
**R-MW5 (42.4 to 27.4 feet NAVD), Dexter Ave N ROW, E side**  
**American Linen Supply Co Dexter Ave Site**

1. All results detected below the laboratory MDLs are shown as hollow data points.
2. Preliminary Cleanup Levels: PCE = 5 µg/L, TCE = 4 µg/L, cDCE = 16 µg/L, and VC = 0.29 µg/L.
