**Attachment A**  
**Well Completion Table**  
**American Linen Supply Co Dexter Ave Site**  
**700 Dexter Avenue North**  
**Seattle, Washington**

**ATTACHMENT B**

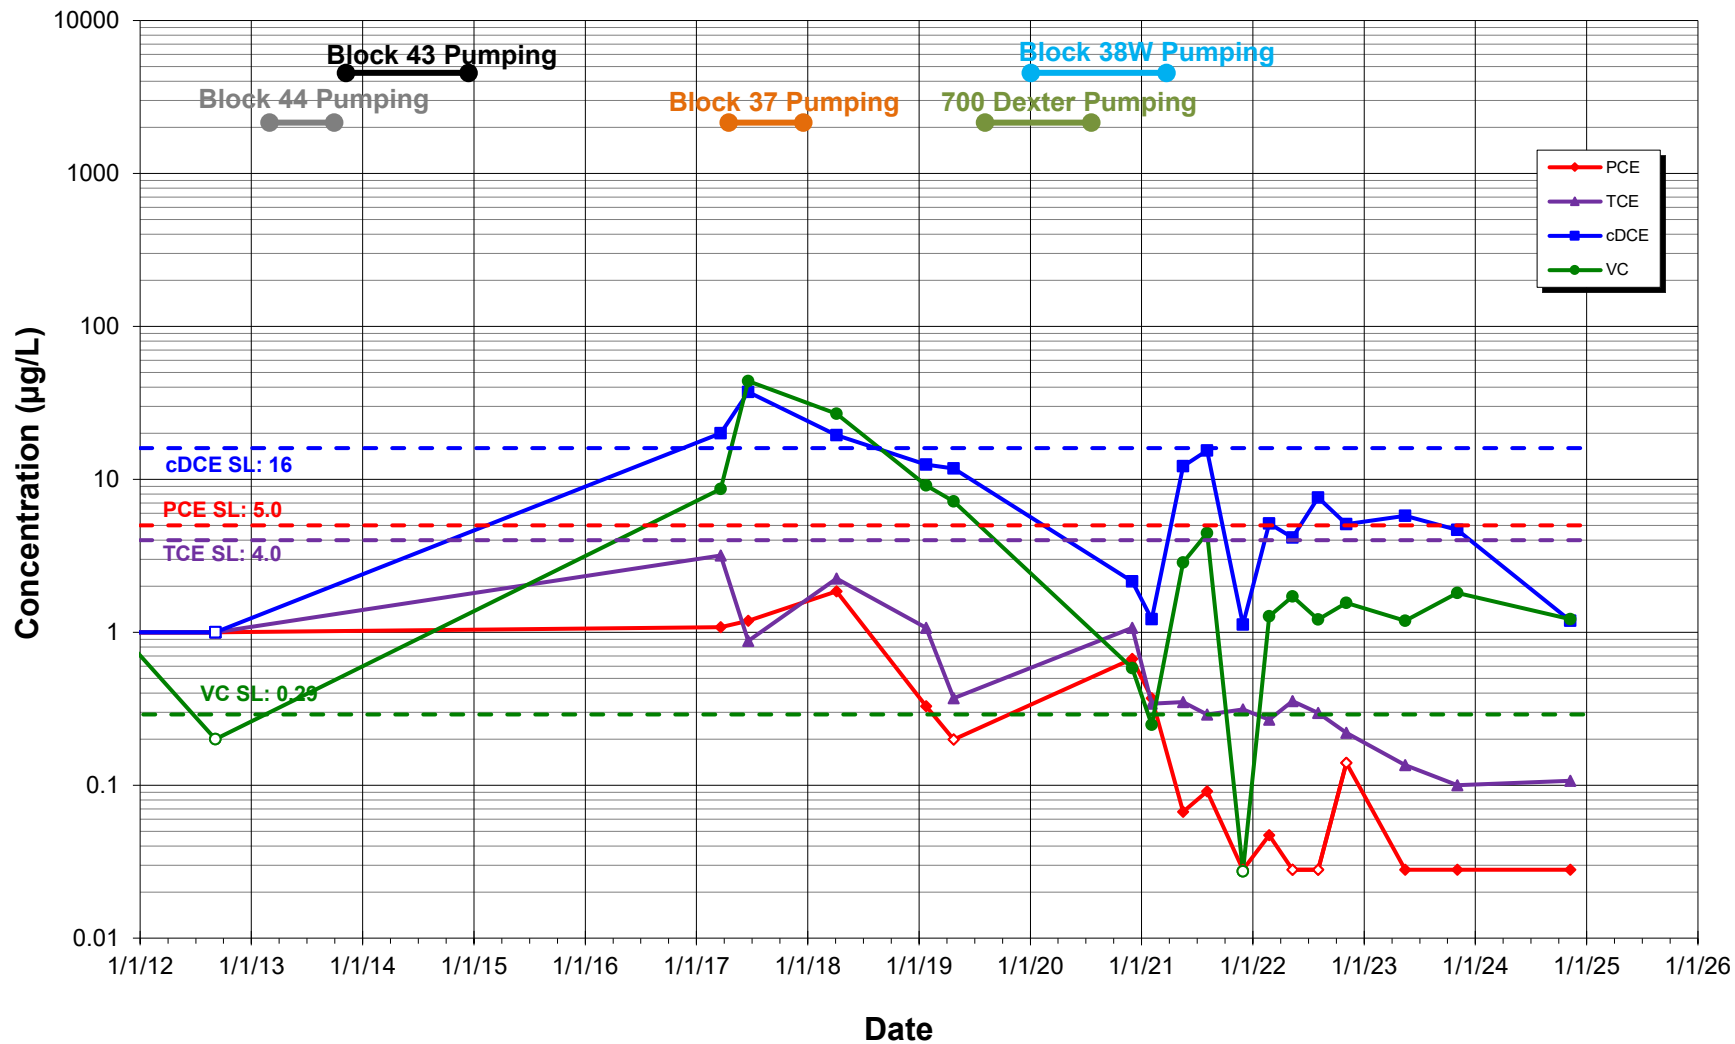
**Concentration vs Time**  
**R-MW6 (33.3 to 23.3 feet NAVD), 8th Ave N ROW, W side**  
**American Linen Supply Co Dexter Ave Site**

1. All results detected below the laboratory MDLs are shown as hollow data points.
2. Preliminary Cleanup Levels: PCE = 5 µg/L, TCE = 4 µg/L, cDCE = 16 µg/L, and VC = 0.29 µg/L.

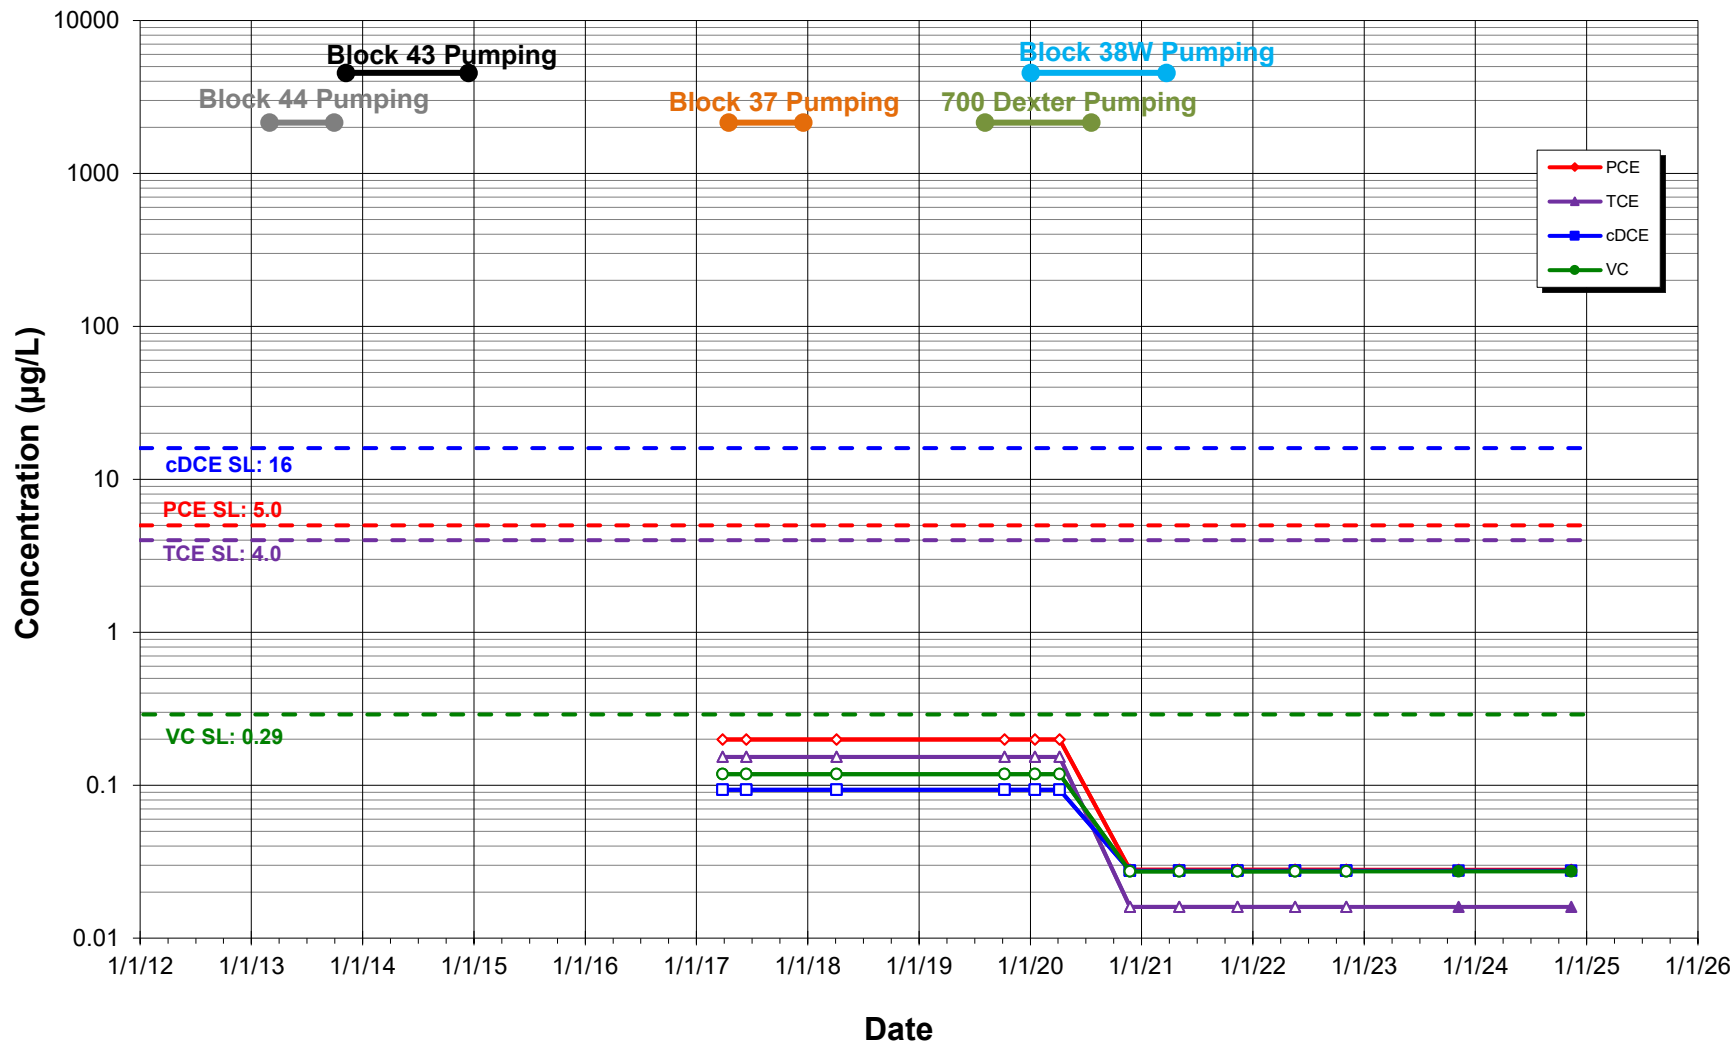
**Concentration vs Time**  
**SCL-MW101 (25.5 to 15.5 feet NAVD), Alley E of Seattle Roy Aloha Shops**  
**American Linen Supply Co Dexter Ave Site**

1. All results detected below the laboratory MDLs are shown as hollow data points.
2. Preliminary Cleanup Levels: PCE = 5 µg/L, TCE = 4 µg/L, cDCE = 16 µg/L, and VC = 0.29 µg/L.

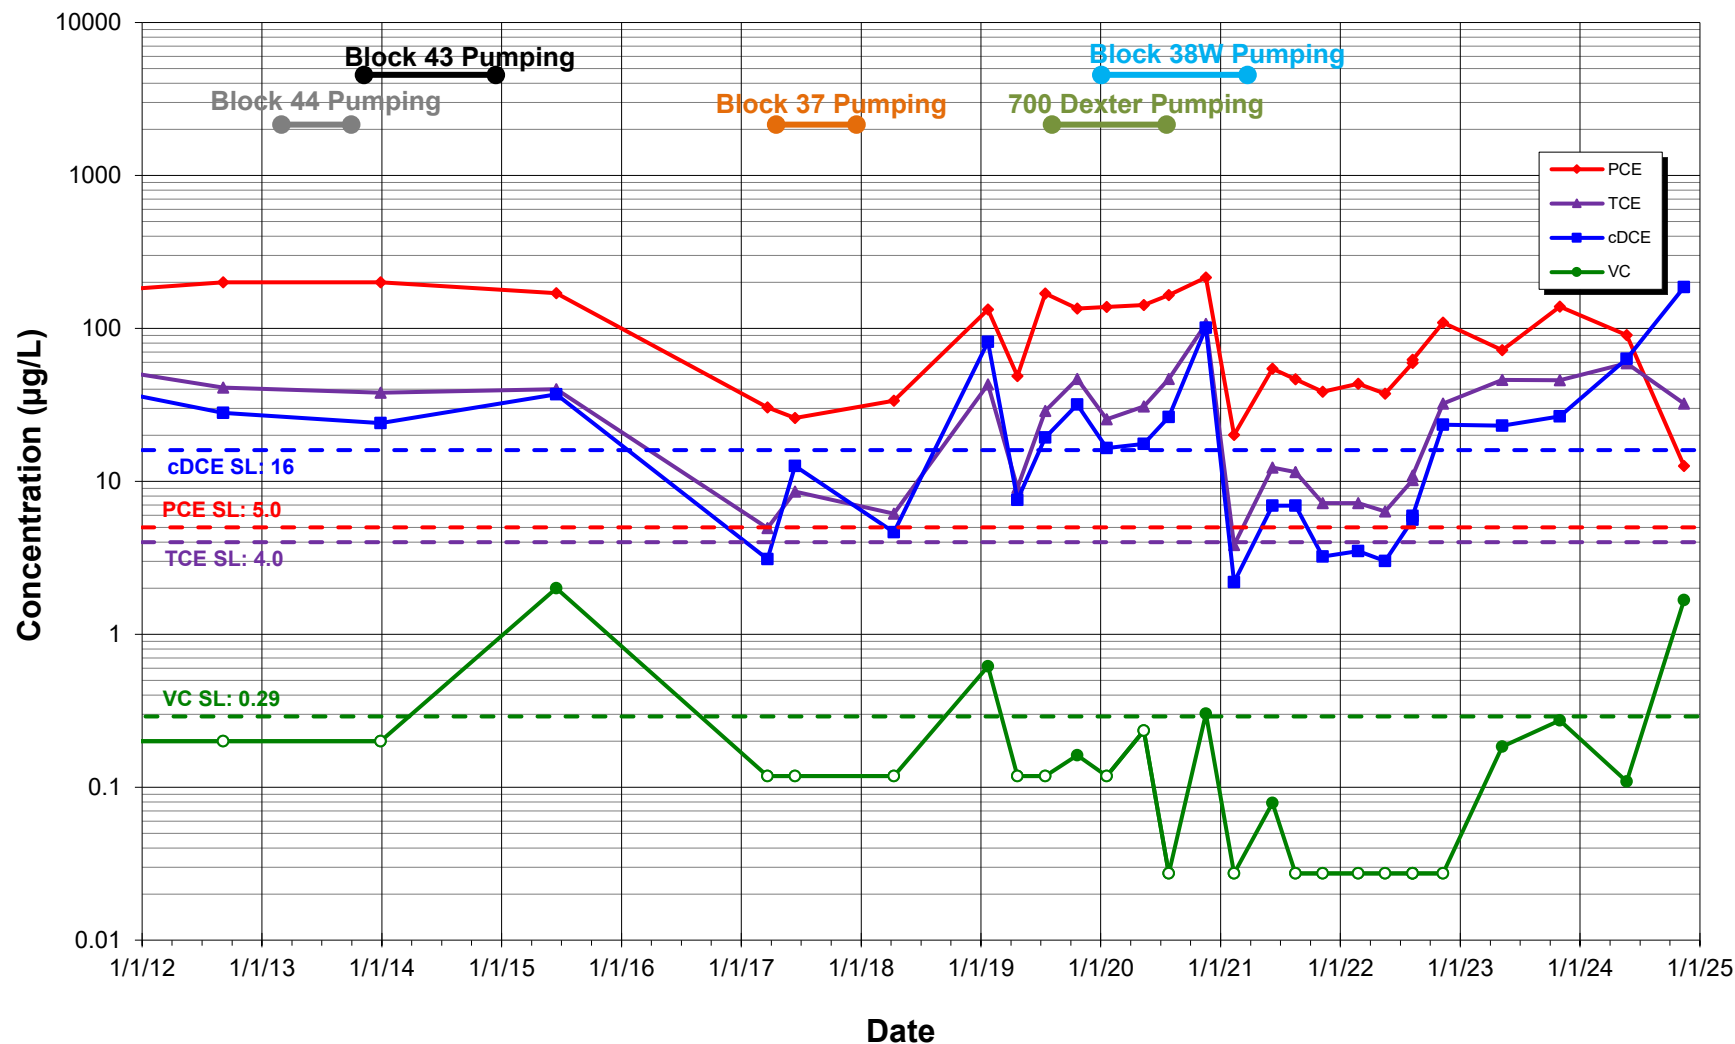
**Concentration vs Time**  
**BB-8 (14.0 to 4.0 feet NAVD), Roy St ROW, S side**  
**American Linen Supply Co Dexter Ave Site**

- 1) All results detected below the laboratory MDLs are shown as hollow data points.
- 2) Preliminary Screening Levels: PCE = 5.0 µg/L, TCE = 4.0 µg/L, cDCE = 16 µg/L, and VC = 0.29 µg/L.

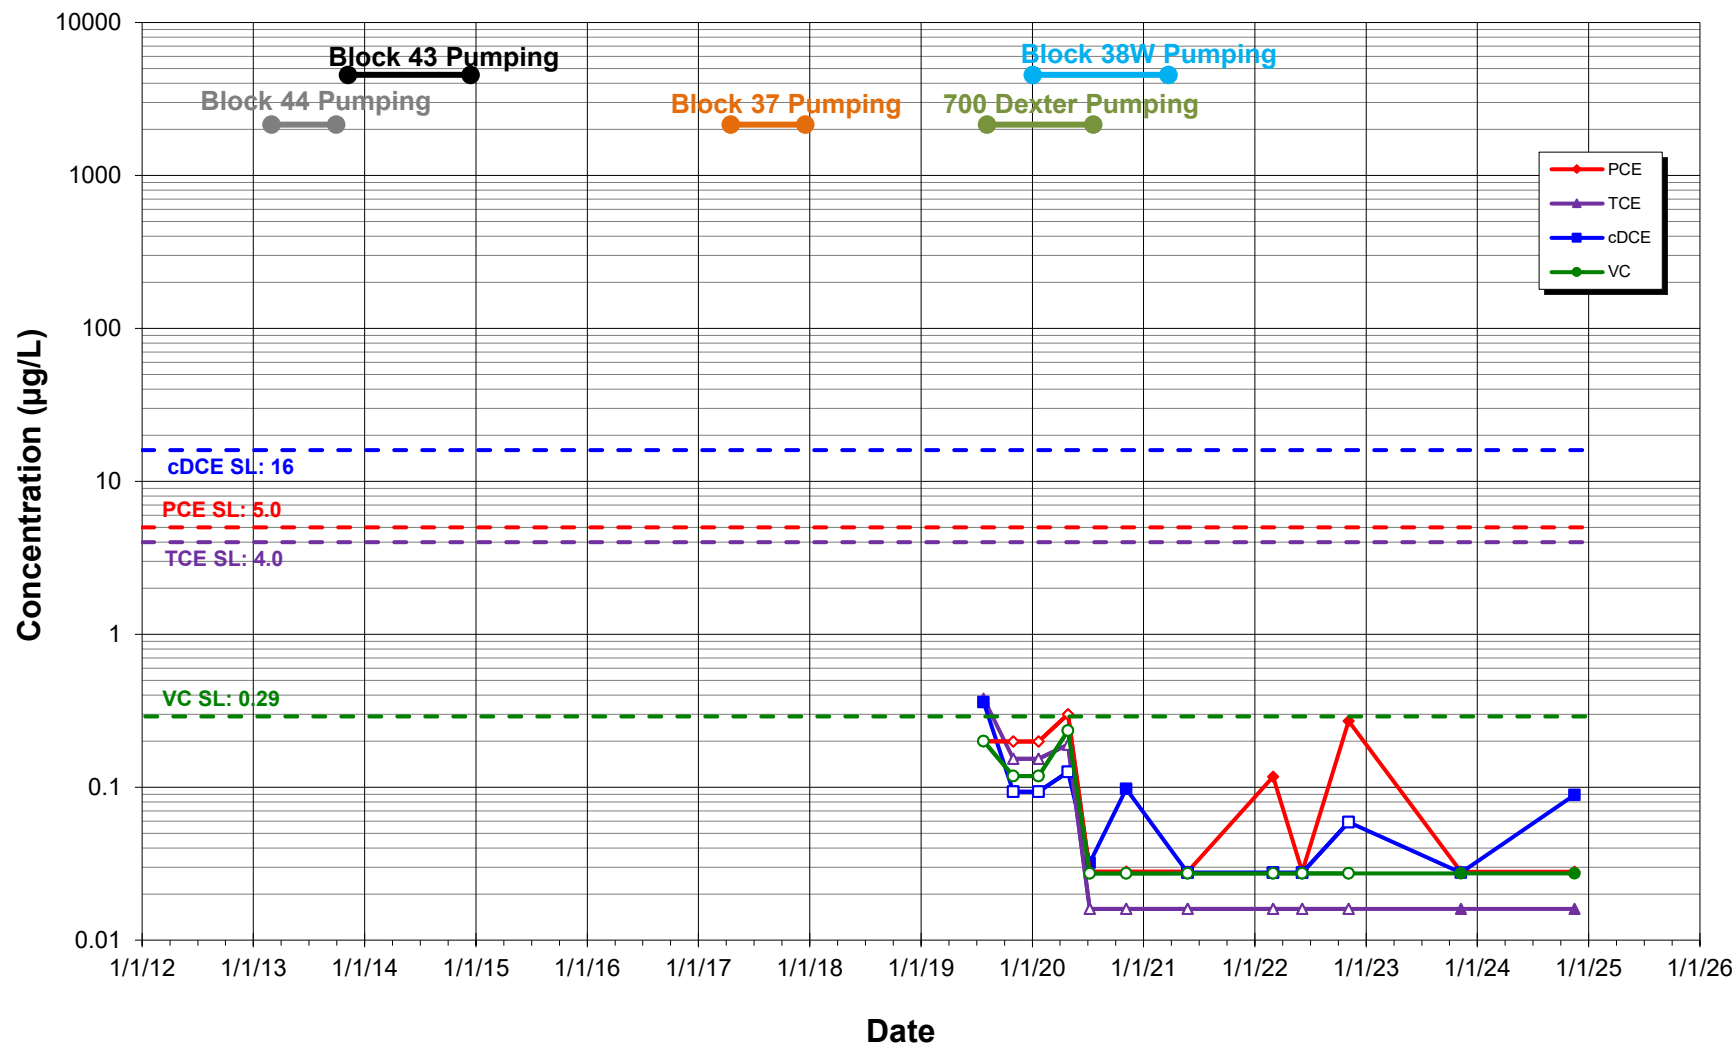
**Concentration vs Time**  
**FMW-142 (-4.2 to -9.6 feet NAVD), 9th Ave N ROW, E side**  
**American Linen Supply Co Dexter Ave Site**

- 1) All results detected below the laboratory MDLs are shown as hollow data points.
- 2) Preliminary Screening Levels: PCE = 5.0 µg/L, TCE = 4.0 µg/L, cDCE = 16 µg/L, and VC = 0.29 µg/L.

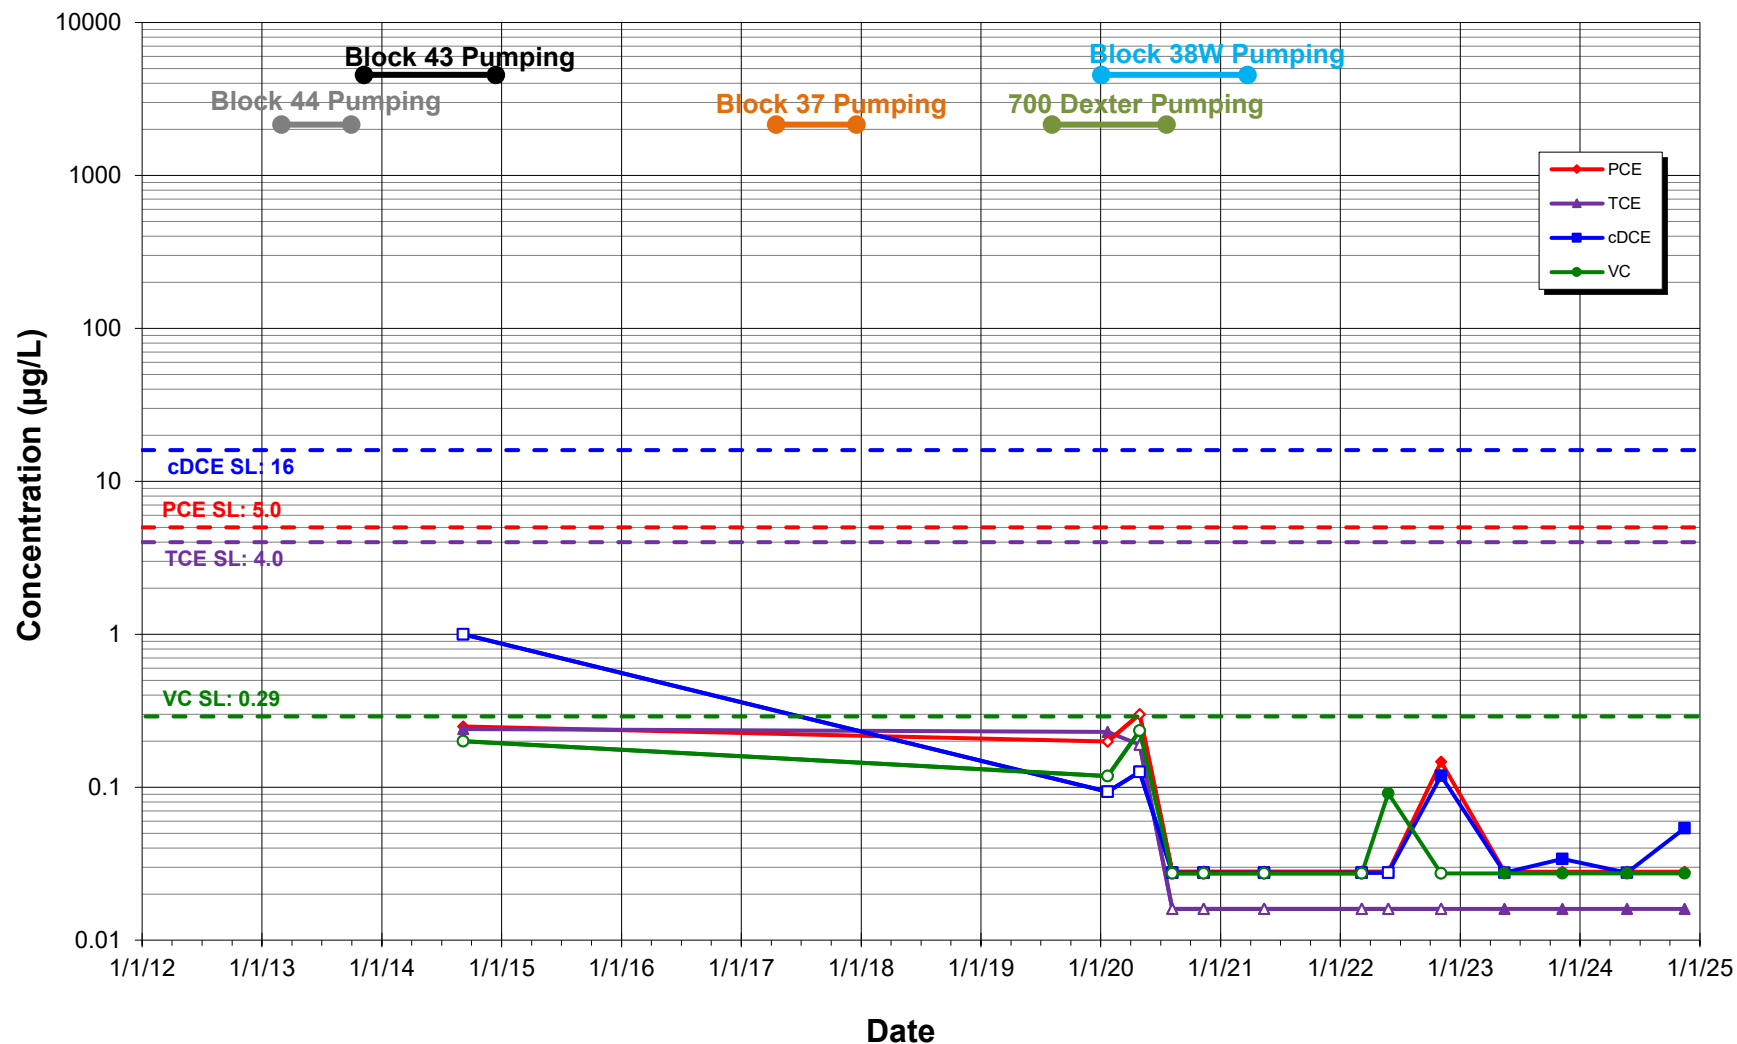
**Concentration vs Time**  
**GEI-MW-1 (-9.7 to -29.7 feet NAVD), Block 79 East, N end**  
**American Linen Supply Co Dexter Ave Site**

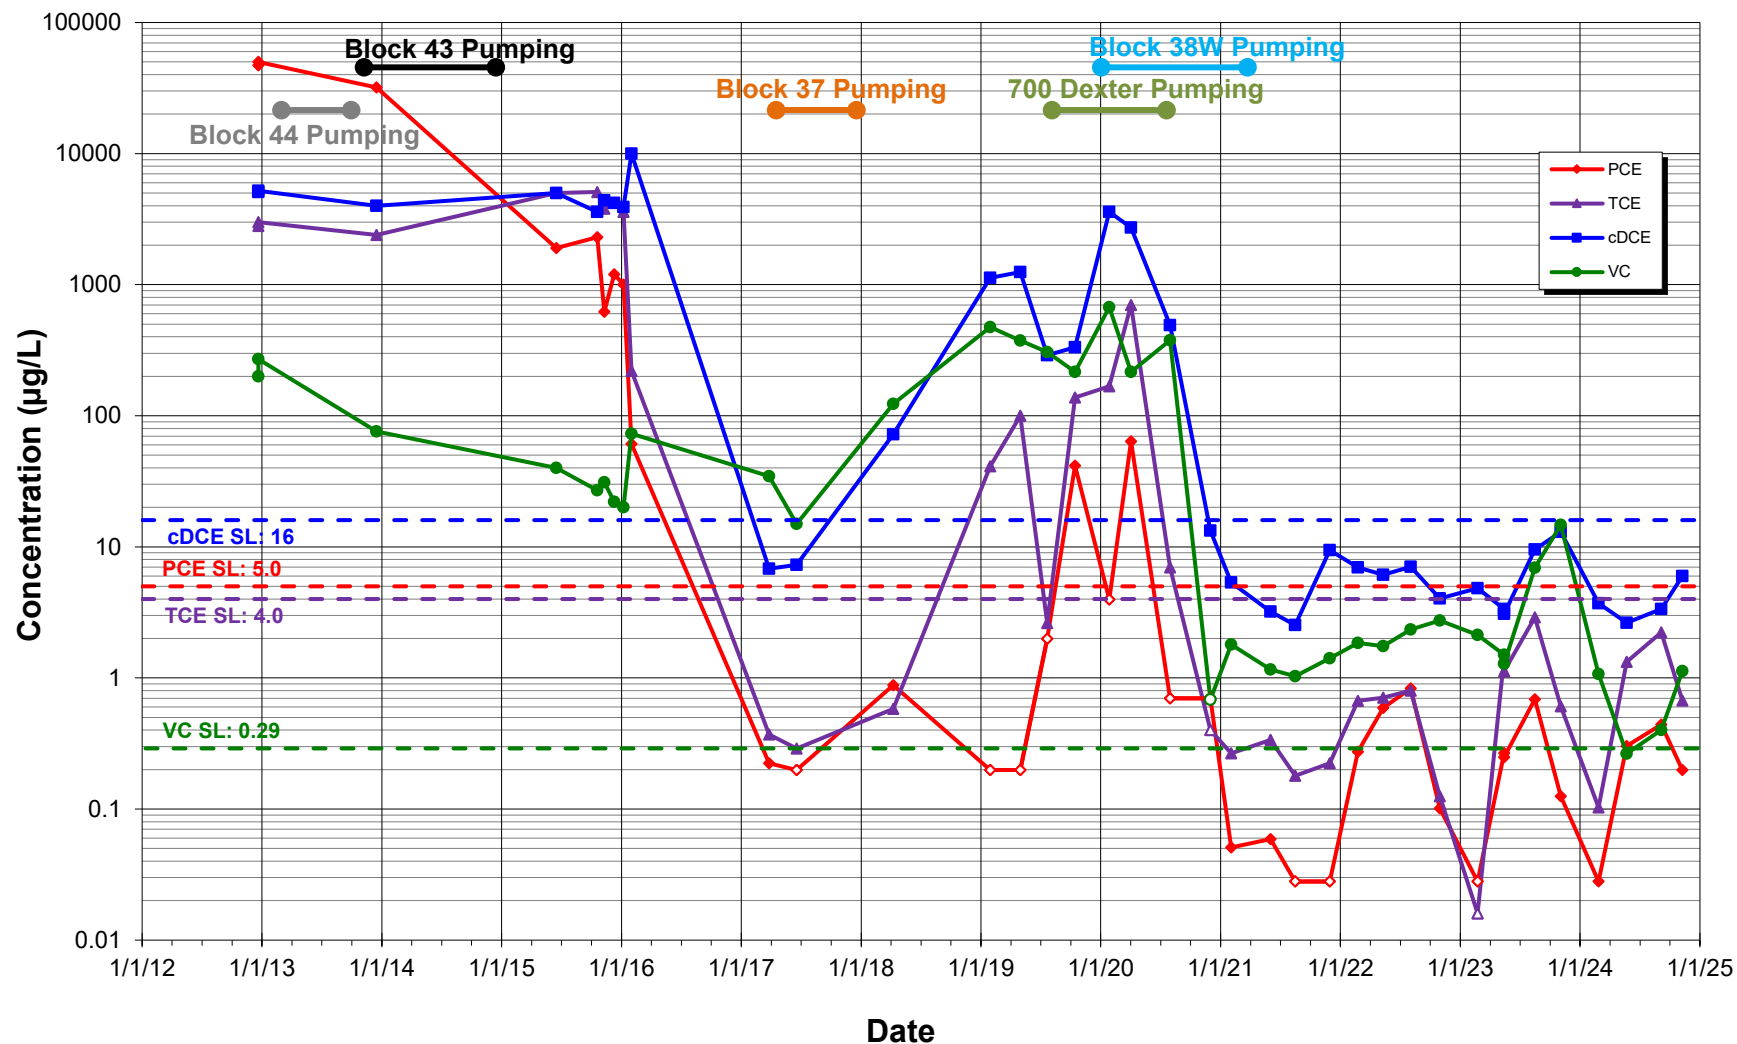
**Concentration vs Time**  
**MW107 (8.8 to -1.2 feet NAVD), 8th Ave N ROW, W side**  
**American Linen Supply Co Dexter Ave Site**

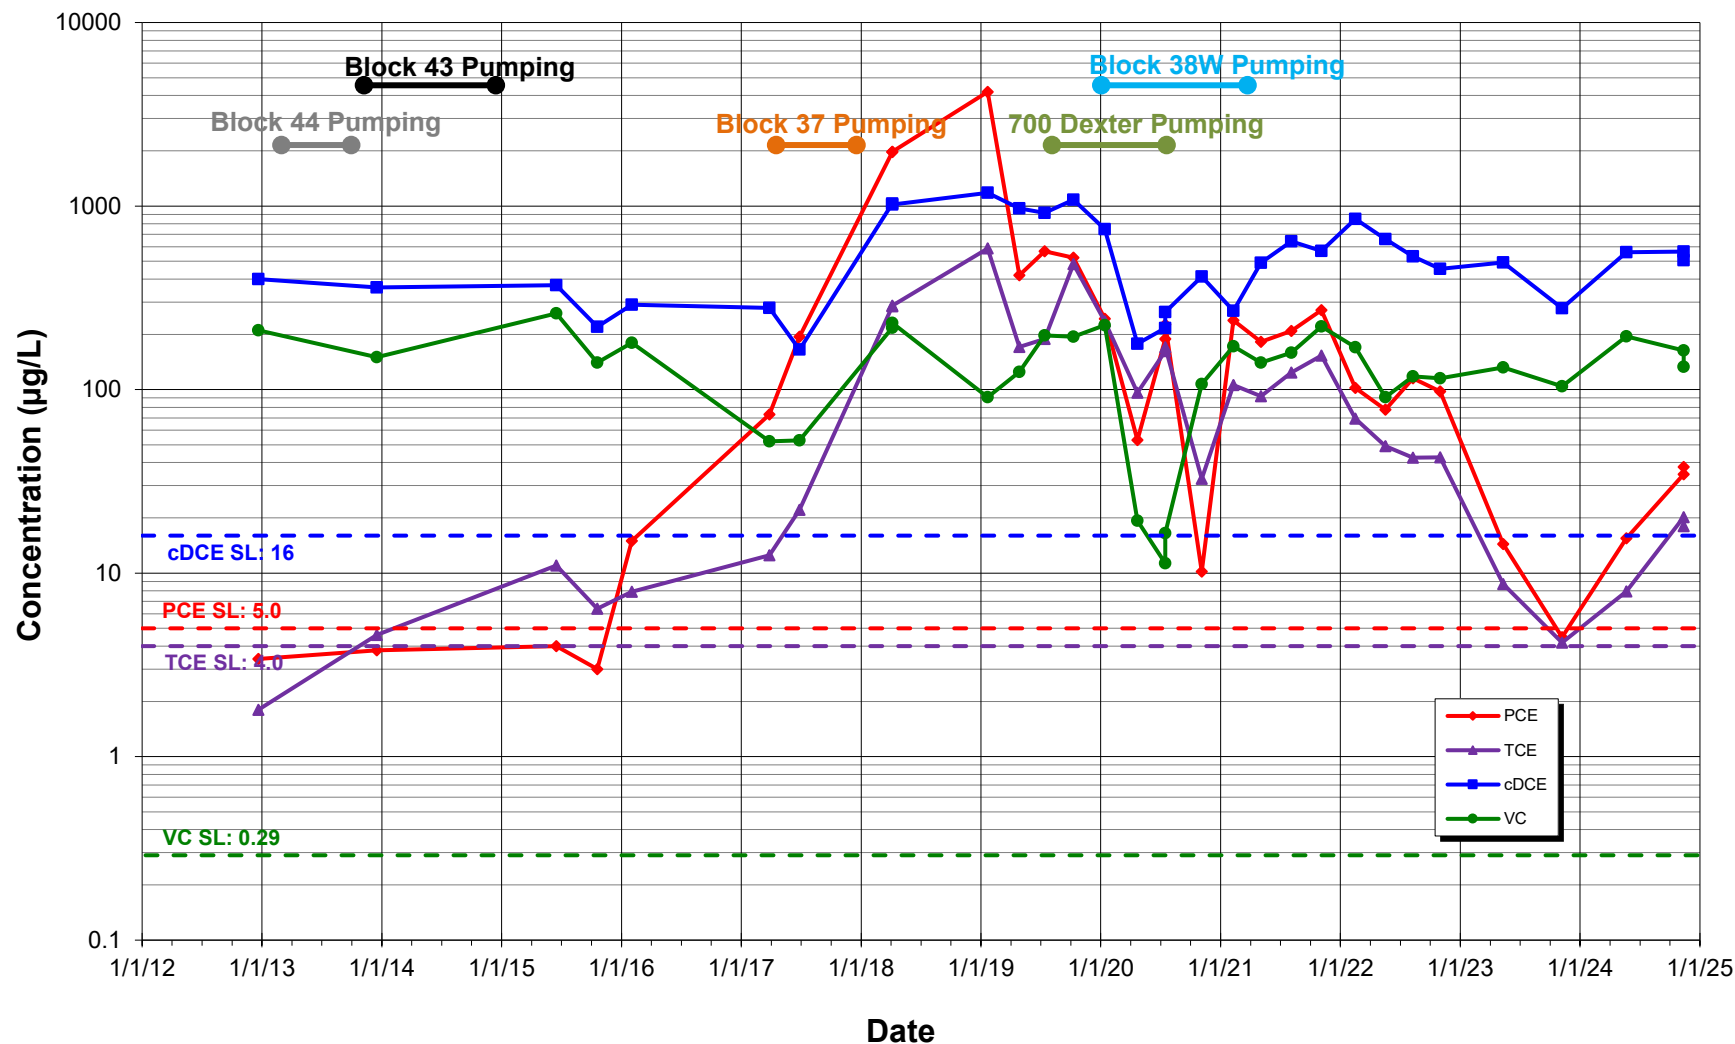
**Concentration vs Time**  
**MW108 (-7.2 to -17.2 feet NAVD), Alley E of Seattle Roy Aloho Shops**  
**American Linen Supply Co Dexter Ave Site**

- 1) All results detected below the laboratory MDLs are shown as hollow data points.
- 2) Preliminary Screening Levels: PCE = 5.0 µg/L, TCE = 4.0 µg/L, cDCE = 16 µg/L, and VC = 0.29 µg/L.

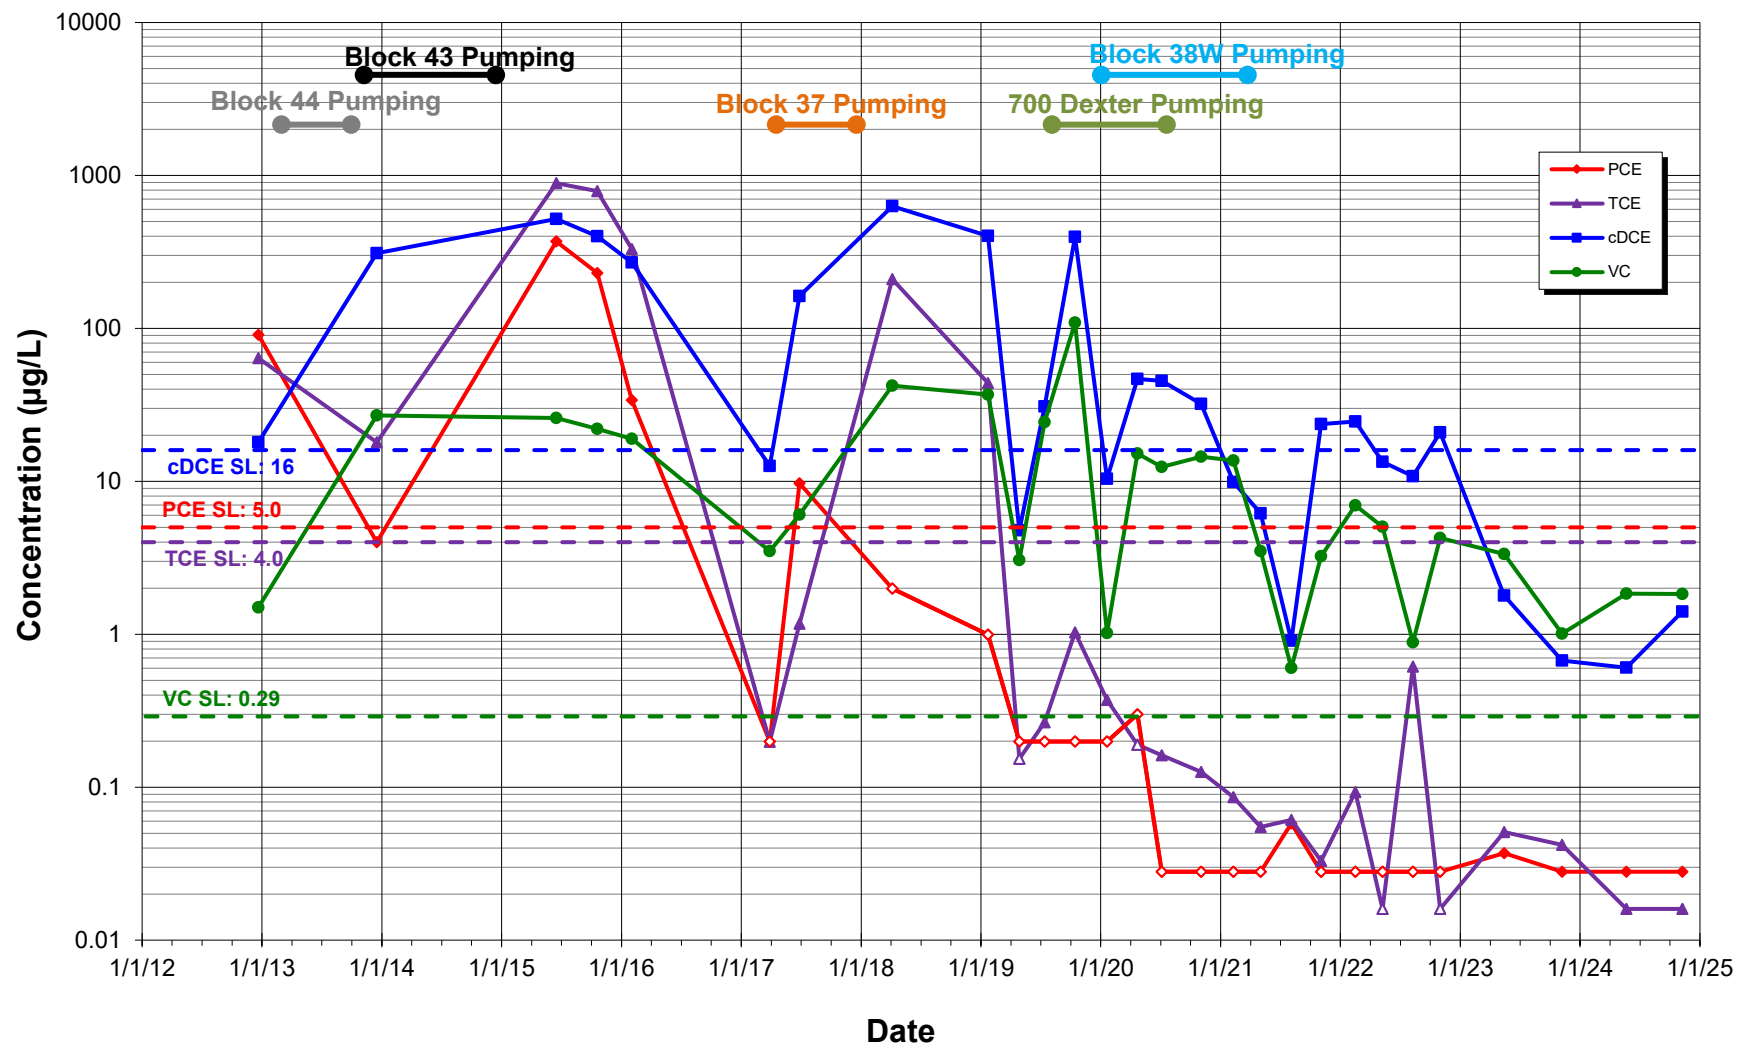
**Concentration vs Time**  
**MW109 (0.0 to -10.0 feet NAVD), Alley E of Seattle Roy Aloha Shops**  
**American Linen Supply Co Dexter Ave Site**

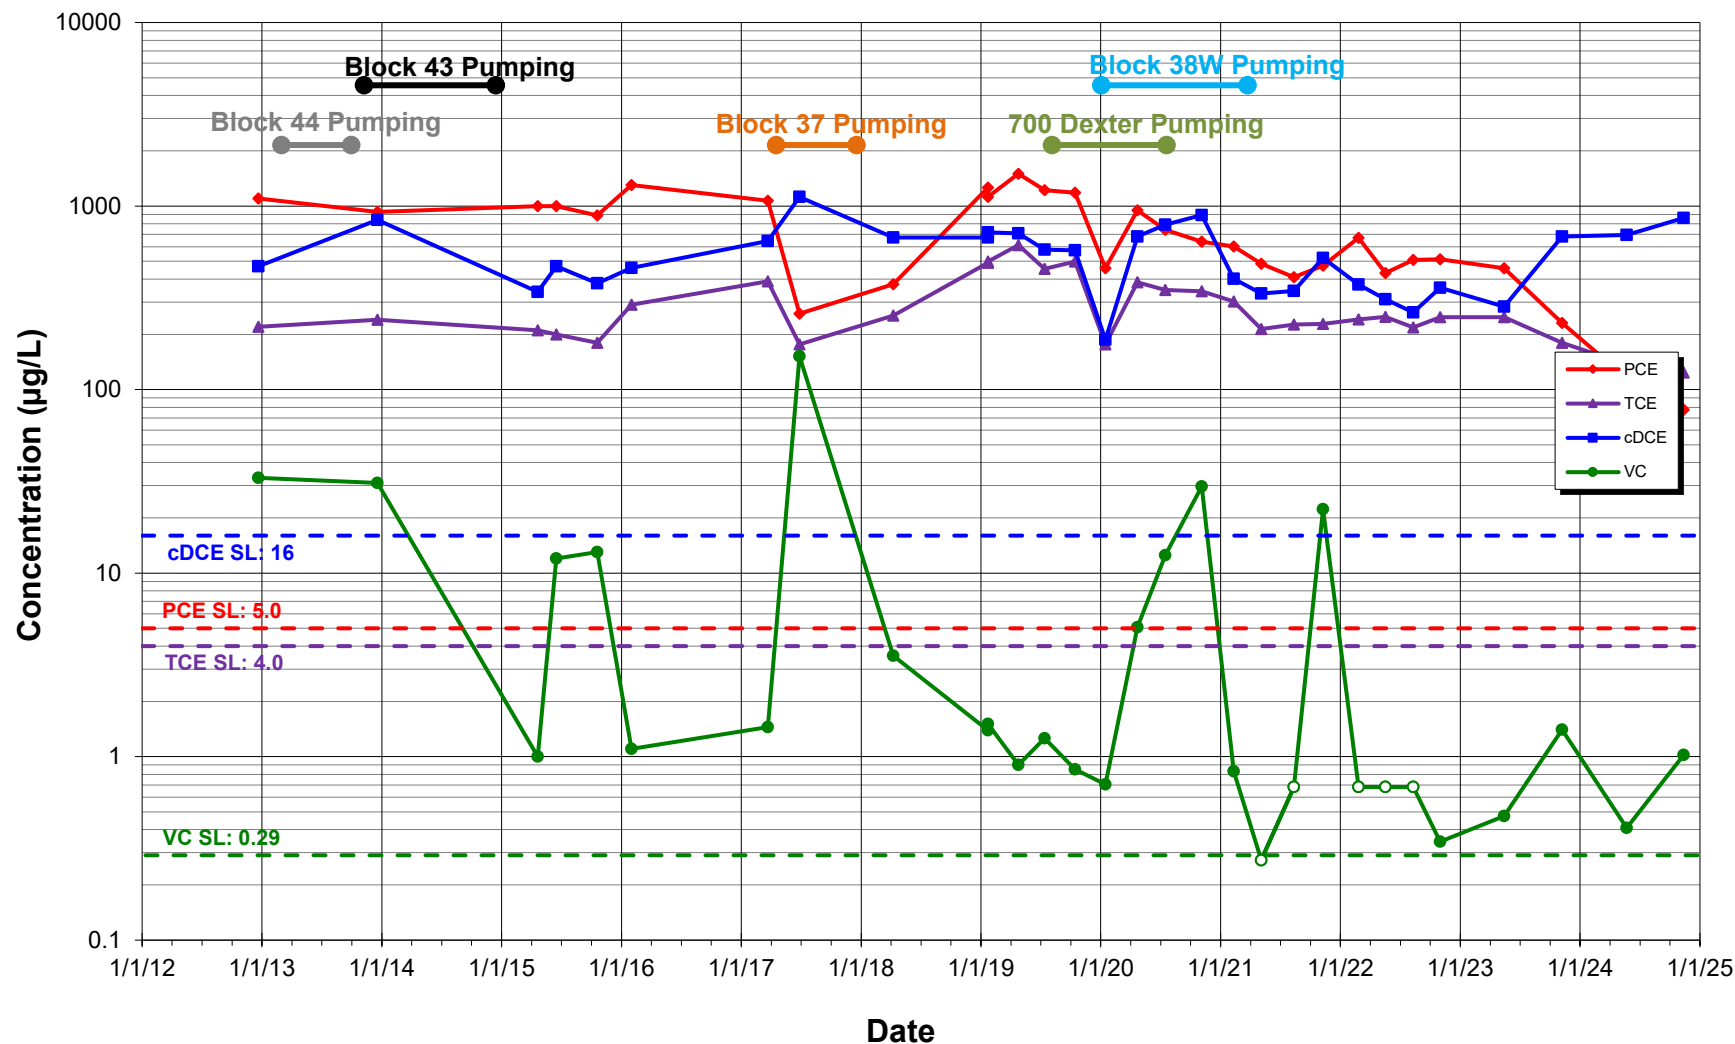
**Concentration vs Time**  
**MW110 (4.7 to -5.3 feet NAVD), Alley E of Seattle Roy Aloha Shops**  
**American Linen Supply Co Dexter Ave Site**

- 1) All results detected below the laboratory MDLs are shown as hollow data points.
- 2) Preliminary Screening Levels: PCE = 5.0 µg/L, TCE = 4.0 µg/L, cDCE = 16 µg/L, and VC = 0.29 µg/L.

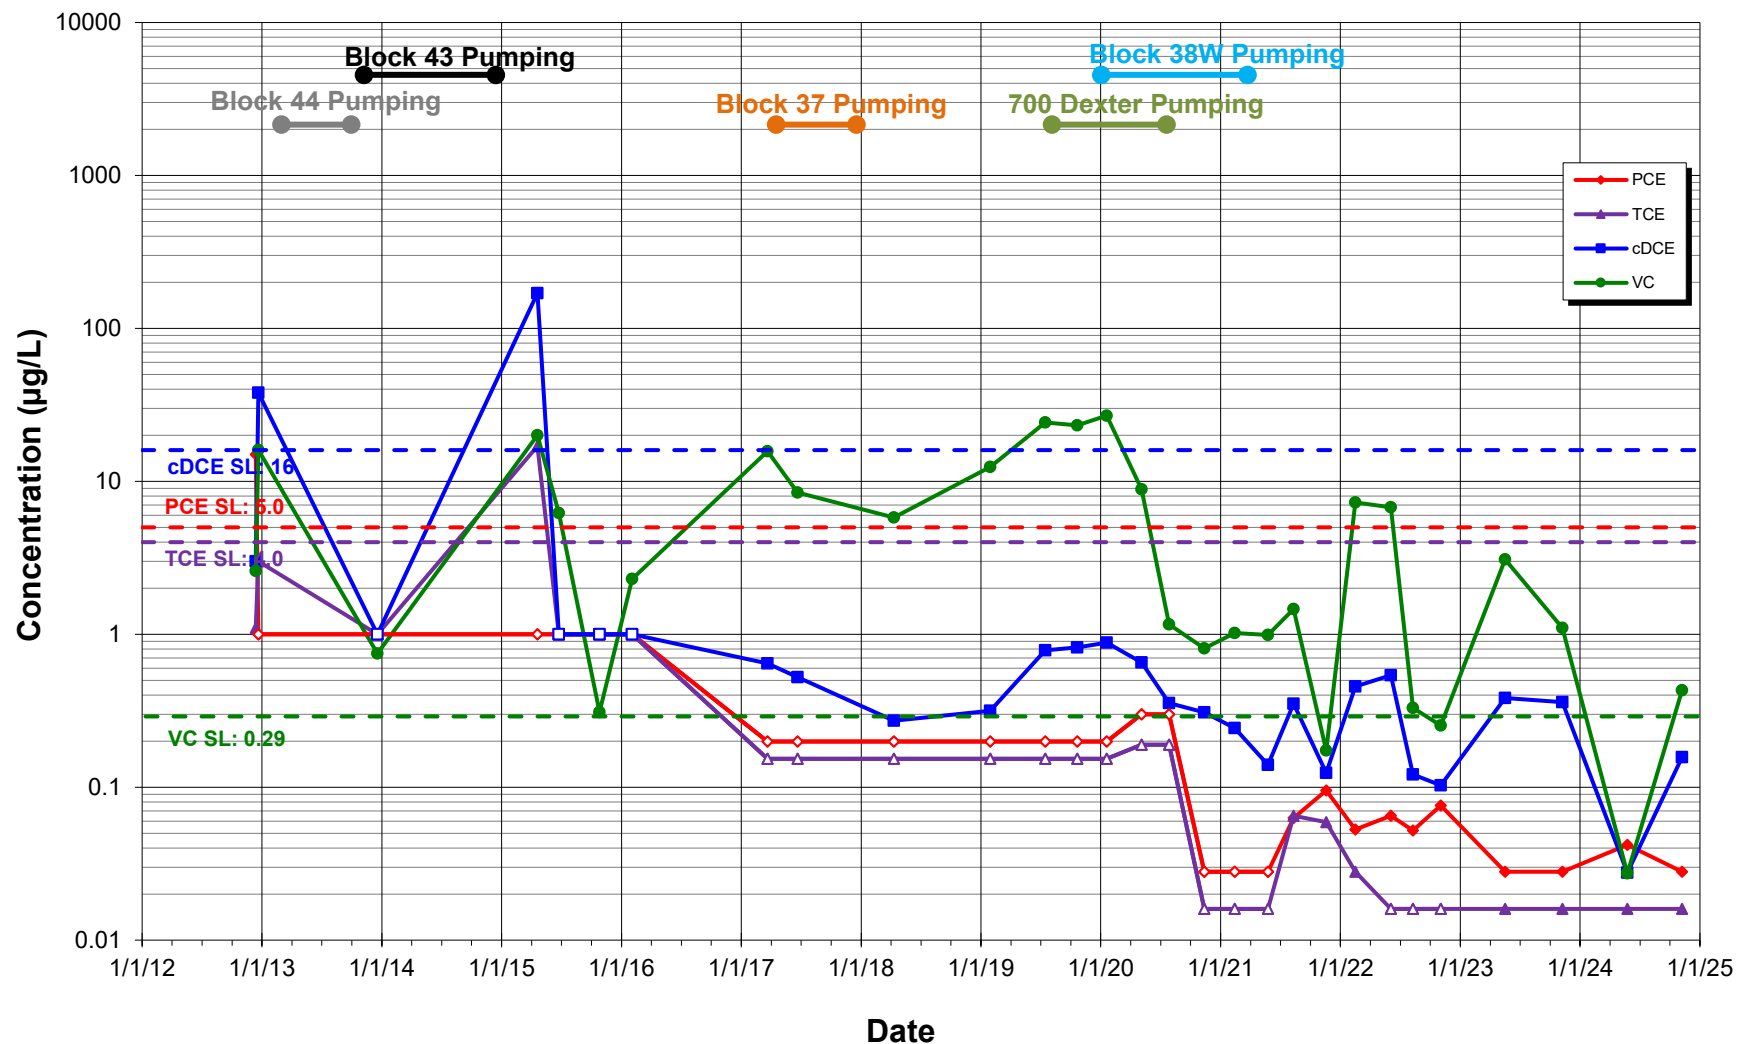
**Concentration vs Time**  
**MW115 (-0.6 to -10.6 feet NAVD), 9th Ave N ROW, W side**  
**American Linen Supply Co Dexter Ave Site**

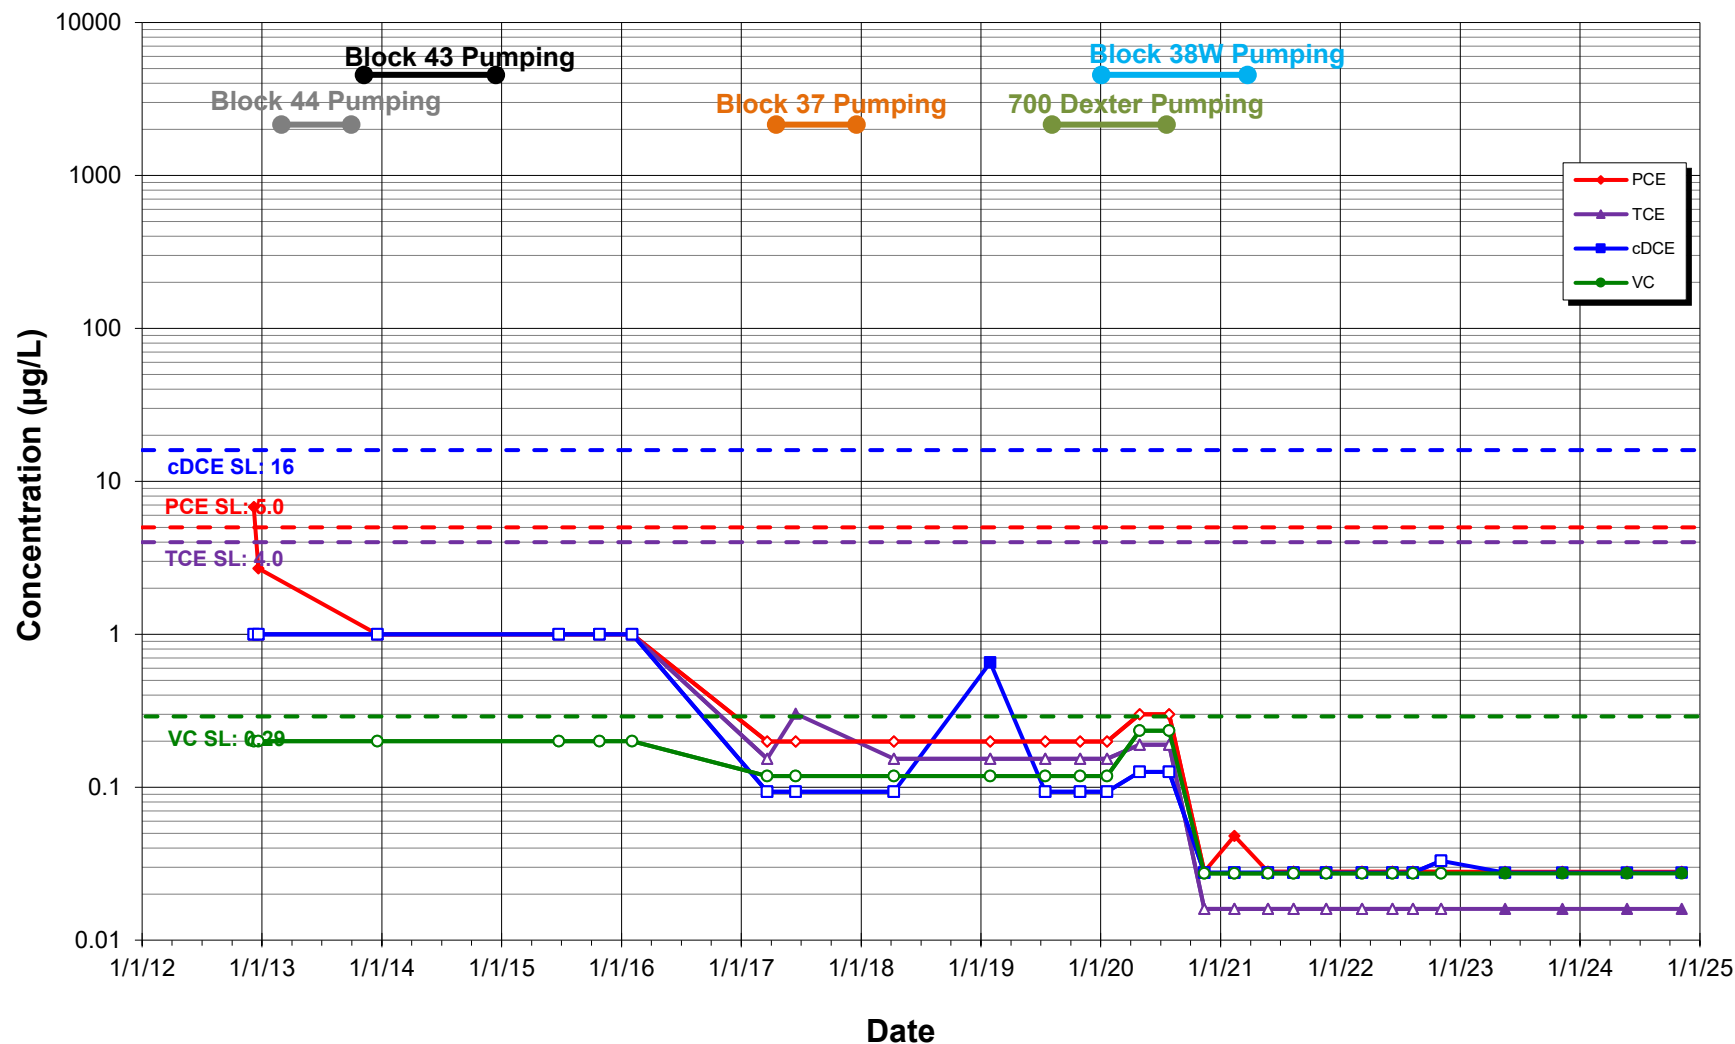
**Concentration vs Time**  
**MW116 (-3.1 to -13.1 feet NAVD) 9th Ave N ROW, W side**  
**American Linen Supply Co Dexter Ave Site**

- 1) All results detected below the laboratory MDLs are shown as hollow data points.
- 2) Preliminary Screening Levels: PCE = 5.0 µg/L, TCE = 4.0 µg/L, cDCE = 16 µg/L, and VC = 0.29 µg/L.

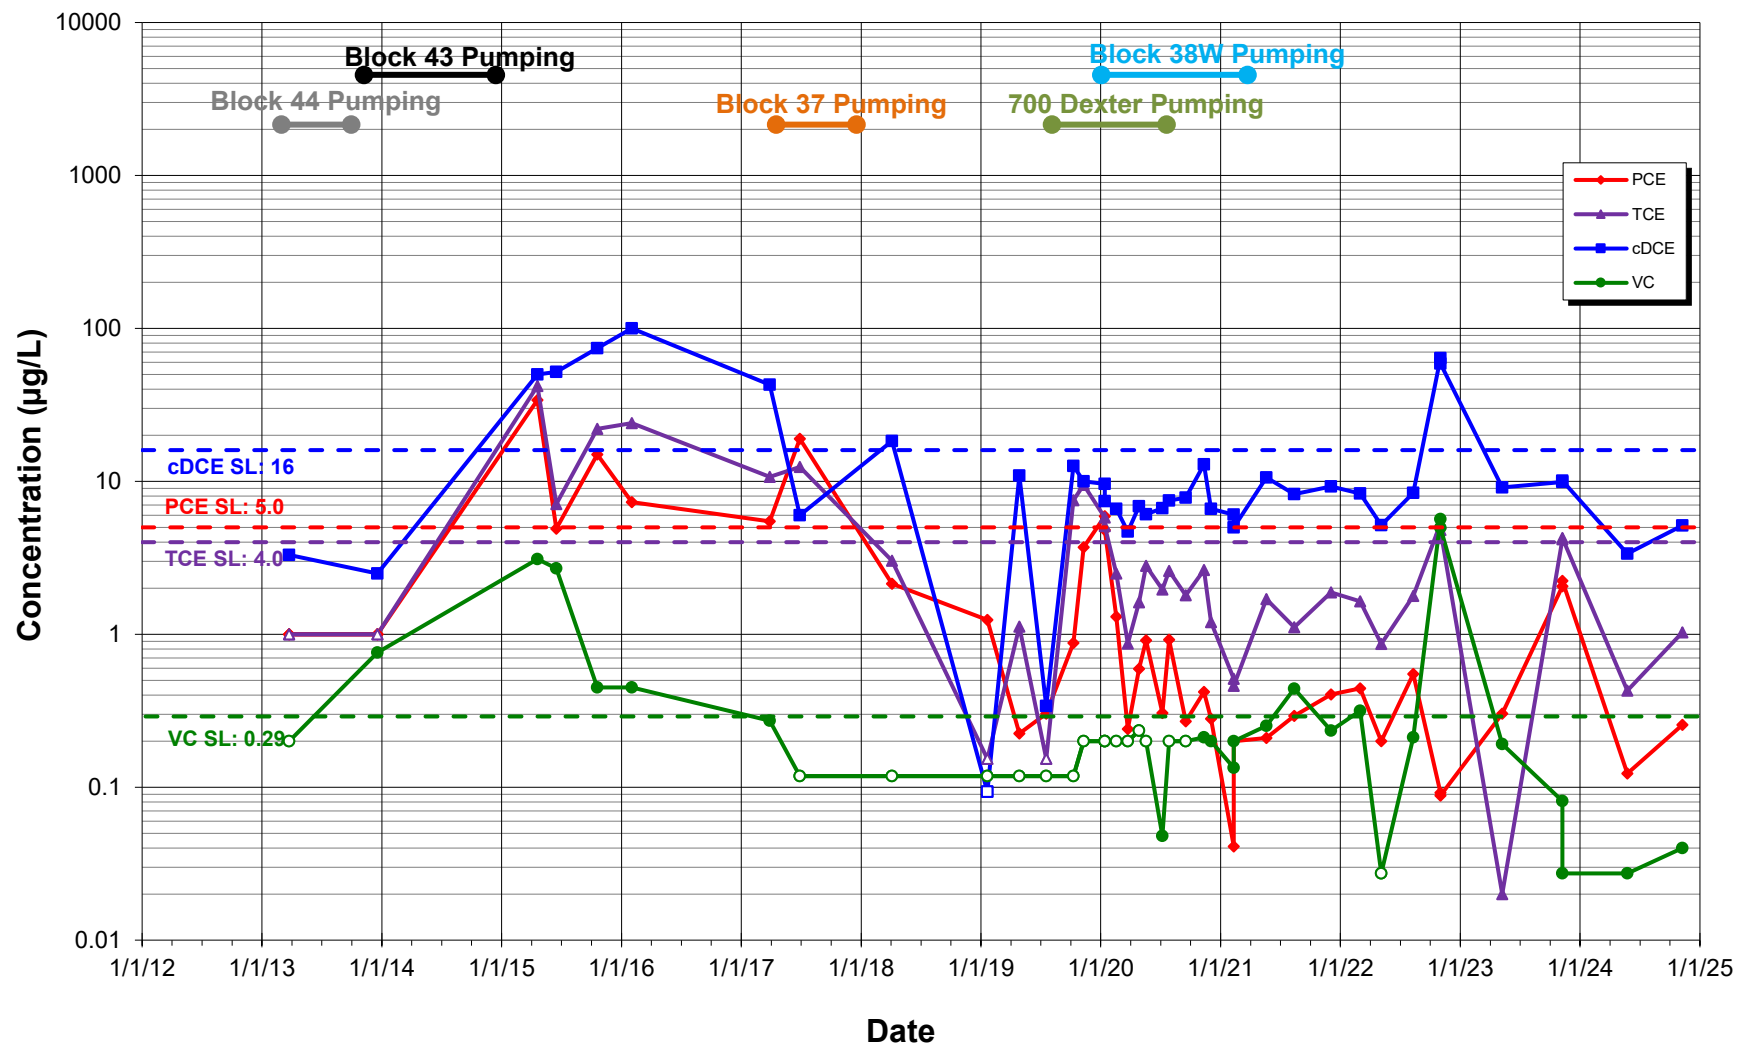
**Concentration vs Time**  
**MW119 (2.7 to -7.3 feet NAVD), 9th Ave N ROW, W side**  
**American Linen Supply Co Dexter Ave Site**
