**Attachment A**  
**Well Completion Table**  
**American Linen Supply Co Dexter Ave Site**  
**700 Dexter Avenue North**  
**Seattle, Washington**

**ATTACHMENT B**

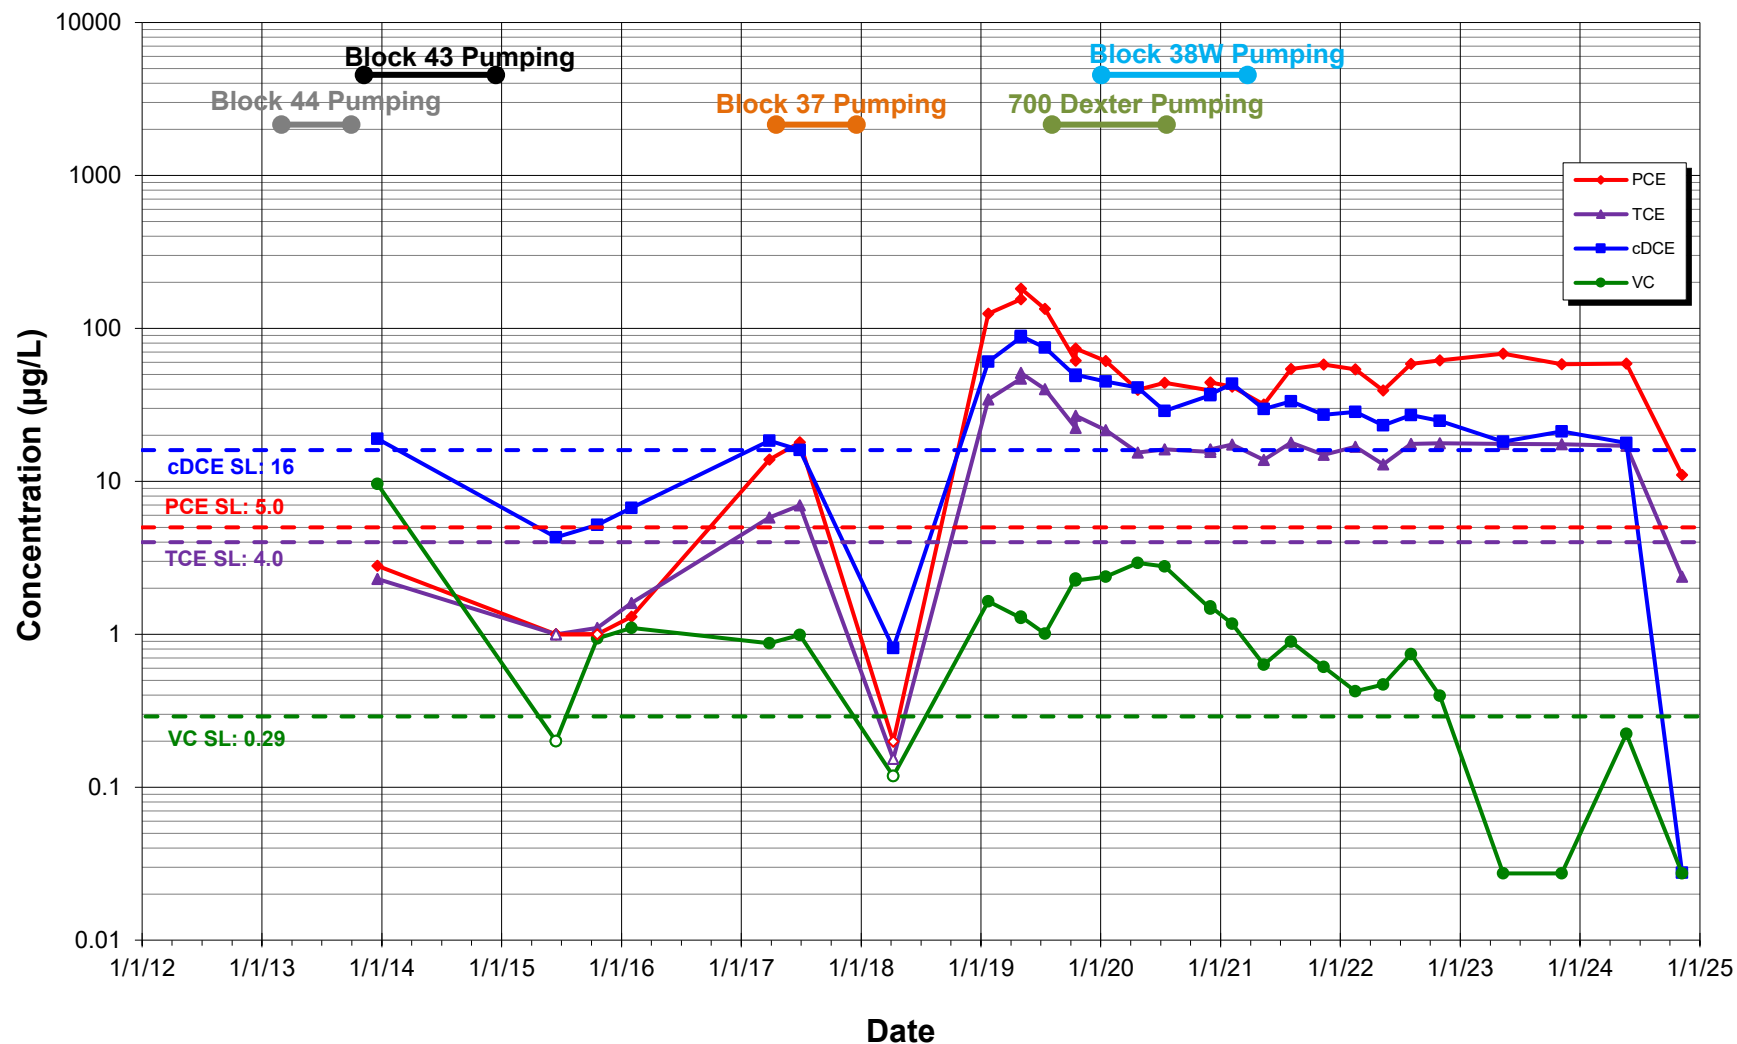
**Concentration vs Time**  
**MW120 (0.0 to -10.0 feet NAVD), 8th Ave N ROW, E side**  
**American Linen Supply Co Dexter Ave Site**

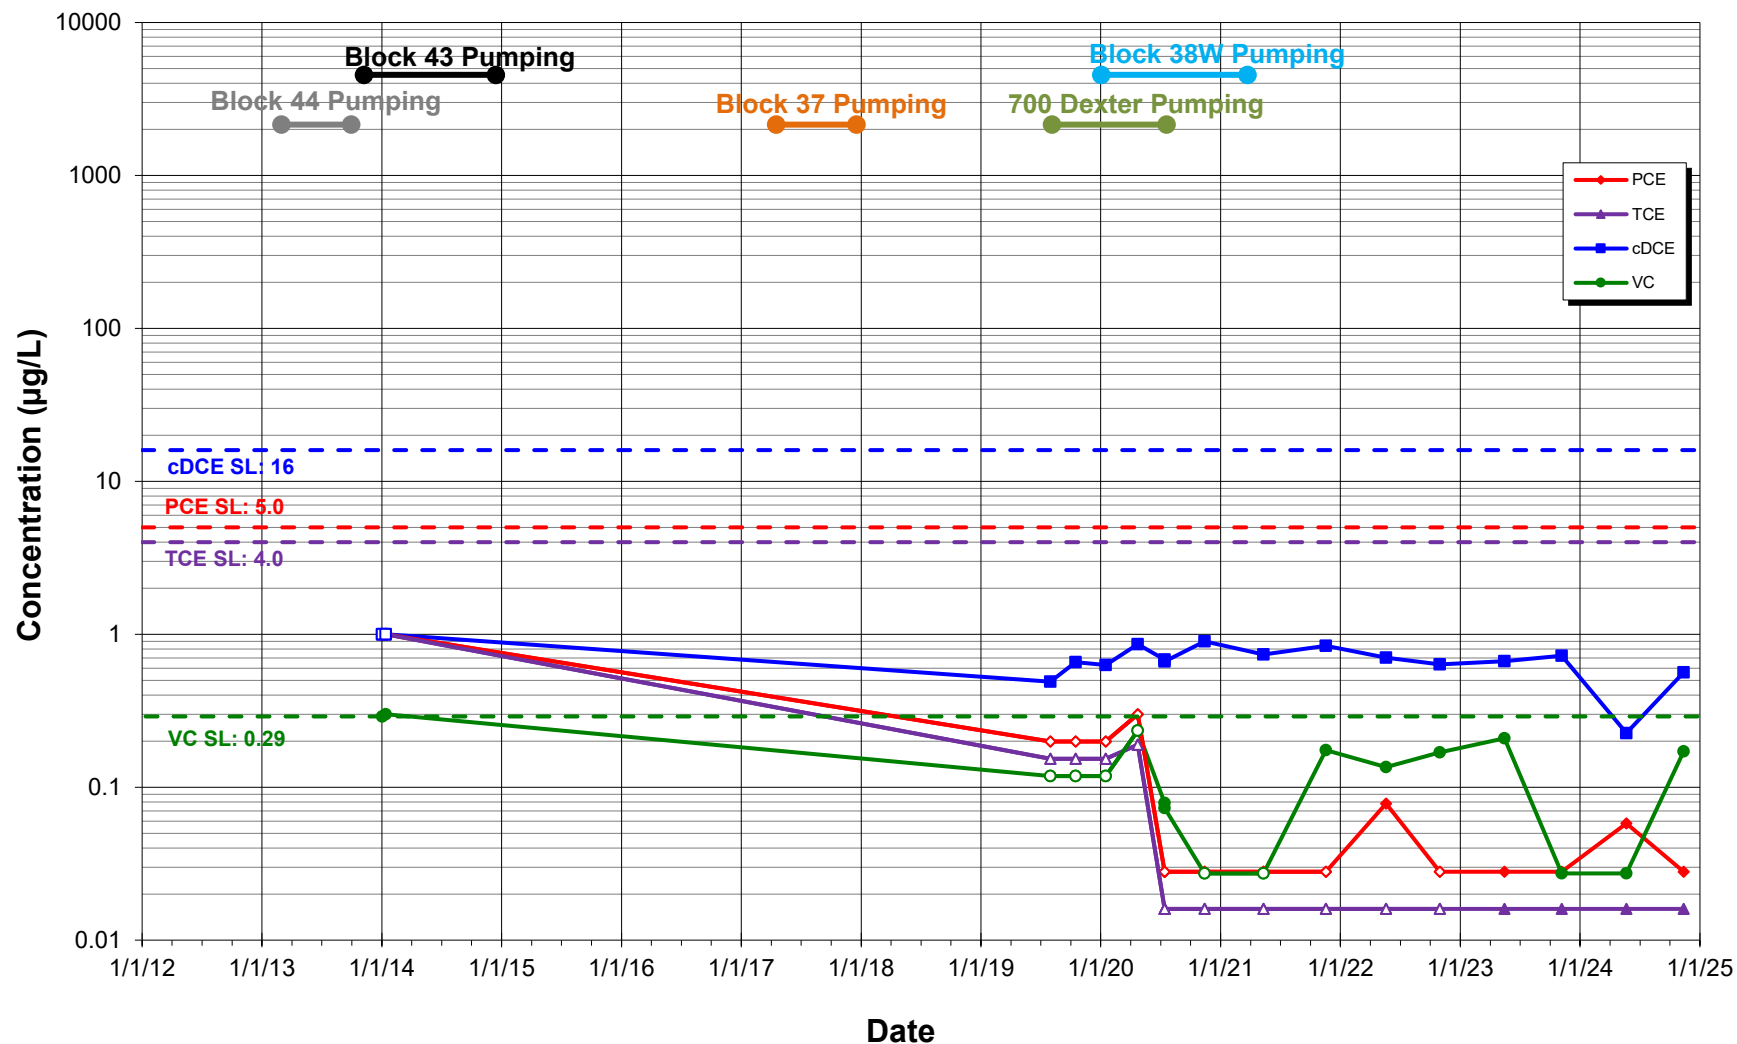
**Concentration vs Time**  
**MW127 (-1 to -11.0 feet NAVD), 8th Ave N ROW, E side**  
**American Linen Supply Co Dexter Ave Site**

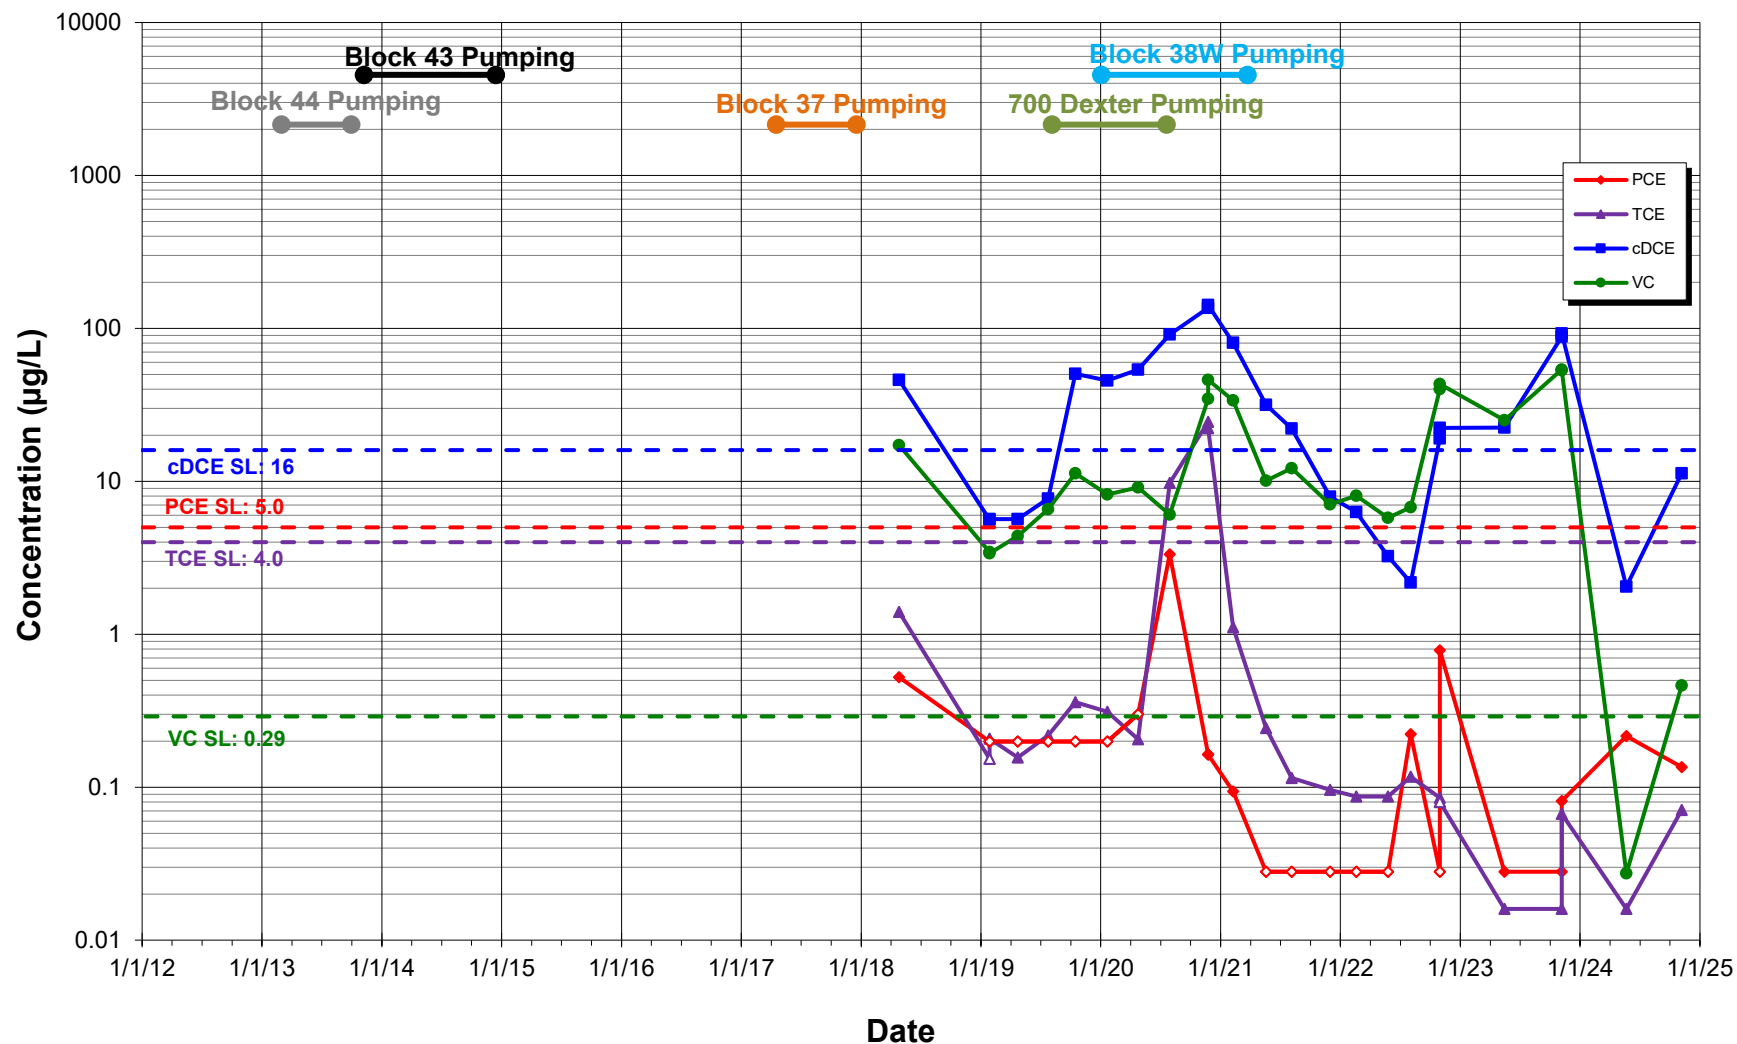
**Concentration vs Time**  
**MW-142 (2.4 to -7.6 feet NAVD), 8th Ave N ROW, E side**  
**American Linen Supply Co-Dexter Ave Site**

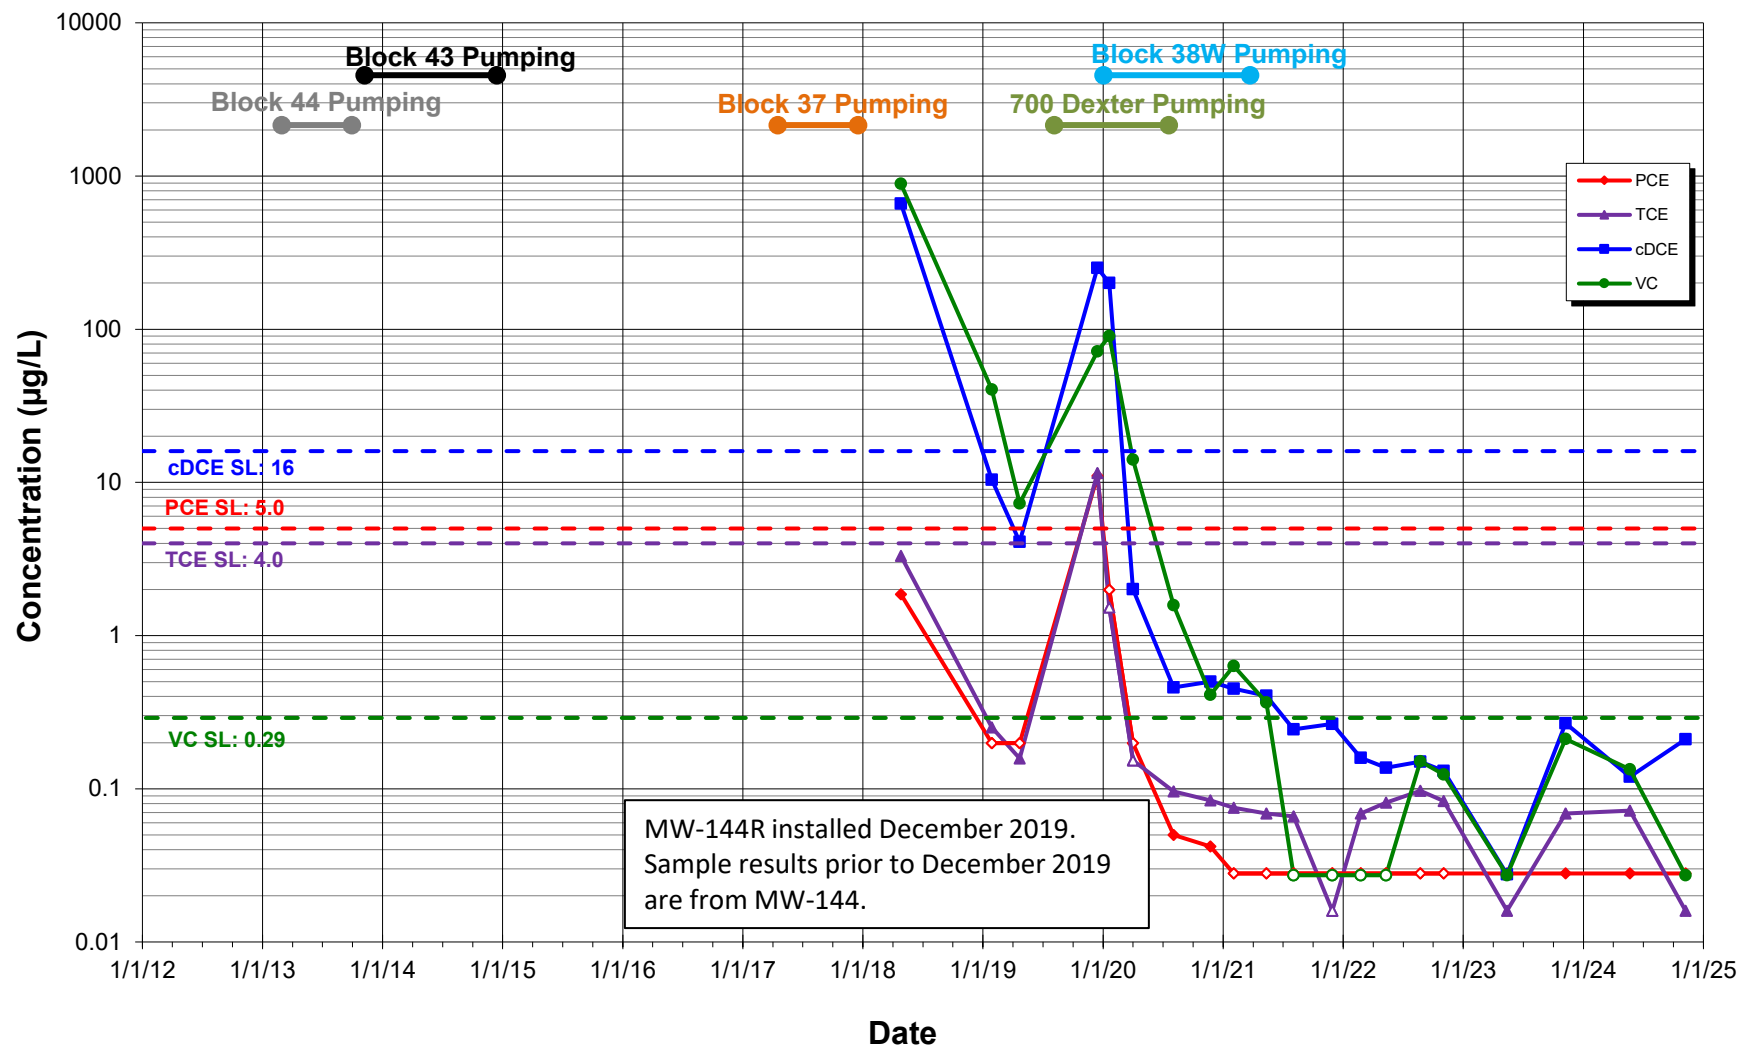
**Concentration vs Time**  
**MW-144R (3.9 to -6.5 feet NAVD), 8th Ave N ROW, E side**  
**American Linen Supply Co Dexter Ave Site**

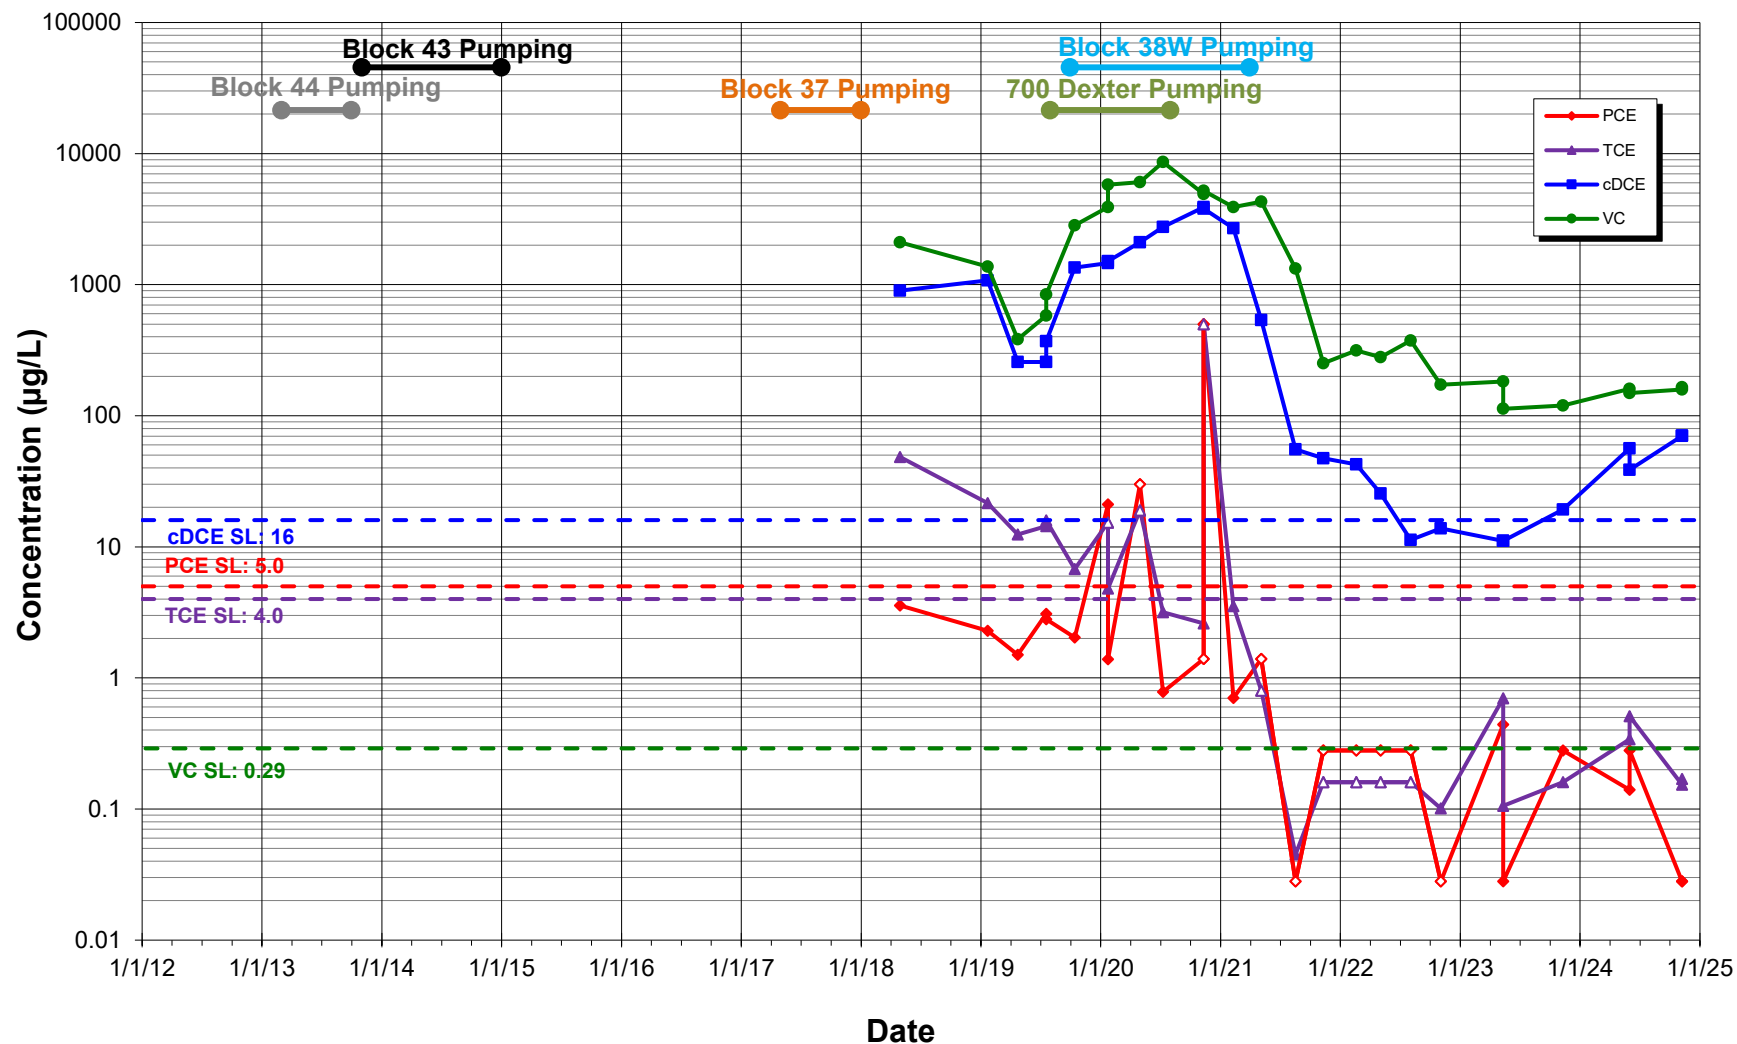
**Concentration vs Time**  
**MW-146 (12.8 to 2.8 feet NAVD), Roy St ROW, S side**  
**American Linen Supply Co Dexter Ave Site**

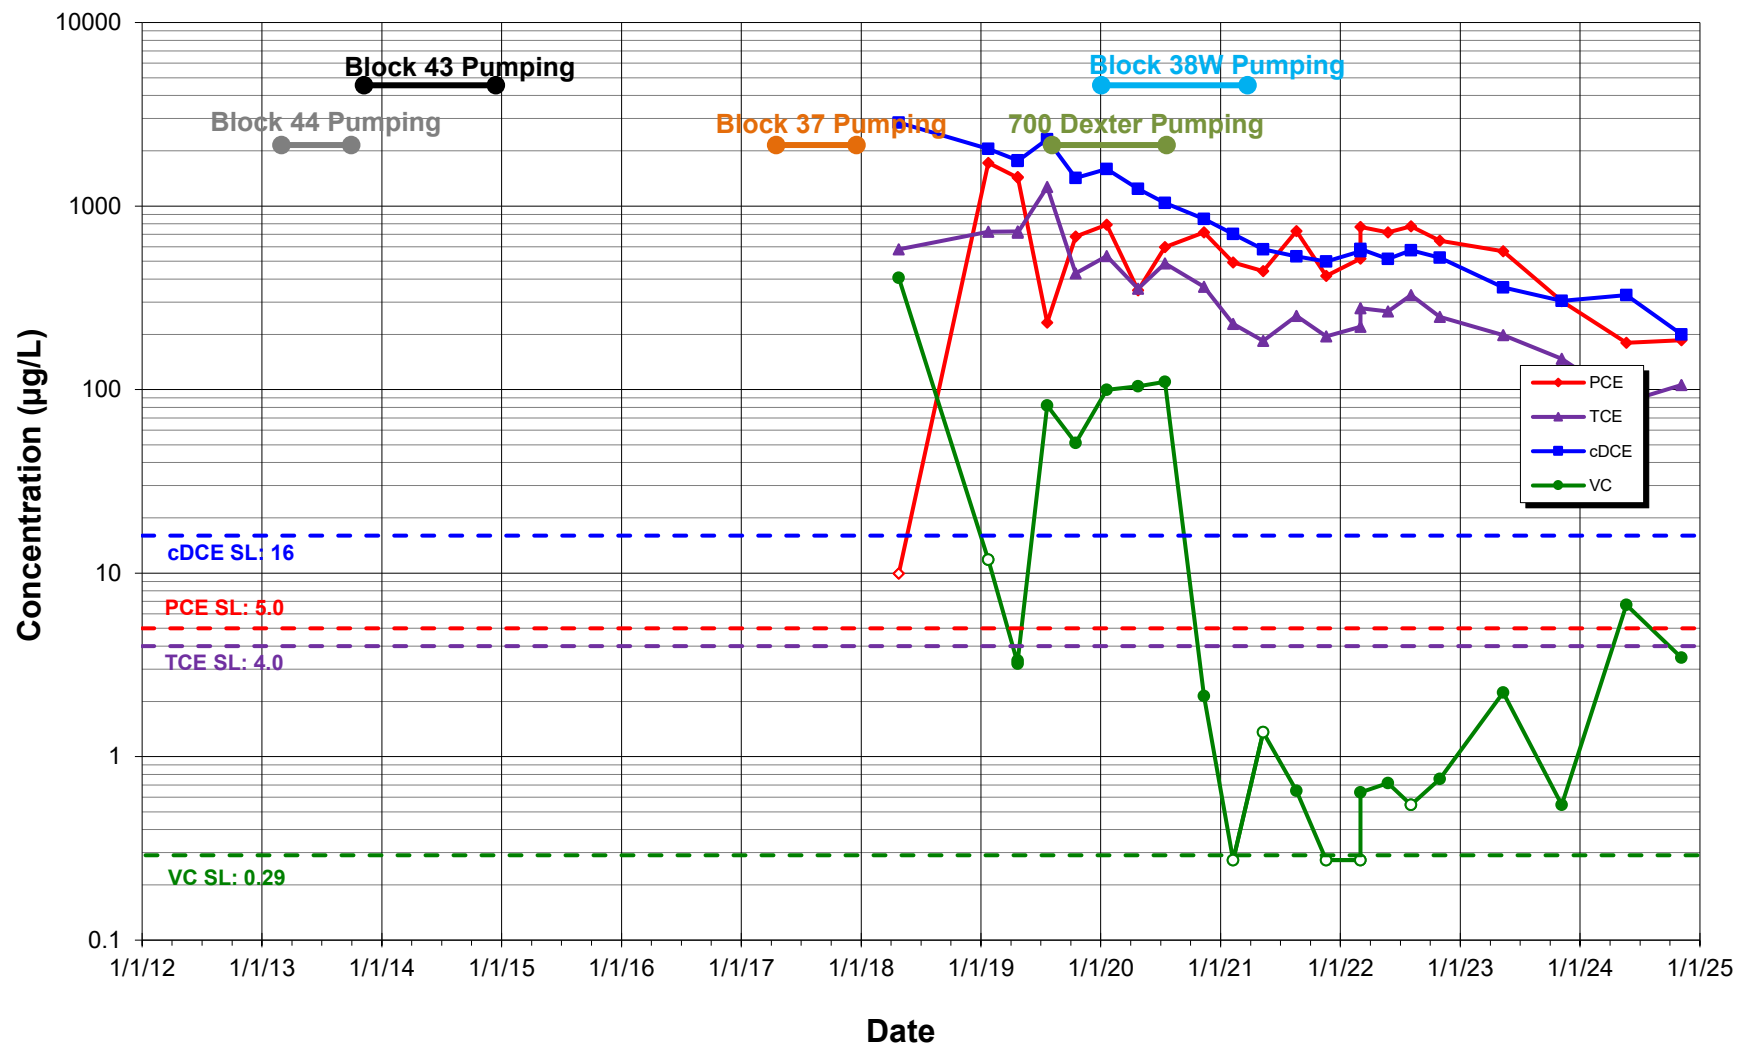
**Concentration vs Time**  
**MW-156 (2.0 to -8.0 feet NAVD), 8th Ave N ROW, E side**  
**American Linen Supply Co Dexter Ave Site**

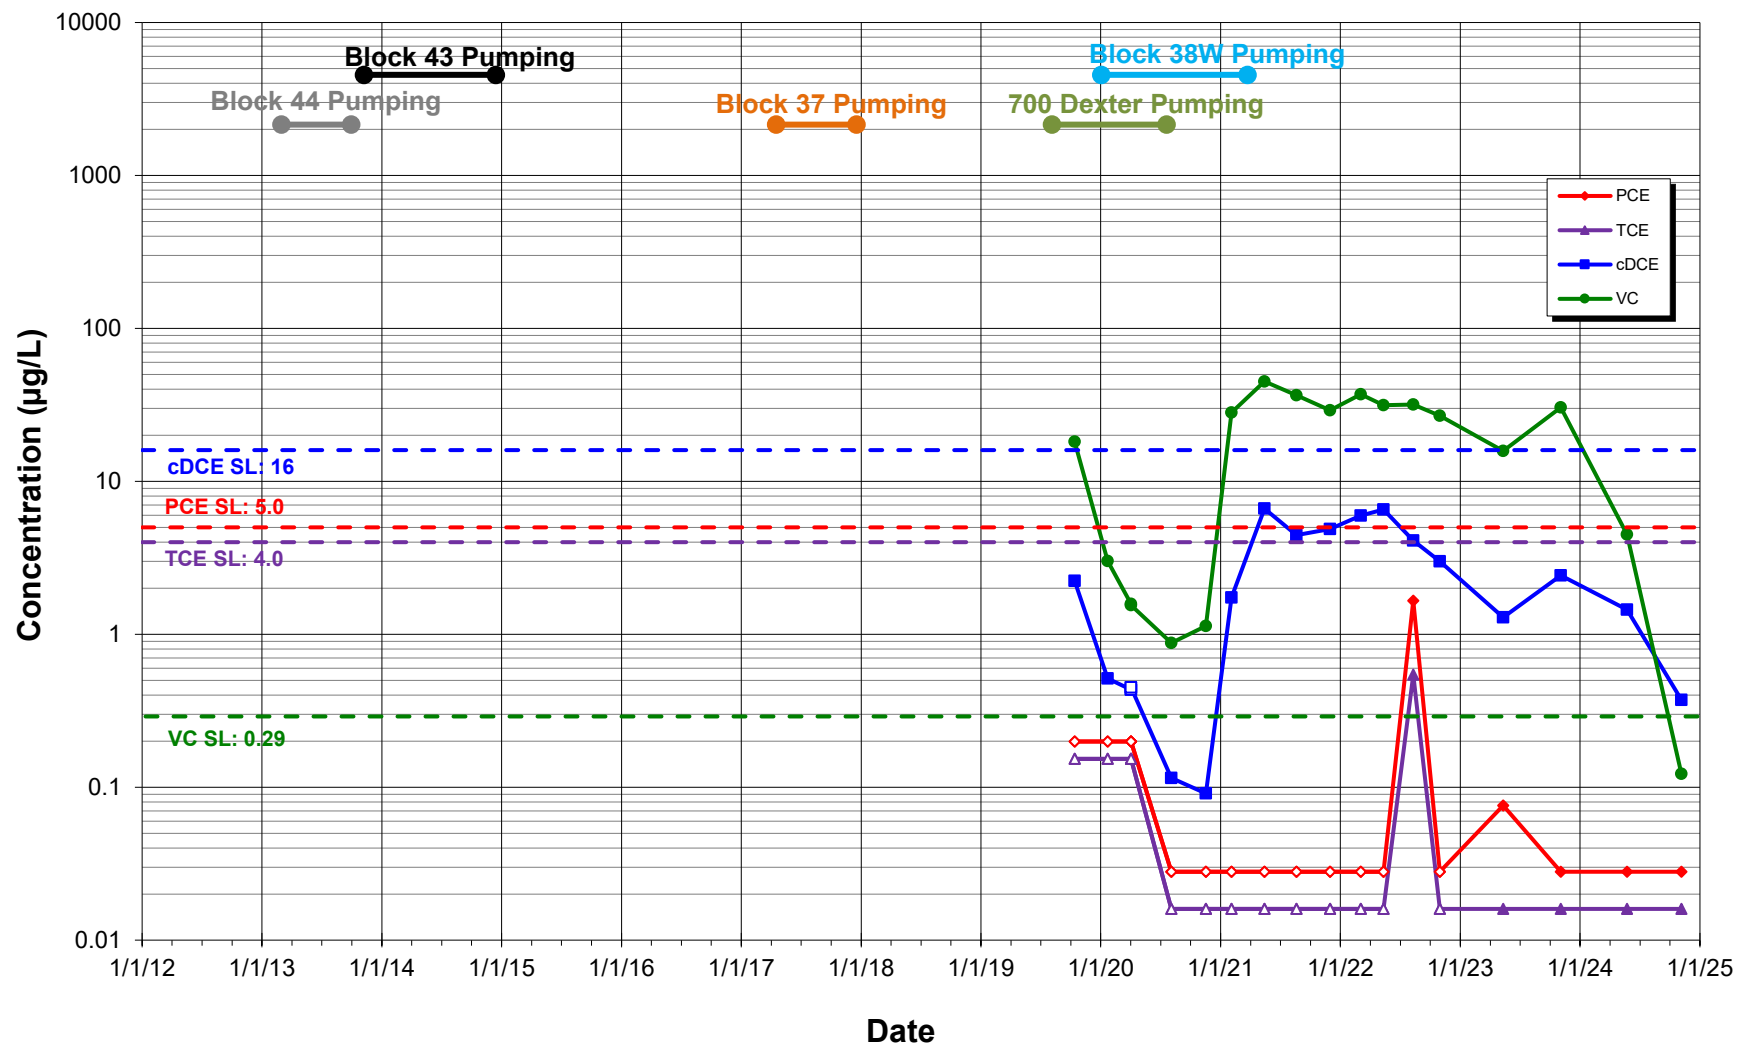
**Concentration vs Time**  
**MW-189 (-1.2 to -11.2 feet NAVD), Valley St ROW, S side**  
**American Linen Supply Co Dexter Ave Site**

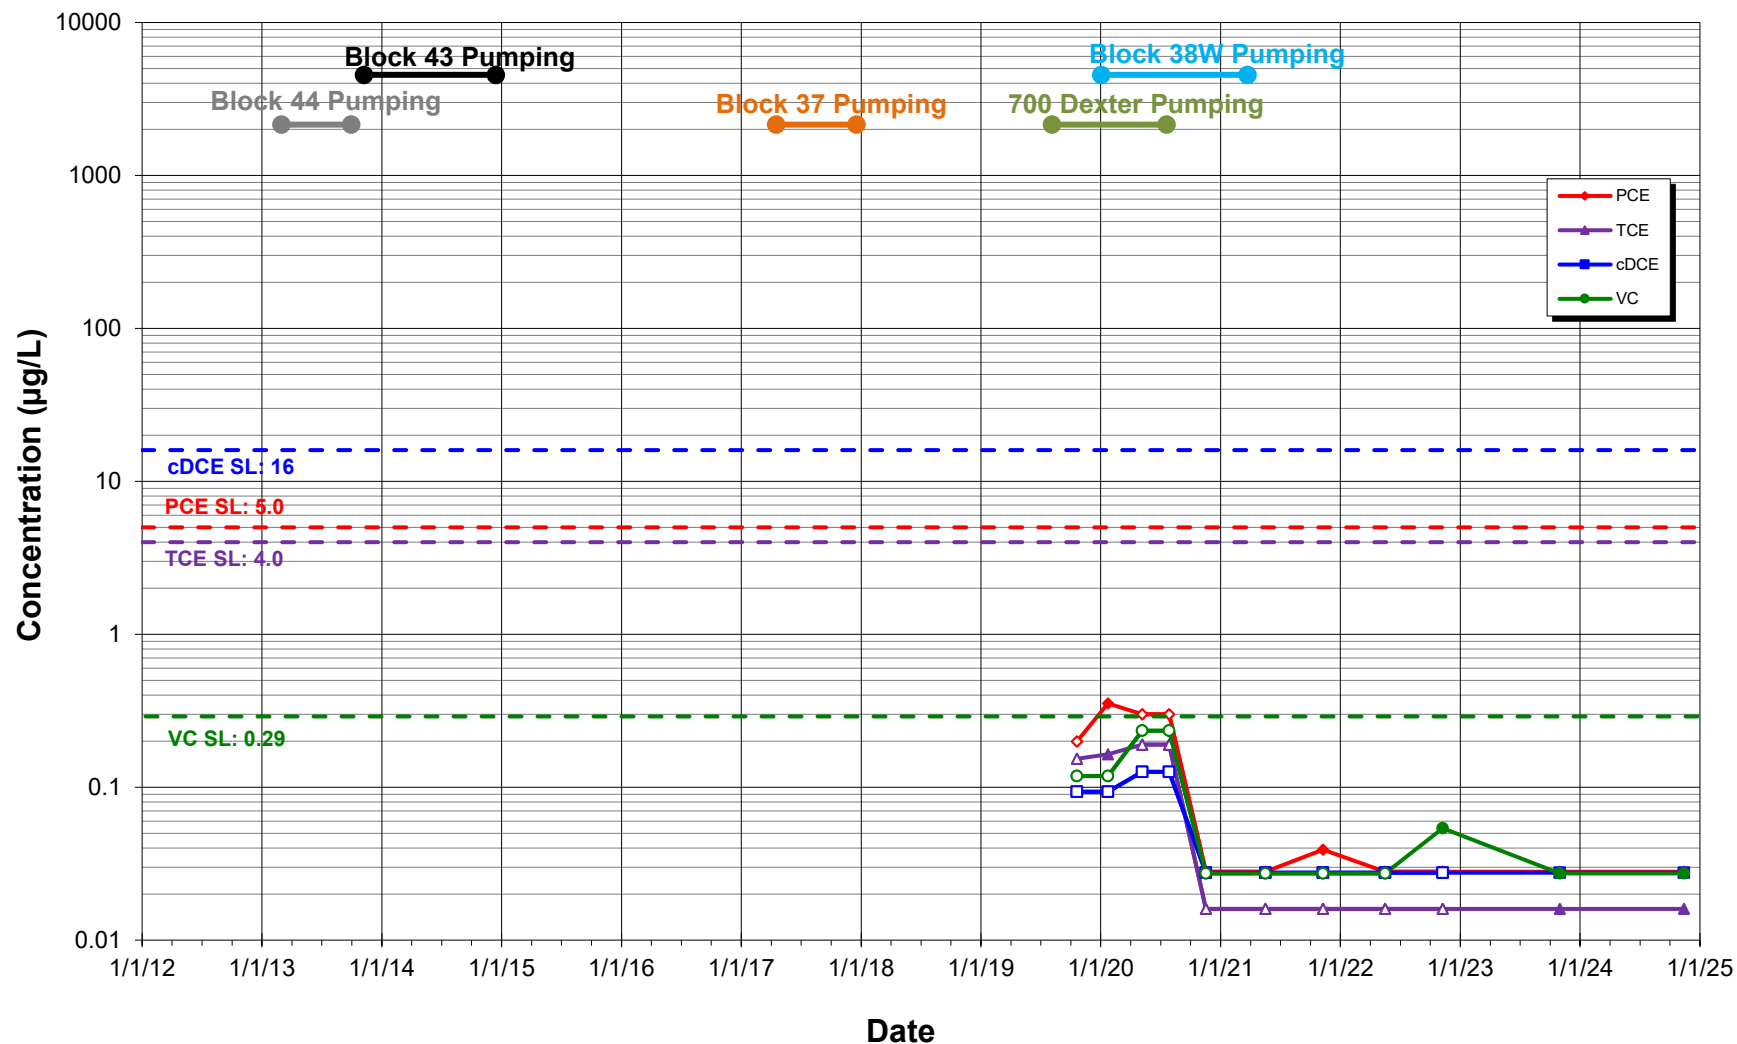
**Concentration vs Time**  
**MW-302 (3.0 to -7.0 feet NAVD), Dexter Ave N ROW, E side**  
**American Linen Supply Co Dexter Ave Site**

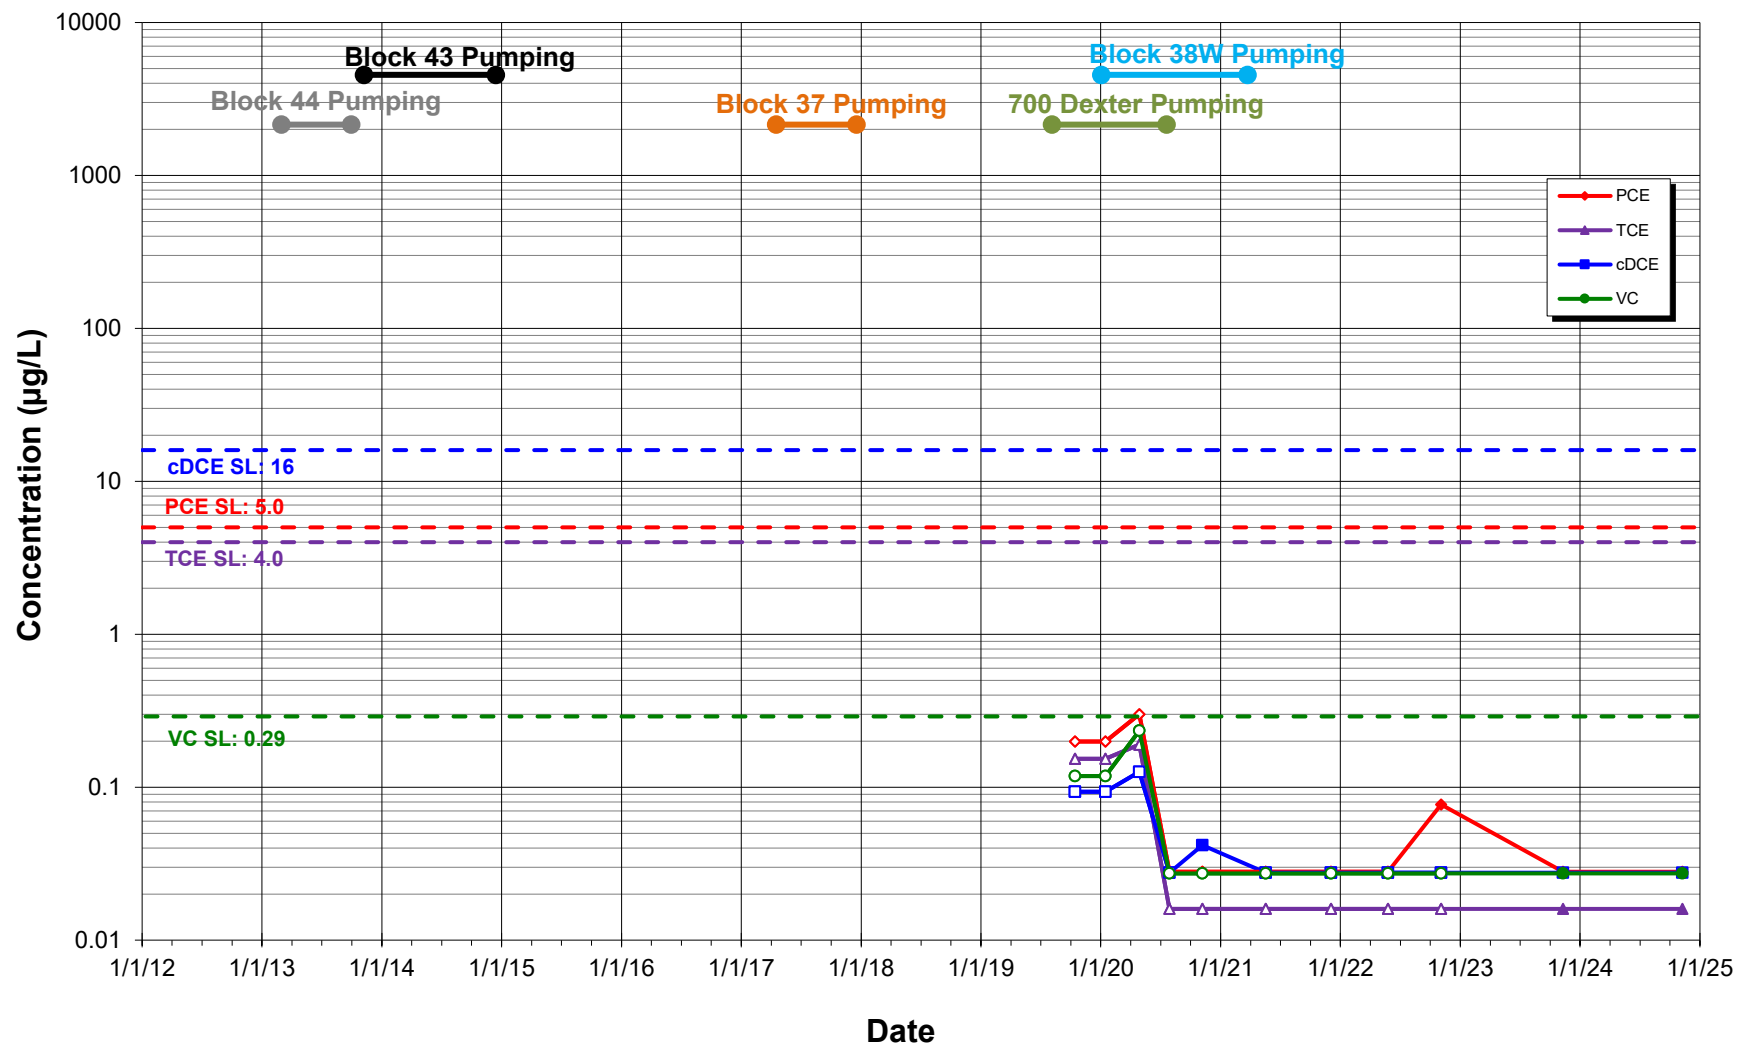
**Concentration vs Time**  
**MW-306 (17.2 to 7.2 feet NAVD), Roy St ROW, S side**  
**American Linen Supply Co Dexter Ave Site**

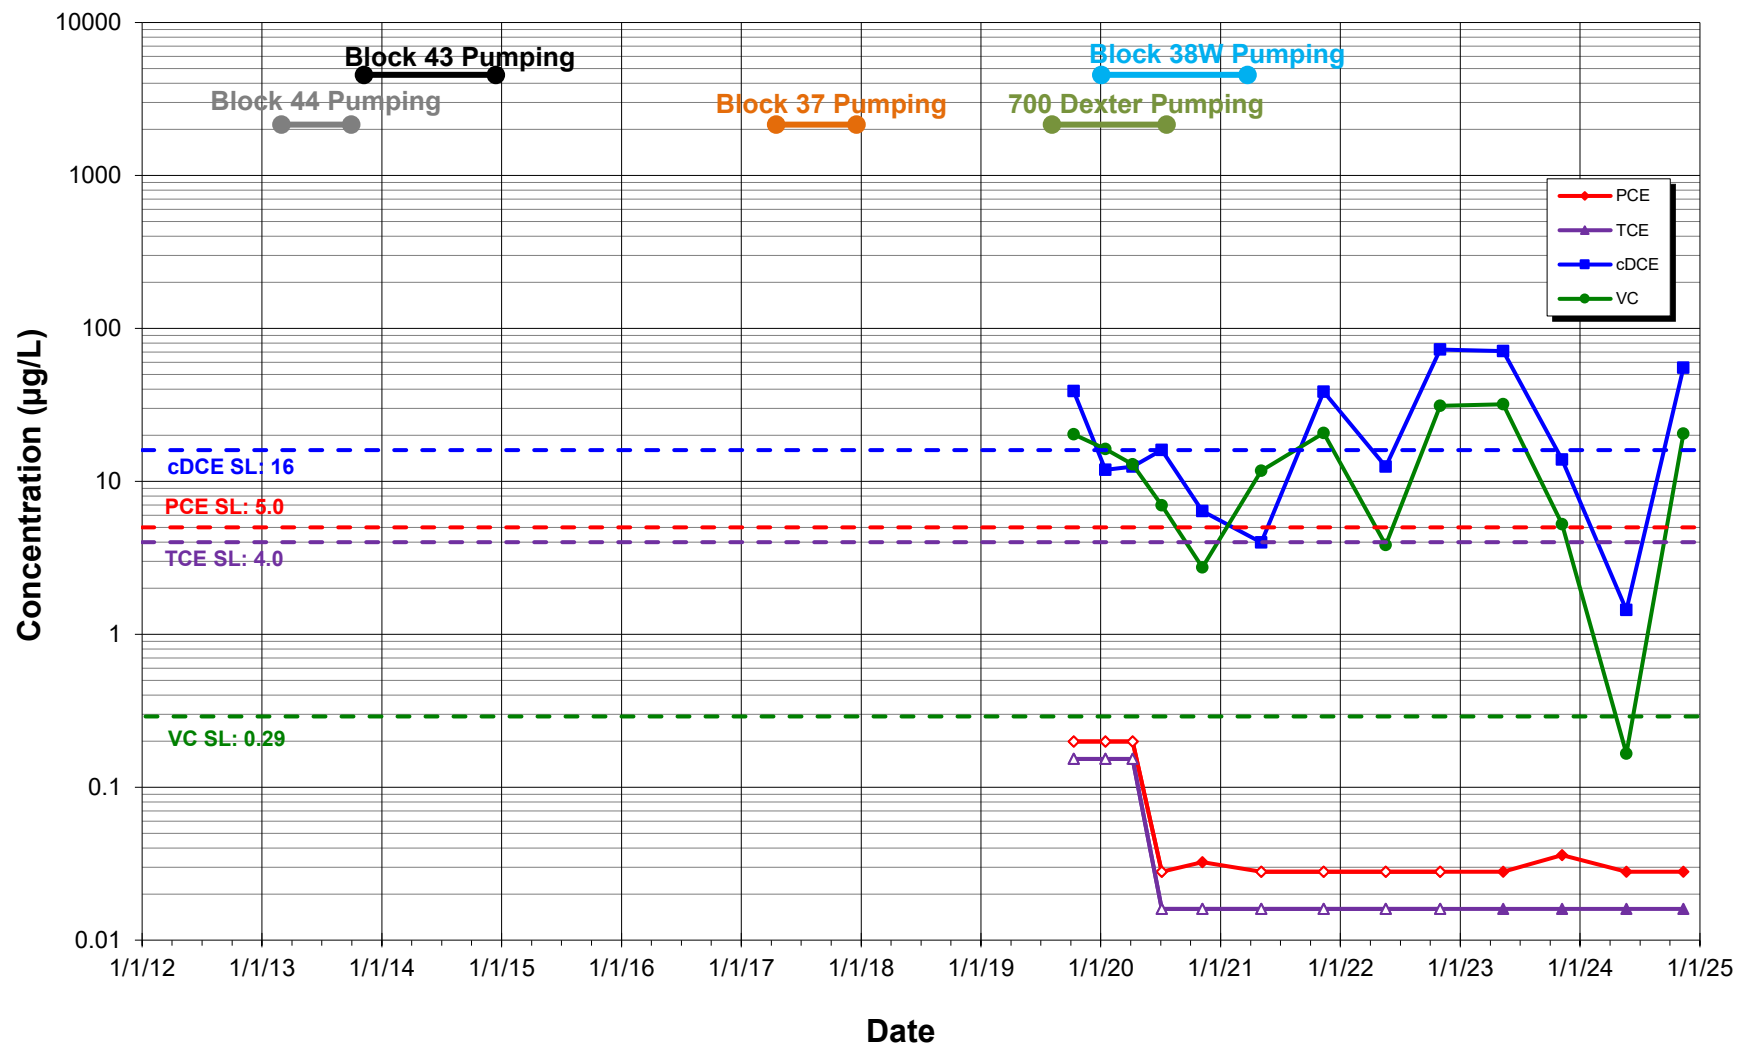
**Concentration vs Time**  
**MW-308 (-4.7 to -14.7 feet NAVD), Alley E of Seattle Roy Aloha Shops**  
**American Linen Supply Co Dexter Ave Site**

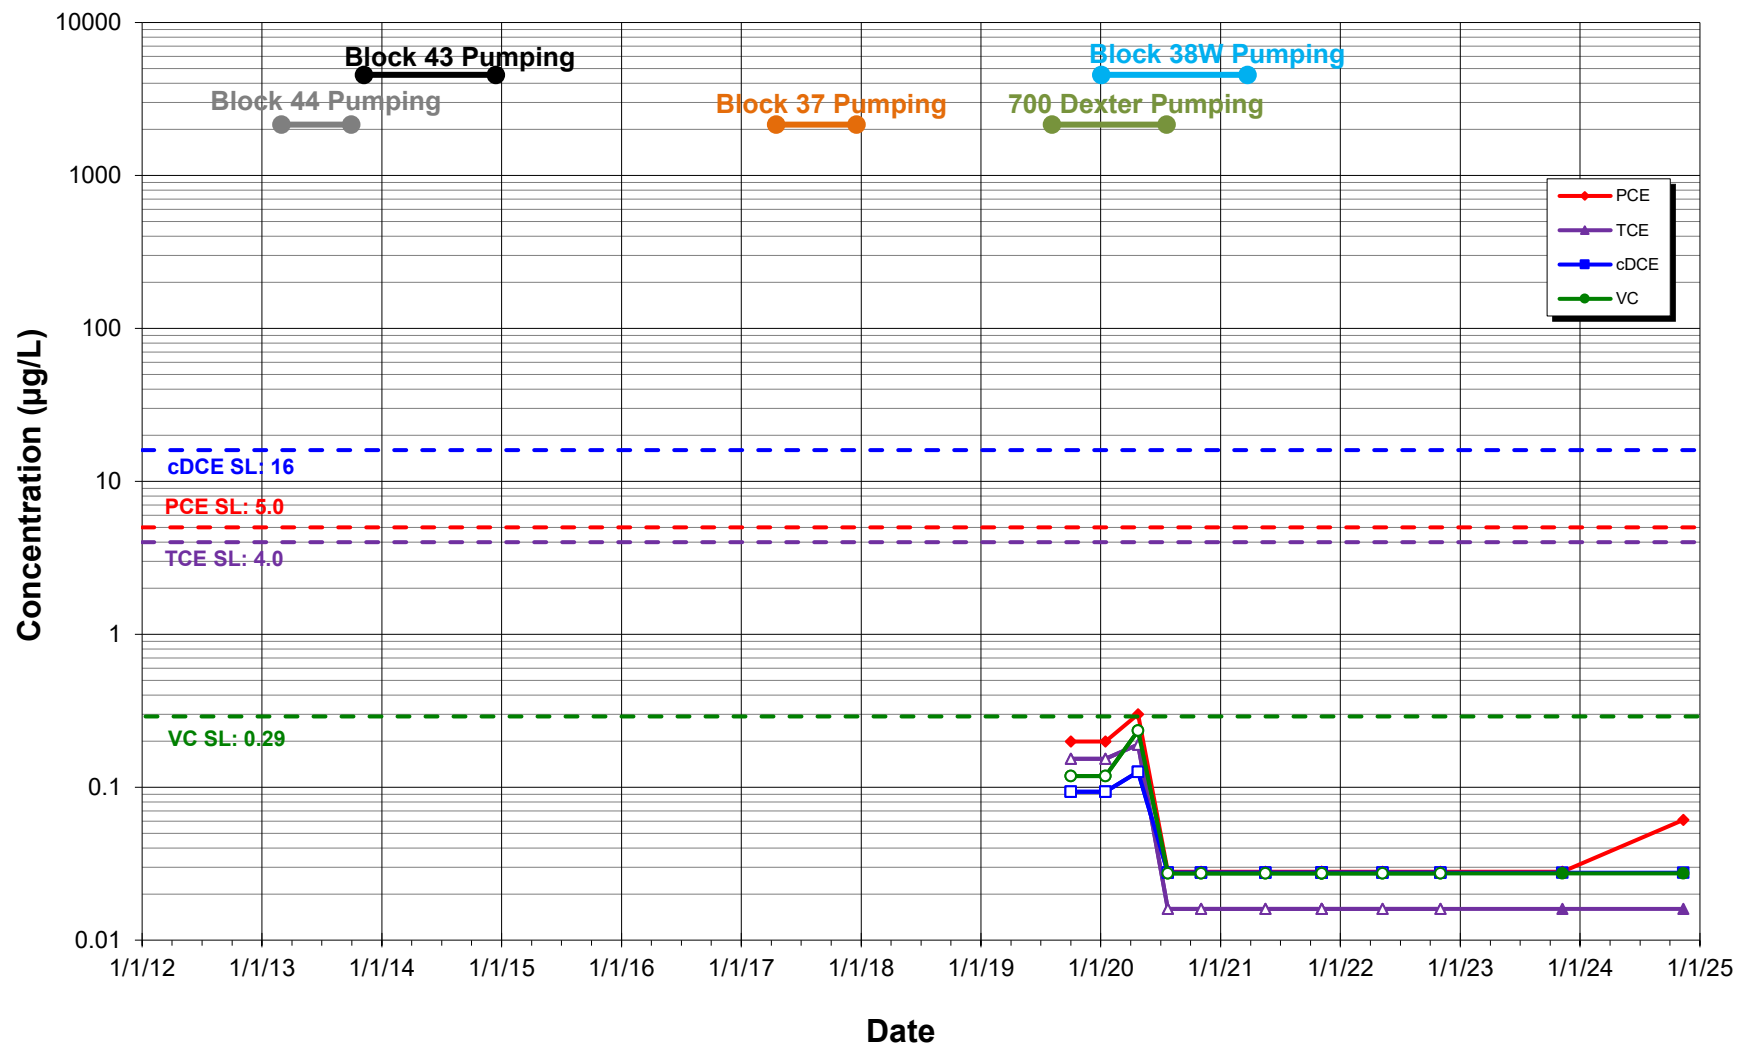
**Concentration vs Time**  
**MW-315 (12.2 to 2.3 feet NAVD), Mercer St ROW, N side**  
**American Linen Supply Co Dexter Ave Site**

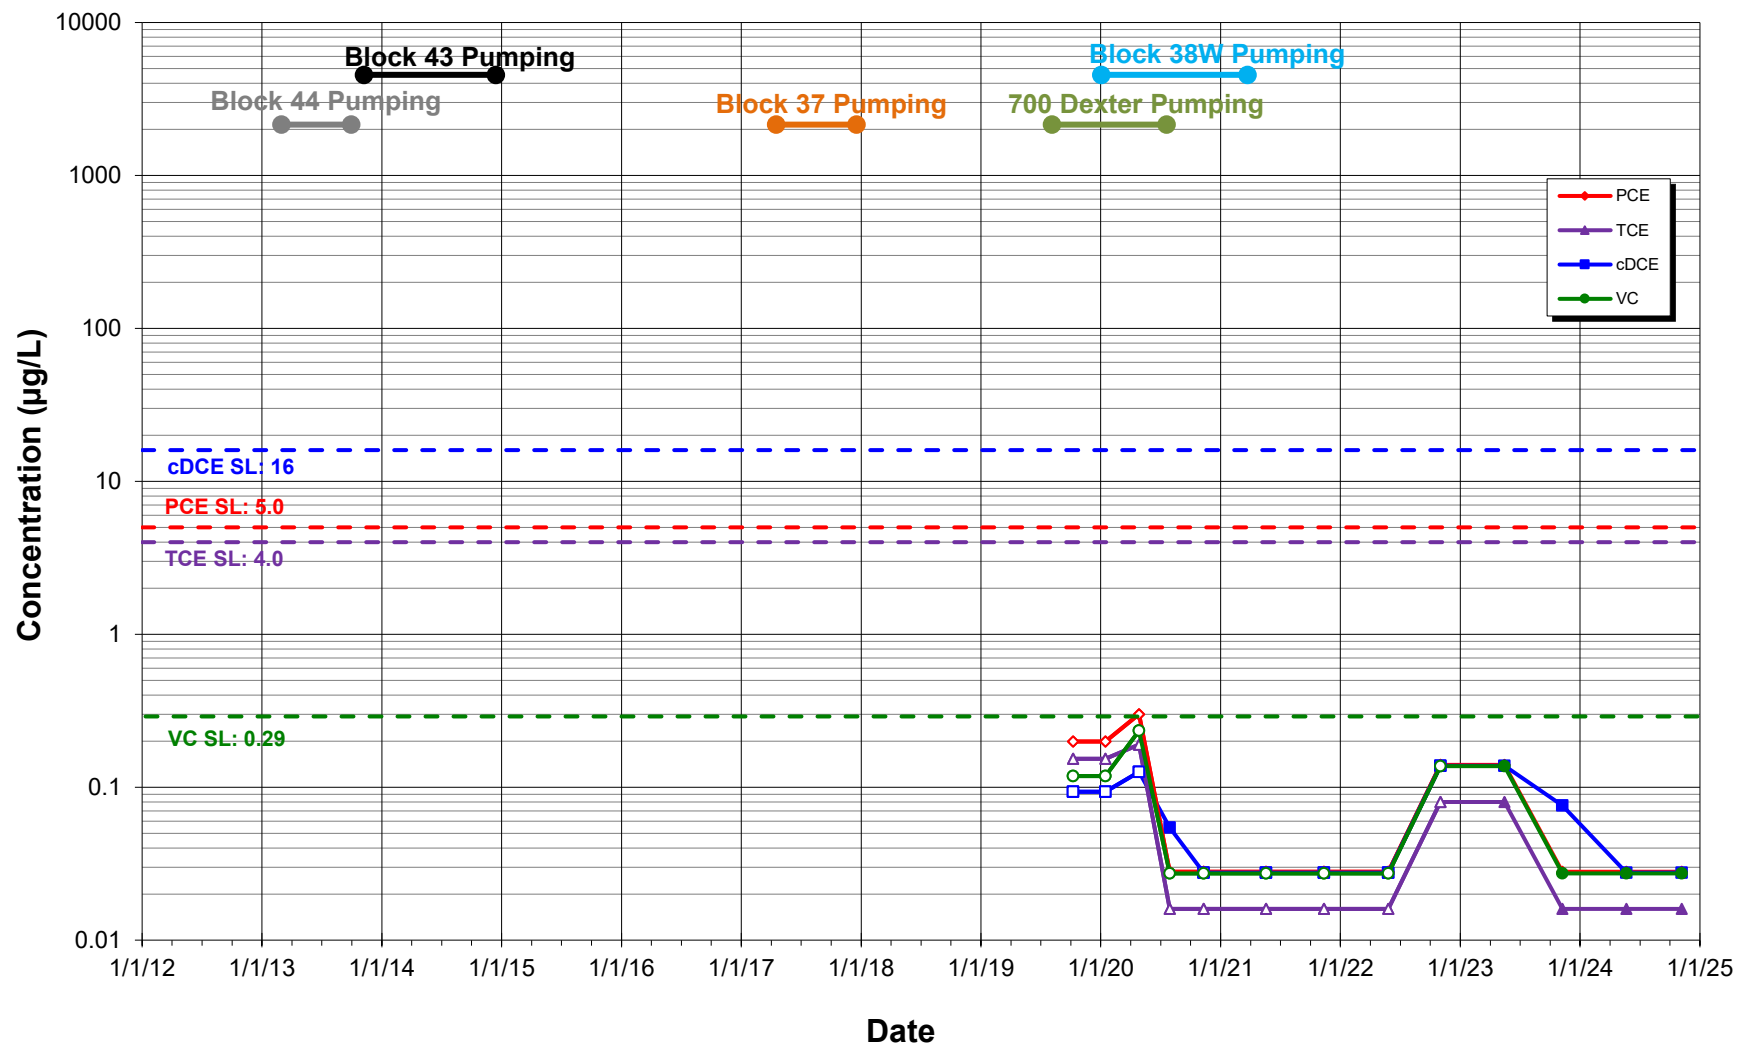
**Concentration vs Time**  
**MW-317 (3.4 to -6.6 feet NAVD), 9th Ave N ROW, W side**  
**American Linen Supply Co Dexter Ave Site**
