**Attachment A**  
**Well Completion Table**  
**American Linen Supply Co Dexter Ave Site**  
**700 Dexter Avenue North**  
**Seattle, Washington**

**ATTACHMENT B**

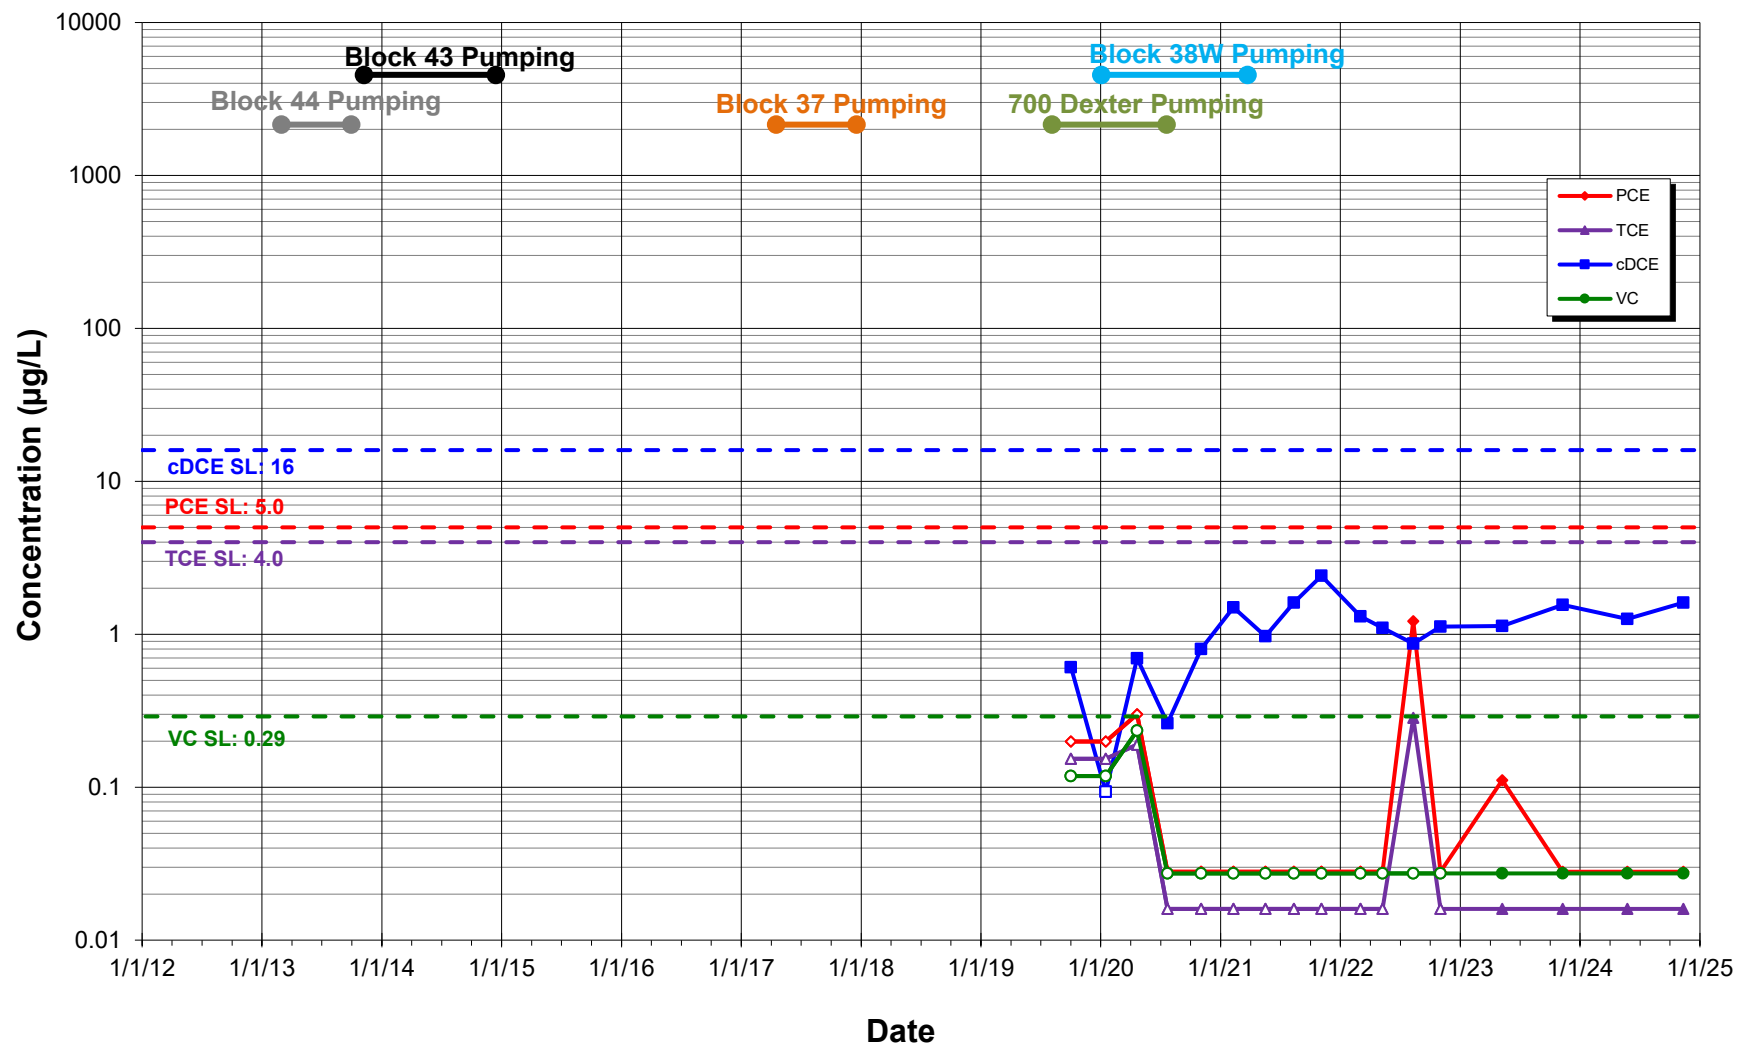
**Concentration vs Time**  
**MW-325 (7.0 to -3.0 feet NAVD), Mercer St ROW, N side**  
**American Linen Supply Co-Dexter Ave Site**

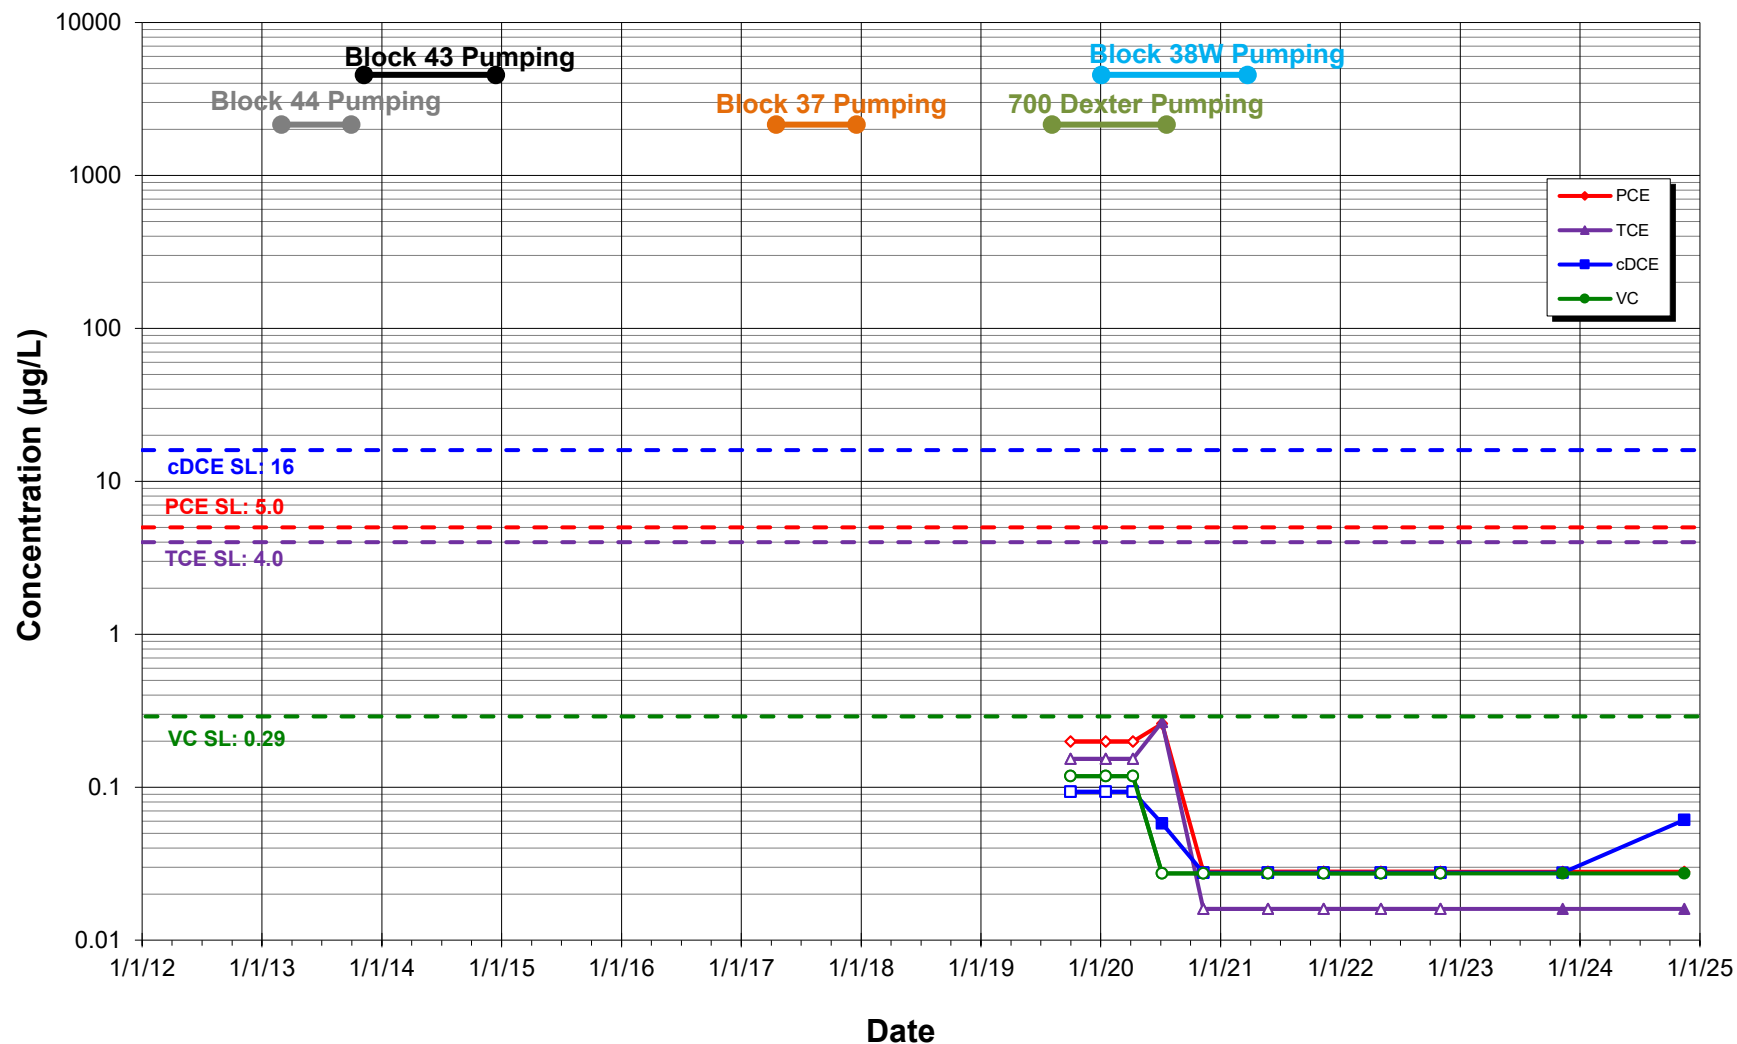
**Concentration vs Time**  
**MW-327 (3.6 to -6.3 feet NAVD), Lake Union Park, S side**  
**American Linen Supply Co Dexter Ave Site**

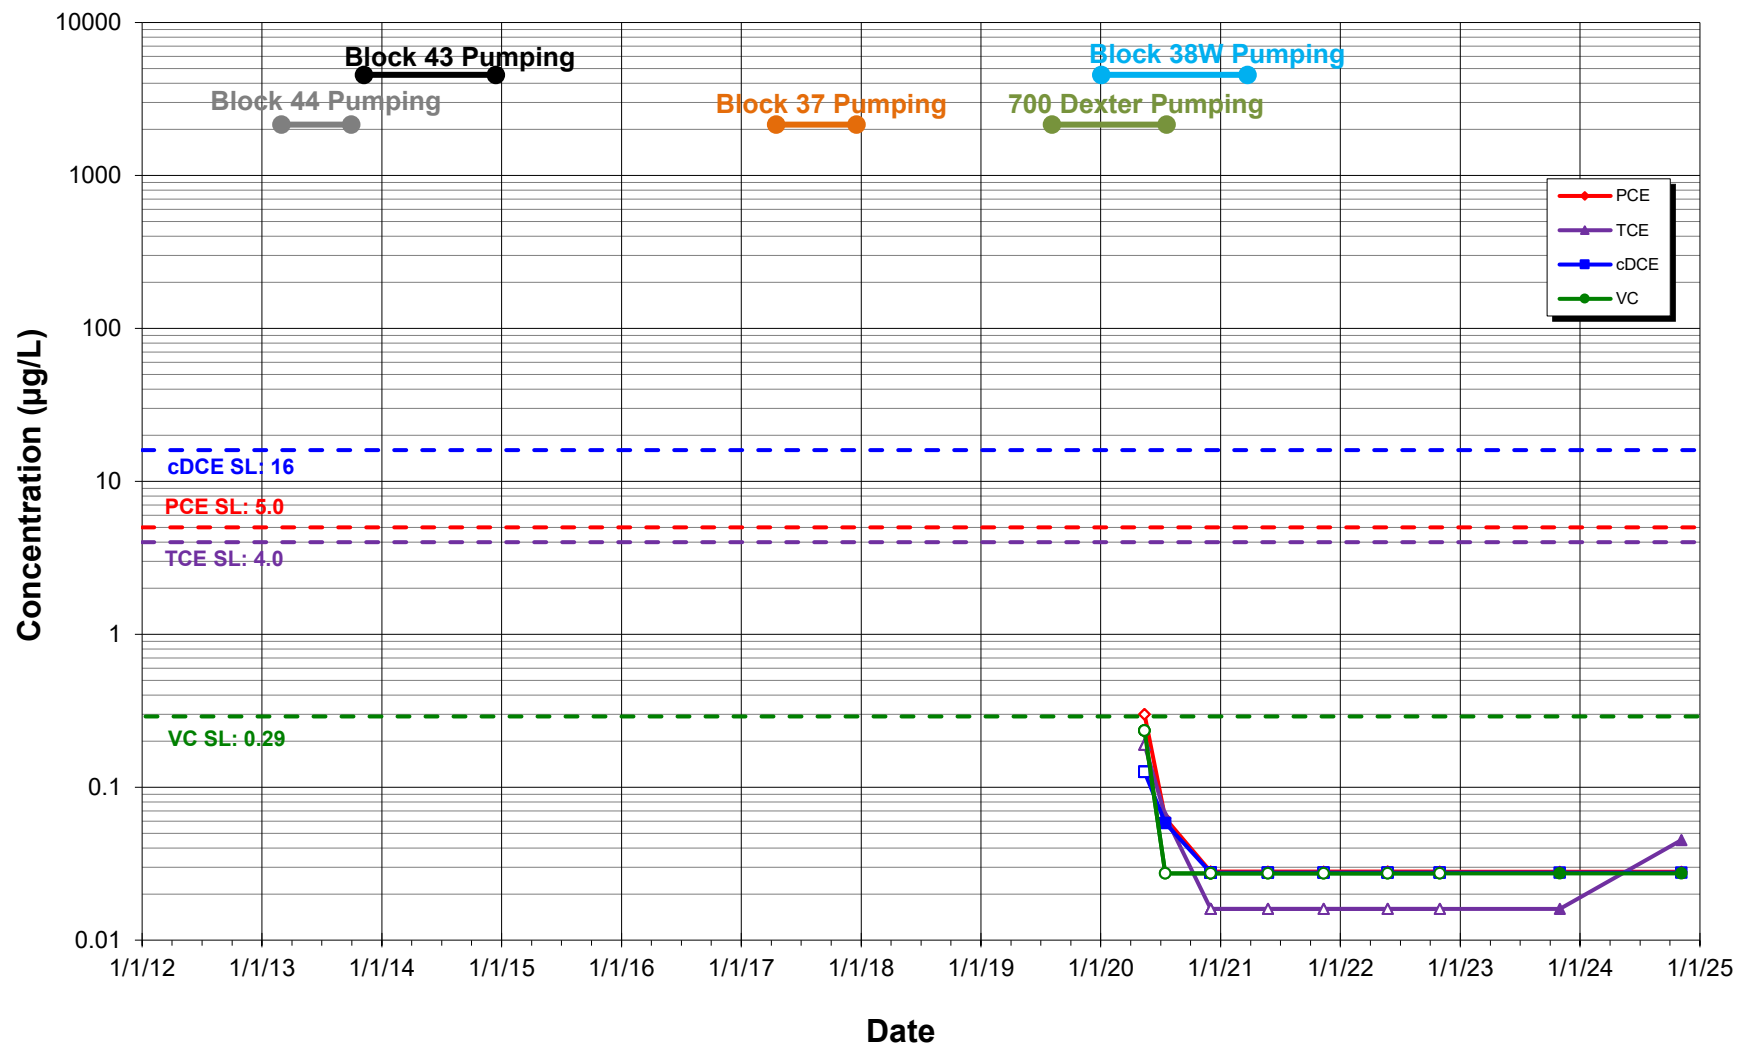
**Concentration vs Time**  
**MW-330 (0.0 to -10.0 feet NAVD), Valley St ROW, N side**  
**American Linen Supply Co Dexter Ave Site**

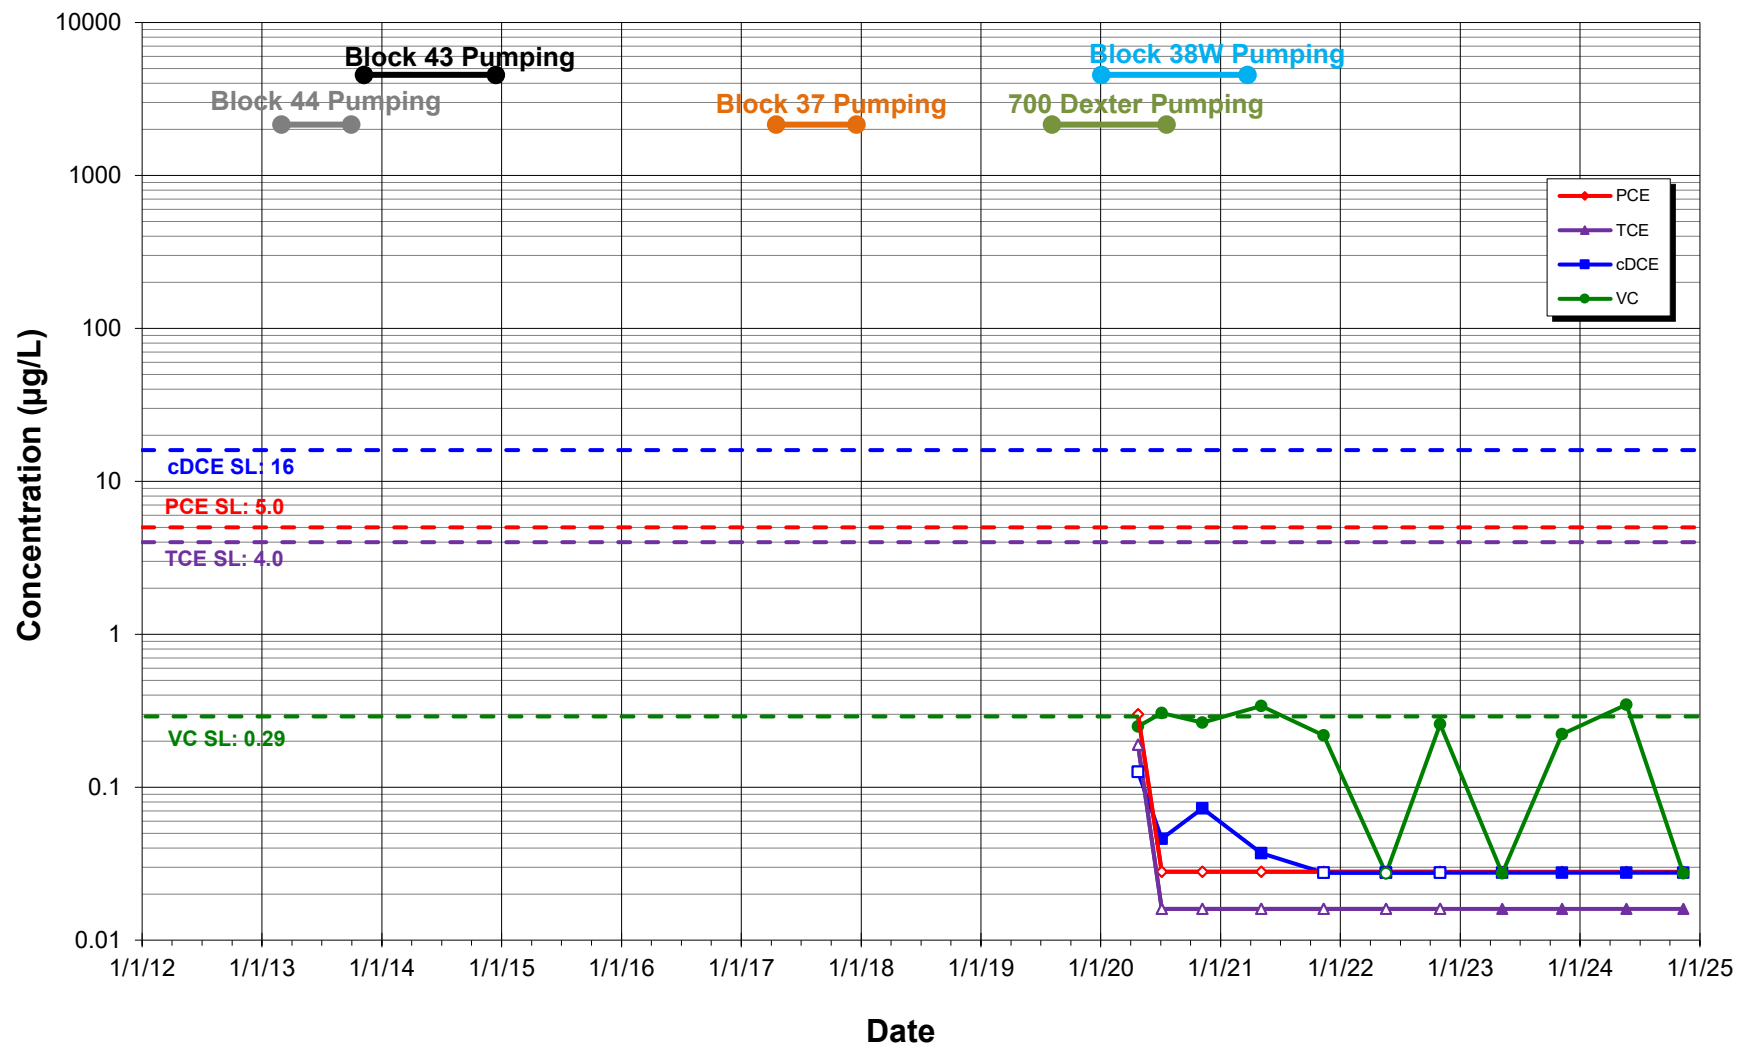
**Concentration vs Time**  
**MW-331 (-4.3 to -14.3 feet NAVD), Alley E of Seattle Roy Aloha Shops**  
**American Linen Supply Co Dexter Ave Site**

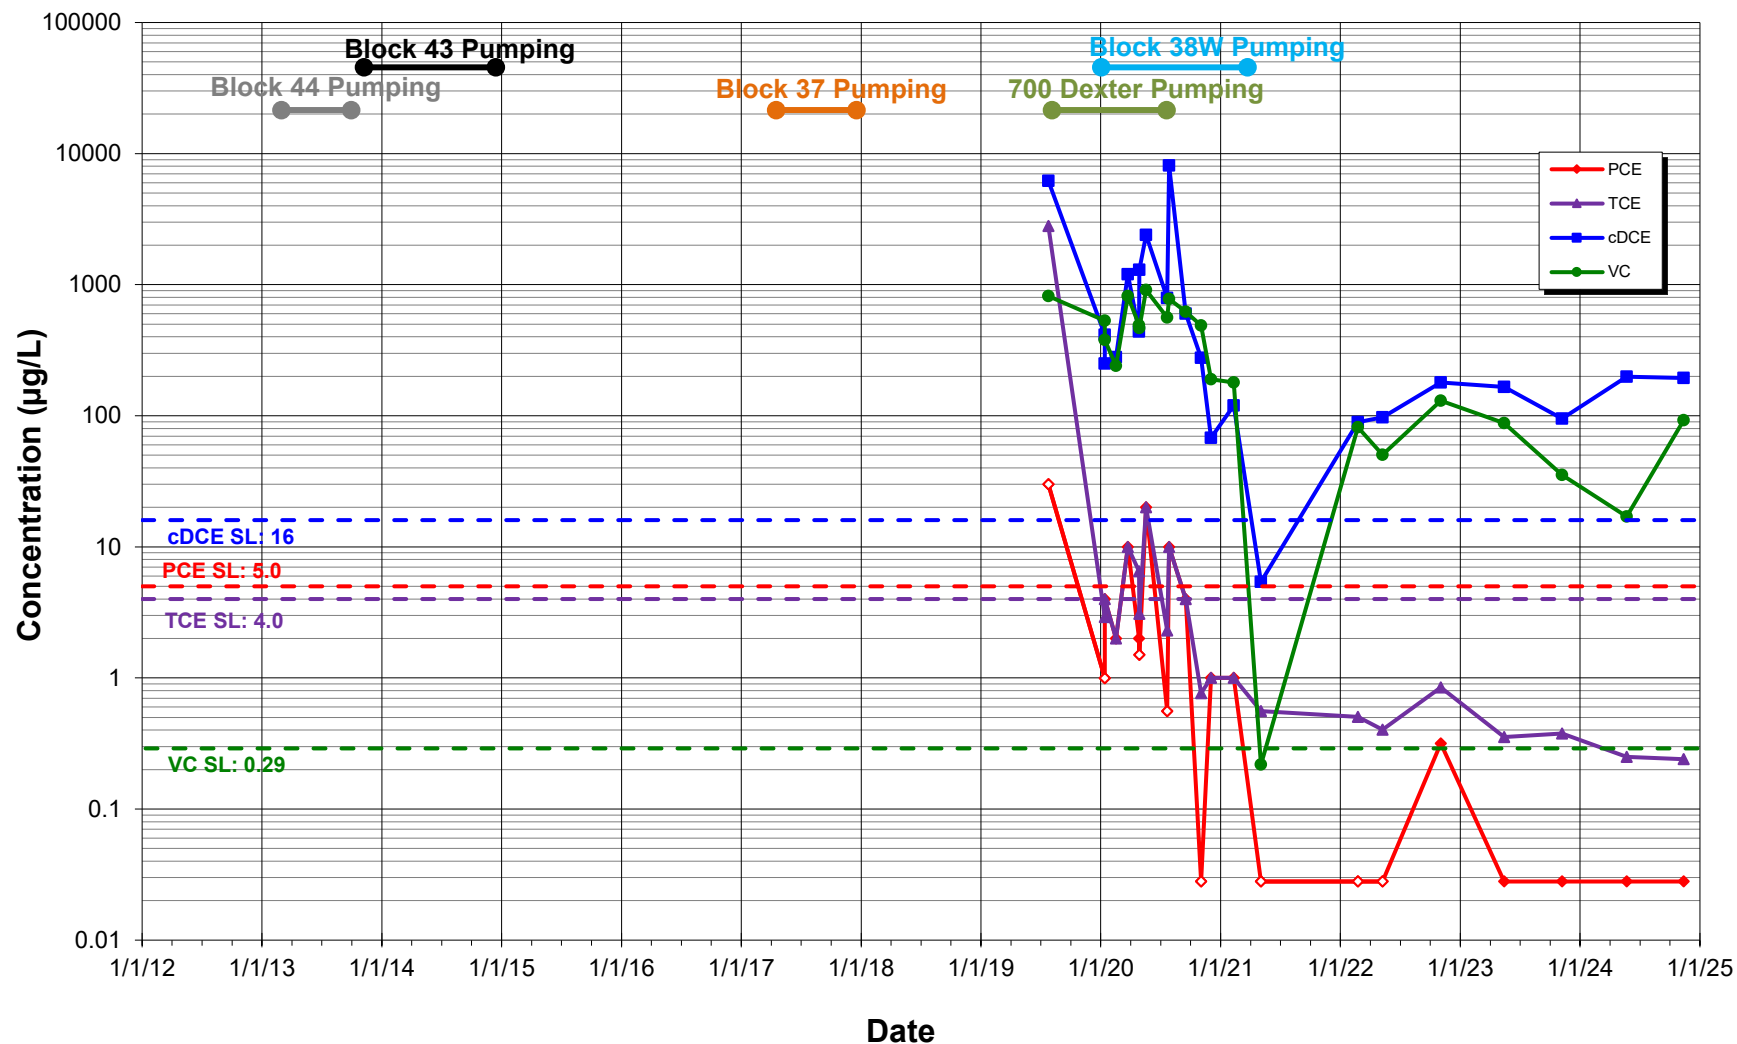
**Concentration vs Time**  
**FMW-141 (-12.1 to -22.1 feet NAVD), Alley E of Seattle Roy Aloha Shops**  
**American Linen Supply Co Dexter Ave Site**

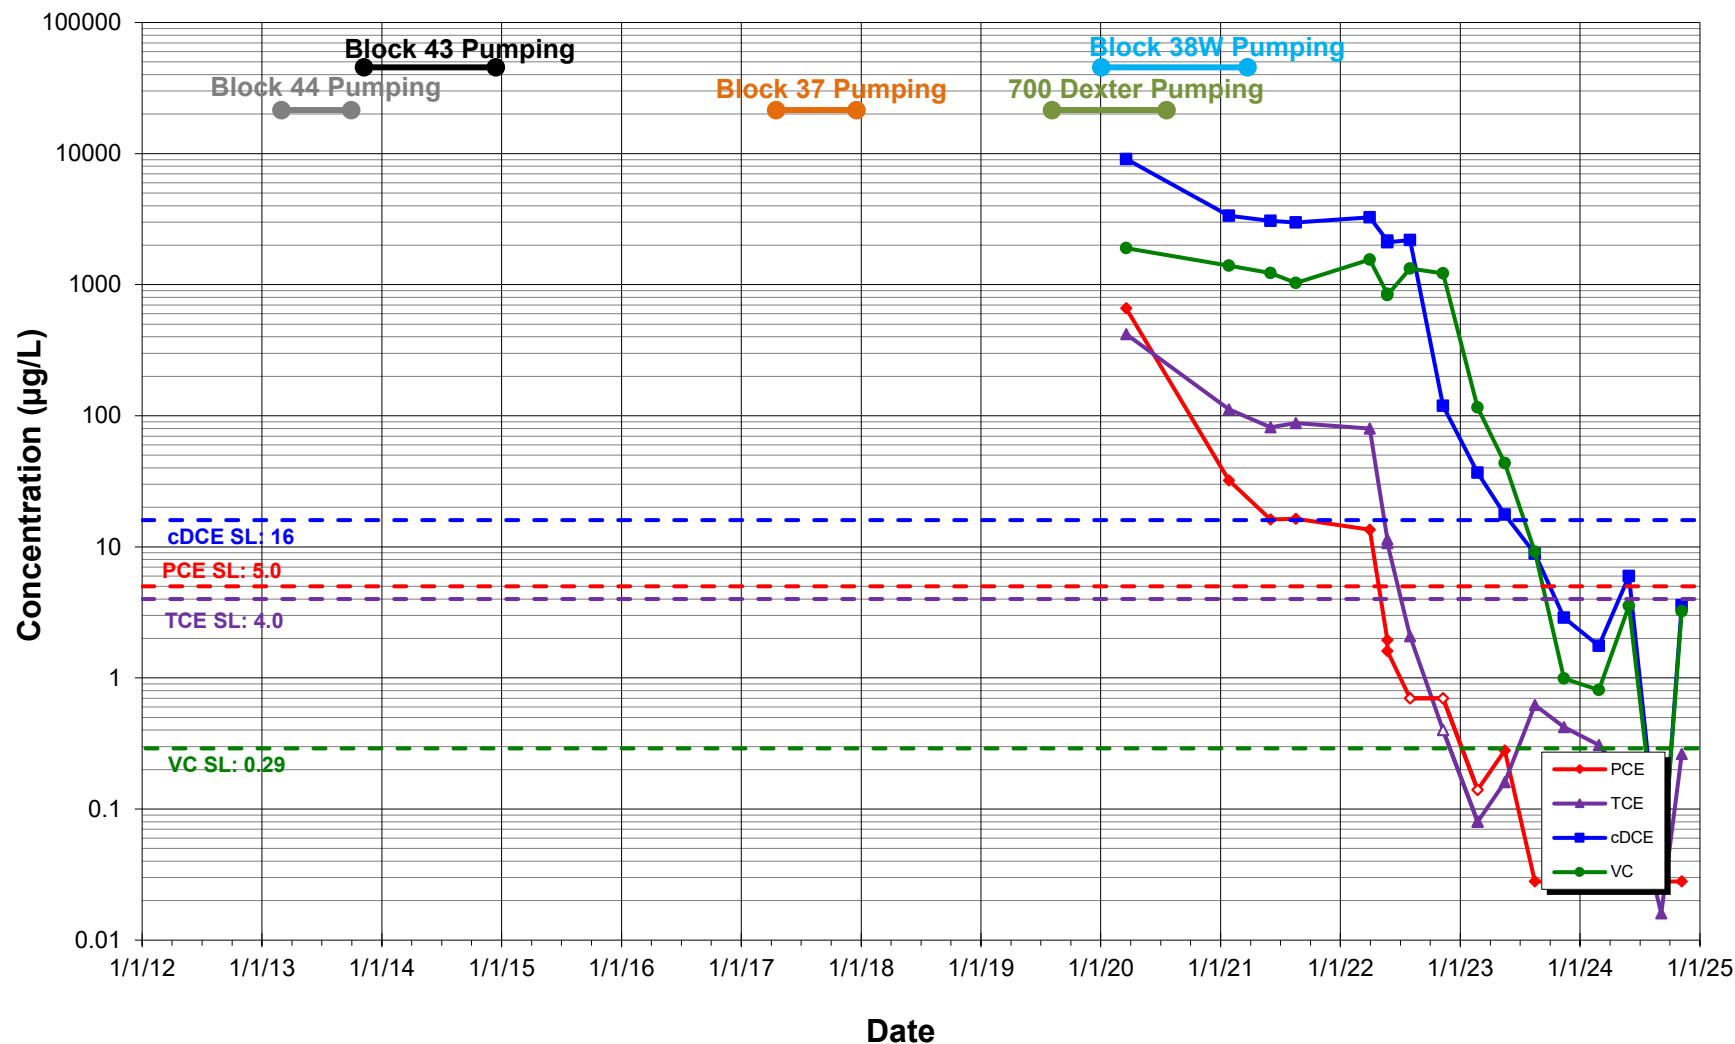
**Concentration vs Time**  
**HMW-9IB (-1.6 to -11.6 feet NAVD), Seattle DOT Mercer Parcels, SW quadrant**  
**American Linen Supply Co–Dexter Ave Site**

- 1) All results detected below the laboratory MDLs are shown as hollow data points.
- 2) Preliminary Screening Levels: PCE = 5.0 µg/L, TCE = 4.0 µg/L, cDCE = 16 µg/L, and VC = 0.29 µg/L.

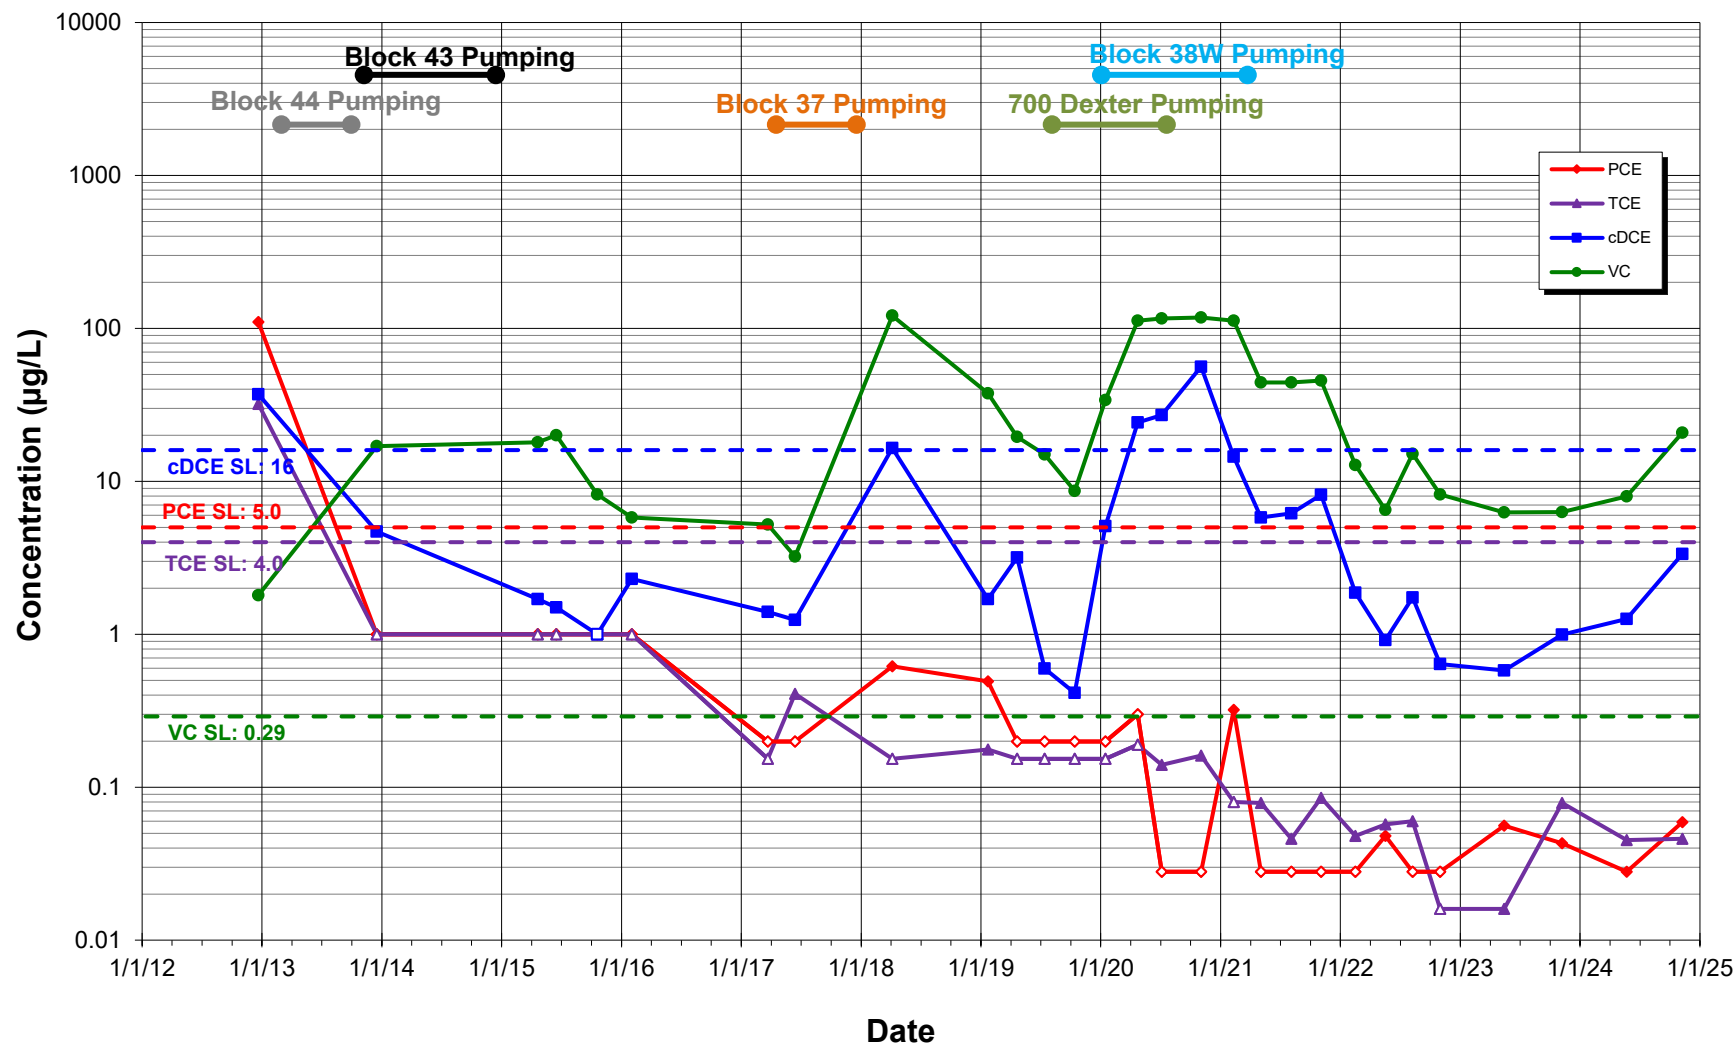
**Concentration vs Time**  
**MW111 (-33.5 to -43.5 feet NAVD), Alley E of Seattle Roy Aloha Shops**  
**American Linen Supply Co Dexter Ave Site**

- 1) All results detected below the laboratory MDLs are shown as hollow data points.
- 2) Preliminary Screening Levels: PCE = 5.0 µg/L, TCE = 4.0 µg/L, cDCE = 16 µg/L, and VC = 0.29 µg/L.

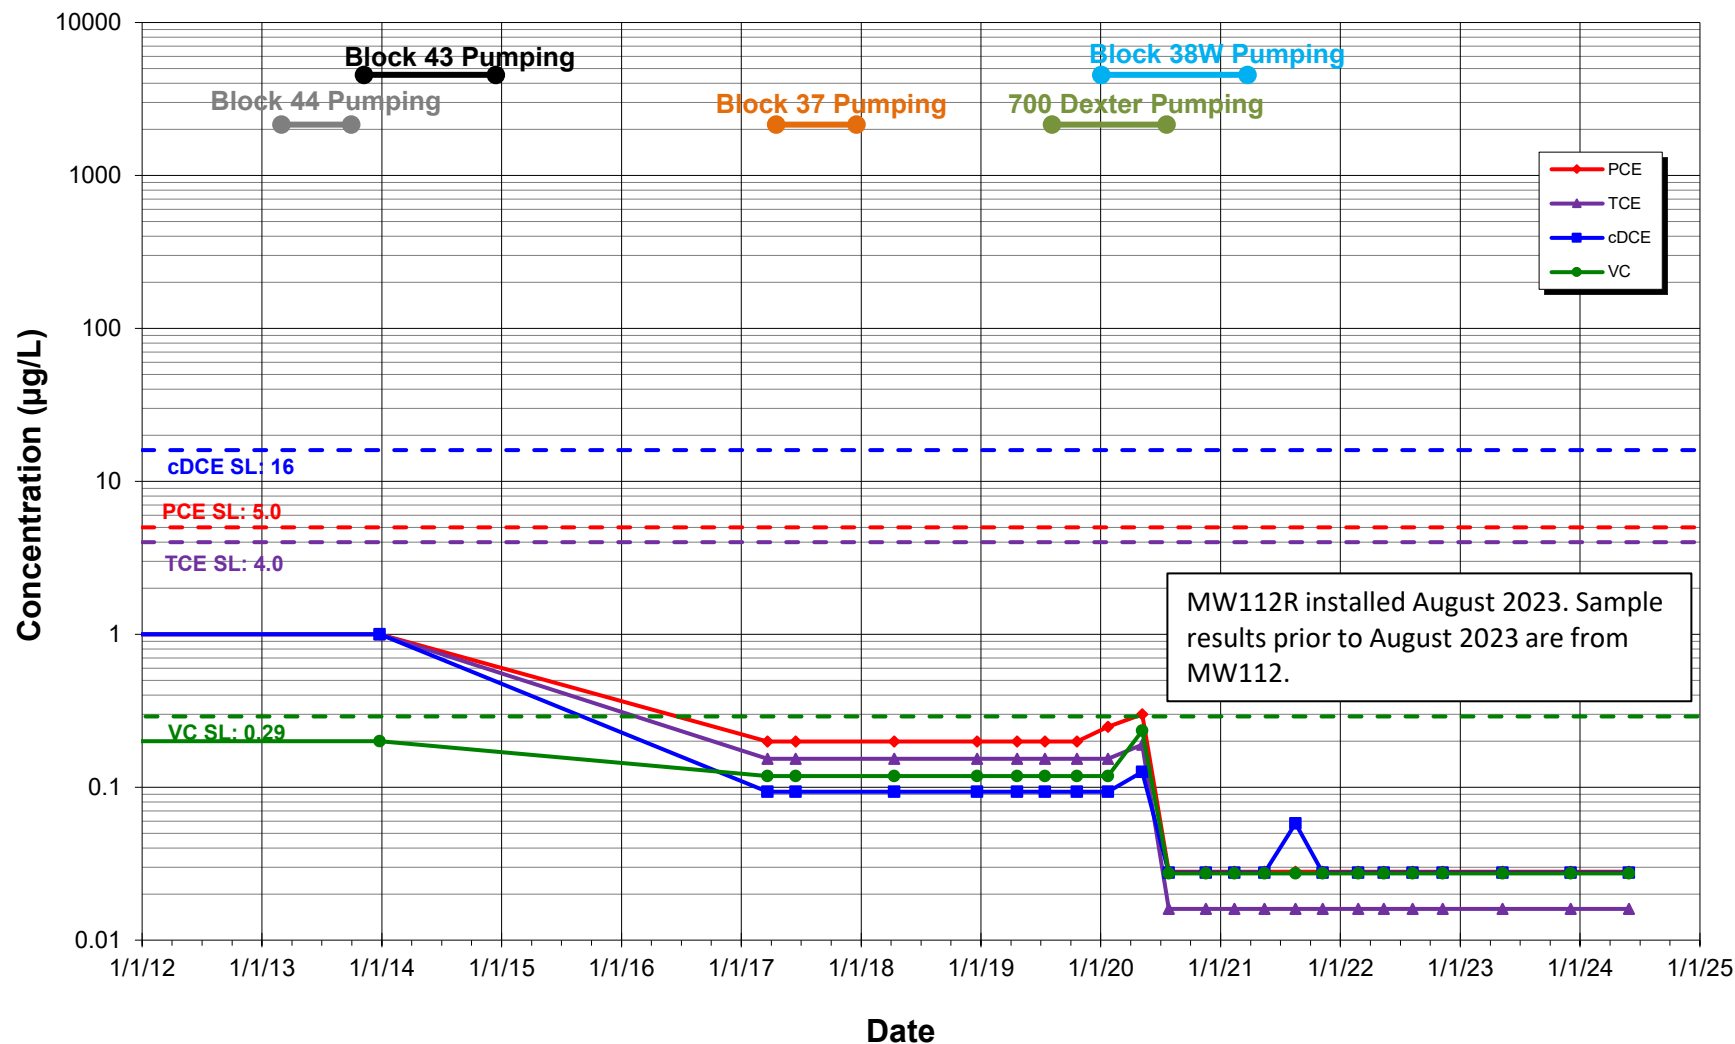
**Concentration vs Time**  
**MW112R (Not Yet Surveyed), Dexter Ave N ROW, W side**  
**American Linen Supply Co Dexter Ave Site**

- 1) All results detected below the laboratory MDLs are shown as hollow data points.
- 2) Preliminary Screening Levels: PCE = 5.0 µg/L, TCE = 4.0 µg/L, cDCE = 16 µg/L, and VC = 0.29 µg/L.

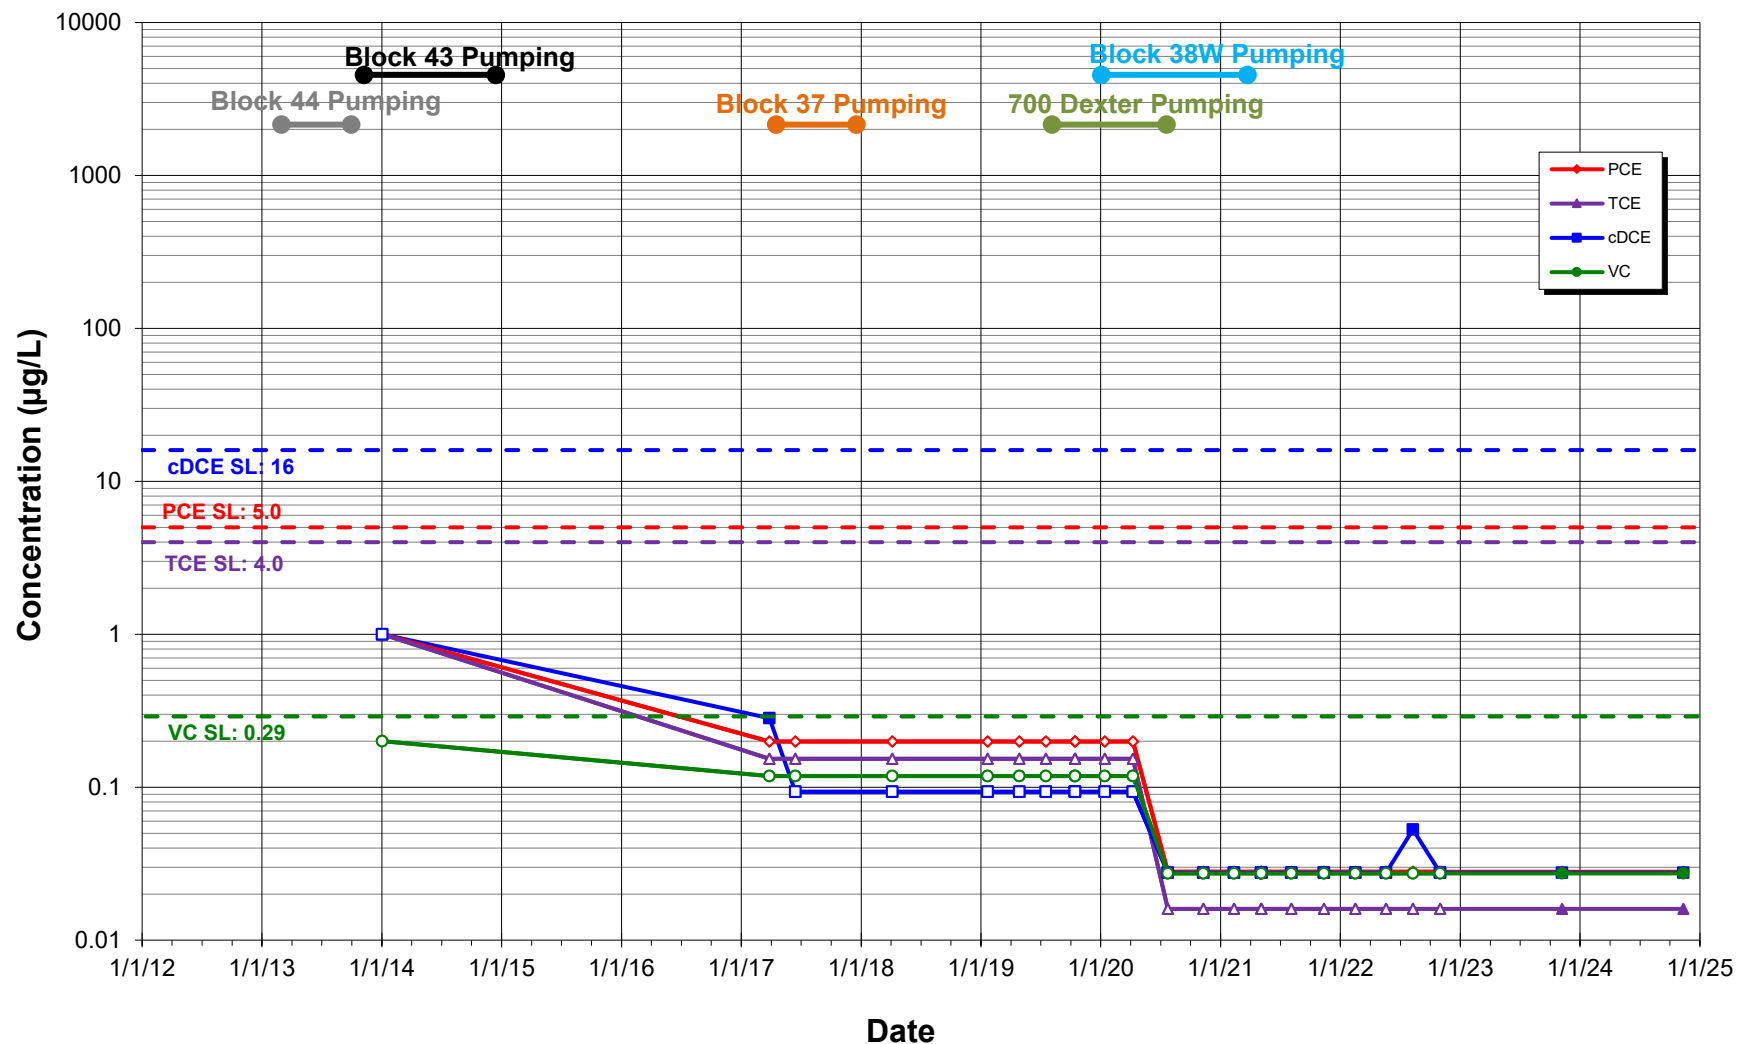
**Concentration vs Time**  
**MW126 (-54.1 to -64.1 feet NAVD), Alley E of Seattle Roy Aloha Shops**  
**American Linen Supply Co Dexter Ave Site**

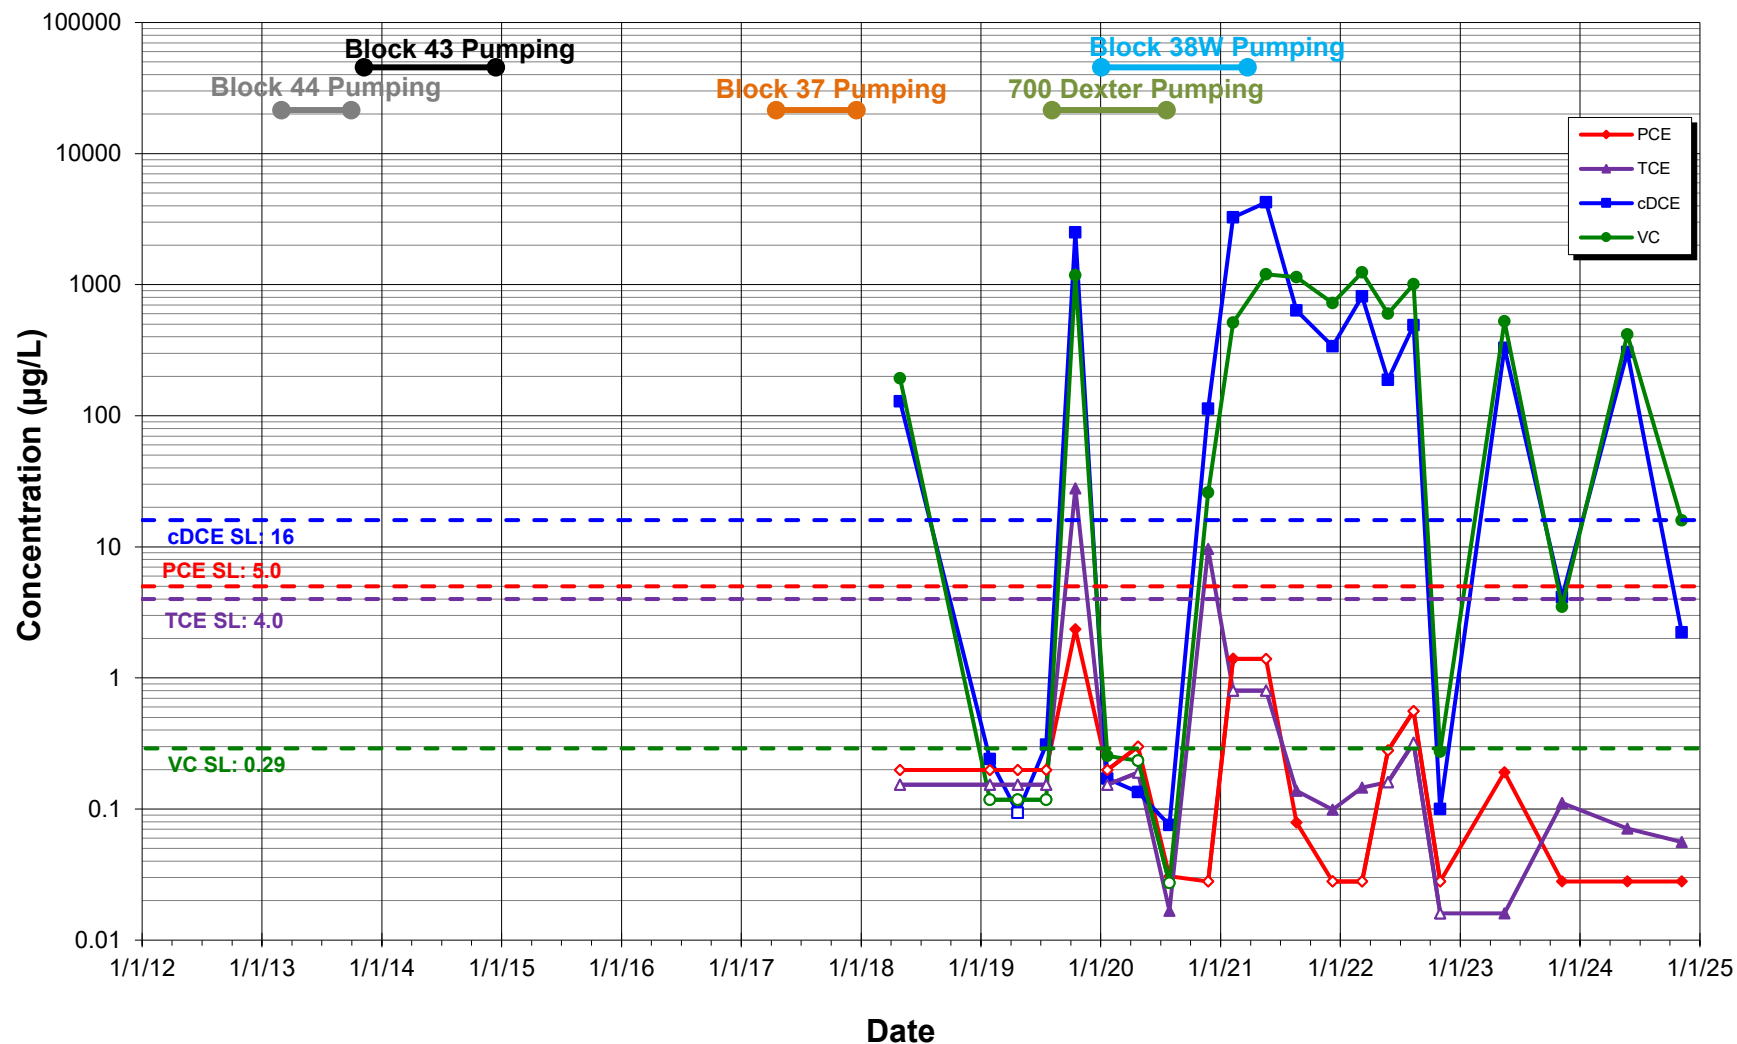
**Concentration vs Time**  
**MW-143 (-27.7 to -37.6 feet NAVD), 8th Ave N ROW, E side**  
**American Linen Supply Co Dexter Ave Site**

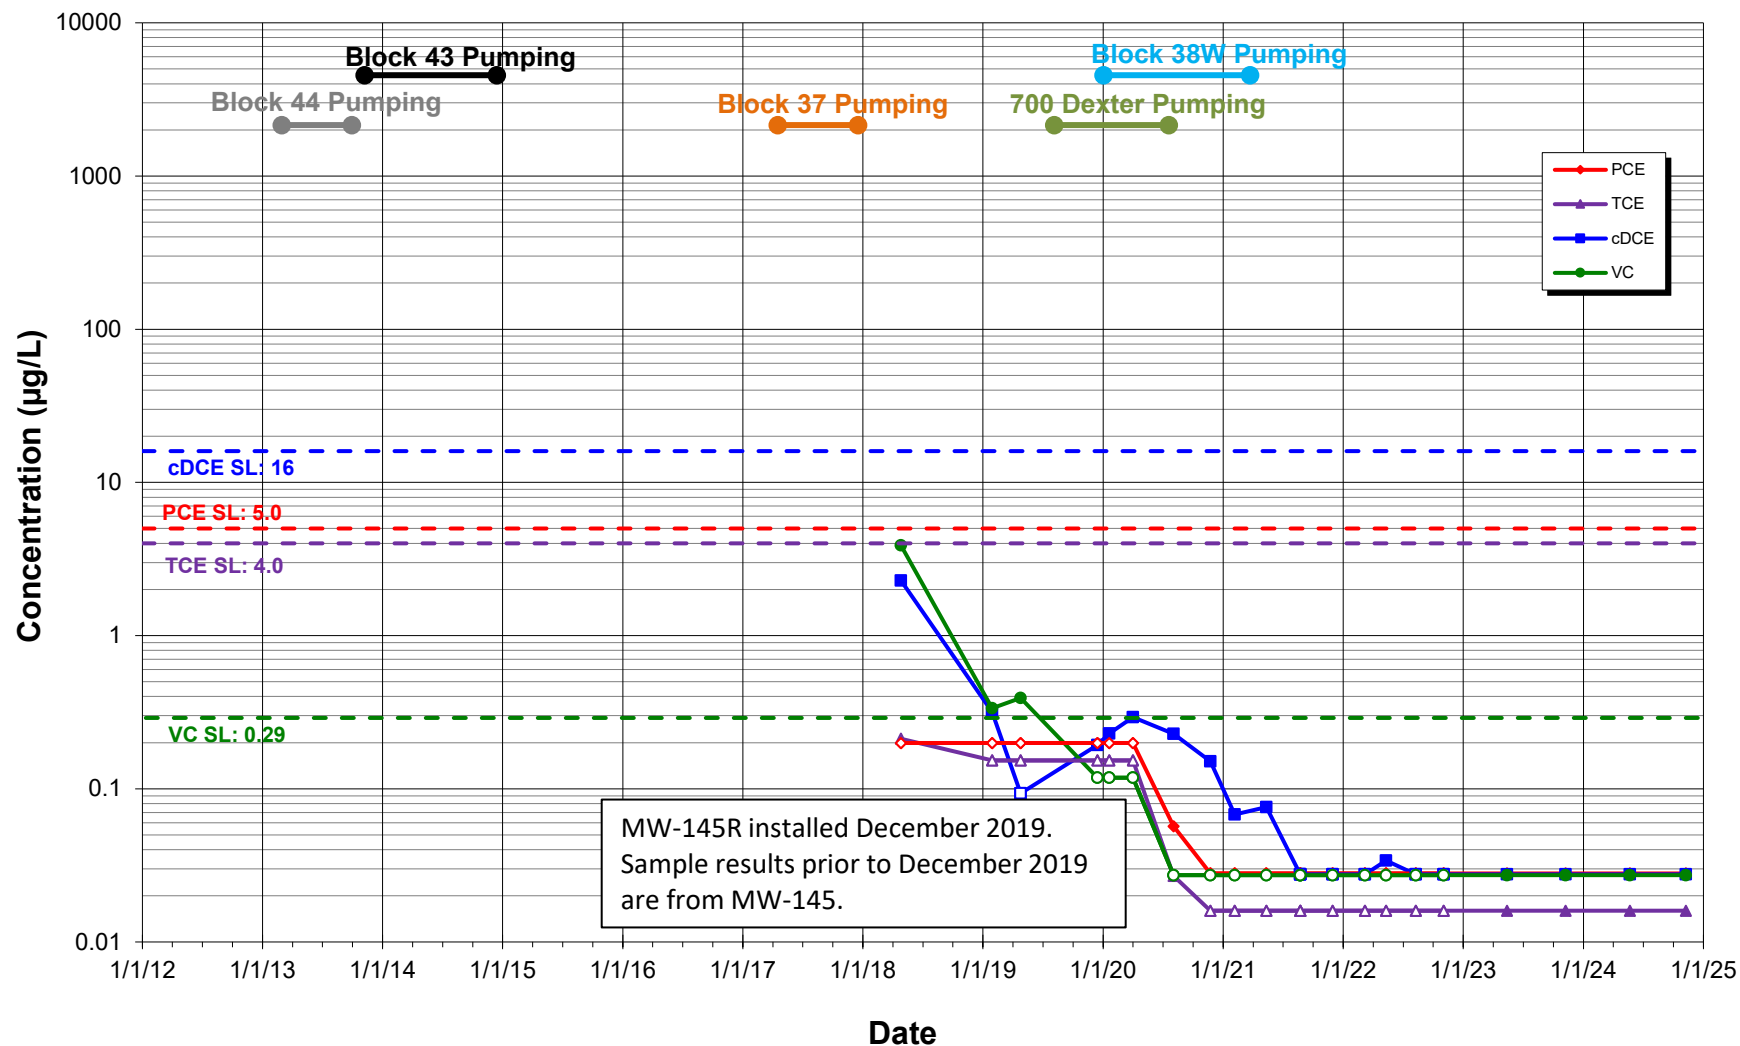
**Concentration vs Time**  
**MW-145R (-27.2 to -37.2 feet NAVD), 8th Ave N ROW, E side**  
**American Linen Supply Co Dexter Ave Site**

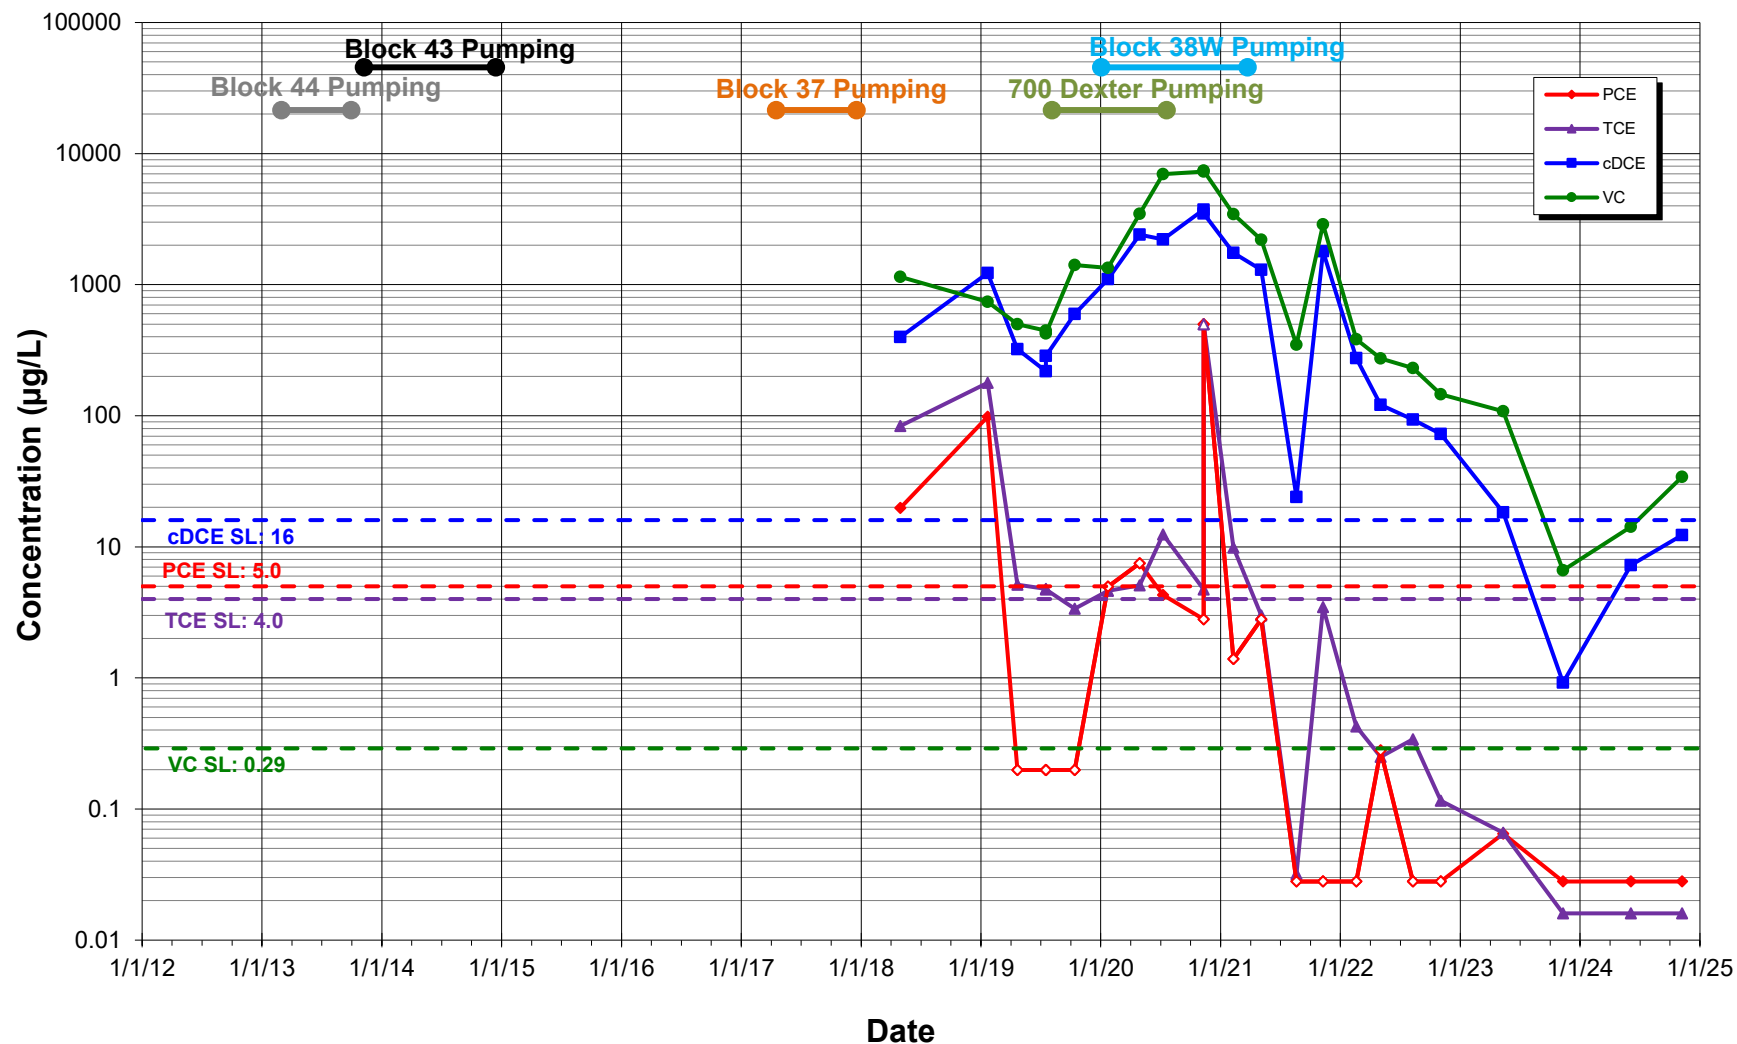
**Concentration vs Time**  
**MW-147 (-17.6 to -27.6 feet NAVD), Roy St ROW, S side**  
**American Linen Supply Co Dexter Ave Site**
