**Attachment A**  
**Well Completion Table**  
**American Linen Supply Co Dexter Ave Site**  
**700 Dexter Avenue North**  
**Seattle, Washington**

**ATTACHMENT B**

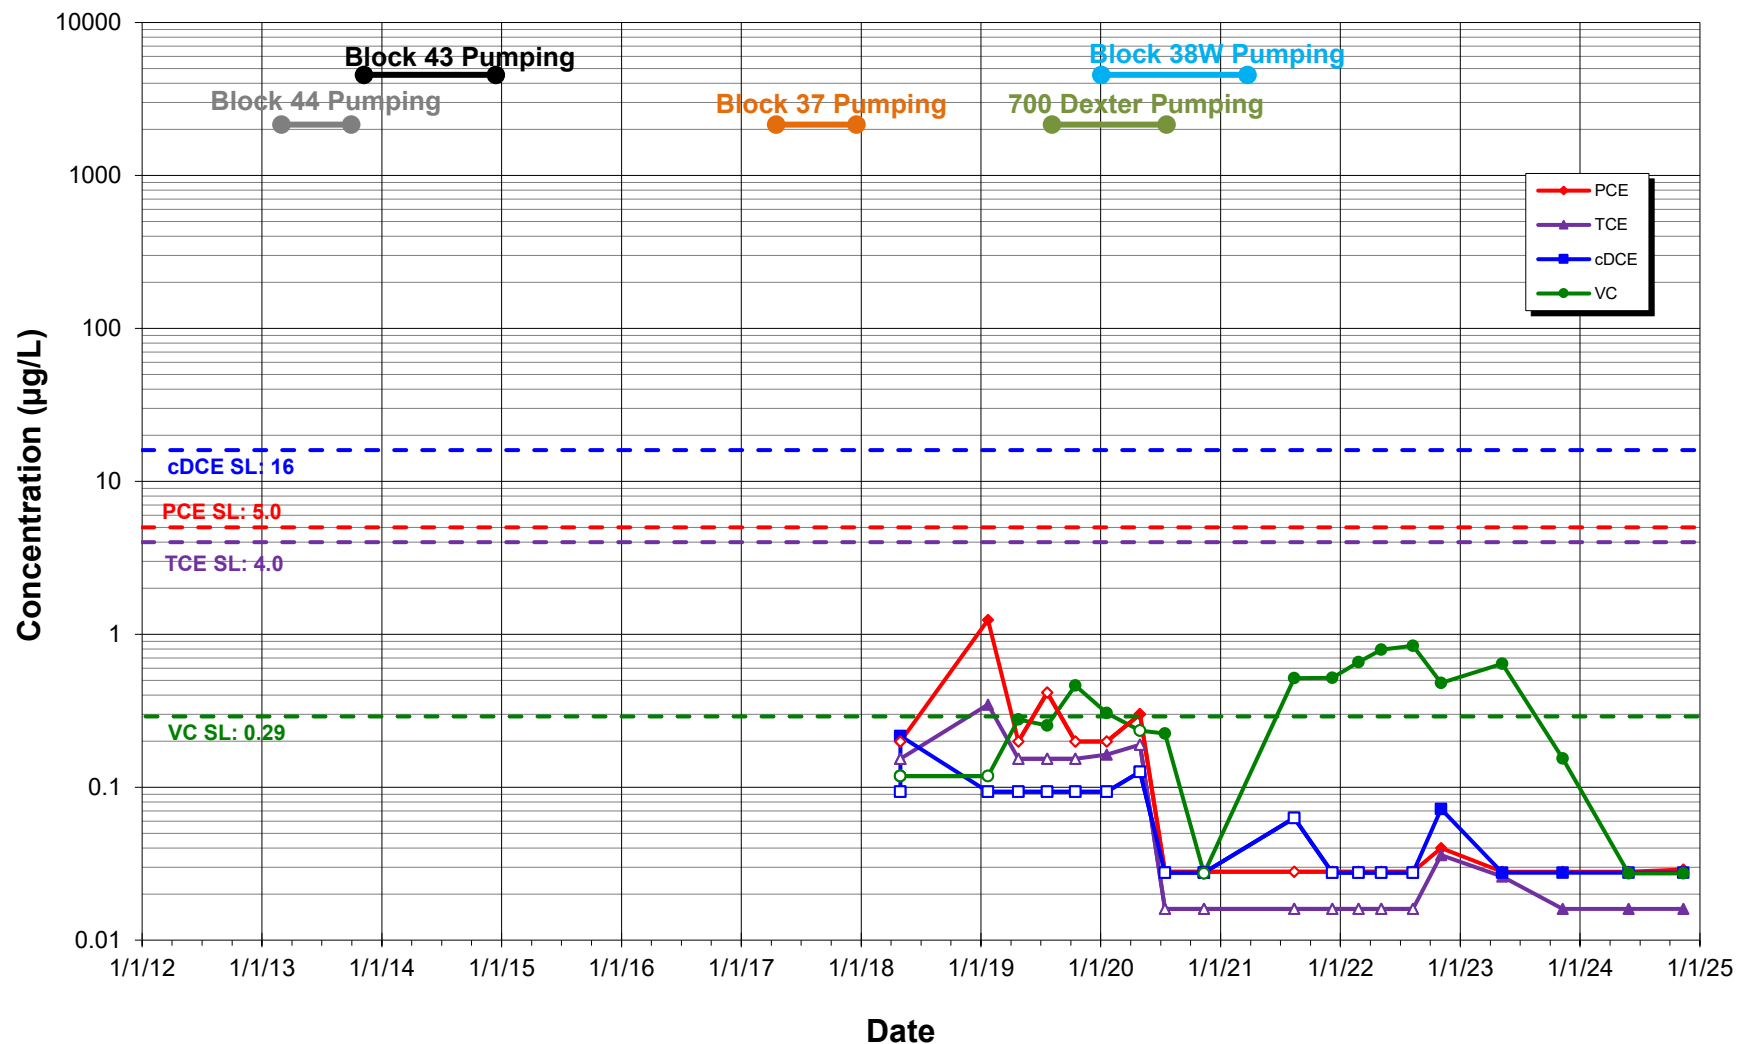
**Concentration vs Time**  
**MW-148 (-25.7 to -35.7 feet NAVD), Roy St ROW, S side**  
**American Linen Supply Co Dexter Ave Site**

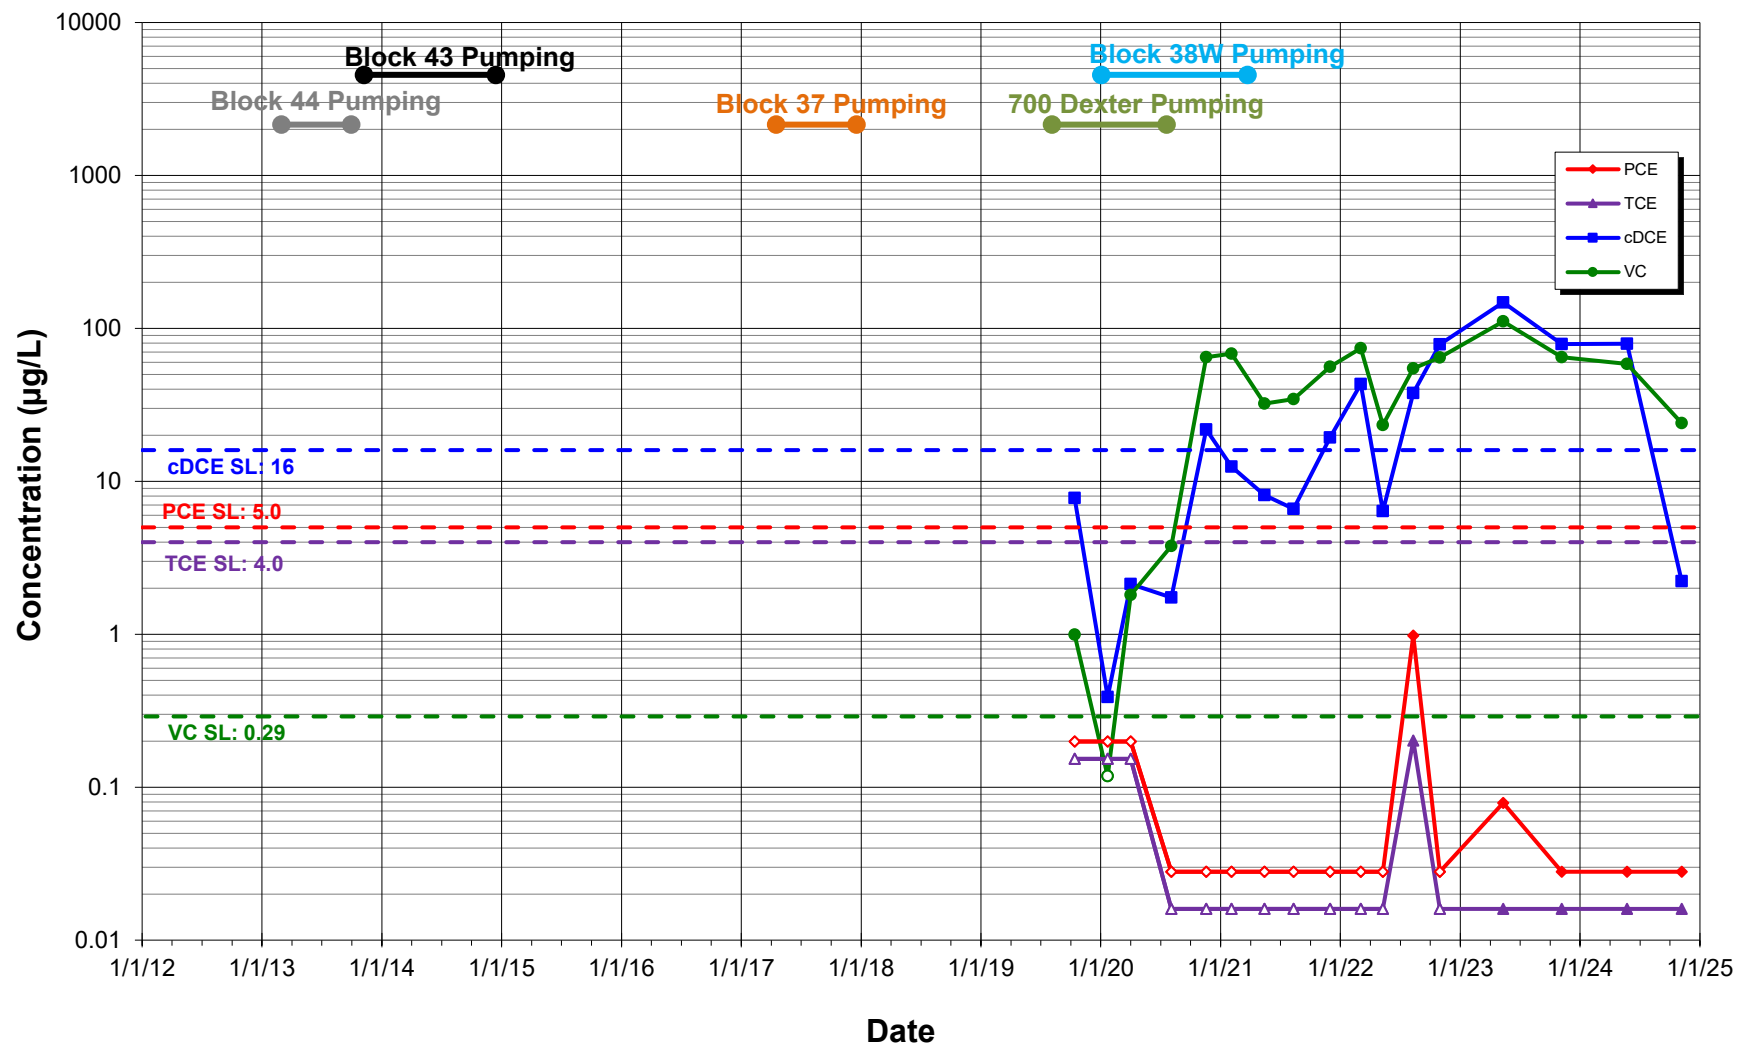
**Concentration vs Time**  
**MW-190 (-30.2 to -40.2 feet NAVD), Valley St ROW, S side**  
**American Linen Supply Co Dexter Ave Site**

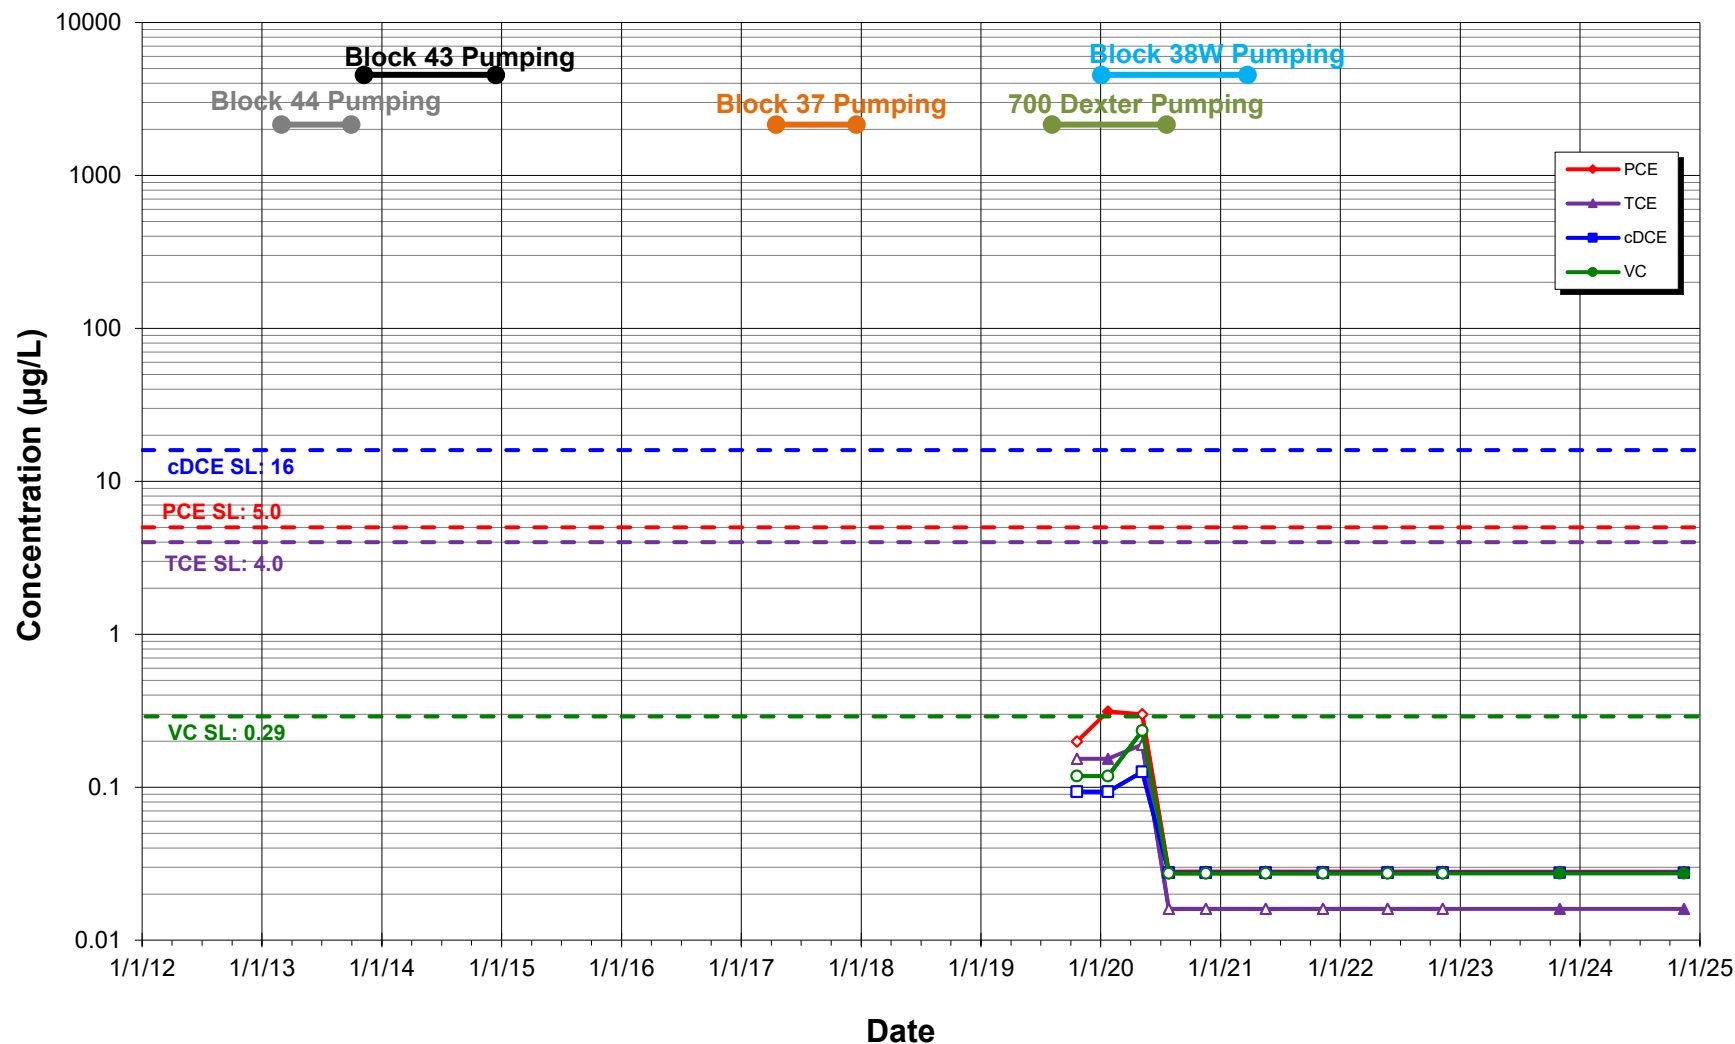
**Concentration vs Time**  
**MW-303 (-13.8 to -23.8 feet NAVD), Dexter Ave N ROW, E side**  
**American Linen Supply Co Dexter Ave Site**

- 1) All results detected below the laboratory MDLs are shown as hollow data points.
- 2) Preliminary Screening Levels: PCE = 5.0 µg/L, TCE = 4.0 µg/L, cDCE = 16 µg/L, and VC = 0.29 µg/L.

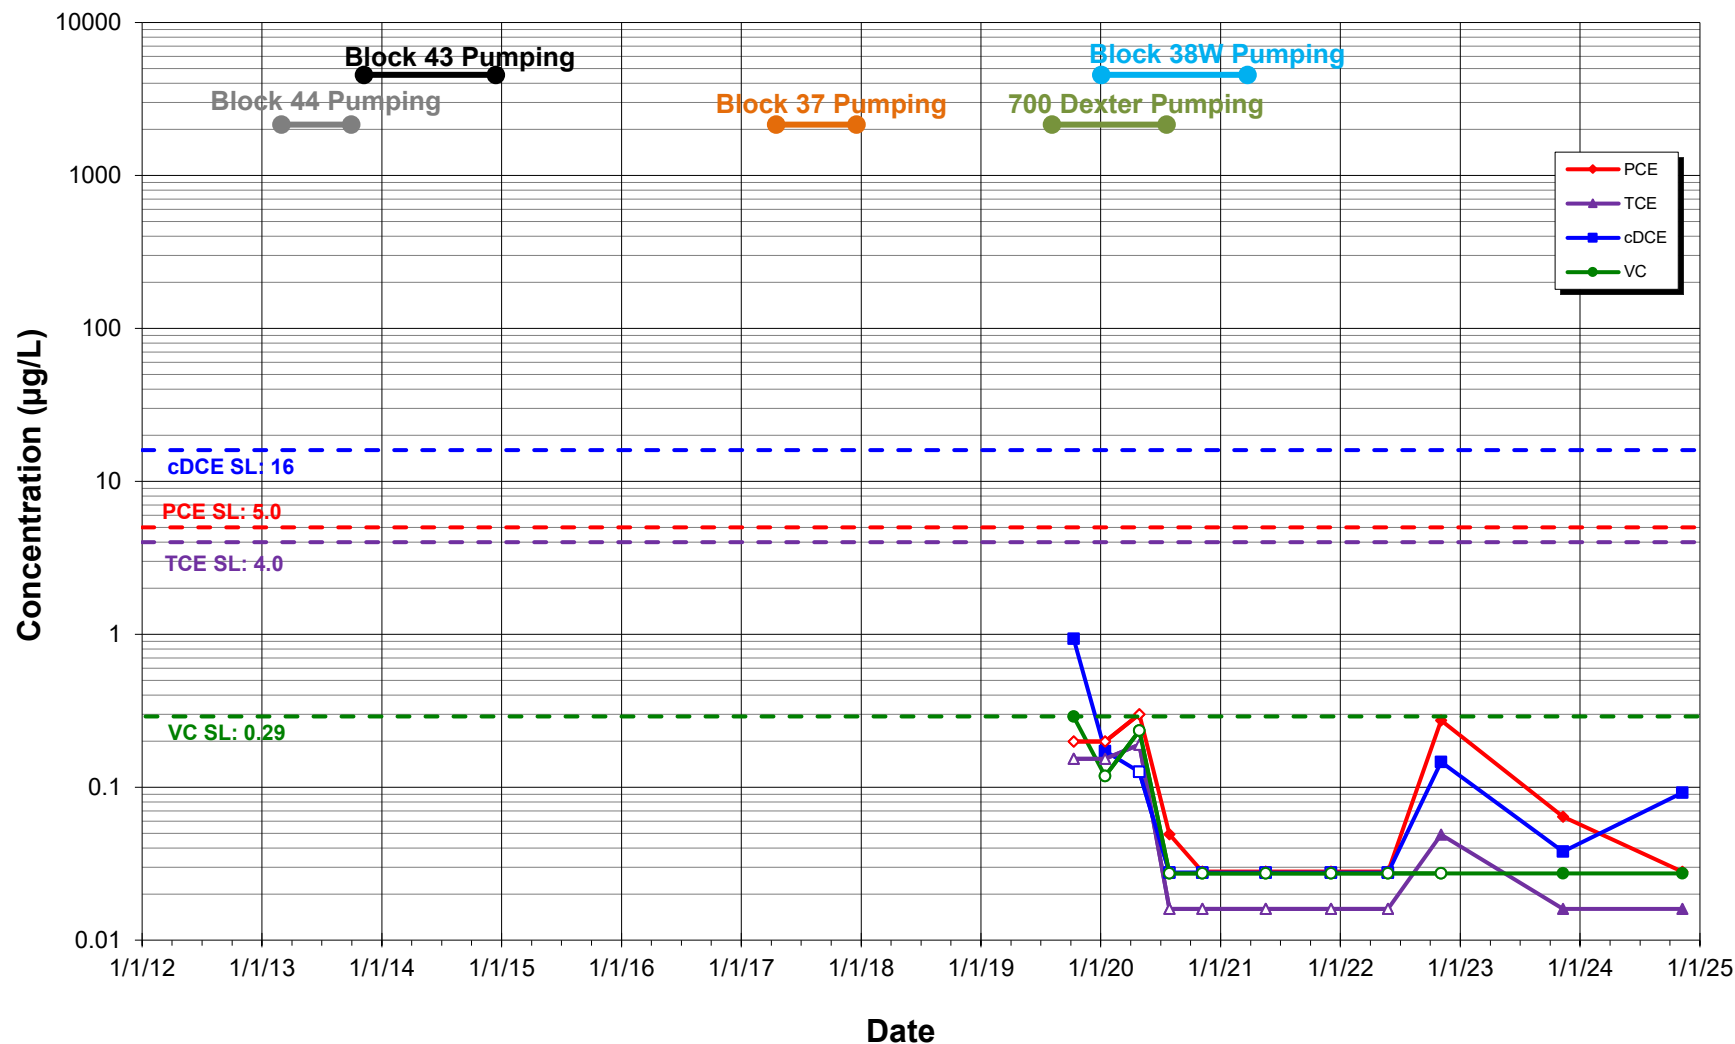
**Concentration vs Time**  
**MW-307 (-12.4 to -22.4 feet NAVD), Roy St ROW, S side**  
**American Linen Supply Co Dexter Ave Site**

- 1) All results detected below the laboratory MDLs are shown as hollow data points.
- 2) Preliminary Screening Levels: PCE = 5.0 µg/L, TCE = 4.0 µg/L, cDCE = 16 µg/L, and VC = 0.29 µg/L.

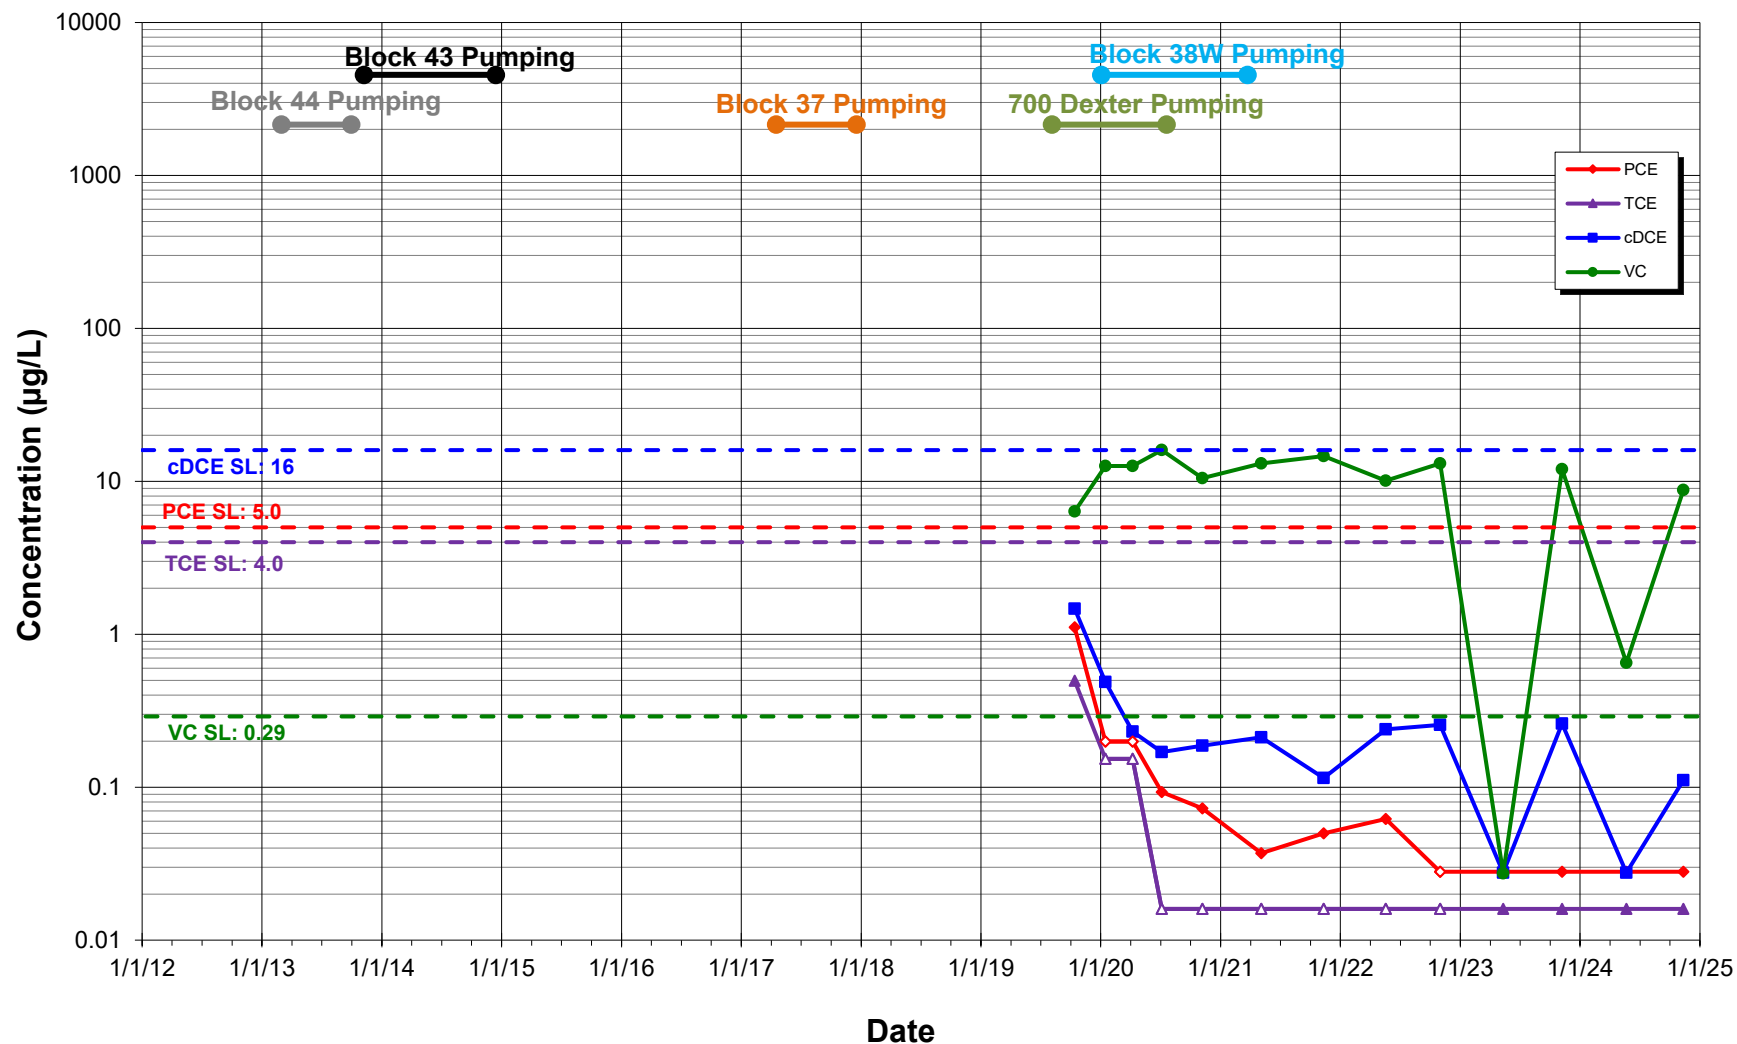
**Concentration vs Time**  
**MW-309 (-32.0 to -42.0 feet NAVD), Alley E of Seattle Roy Aloha Shops**  
**American Linen Supply Co Dexter Ave Site**

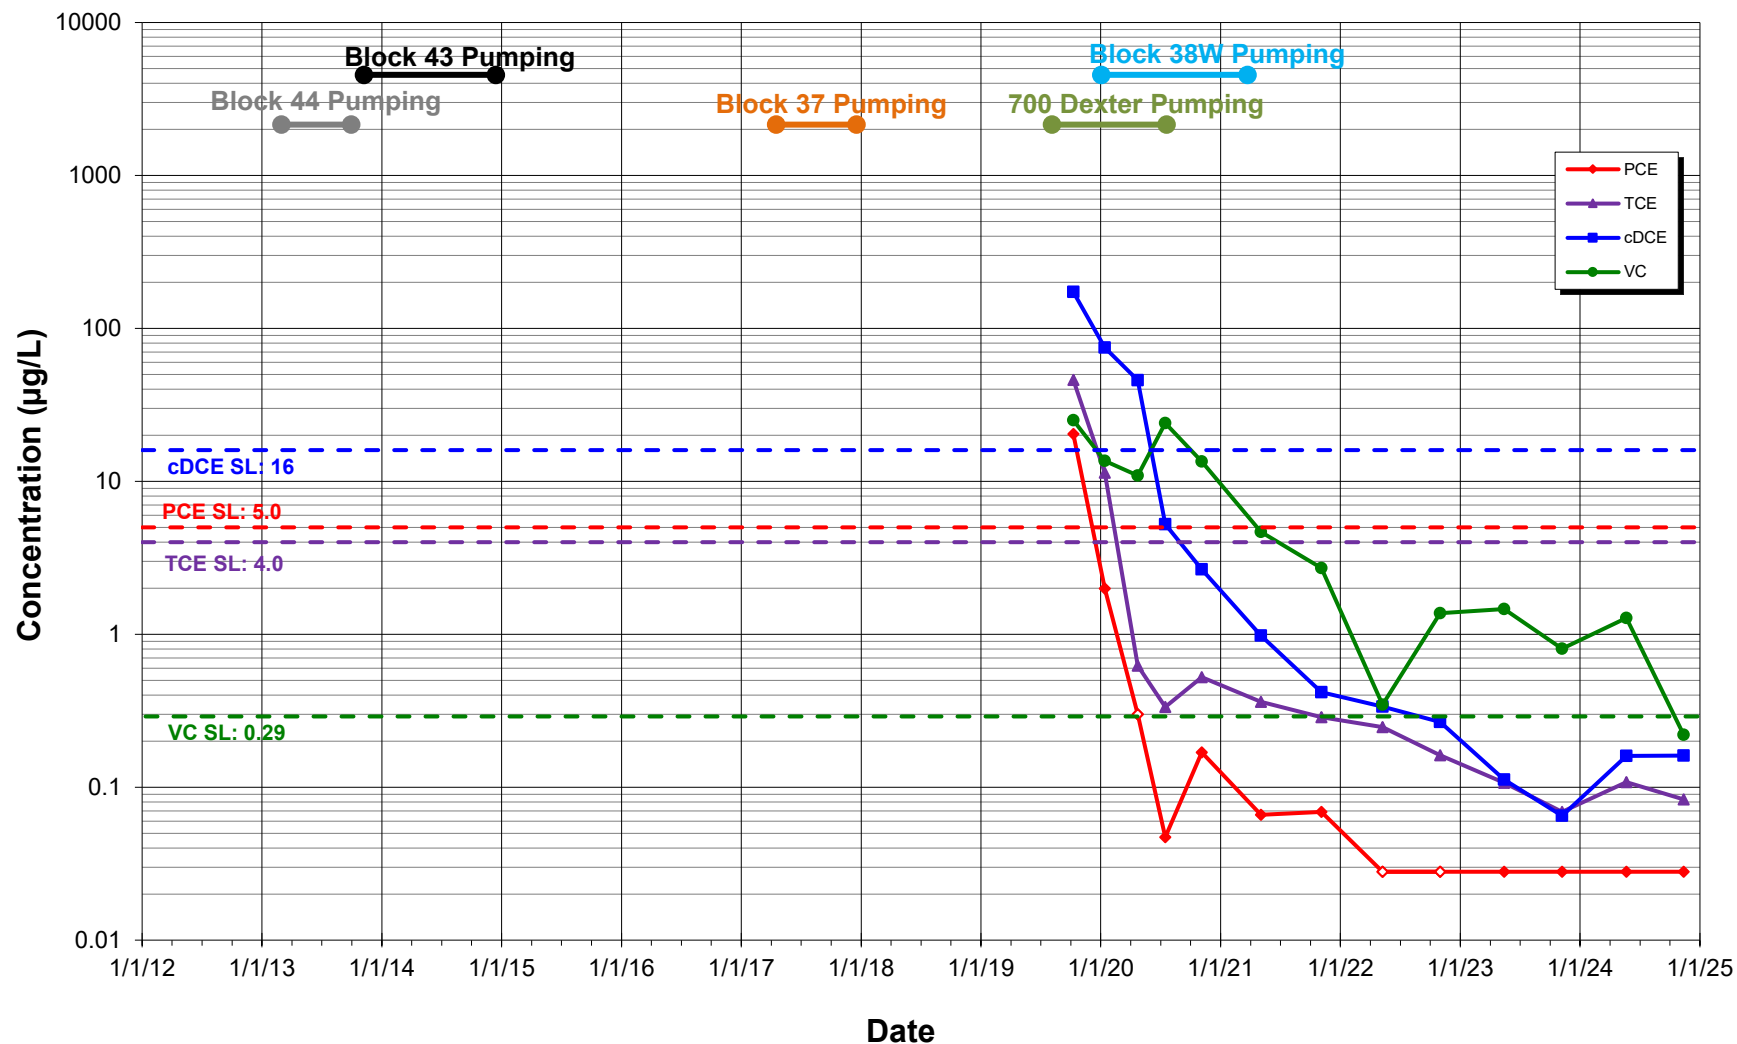
**Concentration vs Time**  
**MW-311 (-29.1 to -39.1 feet NAVD), Alley E of Seattle Roy Aloha Shops**  
**American Linen Supply Co Dexter Ave Site**

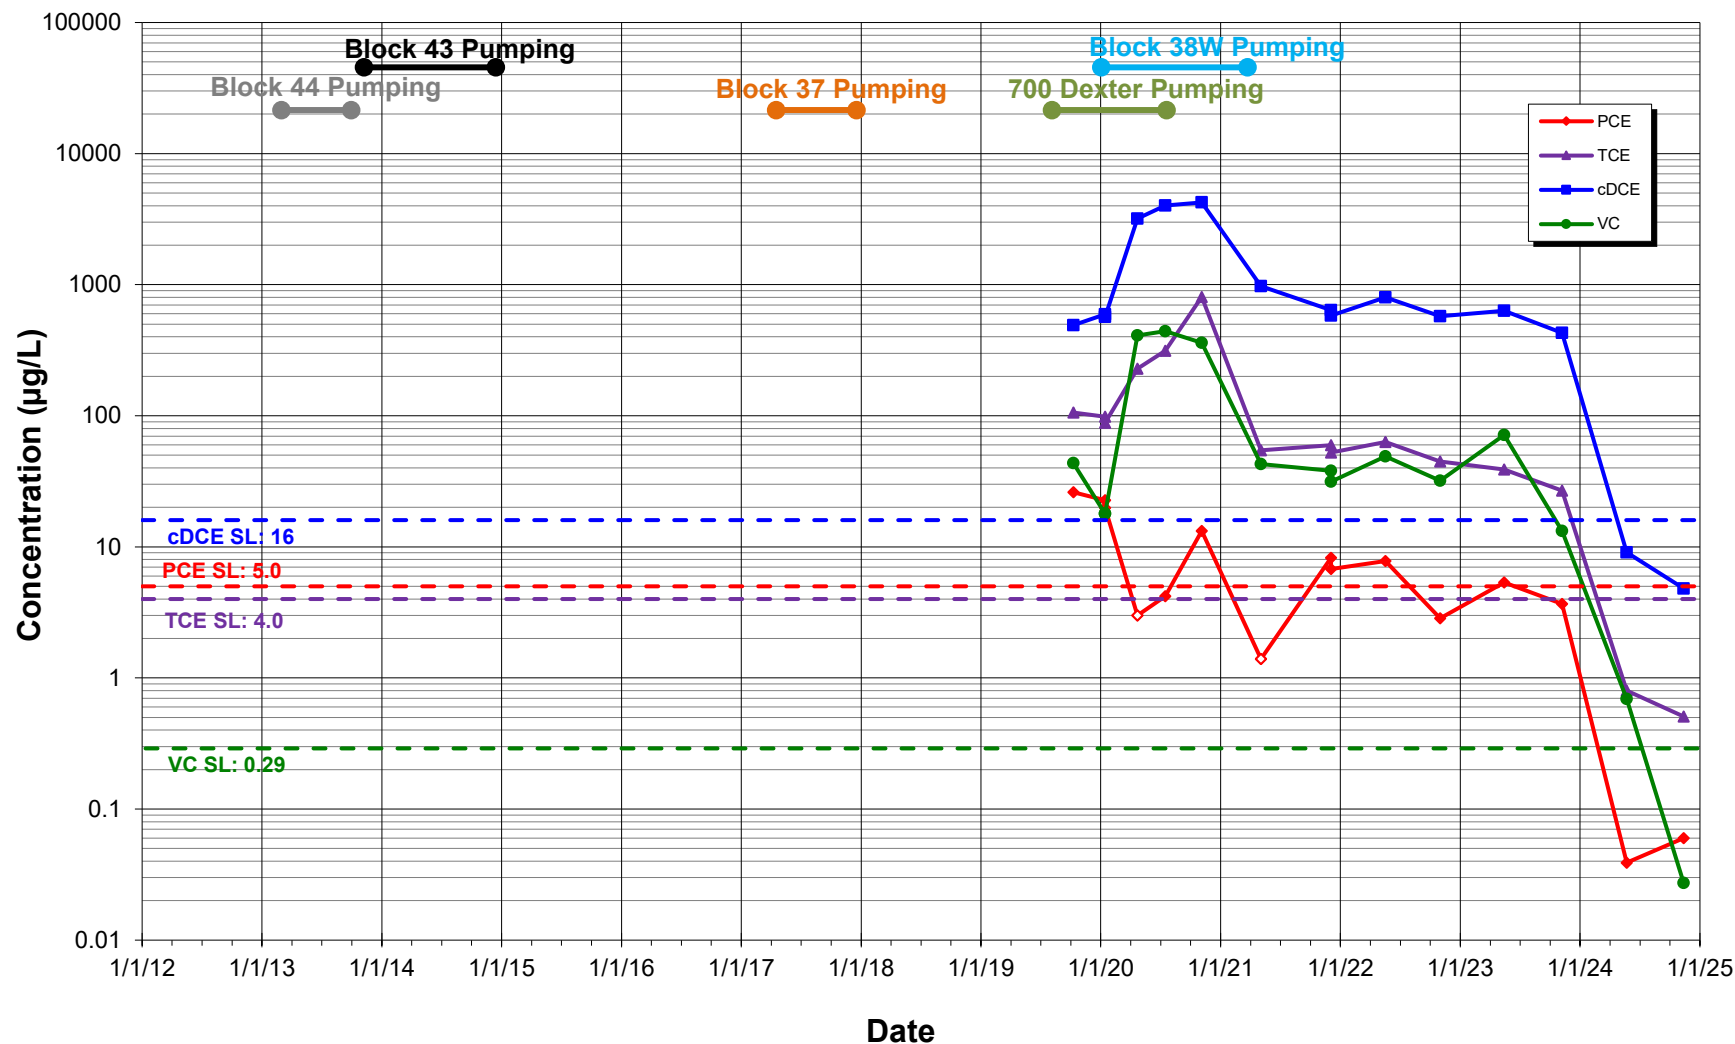
**Concentration vs Time**  
**MW-314 (-28.0 to -38.0 feet NAVD), Alley E of Seattle Roy Aloha Shops**  
**American Linen Supply Co Dexter Ave Site**

- 1) All results detected below the laboratory MDLs are shown as hollow data points.
- 2) Preliminary Screening Levels: PCE = 5.0 µg/L, TCE = 4.0 µg/L, cDCE = 16 µg/L, and VC = 0.29 µg/L.

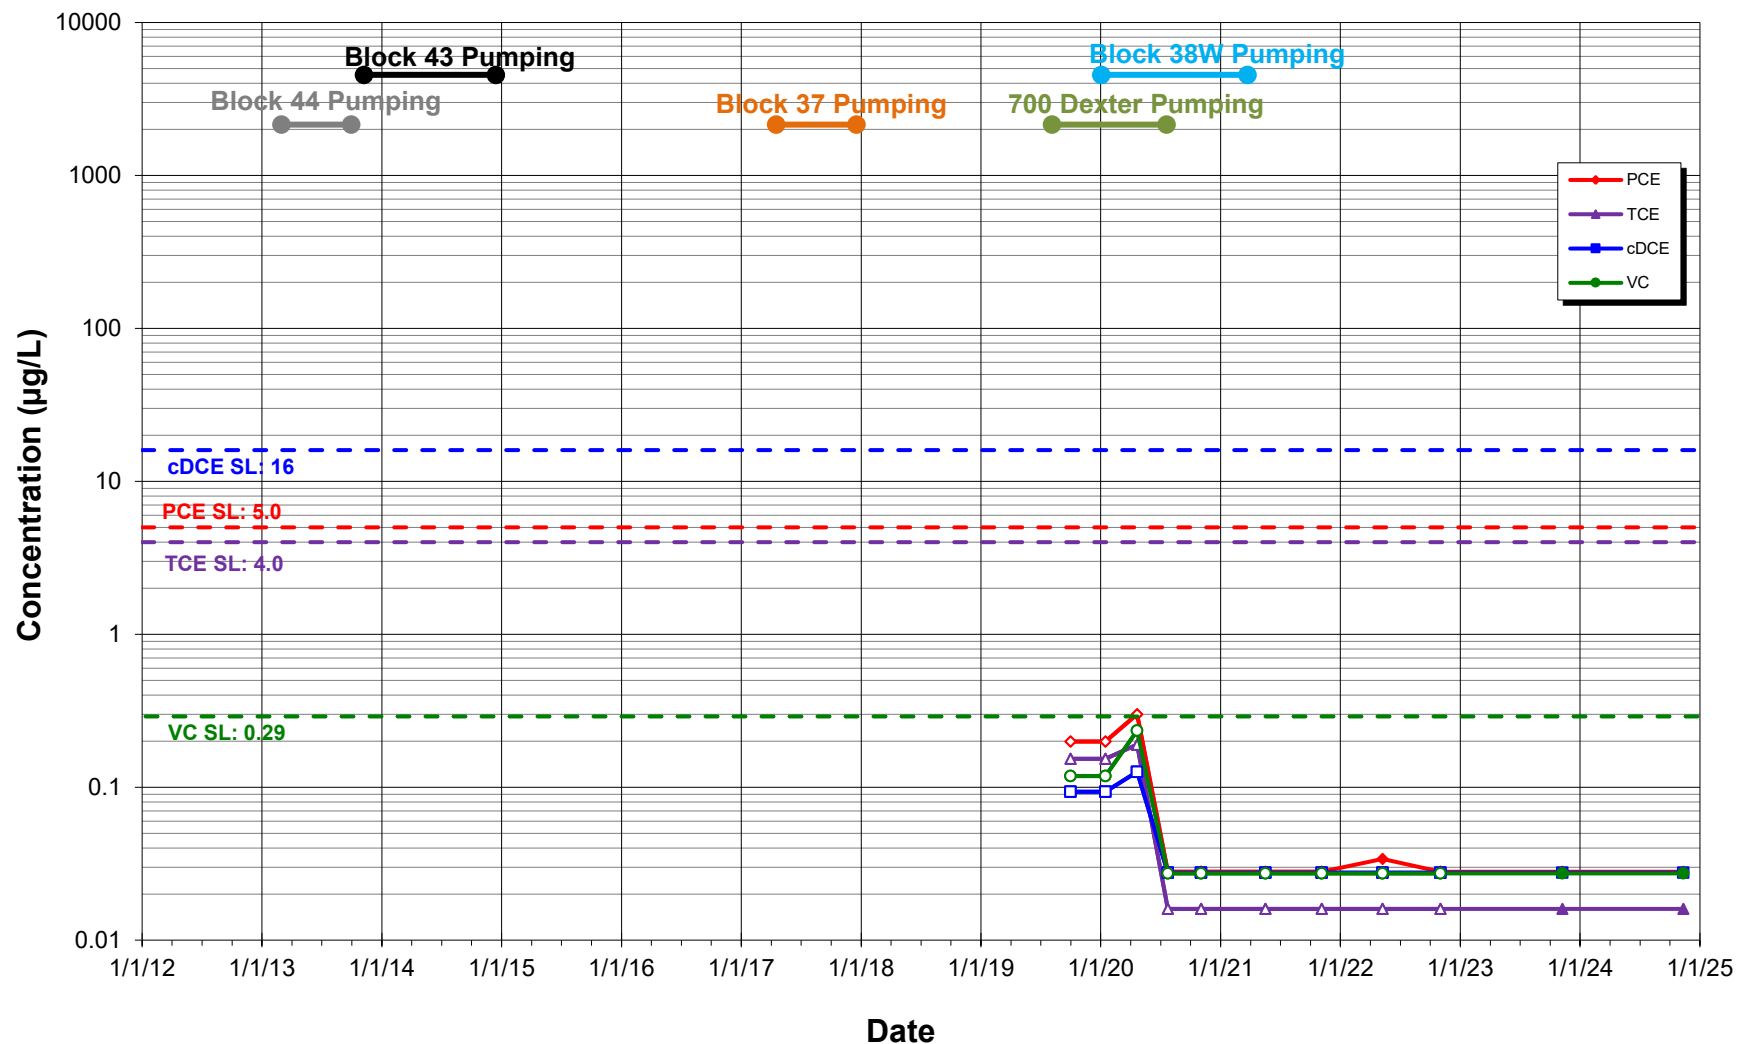
**Concentration vs Time**  
**MW-316 (-10.0 to -20.0 feet NAVD), Mercer St ROW, N side**  
**American Linen Supply Co Dexter Ave Site**

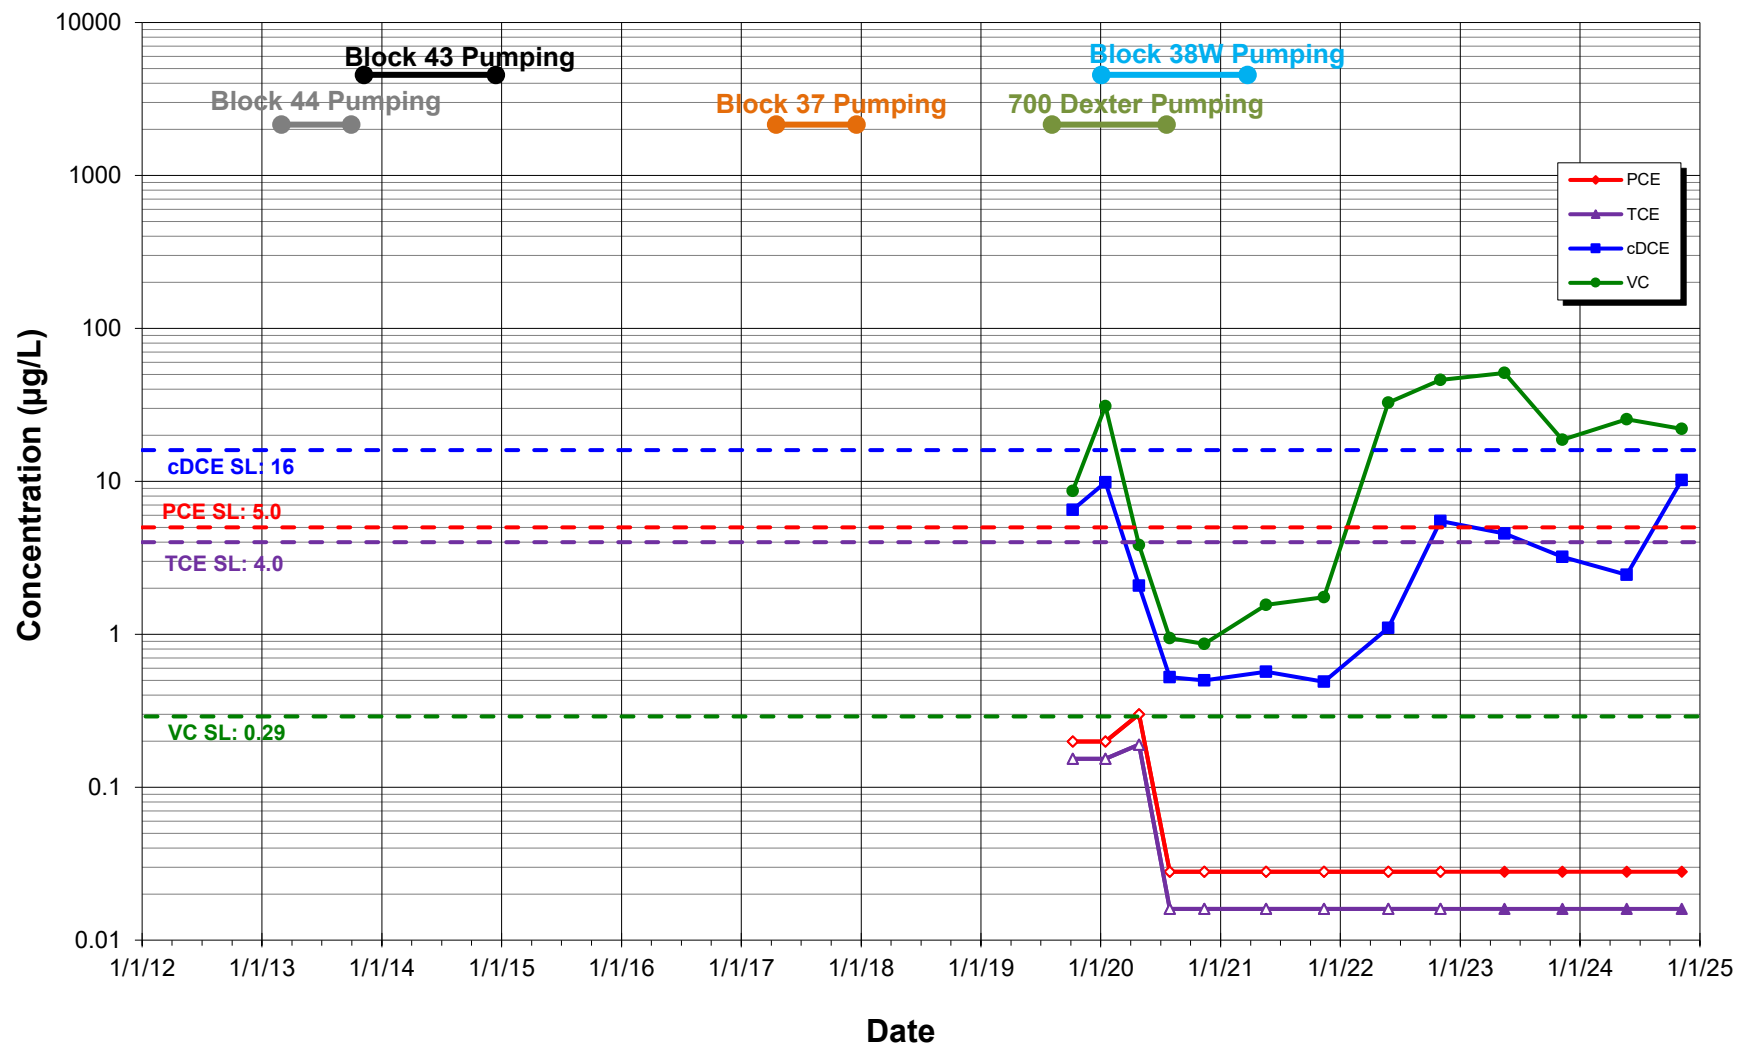
**Concentration vs Time**  
**MW-318 (-23.1 to -33.1 feet NAVD), 9th Ave N ROW, W side**  
**American Linen Supply Co Dexter Ave Site**

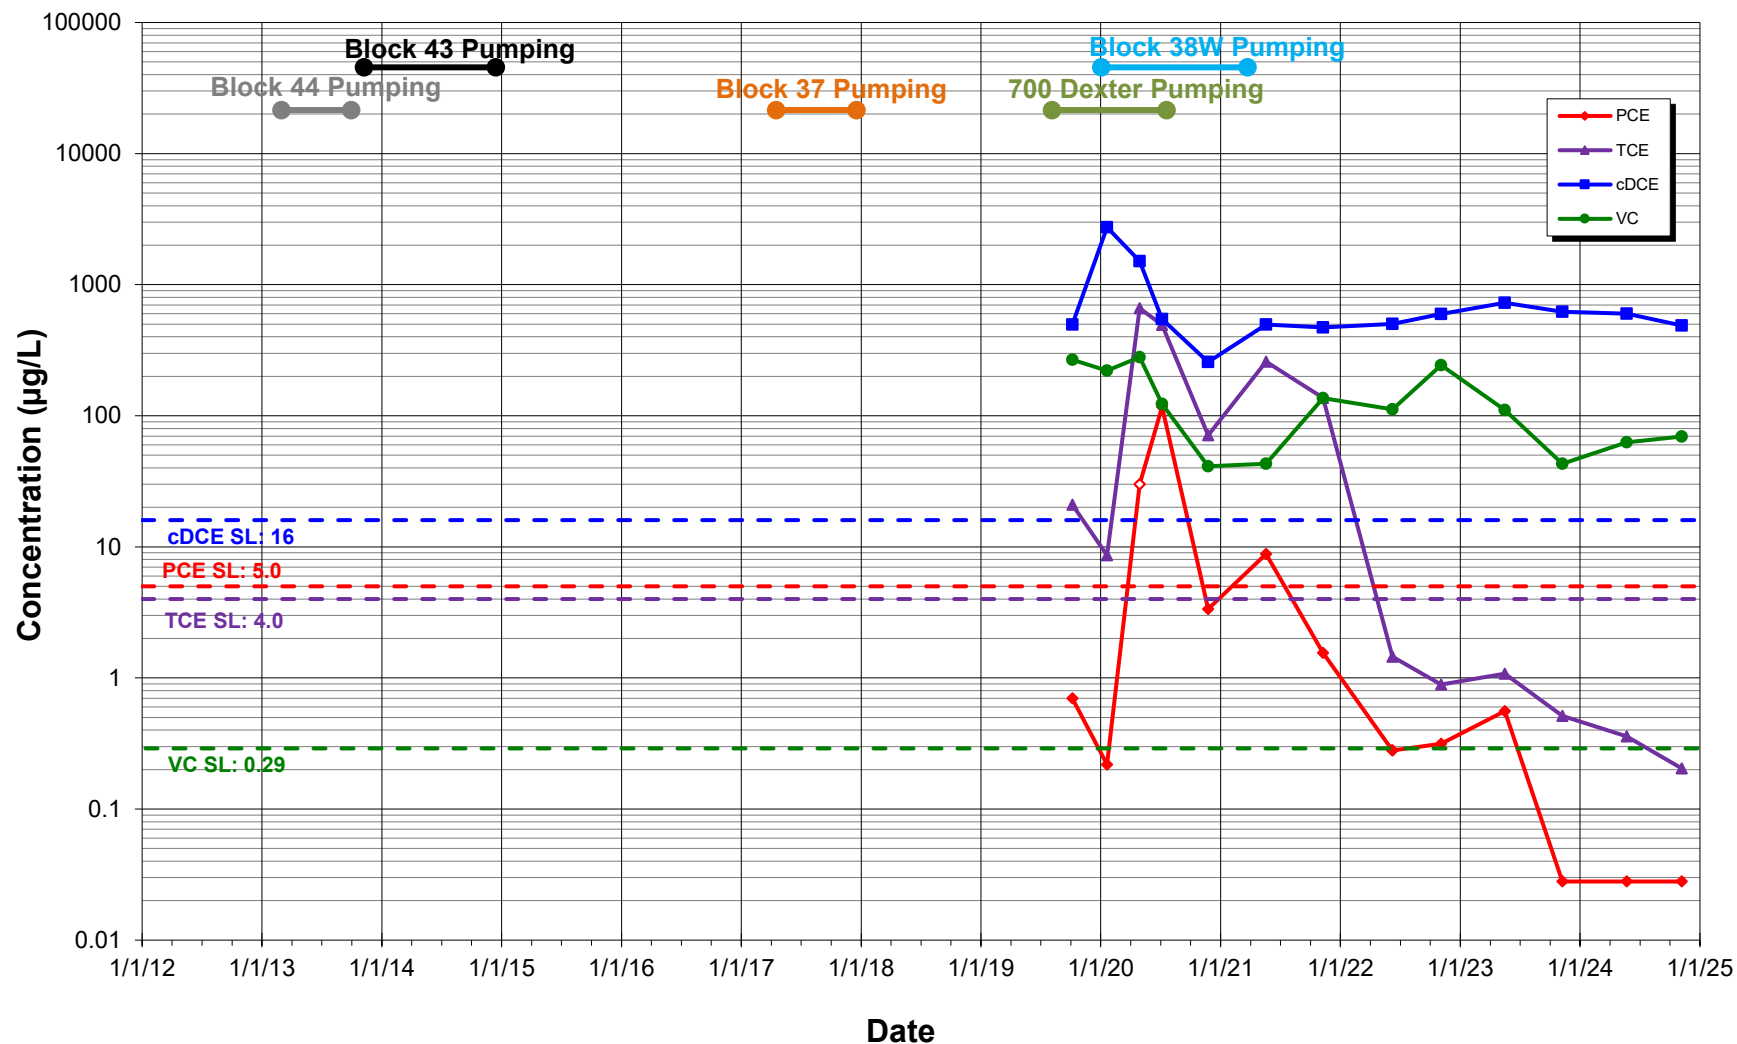
**Concentration vs Time**  
**MW-322 (-23.1 to -31.3 feet NAVD), 9th Avenue North**  
**American Linen Supply Co-Dexter Ave Site**

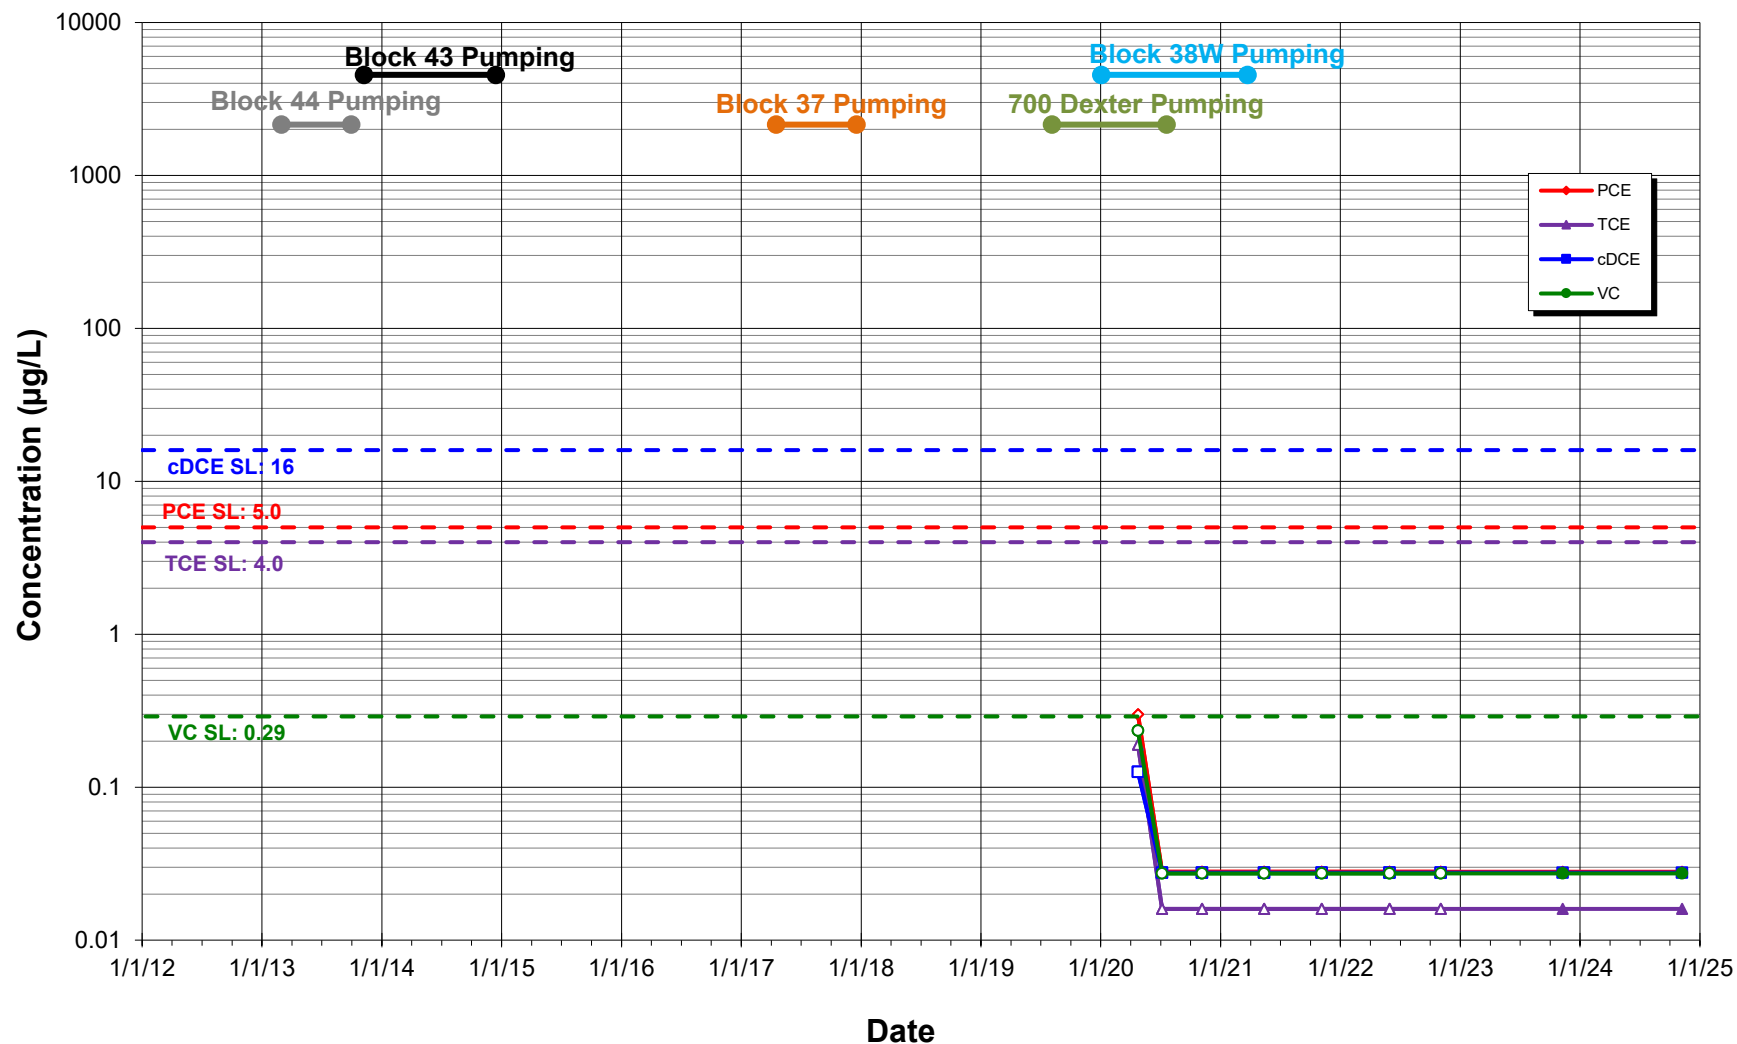
**Concentration vs Time**  
**MW-334 (-21.7 to -31.7 feet NAVD), 900 Roy Street, S end**  
**American Linen Supply Co Dexter Ave Site**

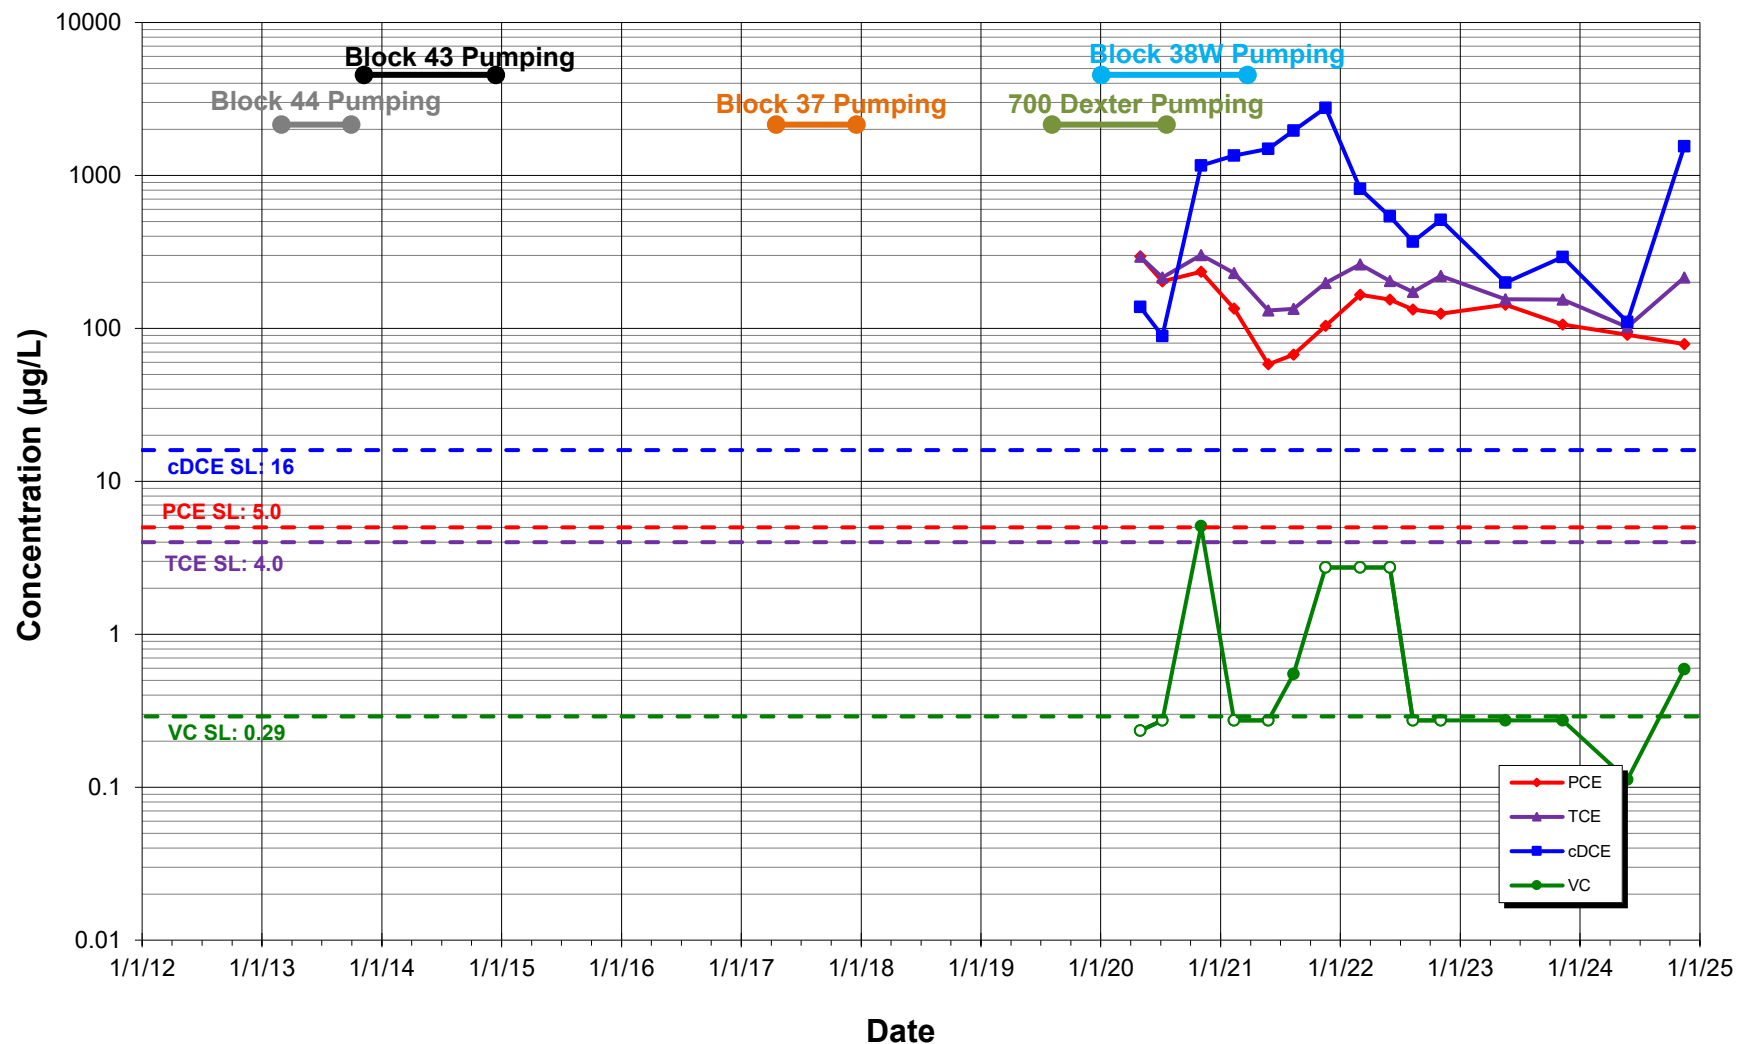
**Concentration vs Time**  
**MW-335 (-25.6 to -35.6 feet NAVD), Mercer St ROW, N side**  
**American Linen Supply Co Dexter Ave Site**
