**Attachment A**  
**Well Completion Table**  
**American Linen Supply Co Dexter Ave Site**  
**700 Dexter Avenue North**  
**Seattle, Washington**

**ATTACHMENT B**

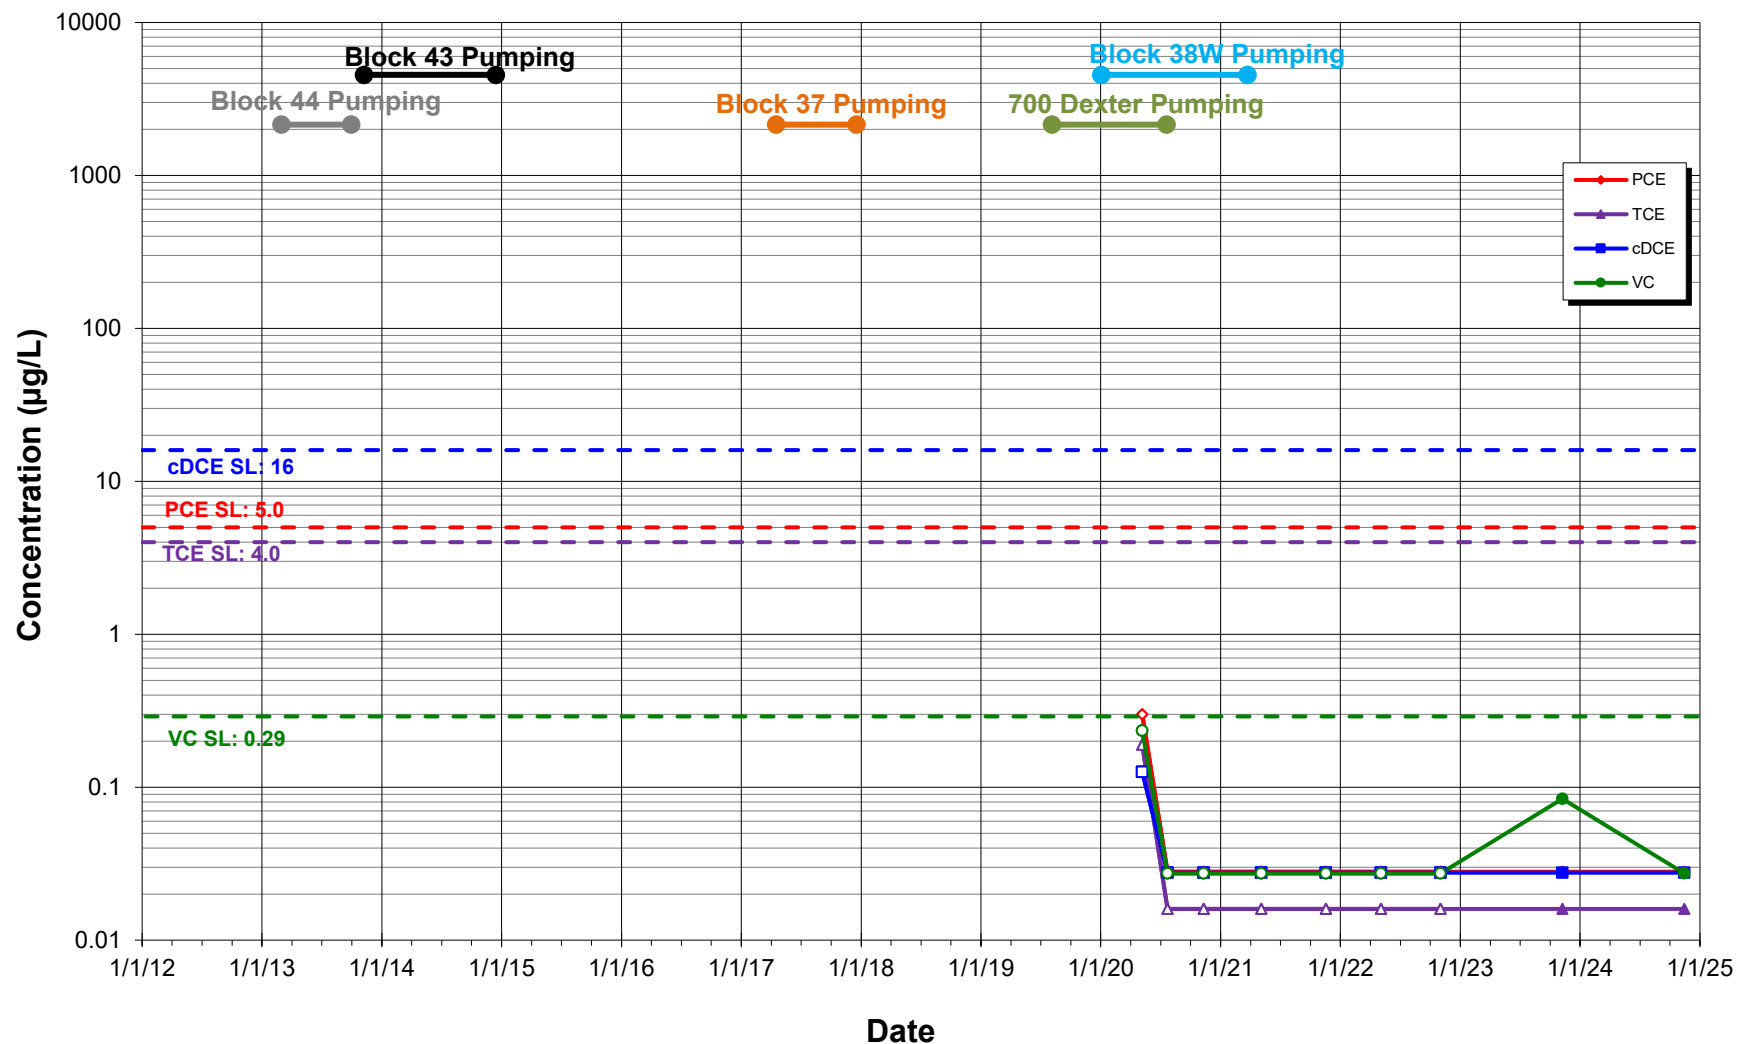
**Concentration vs Time**  
**MW-338 (-16.6 to -26.6 feet NAVD), Lake Union Park, N end**  
**American Linen Supply Co Dexter Ave Site**

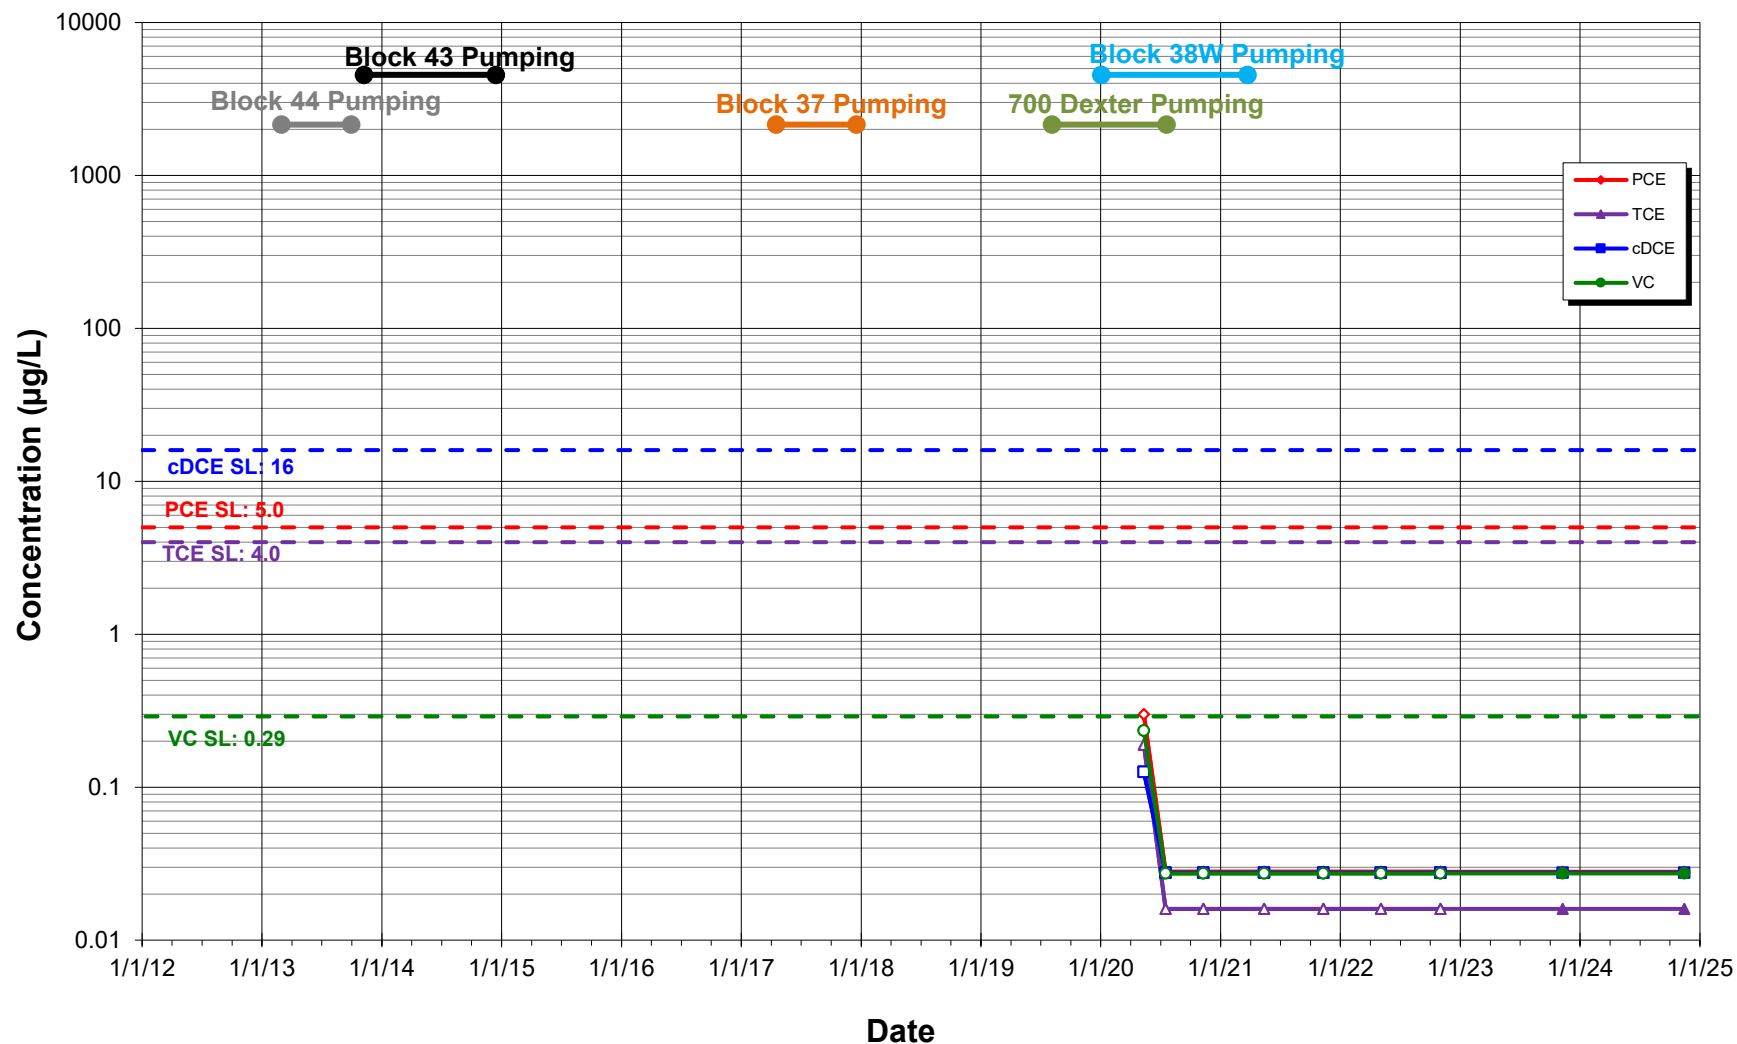
**Concentration vs Time**  
**MW-340 (-16.1 to -26.1 feet NAVD), Lake Union Park, S end**  
**American Linen Supply Co-Dexter Ave Site**

- 1) All results detected below the laboratory MDLs are shown as hollow data points.
- 2) Preliminary Screening Levels: PCE = 5.0 µg/L, TCE = 4.0 µg/L, cDCE = 16 µg/L, and VC = 0.29 µg/L.

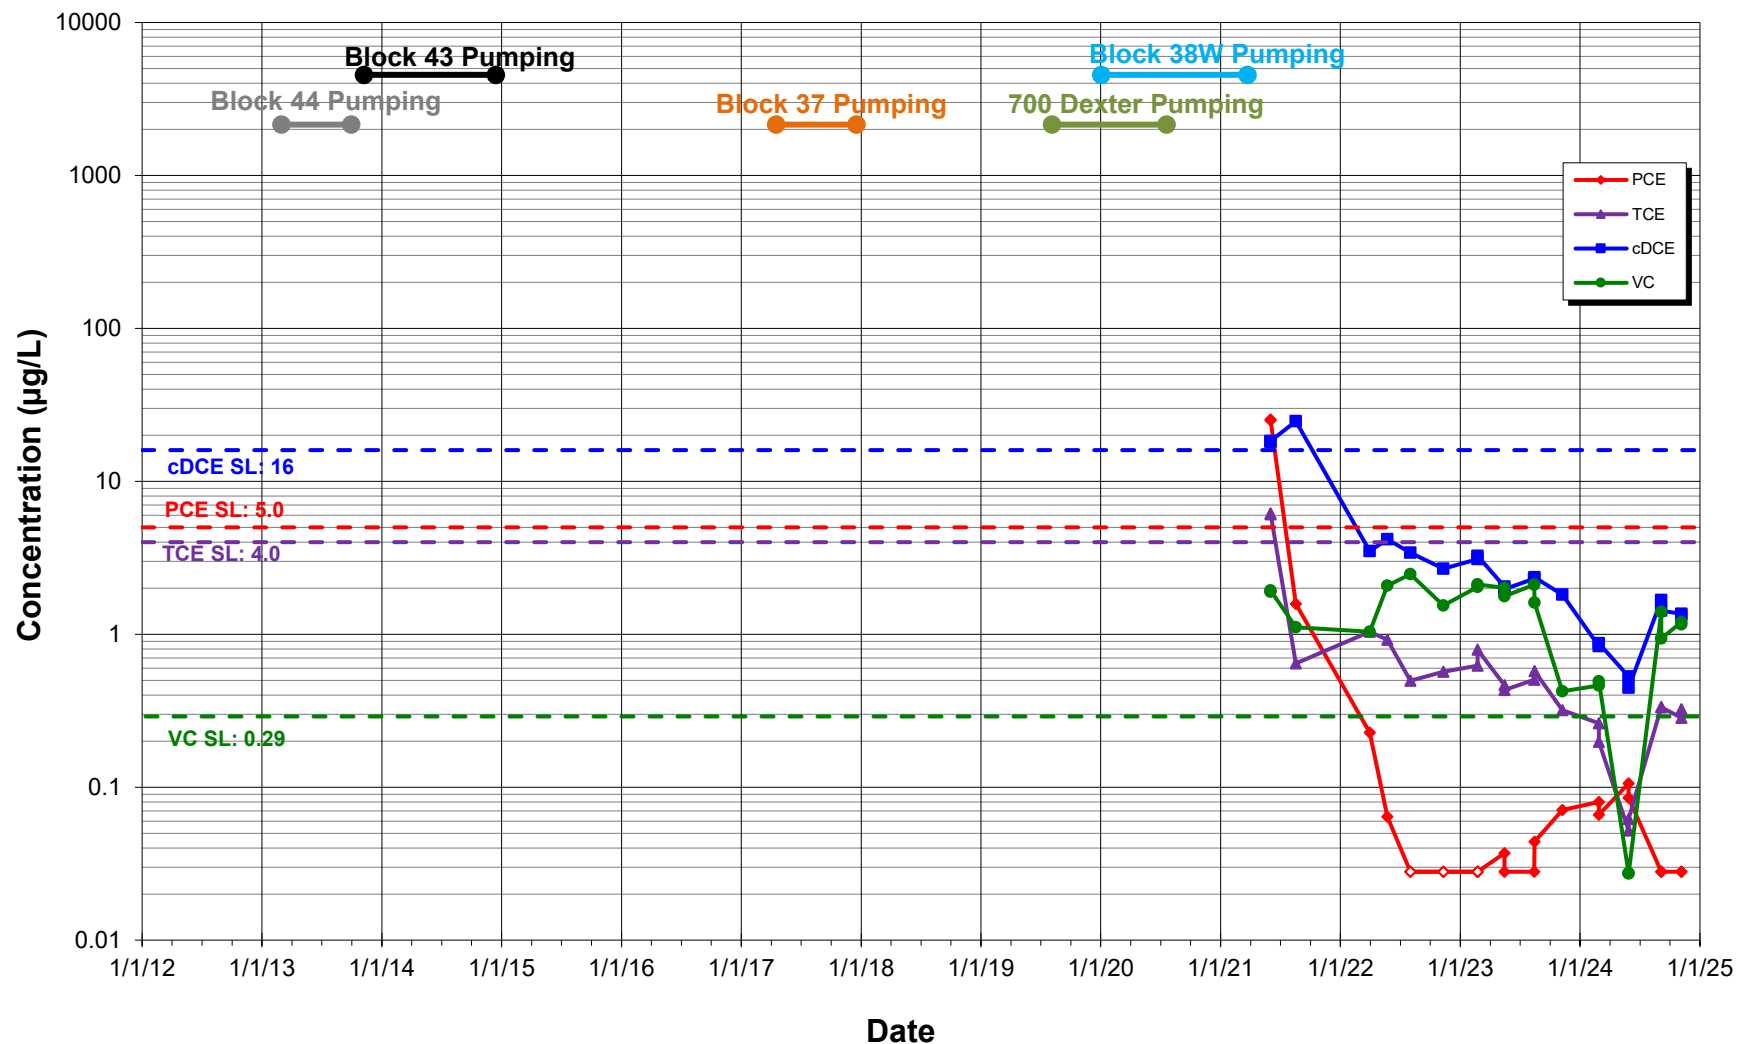
**Concentration vs Time**  
**MW-346 (-2.2 to -12.2 feet NAVD), Seattle DOT Mercer Parcels, NW quadrant**  
**American Linen Supply Co Dexter Ave Site**

- 1) All results detected below the laboratory MDLs are shown as hollow data points.
- 2) Preliminary Screening Levels: PCE = 5.0 µg/L, TCE = 4.0 µg/L, cDCE = 16 µg/L, and VC = 0.29 µg/L.

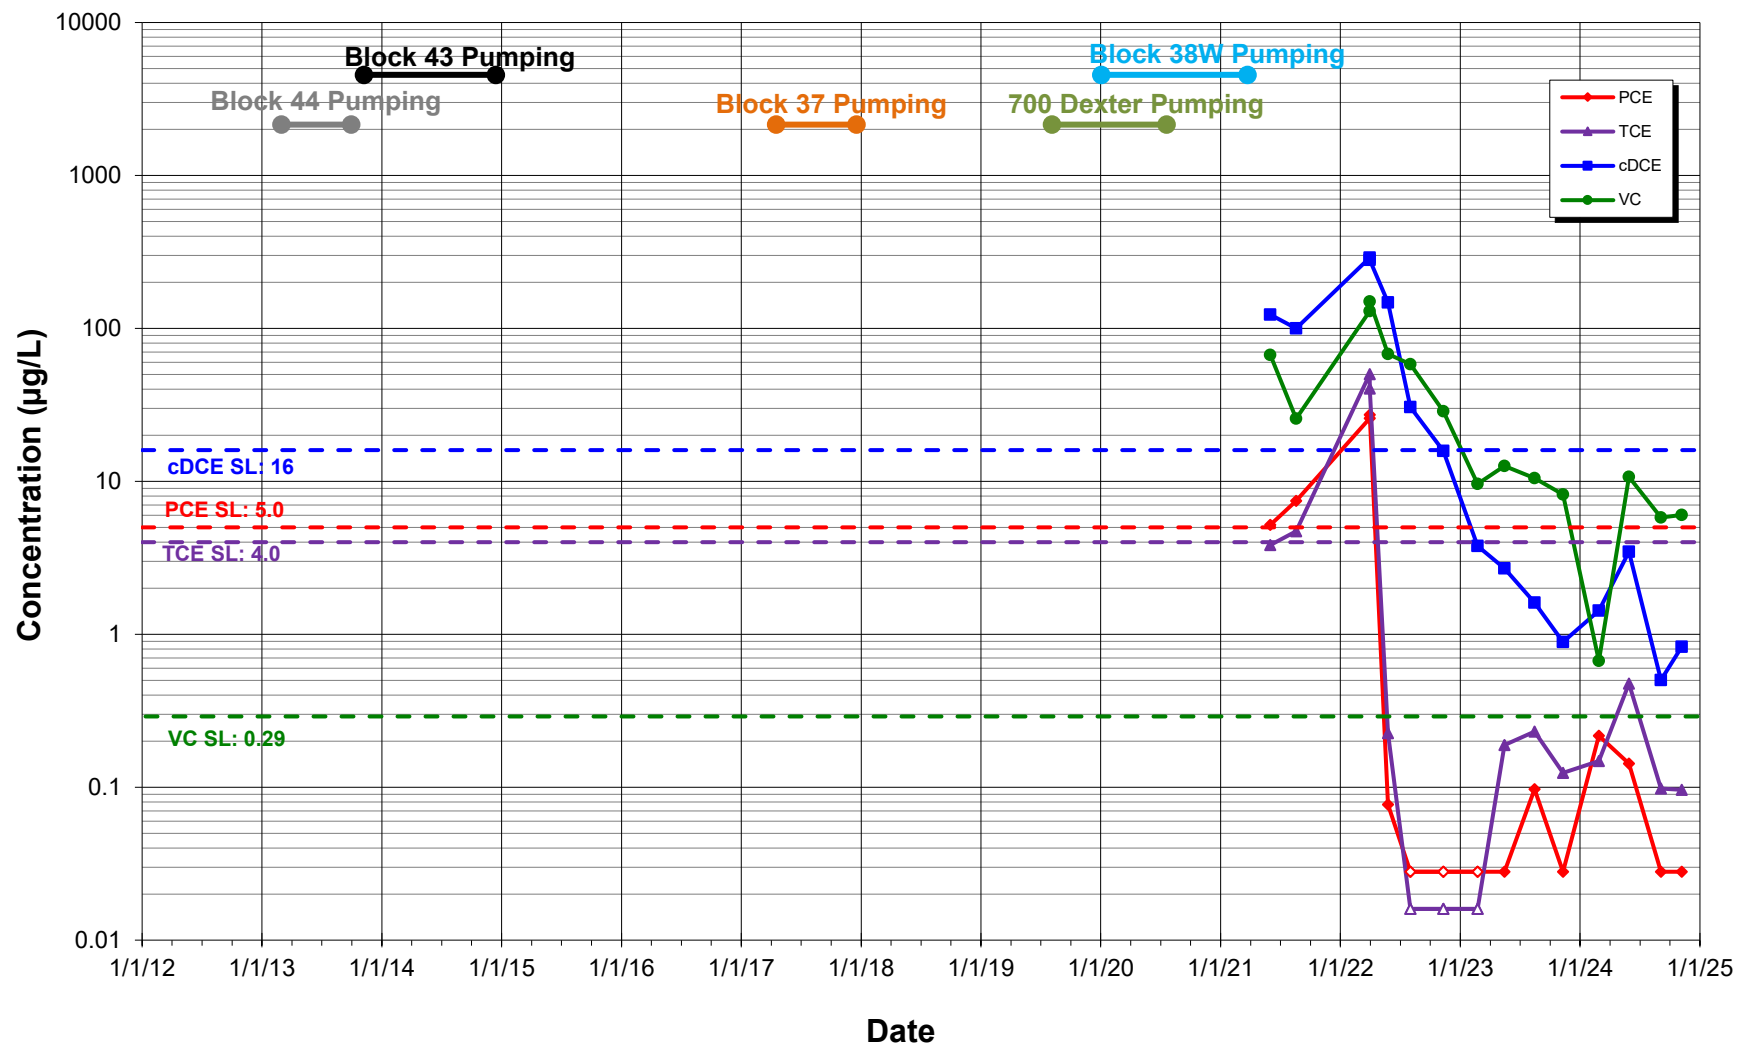
**Concentration vs Time**  
**MW-347 (-1.3 to -11.3 feet NAVD), Seattle DOT Mercer Parcels, NW quadrant**  
**American Linen Supply Co Dexter Ave Site**

- 1) All results detected below the laboratory MDLs are shown as hollow data points.
- 2) Preliminary Screening Levels: PCE = 5.0 µg/L, TCE = 4.0 µg/L, cDCE = 16 µg/L, and VC = 0.29 µg/L.

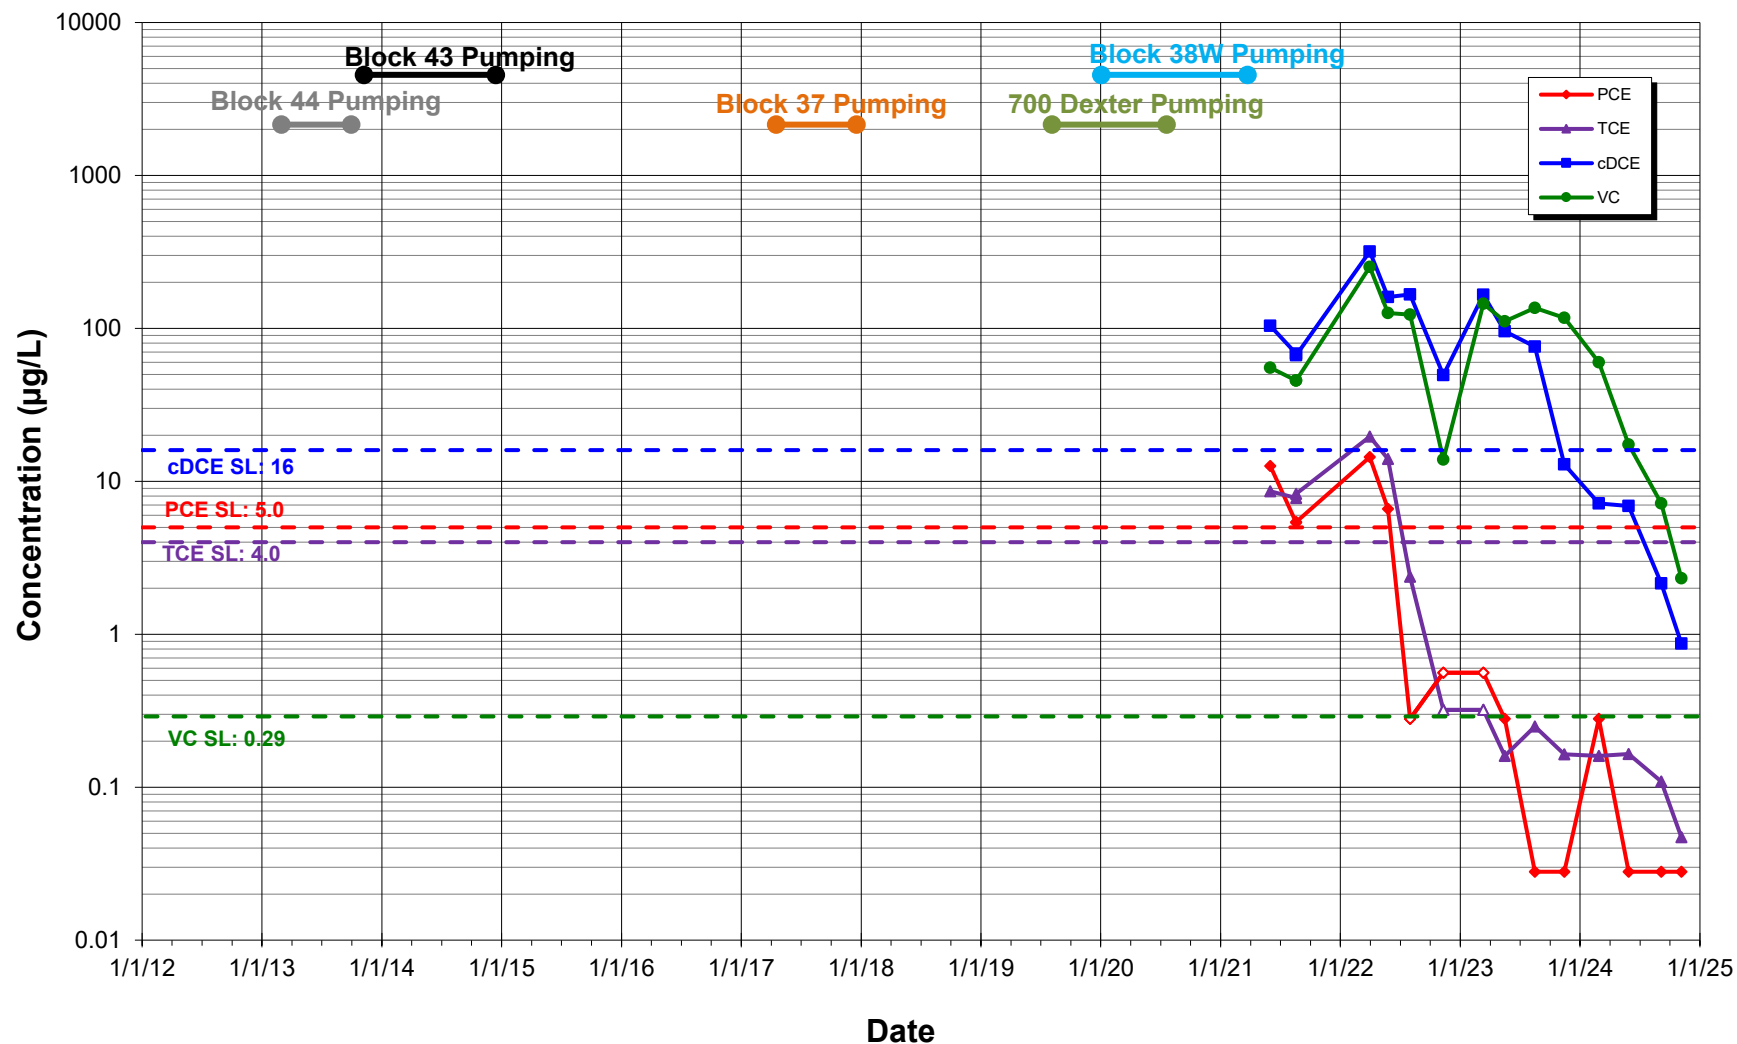
**Concentration vs Time**  
**MW-348 (-4.6 to -14.6 feet NAVD), Seattle DOT Mercer Parcels, SW quadrant**  
**American Linen Supply Co Dexter Ave Site**

- 1) All results detected below the laboratory MDLs are shown as hollow data points.
- 2) Preliminary Screening Levels: PCE = 5.0 µg/L, TCE = 4.0 µg/L, cDCE = 16 µg/L, and VC = 0.29 µg/L.

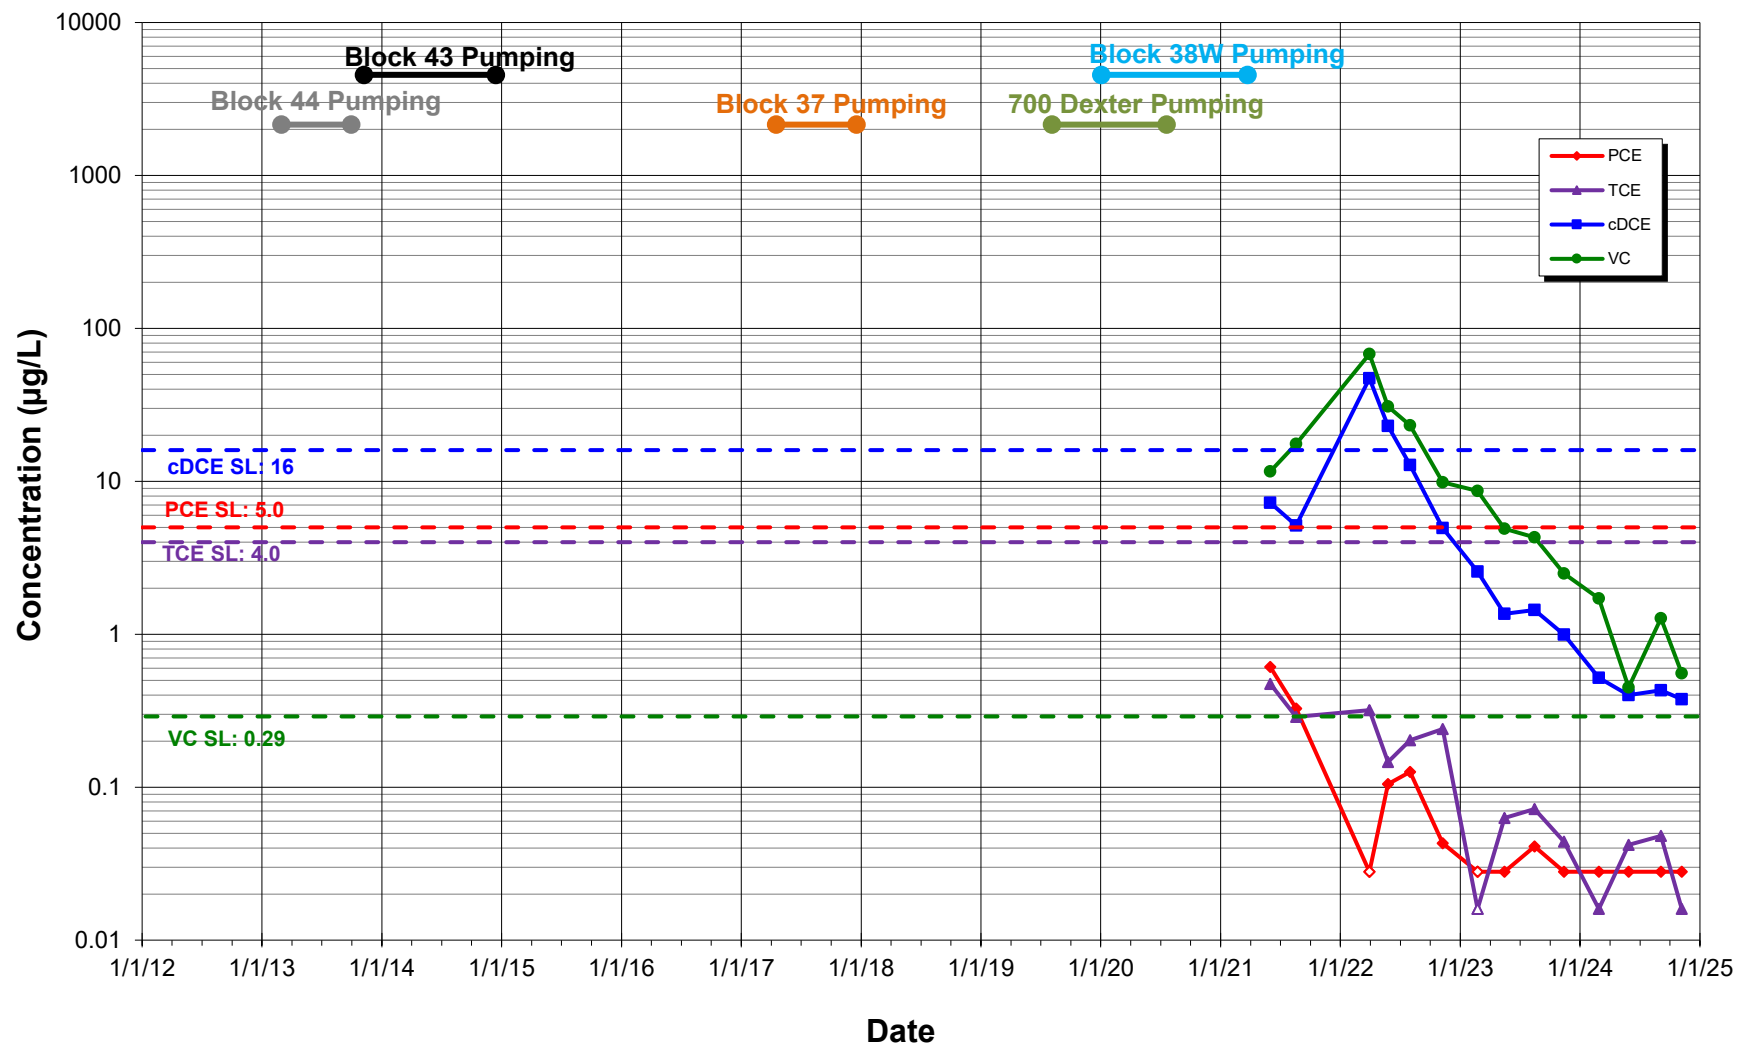
**Concentration vs Time**  
**MW-349 (-2.8 to -12.8 feet NAVD), Seattle DOT Mercer Parcels, SW quadrant**  
**American Linen Supply Co Dexter Ave Site**

- 1) All results detected below the laboratory MDLs are shown as hollow data points.
- 2) Preliminary Screening Levels: PCE = 5.0 µg/L, TCE = 4.0 µg/L, cDCE = 16 µg/L, and VC = 0.29 µg/L.

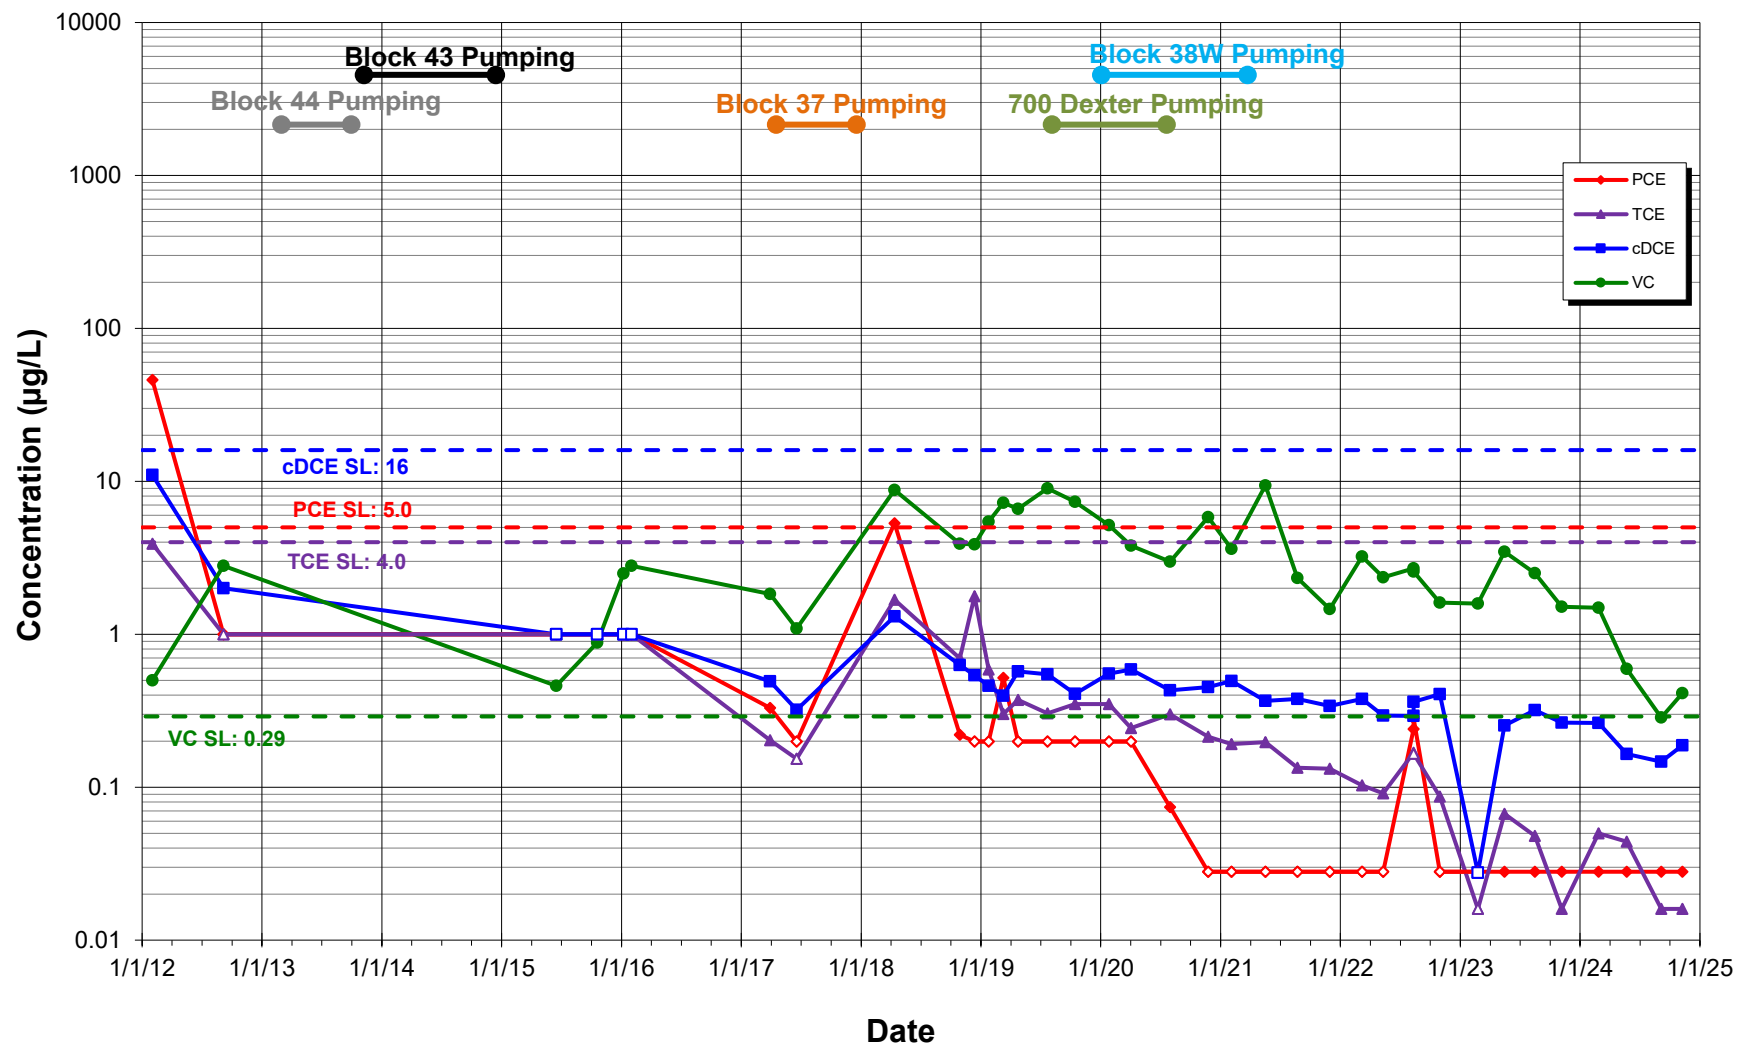
**Concentration vs Time**  
**W-MW-01 (-25.1 to -35.1 feet NAVD), 8th Ave N ROW, W side**  
**American Linen Supply Co Dexter Ave Site**

- 1) All results detected below the laboratory MDLs are shown as hollow data points.
- 2) Preliminary Screening Levels: PCE = 5.0 µg/L, TCE = 4.0 µg/L, cDCE = 16 µg/L, and VC = 0.29 µg/L.

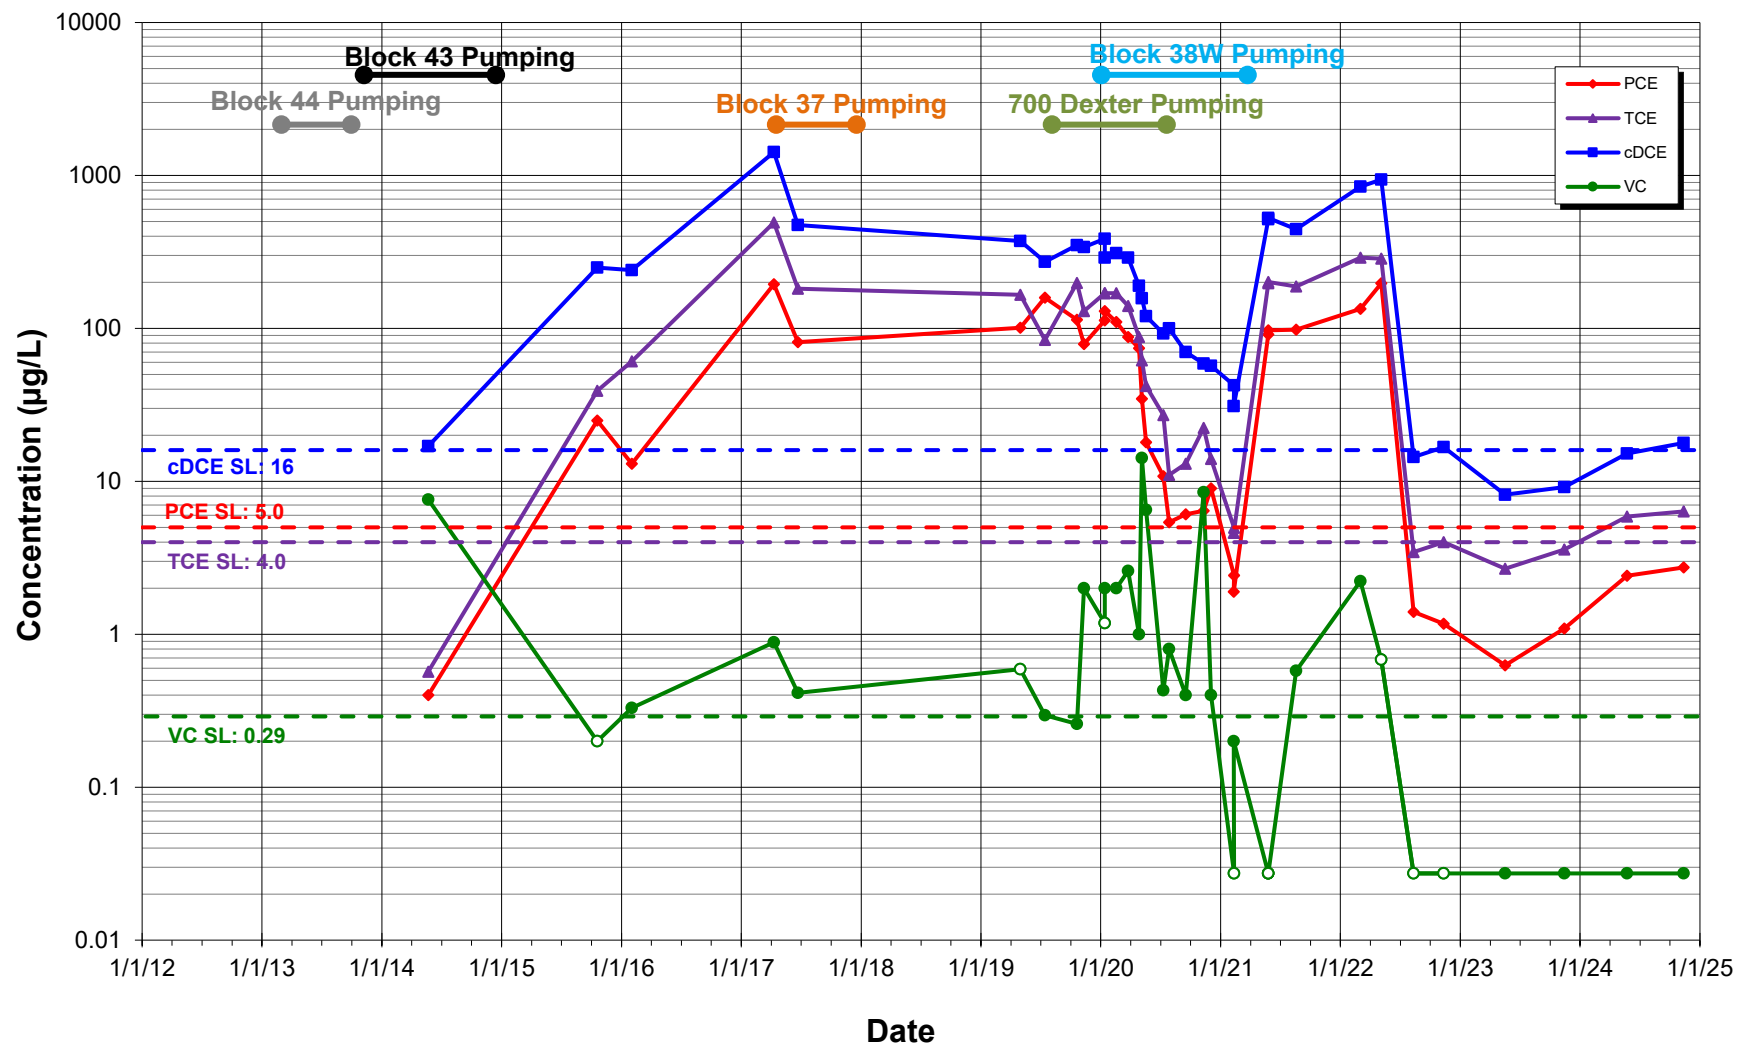
**Concentration vs Time**  
**FMW-129 (-45.6 to -50.6 feet NAVD), SDOT Mercer Parcels, NE Quadrant**  
**American Linen Supply Co Dexter Ave Site**

1. All results detected below the laboratory MDLs are shown as hollow data points.
2. Preliminary Screening Levels: PCE = 5.0 µg/L, TCE = 4.0 µg/L, cDCE = 16 µg/L, and VC = 0.29 µg/L.

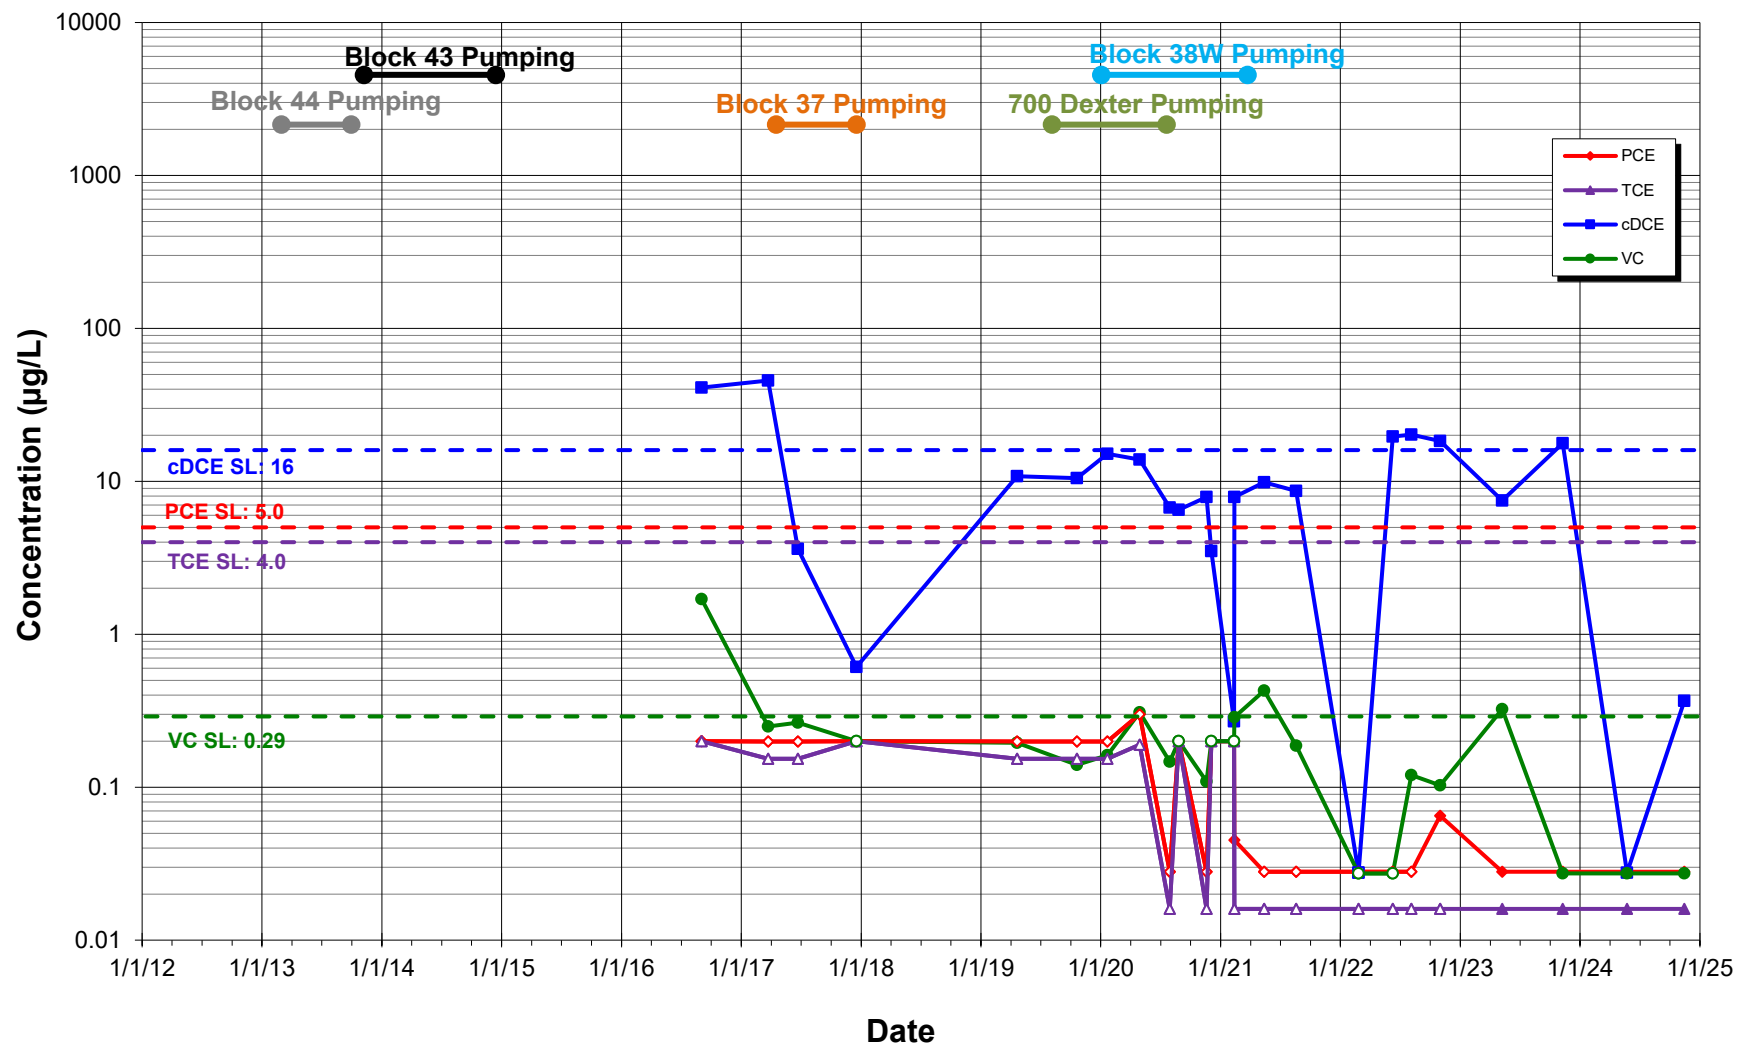
**Concentration vs Time**  
**FMW-131 (-34.7 to -44.7 feet NAVD), Block 37, SE Quadrant**  
**American Linen Supply Co Dexter Ave Site**

1. All results detected below the laboratory MDLs are shown as hollow data points.
2. Preliminary Screening Levels: PCE = 5.0 µg/L, TCE = 4.0 µg/L, cDCE = 16 µg/L, and VC = 0.29 µg/L.

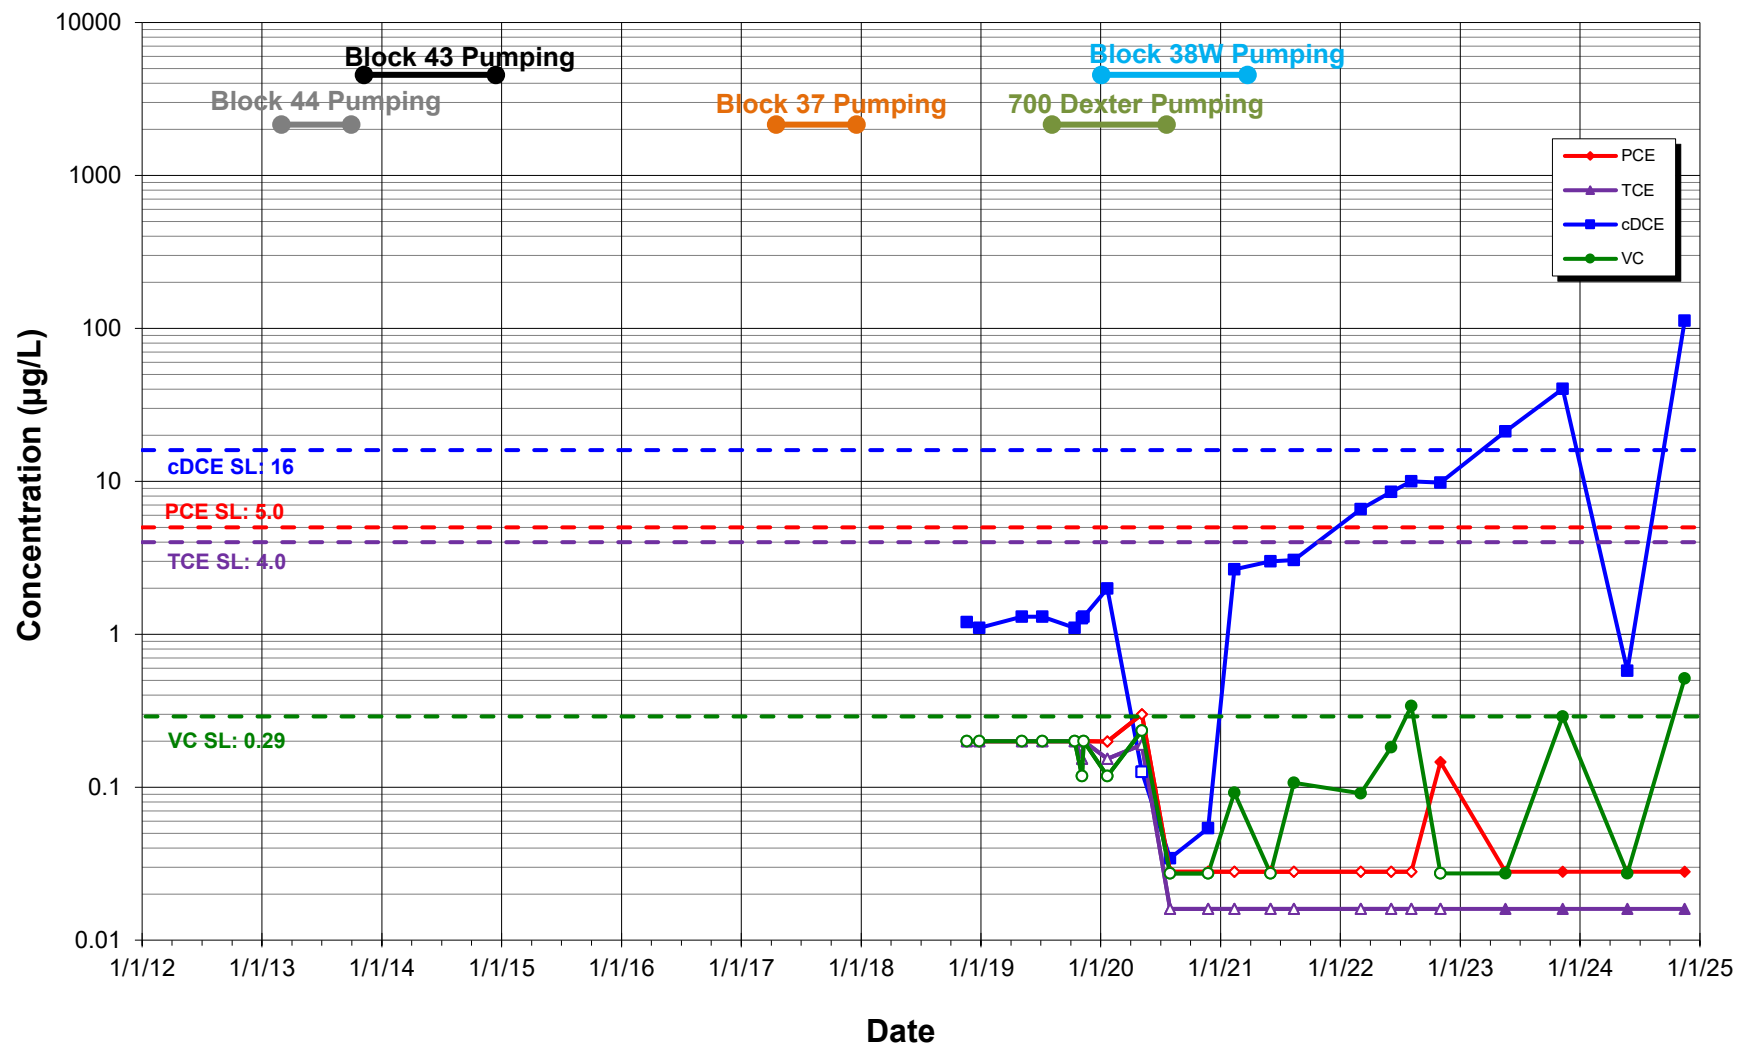
**Concentration vs Time**  
**FMW-137 (-39.9 to -54.9 feet NAVD), Alley E of Block 38W**  
**American Linen Supply Co Dexter Ave Site**

1. All results detected below the laboratory MDLs are shown as hollow data points.
2. Preliminary Screening Levels: PCE = 5.0 µg/L, TCE = 4.0 µg/L, cDCE = 16 µg/L, and VC = 0.29 µg/L.

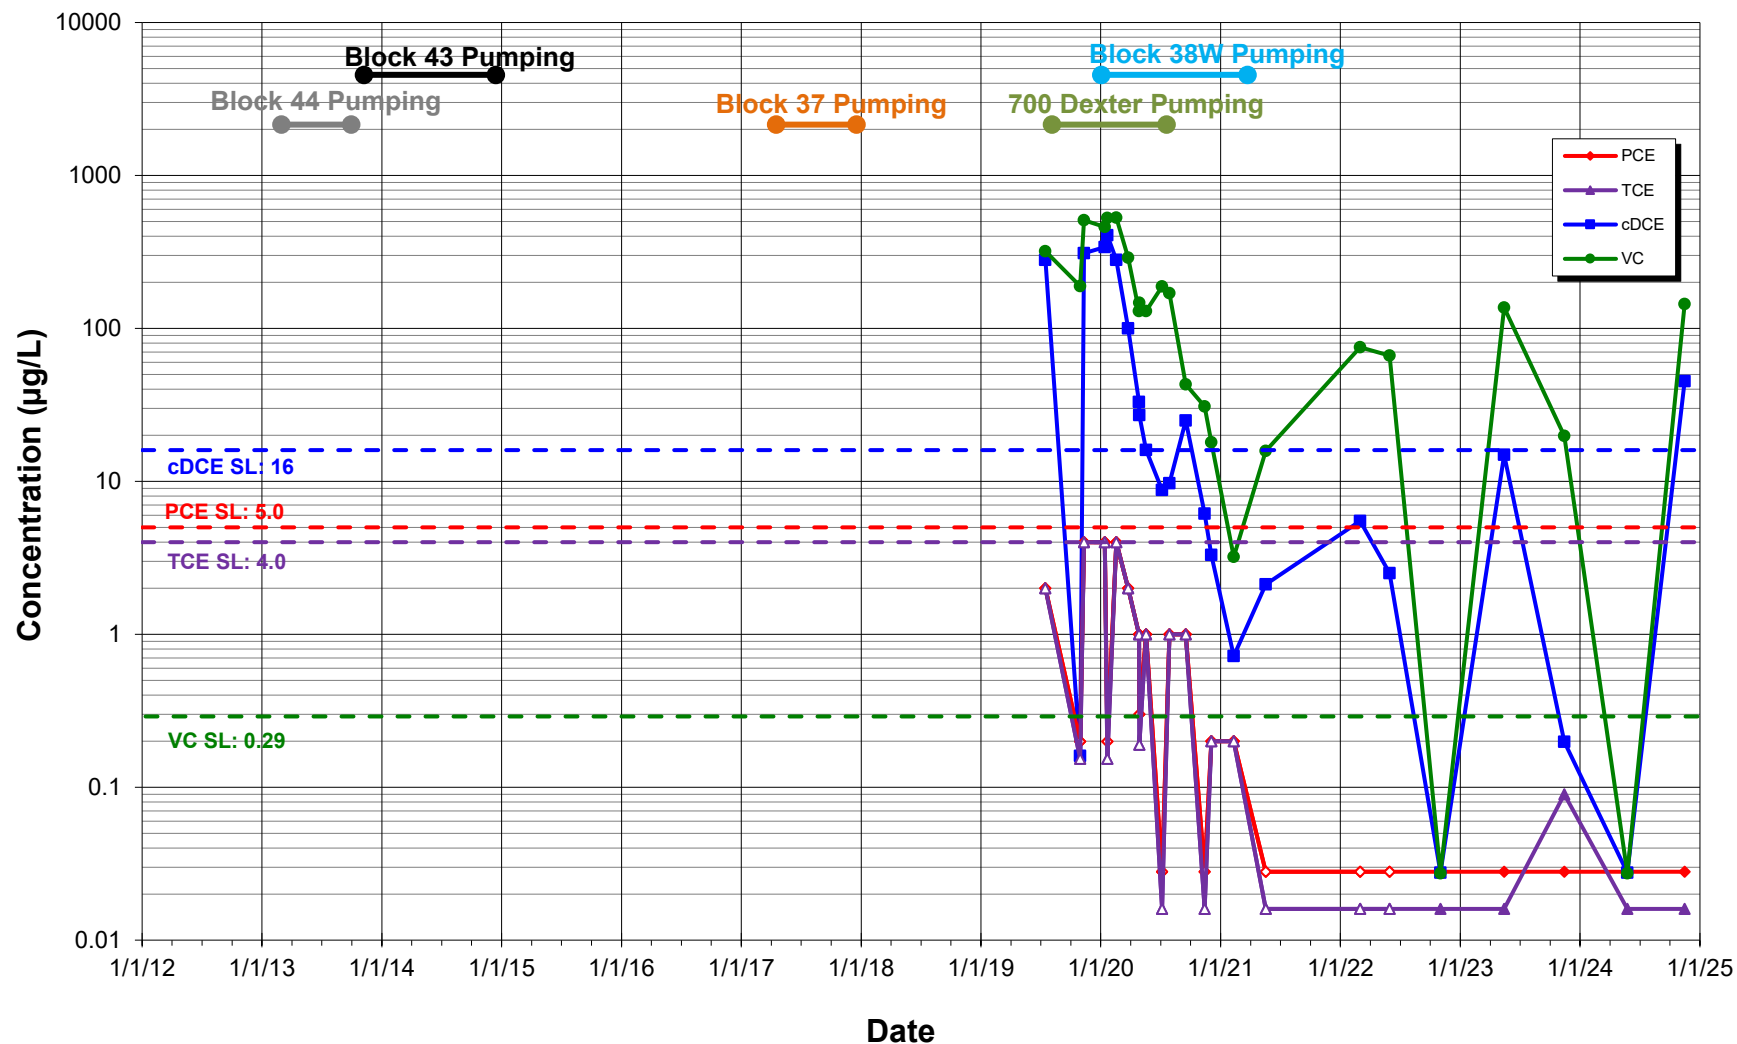
**Concentration vs Time**  
**FMW-140 (-38.0 to -48.0 feet NAVD), 900 Roy St, S end**  
**American Linen Supply Co Dexter Ave Site**

1. All results detected below the laboratory MDLs are shown as hollow data points.
2. Preliminary Screening Levels: PCE = 5.0 µg/L, TCE = 4.0 µg/L, cDCE = 16 µg/L, and VC = 0.29 µg/L.

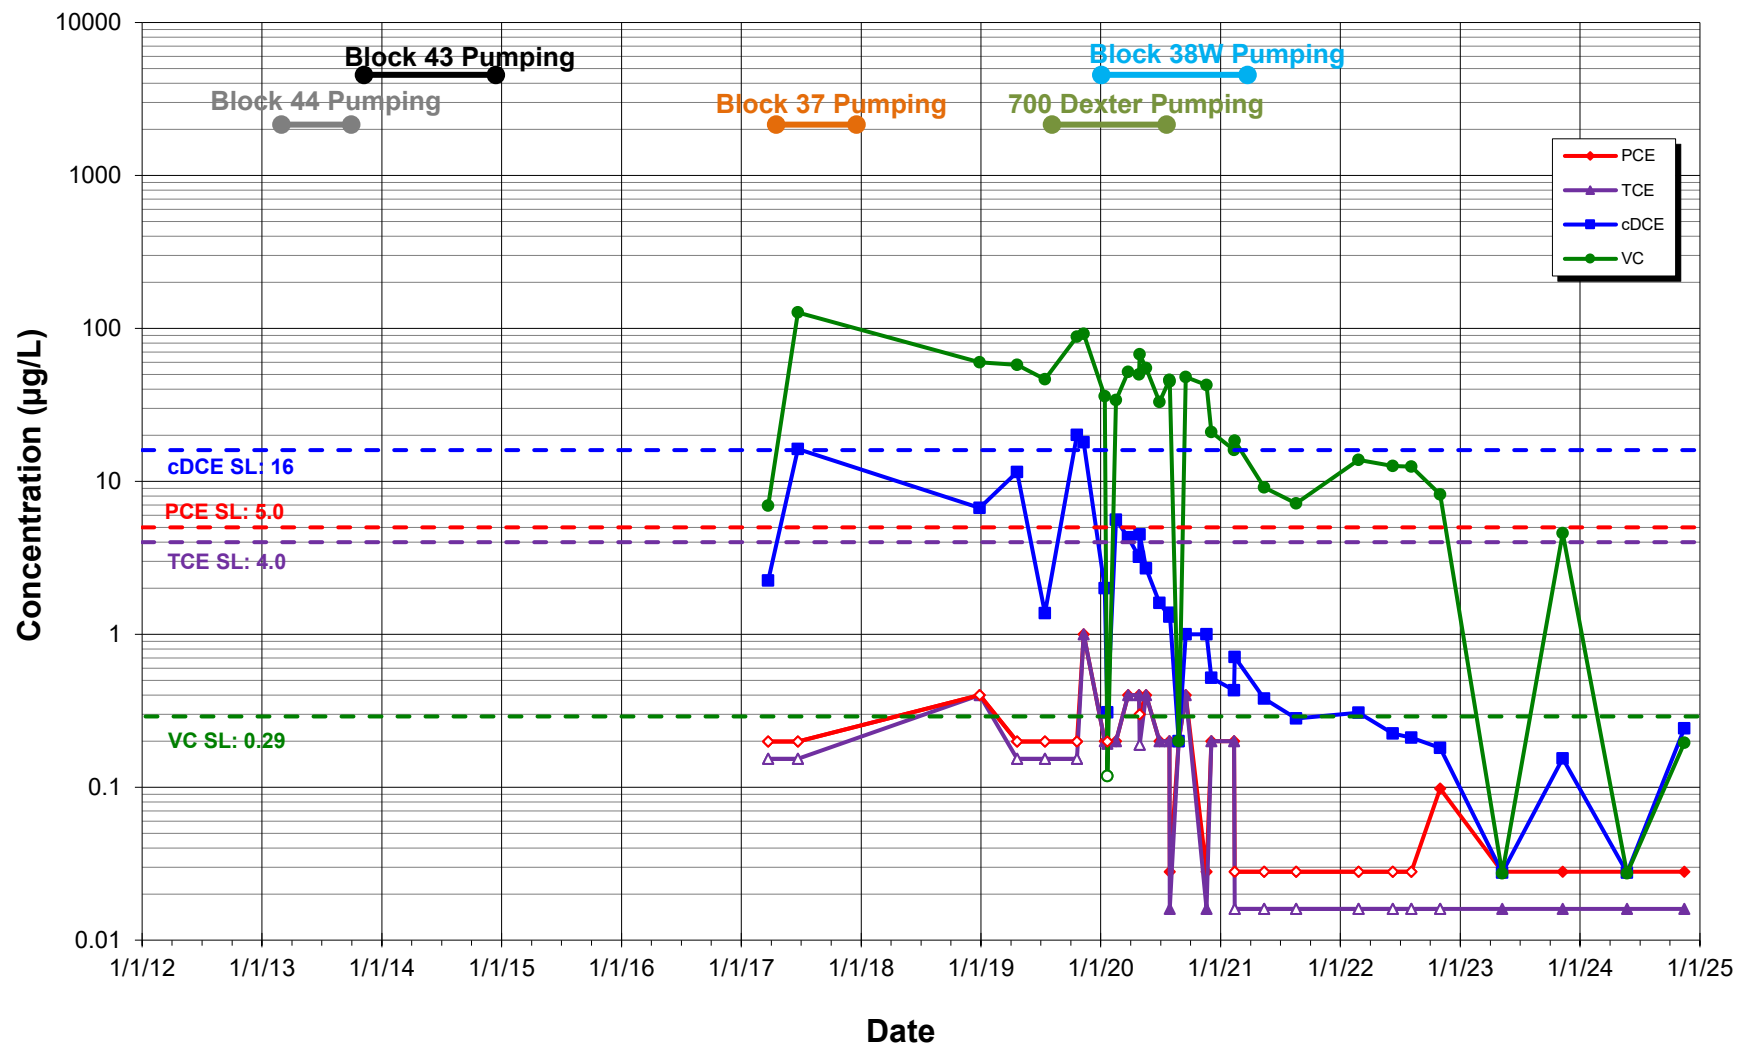
**Concentration vs Time**  
**GEI-2 (-21.1 to -31.1 feet NAVD), Block 37, SW quadrant**  
**American Linen Supply Co Dexter Ave Site**

1. All results detected below the laboratory MDLs are shown as hollow data points.
2. Preliminary Screening Levels: PCE = 5.0 µg/L, TCE = 4.0 µg/L, cDCE = 16 µg/L, and VC = 0.29 µg/L.
