**Attachment A**  
**Well Completion Table**  
**American Linen Supply Co Dexter Ave Site**  
**700 Dexter Avenue North**  
**Seattle, Washington**

**ATTACHMENT B**

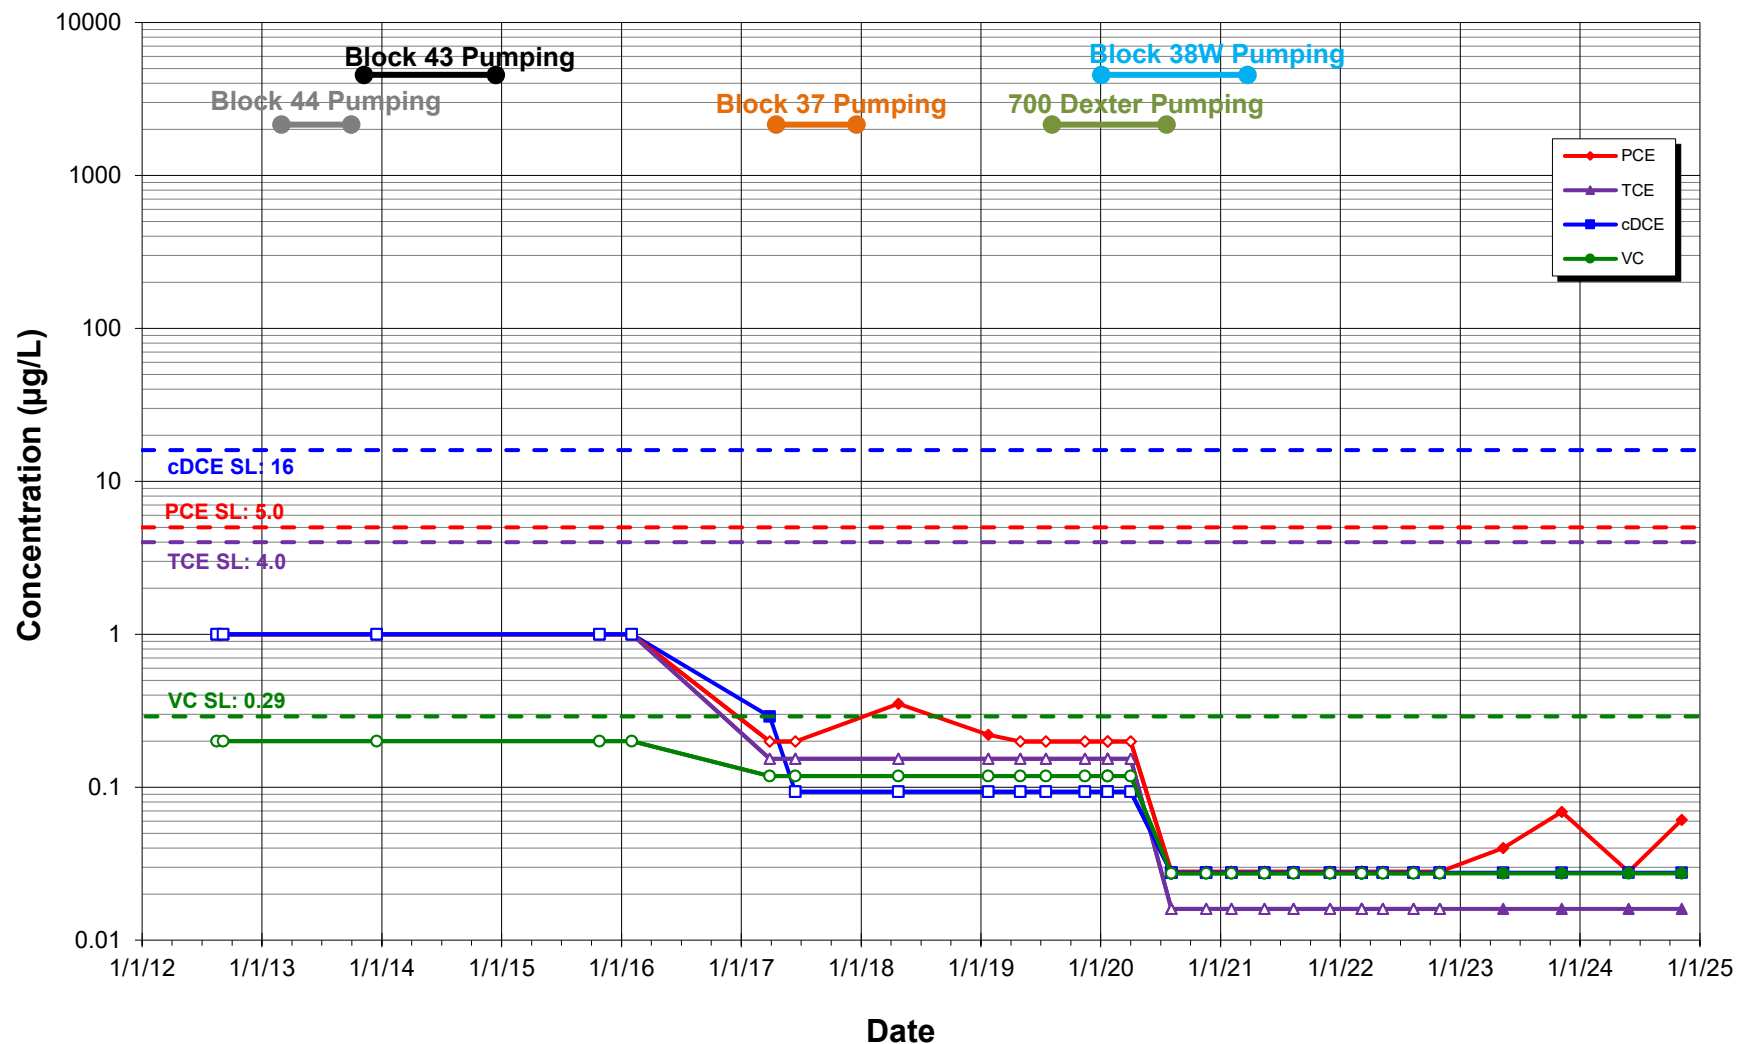
**Concentration vs Time**  
**MW102 (-65.8 to -75.8 feet NAVD), Valley St ROW, S side**  
**American Linen Supply Co Dexter Ave Site**

1. All results detected below the laboratory MDLs are shown as hollow data points.
2. Preliminary Screening Levels: PCE = 5.0 µg/L, TCE = 4.0 µg/L, cDCE = 16 µg/L, and VC = 0.29 µg/L.

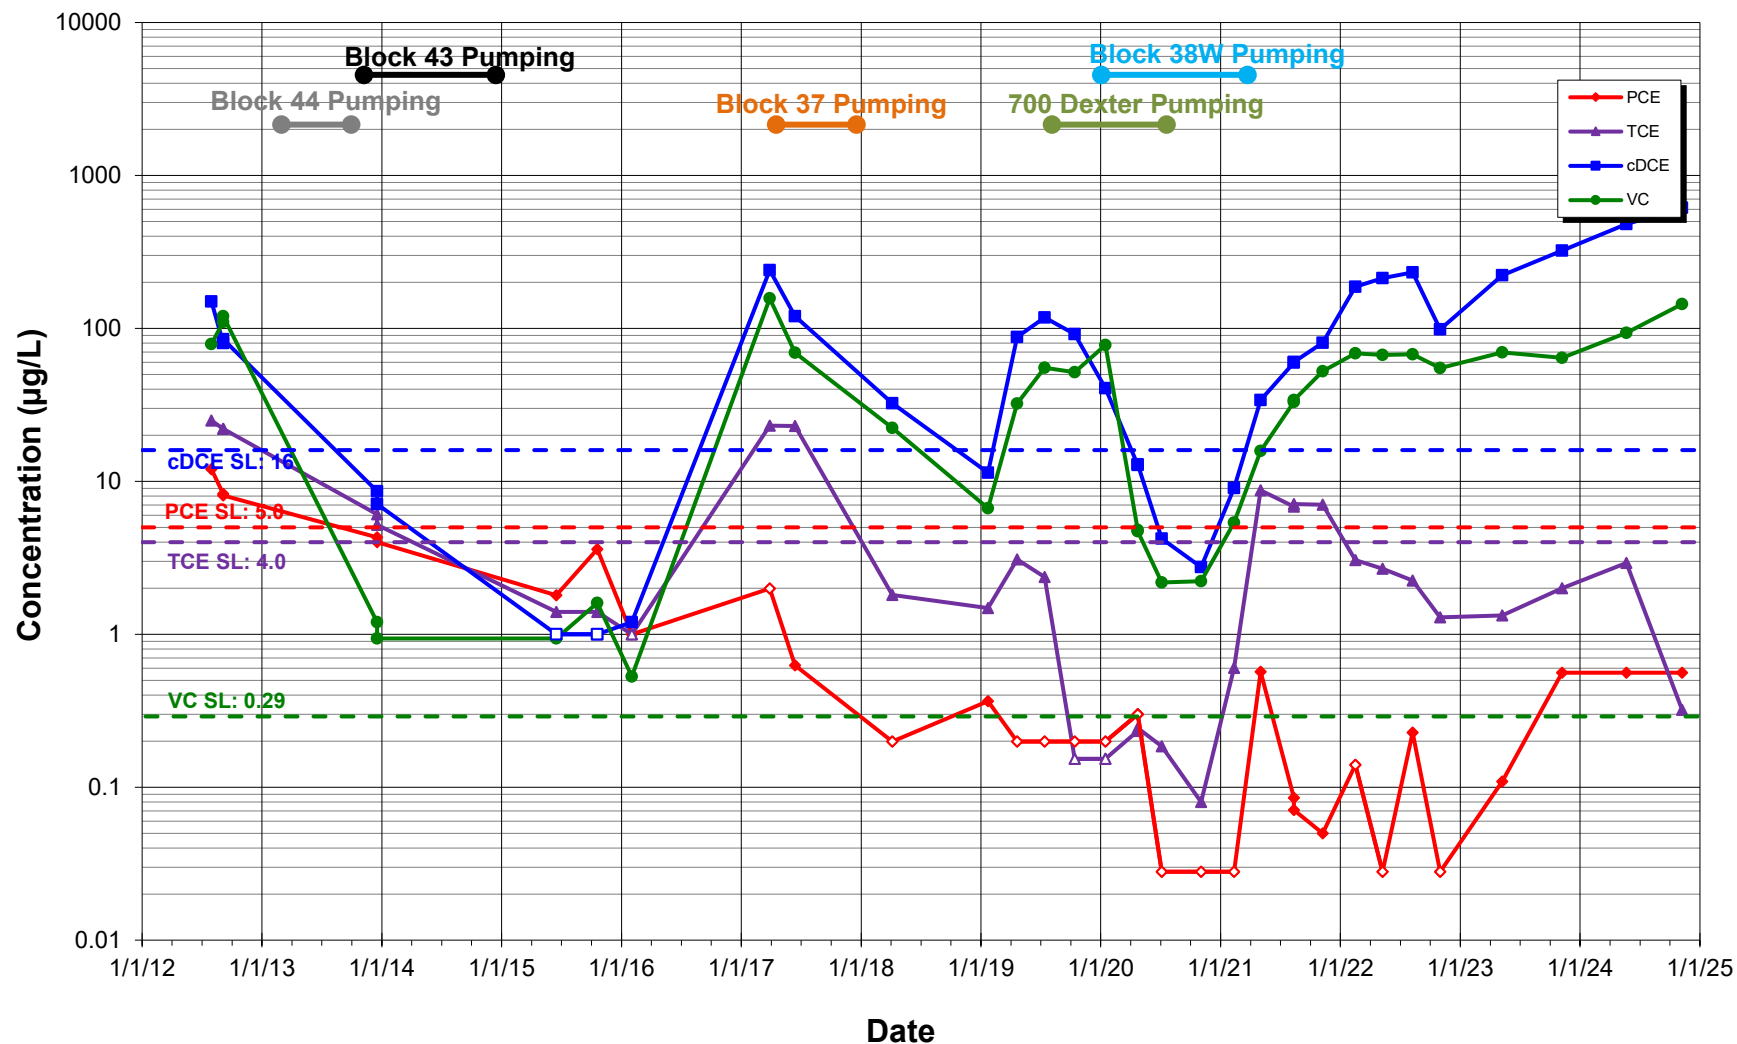
**Concentration vs Time**  
**MW103 (-67.6 to -77.6 feet NAVD), Alley E of Seattle Roy Aloha Shops**  
**American Linen Supply Co Dexter Ave Site**

1. All results detected below the laboratory MDLs are shown as hollow data points.
2. Preliminary Screening Levels: PCE = 5.0 µg/L, TCE = 4.0 µg/L, cDCE = 16 µg/L, and VC = 0.29 µg/L.

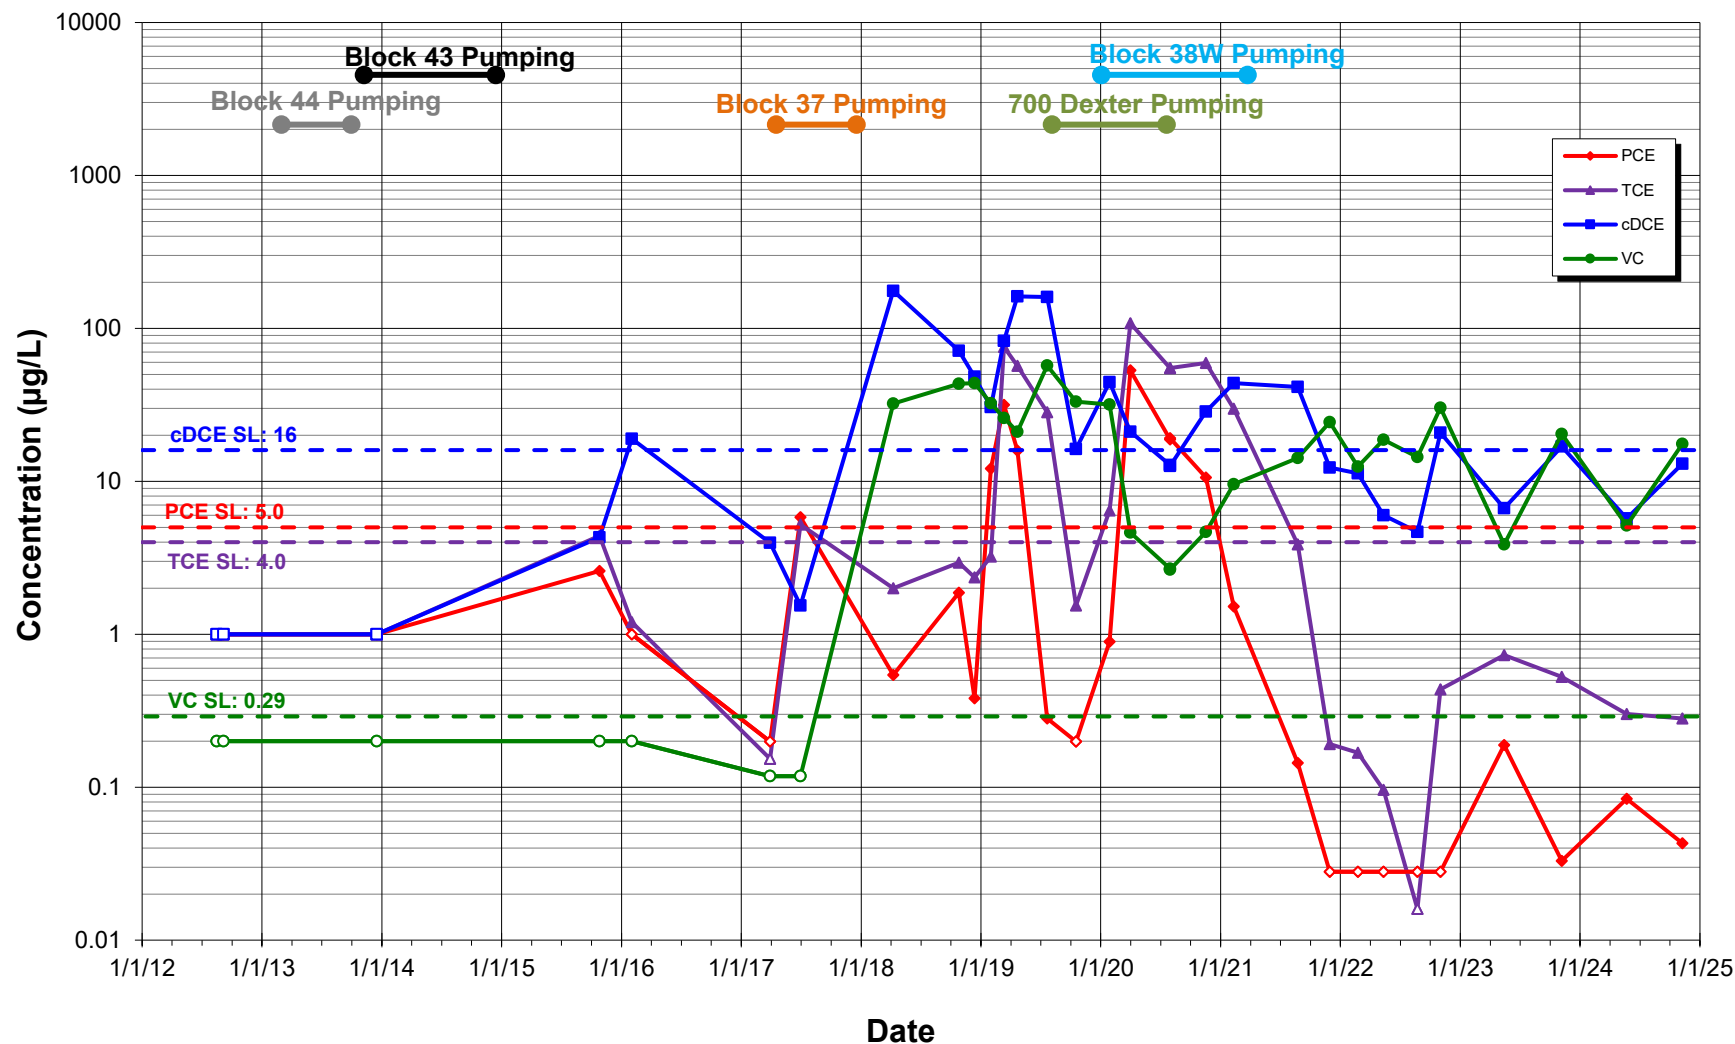
**Concentration vs Time**  
**MW104 (-76.3 to -86.3 feet NAVD), 8th Ave N ROW, W side**  
**American Linen Supply Co Dexter Ave Site**

1. All results detected below the laboratory MDLs are shown as hollow data points.
2. Preliminary Screening Levels: PCE = 5.0 µg/L, TCE = 4.0 µg/L, cDCE = 16 µg/L, and VC = 0.29 µg/L.

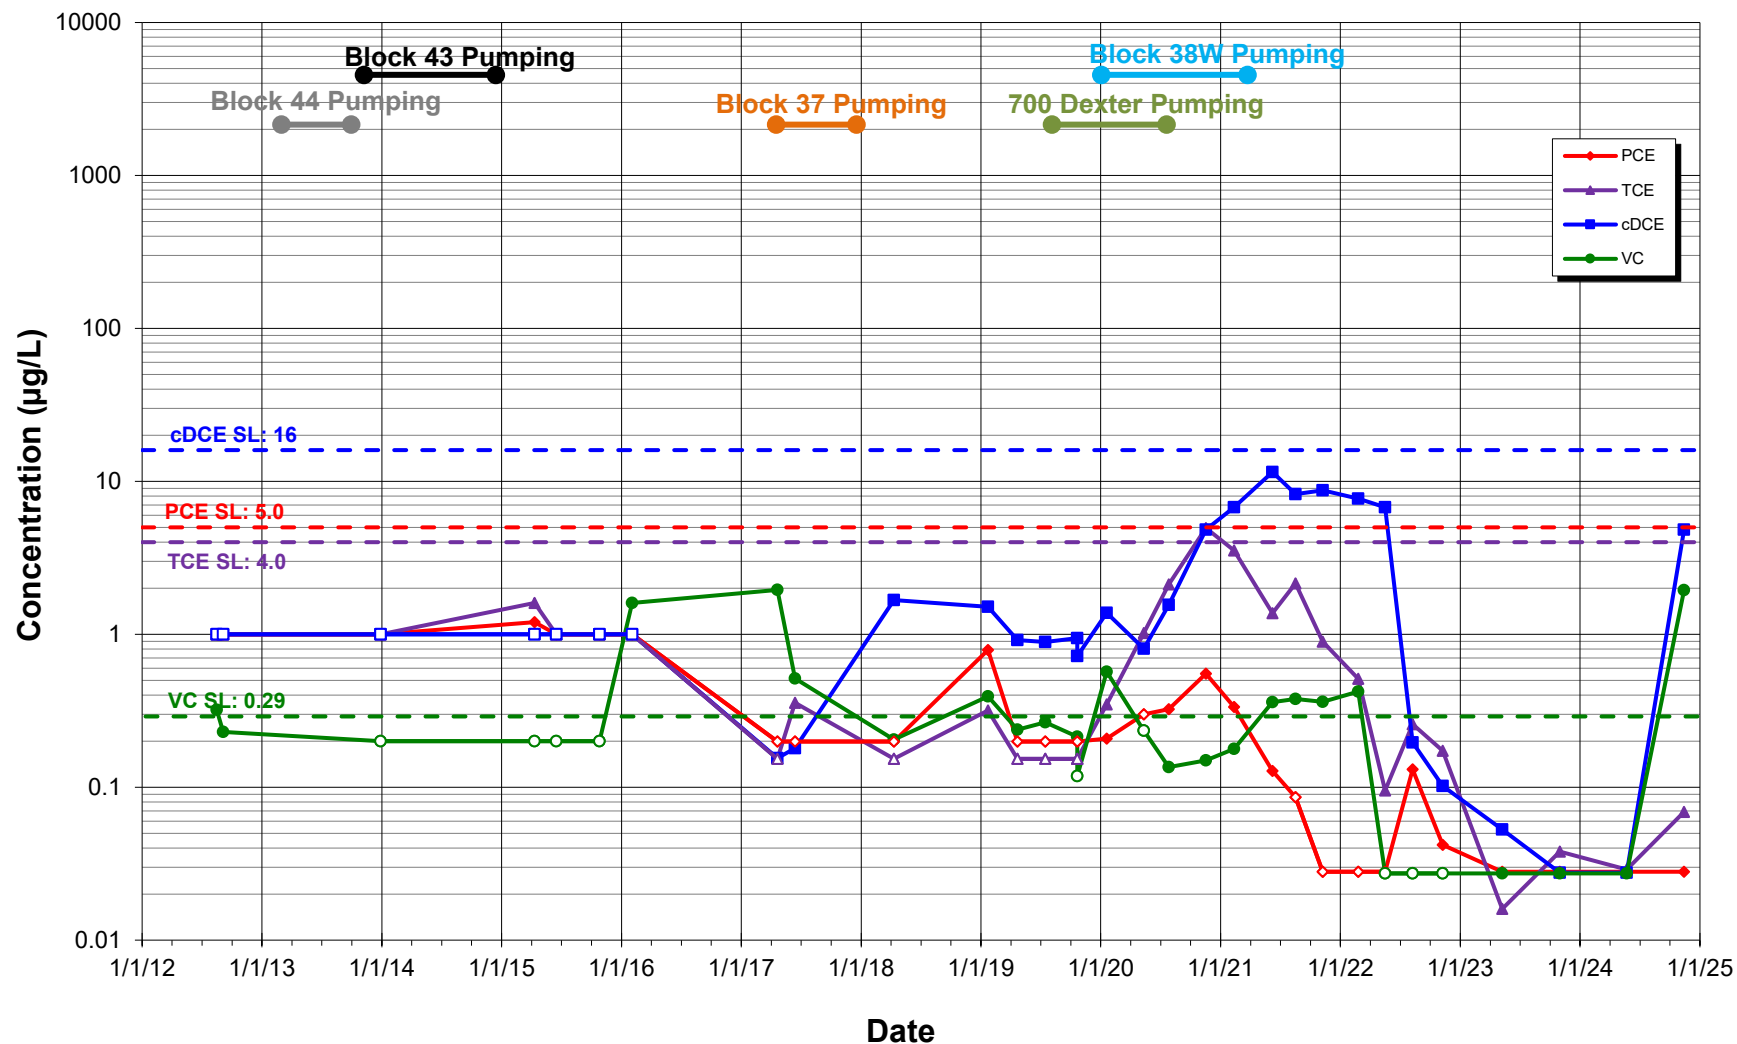
**Concentration vs Time**  
**MW105 (-85.8 to -95.8 feet NAVD), Roy St ROW, S side**  
**American Linen Supply Co Dexter Ave Site**

1. All results detected below the laboratory MDLs are shown as hollow data points.
2. Preliminary Screening Levels: PCE = 5.0 µg/L, TCE = 4.0 µg/L, cDCE = 16 µg/L, and VC = 0.29 µg/L.

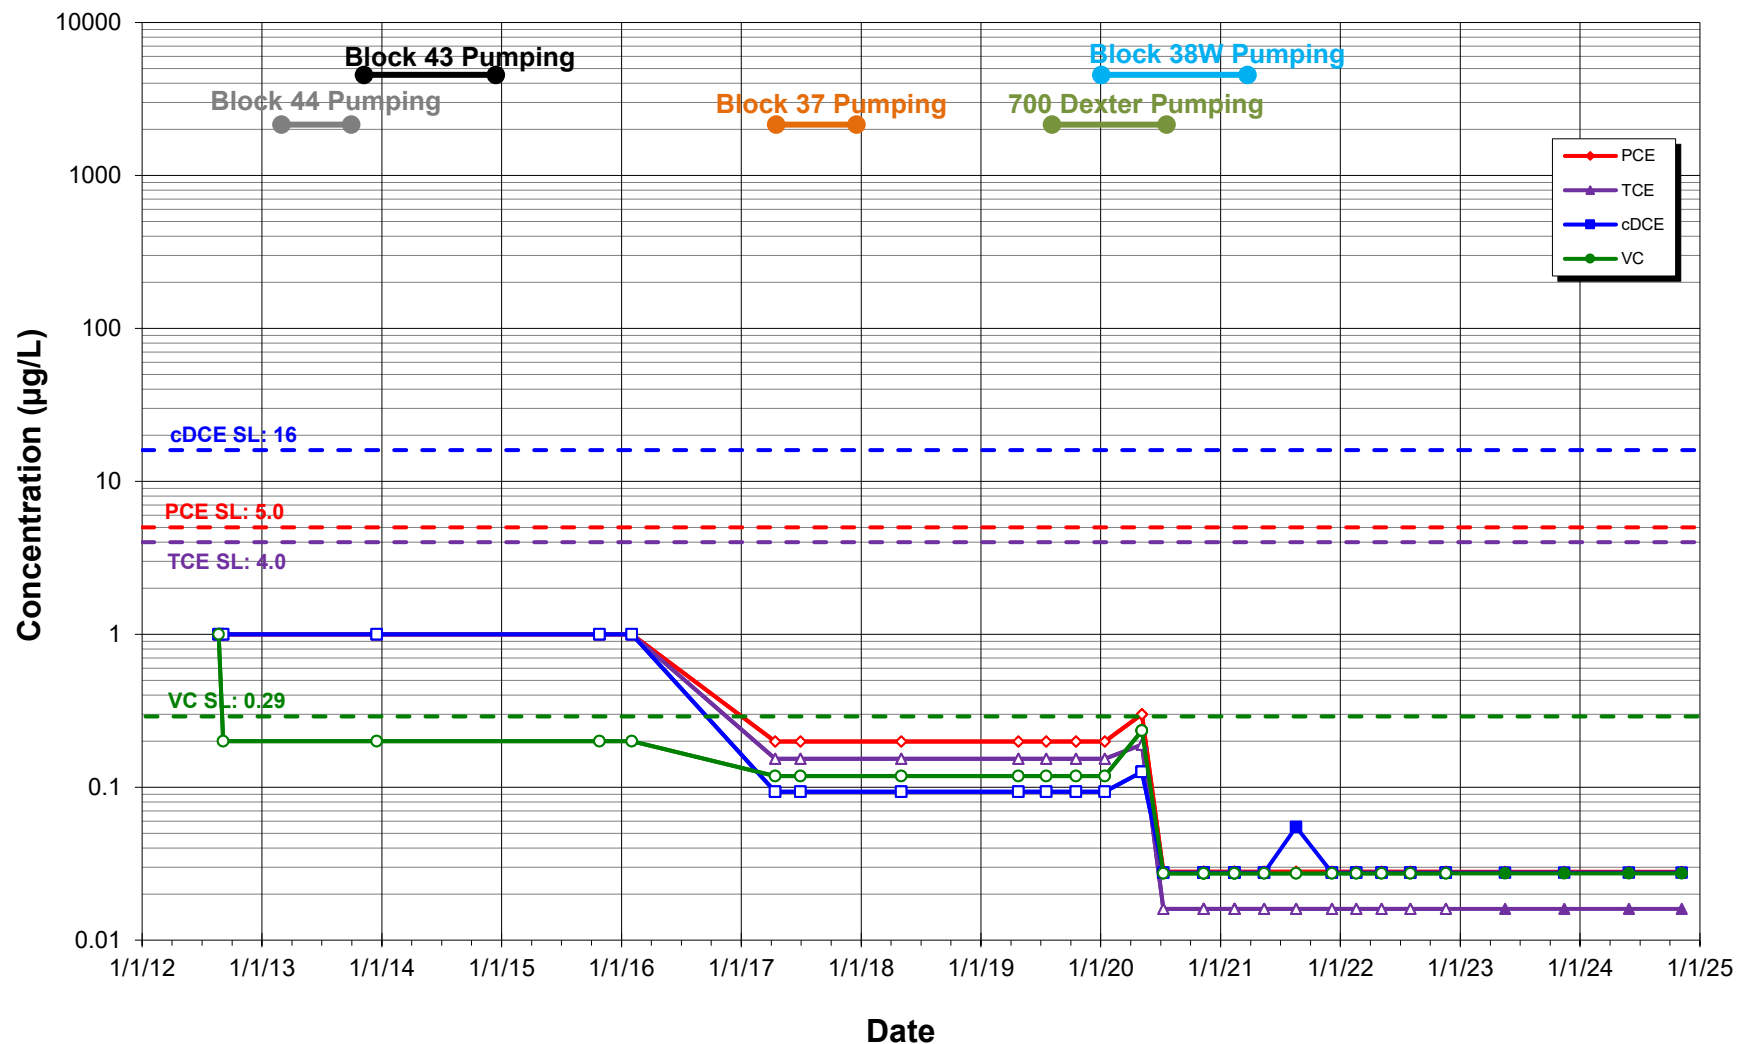
**Concentration vs Time**  
**MW106 (-78.0 to -88.0 feet NAVD), SDOT Mercer Parcels, NW quadrant**  
**American Linen Supply Co Dexter Ave Site**

1. All results detected below the laboratory MDLs are shown as hollow data points.
2. Preliminary Screening Levels: PCE = 5.0 µg/L, TCE = 4.0 µg/L, cDCE = 16 µg/L, and VC = 0.29 µg/L.

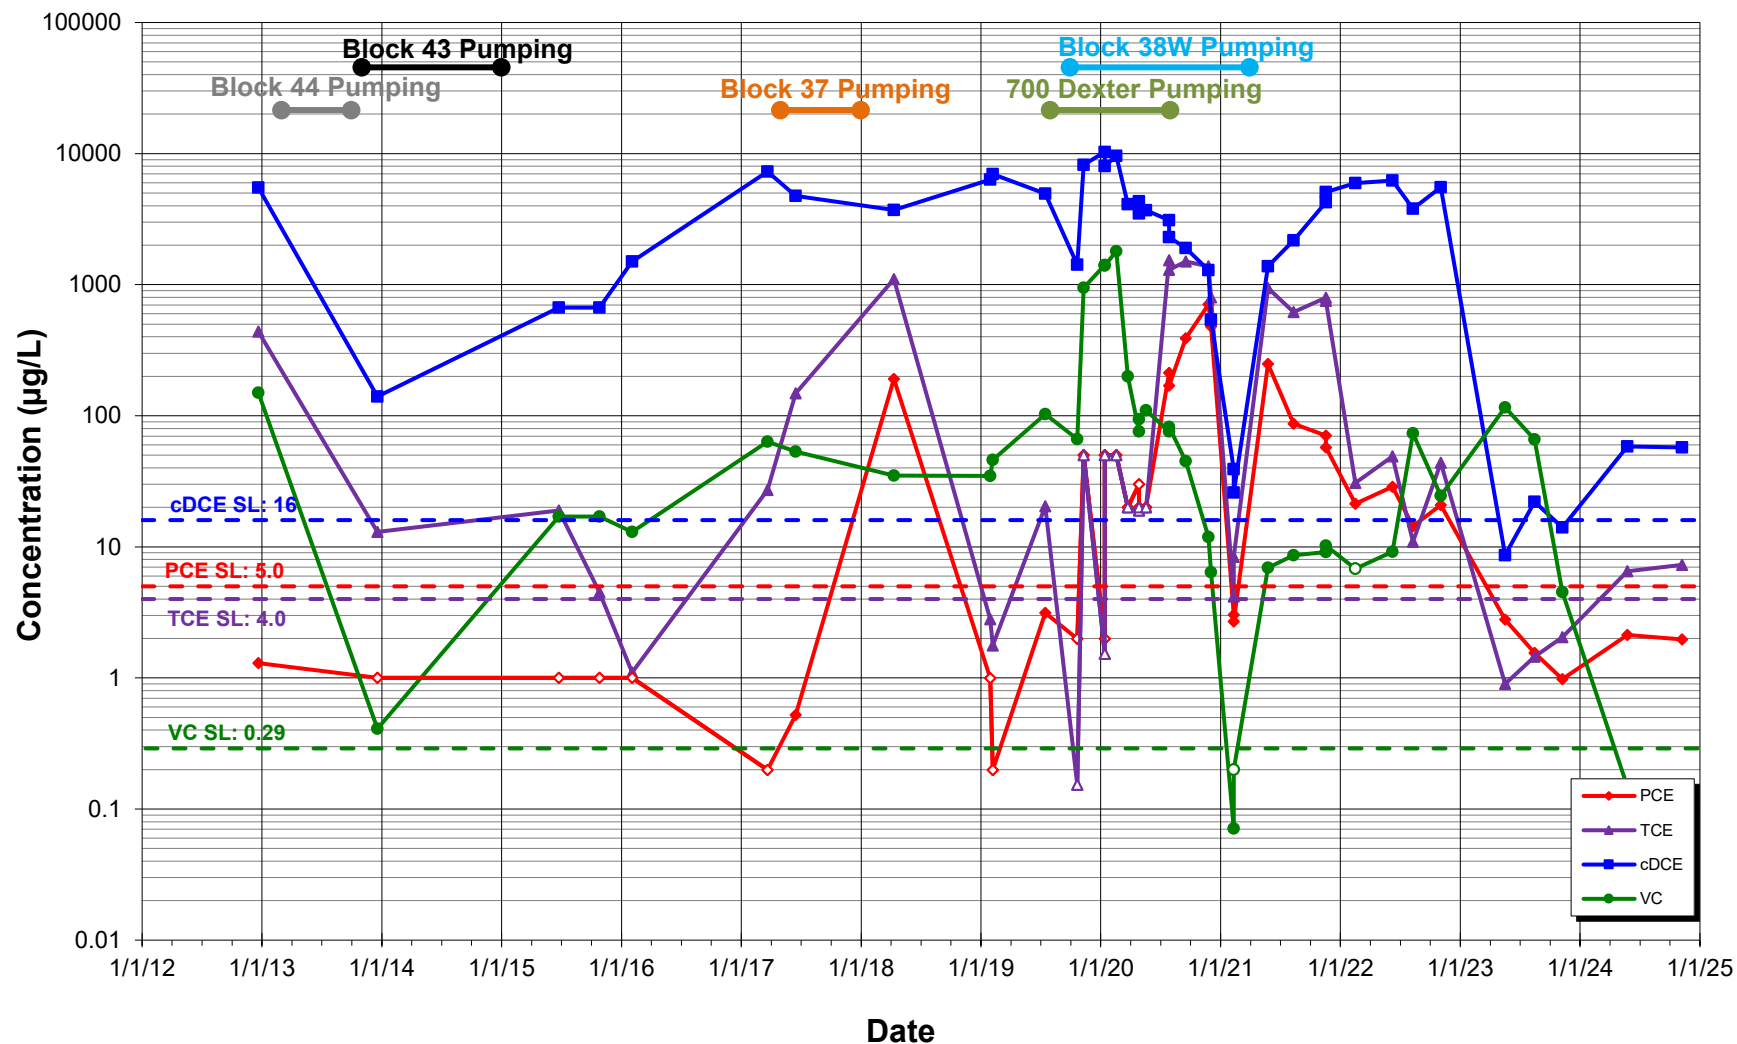
**Concentration vs Time**  
**MW113 (-37.1 to -47.1 feet NAVD), 9th Ave N ROW, W side**  
**American Linen Supply Co Dexter Ave Site**

1. All results detected below the laboratory MDLs are shown as hollow data points.
2. Preliminary Screening Levels: PCE = 5.0 µg/L, TCE = 4.0 µg/L, cDCE = 16 µg/L, and VC = 0.29 µg/L.

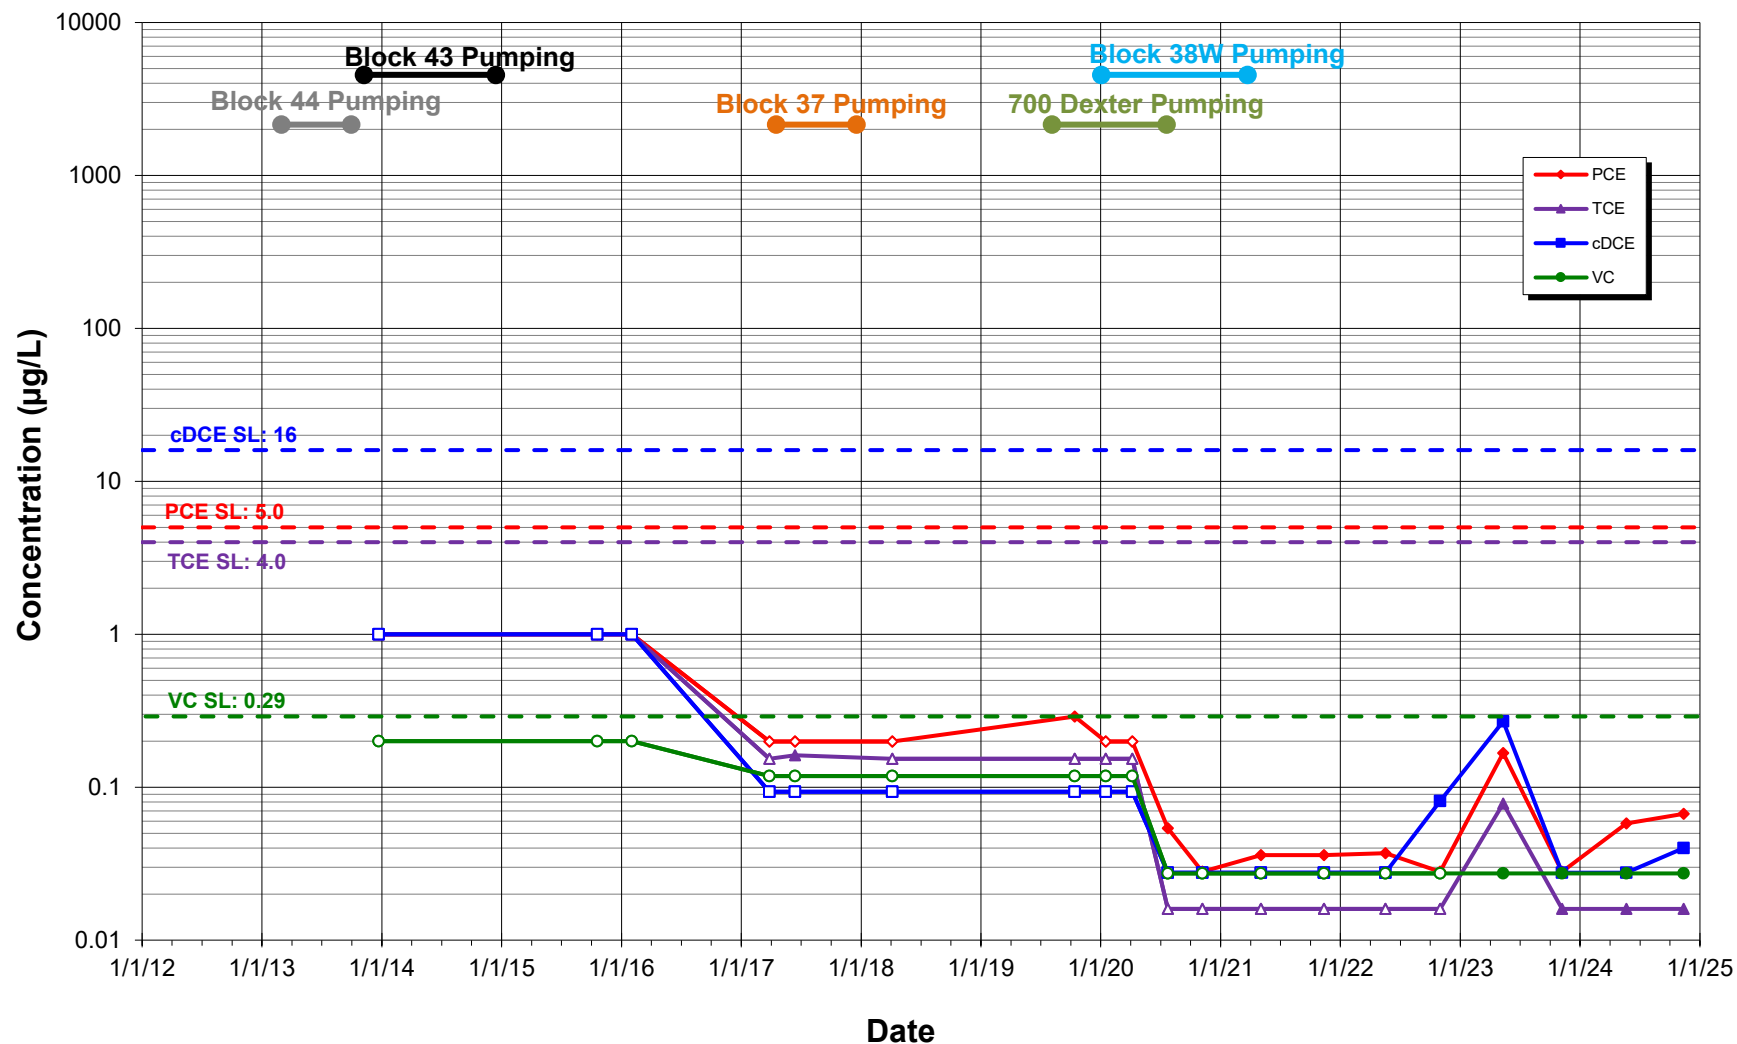
**Concentration vs Time**  
**MW122 (-75.0 to -89.0 feet NAVD), Alley E of Seattle Roy Aloha Shops**  
**American Linen Supply Co Dexter Ave Site**

1. All results detected below the laboratory MDLs are shown as hollow data points.
2. Preliminary Screening Levels: PCE = 5.0 µg/L, TCE = 4.0 µg/L, cDCE = 16 µg/L, and VC = 0.29 µg/L.

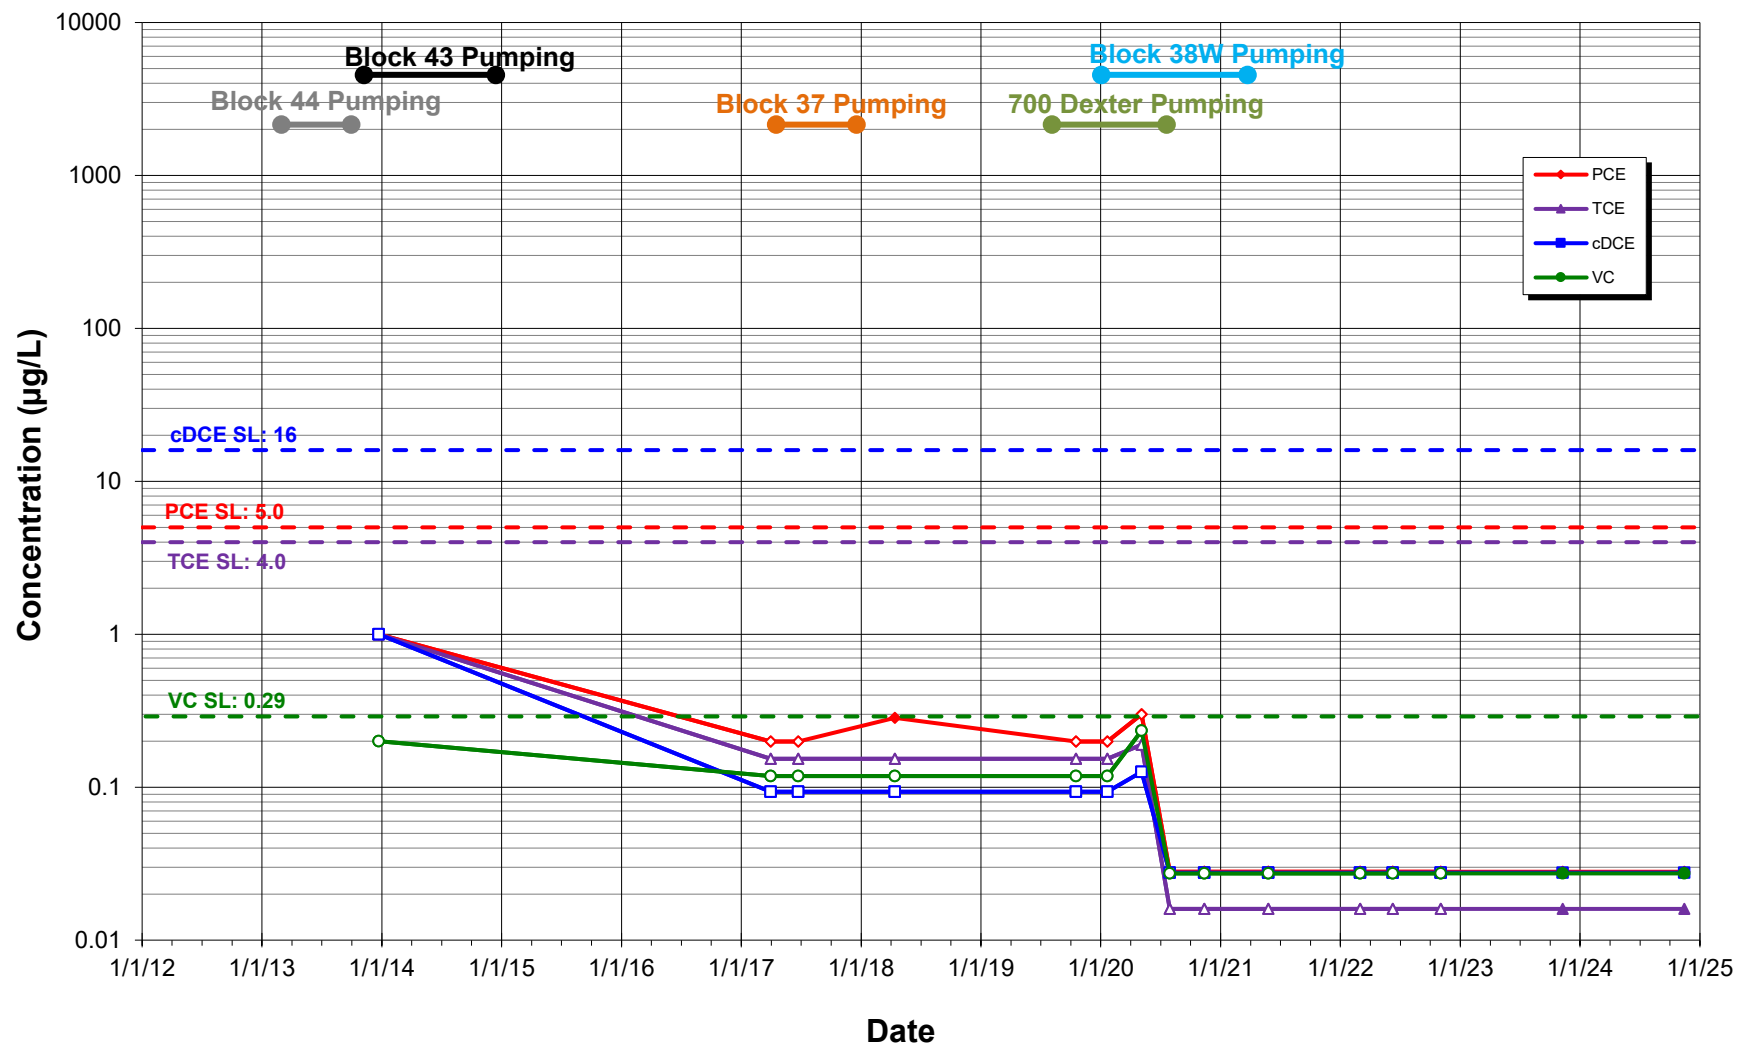
**Concentration vs Time**  
**MW123 (-42.5 to -52.5 feet NAVD), Westlake Ave N ROW, W side**  
**American Linen Supply Co Dexter Ave Site**

1. All results detected below the laboratory MDLs are shown as hollow data points.
2. Preliminary Screening Levels: PCE = 5.0 µg/L, TCE = 4.0 µg/L, cDCE = 16 µg/L, and VC = 0.29 µg/L.

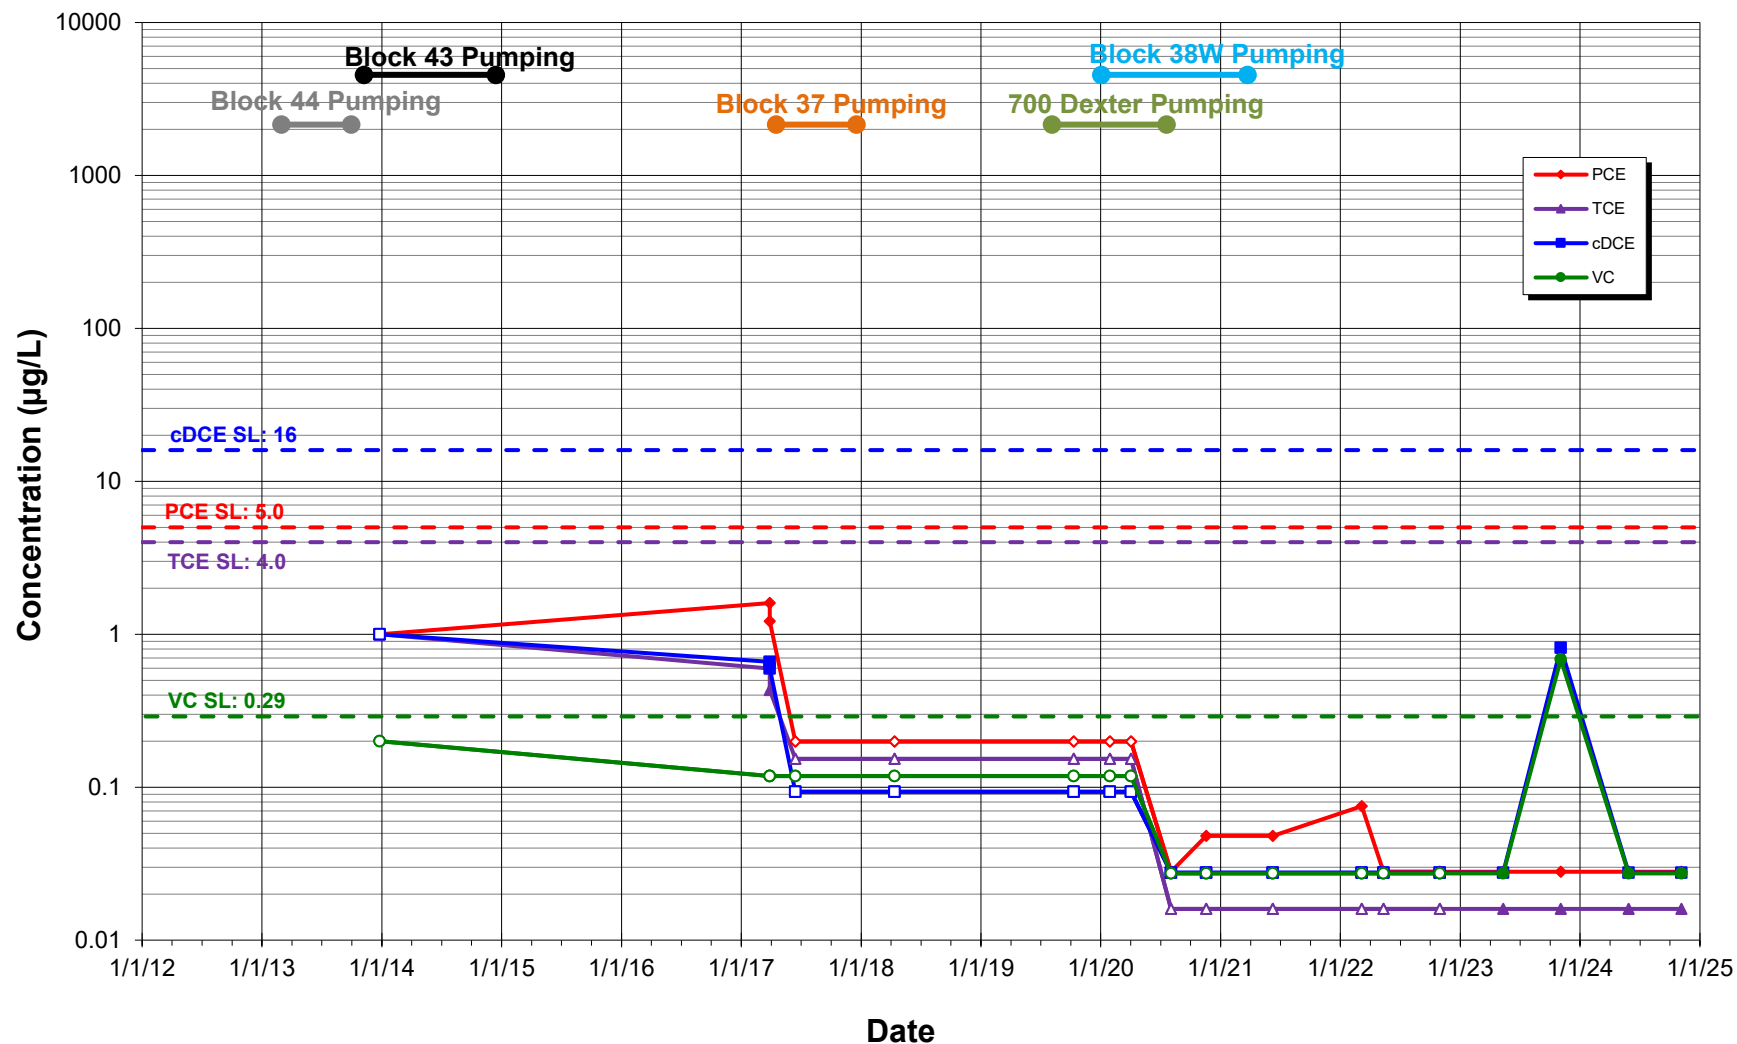
**Concentration vs Time**  
**MW124 (-53.8 to -63.8 feet NAVD), Valley St ROW, S side**  
**American Linen Supply Co Dexter Ave Site**

1. All results detected below the laboratory MDLs are shown as hollow data points.
2. Preliminary Screening Levels: PCE = 5.0 µg/L, TCE = 4.0 µg/L, cDCE = 16 µg/L, and VC = 0.29 µg/L.

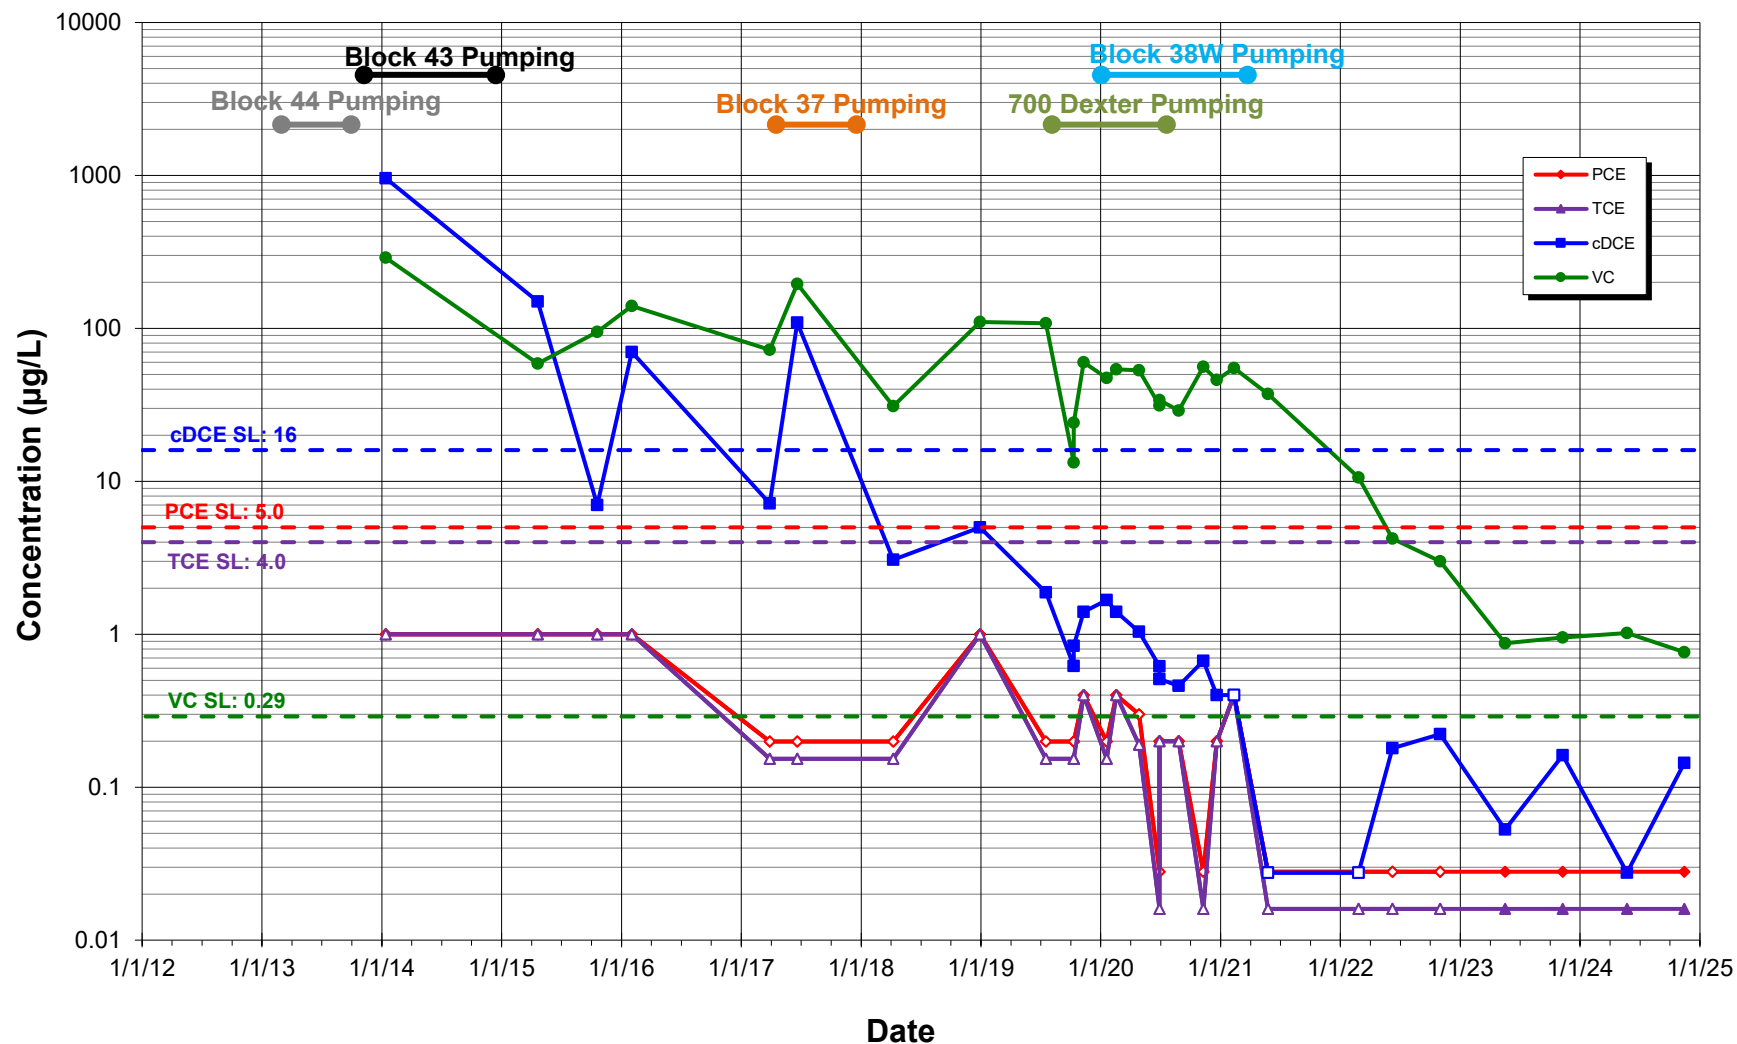
**Concentration vs Time**  
**MW128 (-30.8 to -40.8 feet NAVD), Westlake Ave N ROW, E side**  
**American Linen Supply Co Dexter Ave Site**

1. All results detected below the laboratory MDLs are shown as hollow data points.
2. Preliminary Screening Levels: PCE = 5.0 µg/L, TCE = 4.0 µg/L, cDCE = 16 µg/L, and VC = 0.29 µg/L.

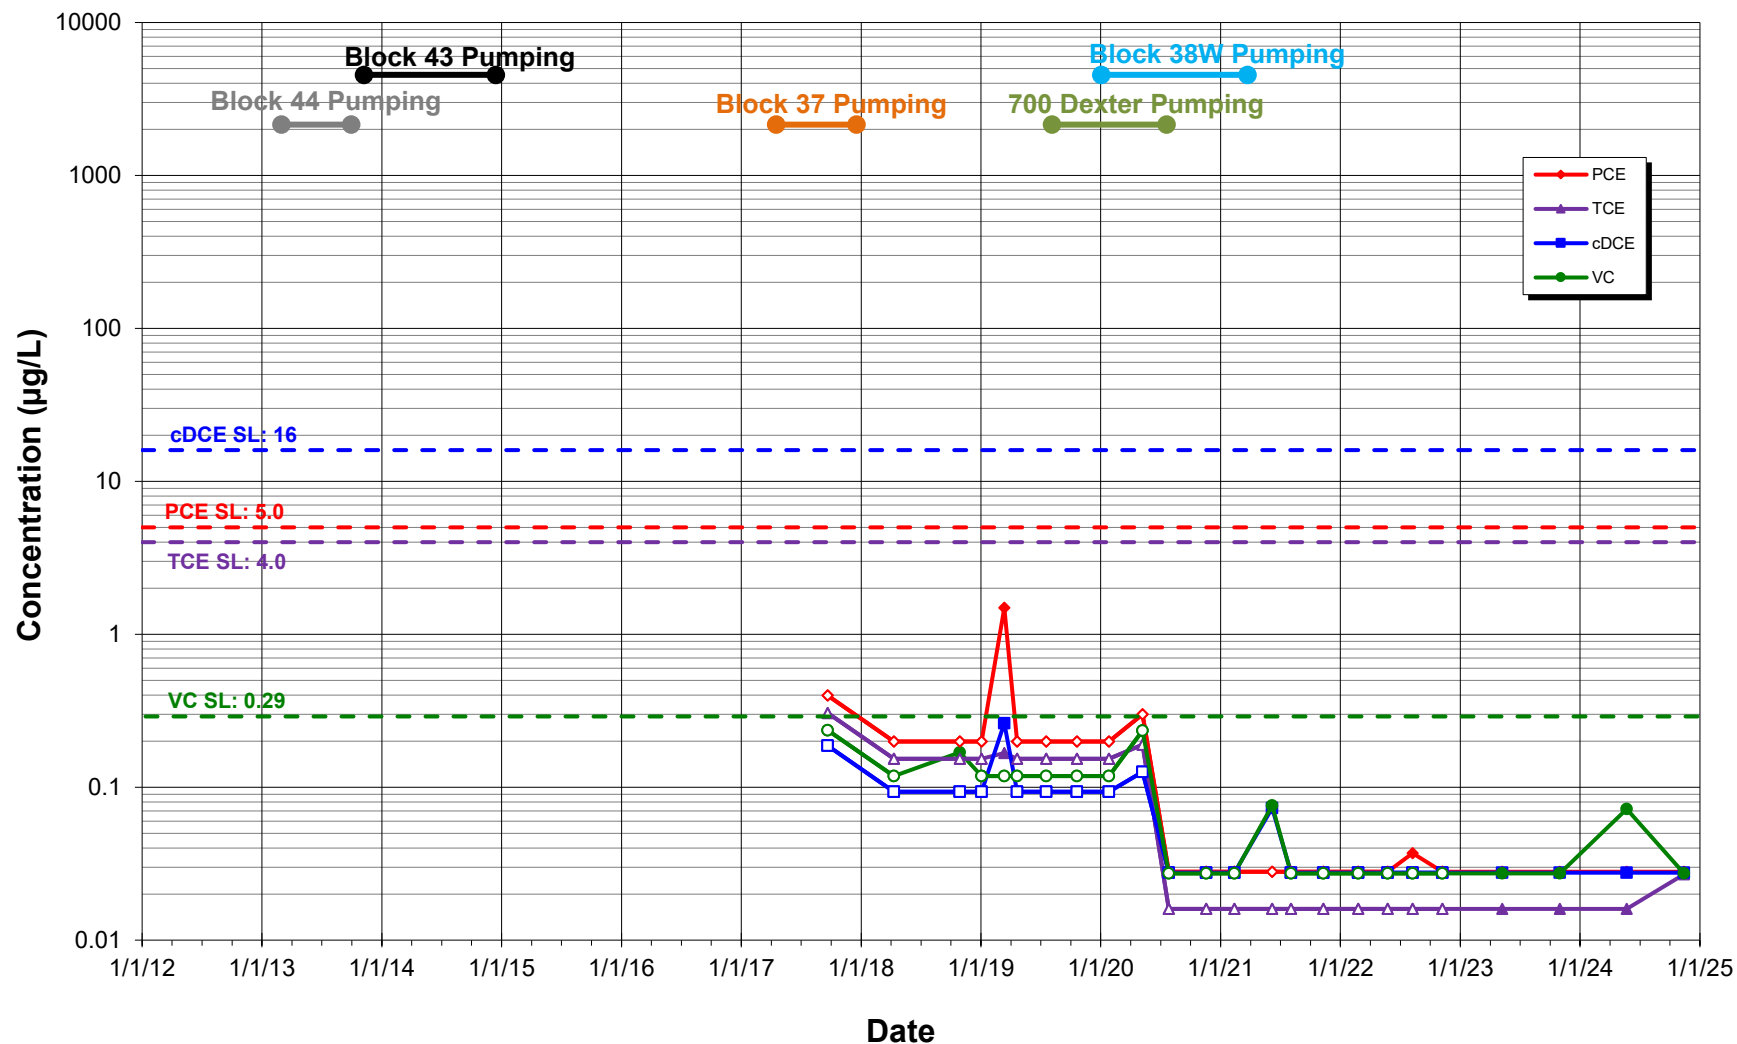
**Concentration vs Time**  
**MW-138 (-47.5 to -57.5 feet NAVD), Dexter Ave N ROW, E side**  
**American Linen Supply Co Dexter Ave Site**

1. All results detected below the laboratory MDLs are shown as hollow data points.
2. Preliminary Screening Levels: PCE = 5.0 µg/L, TCE = 4.0 µg/L, cDCE = 16 µg/L, and VC = 0.29 µg/L.

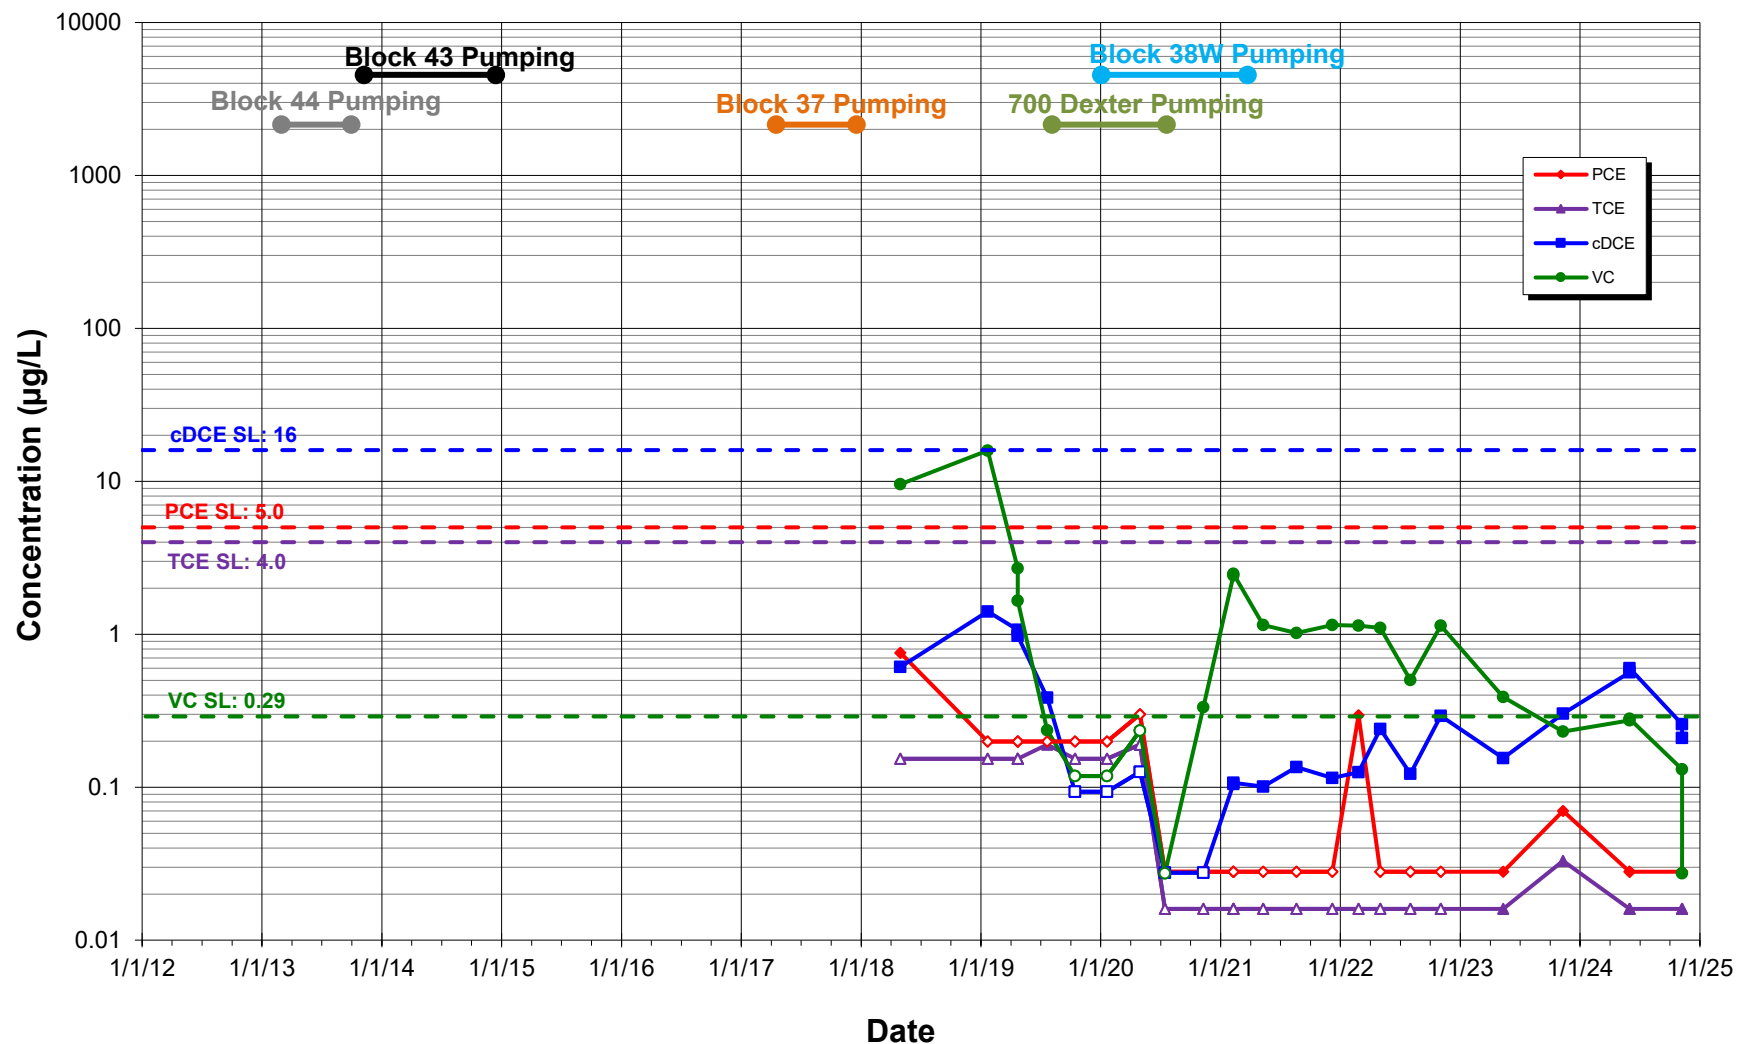
**Concentration vs Time**  
**MW-153 (-65.3 to -75.3 feet NAVD), Roy St ROW, S side**  
**American Linen Supply Co Dexter Ave Site**

1. All results detected below the laboratory MDLs are shown as hollow data points.
2. Preliminary Screening Levels: PCE = 5.0 µg/L, TCE = 4.0 µg/L, cDCE = 16 µg/L, and VC = 0.29 µg/L.
