**Attachment A**  
**Well Completion Table**  
**American Linen Supply Co Dexter Ave Site**  
**700 Dexter Avenue North**  
**Seattle, Washington**

**ATTACHMENT B**

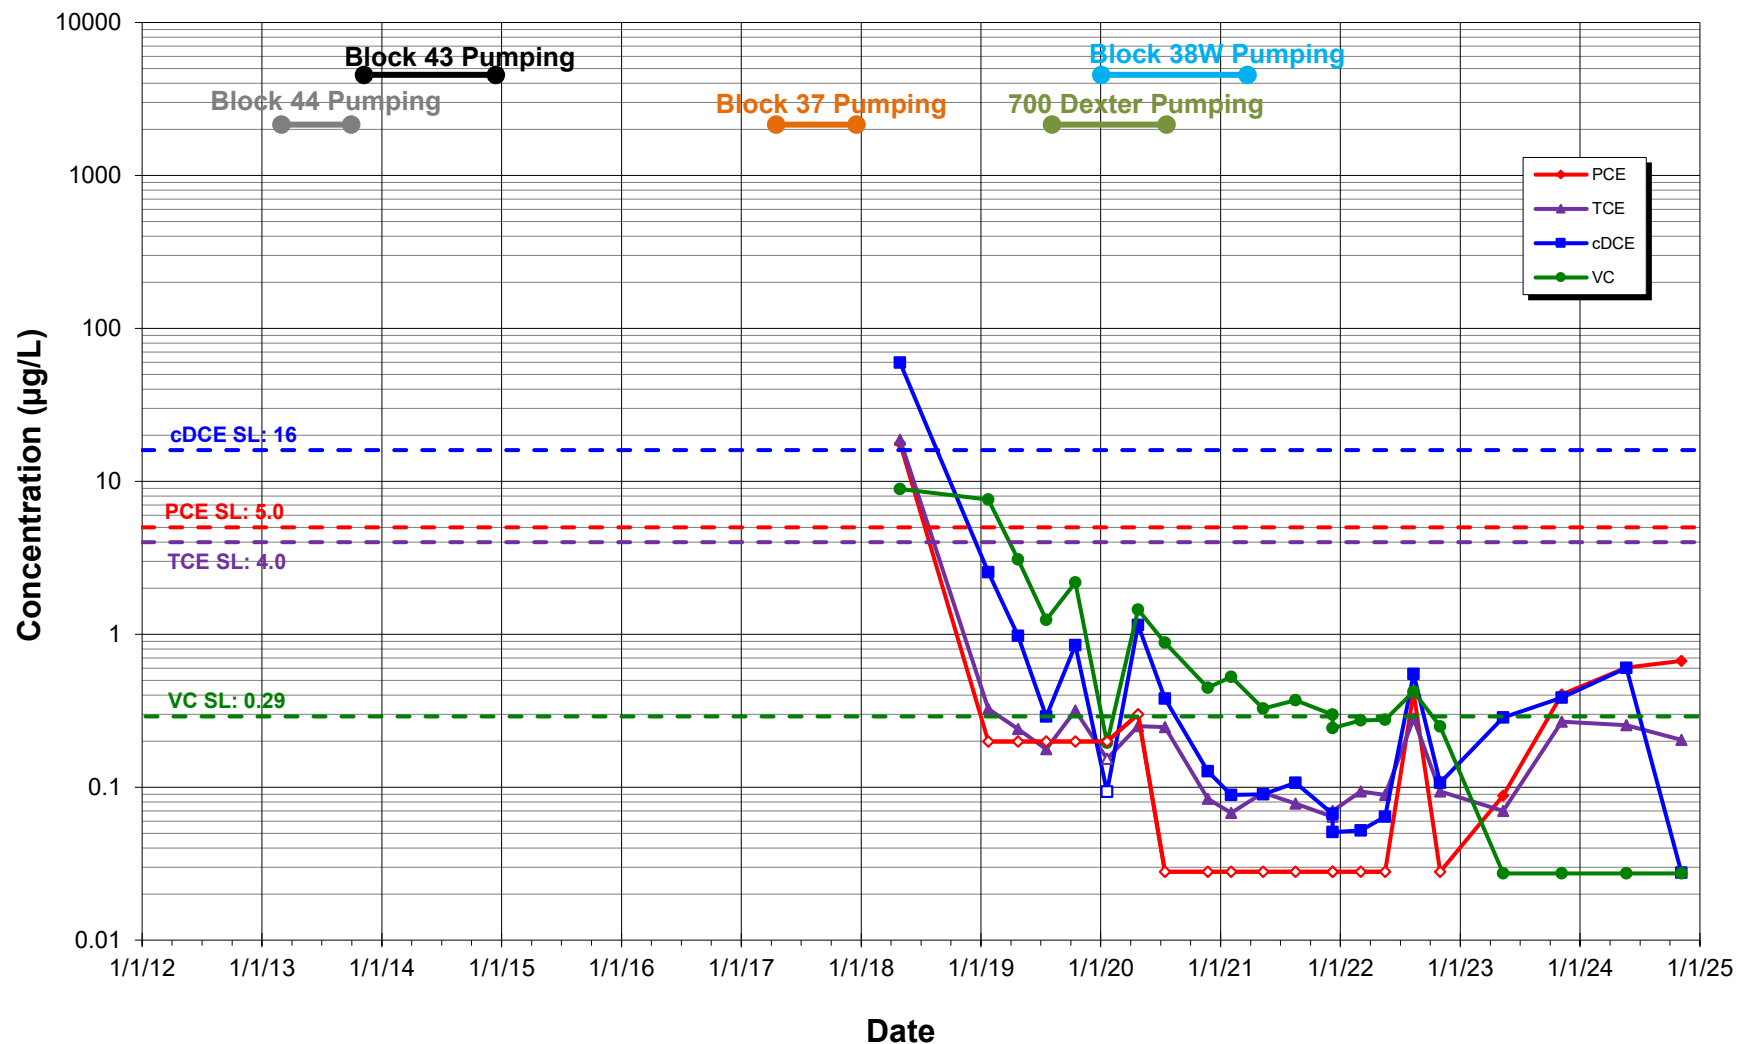
**Concentration vs Time**  
**MW-158A (-47.2 to -58.5 feet NAVD), 8th Ave N, ROW E side**  
**American Linen Supply Co Dexter Ave Site**

1. All results detected below the laboratory MDLs are shown as hollow data points.
2. Preliminary Screening Levels: PCE = 5.0 µg/L, TCE = 4.0 µg/L, cDCE = 16 µg/L, and VC = 0.29 µg/L.

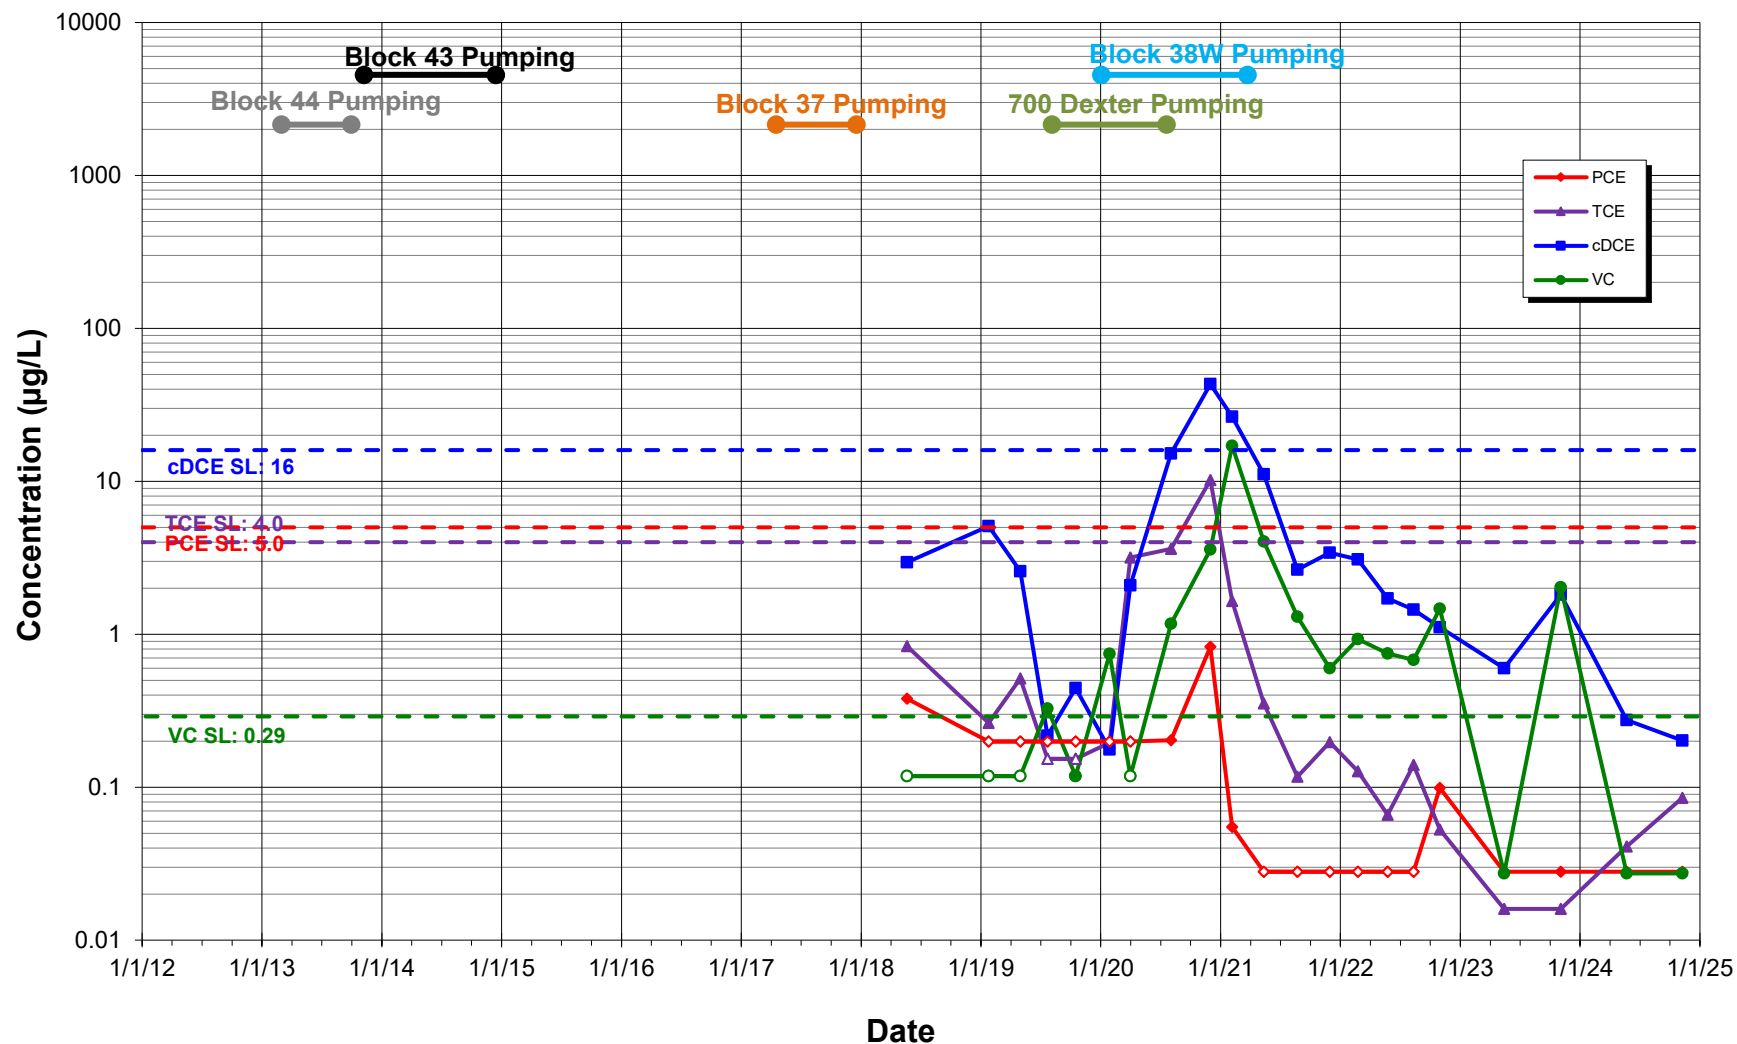
**Concentration vs Time**  
**MW-160 (-76.5 to -86.5 feet NAVD), 8th Ave N ROW, W side**  
**American Linen Supply Co Dexter Ave Site**

1. All results detected below the laboratory MDLs are shown as hollow data points.
2. Preliminary Screening Levels: PCE = 5.0 µg/L, TCE = 4.0 µg/L, cDCE = 16 µg/L, and VC = 0.29 µg/L.

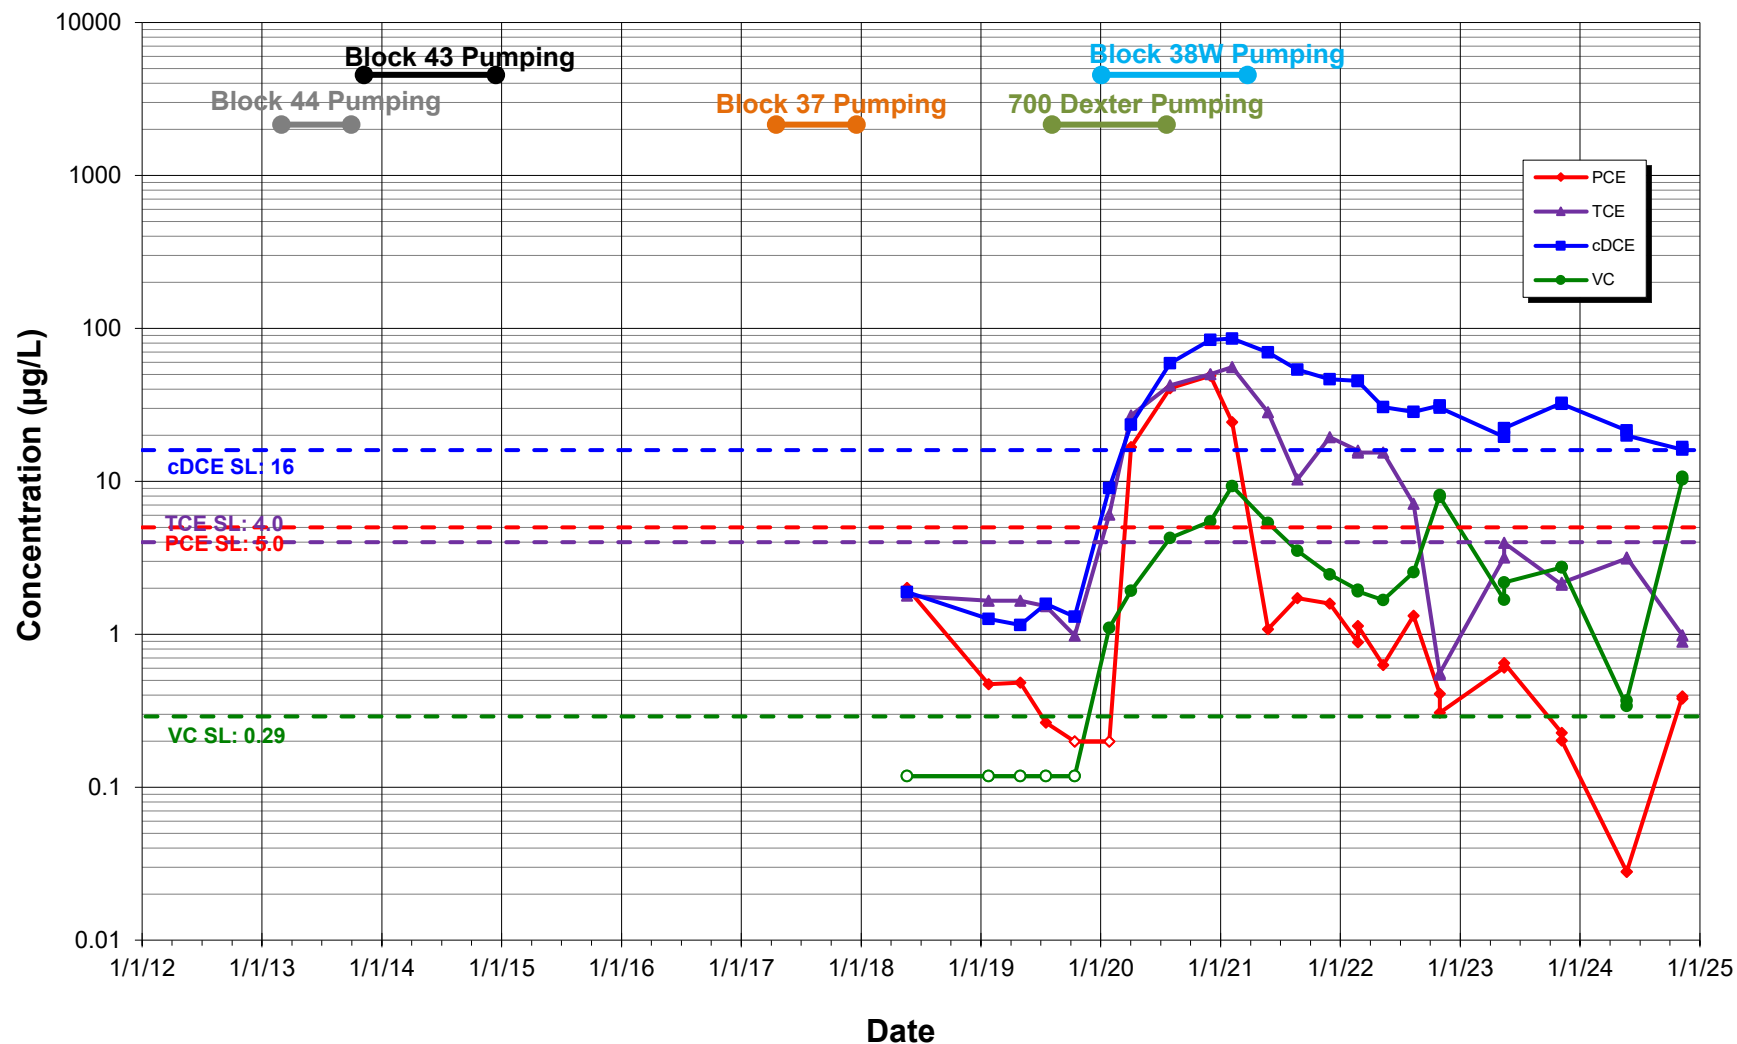
**Concentration vs Time**  
**MW-161 (-78.9 to -89.9 feet NAVD), 8th Ave N ROW, W side**  
**American Linen Supply Co Dexter Ave Site**

1. All results detected below the laboratory MDLs are shown as hollow data points.
2. Preliminary Screening Levels: PCE = 5.0 µg/L, TCE = 4.0 µg/L, cDCE = 16 µg/L, and VC = 0.29 µg/L.

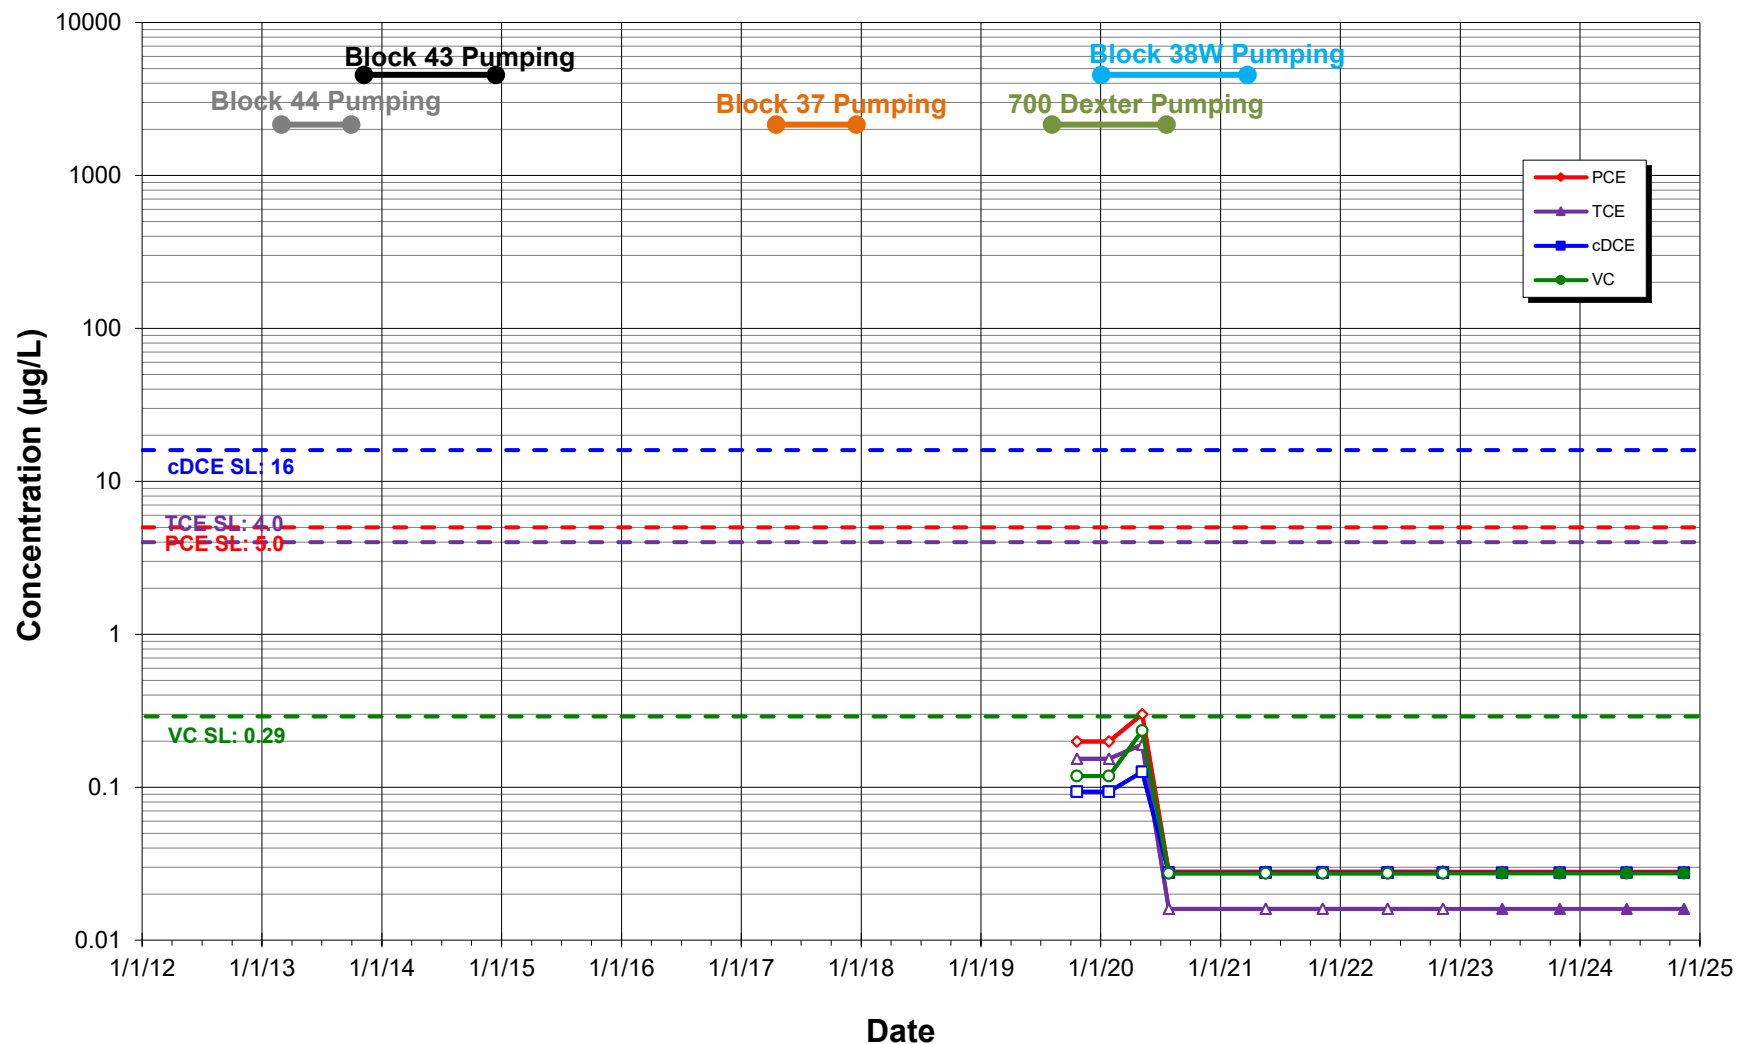
**Concentration vs Time**  
**MW-304 (-47.6 to -57.6 feet NAVD), Dexter Avenue N ROW, E side**  
**American Linen Supply Co Dexter Ave Site**

1. All results detected below the laboratory MDLs are shown as hollow data points.
2. Preliminary Screening Levels: PCE = 5.0 µg/L, TCE = 4.0 µg/L, cDCE = 16 µg/L, and VC = 0.29 µg/L.

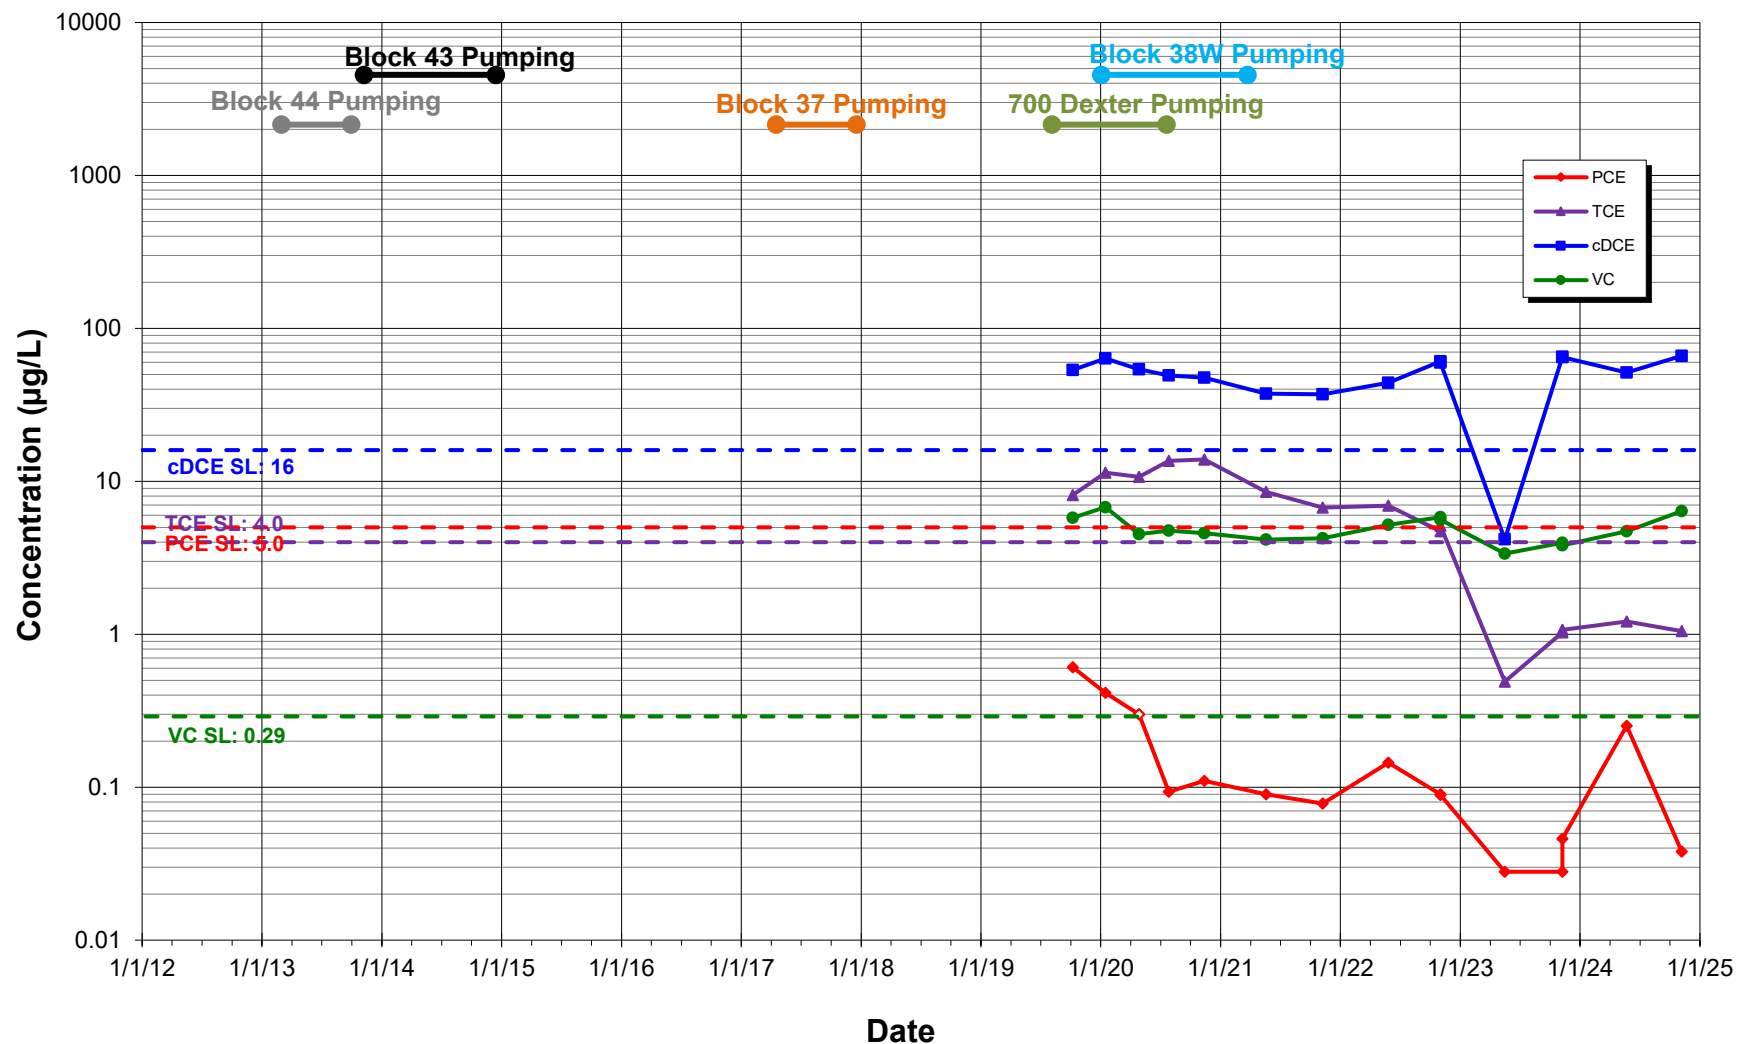
**Concentration vs Time**  
**MW-319 (-42.8 to -52.8 feet NAVD), 9th Ave N ROW, W side**  
**American Linen Supply Co Dexter Ave Site**

1. All results detected below the laboratory MDLs are shown as hollow data points.
2. Preliminary Screening Levels: PCE = 5.0 µg/L, TCE = 4.0 µg/L, cDCE = 16 µg/L, and VC = 0.29 µg/L.

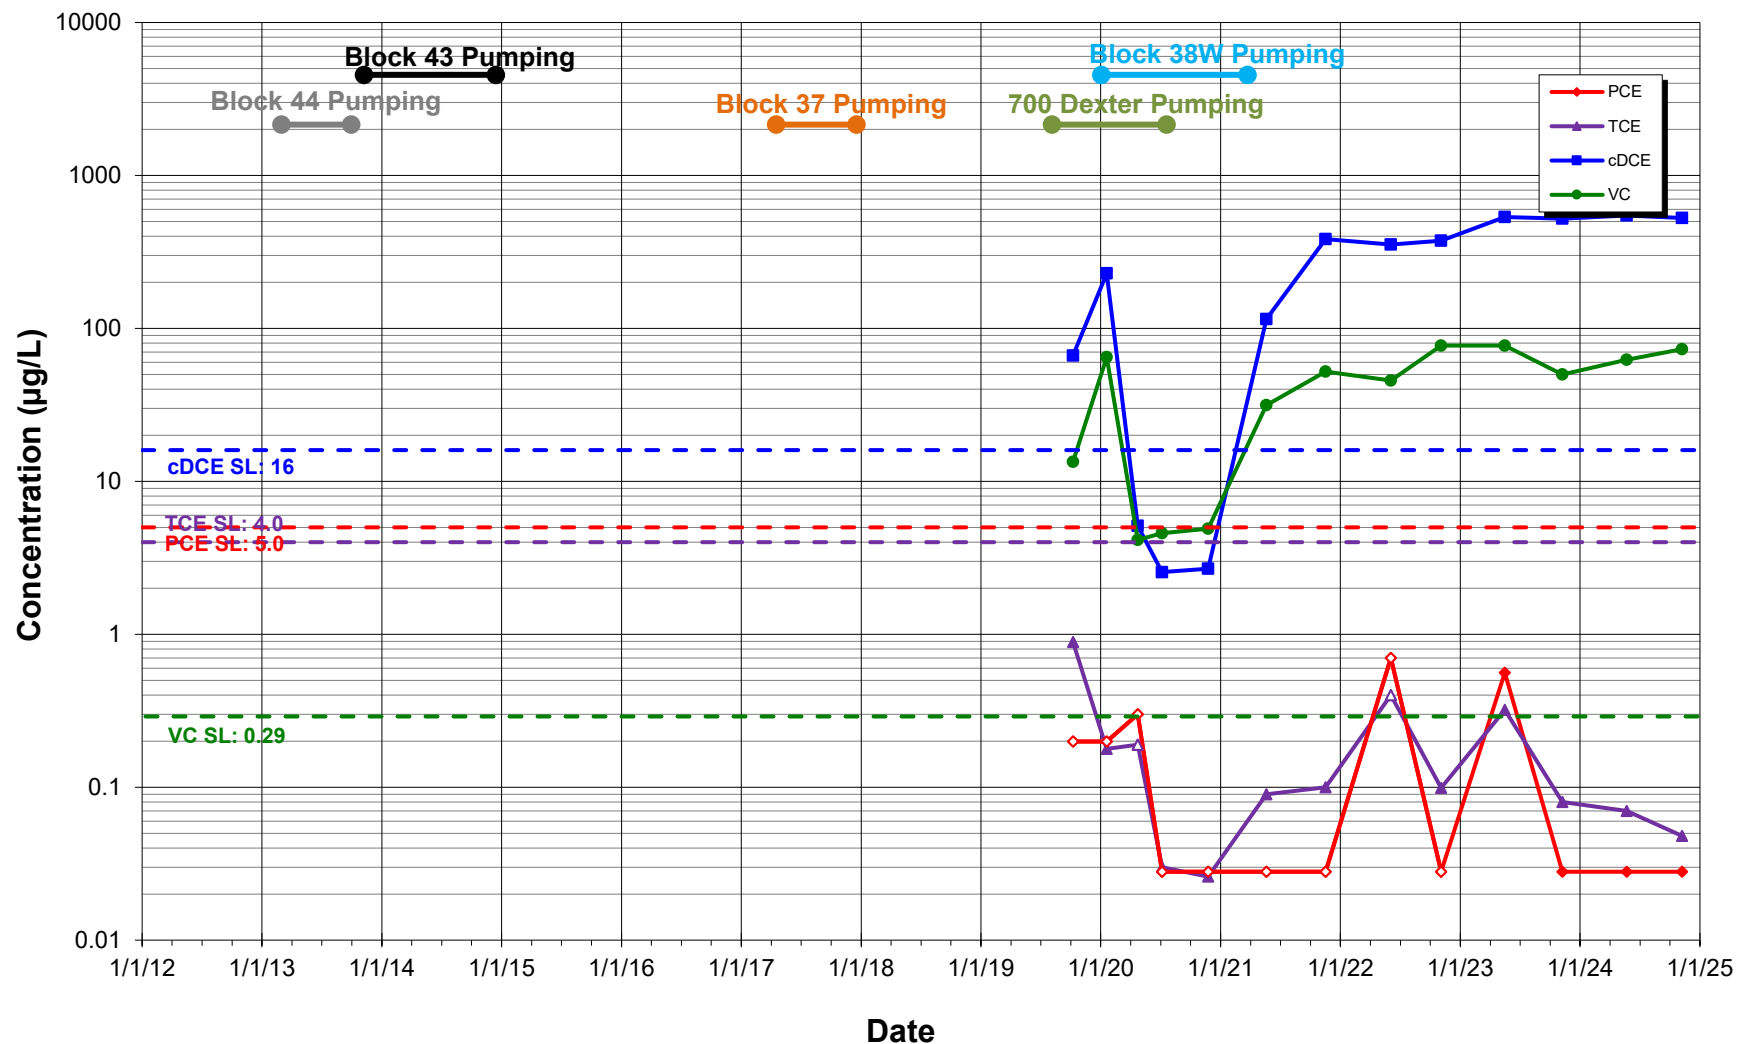
**Concentration vs Time**  
**MW-323 (-65.4 to -75.4 feet NAVD), 9th Ave N ROW, W side**  
**American Linen Supply Co Dexter Ave Site**

1. All results detected below the laboratory MDLs are shown as hollow data points.
2. Preliminary Screening Levels: PCE = 5.0 µg/L, TCE = 4.0 µg/L, cDCE = 16 µg/L, and VC = 0.29 µg/L.

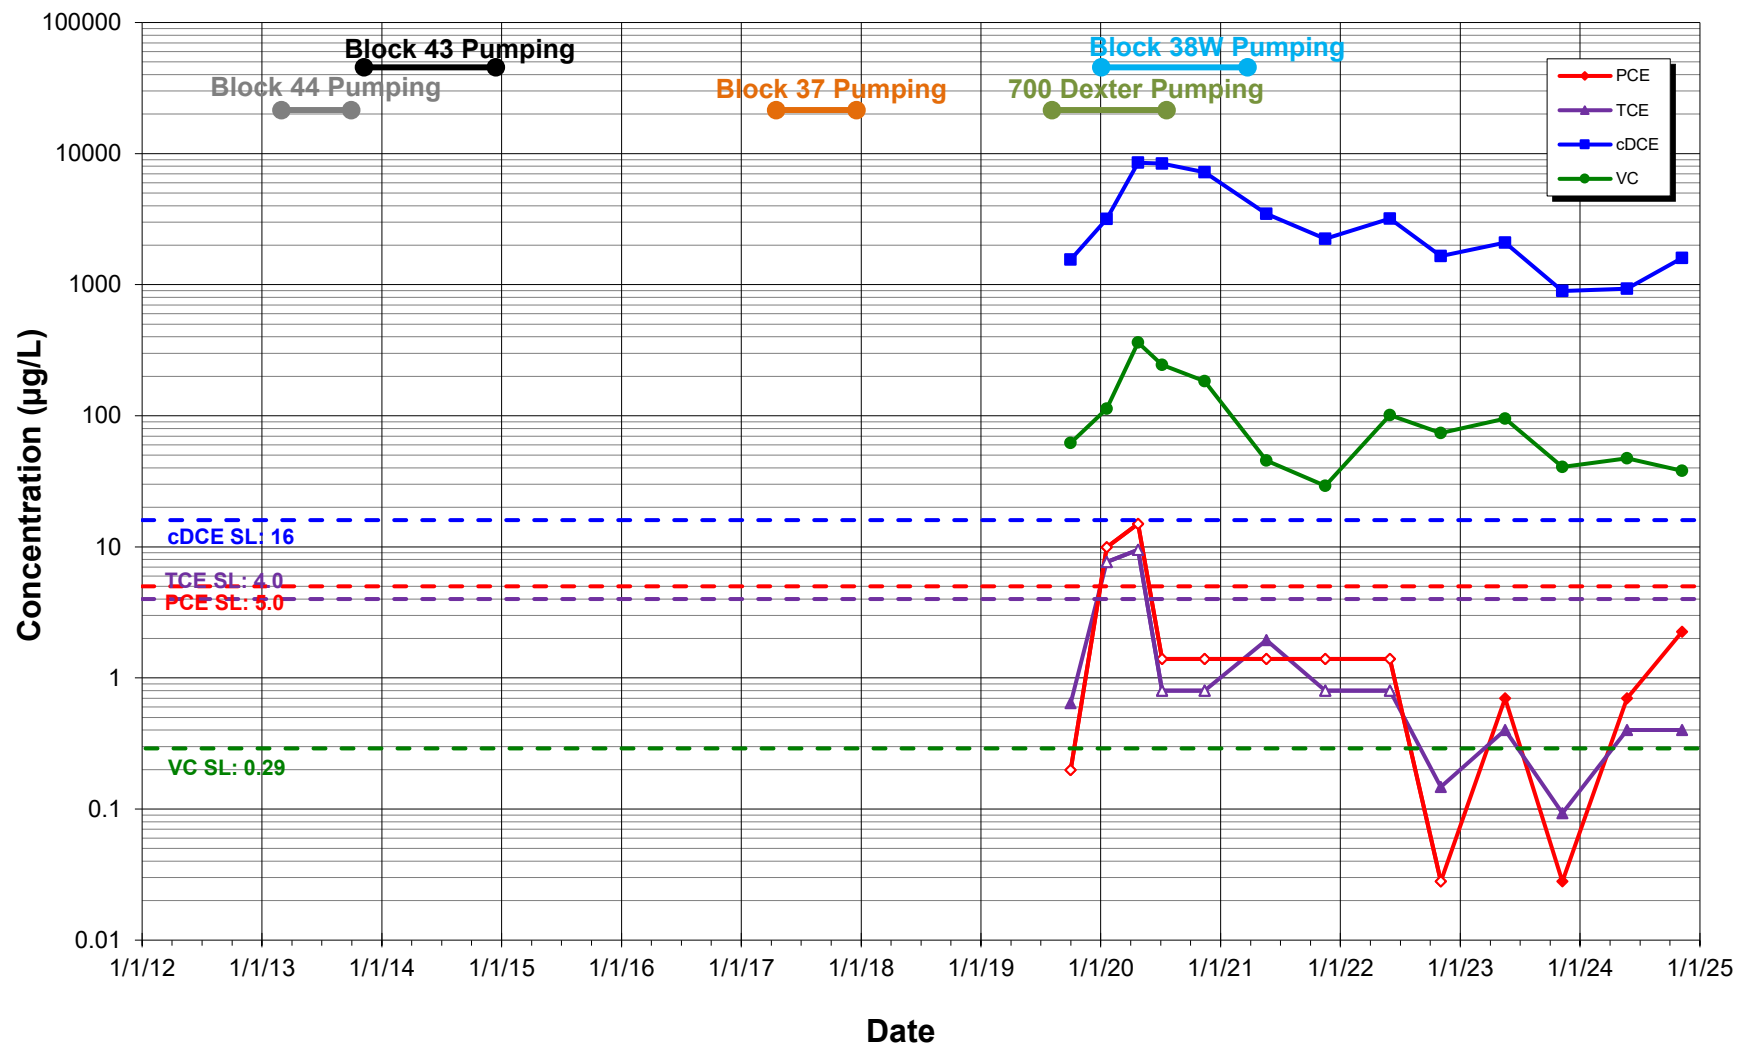
**Concentration vs Time**  
**MW-324 (-32.1 to -42.1 feet NAVD), Roy St ROW, N side**  
**American Linen Supply Co Dexter Ave Site**

1. All results detected below the laboratory MDLs are shown as hollow data points.
2. Preliminary Screening Levels: PCE = 5.0 µg/L, TCE = 4.0 µg/L, cDCE = 16 µg/L, and VC = 0.29 µg/L.

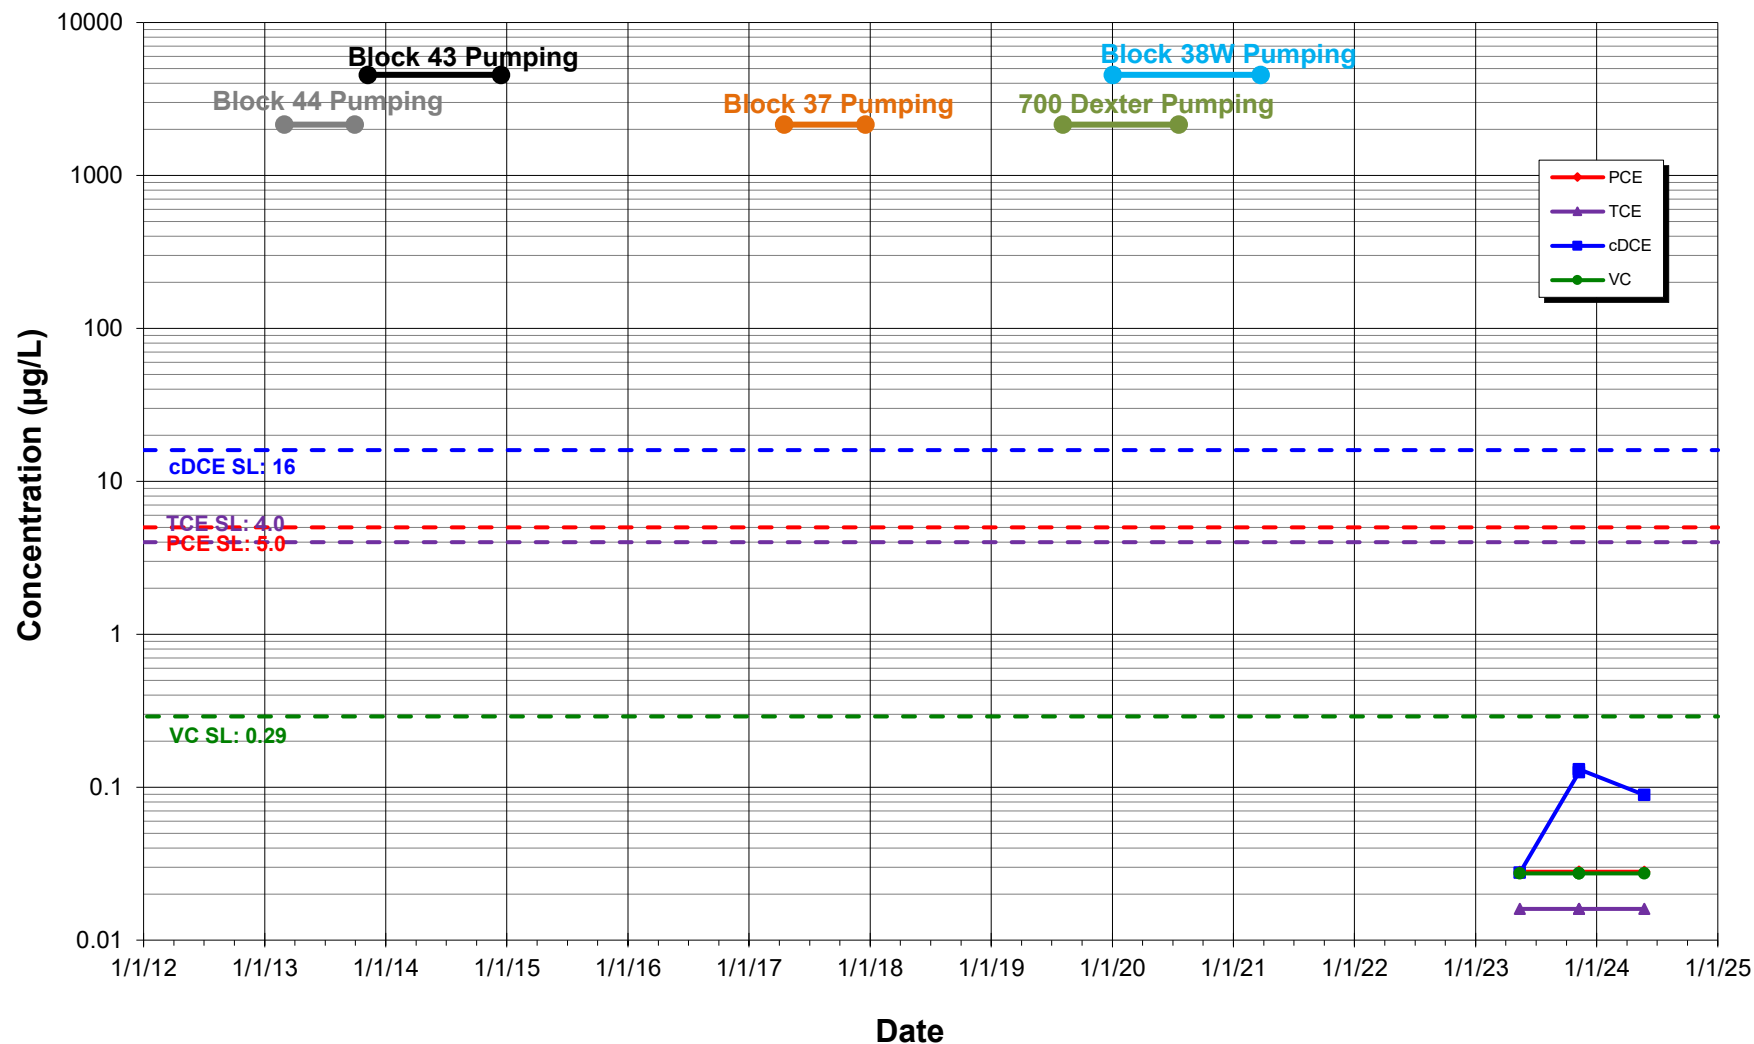
**Concentration vs Time**  
**MW-326R (-48.7 to -58.7 feet NAVD), Mercer St ROW, N side**  
**American Linen Supply Co Dexter Ave Site**

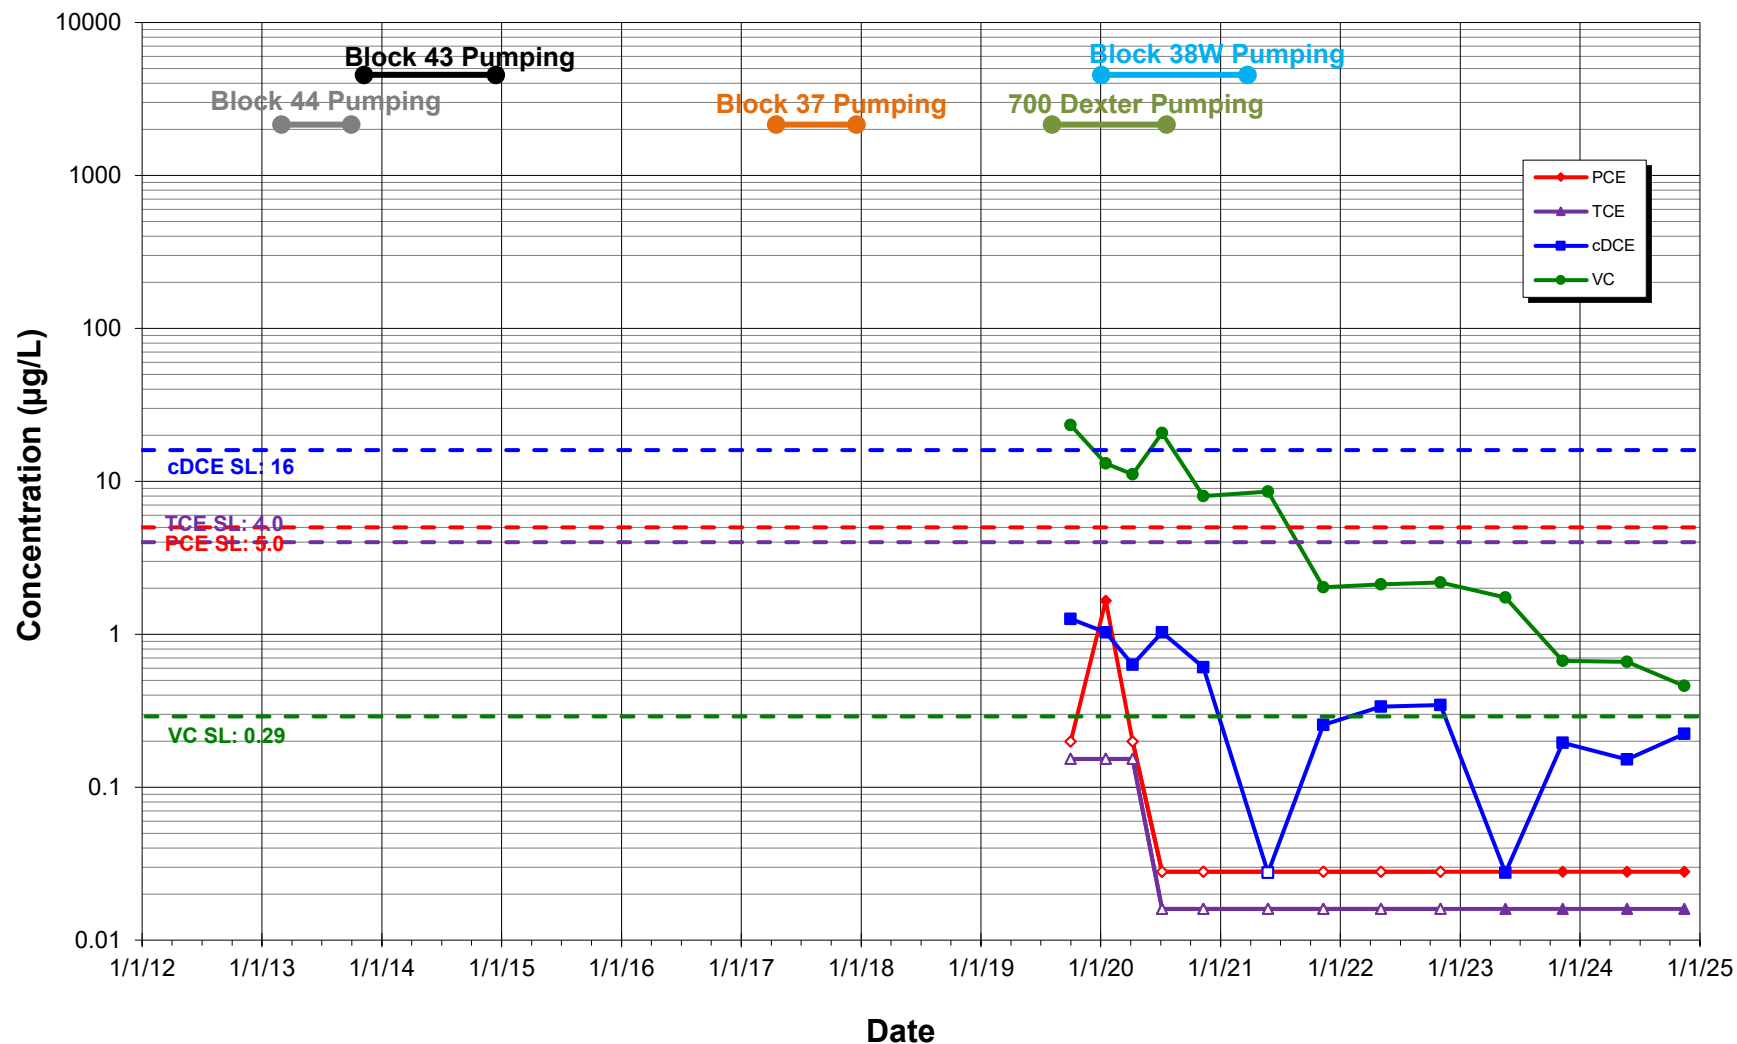
**Concentration vs Time**  
**MW-328 (-36.1 to -46.1 feet NAVD), Lake Union Park, S side**  
**American Linen Supply Co Dexter Ave Site**

1. All results detected below the laboratory MDLs are shown as hollow data points.
2. Preliminary Screening Levels: PCE = 5.0 µg/L, TCE = 4.0 µg/L, cDCE = 16 µg/L, and VC = 0.29 µg/L.

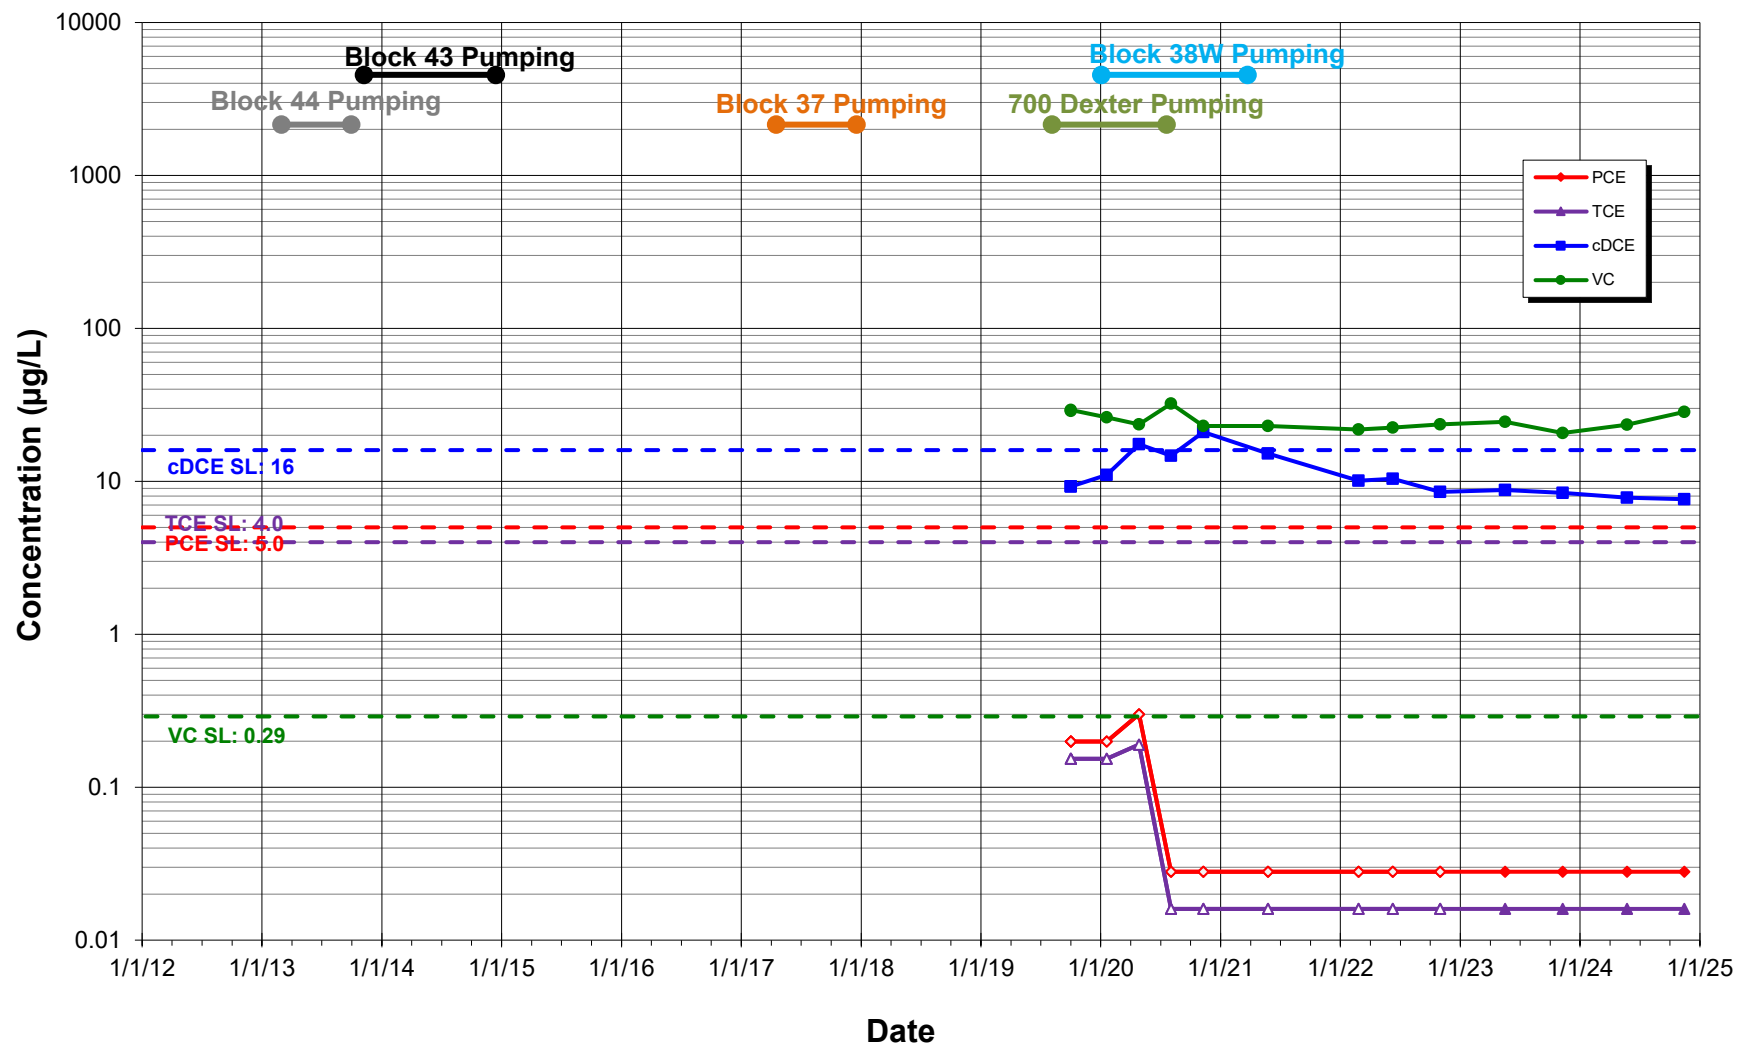
**Concentration vs Time**  
**MW-329 (-69.0 to -79.0 feet NAVD), Westlake Ave N ROW, E side**  
**American Linen Supply Co Dexter Ave Site**

1. All results detected below the laboratory MDLs are shown as hollow data points.
2. Preliminary Screening Levels: PCE = 5.0 µg/L, TCE = 4.0 µg/L, cDCE = 16 µg/L, and VC = 0.29 µg/L.

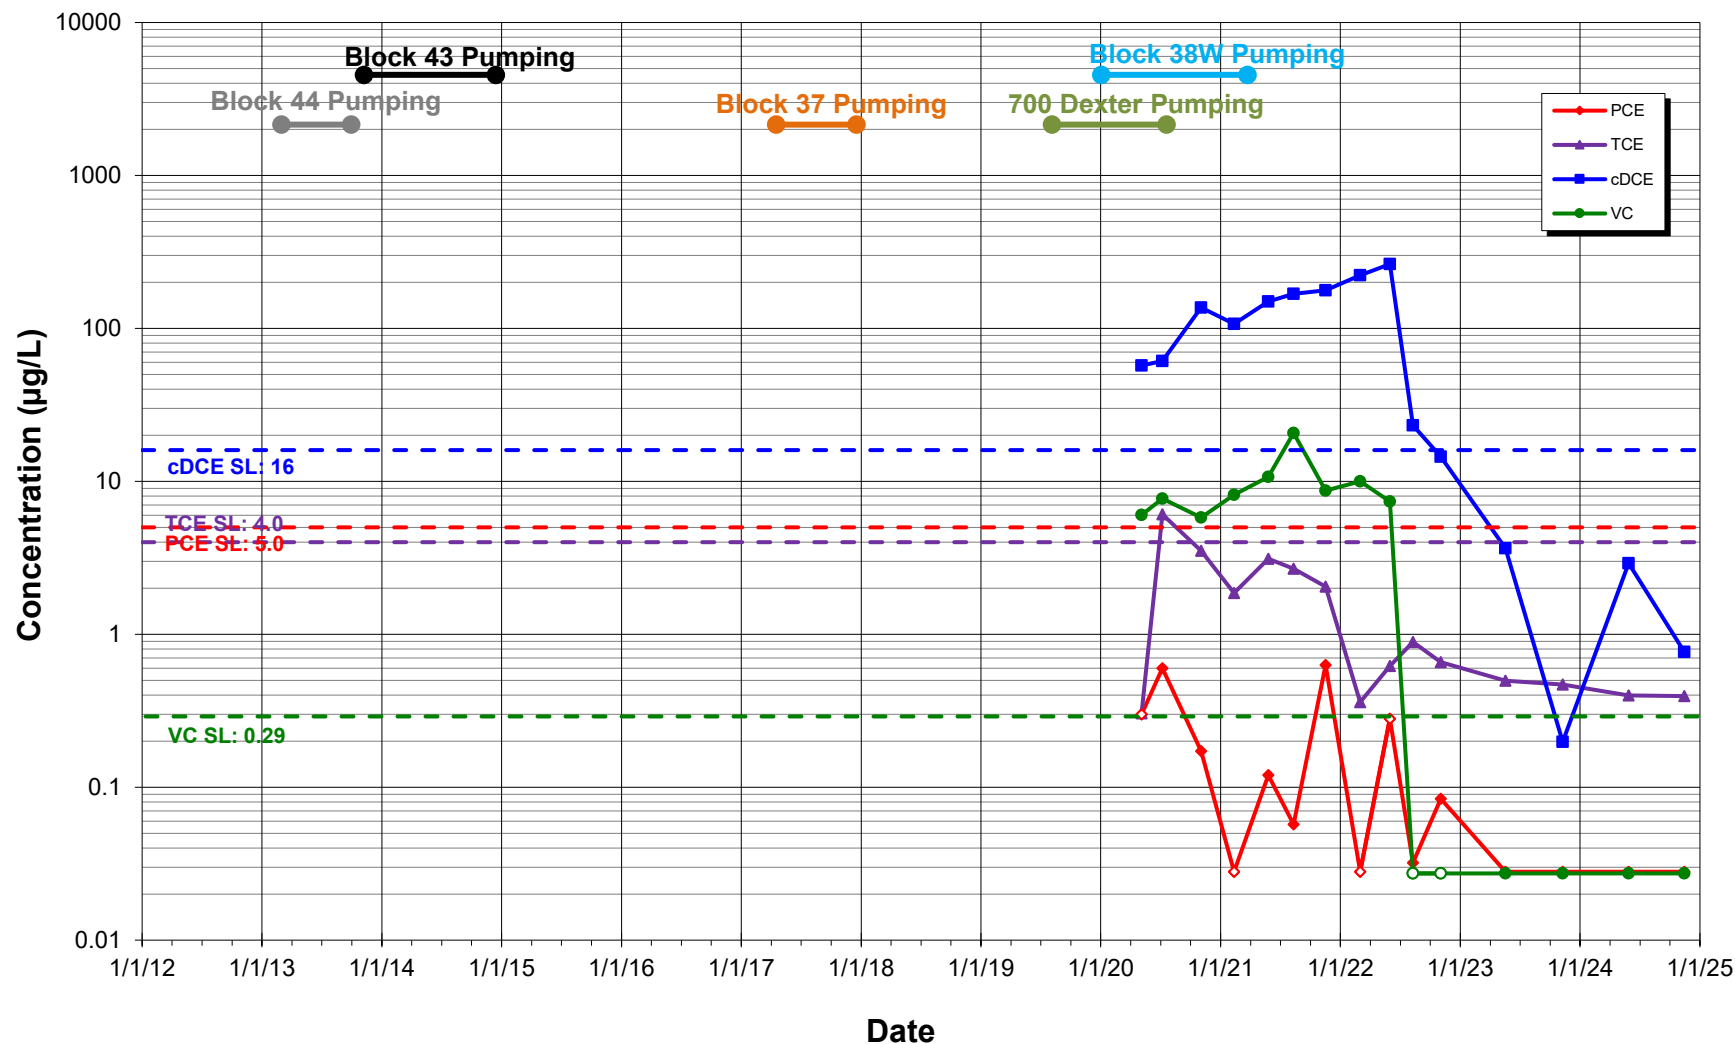
**Concentration vs Time**  
**MW-336 (-51.6 to -61.6 feet NAVD), Mercer St ROW, N side**  
**American Linen Supply Co Dexter Ave Site**

1. All results detected below the laboratory MDLs are shown as hollow data points.
2. Preliminary Screening Levels: PCE = 5.0 µg/L, TCE = 4.0 µg/L, cDCE = 16 µg/L, and VC = 0.29 µg/L.

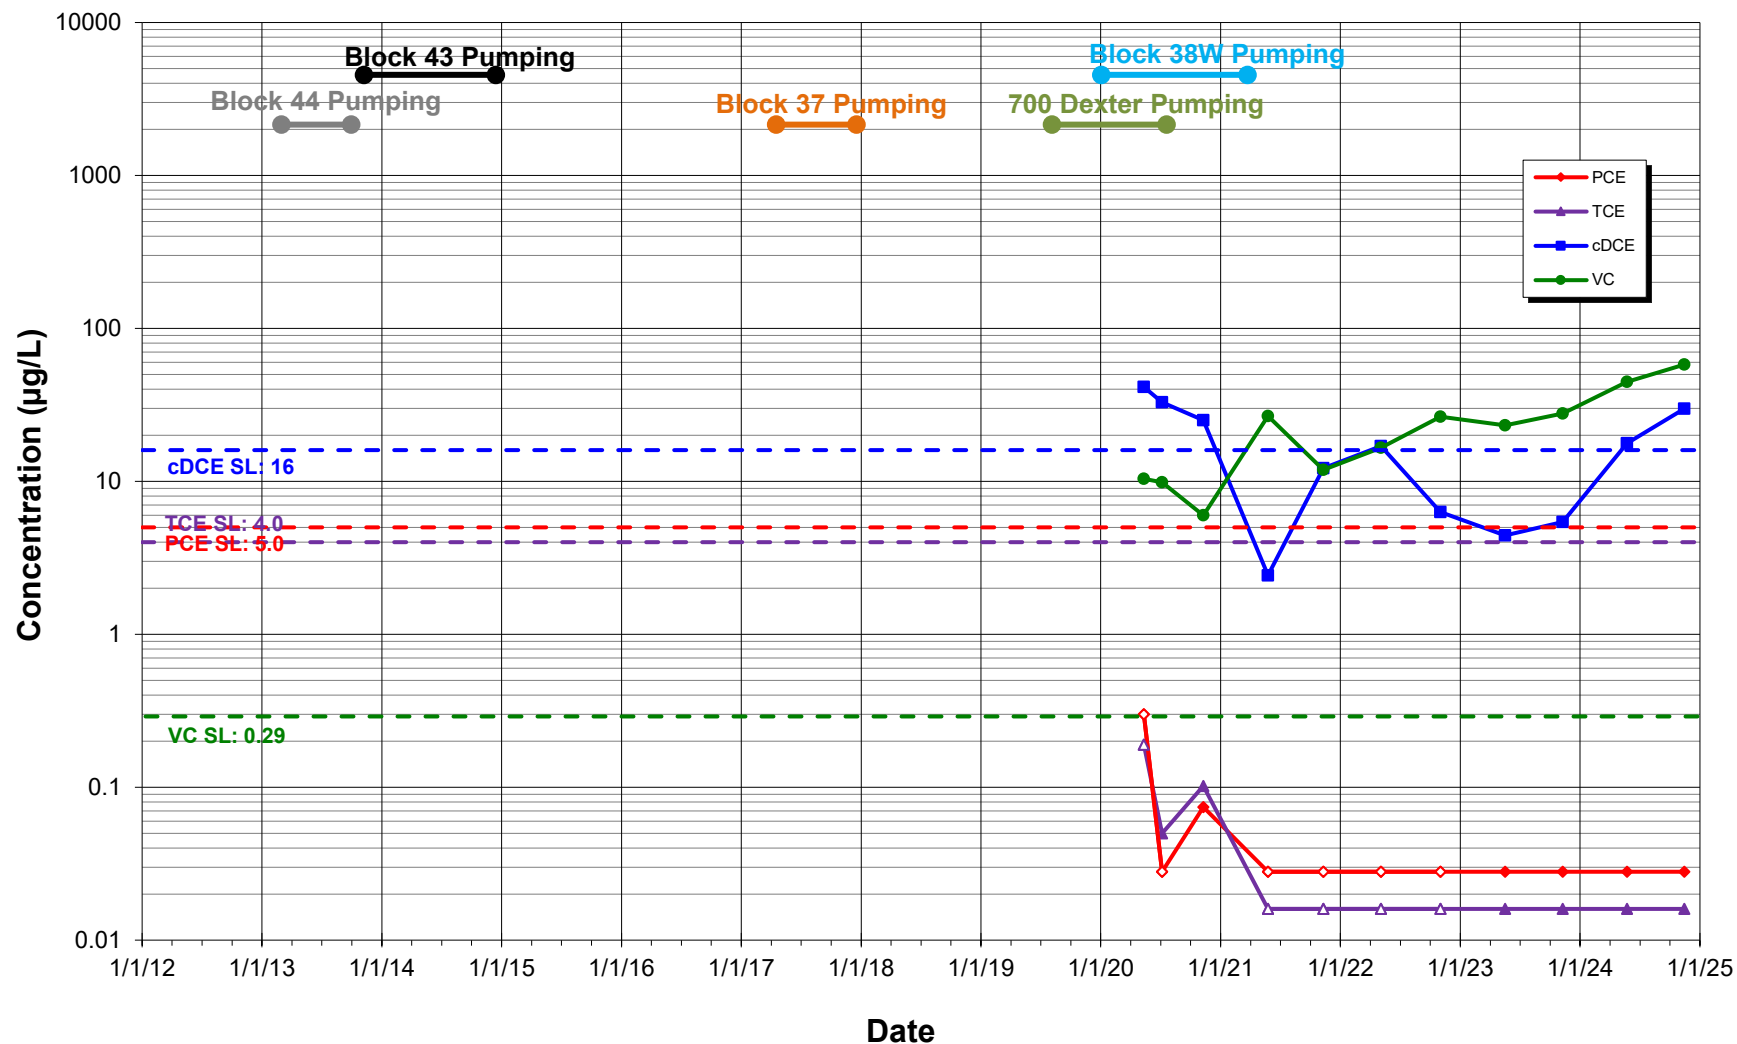
**Concentration vs Time**  
**MW-341 (-66.8 to -76.8 feet NAVD), Lake Union Park, S end**  
**American Linen Supply Co Dexter Ave Site**

1. All results detected below the laboratory MDLs are shown as hollow data points.
2. Preliminary Screening Levels: PCE = 5.0 µg/L, TCE = 4.0 µg/L, cDCE = 16 µg/L, and VC = 0.29 µg/L.
