**Attachment A**  
**Well Completion Table**  
**American Linen Supply Co Dexter Ave Site**  
**700 Dexter Avenue North**  
**Seattle, Washington**

**ATTACHMENT B**

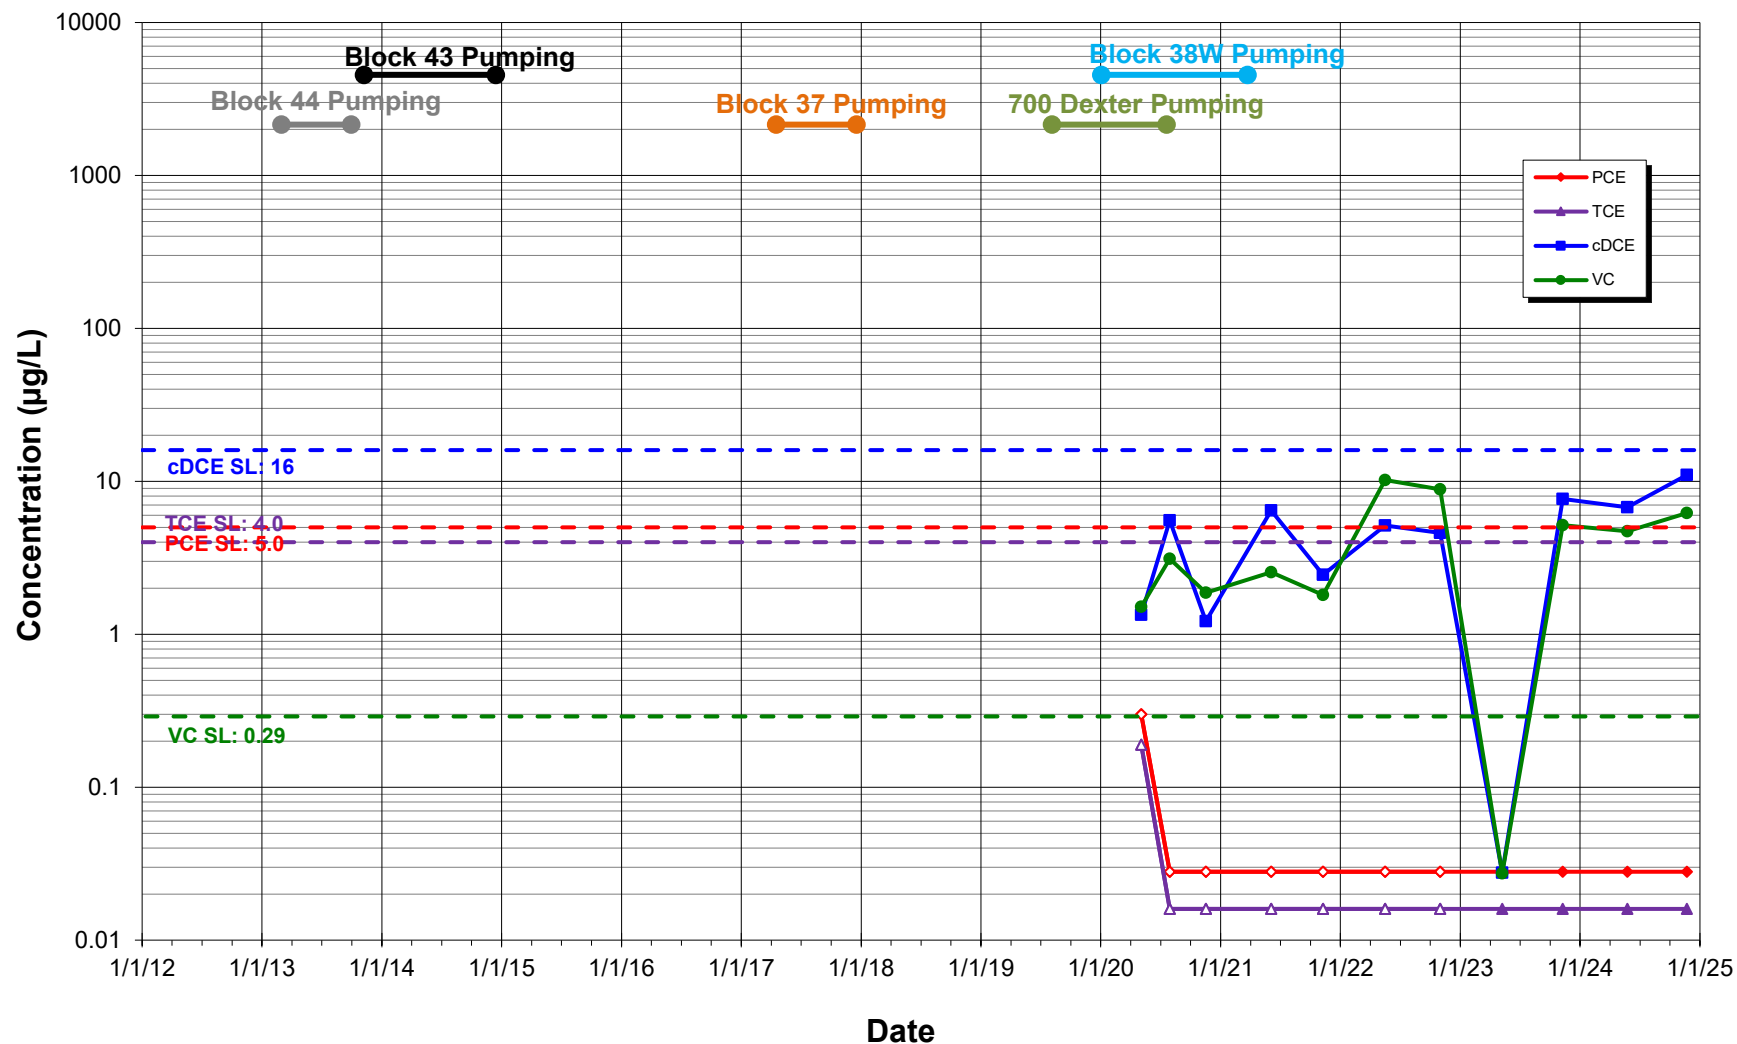
**Concentration vs Time**  
**MW-342 (-32.4 to -42.4 feet NAVD), Valley St ROW, S side**  
**American Linen Supply Co Dexter Ave Site**

1. All results detected below the laboratory MDLs are shown as hollow data points.
2. Preliminary Screening Levels: PCE = 5.0 µg/L, TCE = 4.0 µg/L, cDCE = 16 µg/L, and VC = 0.29 µg/L.

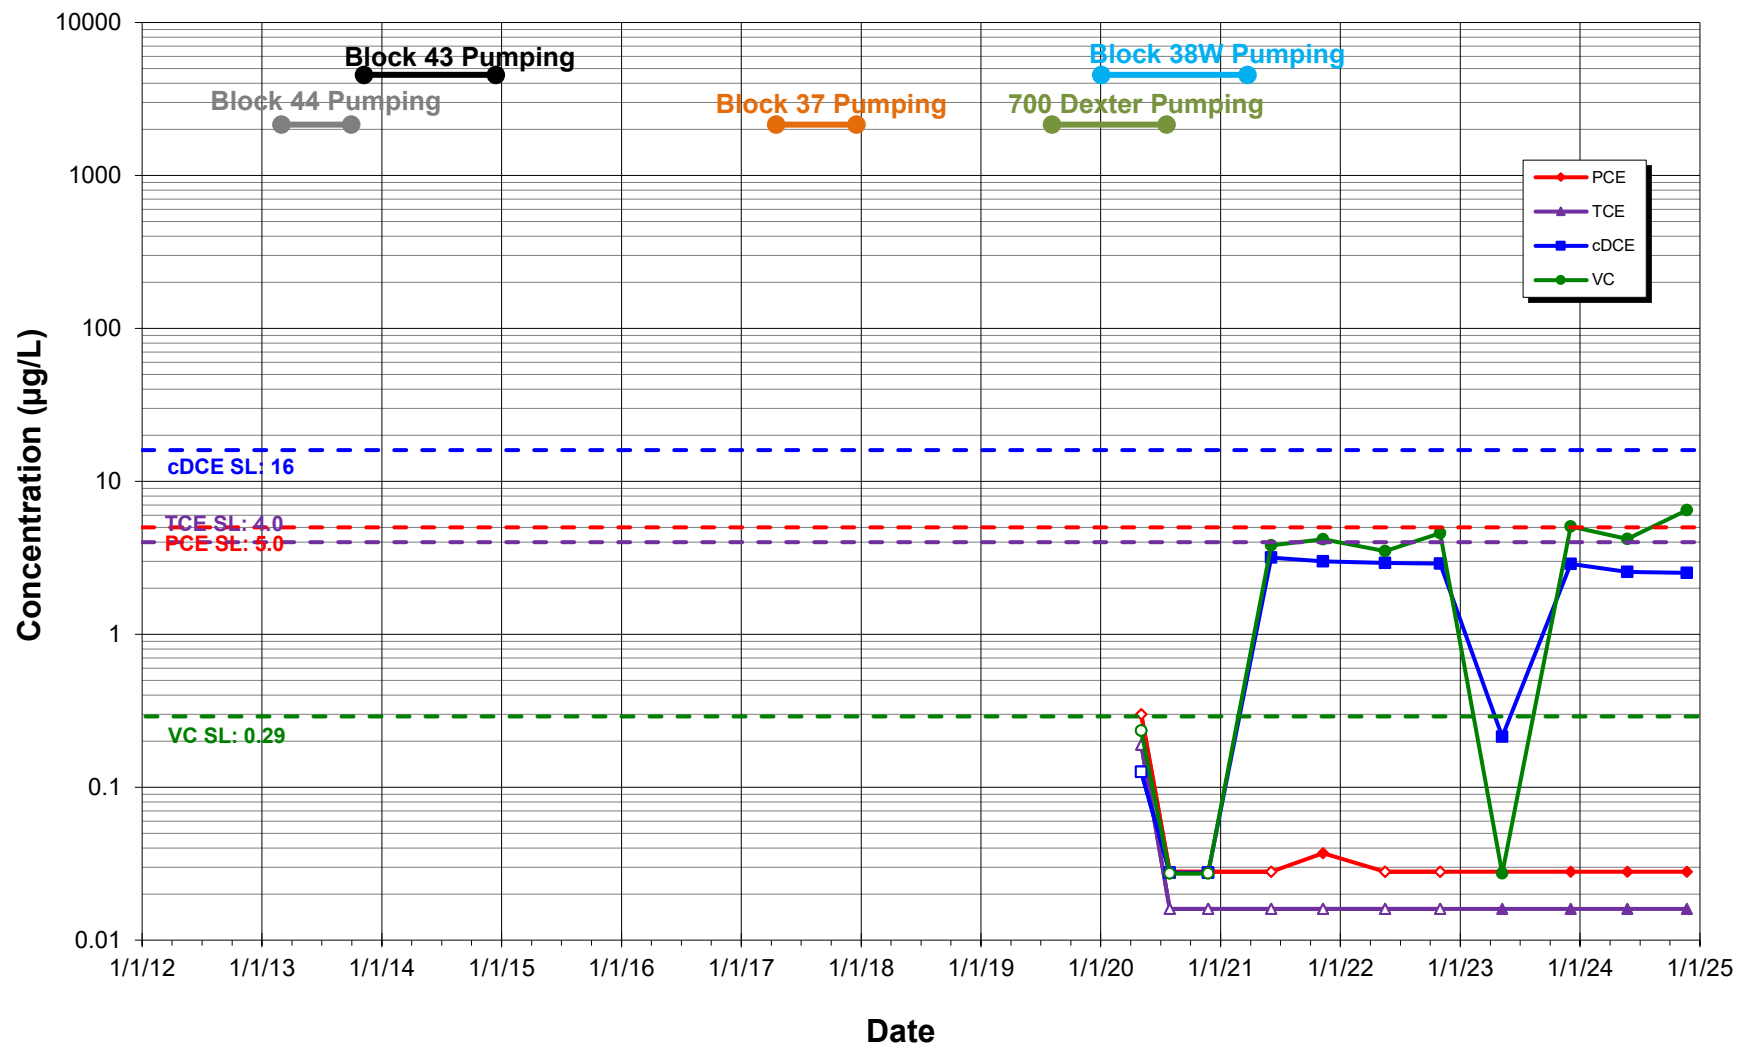
**Concentration vs Time**  
**MW-343 (-71.5 to -81.5 feet NAVD), Valley St ROW, S side**  
**American Linen Supply Co Dexter Ave Site**

1. All results detected below the laboratory MDLs are shown as hollow data points.
2. Preliminary Screening Levels: PCE = 5.0 µg/L, TCE = 4.0 µg/L, cDCE = 16 µg/L, and VC = 0.29 µg/L.

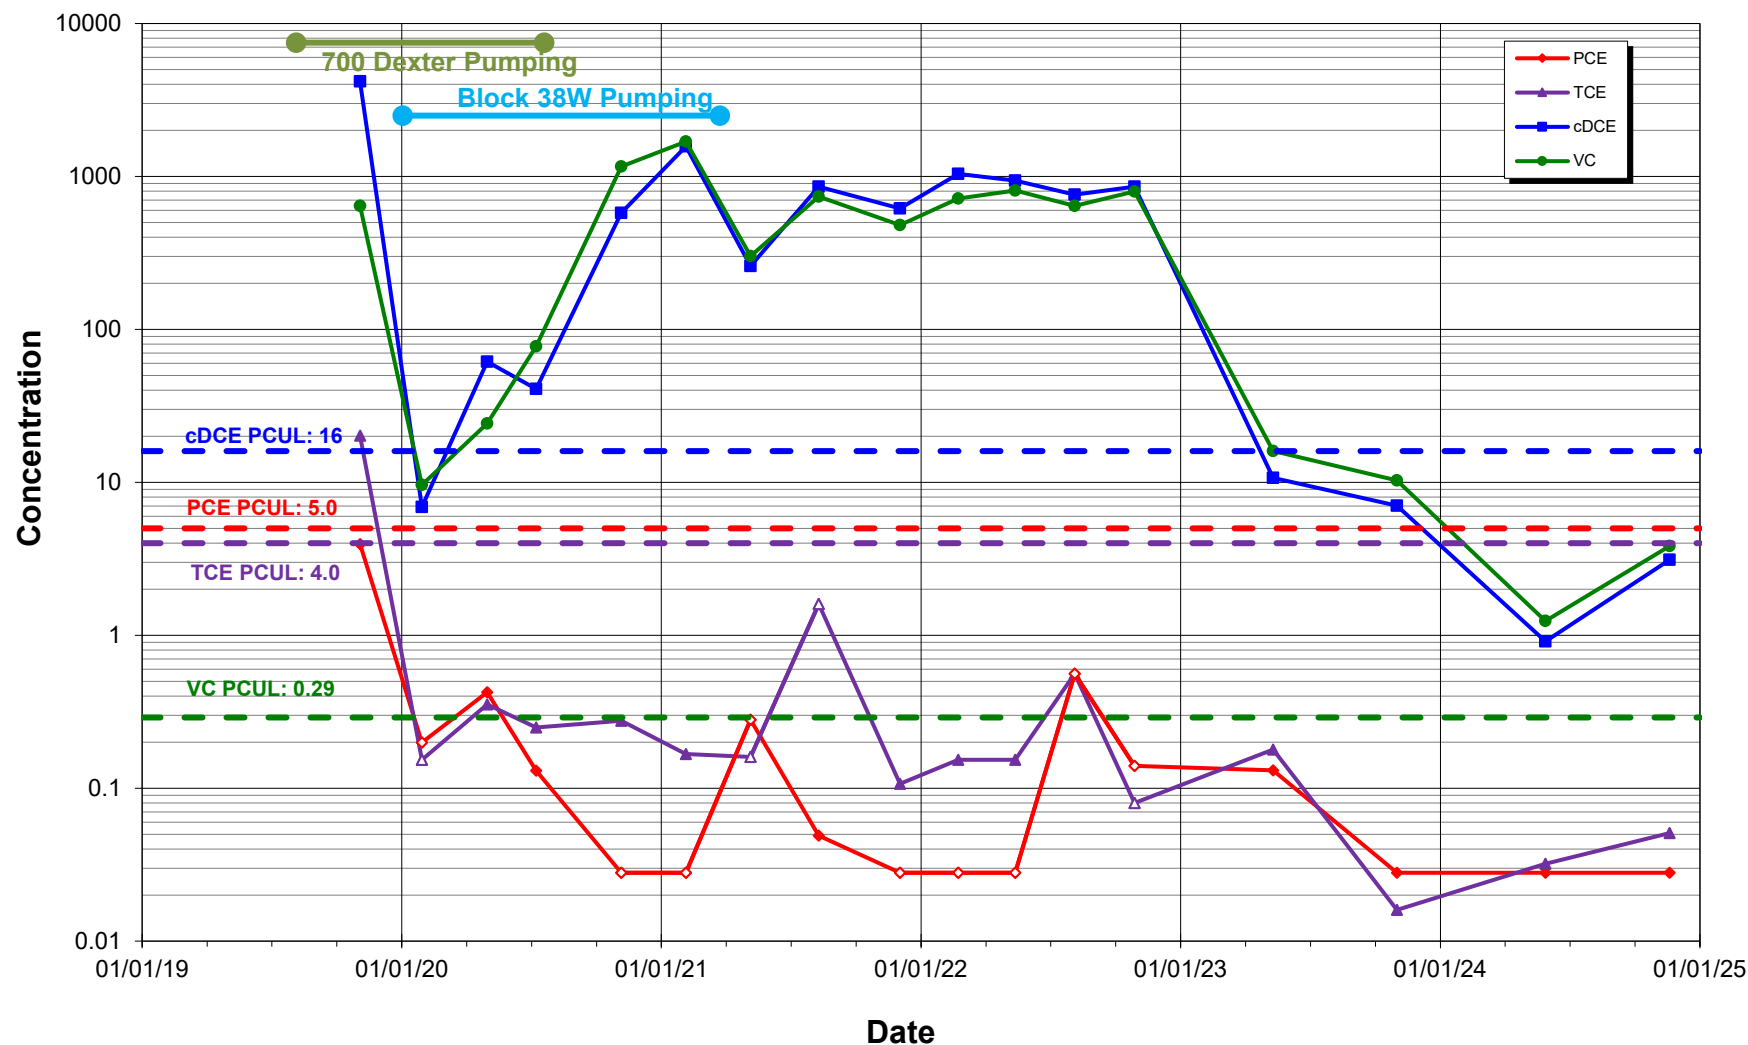
**Concentration vs Time**  
**MW-165 (1.3 to -8.8 feet NAVD), Cluster 1, Treatment Zone A**  
**American Linen Supply Co-Dexter Ave Site**

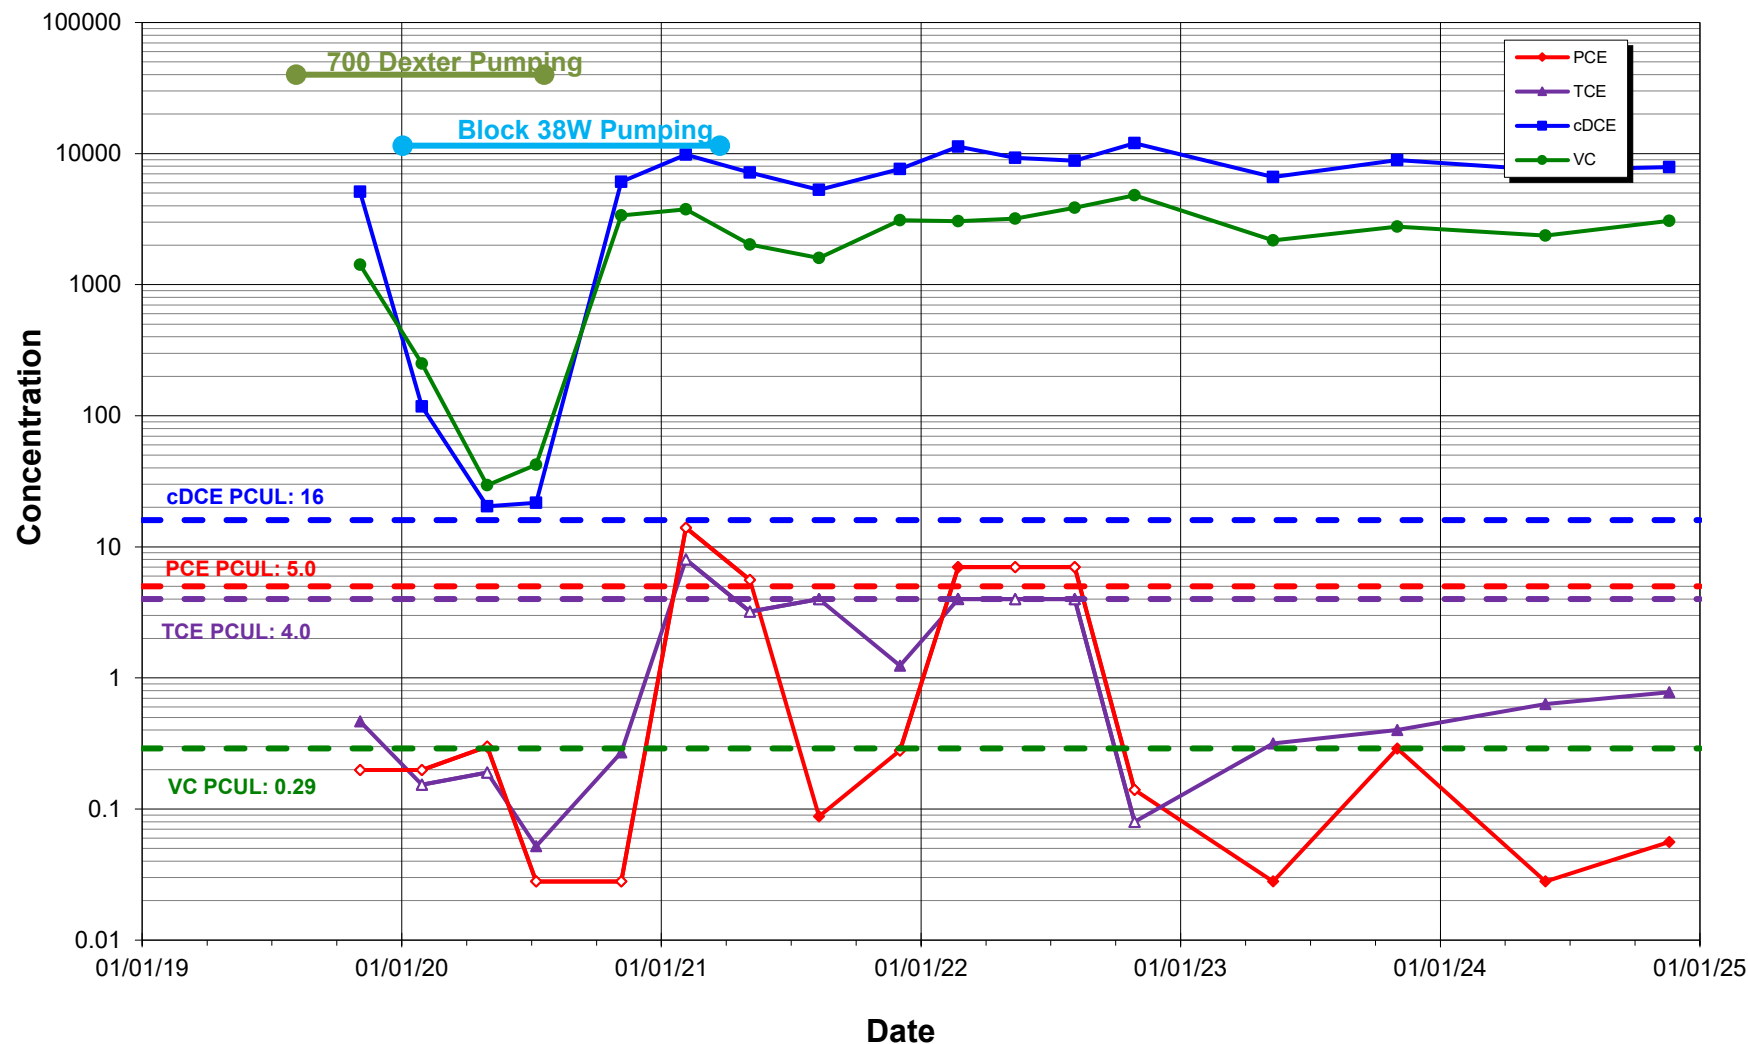
**Concentration vs Time**  
**MW-166 (-12.6 to -22.6 feet NAVD), Cluster 1, Treatment Zone B**  
**American Linen Supply Co-Dexter Ave Site**

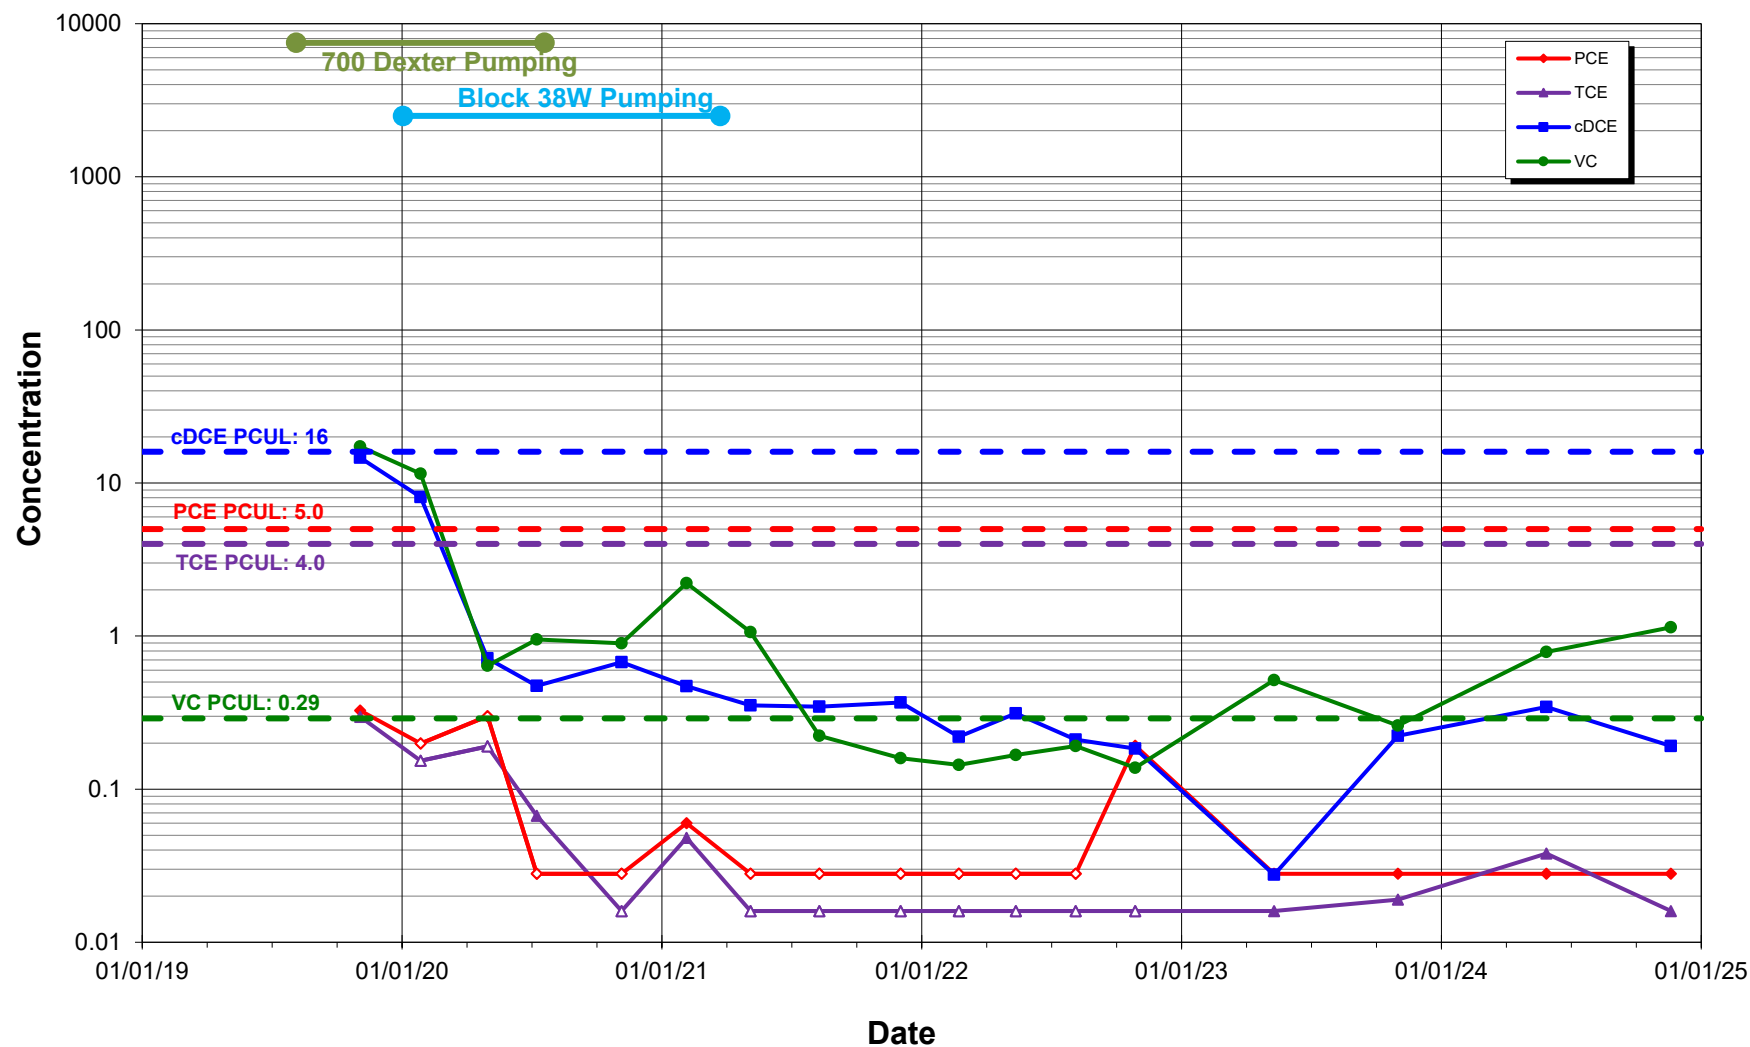
**Concentration vs Time**  
**MW-167 (-27.9 to -37.9 feet NAVD), Cluster 1, Treatment Zone C**  
**American Linen Supply Co-Dexter Ave Site**

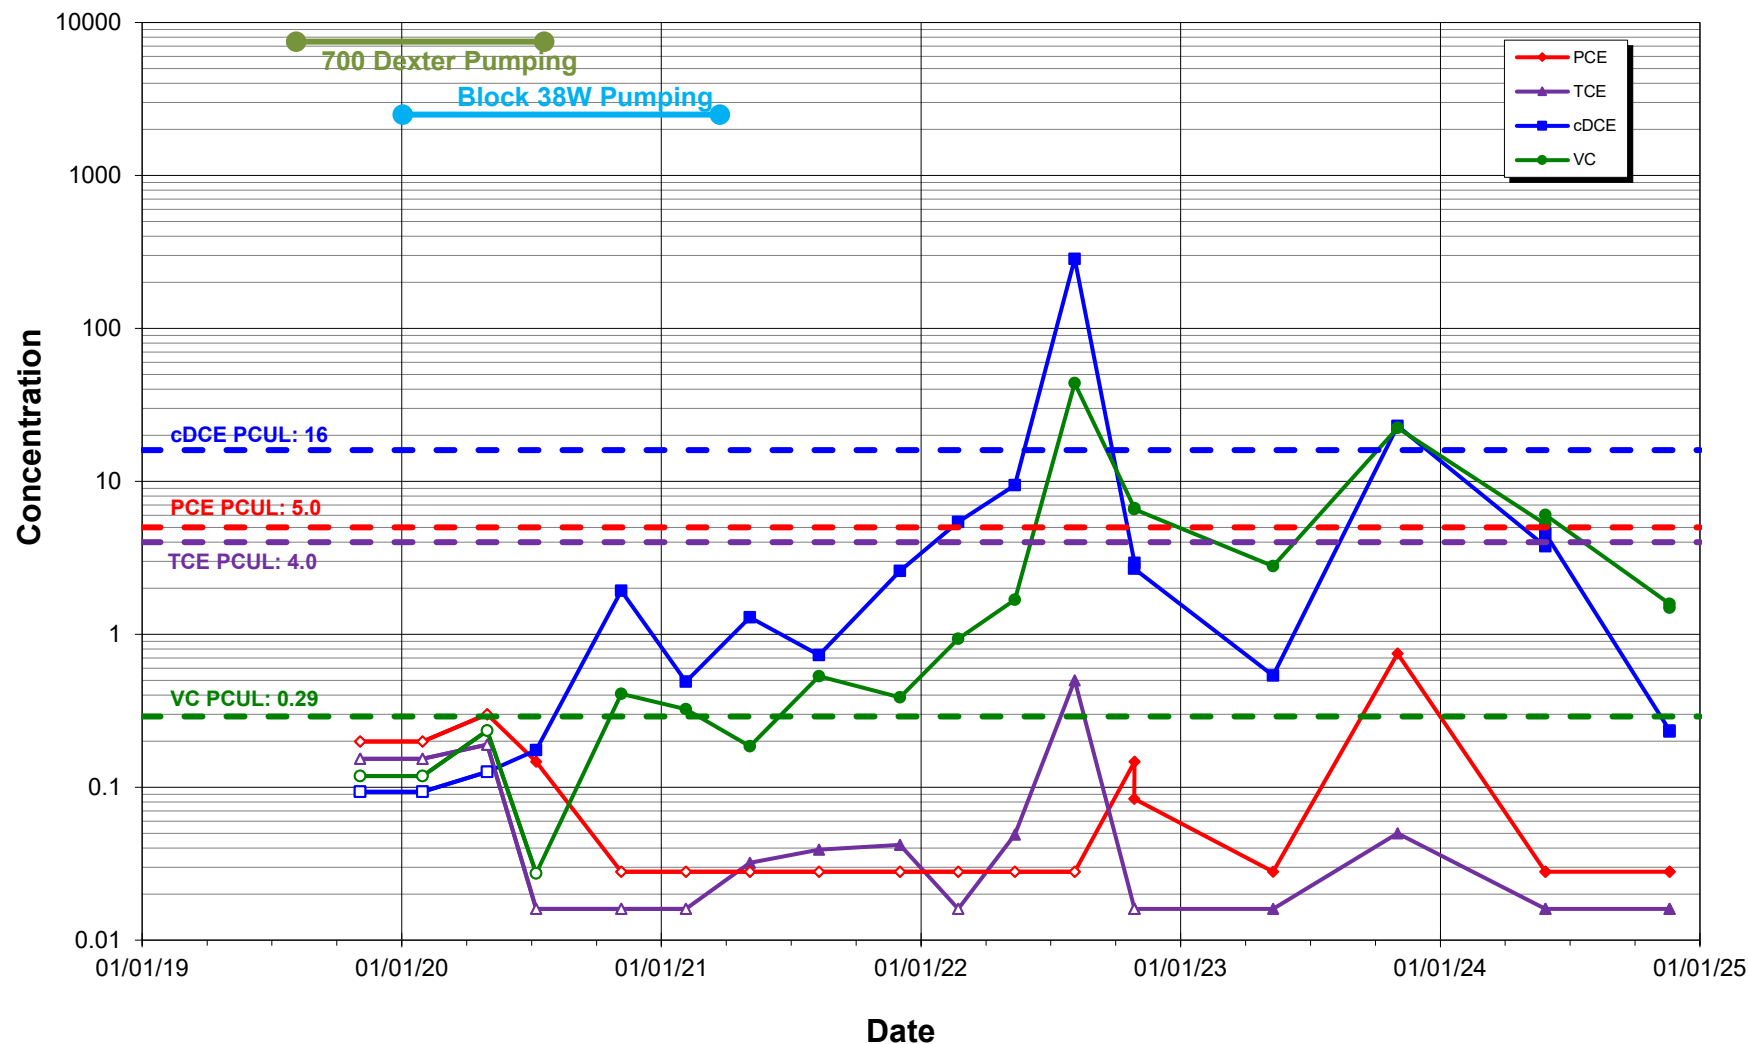
**Concentration vs Time**  
**MW-168 (-43 to -53 feet NAVD), Cluster 1, Treatment Zone D**  
**American Linen Supply Co-Dexter Ave Site**

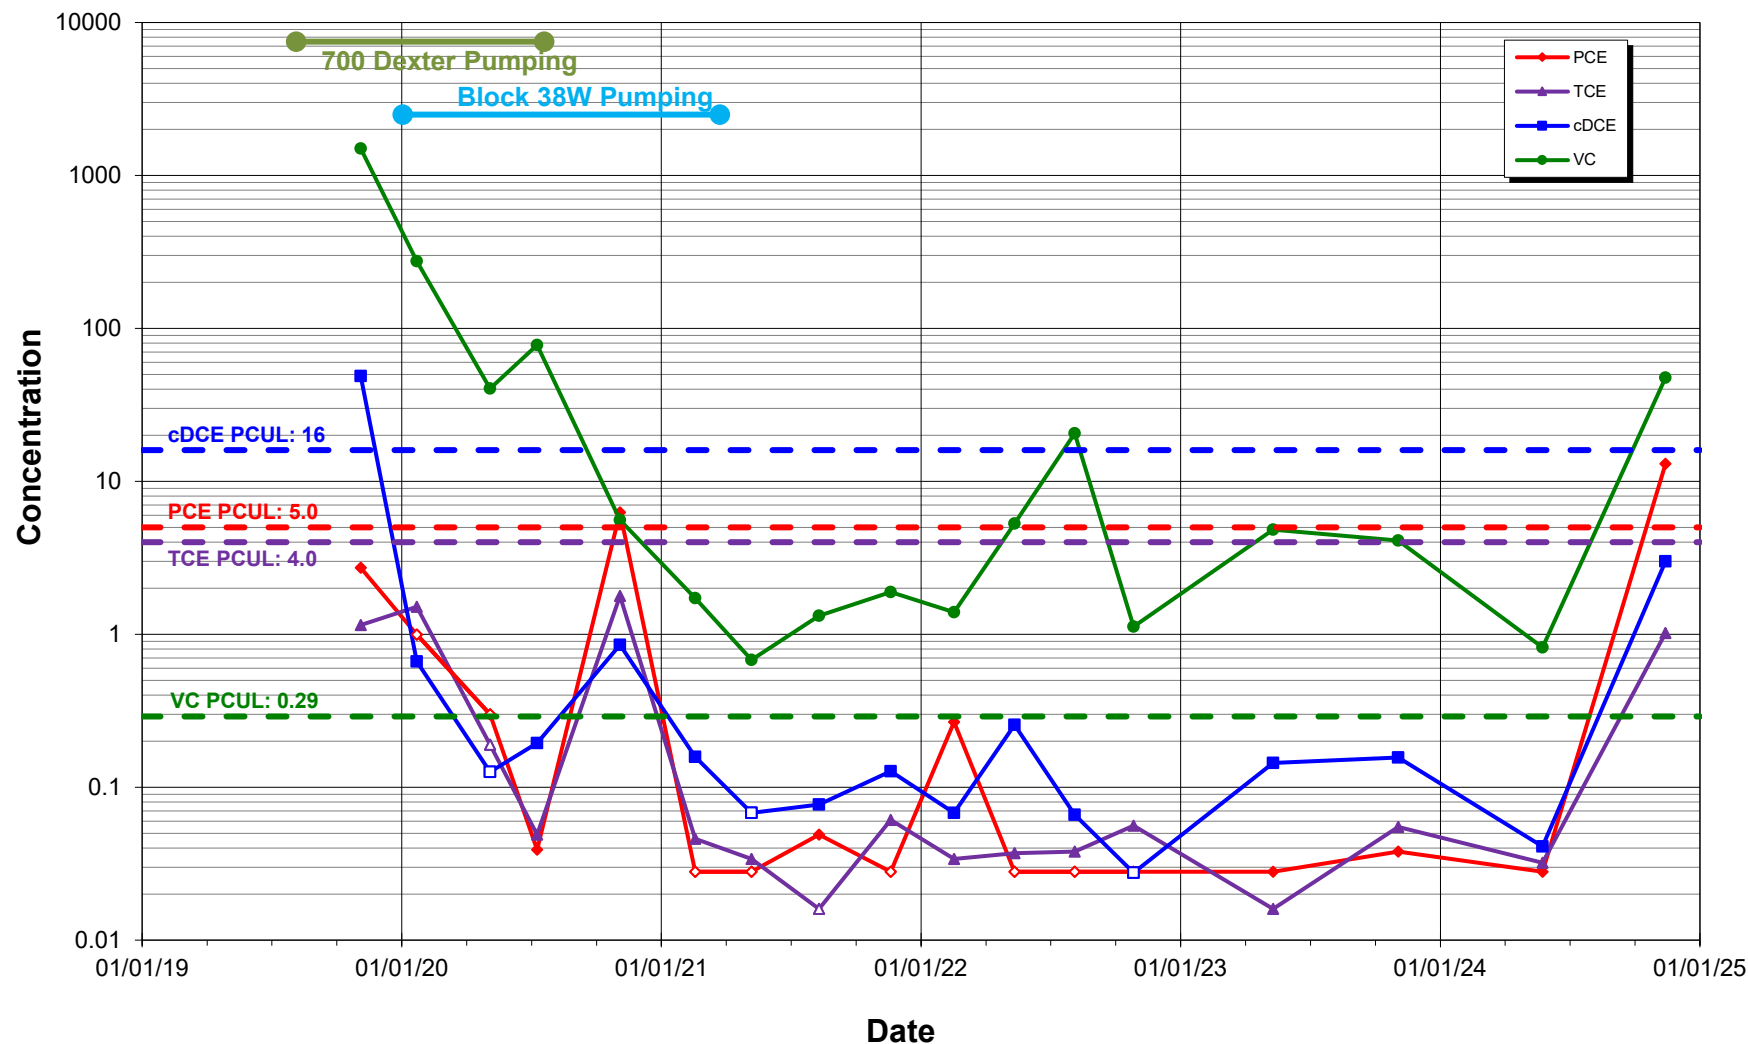
**Concentration vs Time**  
**MW-169 (1.2 to -8.8 feet NAVD), Cluster 2, Treatment Zone A**  
**American Linen Supply Co-Dexter Ave Site**

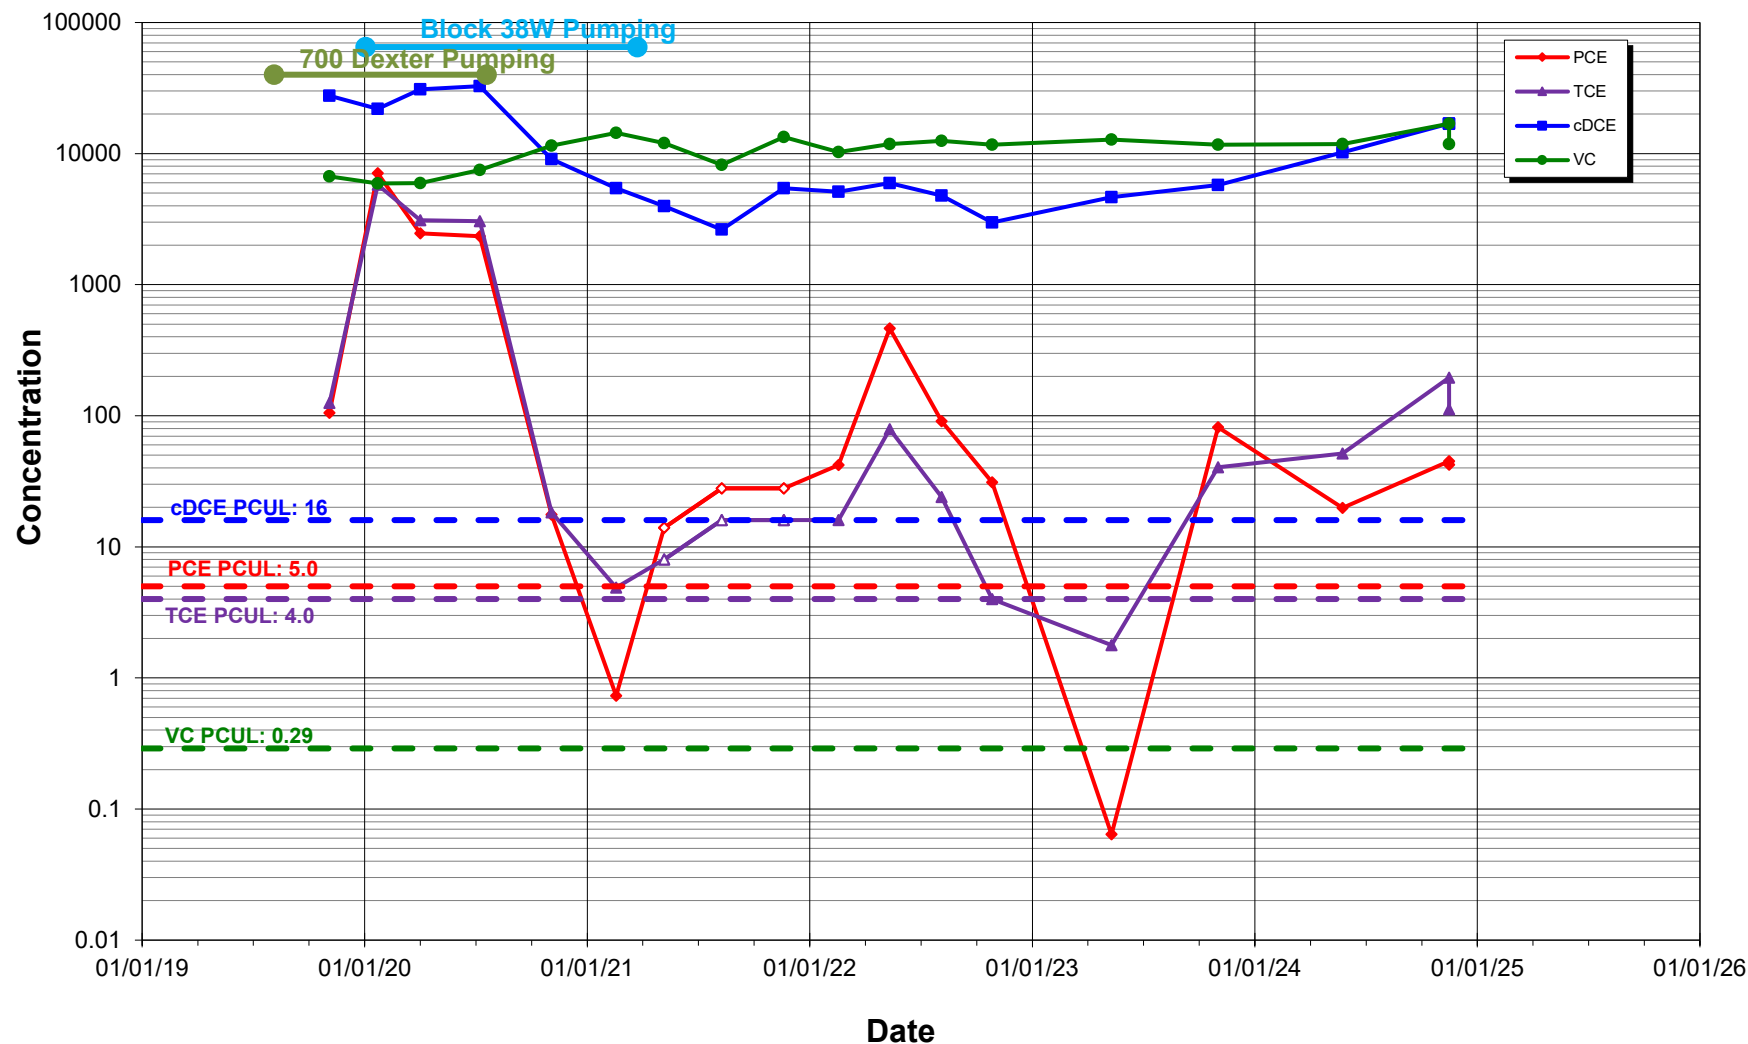
**Concentration vs Time**  
**MW-170 (-12.8 to -22.8 feet NAVD), Cluster 2, Treatment Zone B**  
**American Linen Supply Co-Dexter Ave Site**

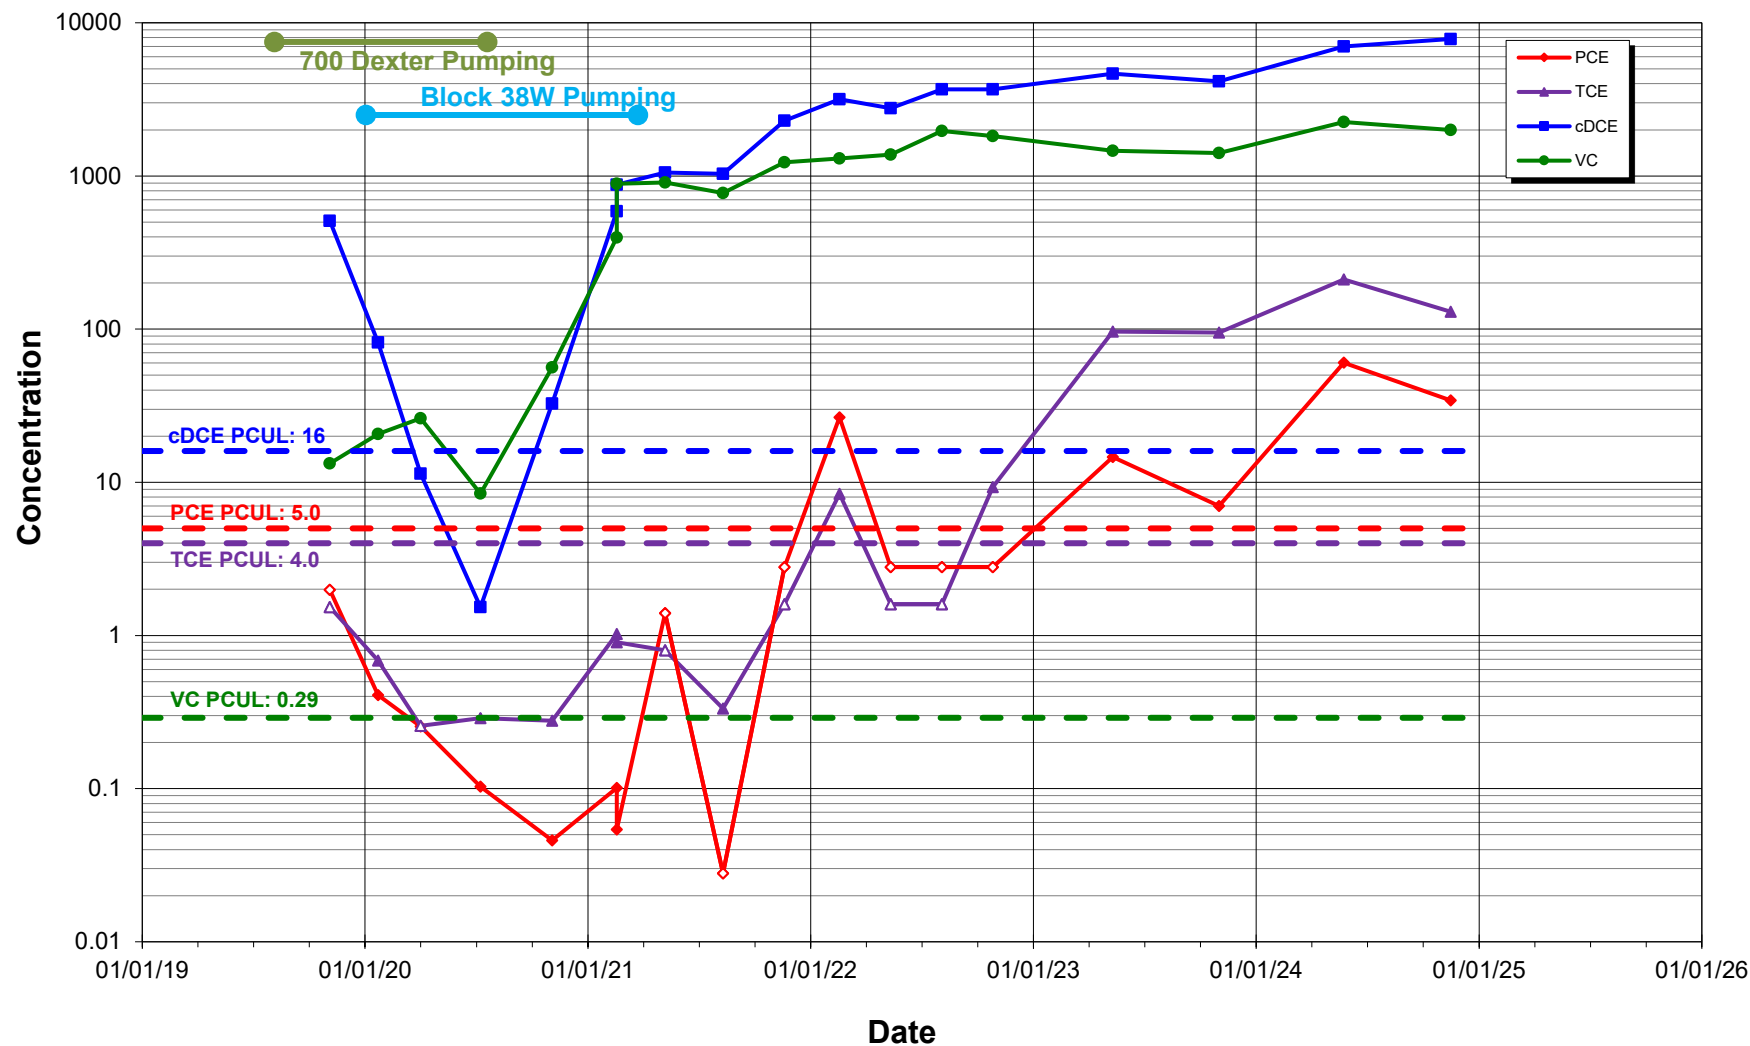
**Concentration vs Time**  
**MW-171 (-27.6 to -37.6 feet NAVD), Cluster 2, Treatment Zone C**  
**American Linen Supply Co-Dexter Ave Site**

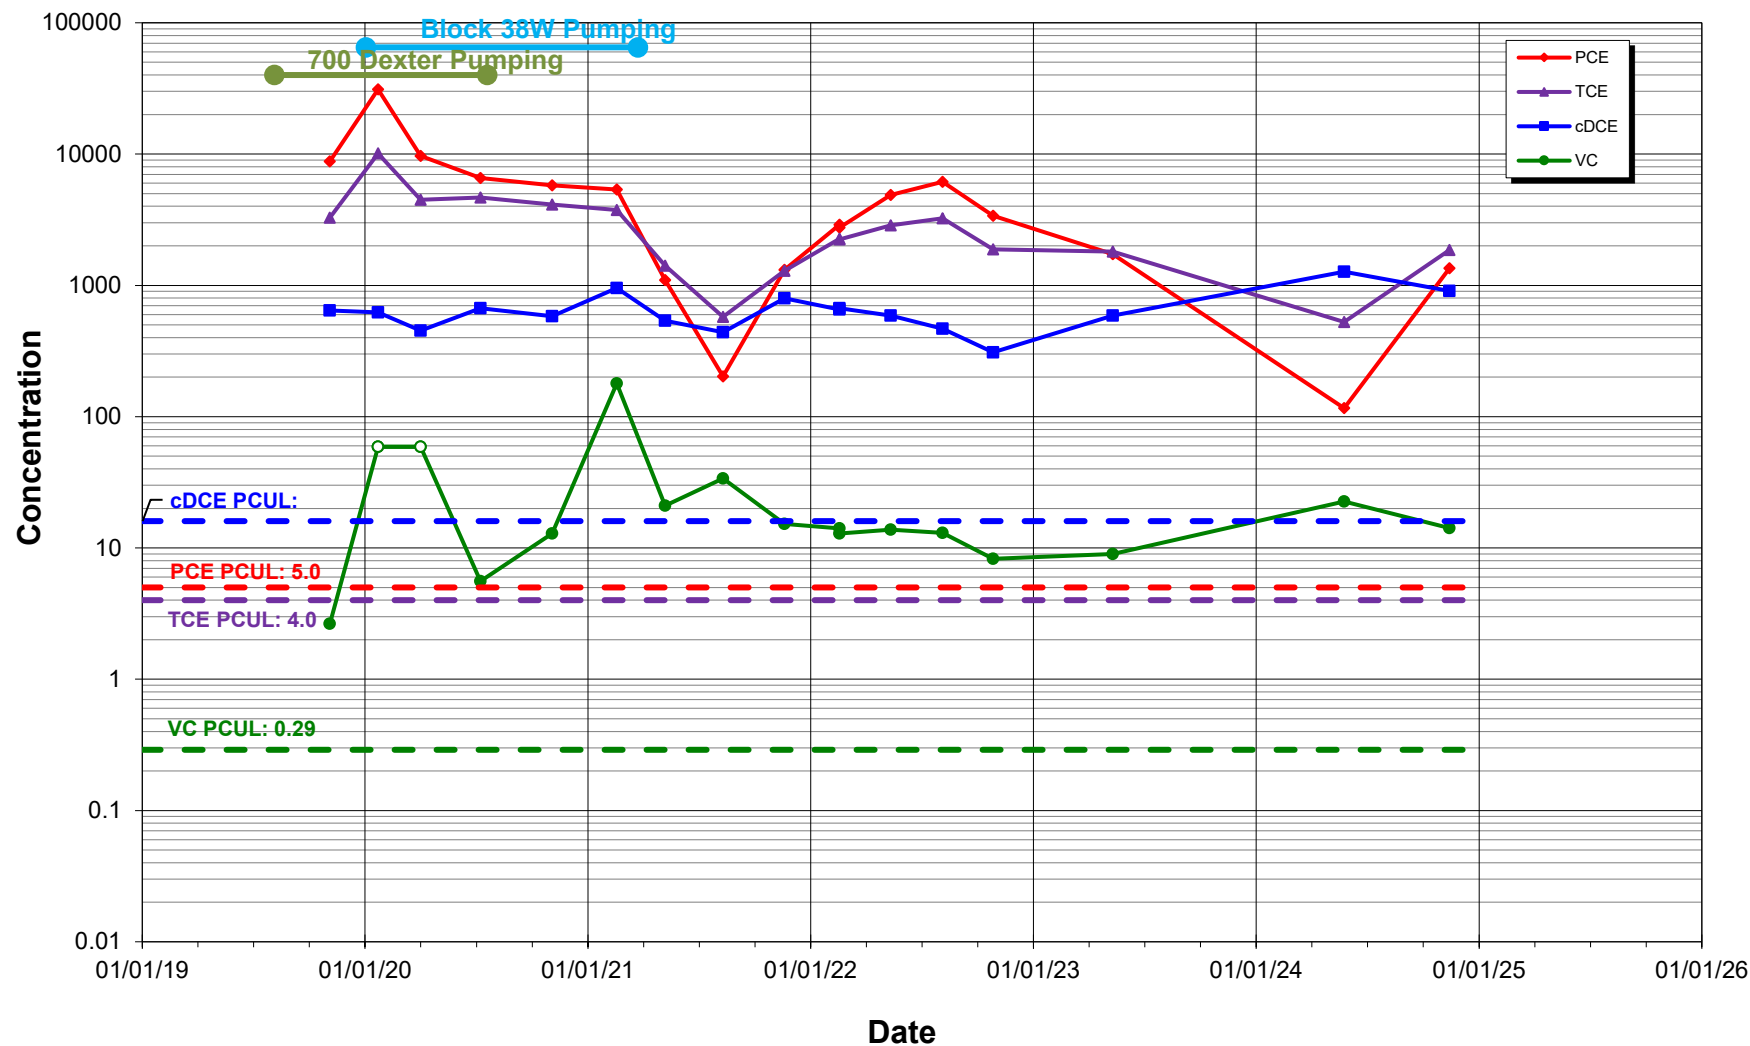
**Concentration vs Time**  
**MW-172 (-42.5 to -52.5 feet NAVD), Cluster 2, Treatment Zone D**  
**American Linen Supply Co-Dexter Ave Site**

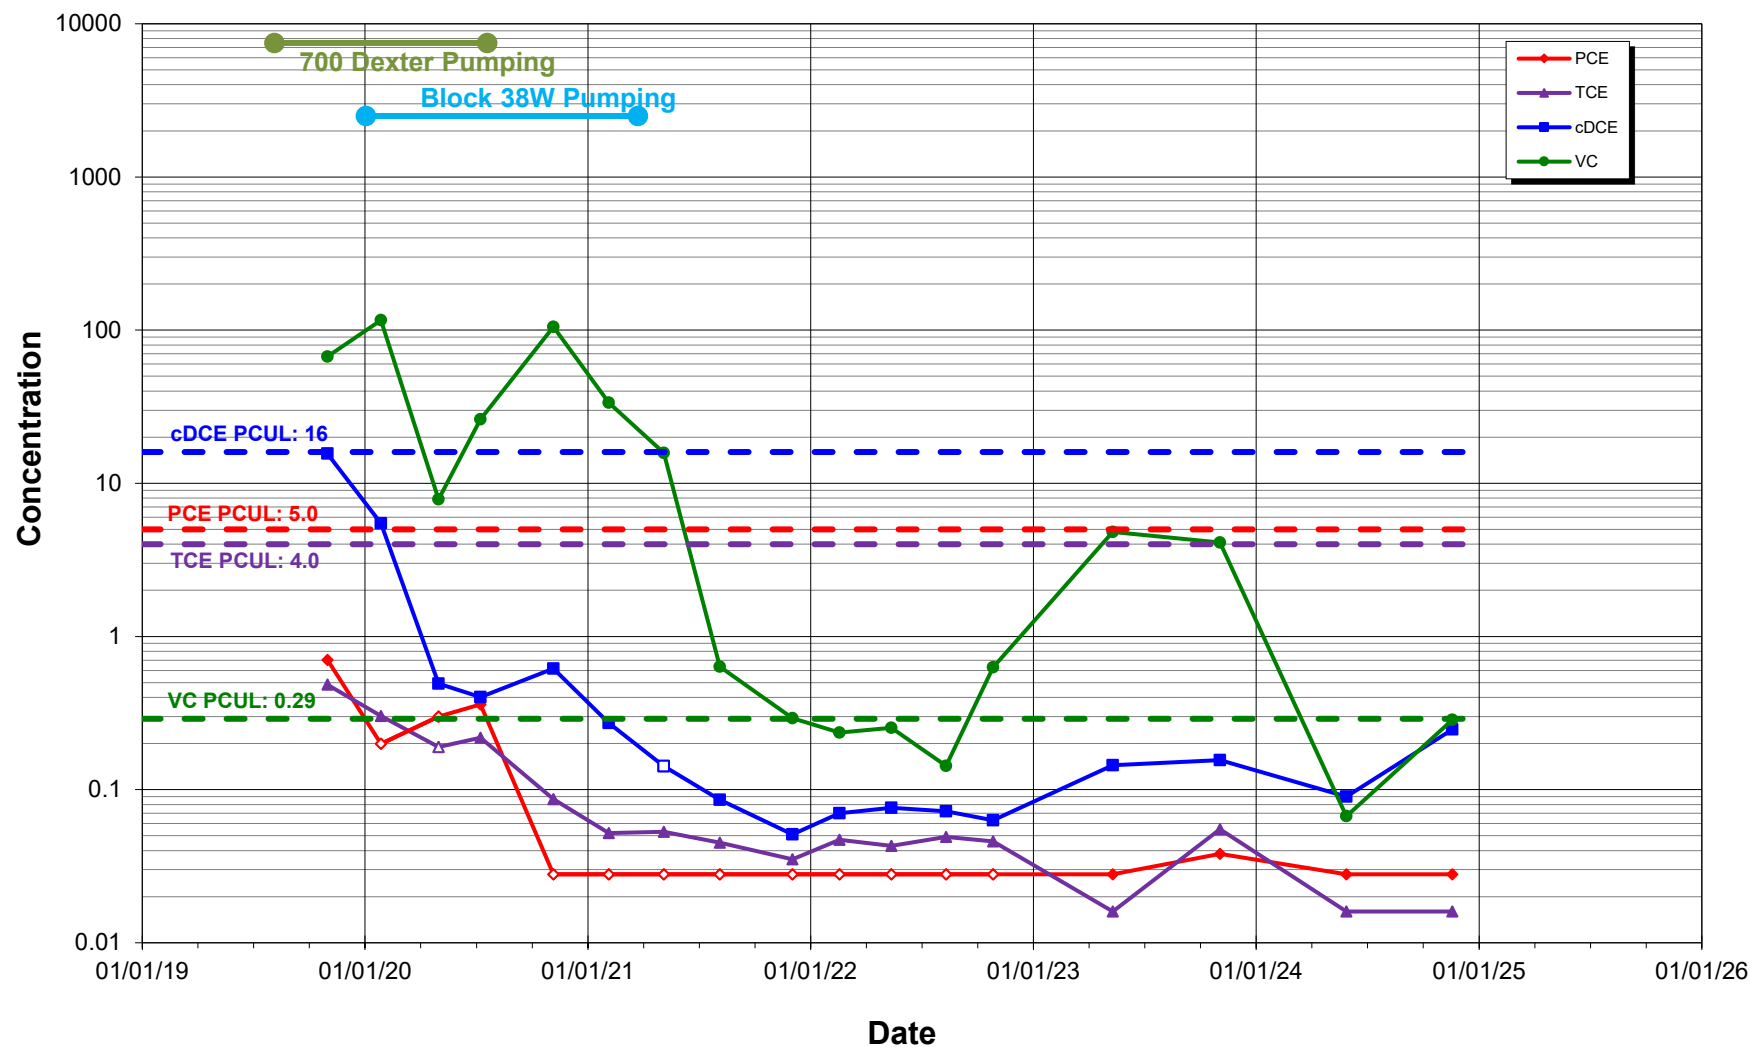
**Concentration vs Time**  
**MW-173 (2.2 to -7.8 feet NAVD), Cluster 3, Treatment Zone A**  
**American Linen Supply Co-Dexter Ave Site**

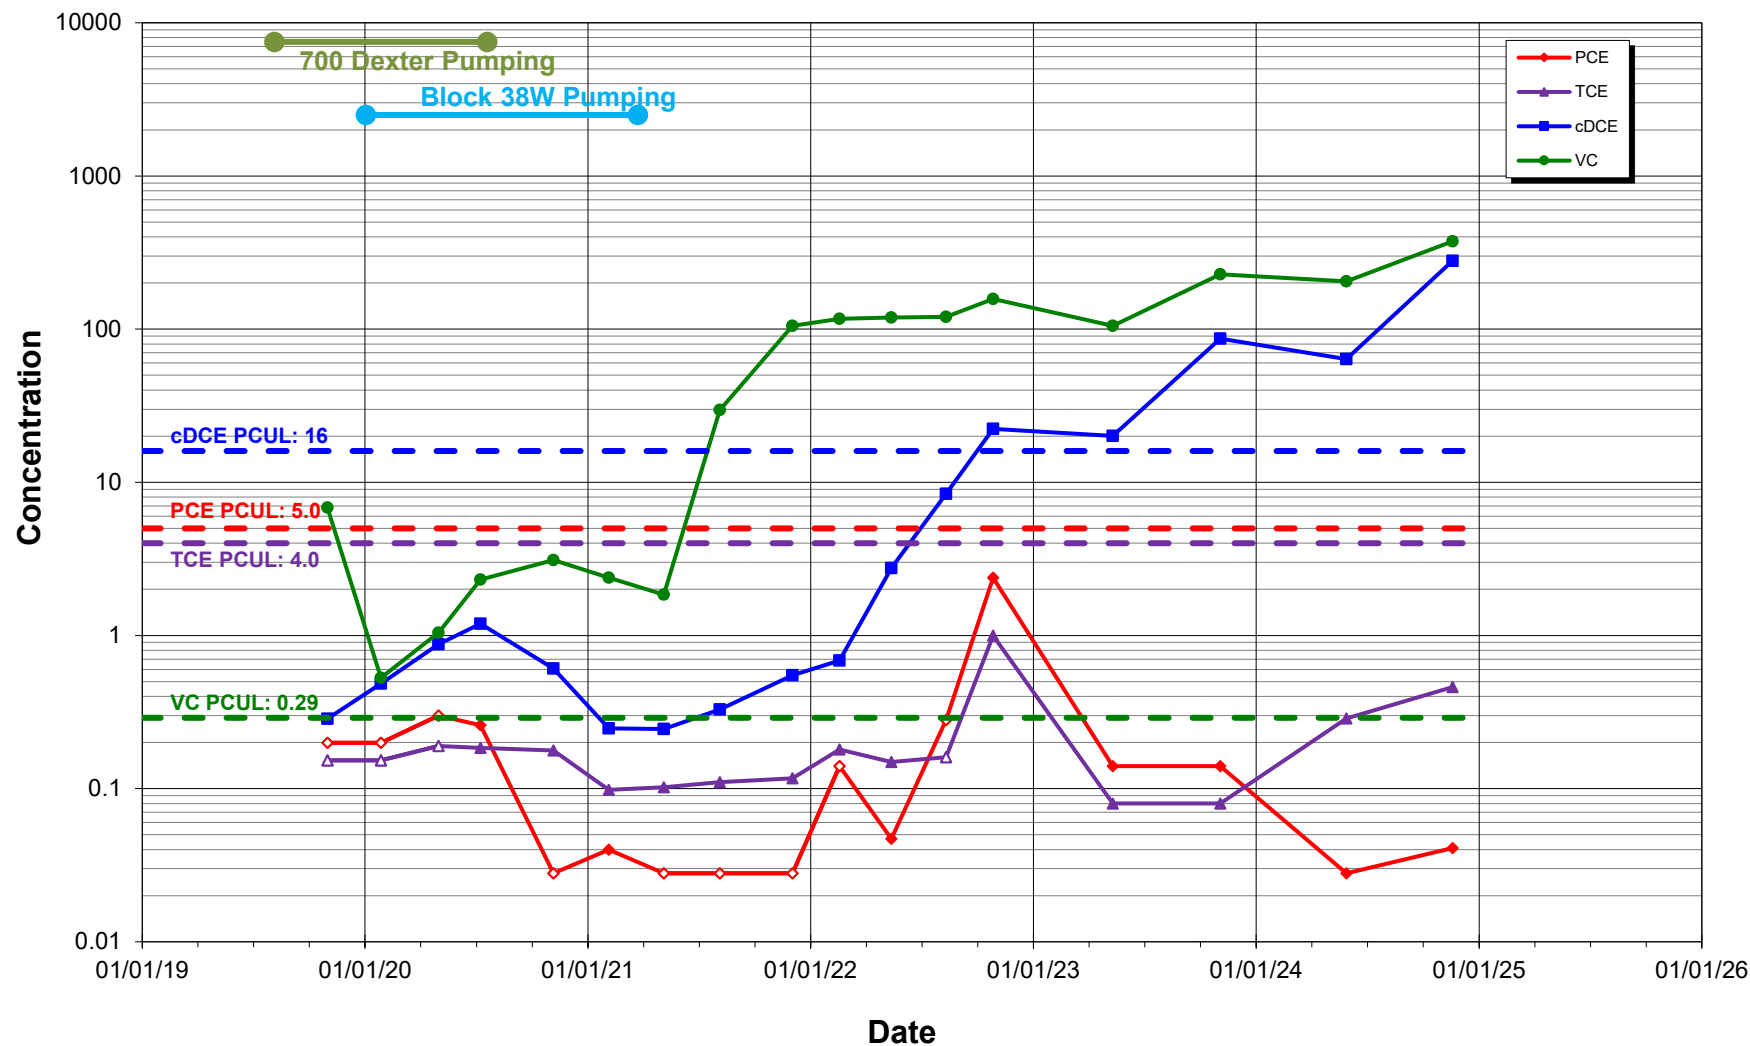
**Concentration vs Time**  
**MW-174 (-12.3 to -22.3 feet NAVD), Cluster 3, Treatment Zone B**  
**American Linen Supply Co-Dexter Ave Site**
