**Attachment A**  
**Well Completion Table**  
**American Linen Supply Co Dexter Ave Site**  
**700 Dexter Avenue North**  
**Seattle, Washington**

**ATTACHMENT B**

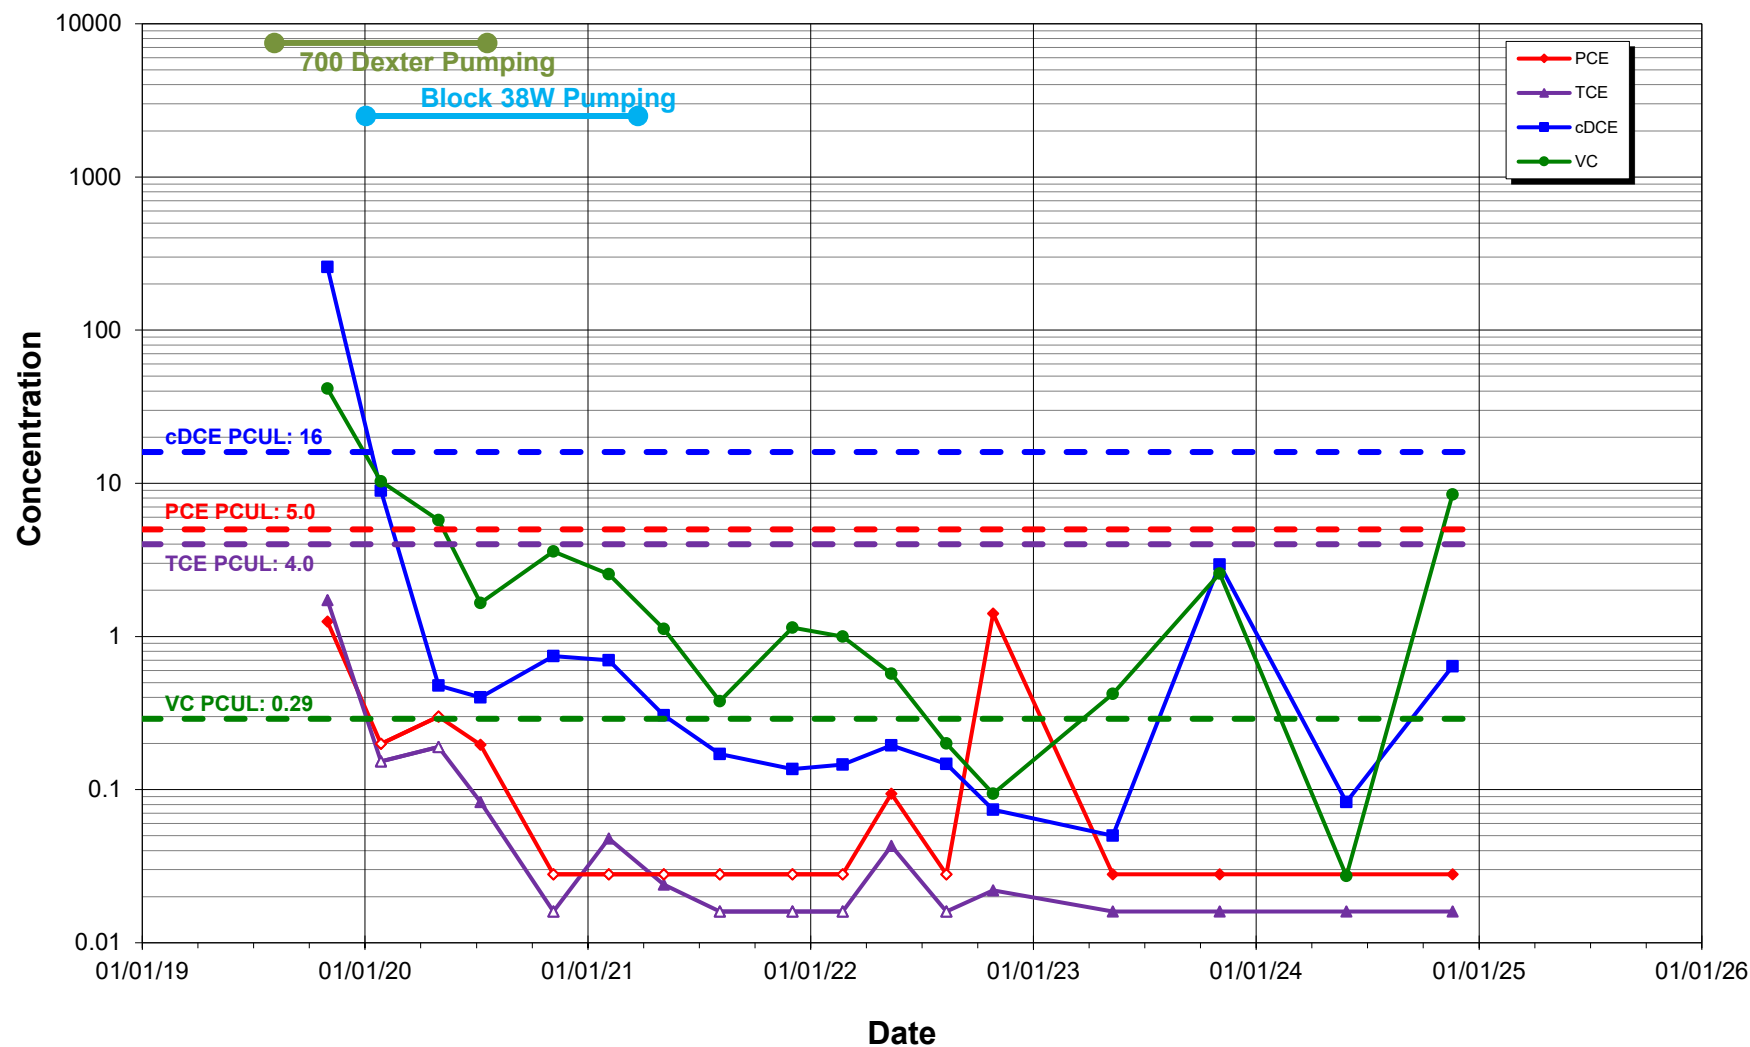
**Concentration vs Time**  
**MW-175 (-27.8 to -37.8 feet NAVD), Cluster 3, Treatment Zone C**  
**American Linen Supply Co-Dexter Ave Site**

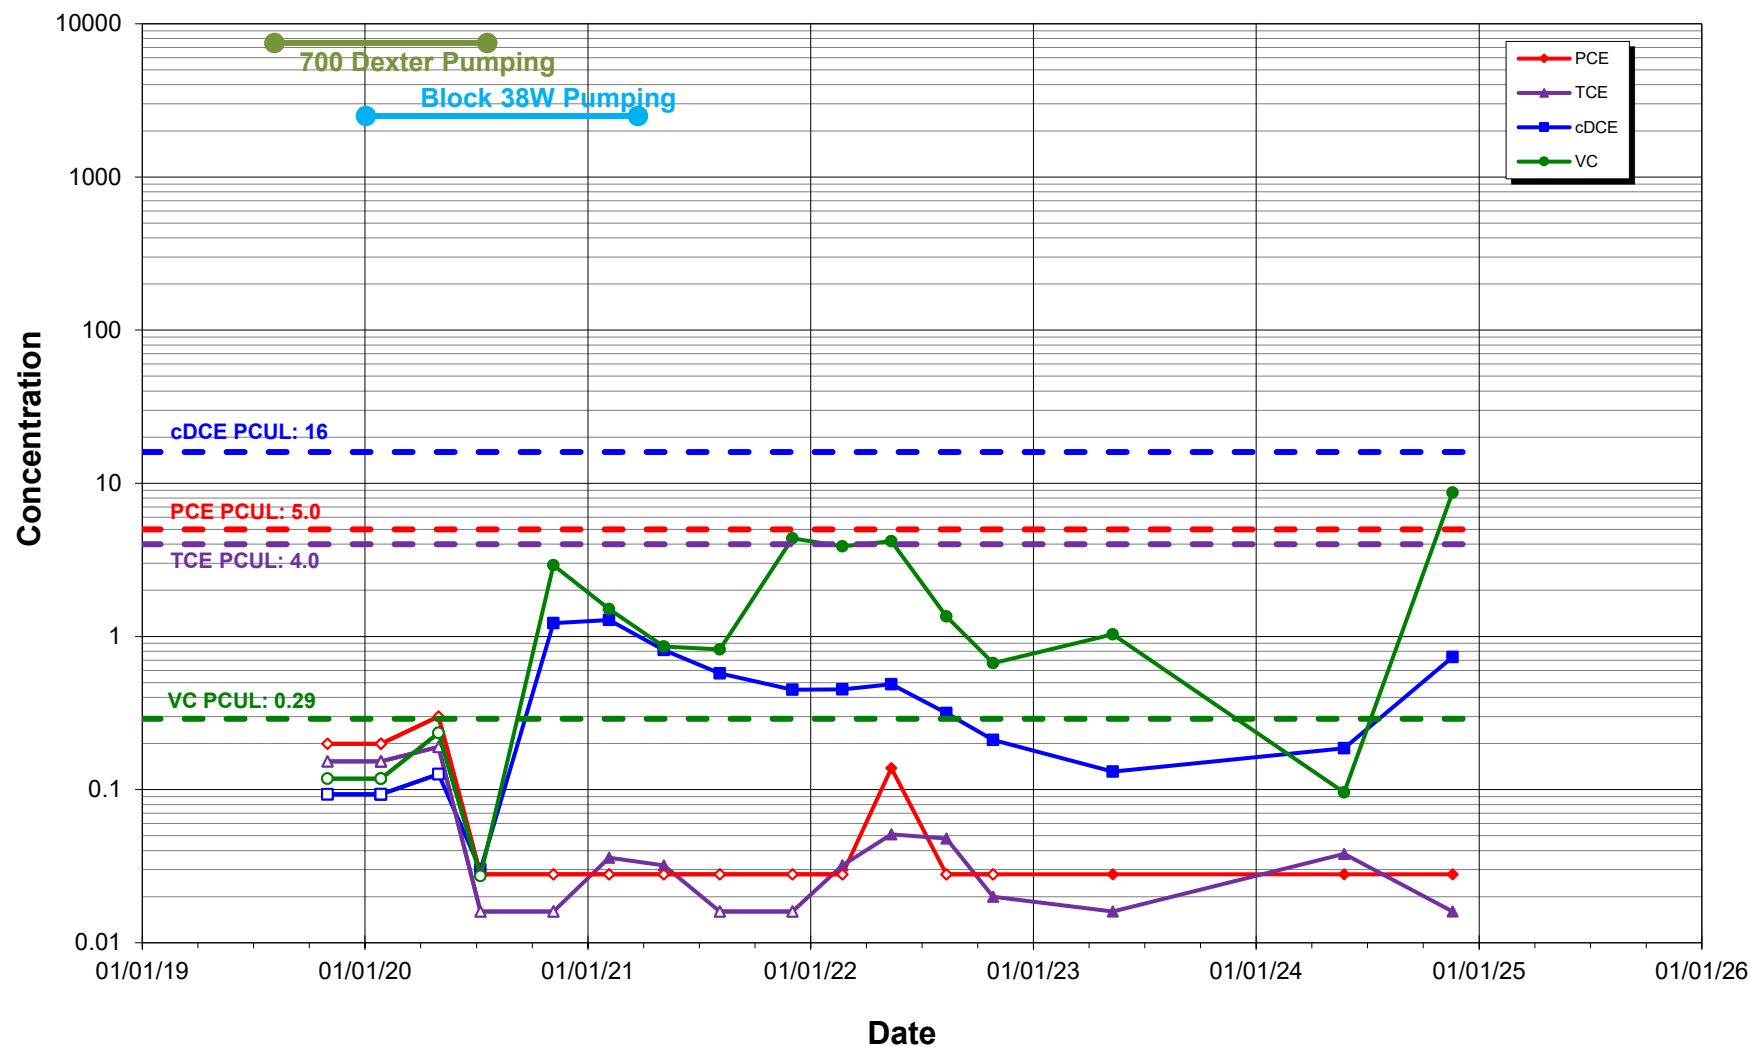
**Concentration vs Time**  
**MW-176 (-42.7 to -52.7 feet NAVD), Cluster 3, Treatment Zone D**  
**American Linen Supply Co-Dexter Ave Site**

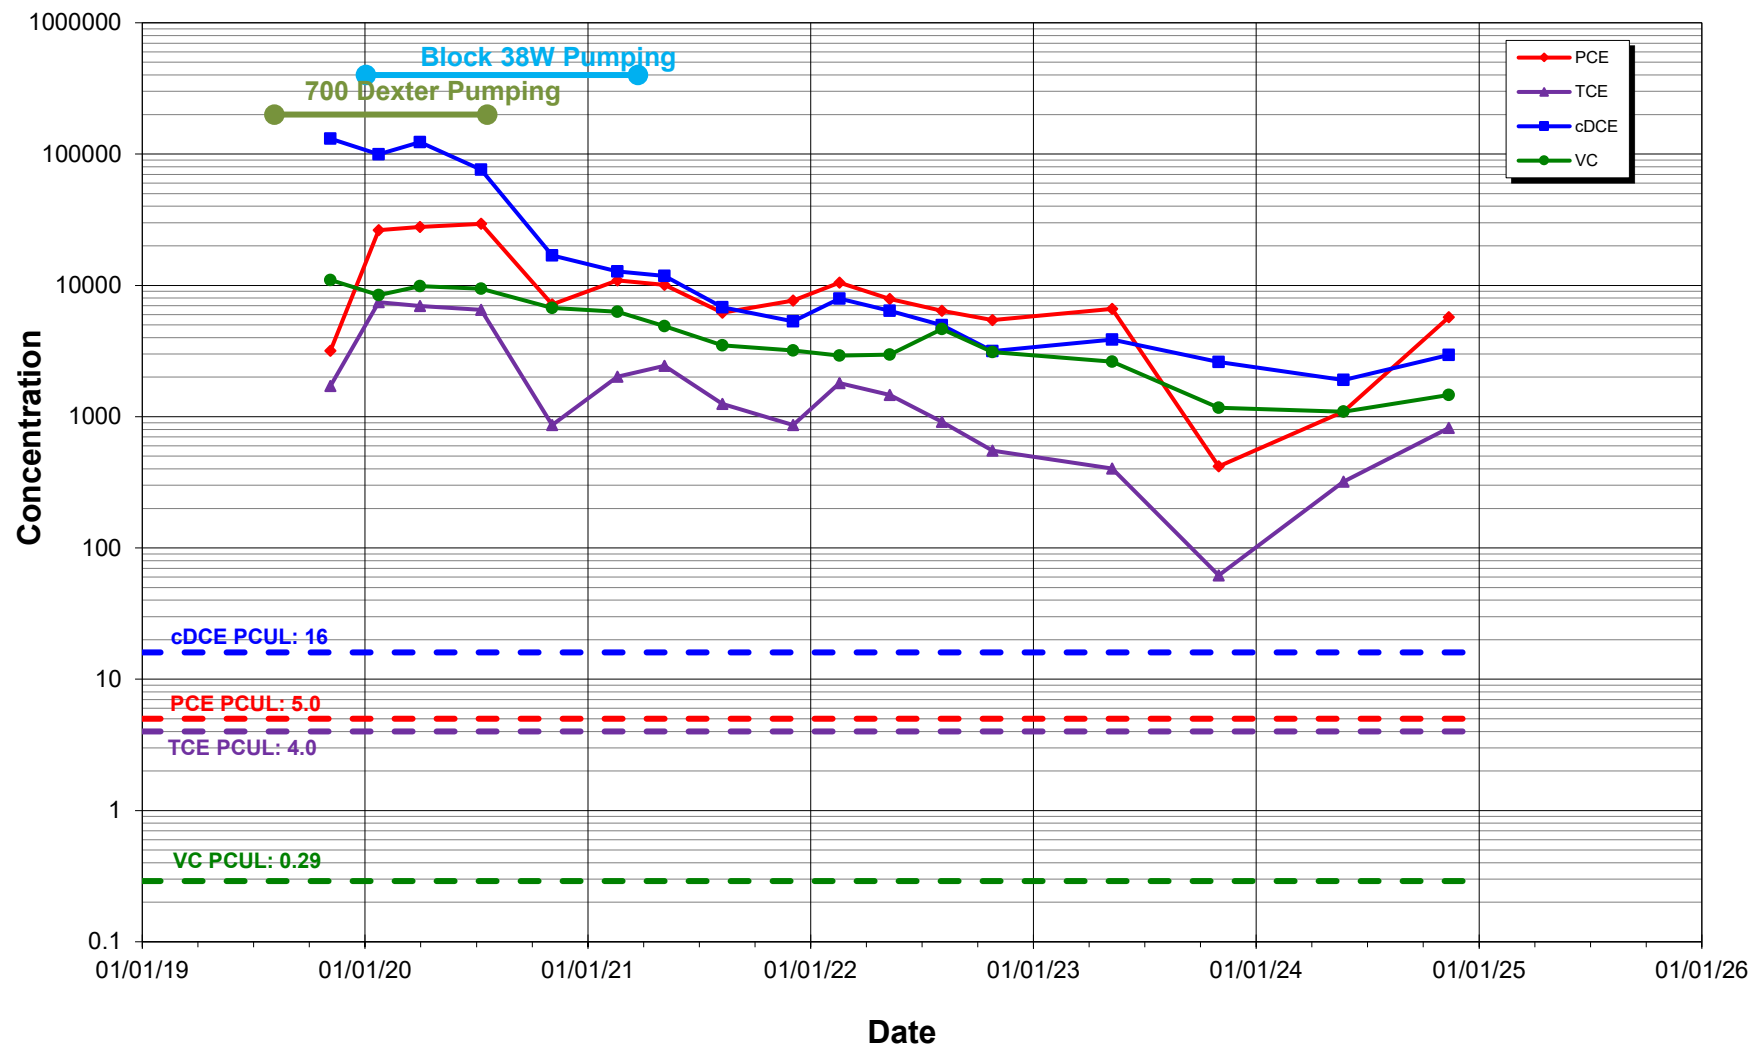
**Concentration vs Time**  
**MW-177 (2.3 to -7.7 feet NAVD), Cluster 4, Treatment Zone A**  
**American Linen Supply Co-Dexter Ave Site**

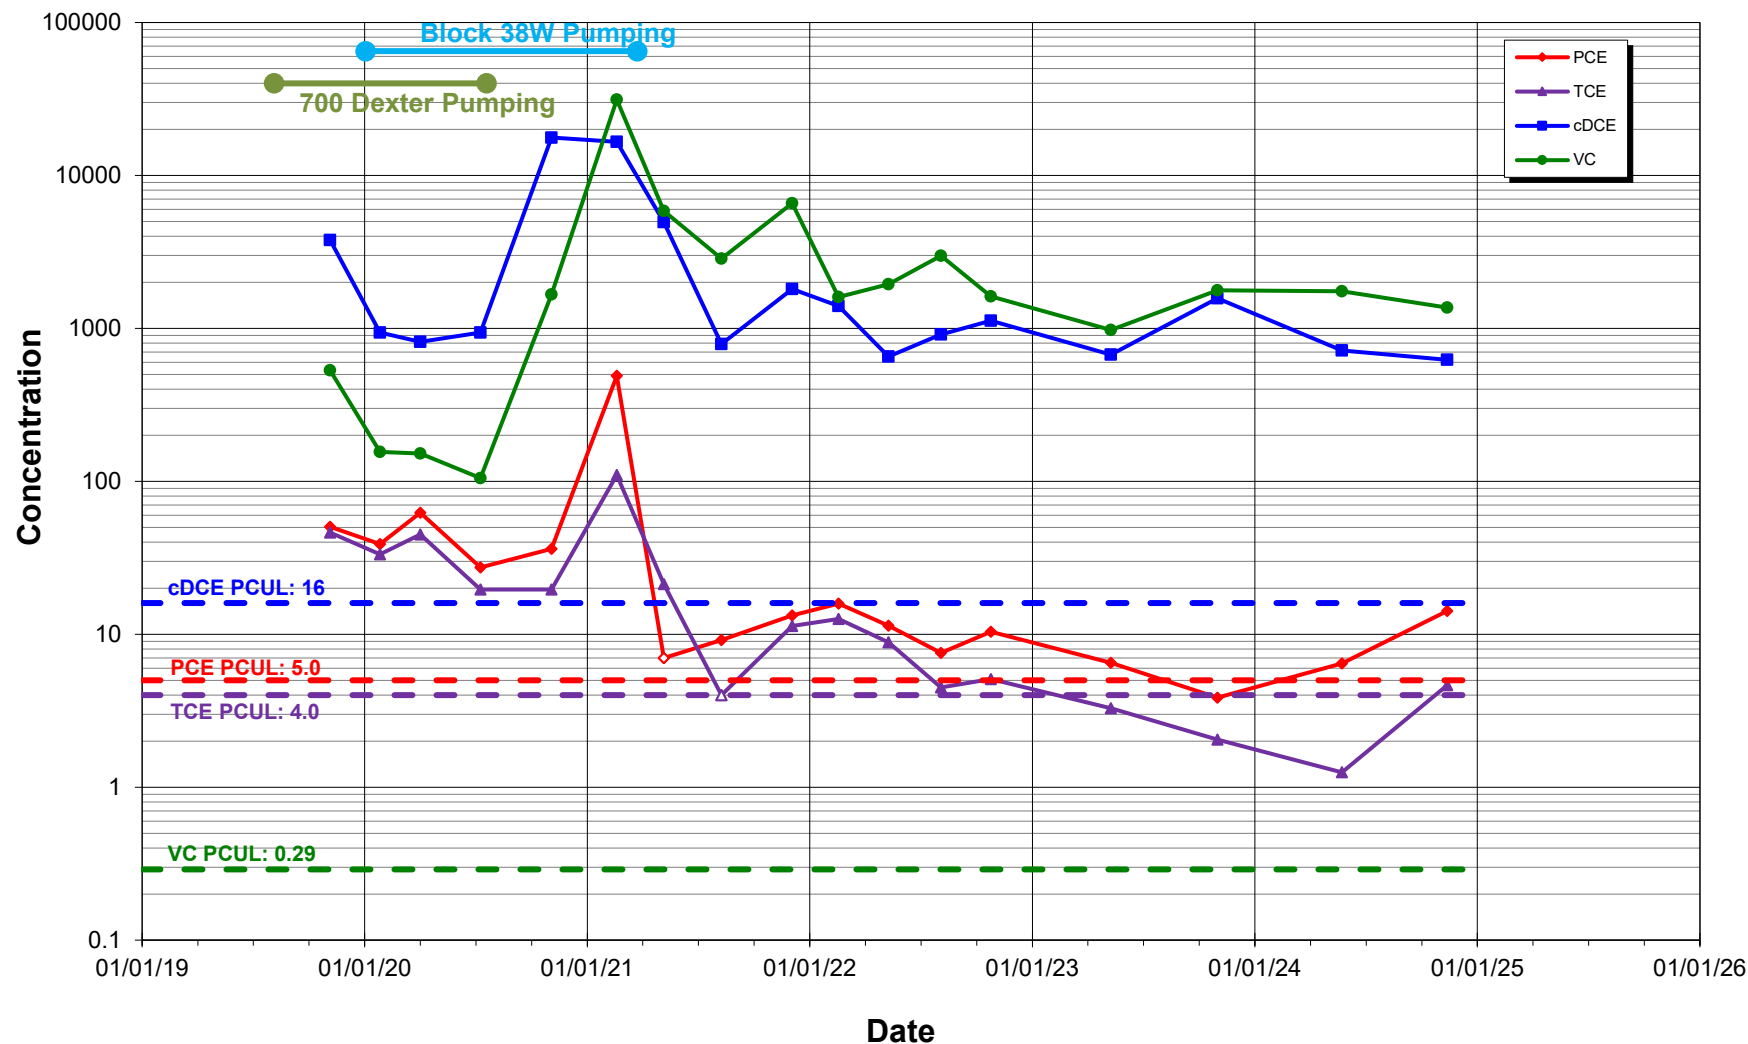
**Concentration vs Time**  
**MW-179 (-27.2 to -37.2 feet NAVD), Cluster 4, Treatment Zone C**  
**American Linen Supply Co-Dexter Ave Site**

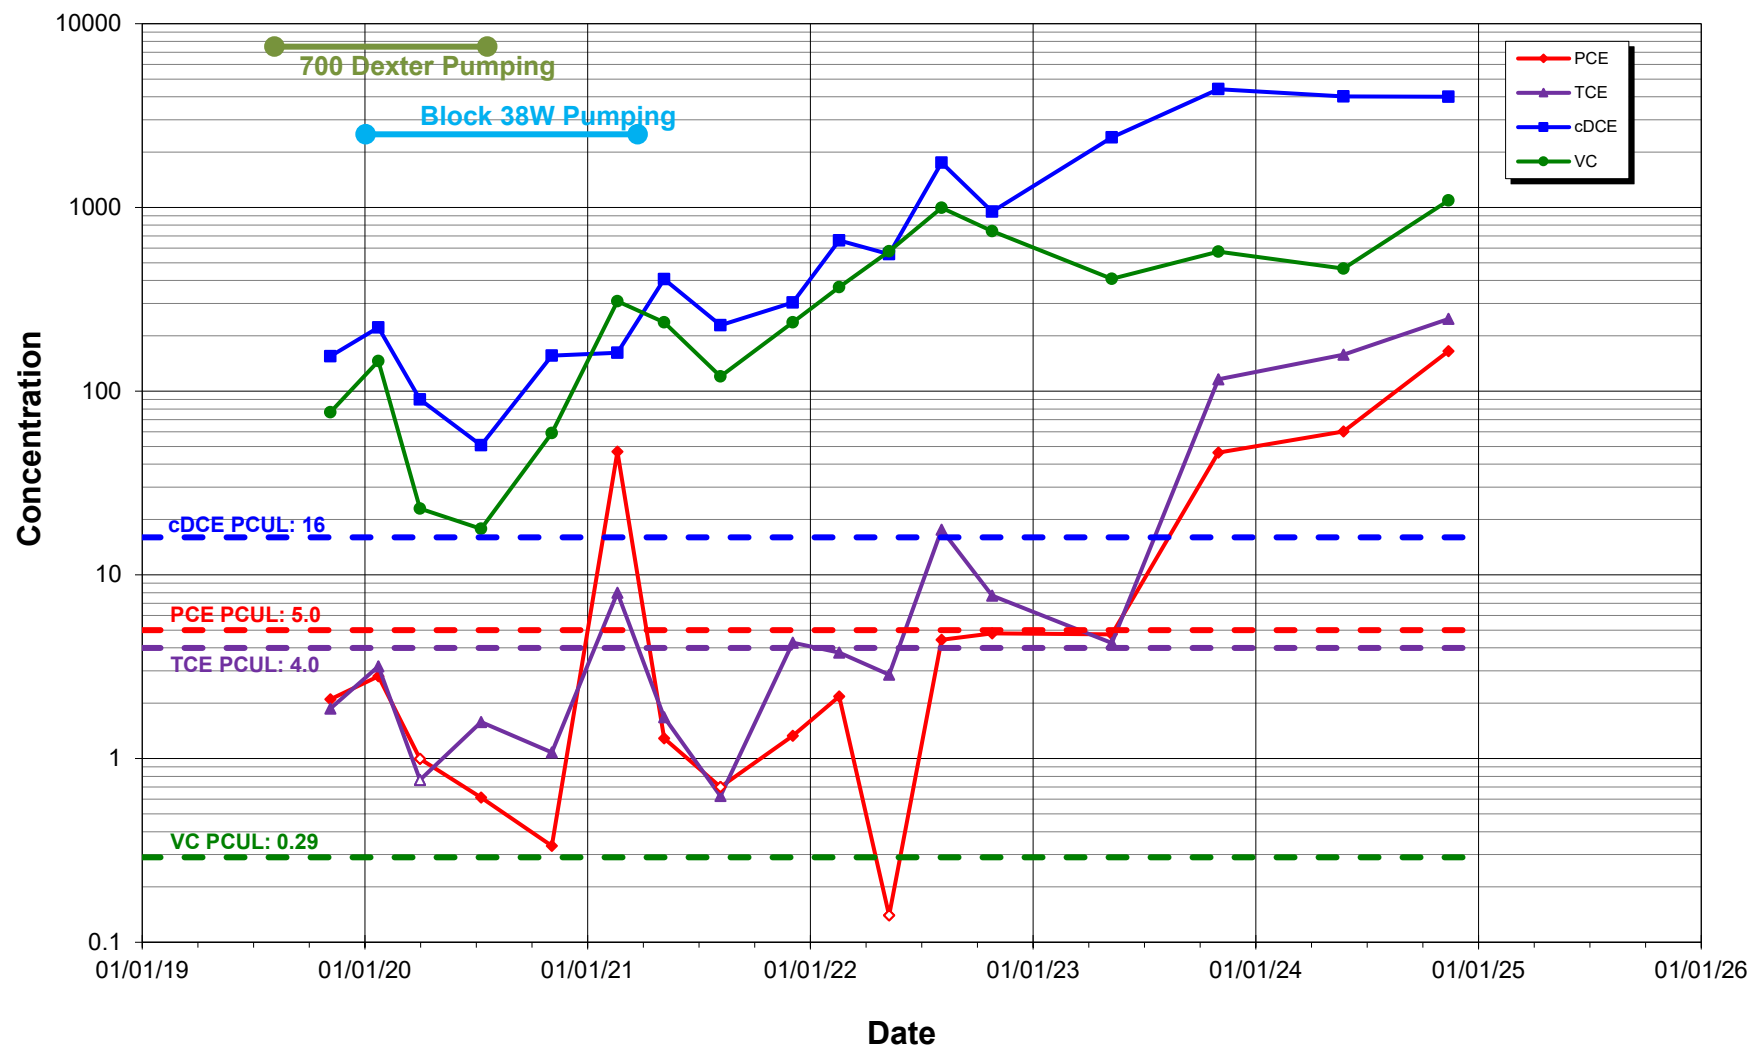
**Concentration vs Time**  
**MW-180 (-42.5 to -52.5 feet NAVD), Cluster 4, Treatment Zone D**  
**American Linen Supply Co-Dexter Ave Site**

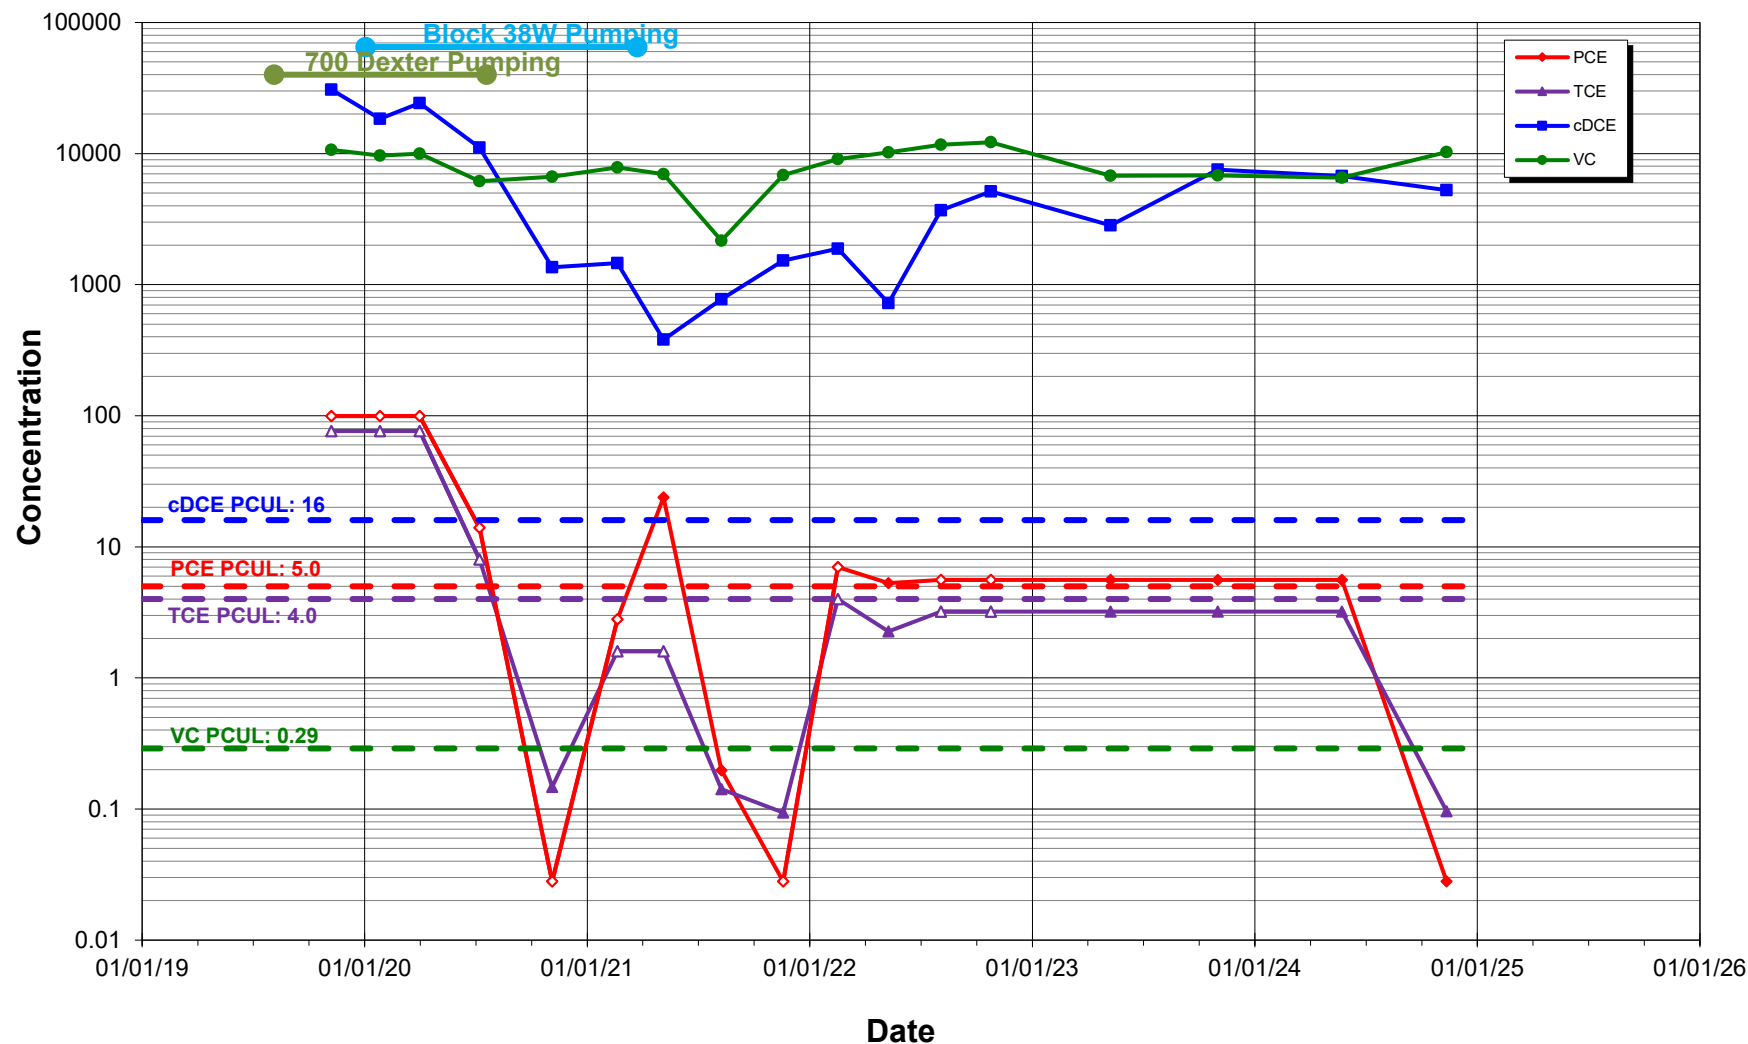
**Concentration vs Time**  
**MW-181 (1.5 to -8.5 feet NAVD), Cluster 5, Treatment Zone A**  
**American Linen Supply Co-Dexter Ave Site**

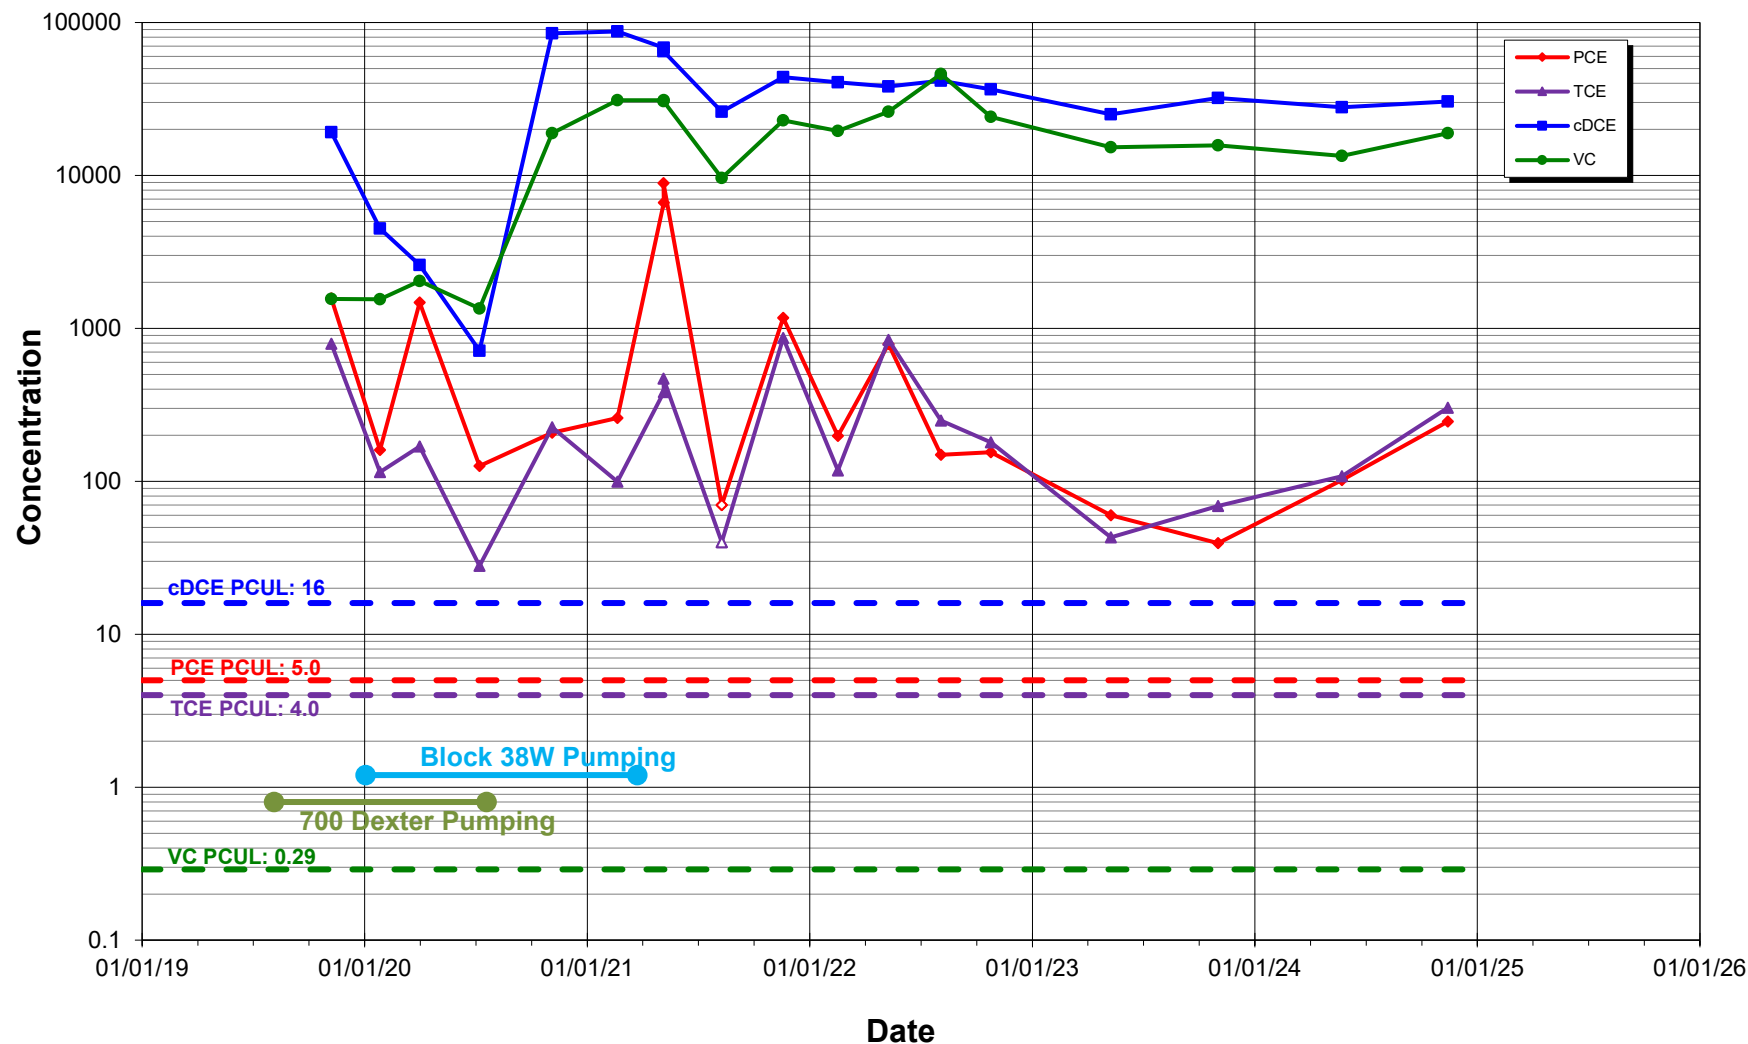
**Concentration vs Time**  
**MW-182 (-12.5 to -22.5 feet NAVD), Cluster 5, Treatment Zone B**  
**American Linen Supply Co-Dexter Ave Site**

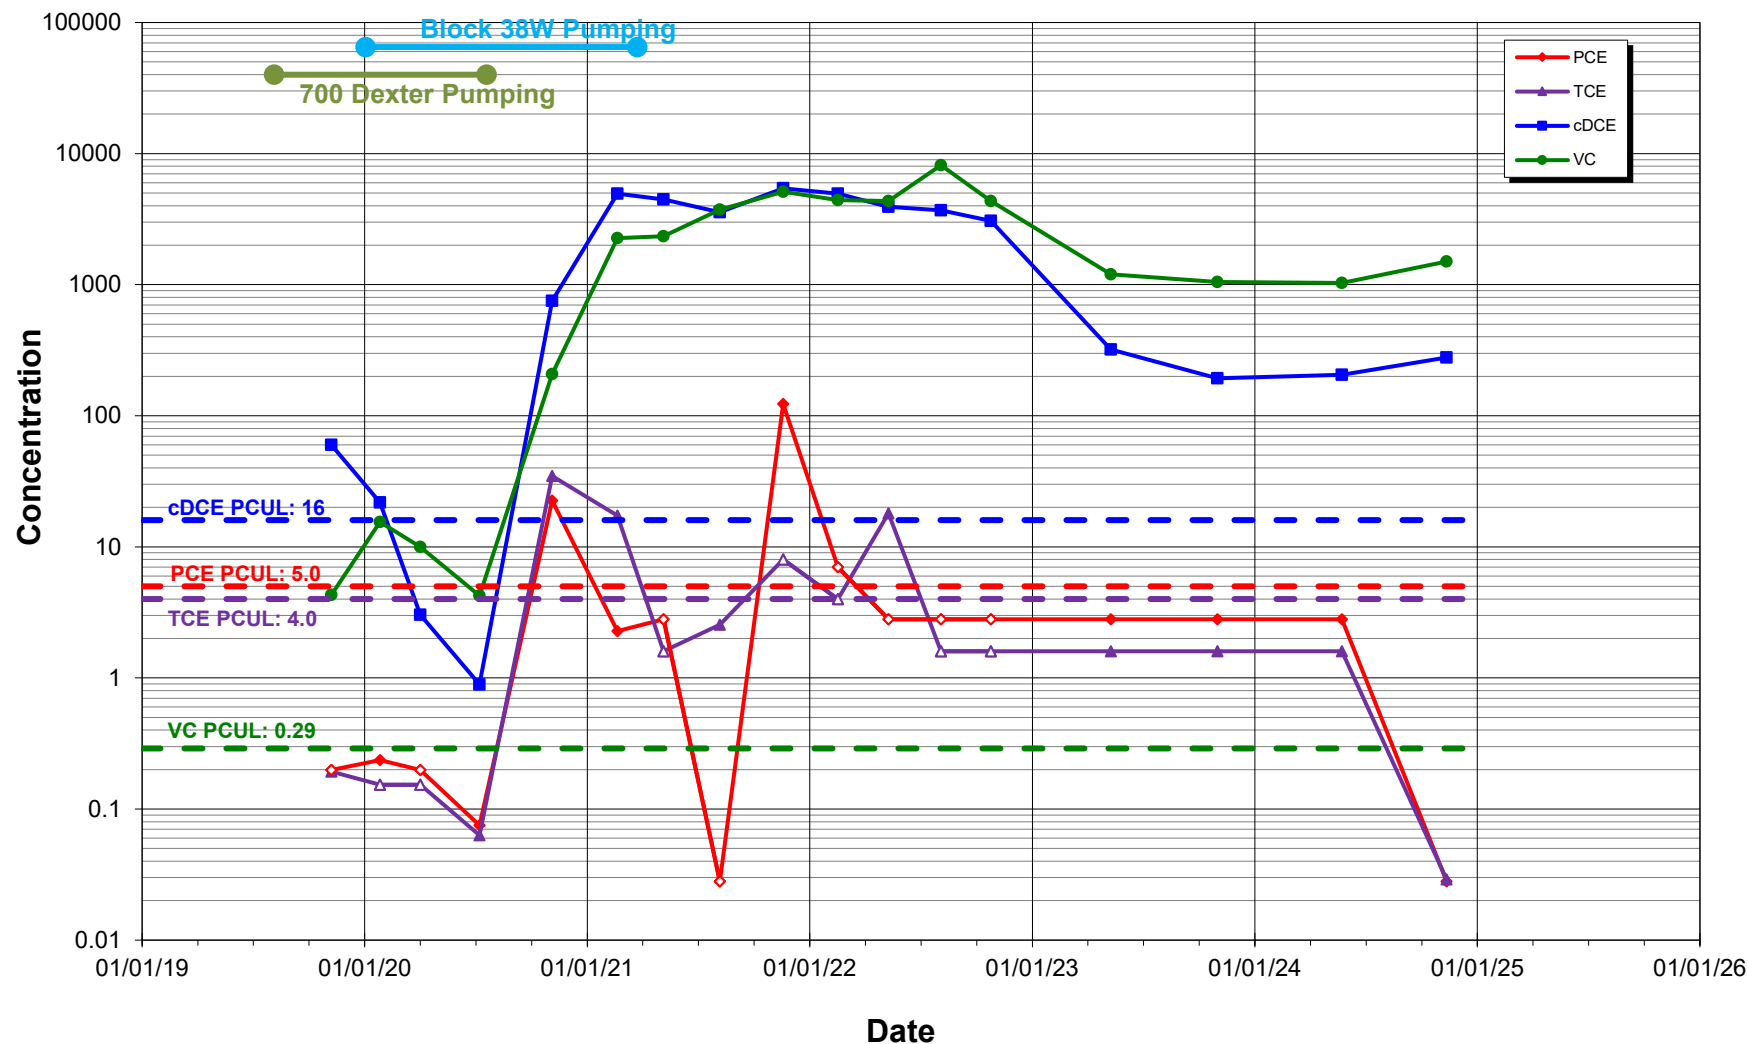
**Concentration vs Time**  
**MW-183 (-27.4 to -37.4 feet NAVD), Cluster 5, Treatment Zone C**  
**American Linen Supply Co-Dexter Ave Site**

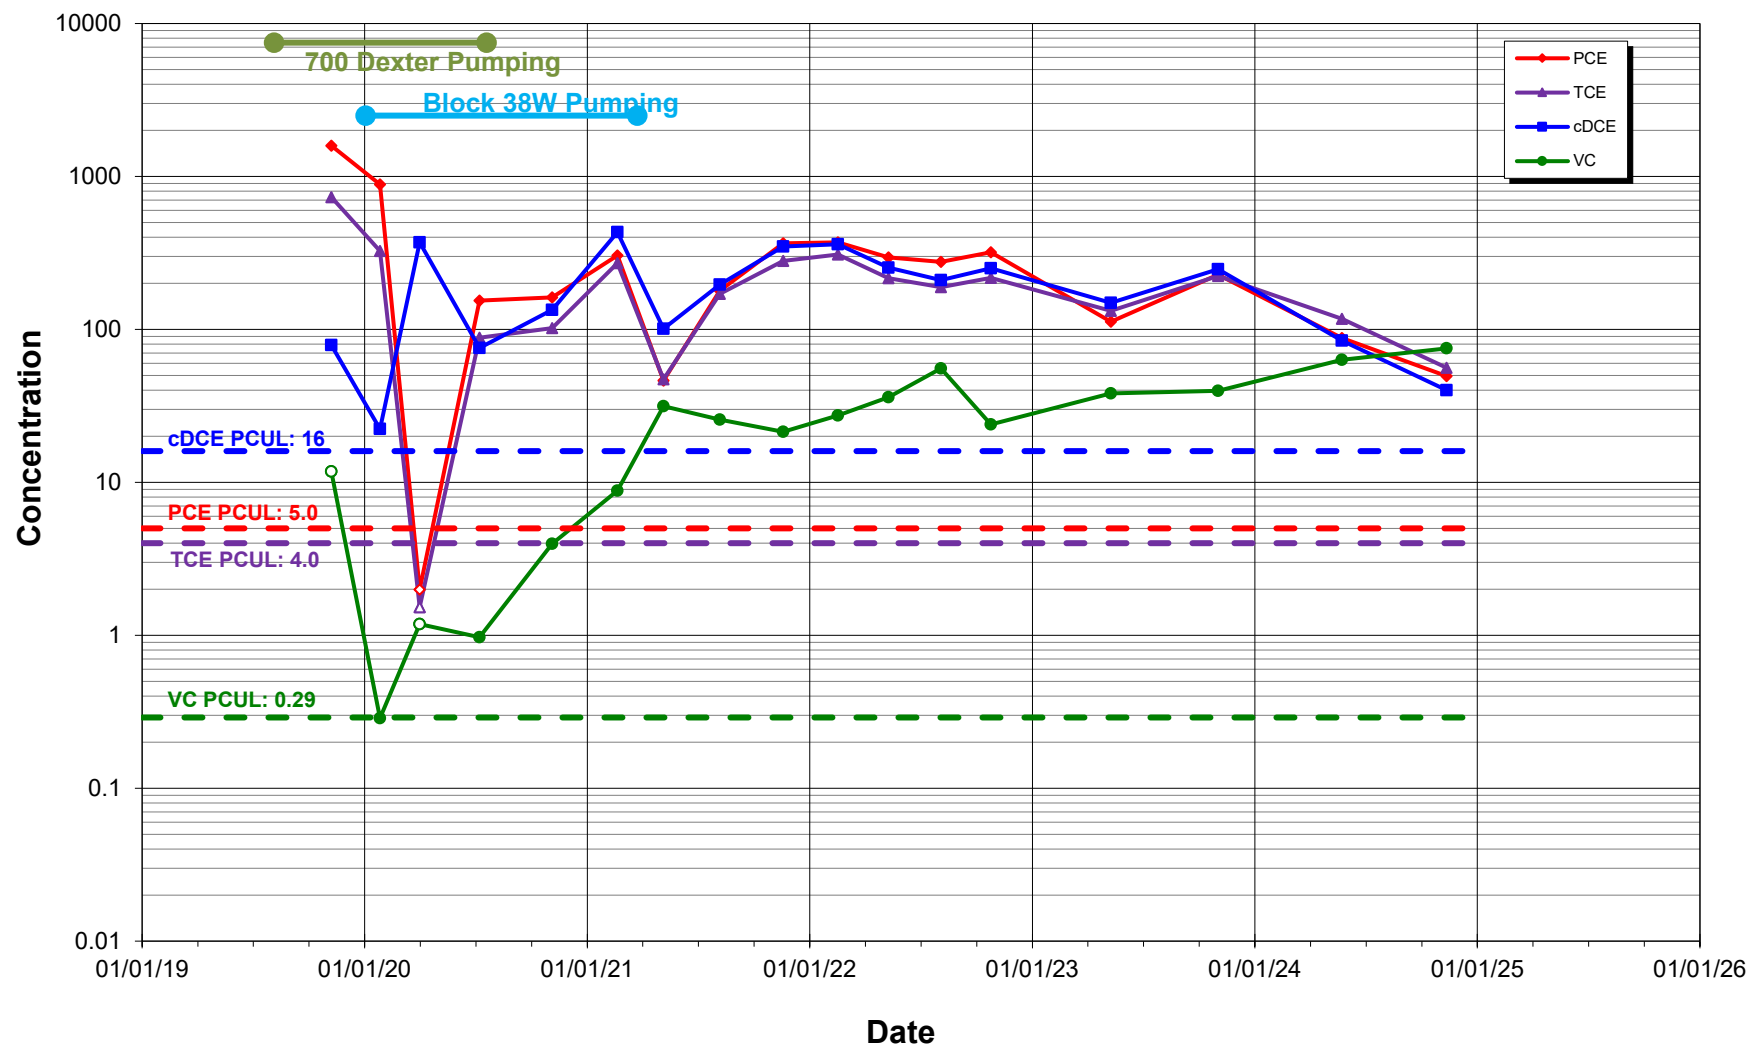
**Concentration vs Time**  
**MW-184 (-42.5 to -52.5 feet NAVD), Cluster 5, Treatment Zone D**  
**American Linen Supply Co-Dexter Ave Site**

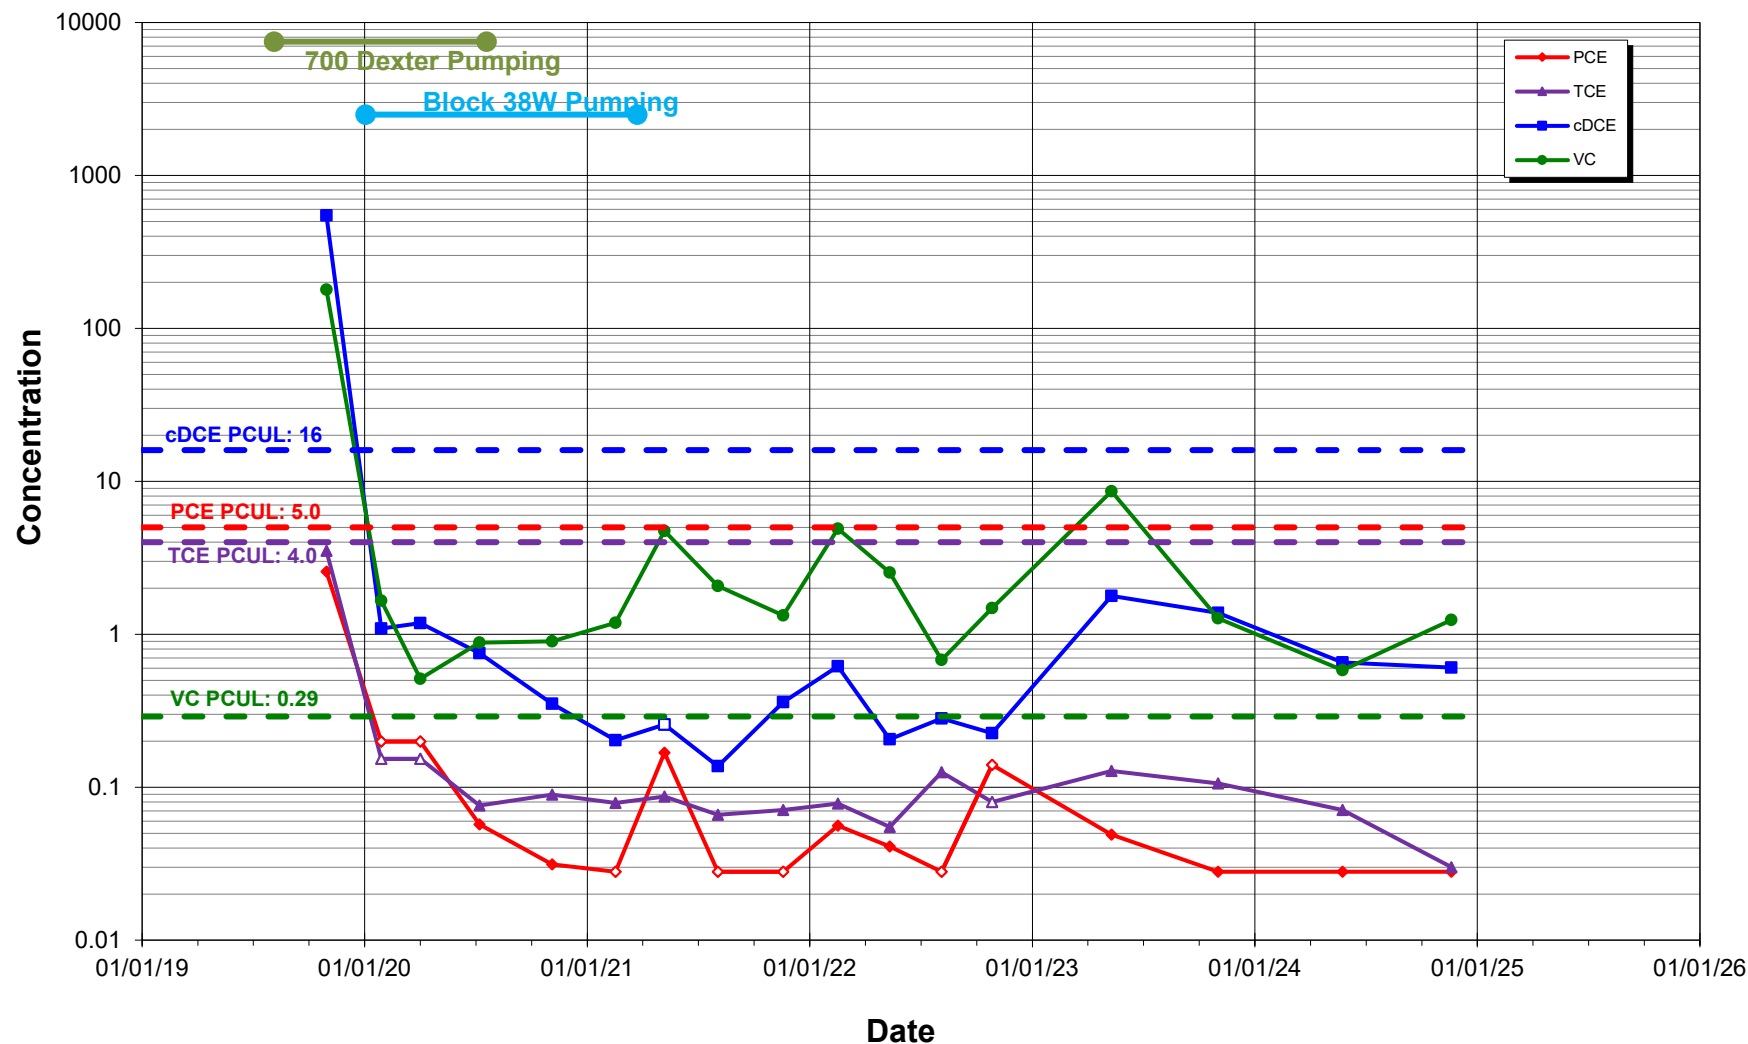
**Concentration vs Time**  
**MW-185 (1.4 to -8.7 feet NAVD), Cluster 6, Treatment Zone A**  
**American Linen Supply Co-Dexter Ave Site**

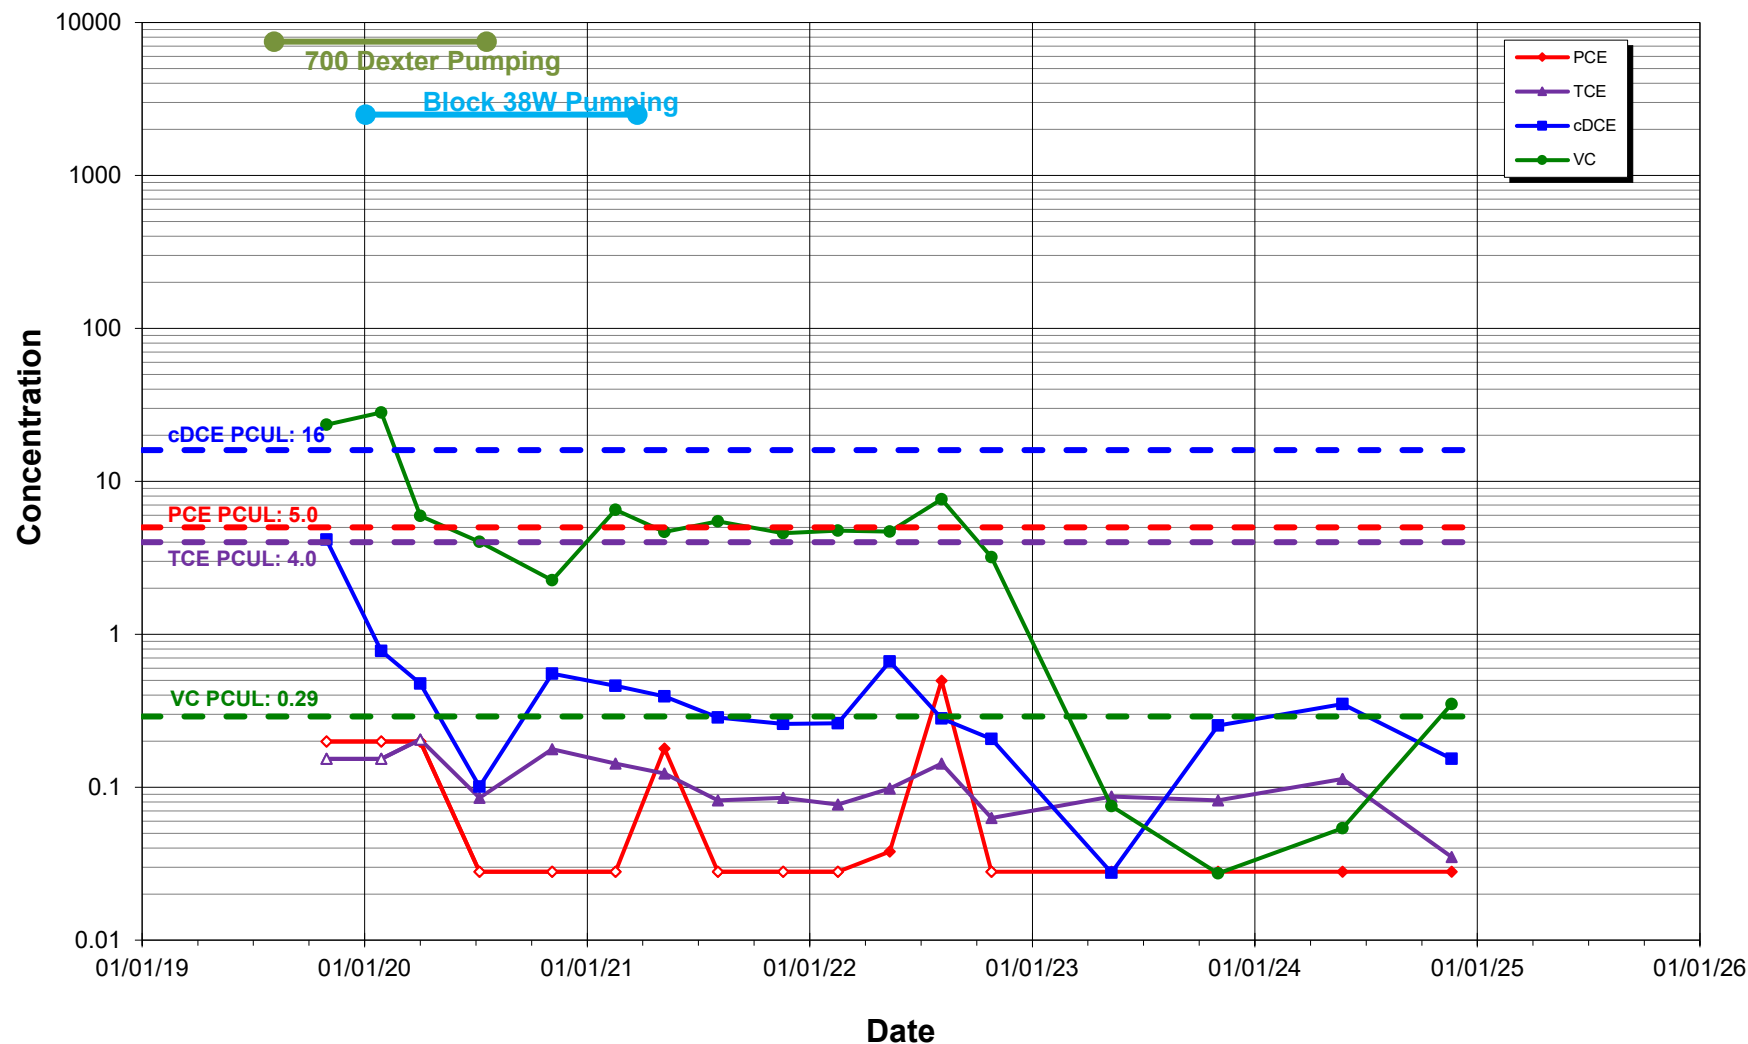
**Concentration vs Time**  
**MW-186 (-12.7 to -22.7 feet NAVD), Cluster 6, Treatment Zone B**  
**American Linen Supply Co-Dexter Ave Site**

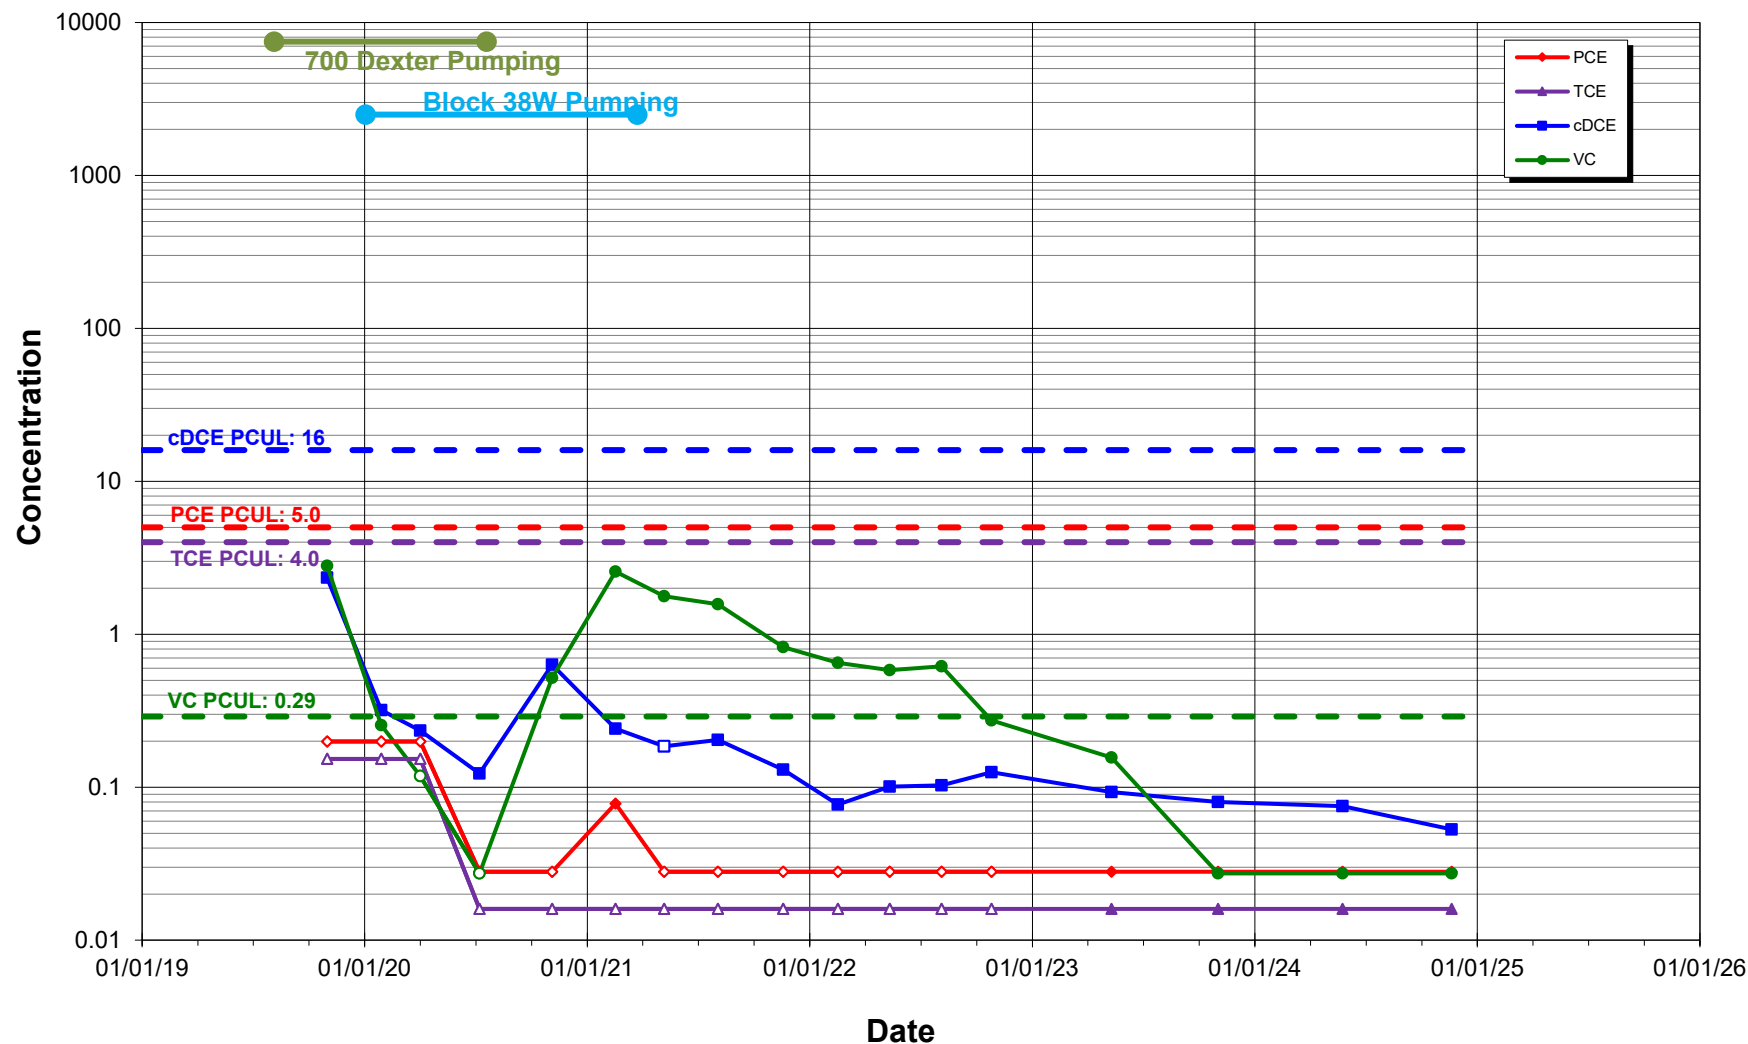
**Concentration vs Time**  
**MW-187 (-27.0 to -37.0 feet NAVD), Cluster 6, Treatment Zone C**  
**American Linen Supply Co-Dexter Ave Site**
