**Attachment A**  
**Well Completion Table**  
**American Linen Supply Co Dexter Ave Site**  
**700 Dexter Avenue North**  
**Seattle, Washington**

**ATTACHMENT B**

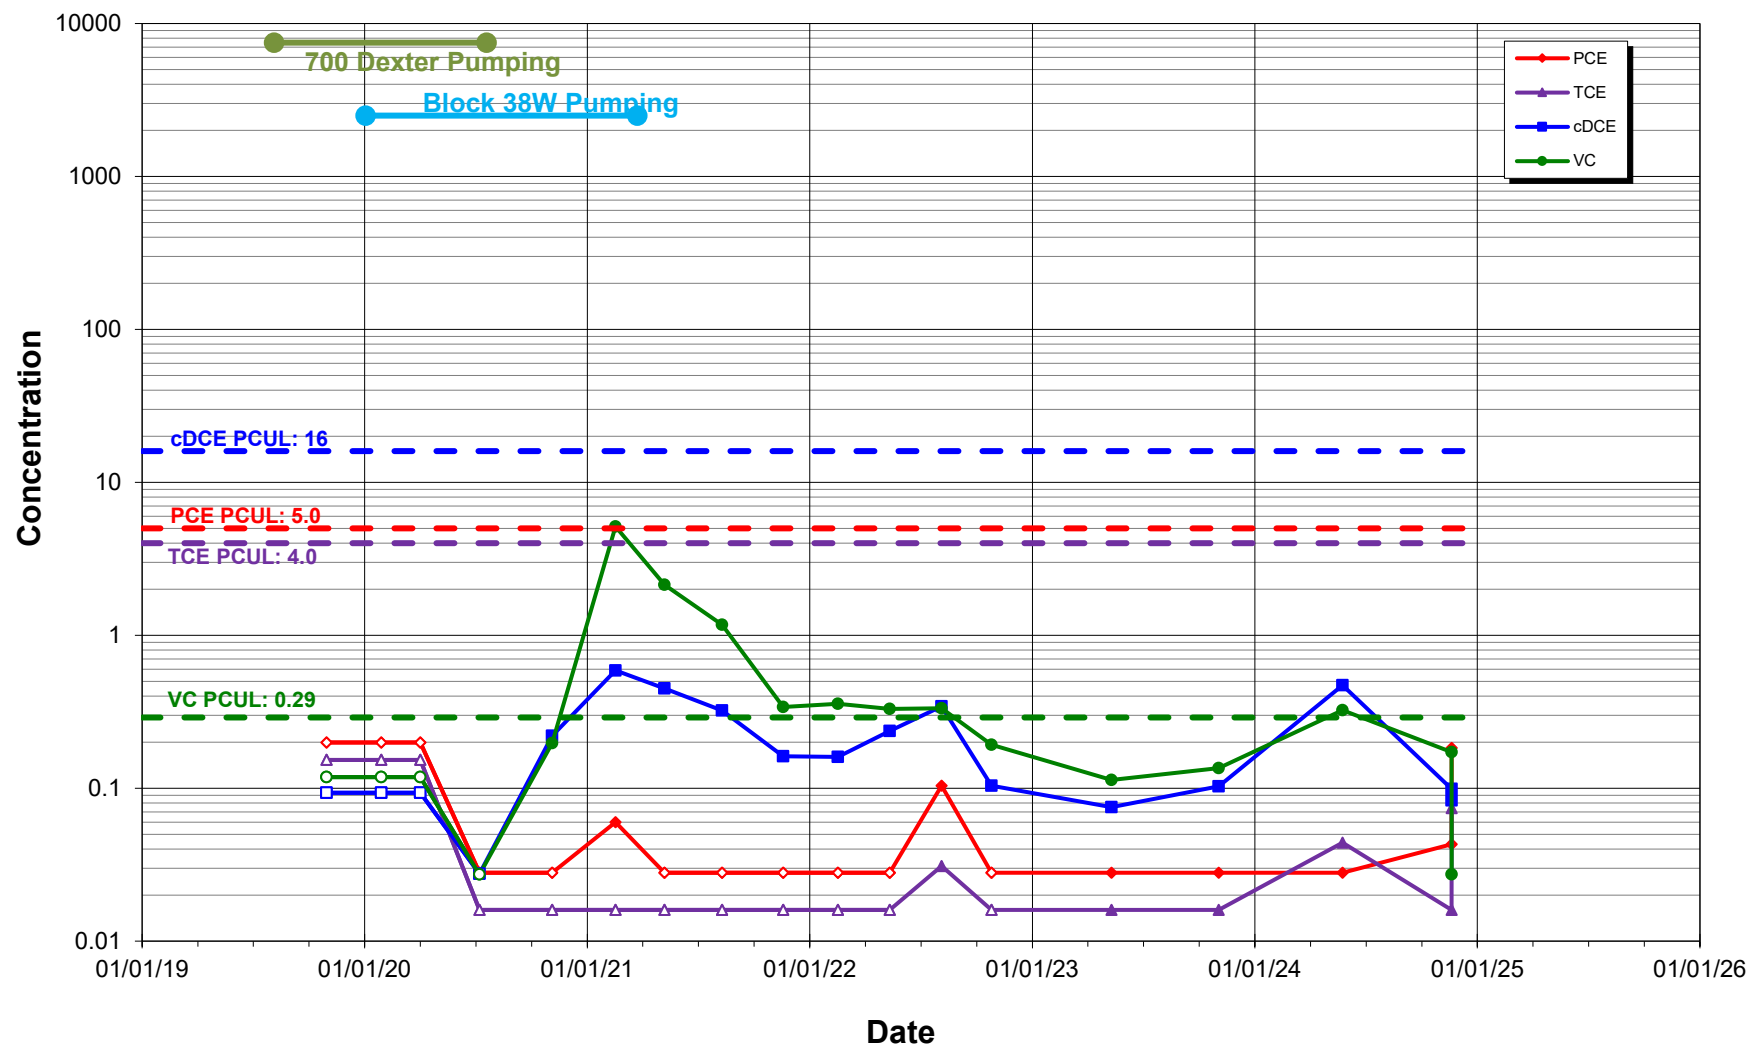
**Concentration vs Time**  
**MW-188 (-42.2 to -52.2 feet NAVD), Cluster 6, Treatment Zone D**  
**American Linen Supply Co-Dexter Ave Site**
