Everett Smelter

4298 Everett Smelter 20240528

SHARP Report — Part 2 of 2

Conceptual site model

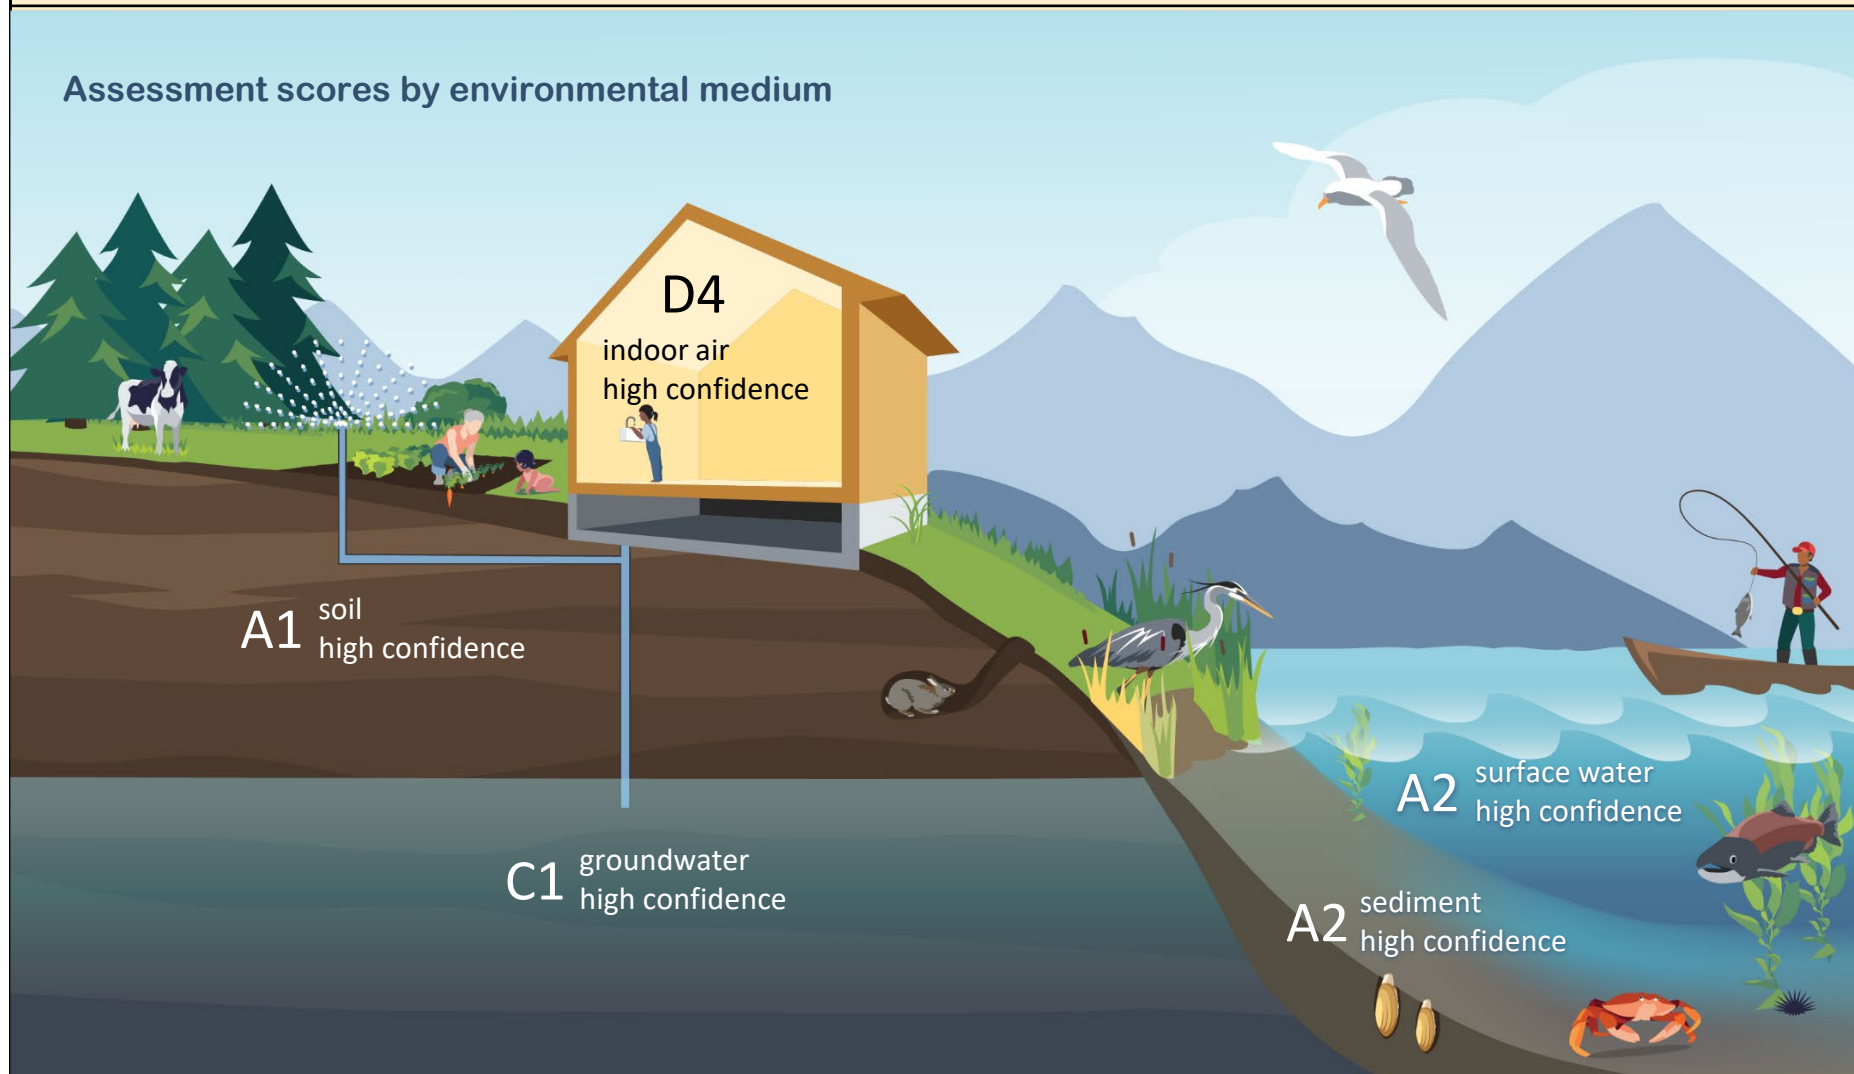
Assessment scores by environmental medium

SHARP Media	Scores	Confidence	Additional Factors	
Indoor air	D4	high	multiple chemical types	⊘
Groundwater	C1	high	risk to off-site people	✓
Surface water	A2	high	climate change impacts	✓
Sediment	A2	high	plant/animal tissue data	⊘
Soil	A1	high
