# Northern State Multi Service Center

SHARP Report — Part 1 of 2

Conceptual site model

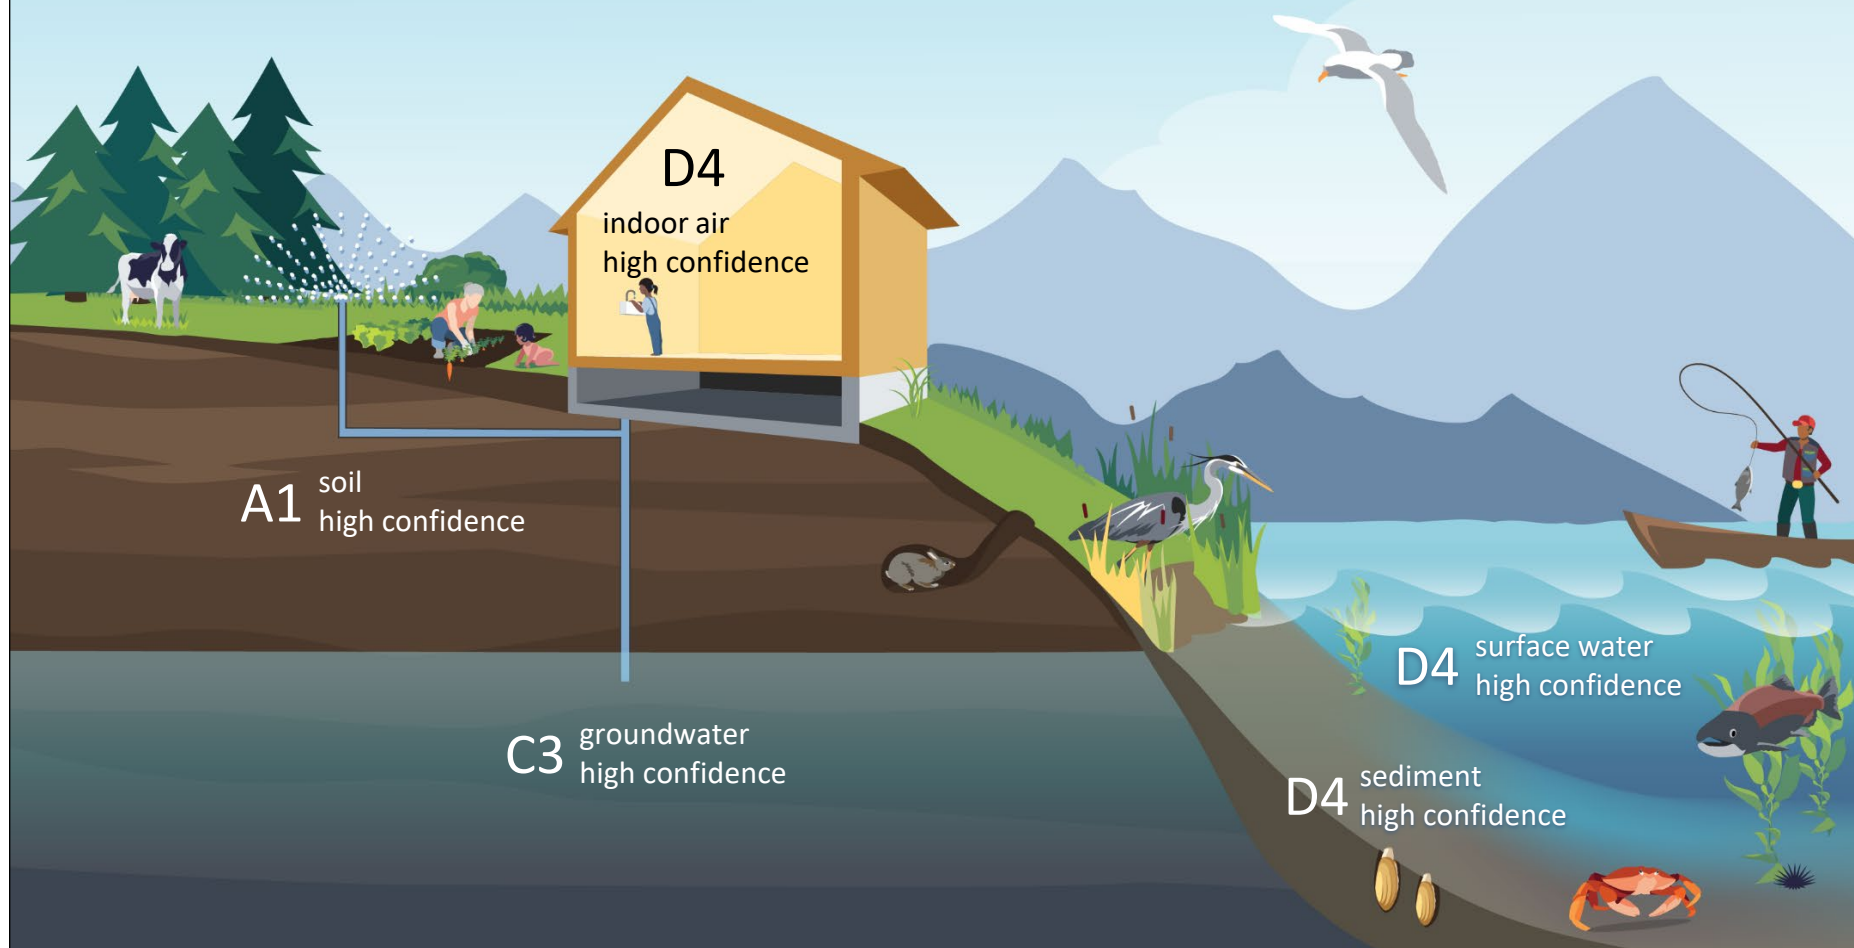
### Assessment scores by environmental medium
