AGENCY REVIEW REVISED DRAFT REMEDIAL INVESTIGATION WORK PLAN FOR UPLAND AREAS

Georgia-Pacific Consumer Products, Camas, Washington

Project: AS130290L

4 August 2025

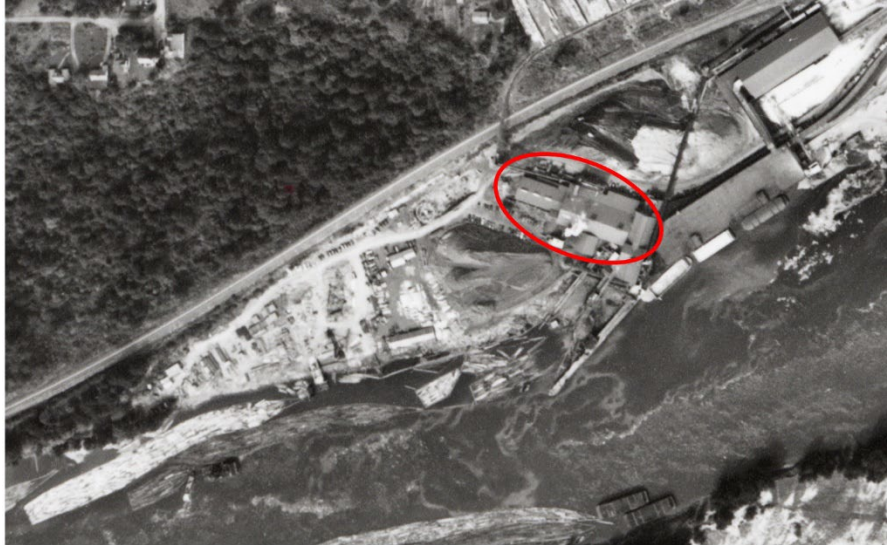
Image 1: Aerial imagery from 1948 showing the First Woodmill

The Woodmill historically served as the handling area for logs staged in the adjacent Camas Slough. Whole, untreated logs were initially processed into wood chips at the original Woodmill (visible in Image 1 below), formerly located in the eastern portion of the Woodyard to the northwest of the Dock Warehouse. It was replaced in 1947 by a Woodmill in the western portion of the Woodyard (seen in Image 2). Both the First and Second Woodmills were demolished in 2003. After demolition, log processing ceased on the Mill Property and wood chips arrived by truck and barge; chips were briefly received via railcar during construction of the truck dumps. The Wood Chip Piles provided feedstock for pulping operations until the cessation of pulping operations in 2018–2019.

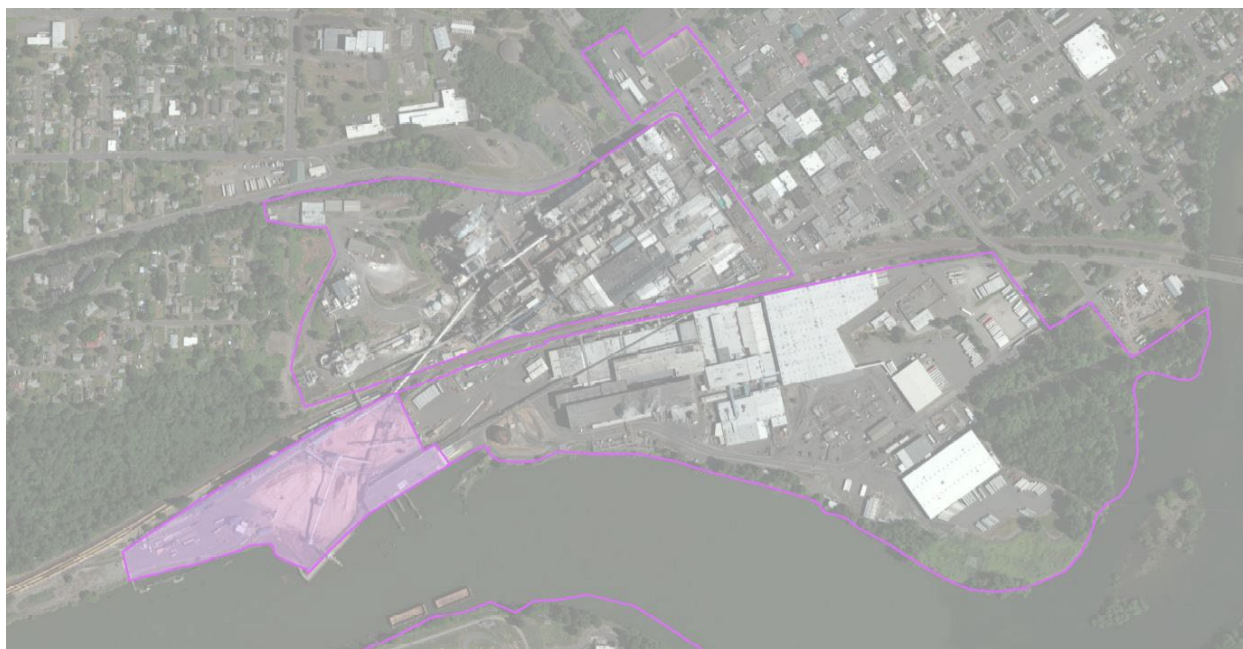
Image 3: Aerial imagery of MOU-A

The Woodyard abuts the banks of the Camas Slough south of the railroad tracks. MOU-A contains OA-A1 (Woodmill), where log processing occurred to create and store wood chips wood chips for use in pulping and papermaking operations.

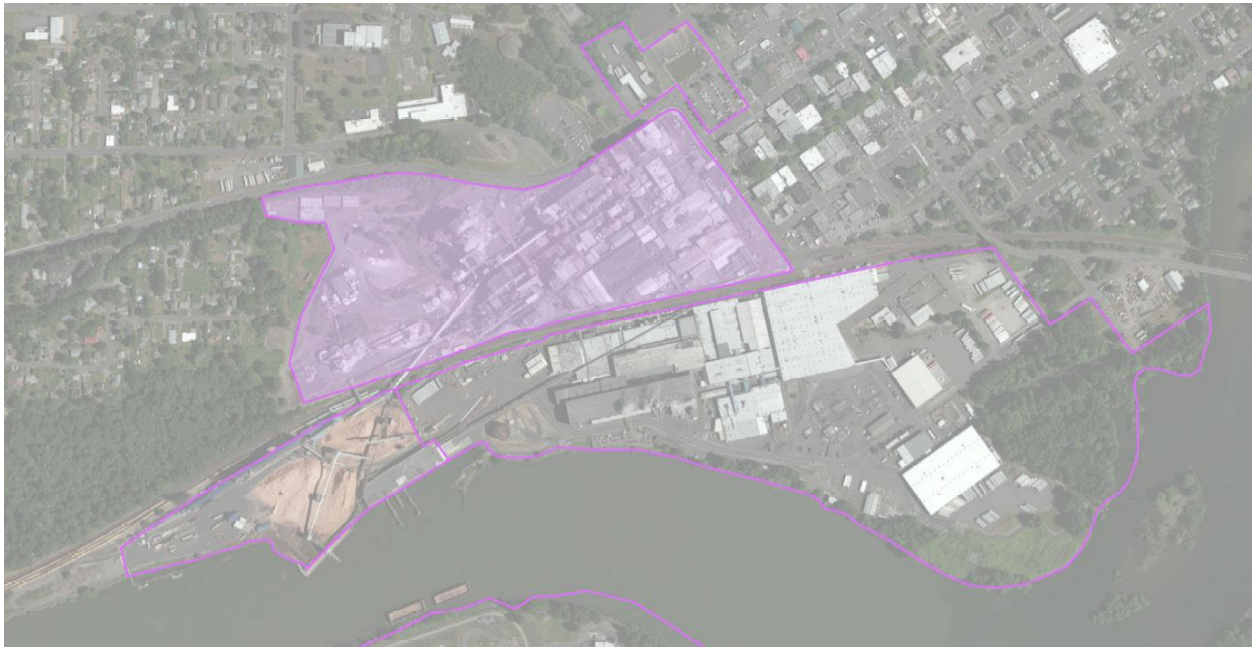
Image 4: Aerial imagery of MOU-B

MMA–North (MOU-B) is located south of NW 6th Avenue and north of the railroad tracks. It encompasses six OAs: Pulping, Power House, Bleaching, Finishing/Coatings, Specialty Minerals, and Warehouse/Product Storage.

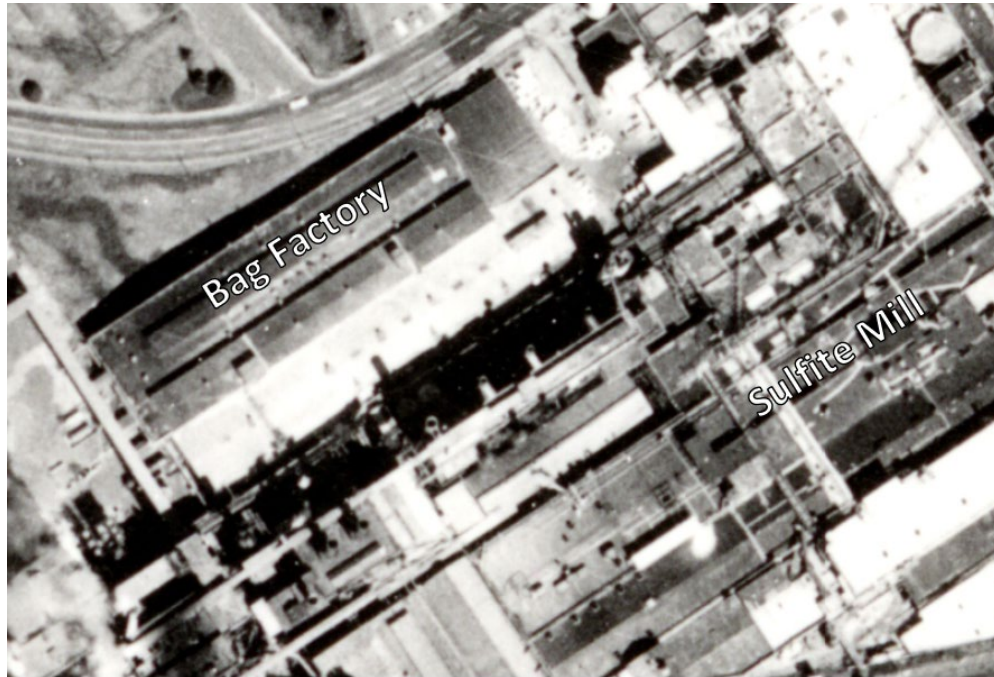
Image 5: Aerial imagery from 1973 showing the Former Bag Factory and Former Sulfite Mill

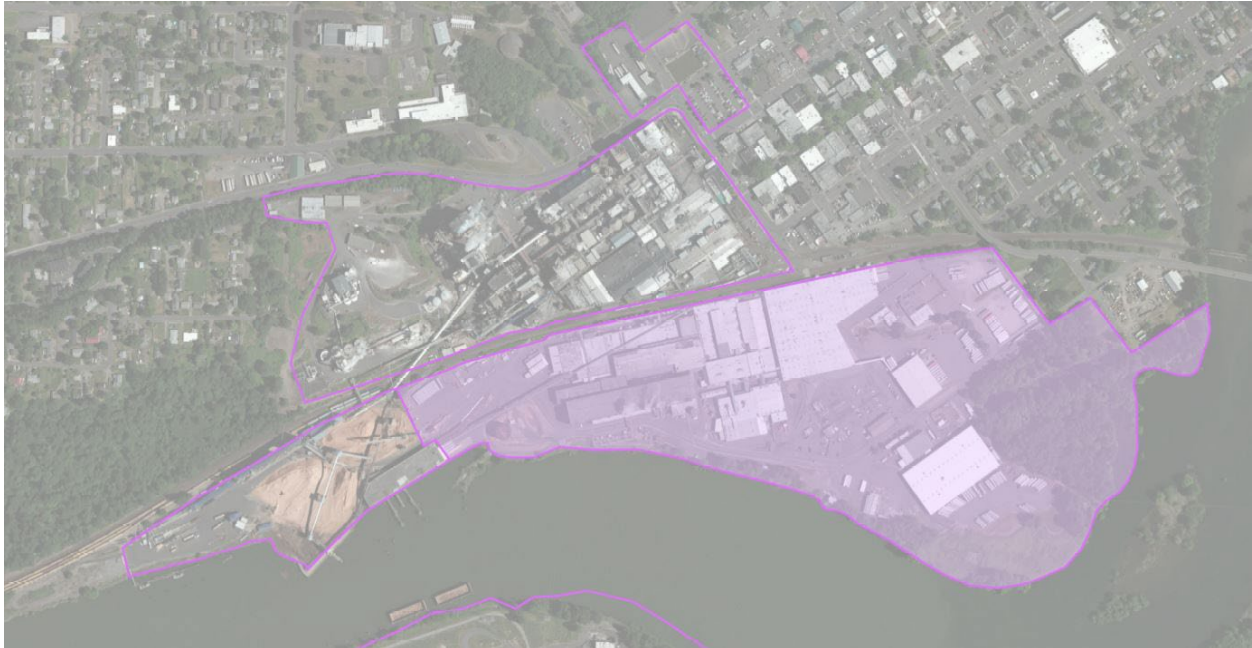
Image 6: Aerial imagery of MOU-C

The Main Mill Area–South (MOU-C) is located between the railroad tracks and the Camas Slough. It encompasses five operational areas which included finishing, coating, product storage, and operational support activities.

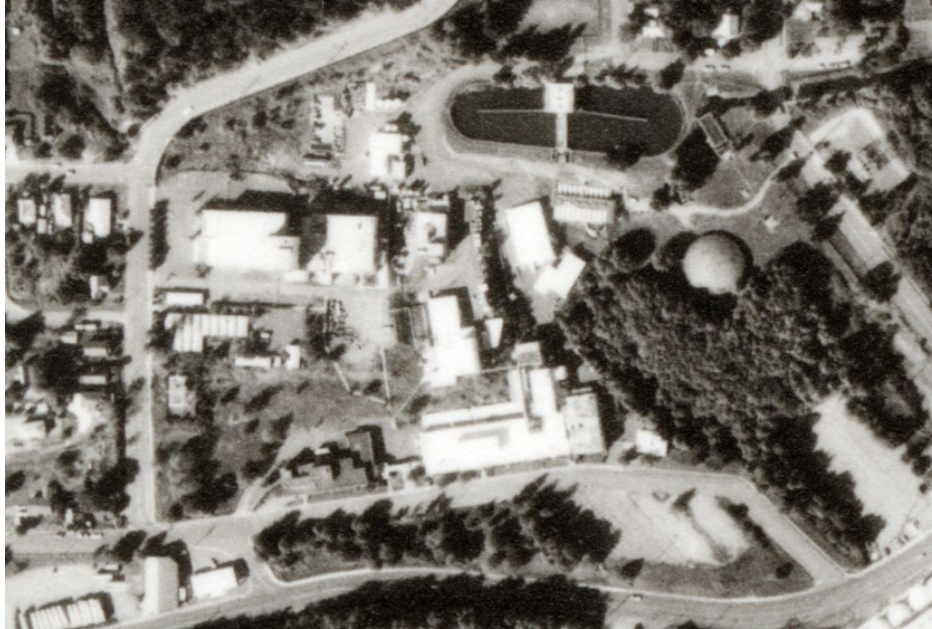
Image 12: Aerial imagery from 1985 showing the CBC, Environmental Center, Specialty Chemicals, and Non-Wovens Plant

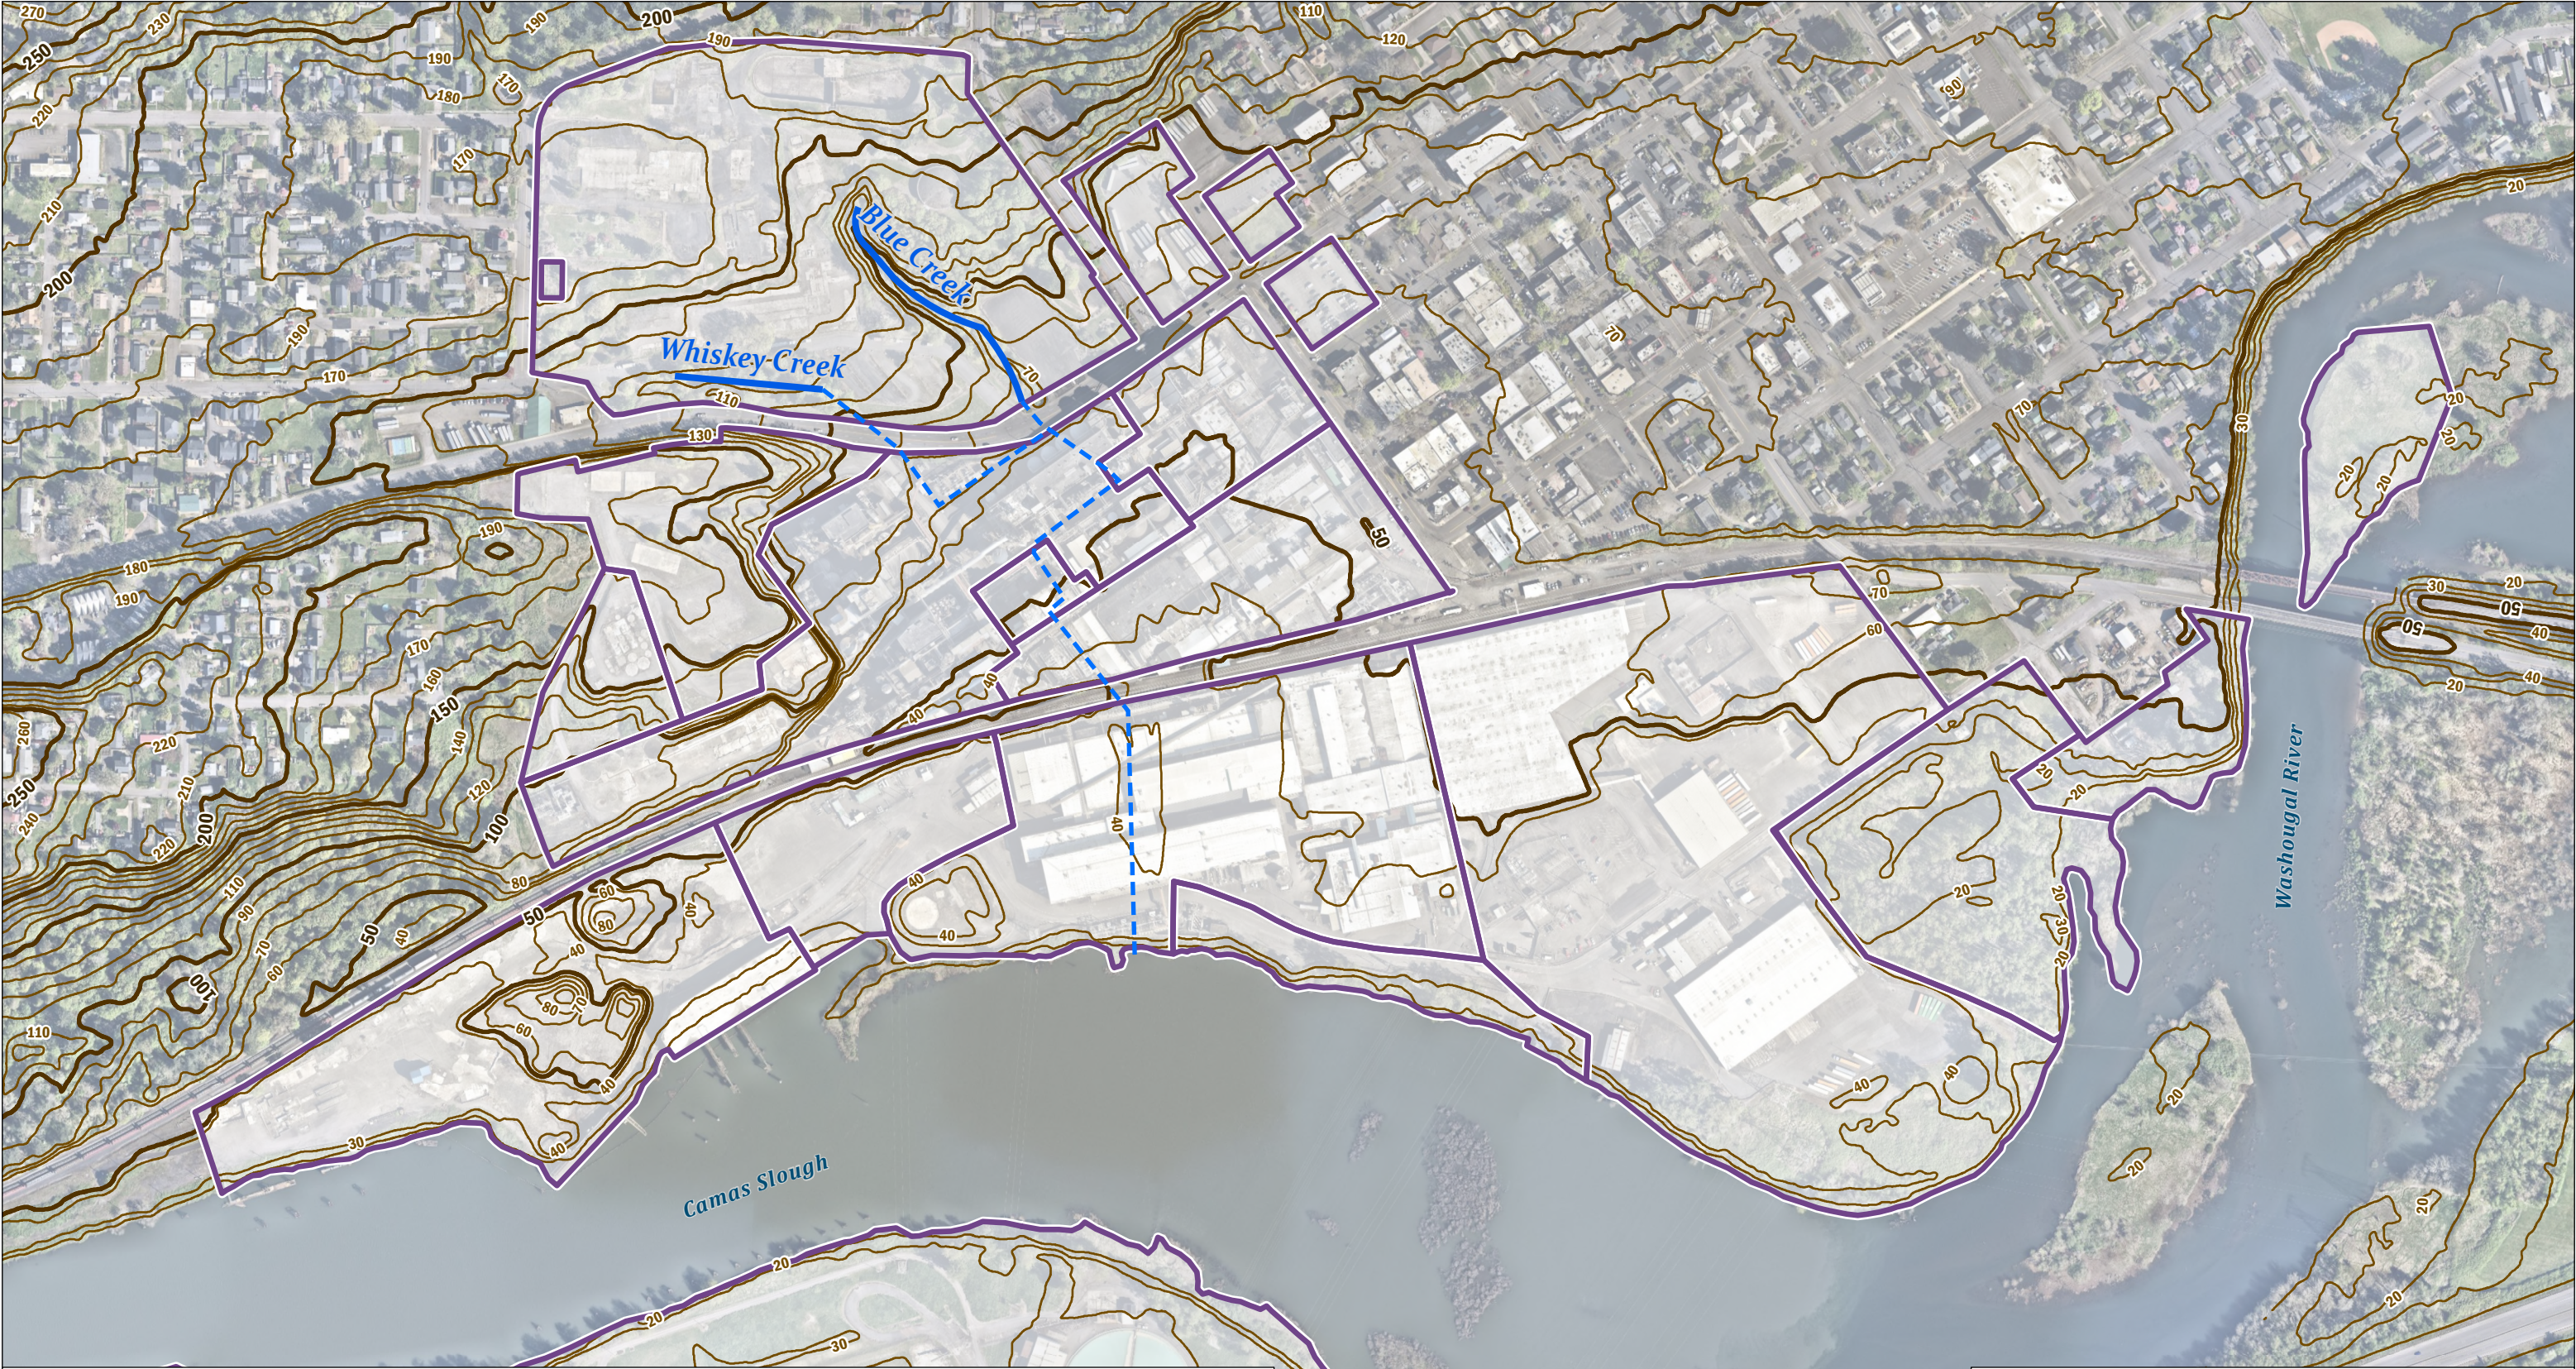
Geosyntec consultants	JUL-2025	BY: IVT / MMP	FIGURE NO. 2B
	PROJECT NO. AS130290L	REVISED BY: --- / ---

Mill Topography
Remedial Investigation Work Plan
Georgia Pacific Consumer Services
Camas, Washington

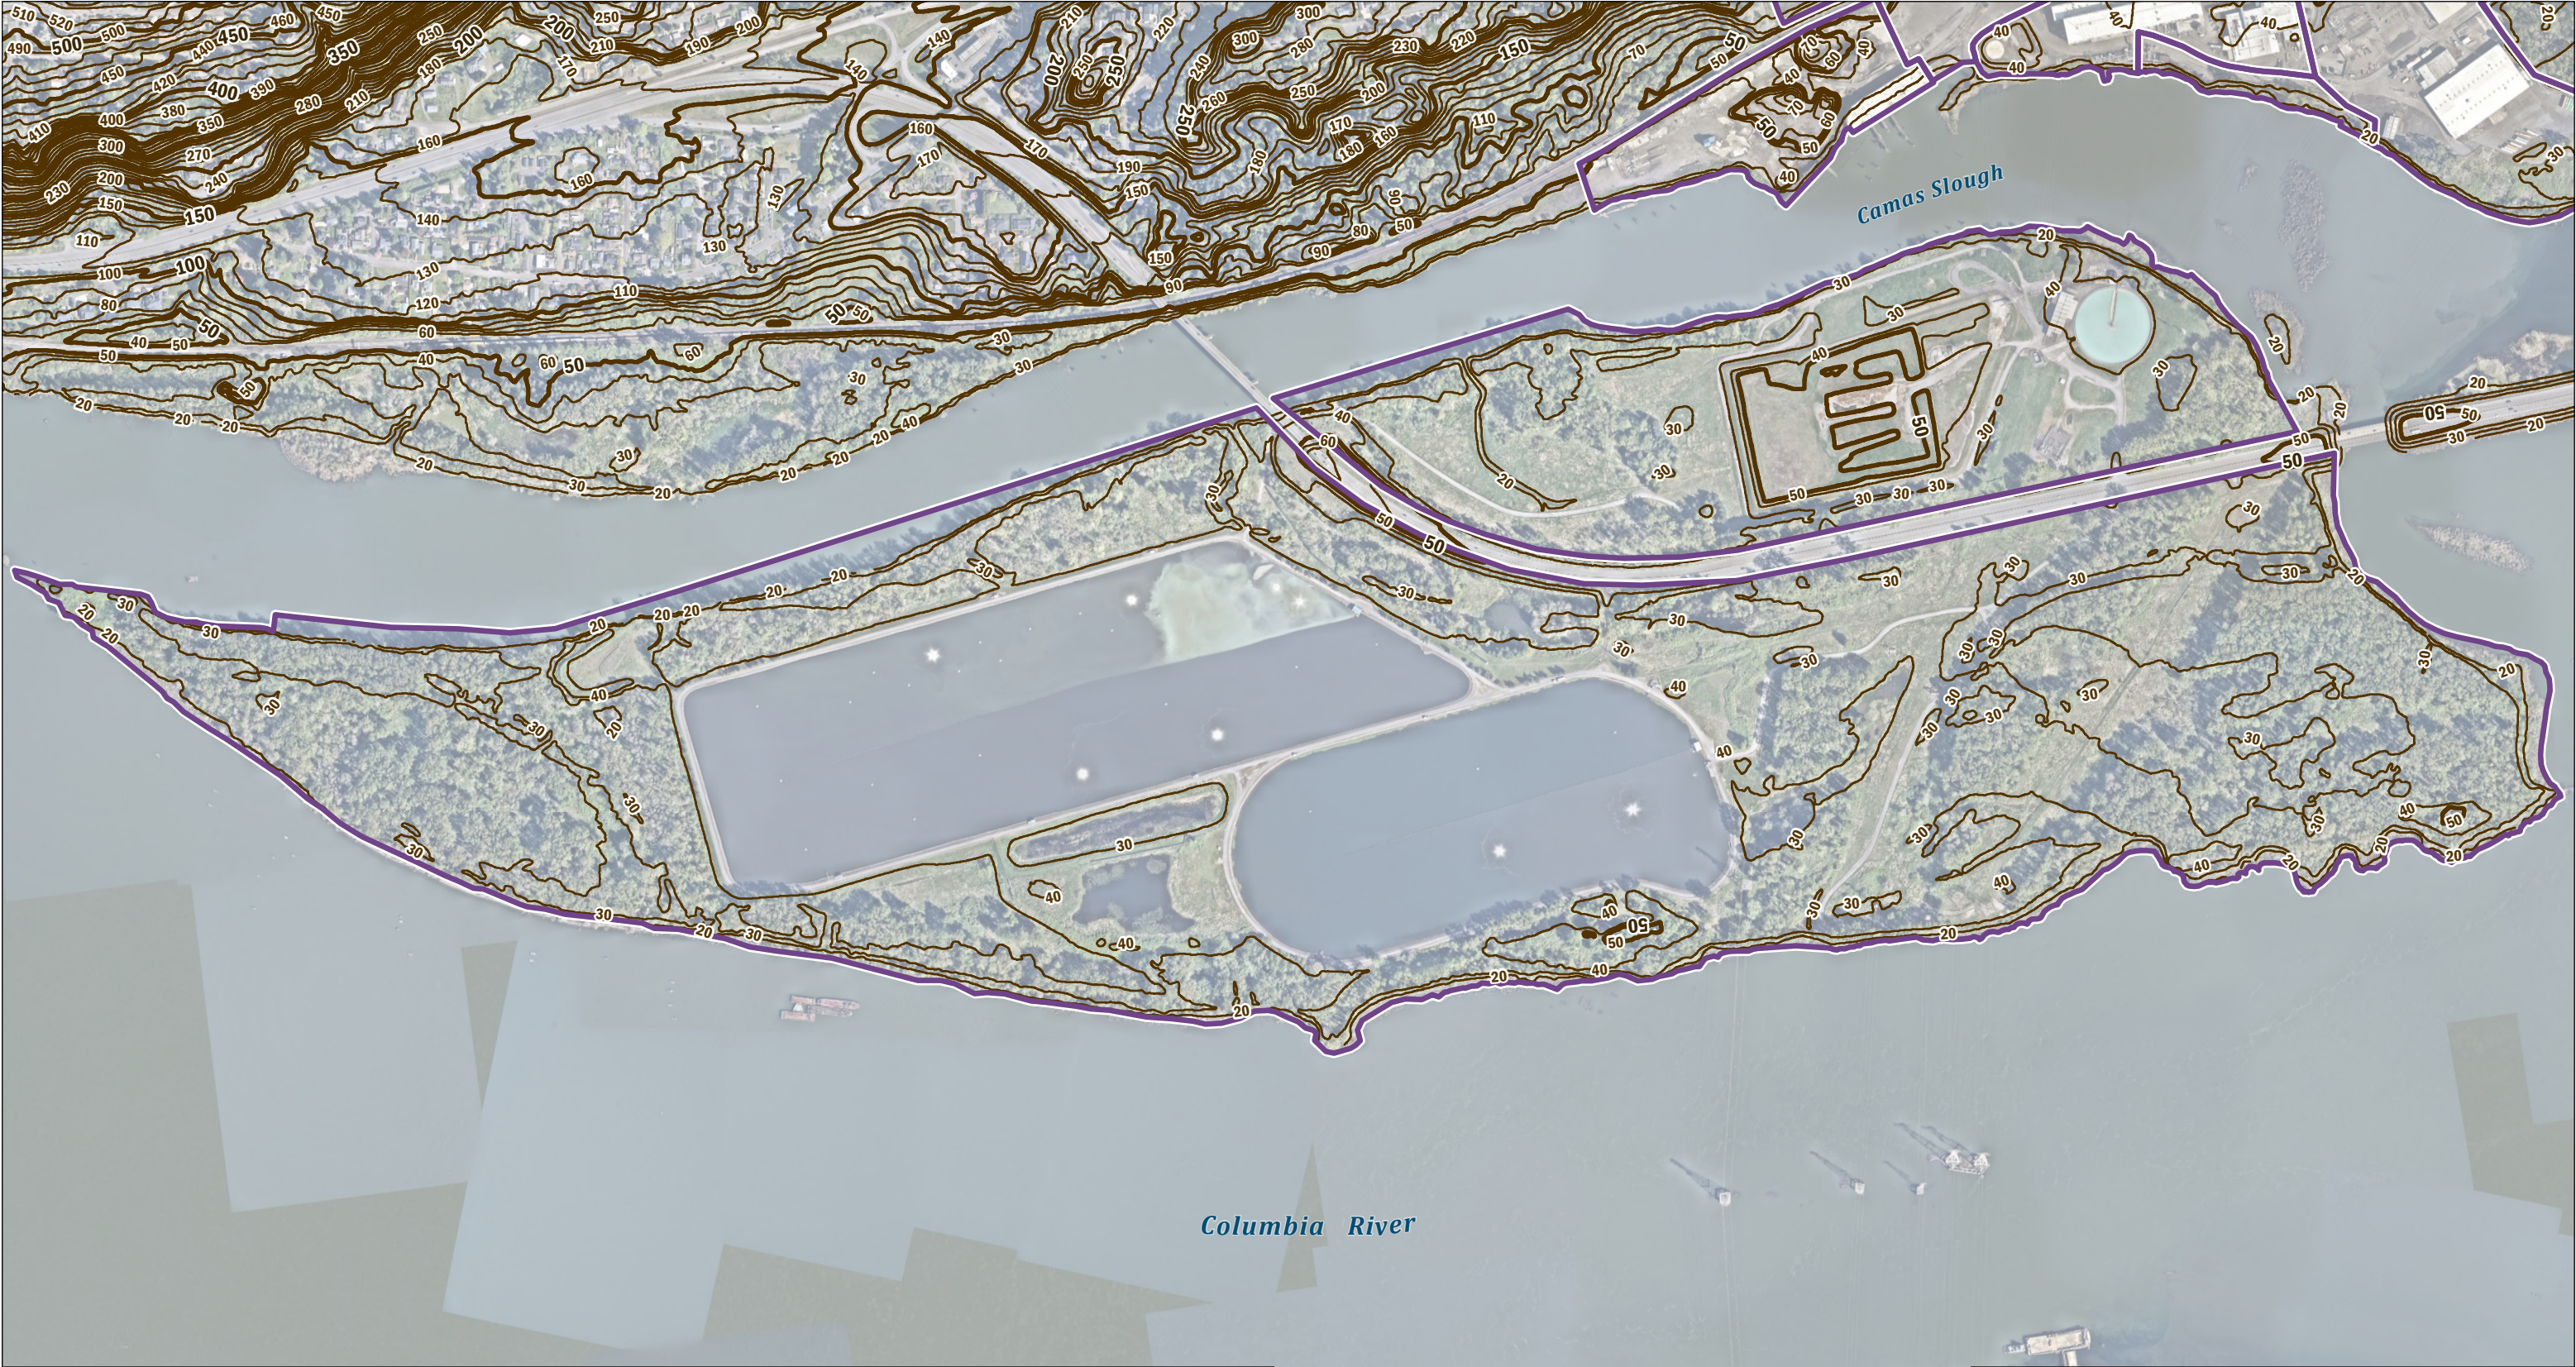
Major Contour (50ft)

Minor Contour (10ft)

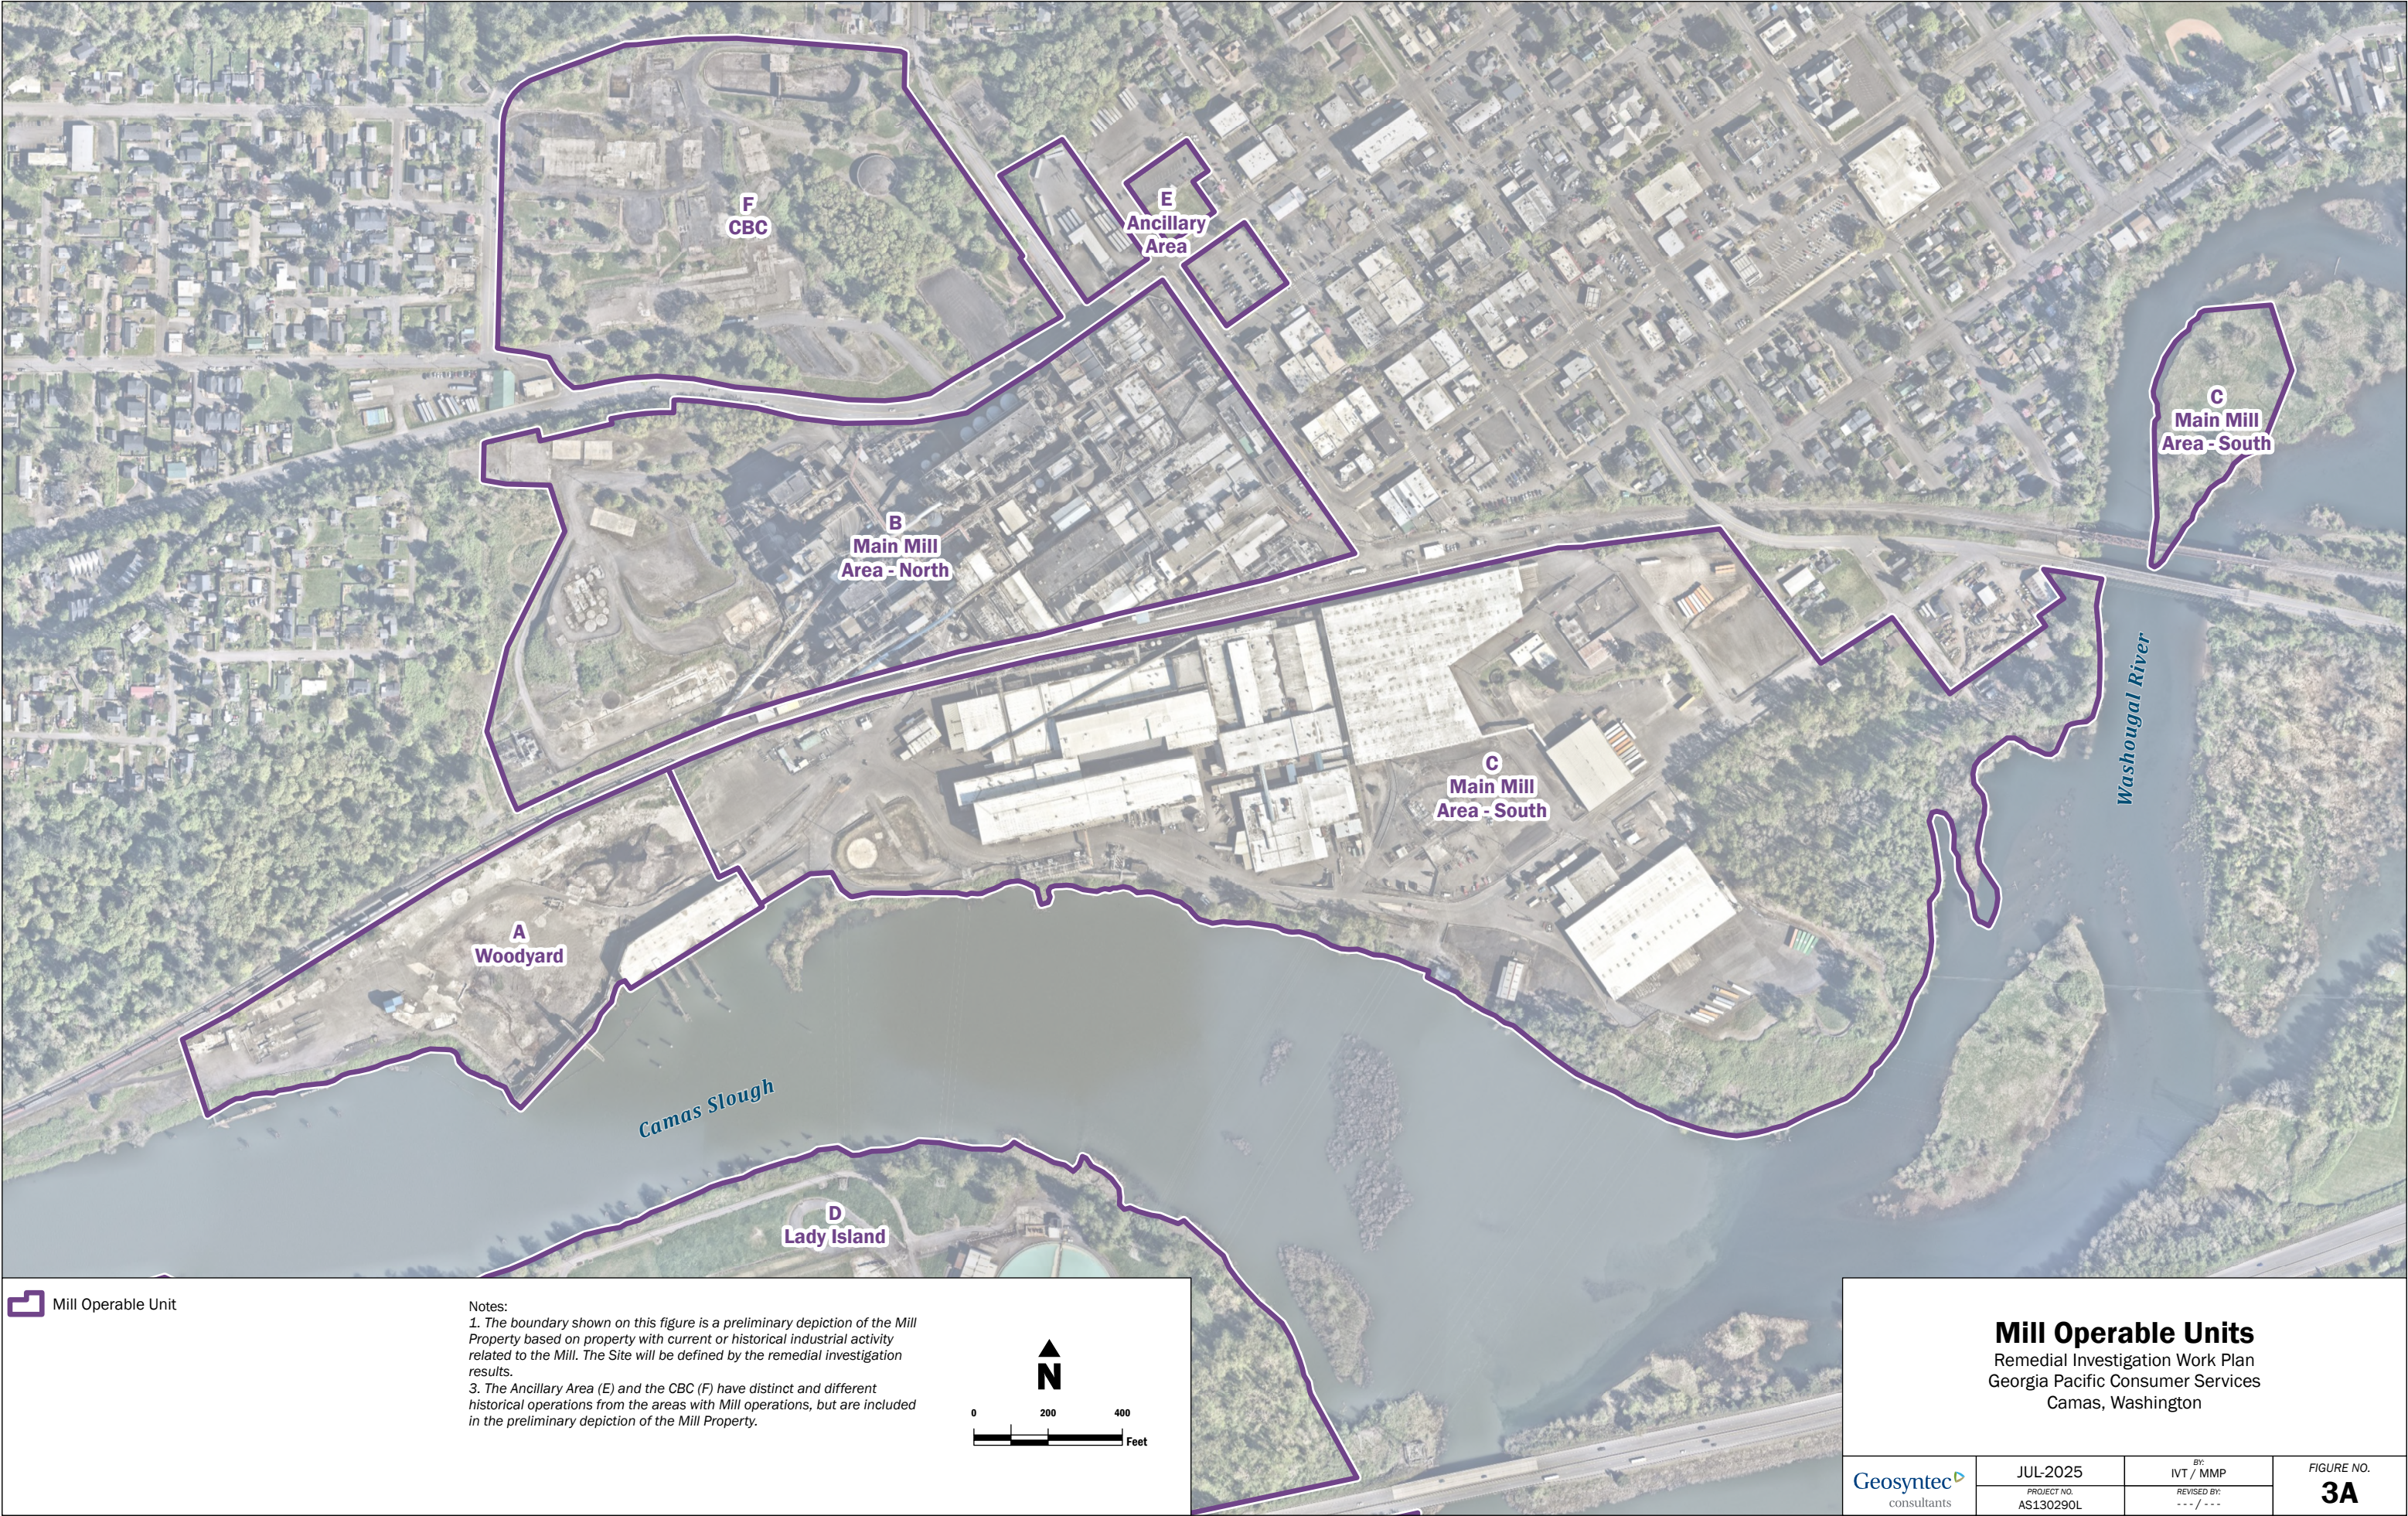
Geosyntec consultants	JUL-2025	BY: IVT / MMP	FIGURE NO. 3A
	PROJECT NO. AS130290L	REVISED BY: --- / ---

Mill Operable Units
Remedial Investigation Work Plan
Georgia Pacific Consumer Services
Camas, Washington

- Six Mill Operational Units (MOUs; Figures 3a and 3b) based on location and historical and continuing mill operations.
- Eighteen Operational Areas (OAs), distributed across the MOUs based on historical and continuing processes and operational features (see Figures 4a and 4b, which also highlight locations of currently inaccessible areas related to continuing operations).

The MOUs and OAs are shown on Figures 3a, 3b, 4a, and 4b, and listed below. Operational features of each are listed in Table 2.

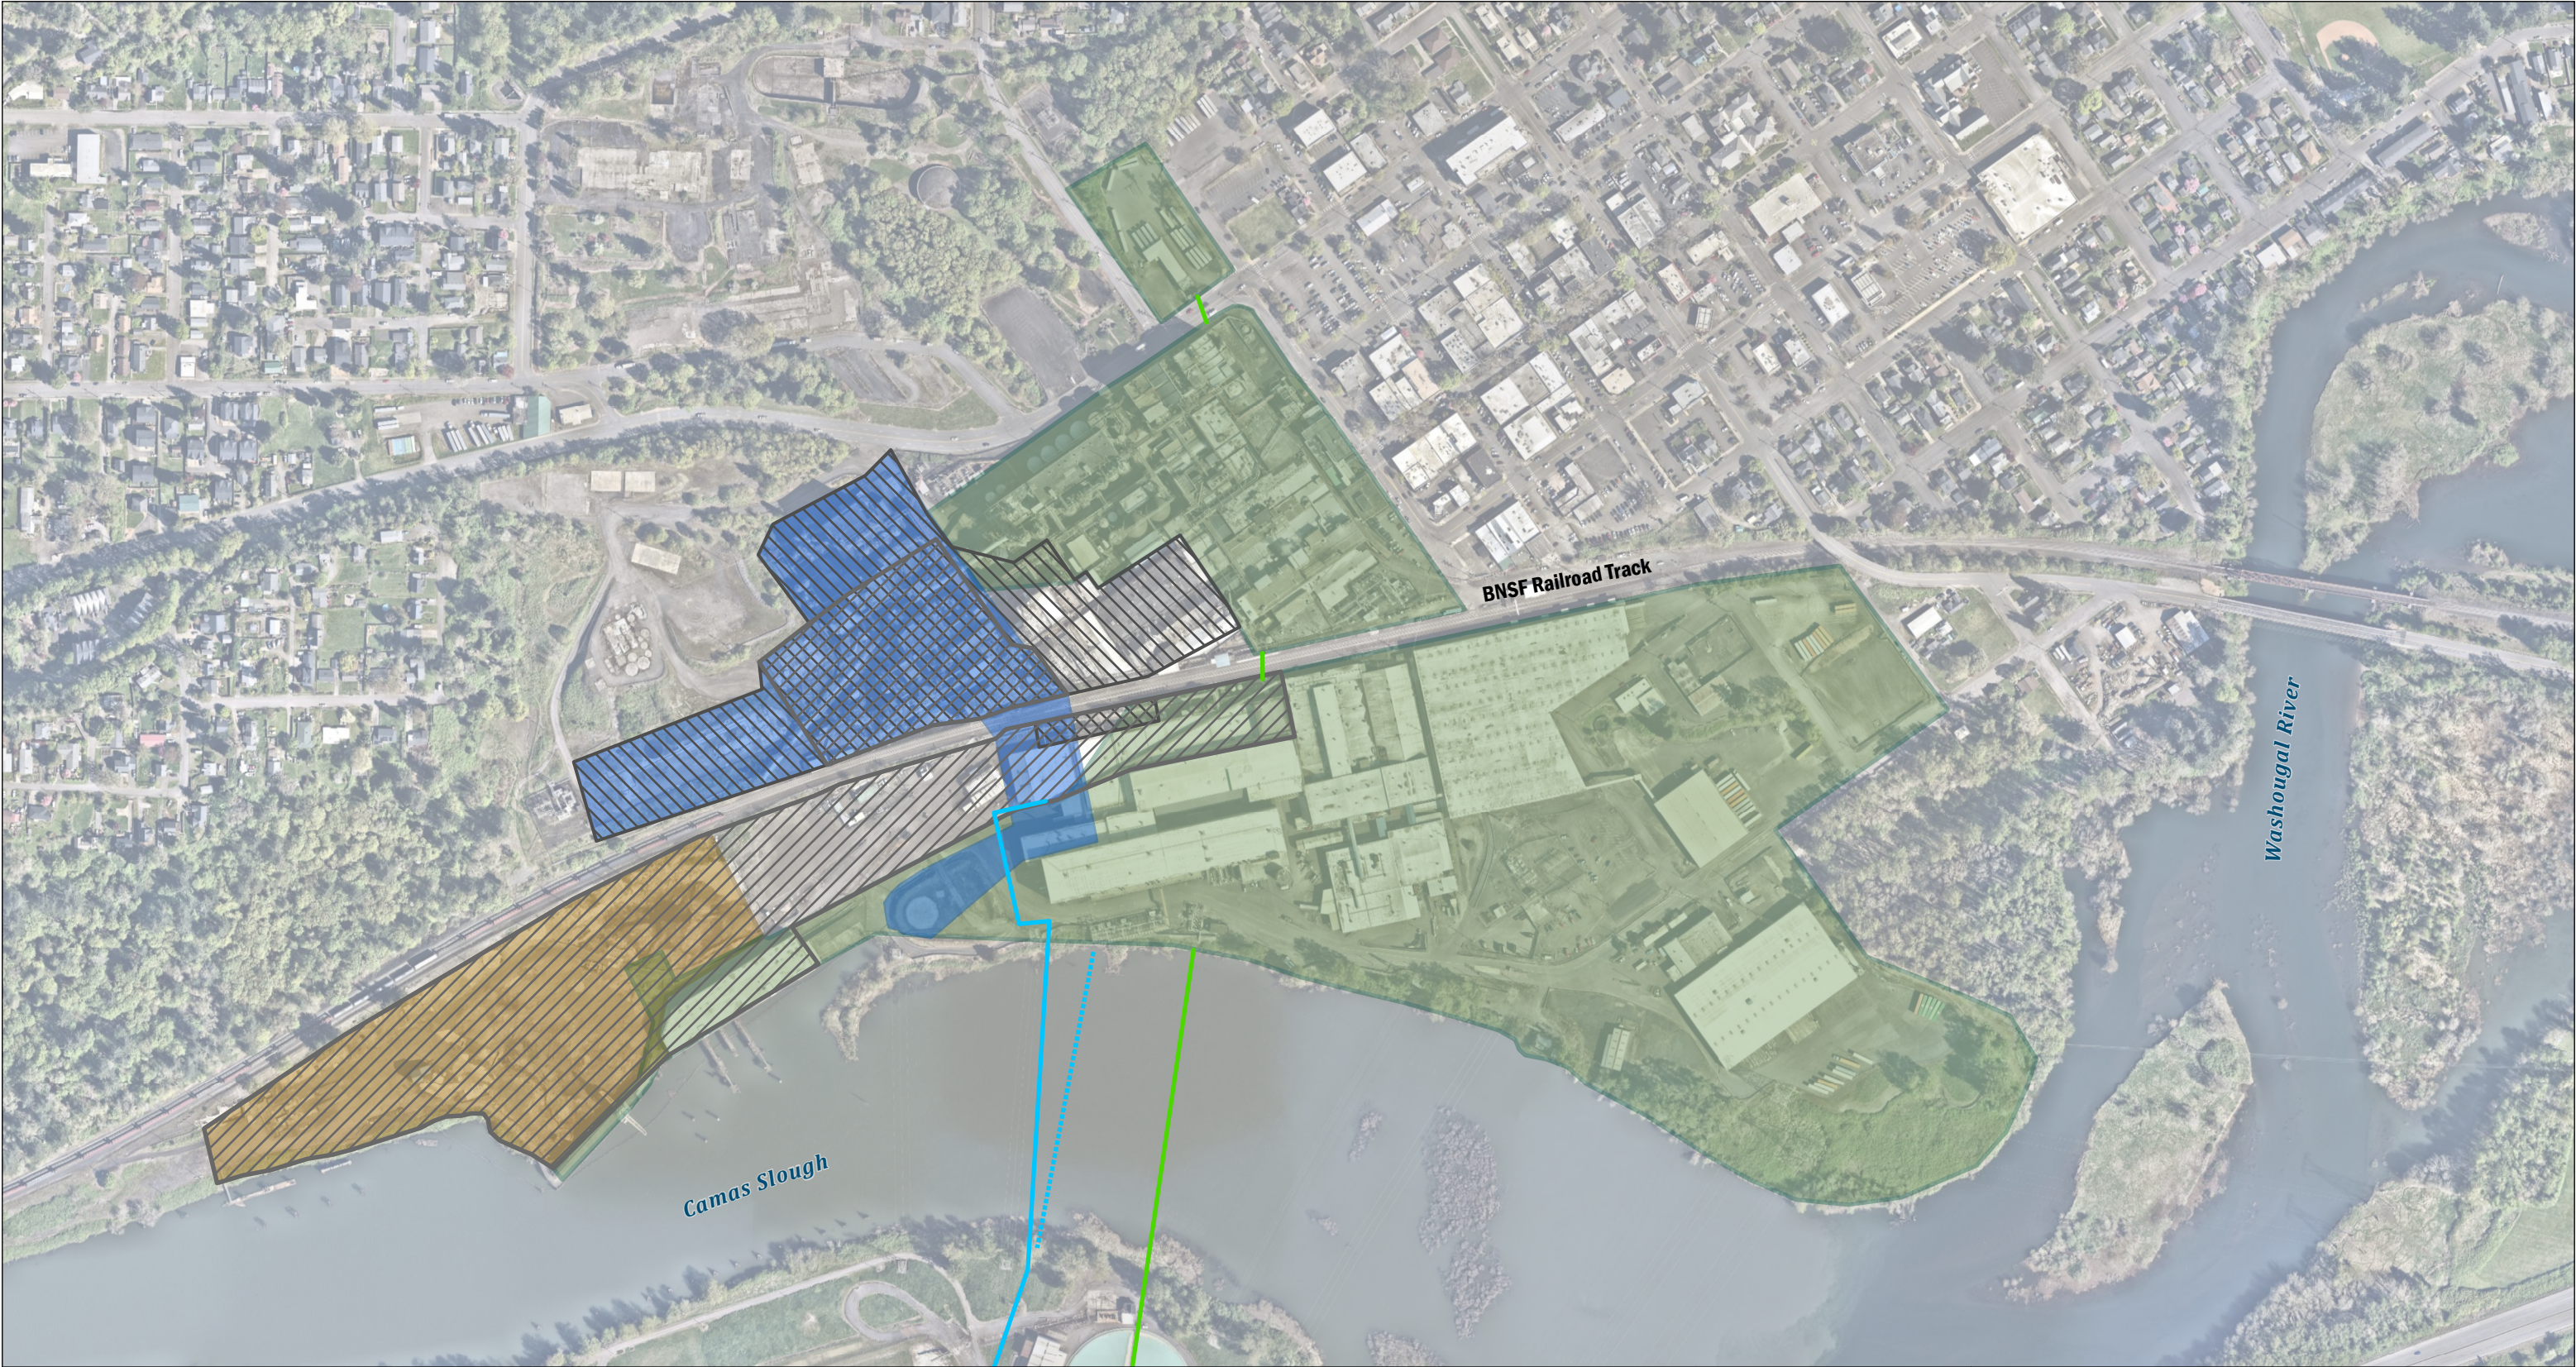
FIGURE NO.
7

- Acid Sewer Pipeline
- Acid Sewer Pipeline (abandoned)
- Process Sewer
- [Hatched] Area Served By K7 Sewer
- [Hatched] Area Served By K6 Sewer

- [Blue Box] Area Served By Fuel Oil Pipelines
- [Green Box] Area Served By Process Sewer (Directly)
- [Orange Box] Area Served By Wood Processing Collections (Grit Sump)

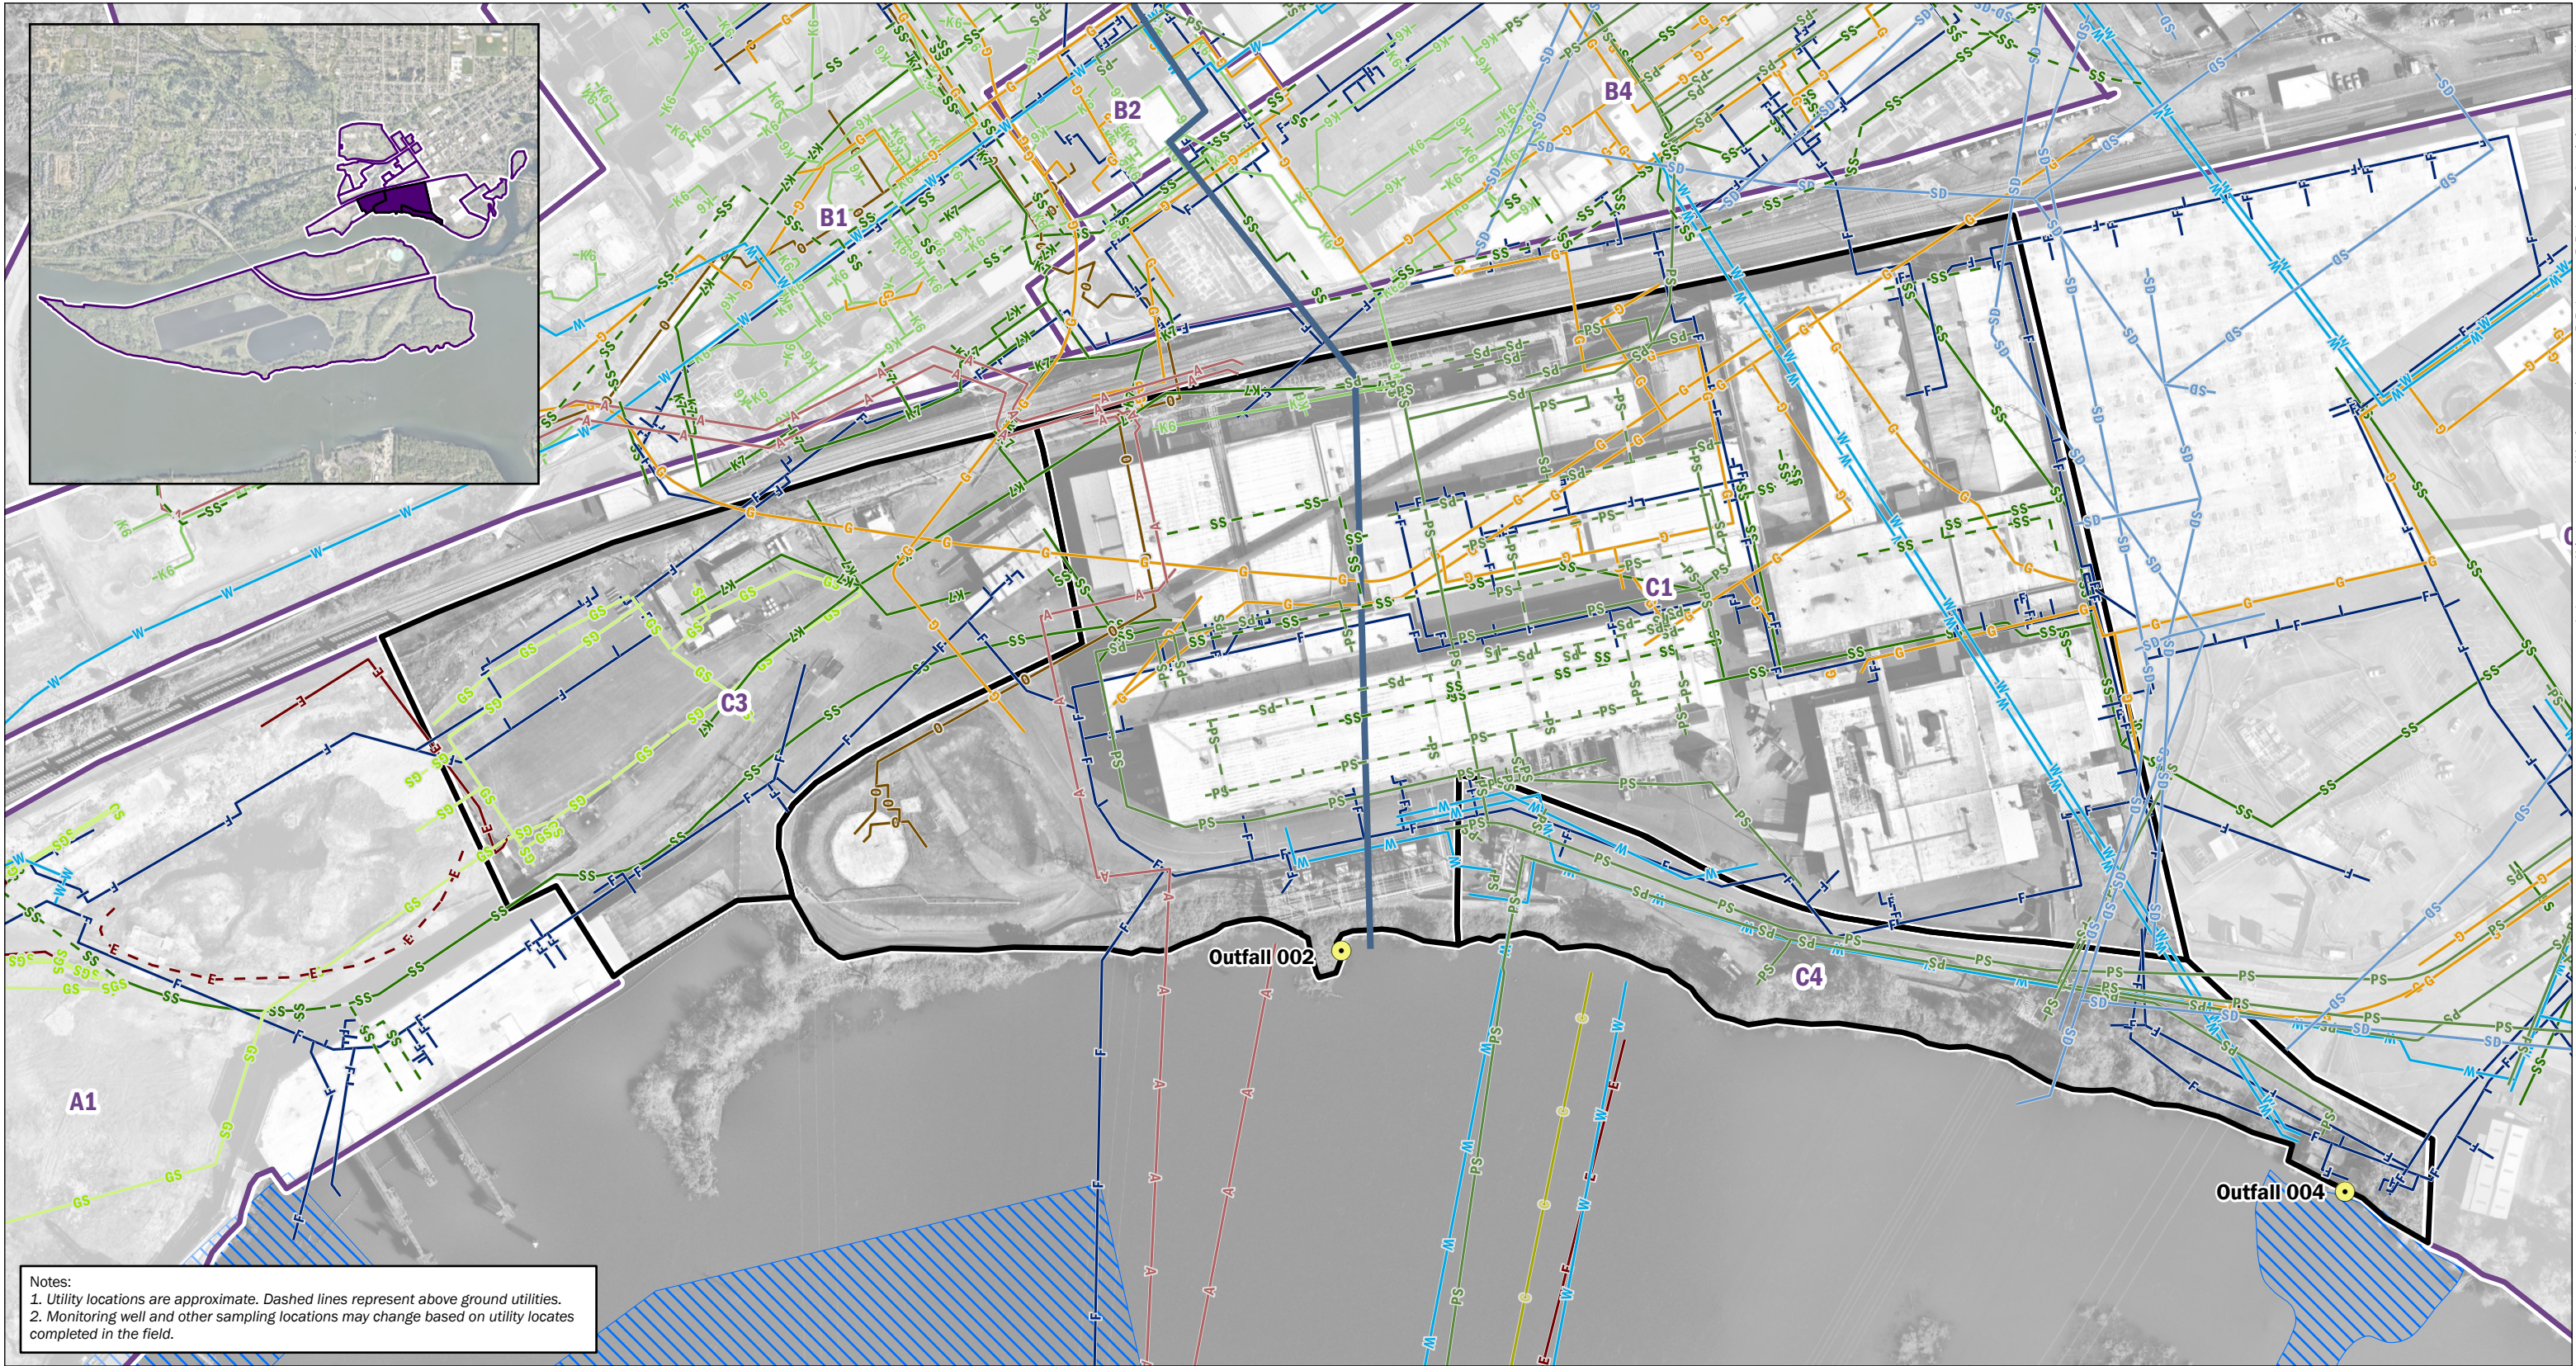
FIGURE NO.
10D

Notes:
1. Utility locations are approximate. Dashed lines represent above ground utilities.
2. Monitoring well and other sampling locations may change based on utility locates completed in the field.
