AGENCY REVIEW REVISED DRAFT REMEDIAL INVESTIGATION WORK PLAN FOR UPLAND AREAS

Georgia-Pacific Consumer Products, Camas, Washington

Project: AS130290L

4 August 2025

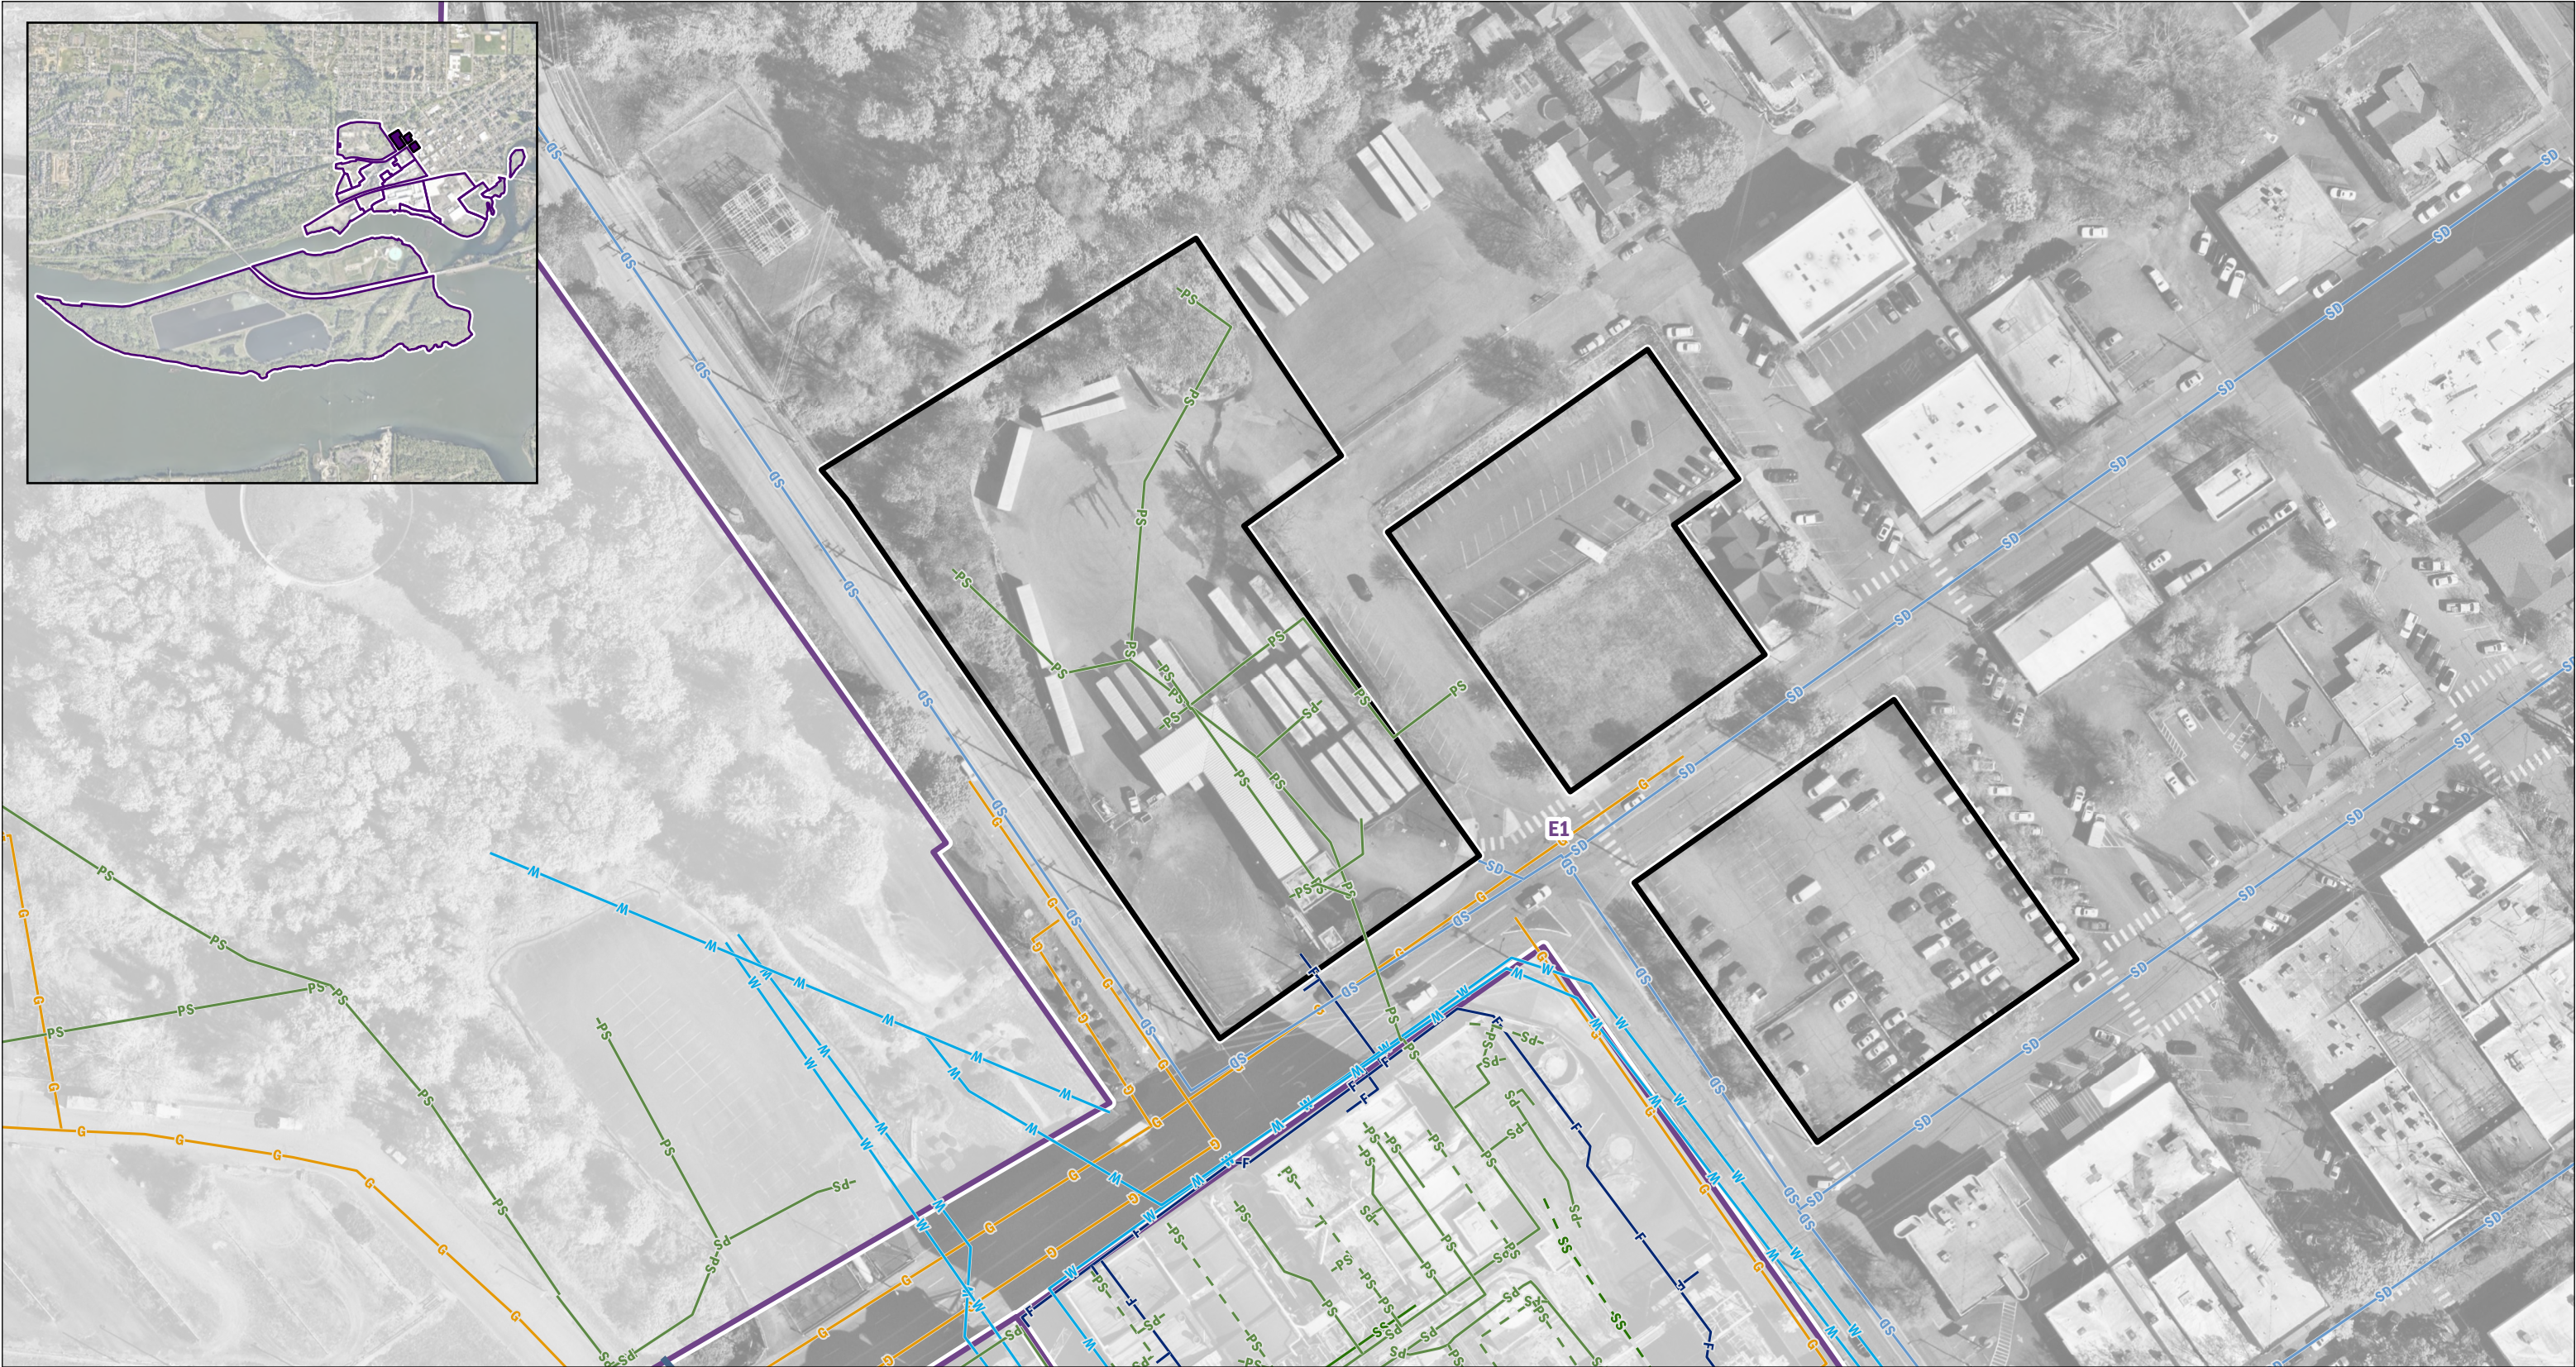
Geosyntec consultants	JUL-2025	BY: IVT / MMP	FIGURE NO. 10H
	PROJECT NO. AS130290L	REVISED BY: --- / ---

Utility Map, Lady Island
Remedial Investigation Work Plan
Georgia Pacific Consumer Services
Camas, Washington

Utilities
Sewer
-SS- Sanitary Sewer
-PS- Process Sewer
Water
-F- Fire Main
-W- Water

Other
-G- Communication Cable
-G- Natural Gas
-SD- Storm Drain
Blue Creek
