# Temple Distributing Carson Oil

SHARP Report — Part 1 of 2

808 South Columbus Avenue, Goldendale, Klickitat County, 98620

Temple Distributing Interim Action Report

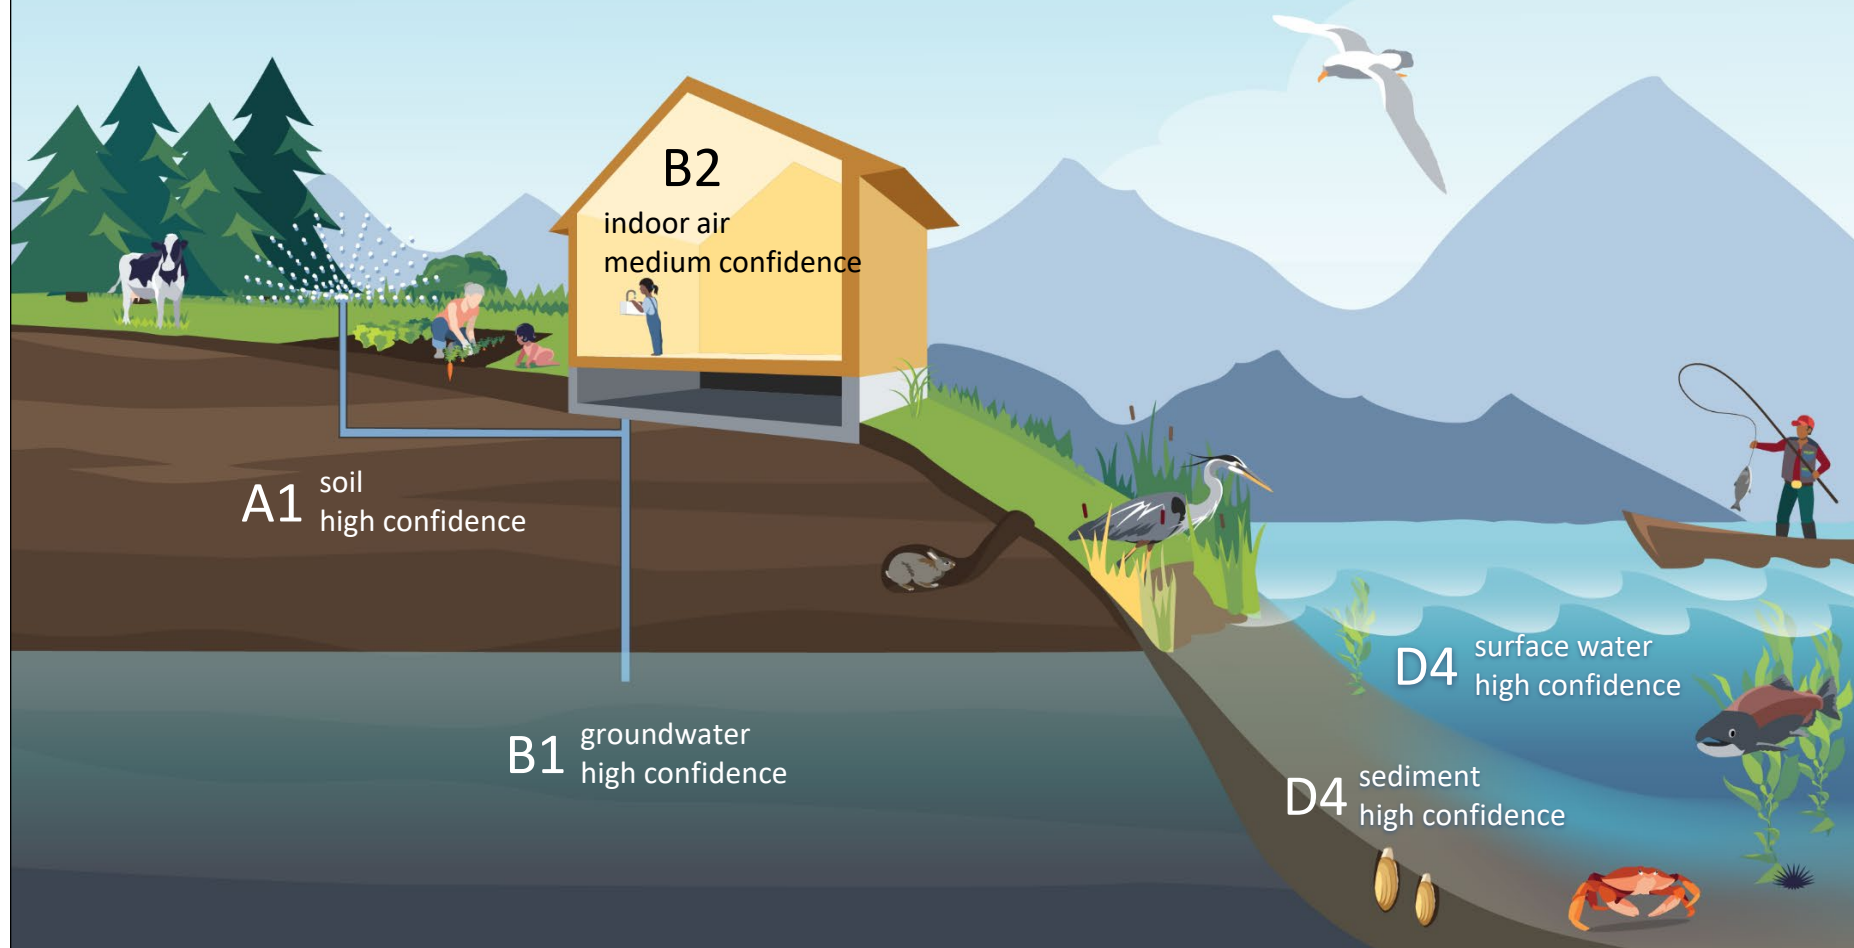
Conceptual site model

| Source/source area description |
|---|
| In 2012, a fuel spill overflow from an above ground storage tank released approximately 970 gallons of gasoline into a gravel area beneath the above ground storage tank. Site soils and groundwater were impacted by this release that resulted in soil and groundwater concentrations exceeding MTCA cleanup levels. Constituents of concern include gasoline, diesel, lube oil, benzene, toluene, ethylbenzene, total xylenes, naphthalene and other petroleum additives. |

## Site history

Site was used as a bulk petroleum fuel distributing site from the 1920s to 2011. Shortly after the release, the site ceased operating as a bulk fuel distributor. It is currently a vacant lot with a small shed on the property.
