## **DRAFT Periodic Review Sauros Cleanerama Tacoma**

**1401 S Pacific Ave, Tacoma, Pierce County, WA 98402  
Facility Site ID: 4339824, Cleanup Site ID: 3310**

**Toxics Cleanup Program, Southwest Region**

March 2026

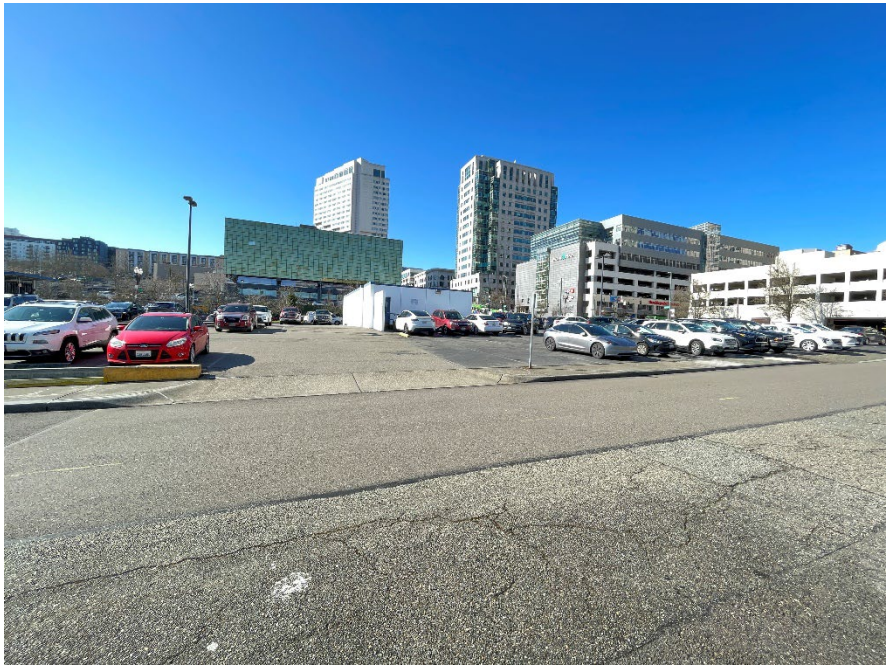
**Photo: 4**

**Direction:**  
Southwest

**Description:**  
View of the building located on the former Budget property. The building is used for storage.

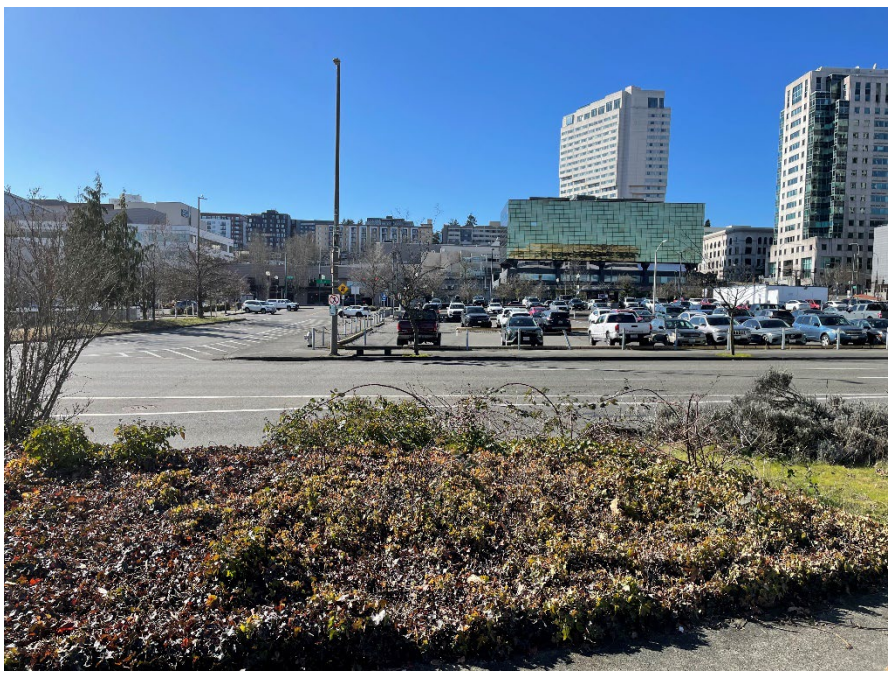
**Photo: 7**

**Direction:**  
Northwest

**Description:**  
View of the intersection of Court A and S 14<sup>th</sup> Street. The former Budget and USPS properties are visible.

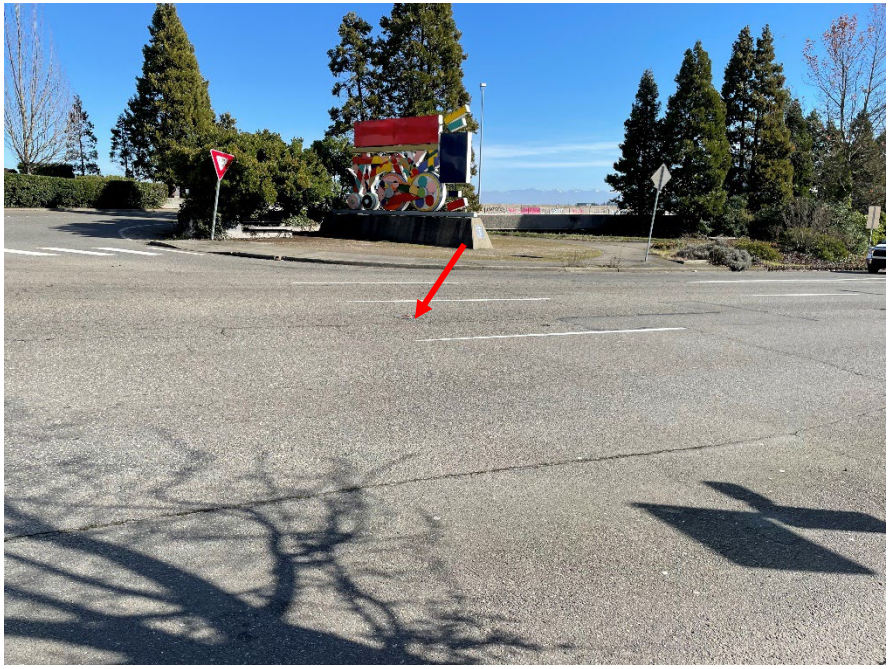
**Photo: 10**

**Direction:**  
West

**Description:**  
View of monitoring well LAI-MW2 along the I-705 ramp.

- All monitoring wells at the Site, including those that are not currently sampled, should be inspected annually during each sampling event to ensure the wells are maintained in good condition if they are needed for future sampling efforts.

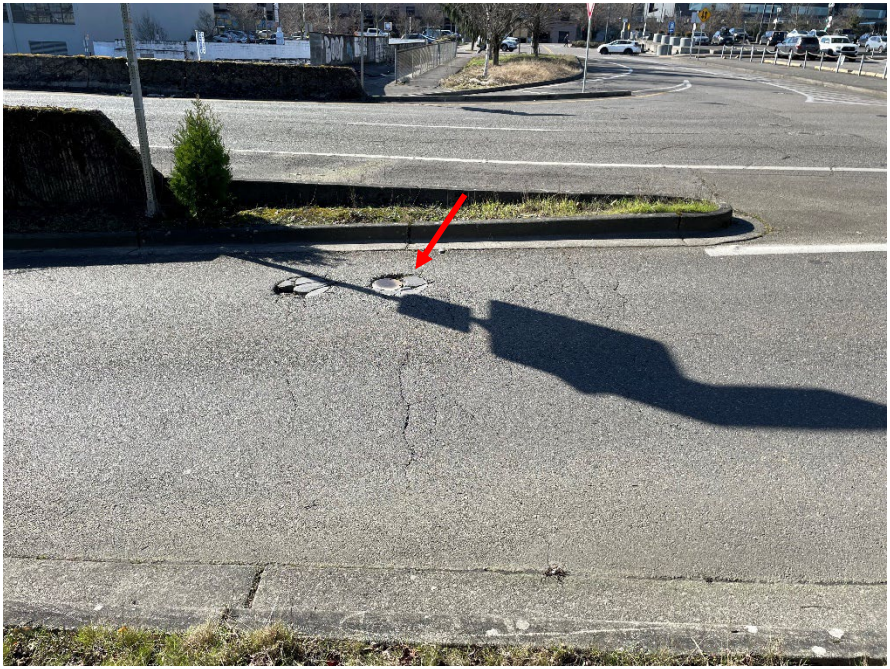
<b>Photo: 11</b>	
<b>Direction:</b> Not applicable (NA)	
<b>Description:</b> View of monitoring well LAI-MW3 within City Park.

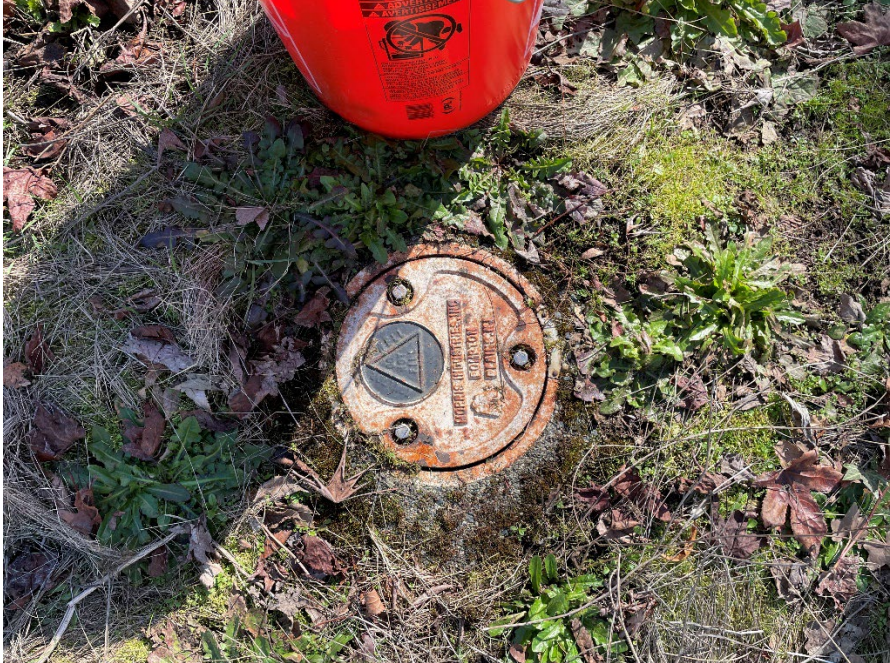
<b>Photo: 12</b>	
<b>Direction:</b> West	
<b>Description:</b> View of monitoring well LAI-MW4 located within Dock Street.

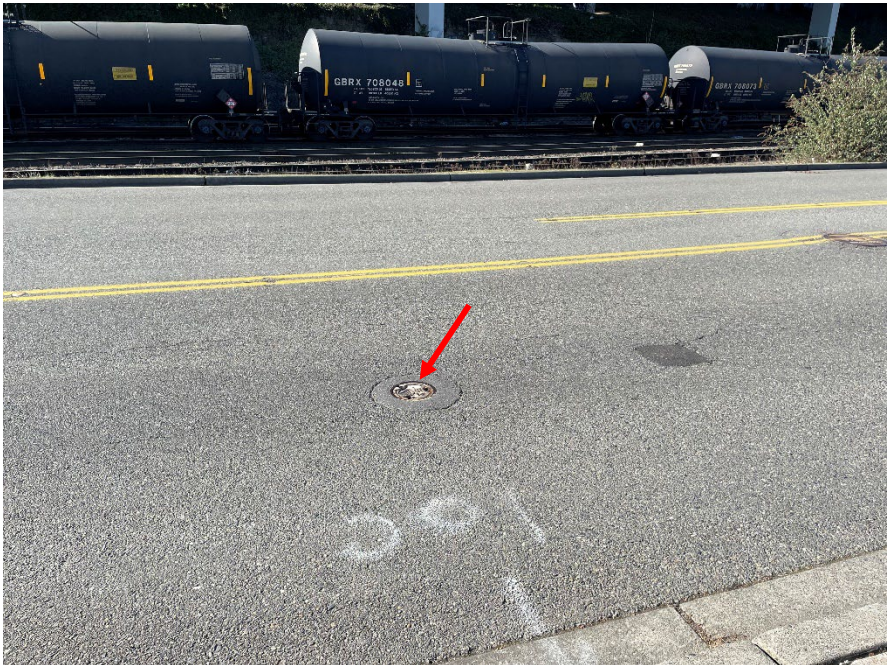
<b>Photo: 13</b>	 
<b>Direction:</b> NA	
<b>Description:</b> View of monitoring well LAI-MW5 located directly north of the former Sauro's property near the intersection of S 14 <sup>th</sup> Street and Court A.

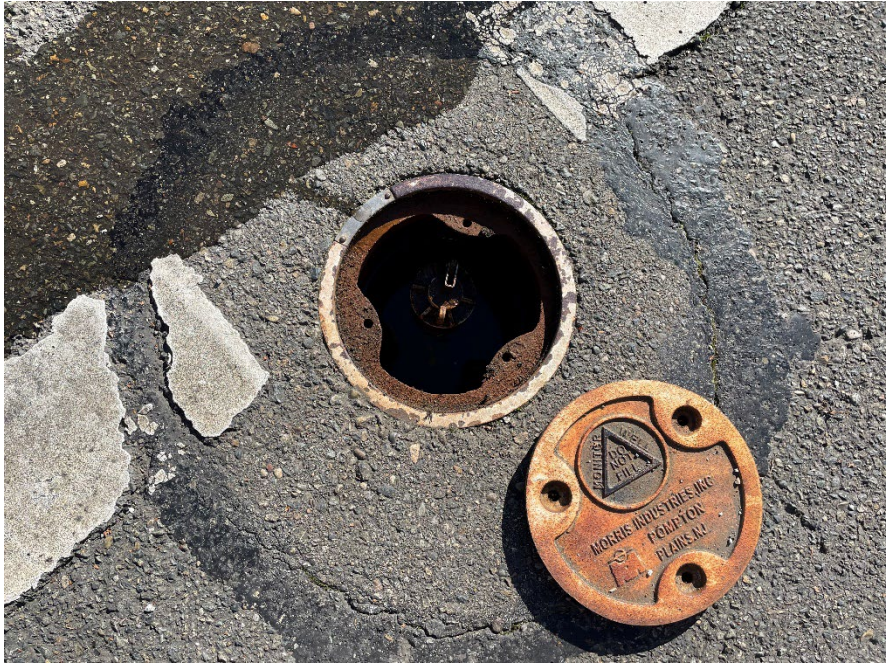
**Photo: 16**

**Direction:**  
NA

**Description:**  
View of monitoring well RNS-MW2 located along Court A across the street from monitoring well MW-2.

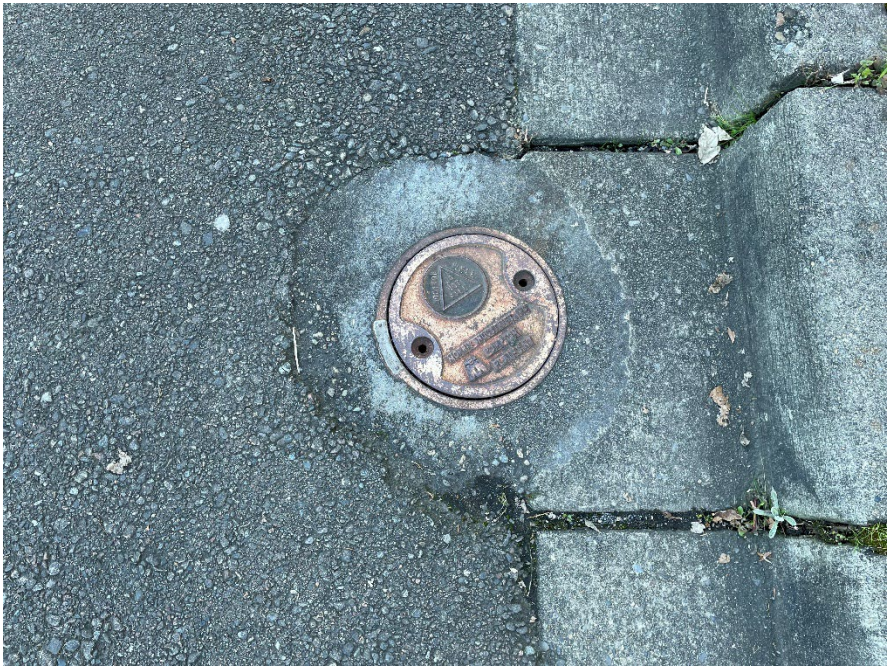
<b>Photo: 17</b>	 
<b>Direction:</b> NA	
<b>Description:</b> View of monitoring well RNS-MW6 located along S 14 <sup>th</sup> Street.
