PERIODIC REVIEW

PENINSULA LIGHT COMPANY
4021 Harborview Drive Northwest
Gig Harbor, WA 98332

Prepared by
Washington State Department of Ecology
Southwest Regional Office
Toxics Cleanup Program
Lacey, Washington

May 2013

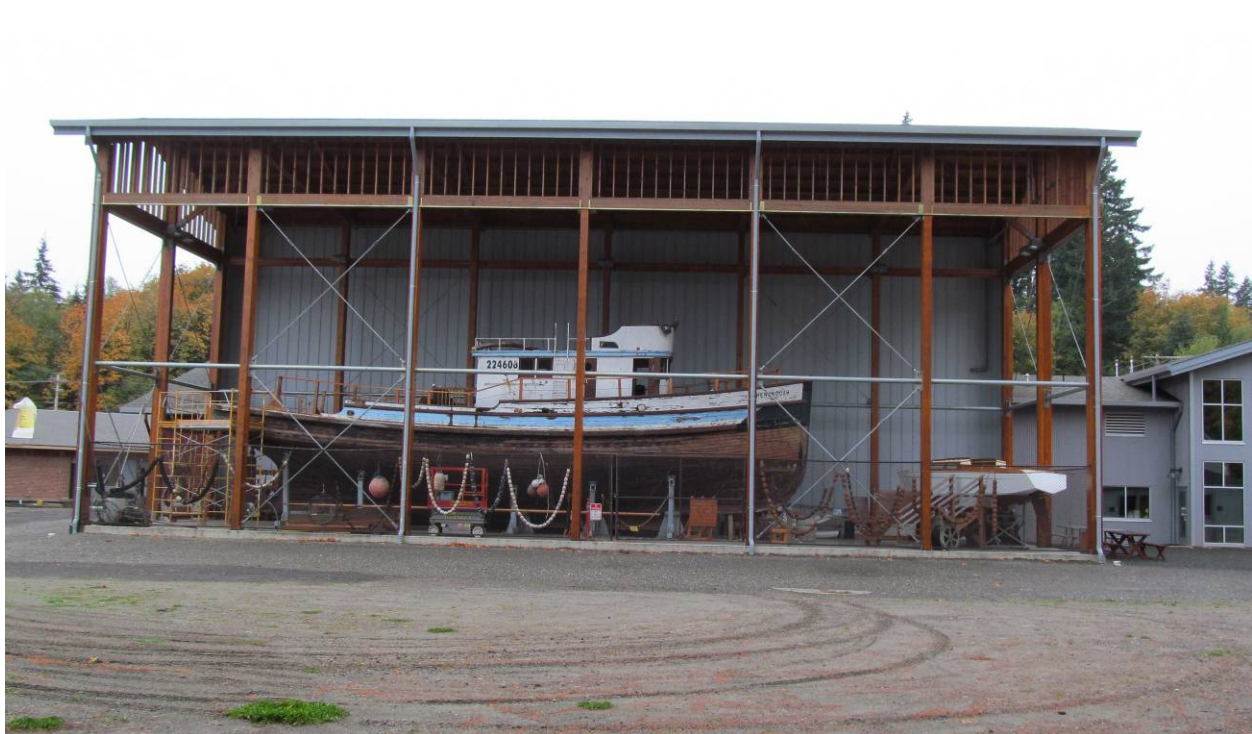
Based upon the Site visit conducted on February 5, 2013, the surface covers appear in excellent condition in the paved portions of the Site. The north end of the Site remains covered in compacted gravel.

Photo 2: North Gravel Parking Lot and Boat Storage Area – from the north

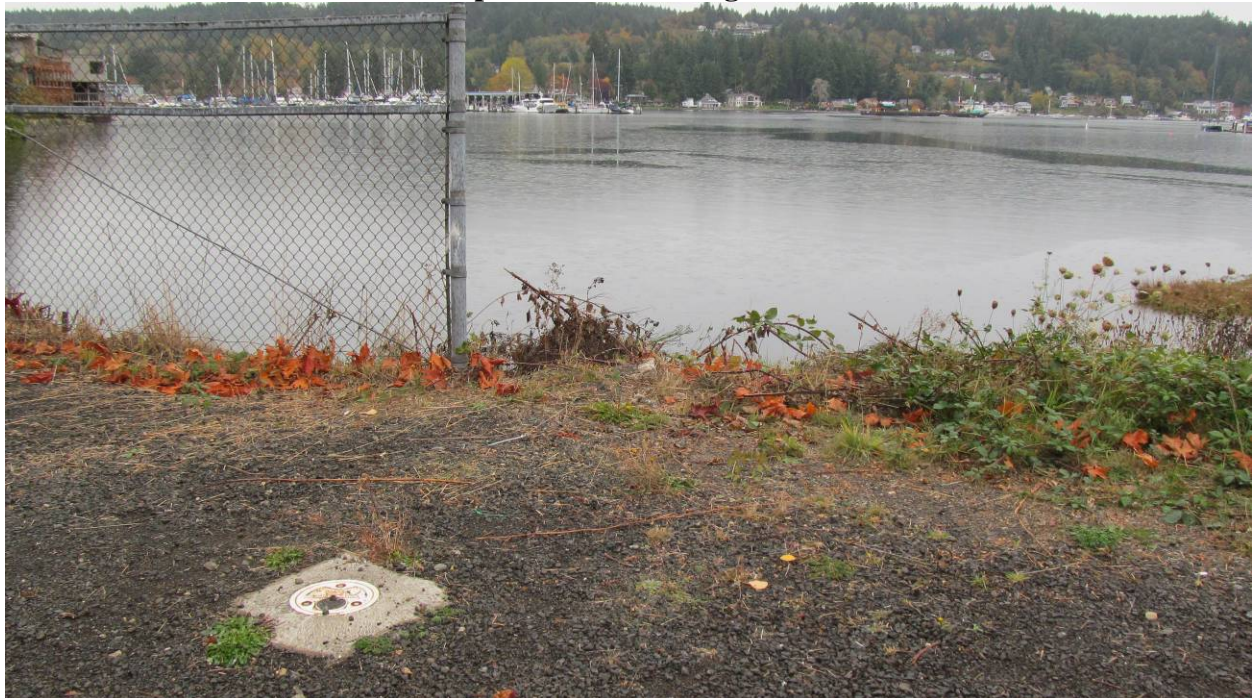
During the Site visit, there was no evidence of new routes of exposure to contaminated groundwater at the Site. All groundwater monitoring wells appeared secured and no repair, maintenance or contingency actions have been required. A photo log is available as Appendix 6.5..

Photo 4: Conditional Point of Compliance Wells along Waterfront – from the west
