**INTERIM ACTION REPORT
ORONDO ELEMENTARY SCHOOL
ORONDO, WASHINGTON**

September 20, 2007

**Prepared by Washington State Department of Ecology
Toxics Cleanup Program
Jeff Newschwander (509) 454-7842**

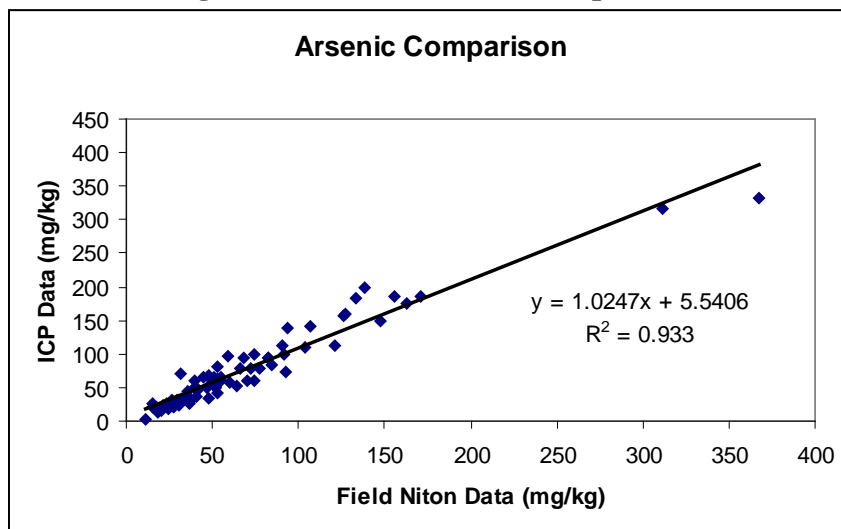
Figure B-1: 2002 Arsenic Comparison

The use of portable XRF units for the determination of soil elemental concentrations has been described by EPA Method 6200 and has been found to provide, “a rapid field screening procedure” for site characterization [US EPA]. Results from the study conducted by Ecology in 2002 (as shown in the graphs below) found that a portable Niton XRF had a correlation coefficient (r^2 value) between field and Inductively-Coupled Plasma (ICP) laboratory analyses of 0.8057 for lead and 0.933 for arsenic. In addition, a verification study conducted by the EPA Superfund Innovative Technology Evaluation (SITE) Monitoring and Measurement Technology (MMT) Program provides additional support for the use of this technology. The investigation compared an Innov-x XRF model, similar to the one used by Ecology, with reference laboratory data and showed a correlation coefficient of 0.8762 for arsenic and 0.91 for lead [US EPA]. All of this data shows that an XRF can be an effective tool for characterizing large contamination sites.

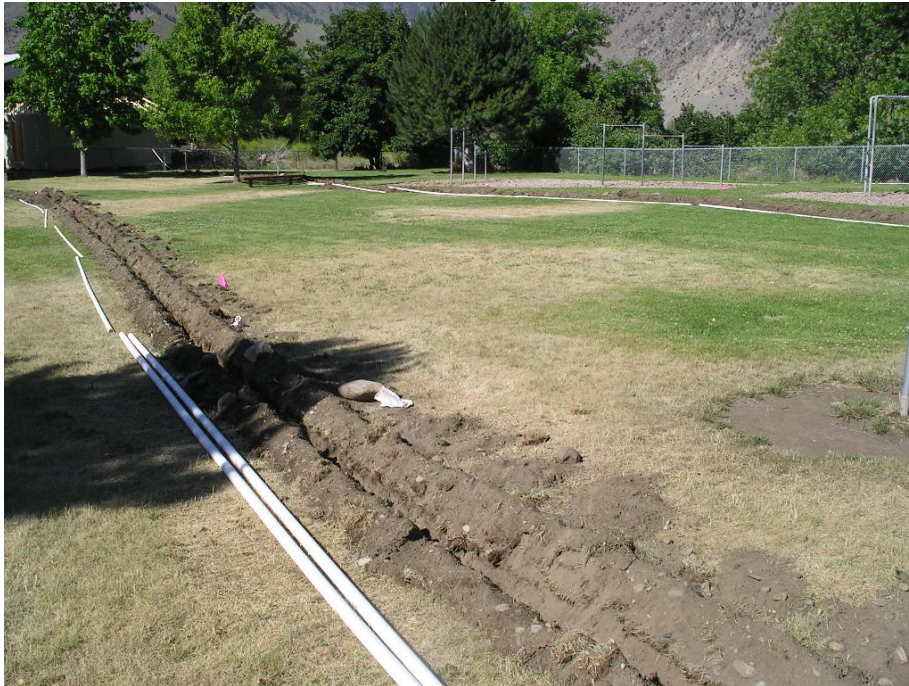
Photo D-1: Orondo Elementary School Pre-Remediation

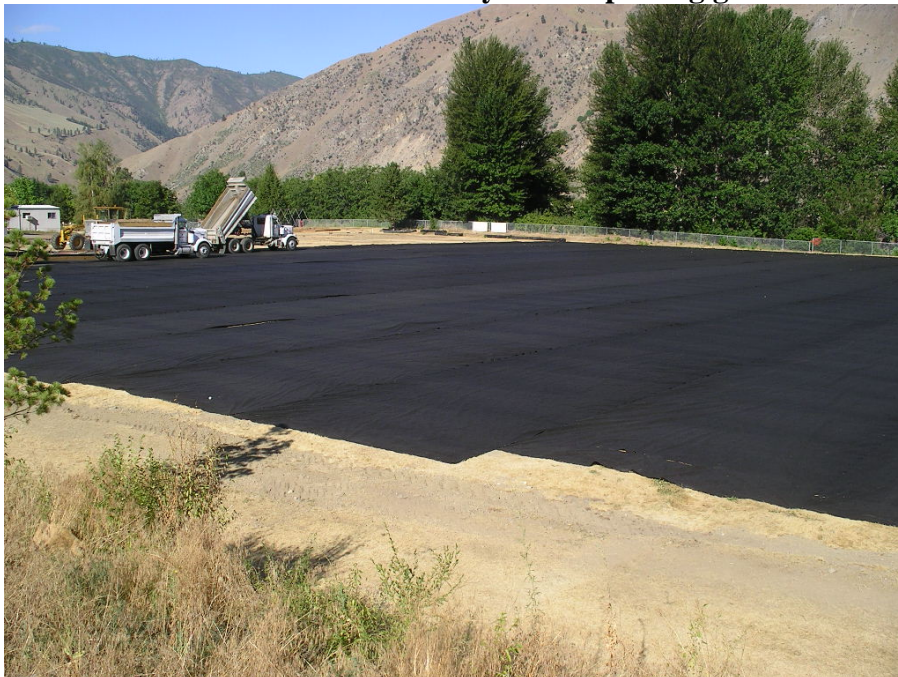
Photo D-2: Orondo Elementary School placing geotextile

The remedial process was very simple. A geotextile membrane was used to cover the existing soil surface. The membrane was placed in rolls that were 15 feet wide and they were overlapped a minimum of 12 inches. It was secured with 6 inch long landscaping staples. The fabric was then covered with clean topsoil imported from a local source. The imported topsoil was tested for the presence of lead and arsenic prior to import. Neither lead nor arsenic were detected above background concentrations in 10 samples taken from the import topsoil. Approximately 8000 tons of topsoil were imported onsite. Following topsoil import, 45,000 square feet of the Site was covered in sod and the remainder was hydroseeded.

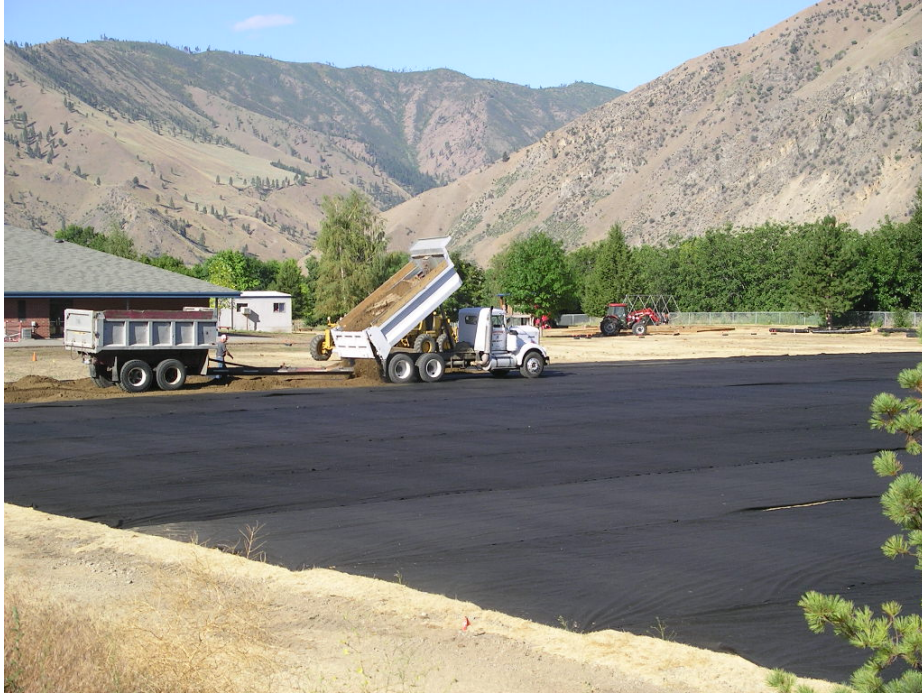
Photo D-3: Orondo Elementary School placing topsoil

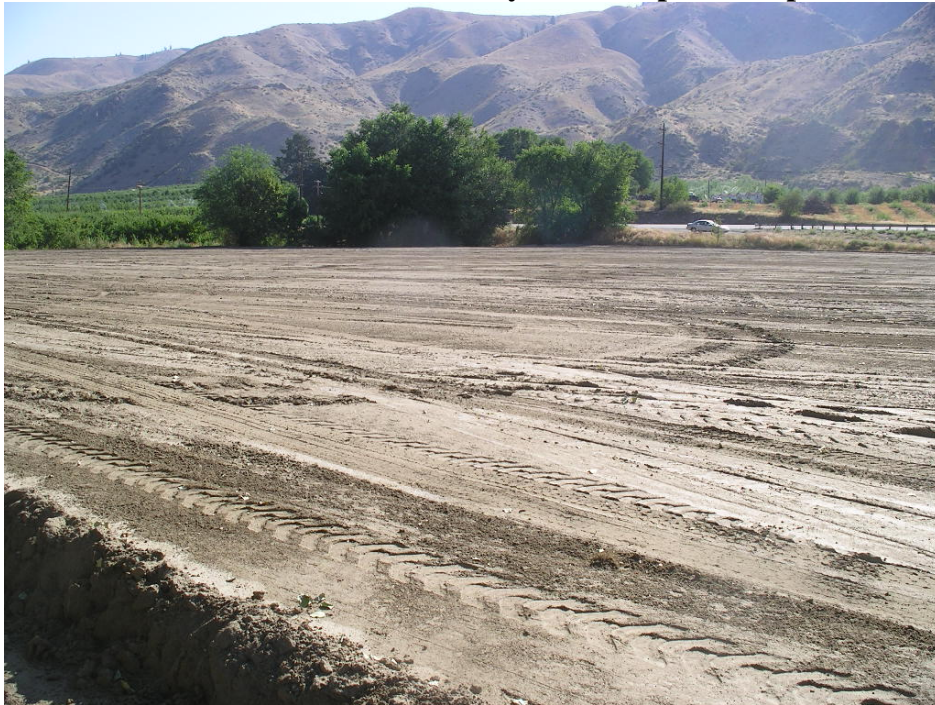
Photo D-4: Orondo Elementary School topsoil complete

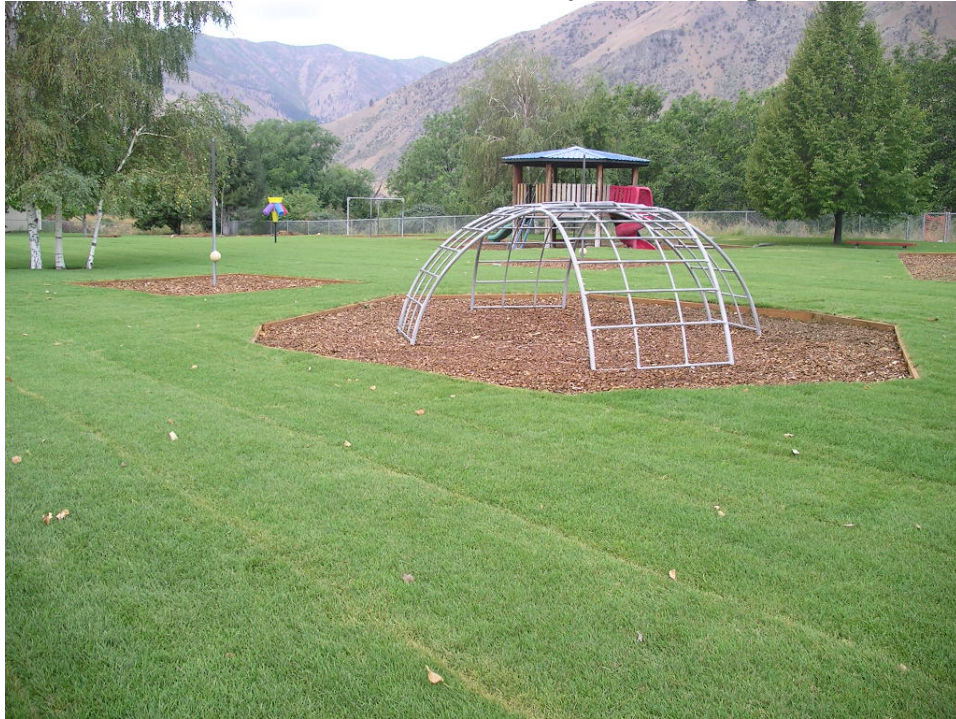
Photo D-5: Orondo Elementary School complete
