SITE HAZARD ASSESSMENT: Facility Site ID 6819

The Tux Shop 5409 15th Ave NW Seattle, WA 98107

SITE HAZARD ASSESSMENT Worksheet 1 Summary Score Sheet

Site Overview Map

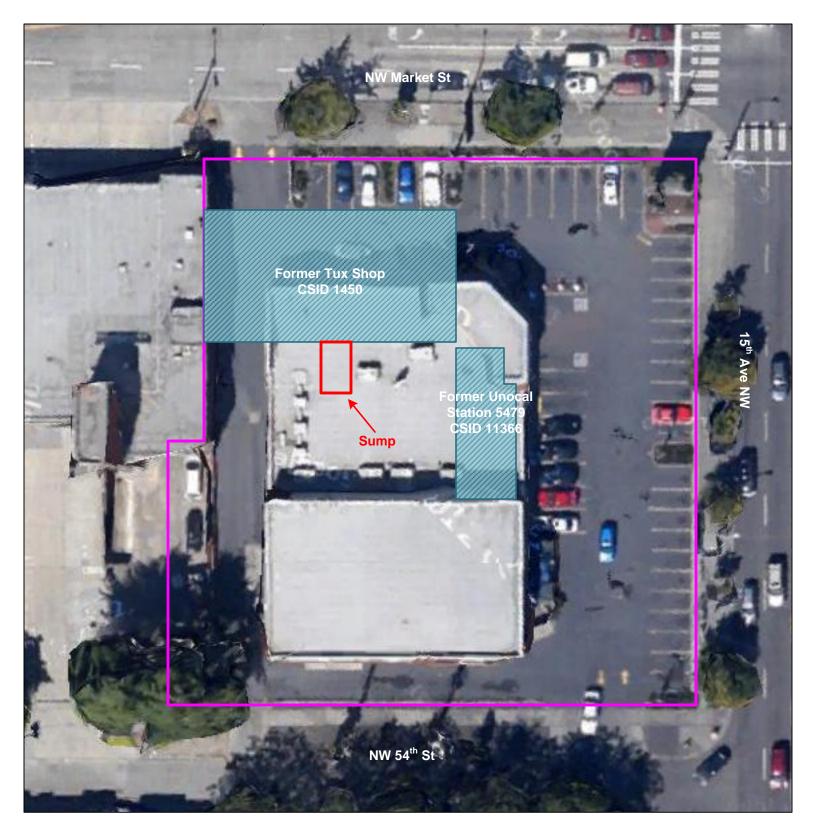
The highest PCE concentrations in soil and groundwater occurred in the vicinity of a sump (sewer drain) located immediately south of the former Tux Shop building. However, no historical records exist regarding the discharge

Sump Excavation Location (approximate)

Former Building Location (approximate)
