Re: SITE HAZARD ASSESSMENT: Facility Site ID 31119824  
Sears Roebuck & Co  
76 S Lander Street  
Seattle, WA 98134  
Property Tax # 7666207220  
Cleanup Site ID 5845

# SITE HAZARD ASSESSMENT

Sears Roebuck & Co

**Site Overview Map**

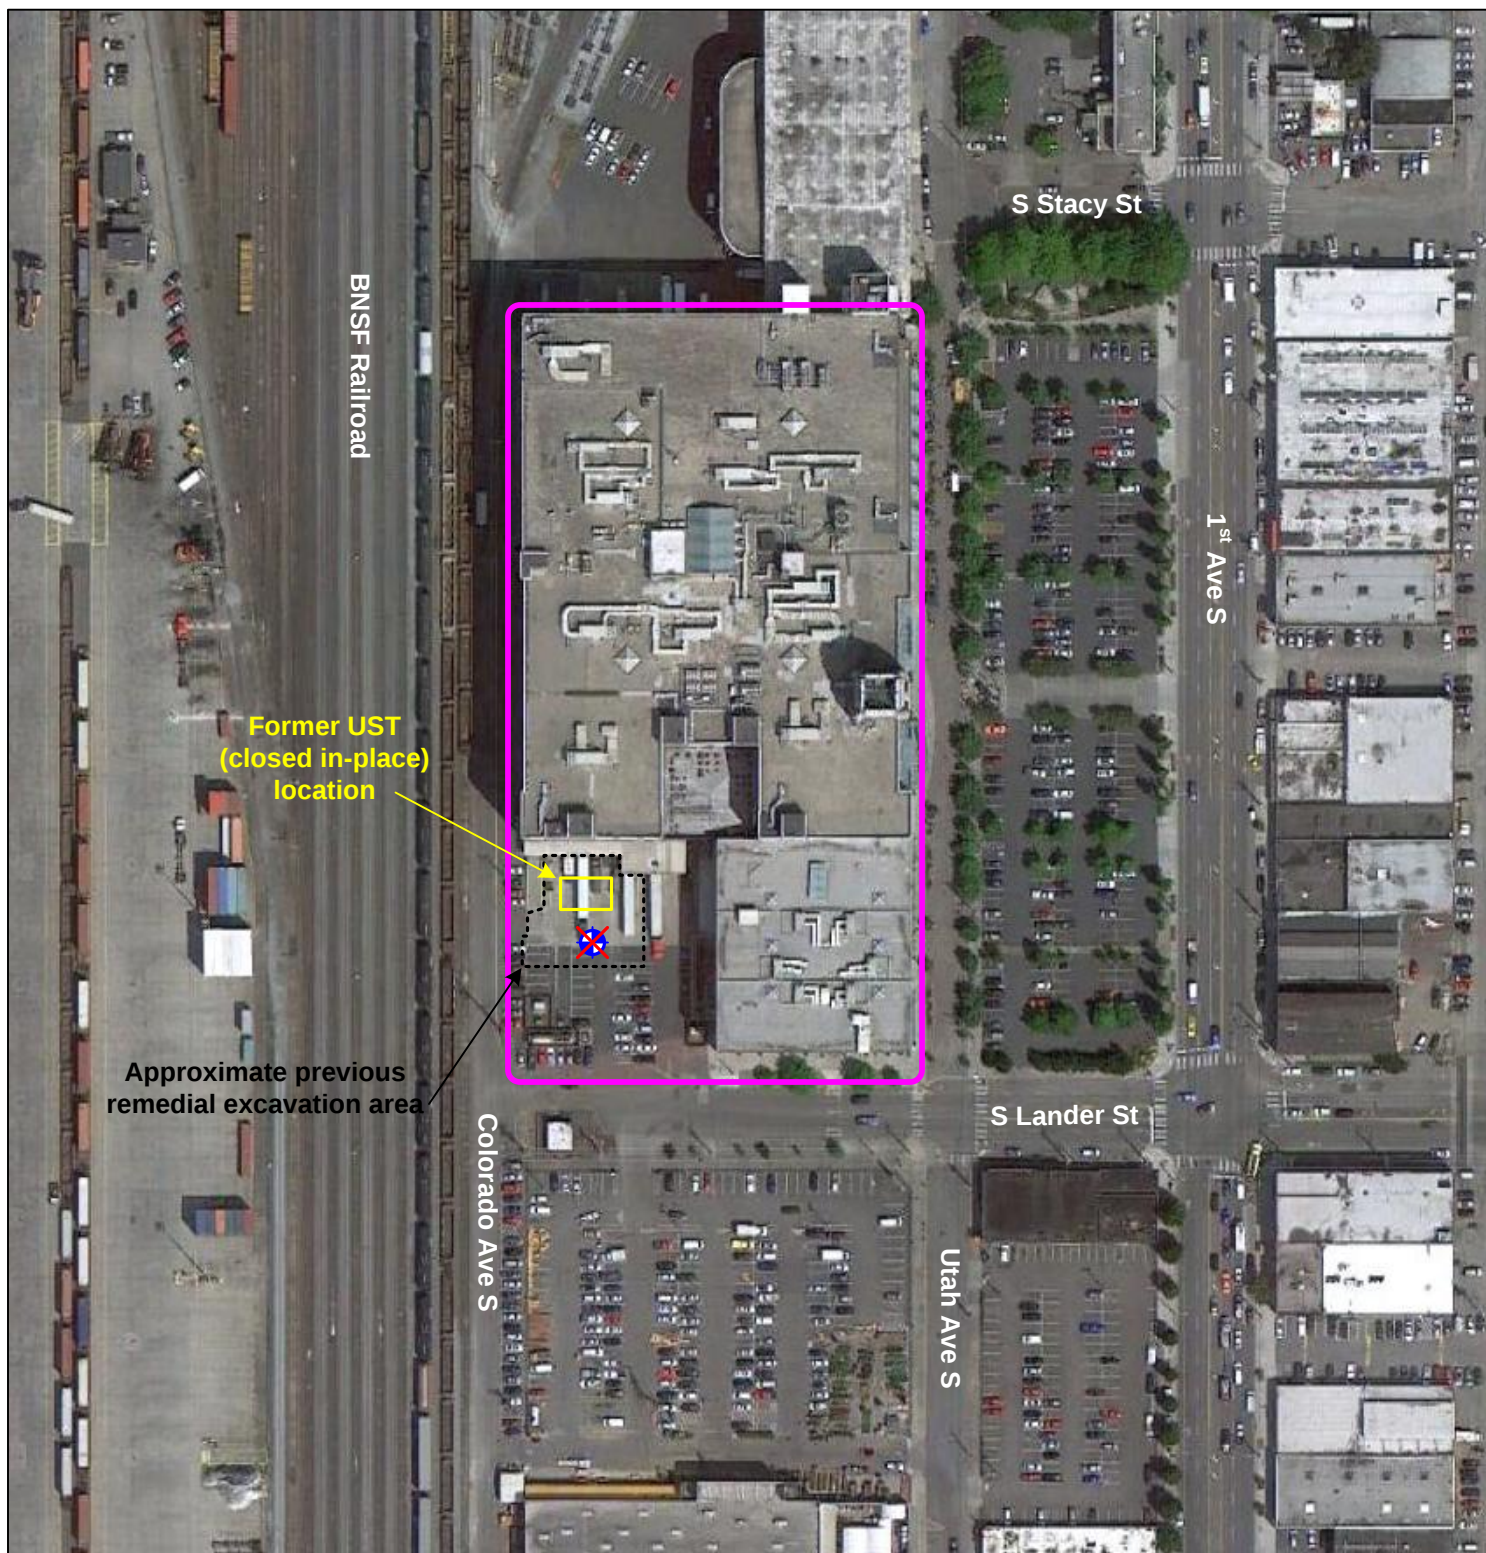
The site is located in the southwestern portion of the Starbuck's SODO Center property in the vicinity of a loading dock located near the southwestern corner of the main building. The loading dock is located the northeast corner of the intersection of Colorado Avenue S and S Lander Street.

- Property location (approximate)
- ✕ Former location of monitoring well with diesel concentration above MTCA Cleanup Level (11 mg/l; 1993)
