**SITE HAZARD ASSESSMENT**  
**Worksheet 1**  
**Summary Score Sheet**

Elliott Tire and Service Co Inc  
1961 4th Ave S  
Seattle, King County, WA 98134

Cleanup Site ID: 7321  
Facility/Site ID: 94563865

**Site Overview Map**

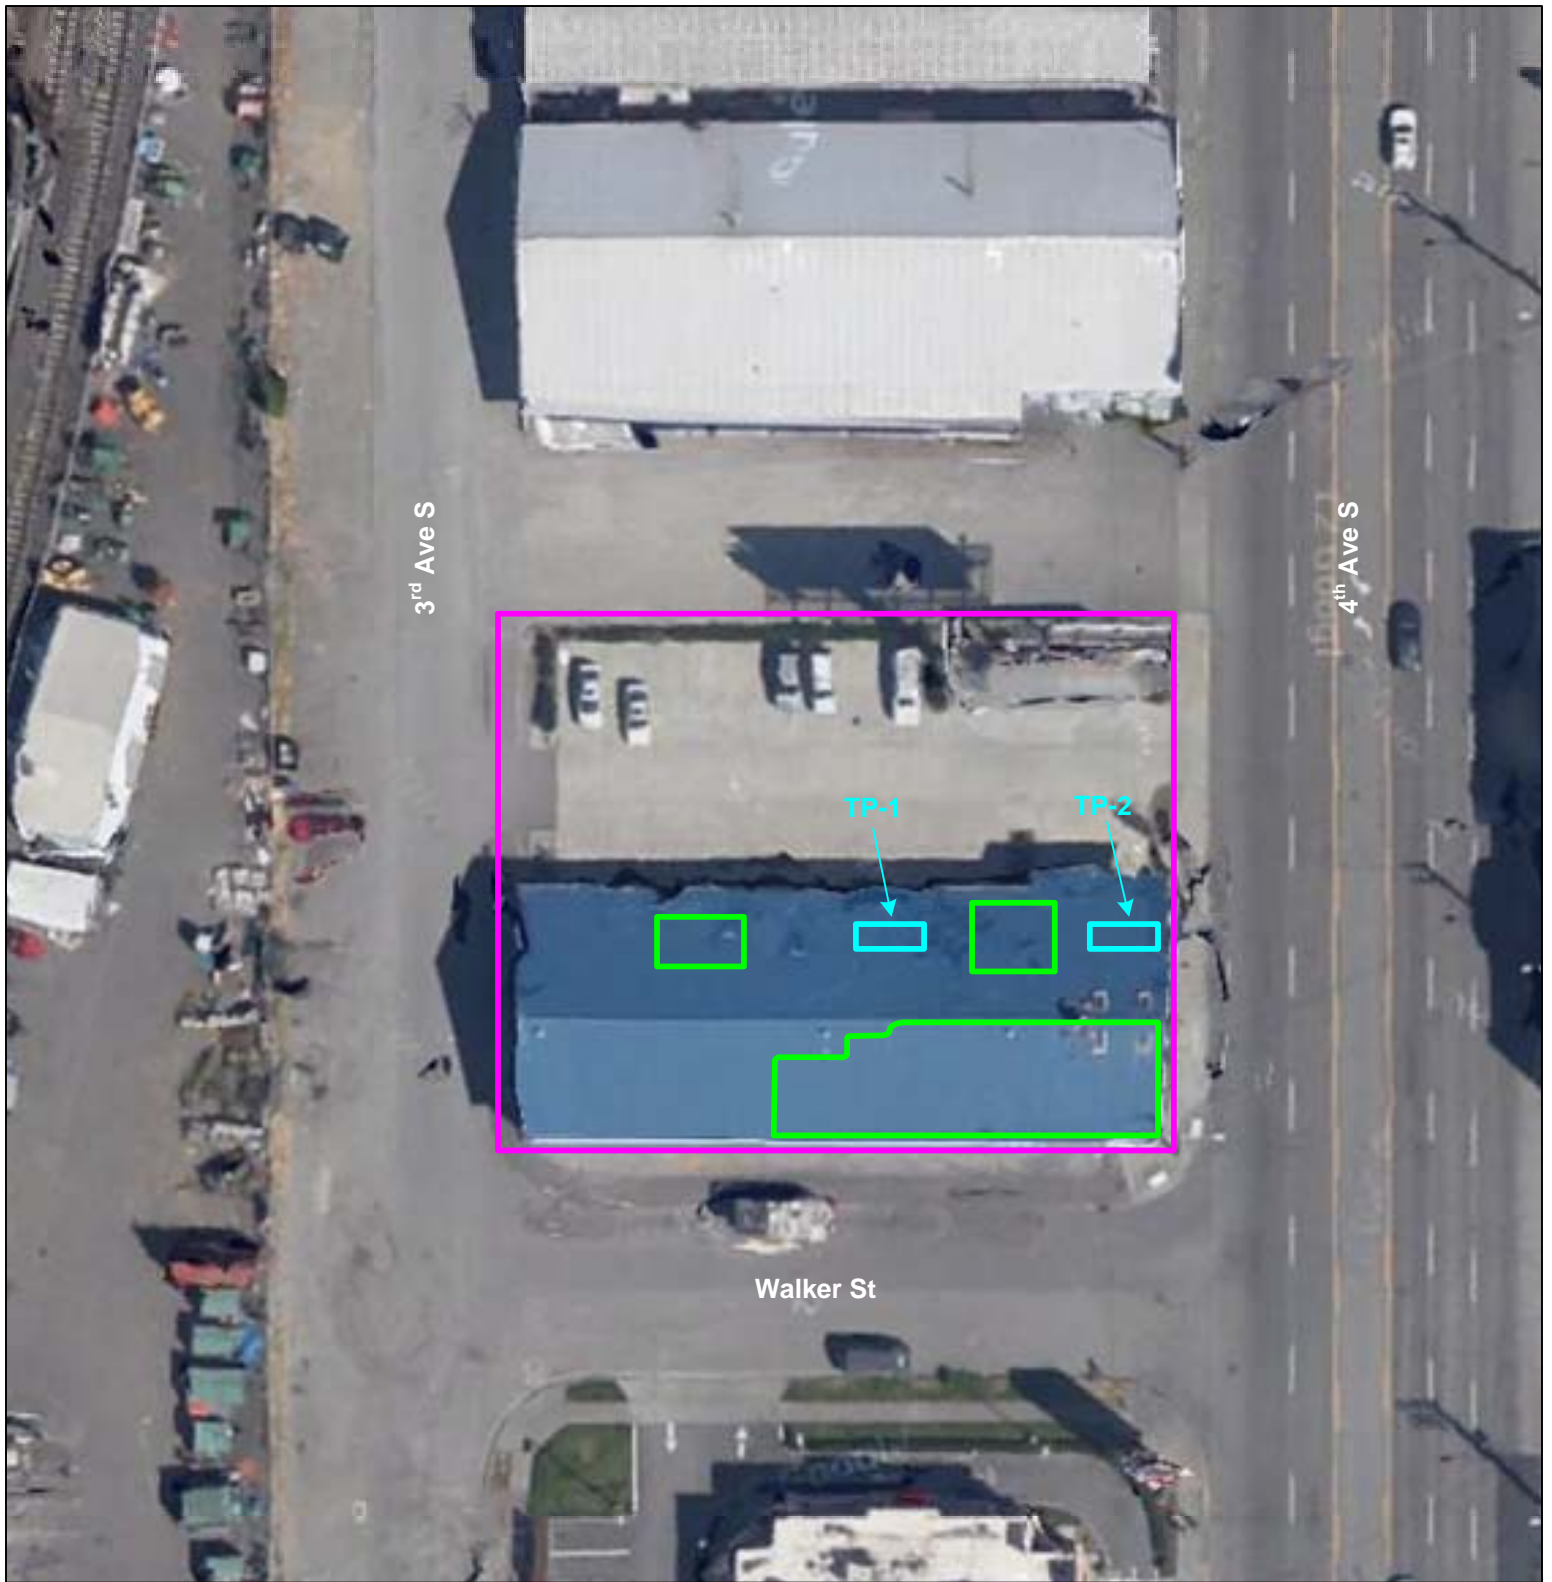
- Property Location (approximate)
- Excavation Location (approximate)
- TP—Test Pit (approximate)

1. All locations are approximate, and not to scale.
