# SITE HAZARD ASSESSMENT

Coldeen Property Old Gas Station

Cleanup Site ID: 11082

**Site Overview Map**

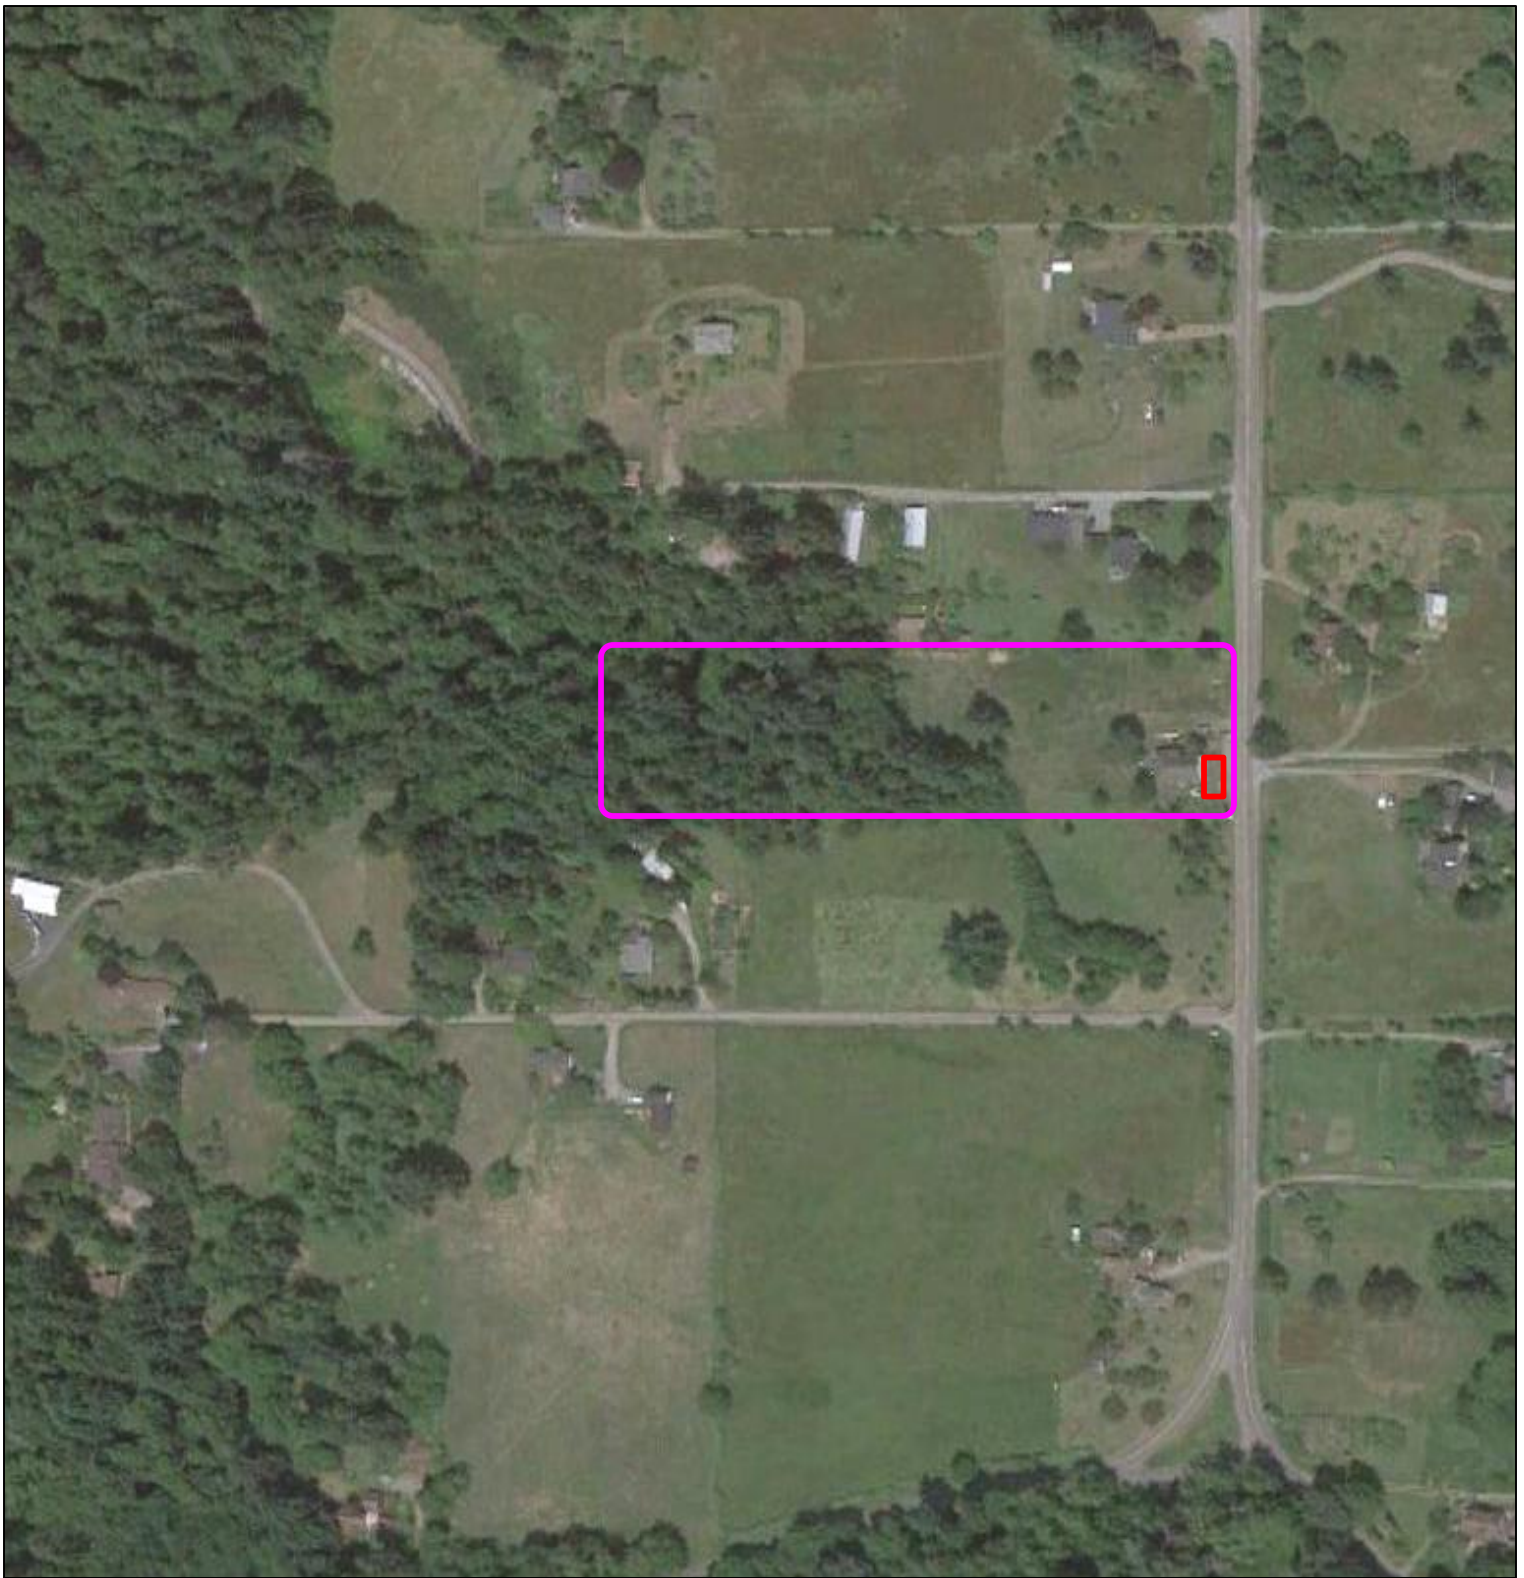
Property location (approximate)
-

Former UST location (approximate)

1. All locations are approximate, and not to scale.
