**INTERIM ACTION REPORT  
ORCHARD MIDDLE SCHOOL  
WENATCHEE, WASHINGTON**

**Facility/Site ID #: 771247**

**November 20, 2009**

**Prepared by Washington State Department of Ecology  
Toxics Cleanup Program  
Mark Dunbar (509) 454-7836**

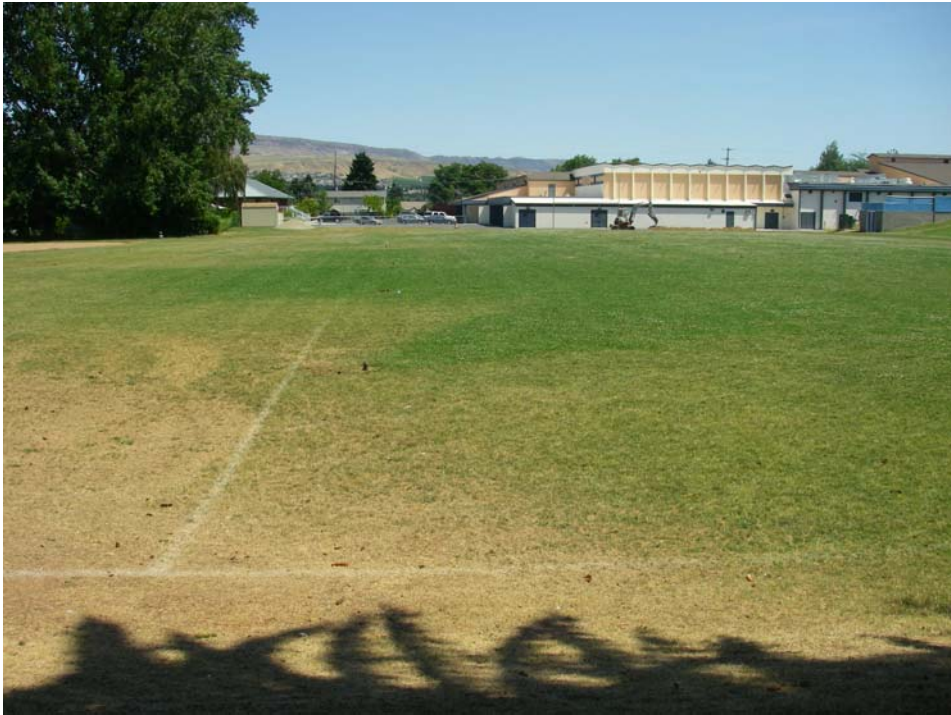
**Photo D-1: Orchard Middle School Pre-Remediation**

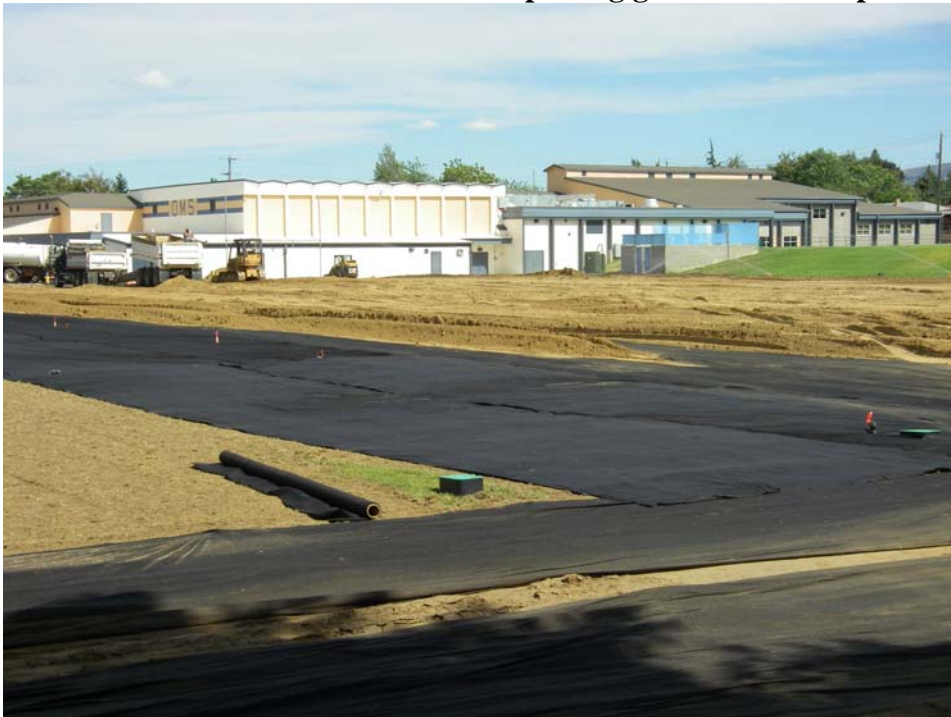
**Photo D-2: Orchard Middle School placing geotextile and topsoil**

Capping was chosen as the most efficient remedial option for the site. The remedial process was very simple. The existing grass turf was tilled to a depth of approximately six inches. A permeable geotextile fabric was then installed over the existing soil surface. The geotextile was placed in rolls that were 15 feet wide and they were overlapped a minimum of 12 inches. The fabric was secured with 6 inch long landscaping staples and then covered with clean topsoil. Approximately 5000 tons of topsoil was imported onsite. The topsoil was tested for the presence of lead and arsenic prior to import. Neither lead nor arsenic were detected above background concentrations. Following topsoil import and grading, compost was worked into the surface as a soil amendment. Sod was installed on the football field and hydro-seed was applied on the softball field. The infield of the softball field was resurfaced with new infield clay.

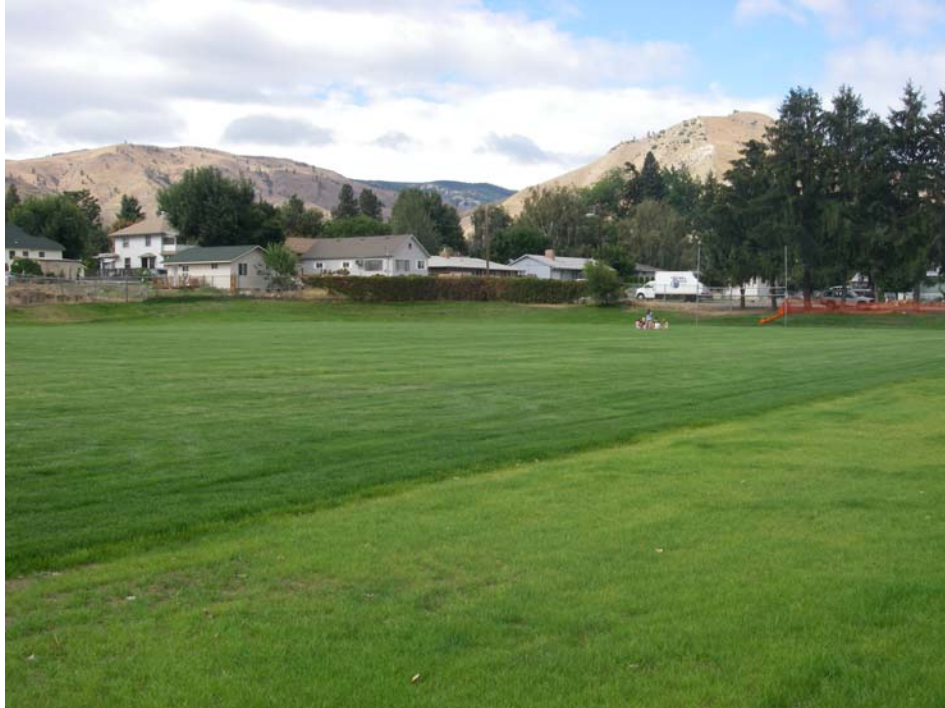
**Photo D-3: Orchard Middle School sod/hydro-seed**

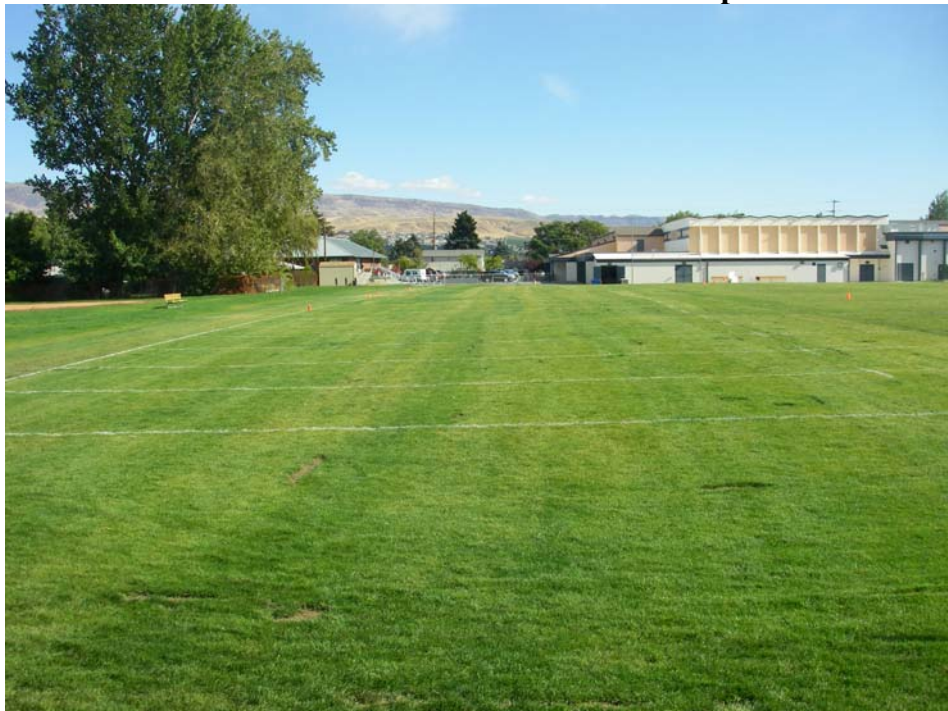
**Photo D-4: Orchard Middle School complete**
