**INTERIM ACTION REPORT
BRIDGEPORT SCHOOL SITE
BRIDGEPORT, WASHINGTON
F/S ID # 724755**

September 25, 2007

**Prepared by Washington State Department of Ecology
Toxics Cleanup Program
Jeff Newschwander (509) 454-7842**

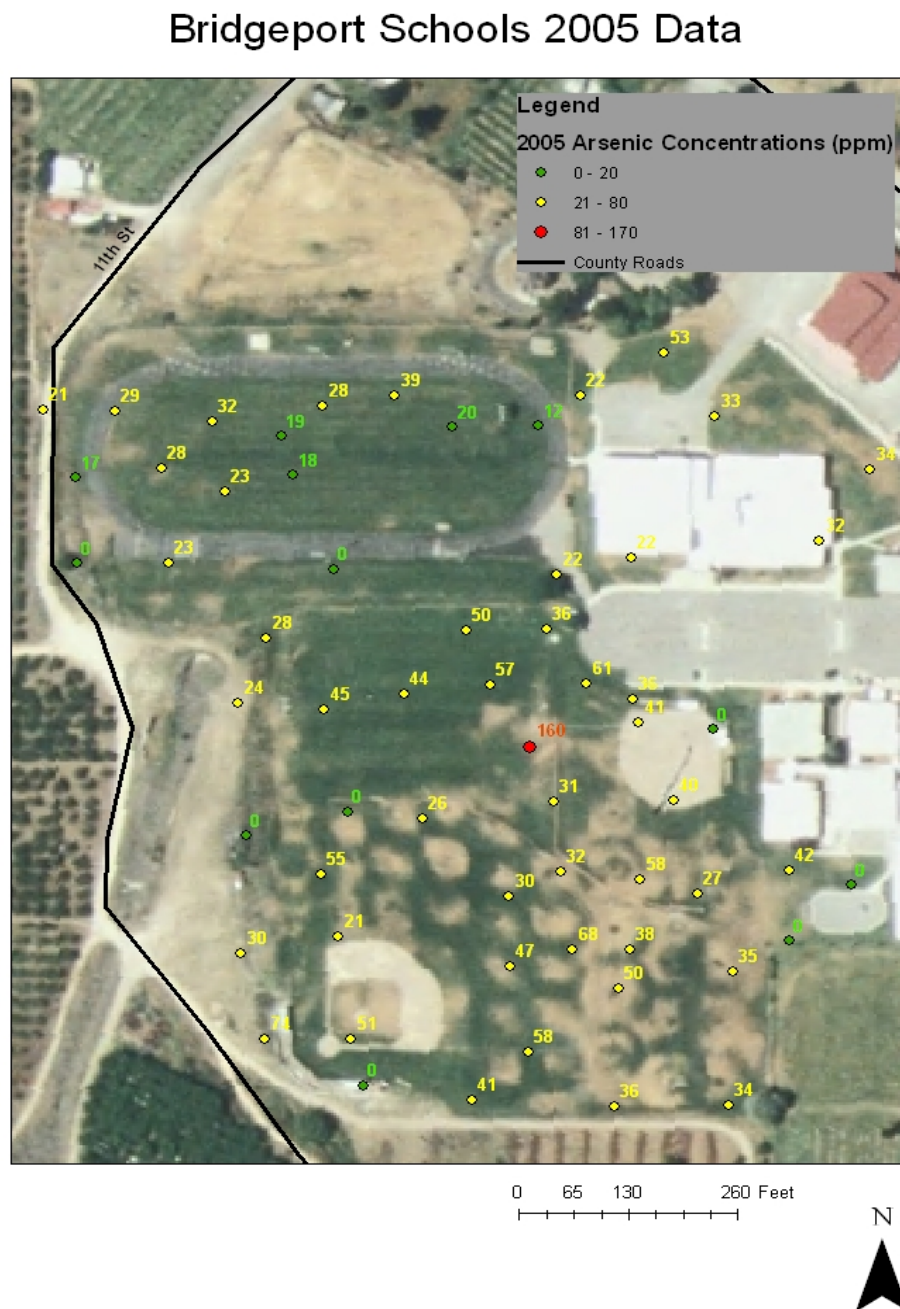
Figure 1: 2005 Sample Data

Ecology began soil screening for lead arsenate contamination at Bridgeport Schools in 2005. Analytical results determined lead and arsenic contamination was present at levels exceeding

MTCA Method A cleanup levels at several points in the school playgrounds. This data is available in the figure below.

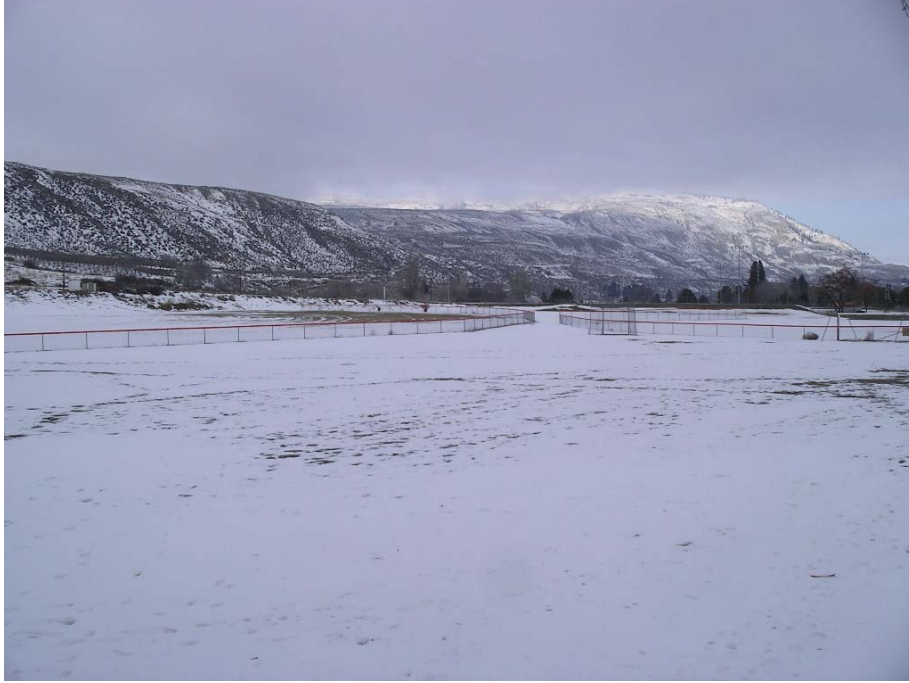
Photo D-1: Bridgeport School Pre-Remediation

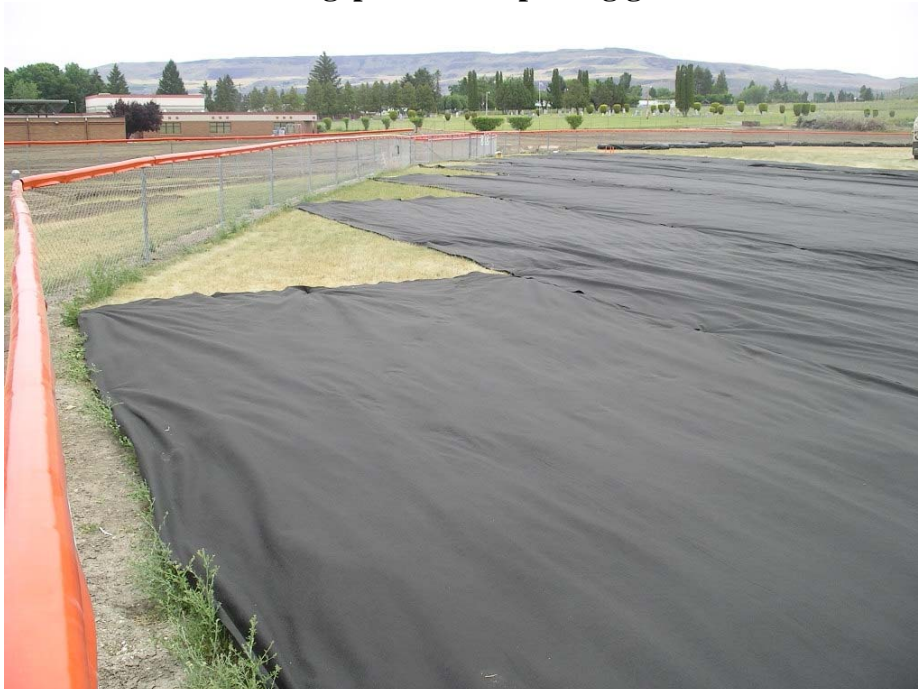
Photo D-2: Bridgeport School placing geotextile liner

The remedial process was very simple. A geotextile membrane was used to cover the existing soil surface. The membrane was placed in rolls that were 15 feet wide and they were overlapped a minimum of 12 inches. It was secured with 6 inch long landscaping staples. The fabric was then covered with clean topsoil imported from a local source. The imported topsoil was tested for the presence of lead and arsenic prior to import. Neither lead nor arsenic were detected above background concentrations in 10 samples taken from the import topsoil. Approximately 8000 tons of topsoil were imported onsite. Following topsoil import, 63,000 square feet of the Site was covered in sod and the remainder was hydroseeded.

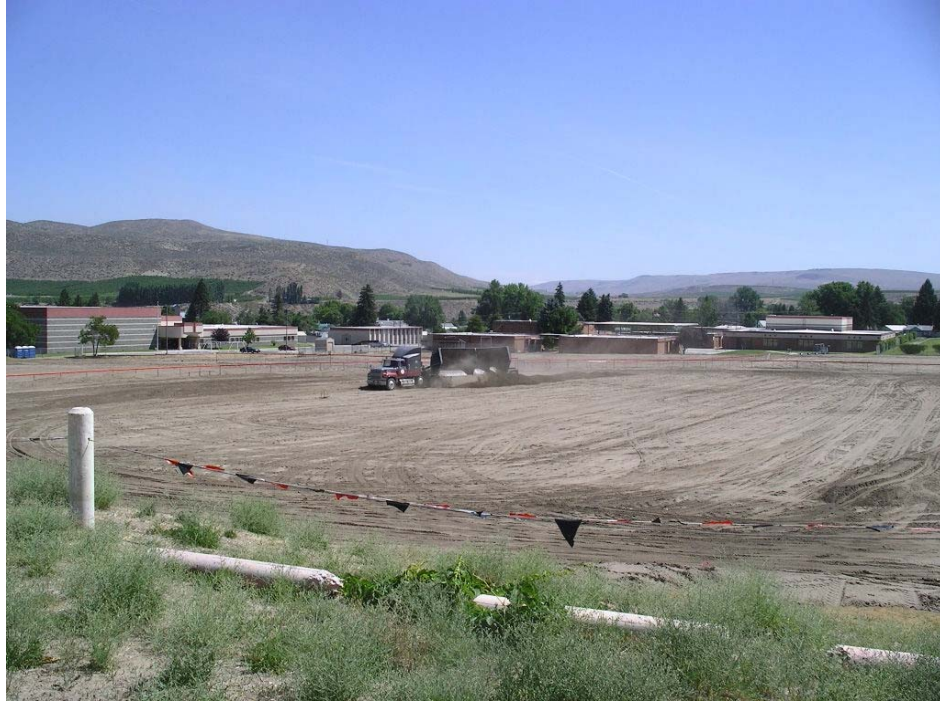
Photo D-3: Bridgeport School placing topsoil

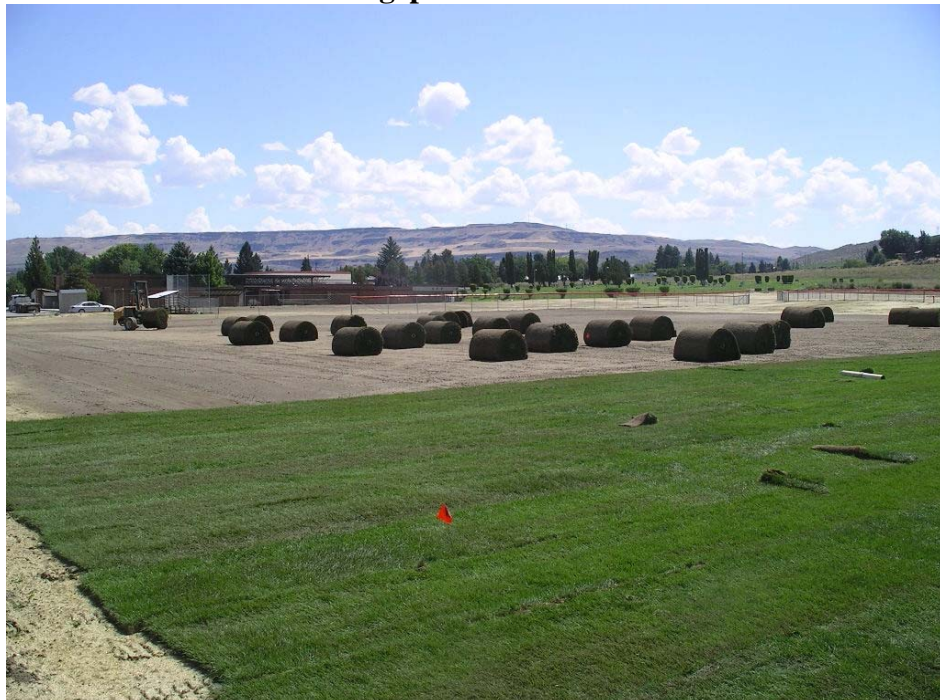
Photo D-4: Bridgeport School Sod Installation

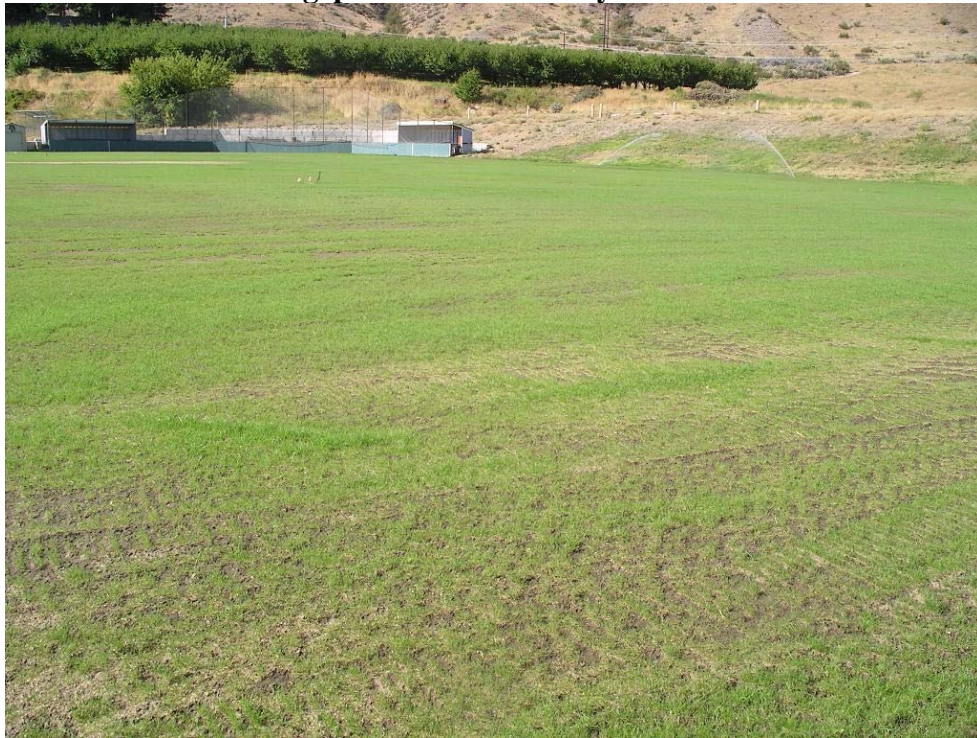
Photo D-5: Bridgeport School after Hydroseed Germination

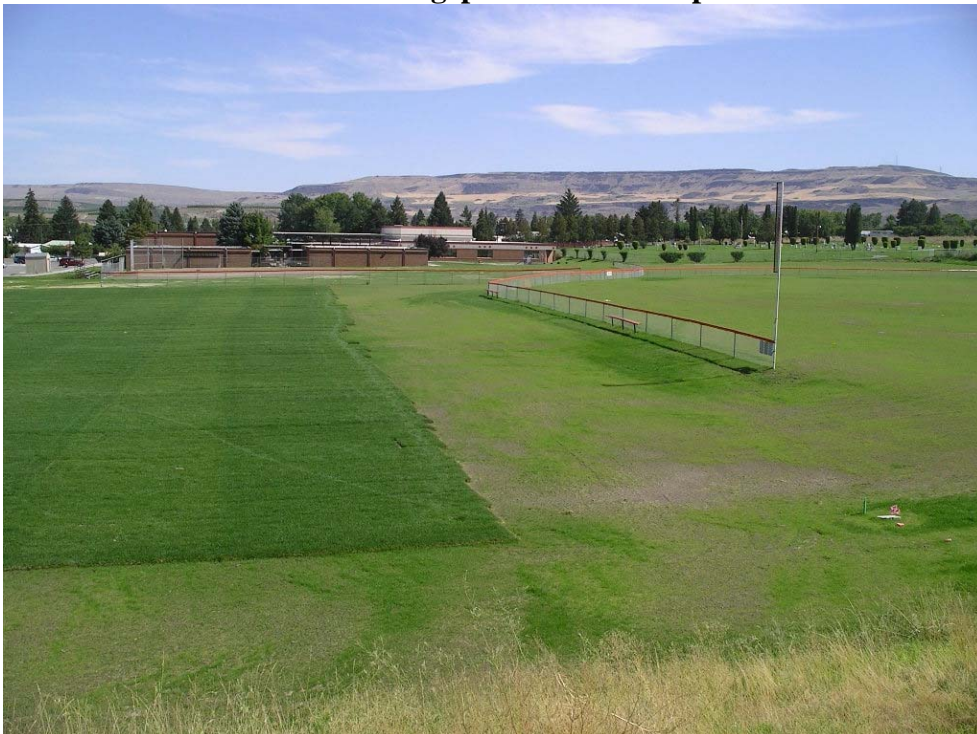
Photo D-6: Bridgeport School Completed

Soil samples collected at the Site during sampling events in 2005 indicated lead and arsenic contamination existed in surface soils at concentrations above MTCA cleanup levels. A soil cap was selected for the remedial action. A non-woven permeable geotextile fabric was to be placed on top of the contaminated soil, followed by new topsoil and turf to restore the Site to the original condition. As a result, the remaining lead and arsenic concentrations were contained below a protective barrier. A restrictive covenant was recorded to restrict future exposure of the contained materials.
