INTERIM ACTION PLAN

Troy Laundry Property
307 Fairview Avenue North
Seattle, Washington

August 21, 2013

Project No.: 0731-004-04

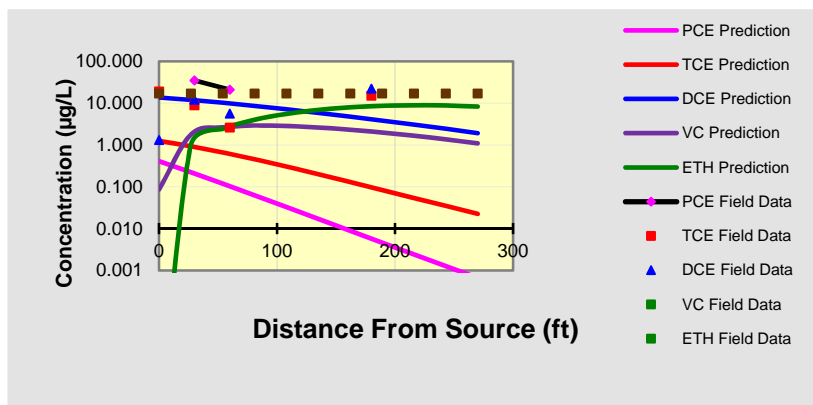
Graph 1. BIOCHLOR Model of natural attenuation of chlorinated solvents at the Site after 25 years. Model assumptions require an ongoing source; however, because the source will be excavated and removed from the Site, it is reasonable to anticipate a more rapid degradation rate than modeled, with or without treatment.

remediation, the Site-specific data was entered into the BIOCHLOR model, a copy of which is provided in Appendix A of the FS Report (SoundEarth 2012b). Because the model output, which assumes a decaying single planar source, suggests that natural attenuation will occur over a longer period of time (25 years), it is reasonable to expect that, following complete source removal and groundwater treatment, PCE and TCE concentrations will decrease more rapidly than the modeled estimate.

Concentrations of 1,2-cis-DCE and VC would be expected to increase slightly, but not to the magnitude predicted by the model because the source area (contaminated soil) would be removed. However, the zone where natural attenuation will, if necessary, supplement active groundwater treatment is upgradient and crossgradient of the treatment area (south and west of the proposed conditional points of compliance), and any generated cis-1,2-dichloroethylene and VC would ultimately be consumed within the anaerobic dechlorination zone.

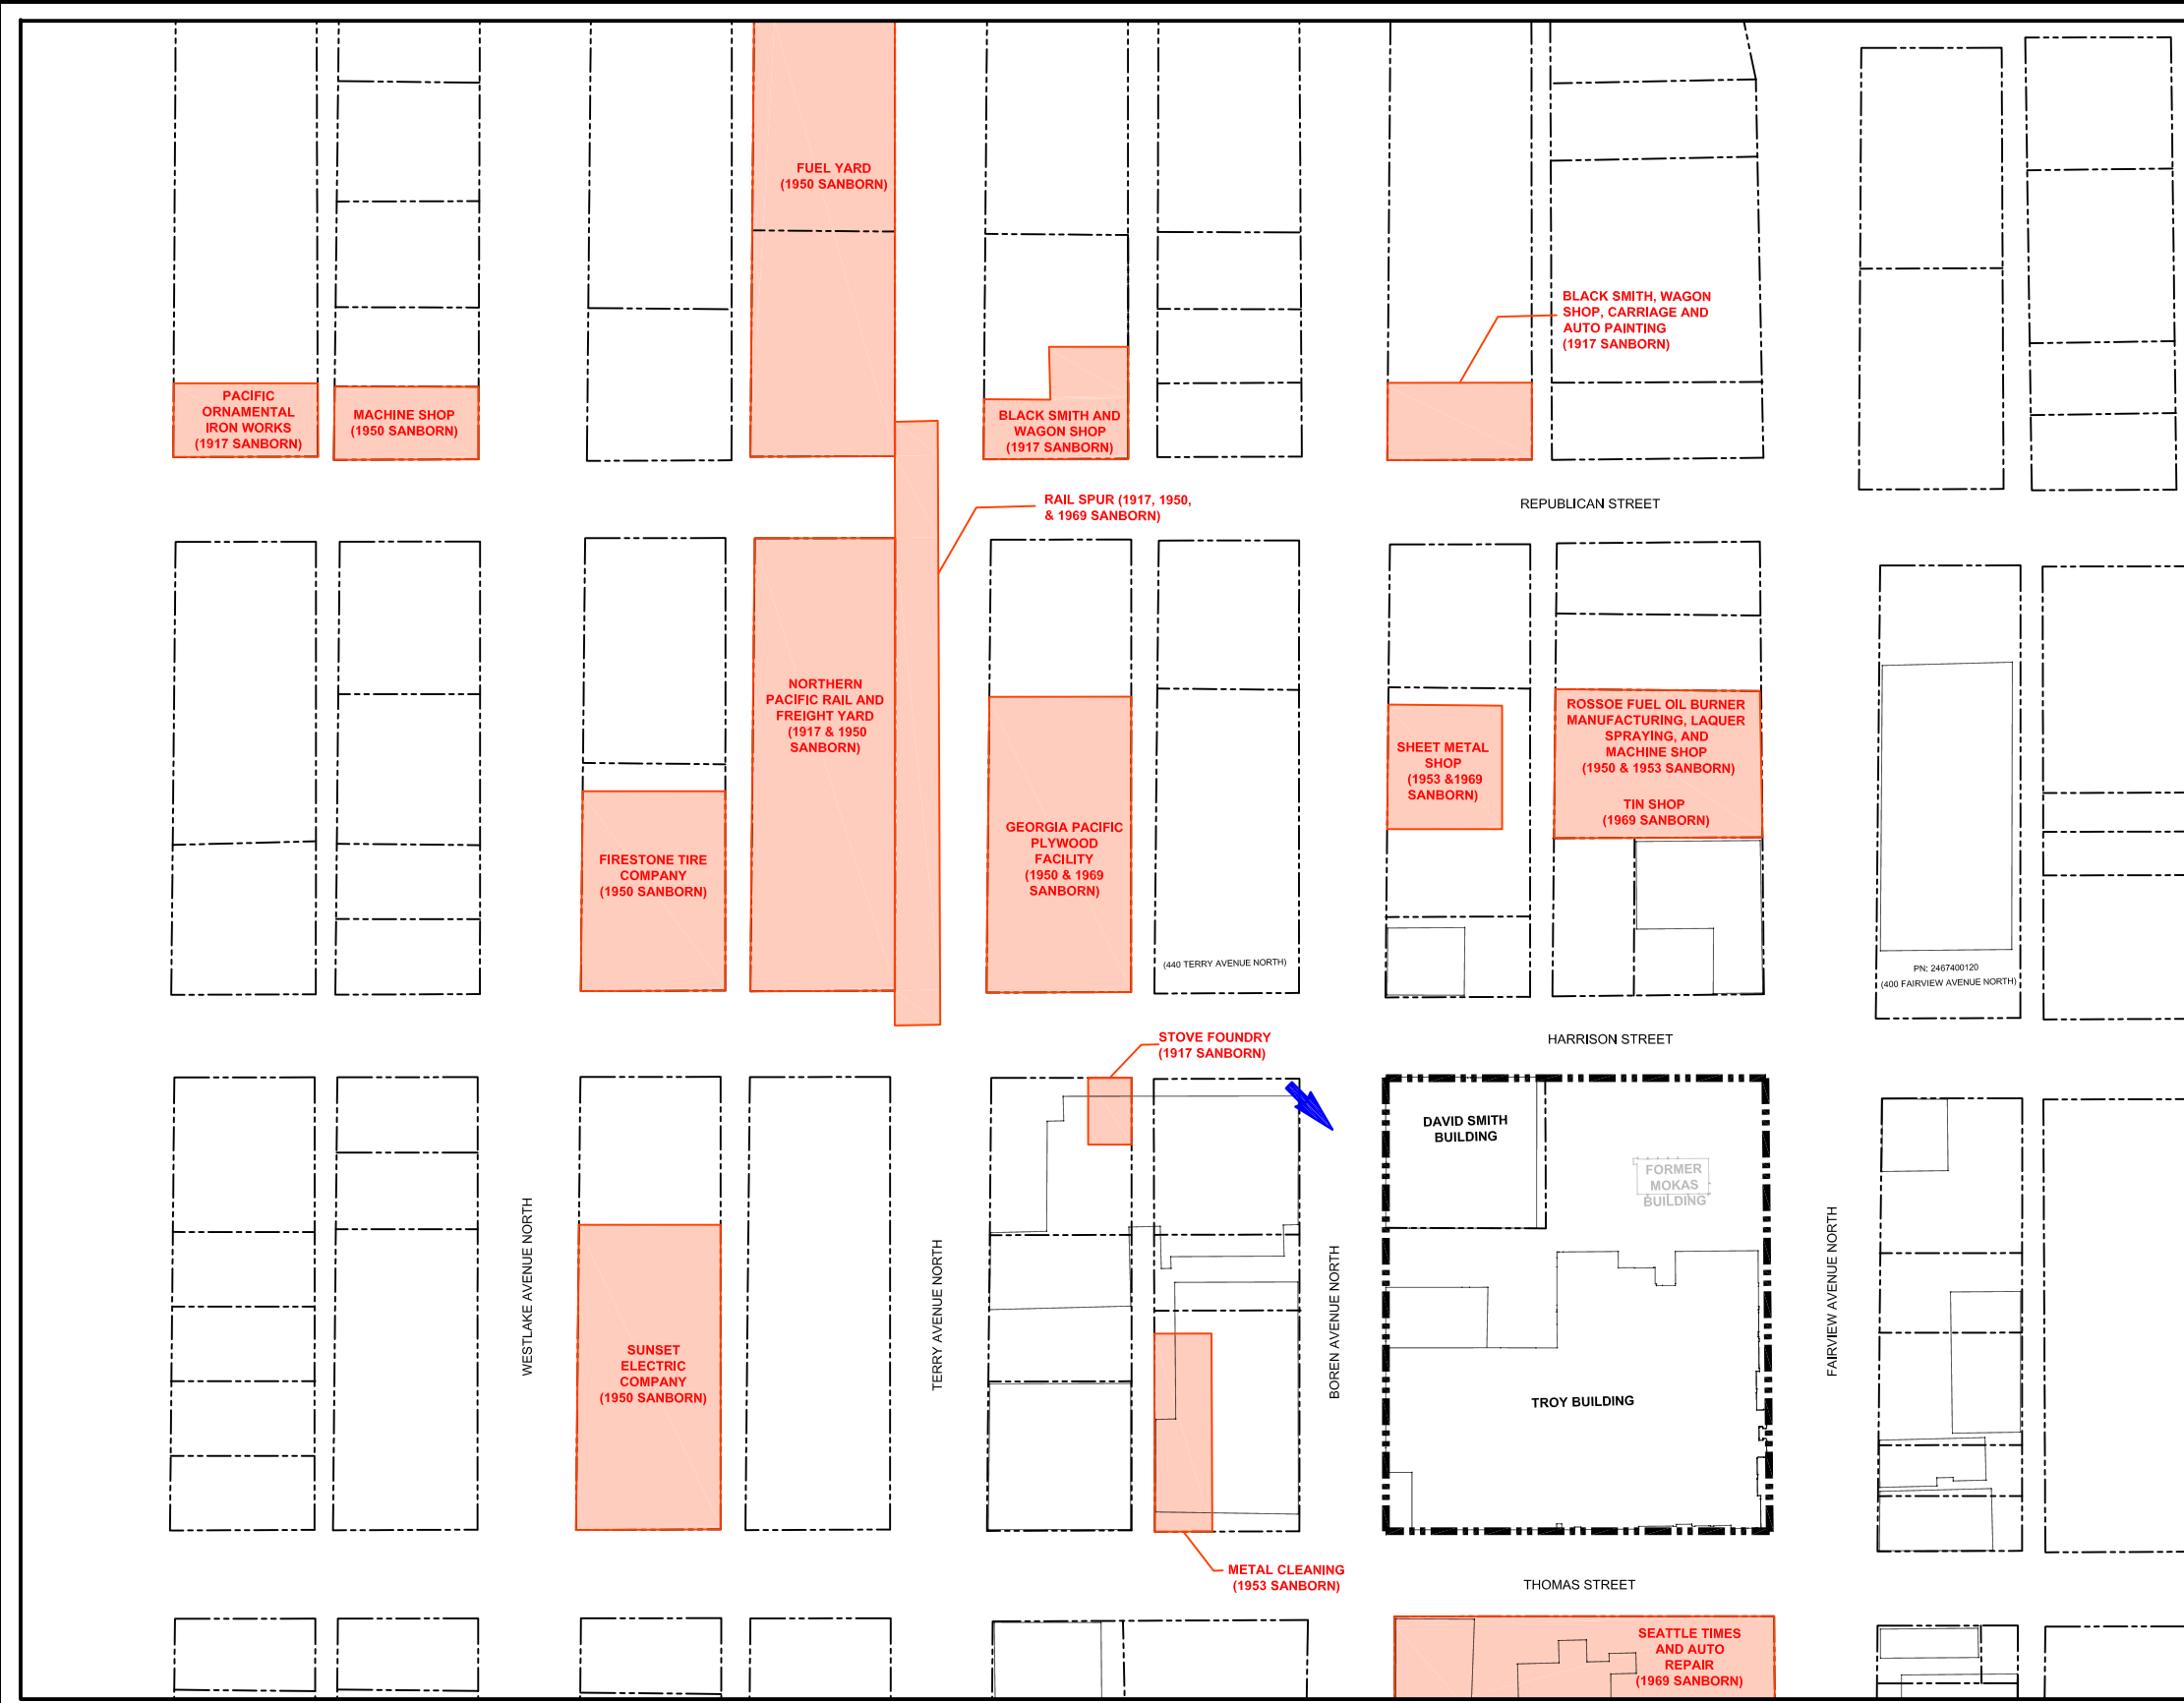
FIGURE 20
 SOLVENT PLUME SOURCE TYPE

- PROPERTY BOUNDARY
- PARCEL BOUNDARY
- BUILDINGS
- POTENTIAL CONTRIBUTING SOURCE TO TCE PLUME, BASED ON HISTORICAL SITE USAGE AS CALLED OUT IN SANBORN FIRE INSURANCE MAPS
- TCE TRICHLOROETHYLENE MEASURED GROUNDWATER FLOW DIRECTION

TCE was detected in groundwater samples collected from MW02, MW04, and MW15; however, unlike the contaminated groundwater identified in association with the Site, the TCE was not observed in conjunction with PCE or any of its degradation products, including cis-1,2-DCE and VC (Figure 20). The TCE detected in these three wells, located north and west of the Site, is not attributed to the Site for the following reasons:

- If PCE was the original source of the TCE detected in these three wells, then cis-1,2-DCE also would be present. Anaerobic dechlorination can stall at cis-1,2-DCE, but has not ever been demonstrated to stall at TCE (e.g., Naval Facilities Engineering Command 2003, Cox et al. 2012). In addition, incomplete dechlorination would result in a buildup of degradation products (commonly referred to as “DCE stall”), none of which were detected in monitoring wells MW02, MW04, or MW15 (Figure 20).
