**Public Review Draft
Remedial Investigation/
Feasibility Study Report**

**Weldcraft Steel and Marine
(Gate 2 Boatyard)
Bellingham, Washington**

May 14, 2014

**Port of Bellingham
Bellingham, Washington**

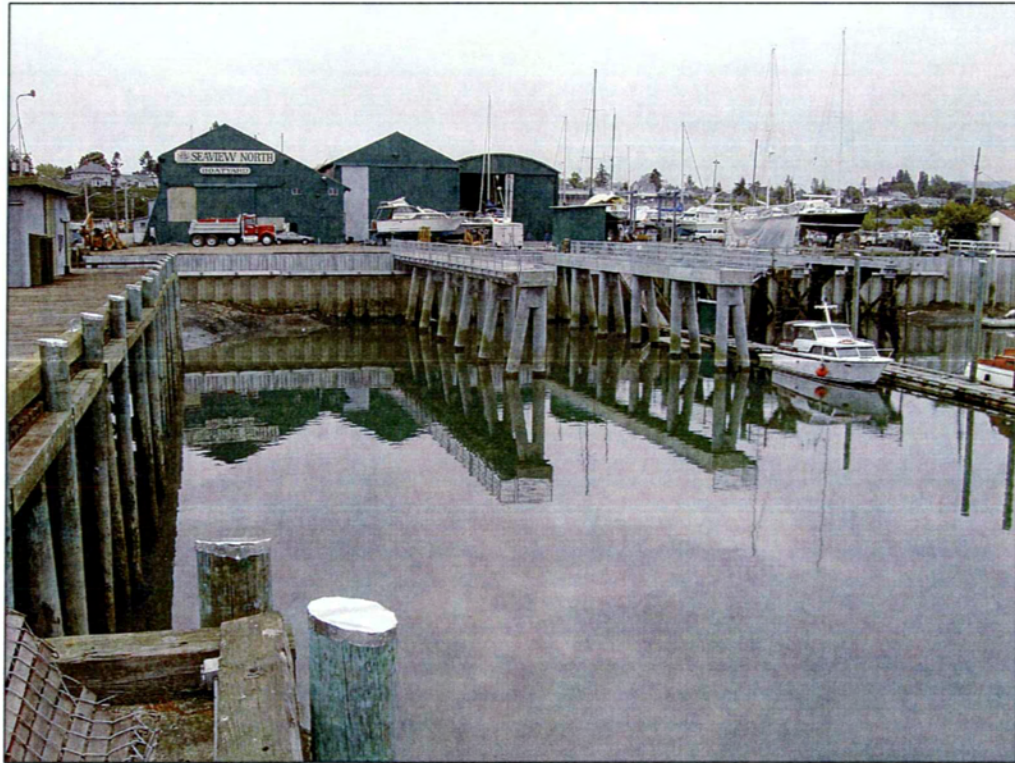
33. Post-construction view of redeveloped Gate 2 Boatyard with new 150-ton travel lift piers.
