INTERIM ACTION REPORT ROBERTSON ELEMENTARY SCHOOL YAKIMA, WASHINGTON

Facility/Site ID # 2322990

July 9, 2010

Prepared by Washington State Department of Ecology Toxics Cleanup Program Mark Dunbar (509) 454-7836

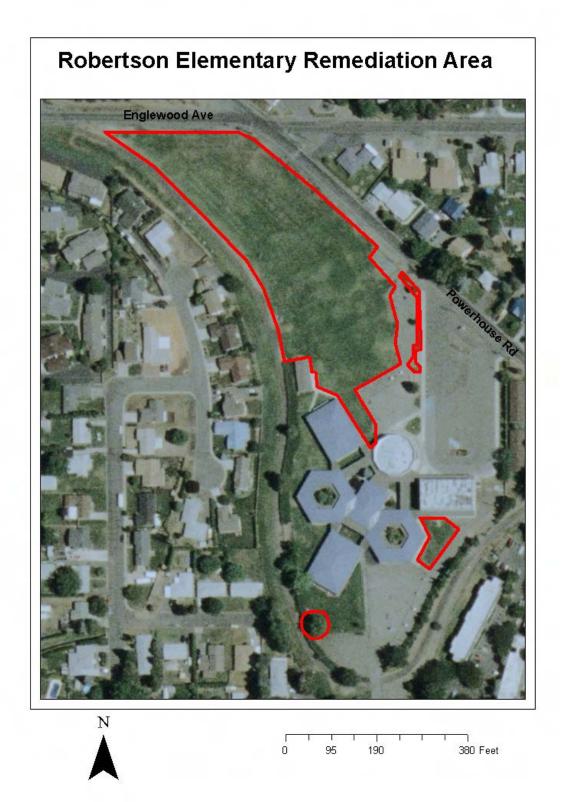
Figure A-2: Remediation Area Map

Robertson Elementary is located at 2807 West Lincoln, Yakima, WA 98902. The school is situated in a residential area in the NW quarter of Section 23, T13N, R18E. The portion of the school grounds remediated for lead and arsenic includes the grass covered play area and sports fields to the north and to the south of the school buildings. Robertson Elementary hosts approximately 488 students.

To prevent exposure to contaminated soil a geotextile barrier and 8-inch cap of clean soil were installed over the existing play area. Turf replacement was accomplished with sod and hydroseed. Because contamination was not removed from the site, a restrictive covenant will be issued to restrict future development or improvements on the site that could expose contaminated soil.

Capping of existing soil with clean soil was chosen as the most efficient remedial option for the site. The remedial process was carried out as follows: The existing grass turf was tilled to a depth of approximately six inches with a tractor-drawn rototiller. The tilled surface was flattened with a roller, and a permeable geotextile fabric was installed over the existing soil surface. The geotextile was rolled out and staked in place with 12 inches of overlap at the seams. At hardscape edges such as pavement and foundations, contaminated soil was excavated to allow the clean soil cap to meet existing grade. A minimum of eight inches of clean toposoil was placed on top of the geotextile and lightly compacted. The imported topsoil was tested for the presence of lead, arsenic, pesticides and petroleum products prior to import. No contaminants of concern were detected. Neither lead nor arsenic were detected above background concentrations. Following topsoil import and grading, sod was installed on the remediated area. Approximately half of the sports field area was treated with hydro-seed rather than sod, and fenced off to allow for the seed to germinate and establish. Analytic sample results of the excavated soil indicated that the soil did not designate as a hazardous waste. The excavated soil was disposed at Terrace Heights landfill.

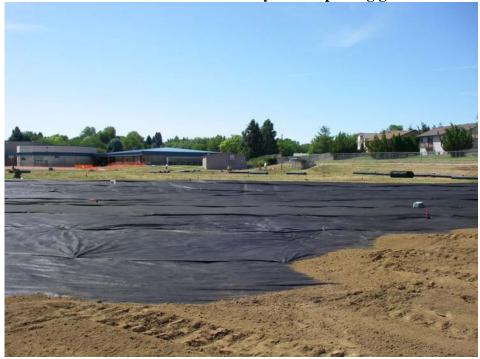
Photo D-1: Robertson Elementary School placing geotextile

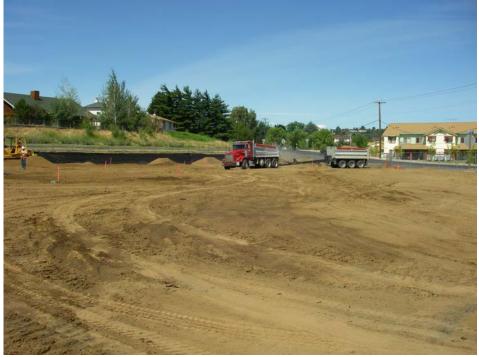
Photo D-2: Robertson Elementary School placing soil

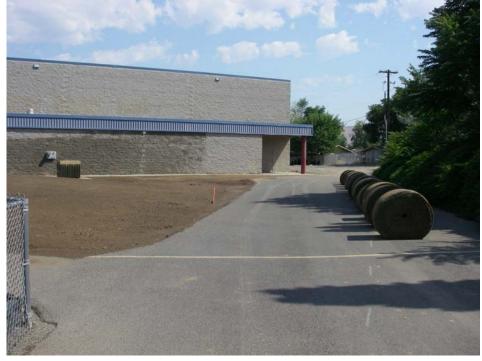
Photo D-3: Robertson Elementary School sod

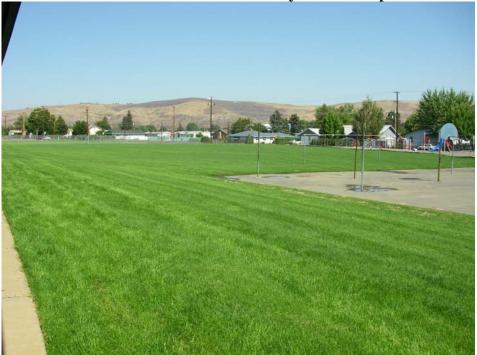
Photo D-4: Robertson Elementary School complete
